PART I  
RISK ASSESSMENT  
TRINITY RIVER CORRIDOR

# Risk Assessment

## Trinity River Corridor Dallas Floodway near Dallas, TX

*7 September 2012*

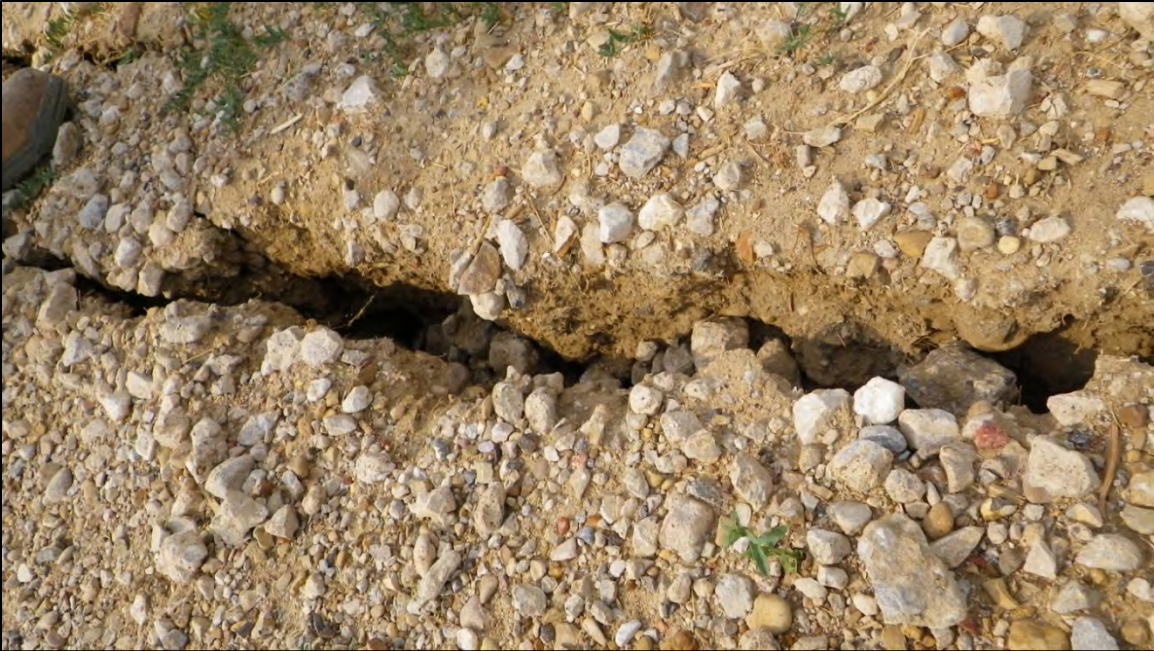
Cracks may swell shut once they are exposed to water from the river. Desiccation cracking observed in dry season, during rainy season they tend to close up
	Cracks traverse to crest are likely not deep (less than five feet) – observed cracking is longitudinal or occurs down on the embankment slope
	Water would need to be near crest of levee to provide enough water and head to drive failure mode
	Possibly short duration of loading of water sufficiently high to enter and erode the cracks, particularly for local thunderstorm loading

Longitudinal cracking in the crest of the embankment.

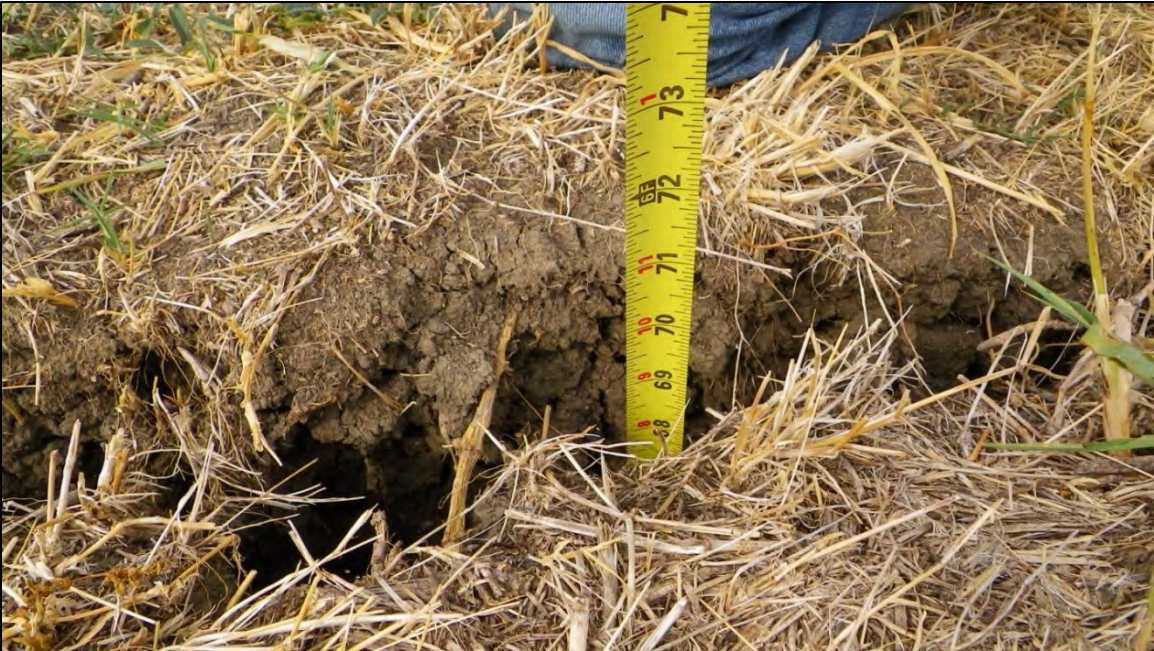
Depth of longitudinal cracking in the crest of the embankment.

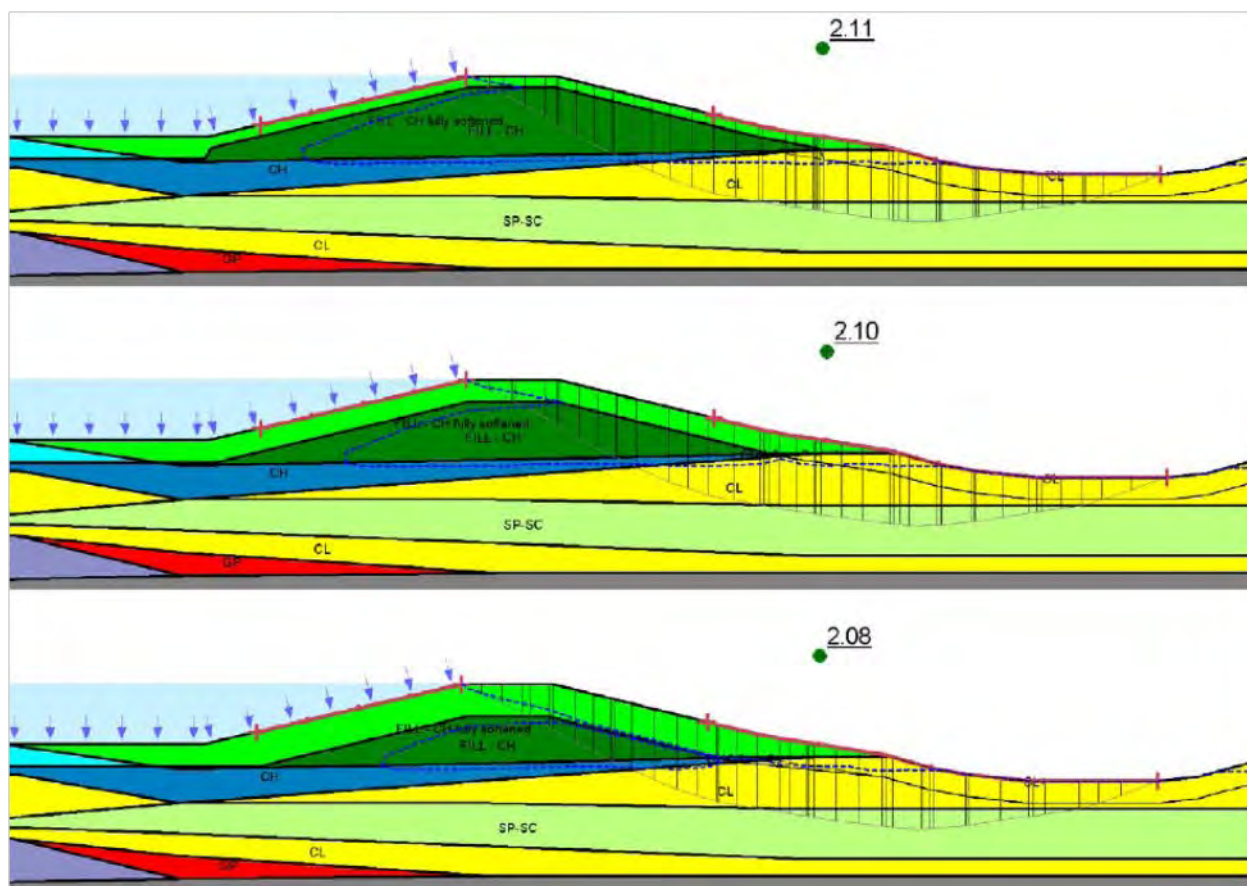
5, 10, and 15 ft. They have mean factors of safety of 2.18, 2.16, and 2.13, respectively. All the analyses used the best estimates of permeability and flood loads corresponding to 100% of the levee height. Due to the relatively low permeability of the intact high plasticity clay, the transient seepage analyses indicate that the piezometric surface will penetrate the desiccated soils completely but won't penetrate into the intact clay core of the levee. This does little to impact stability because the effective overburden stress is only reduced near the surface of the levee where the transient seepage analysis indicates excess pore pressures are present and where overburden stress was already low. This only serves to further reduce the shear strength in an area that offered little contribution to the overall stability to the levee anyway. Any failure surface that would result in a loss of the levee crest (a critical condition as it would not be able to retain a flood) passes through the core of the levee. Desiccation does not penetrate into the intact clay of the levee core so neither does the piezometric surface during a flood event. Since the pore pressures did not significantly increase, the shear strength of the levee material in this area did not change and the stability of the section remains largely unaffected.

**Figure 40 - Stability analysis results showing a 5-ft depth of desiccation on the top figure, 10 ft on middle figure, and 15 ft on the bottom figure. The bright green layer on the top of the levee section and the light blue at the left of the figures represent the desiccated soil.**

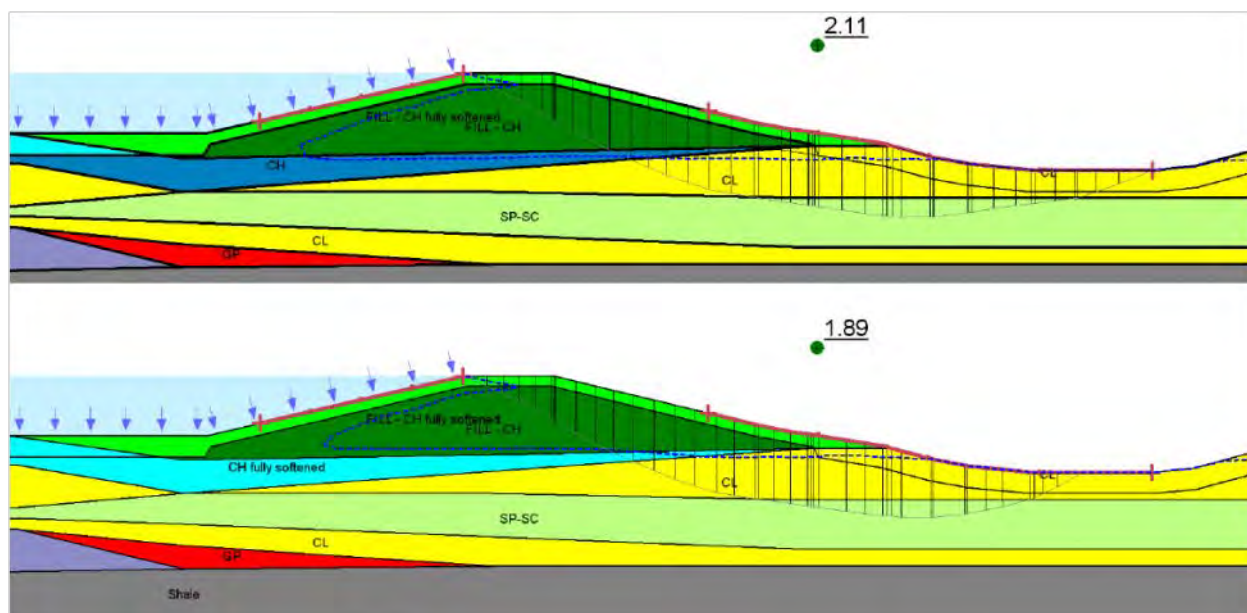
bottom of the levee section it was modeled as fully desiccated. For simplicity, the entire high plasticity clay layer was modeled as desiccated instead of sticking to the maximum desiccation crack penetration depth of 10 ft that was used for free field soils. Figure 43 shows the results of two stability analyses on section 74+00, east alignment, using an intact foundation material and a desiccated foundation material. The results of the seepage analyses indicate that this allowed flood waters to more easily penetrate under the levee, increasing the pore pressure and driving the effective stress down in a soil layer through which the critical failure surface passes. This is demonstrated by a decrease in the mean factor of safety from 2.18 to 1.98. The addition of a desiccated foundation layer was shown to have more of an effect on stability than varying the depth of desiccation on the levee surface, though not enough of an effect to indicate that there was a stability problem under the load of a flood height to the crest of the levee.

**Figure 41 - Stability analysis results using a desiccated foundation layer. The desiccated material is represented by the light blue color.**

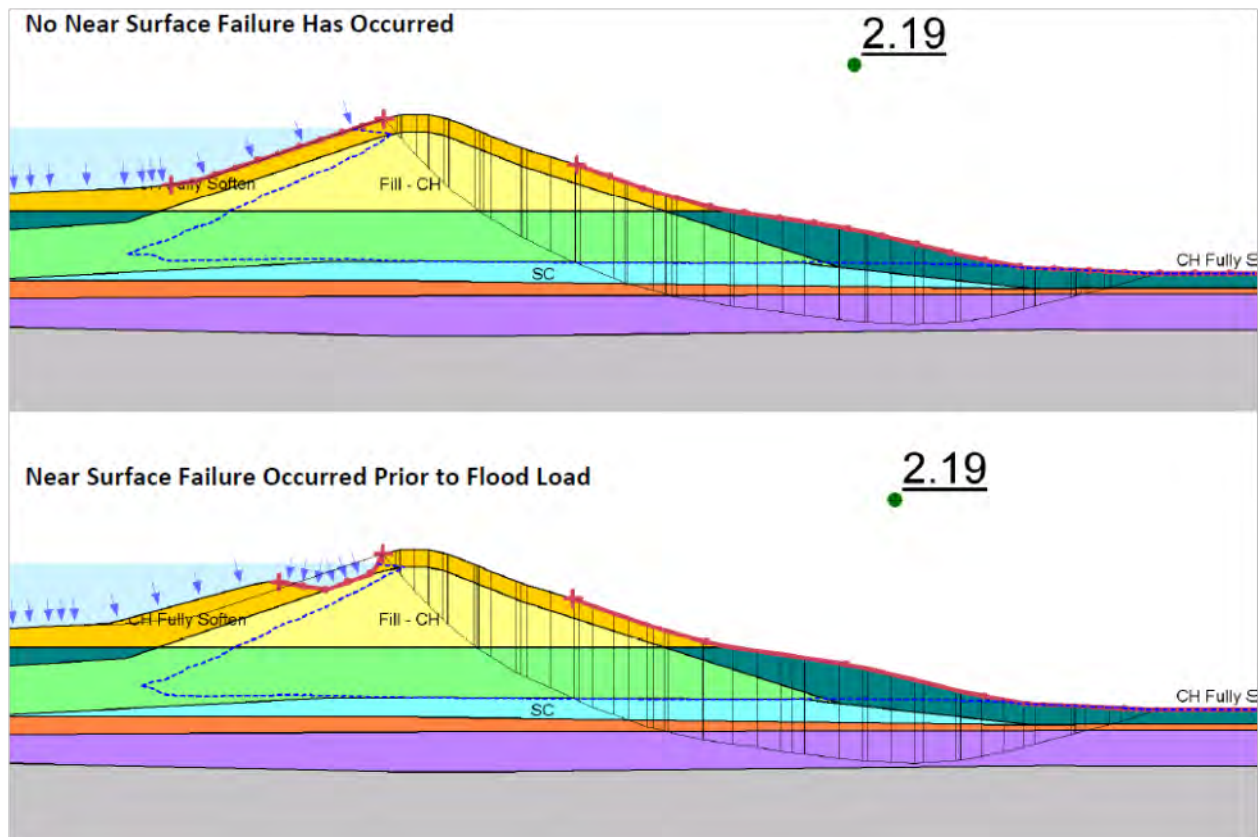
**Figure 42 - Stability analyses results showing the effect of a near surface failure. Both stability runs are based on independent seepage analyses; the top is performed on the fully intact levee section, the bottom seepage analysis was performed on the levee section missing the near surface failure mass.**

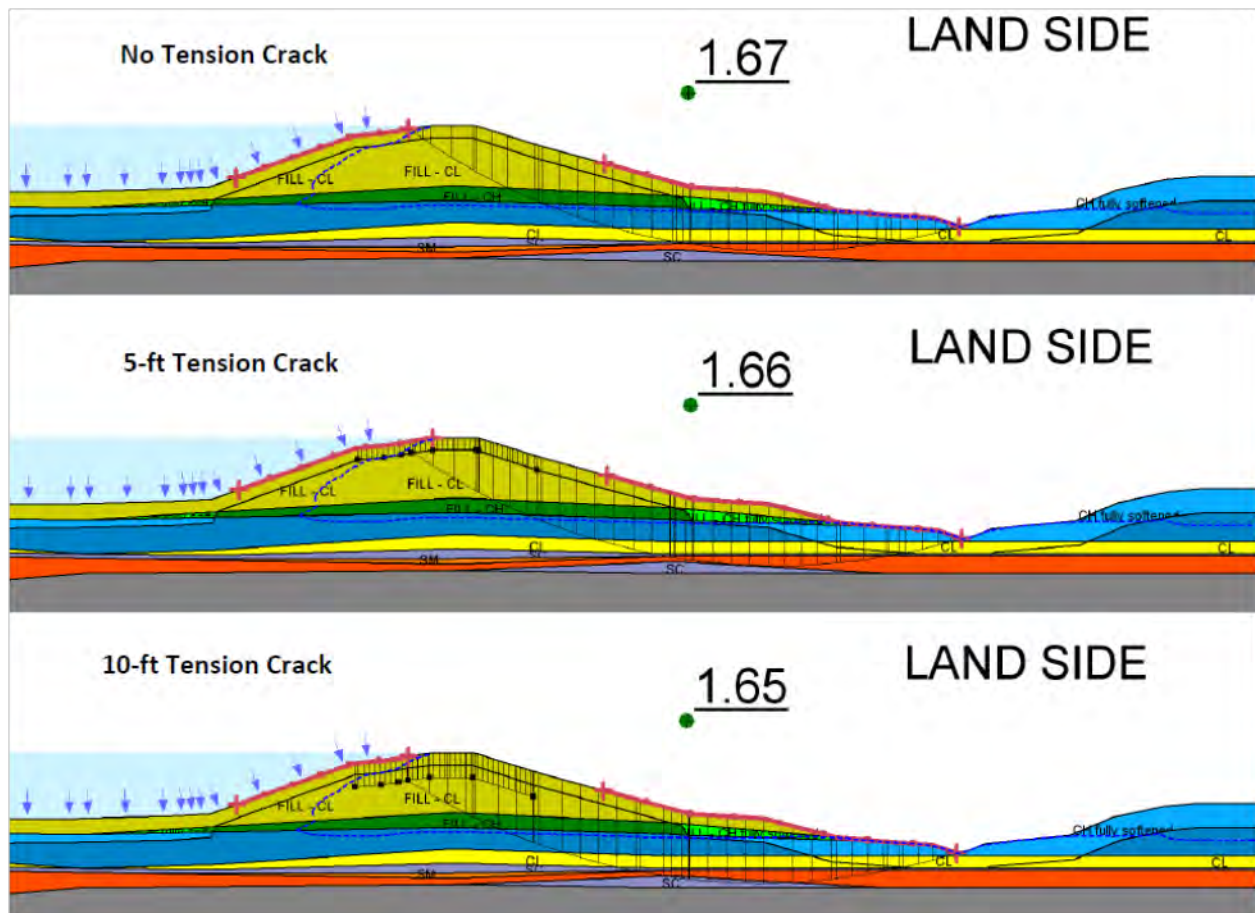
soil is nominal. This results in a minimal effect on factor of safety against stability failure as compared to a section with no tension cracks.

**Figure 43 - Stability analysis results showing varying tension crack depths.**

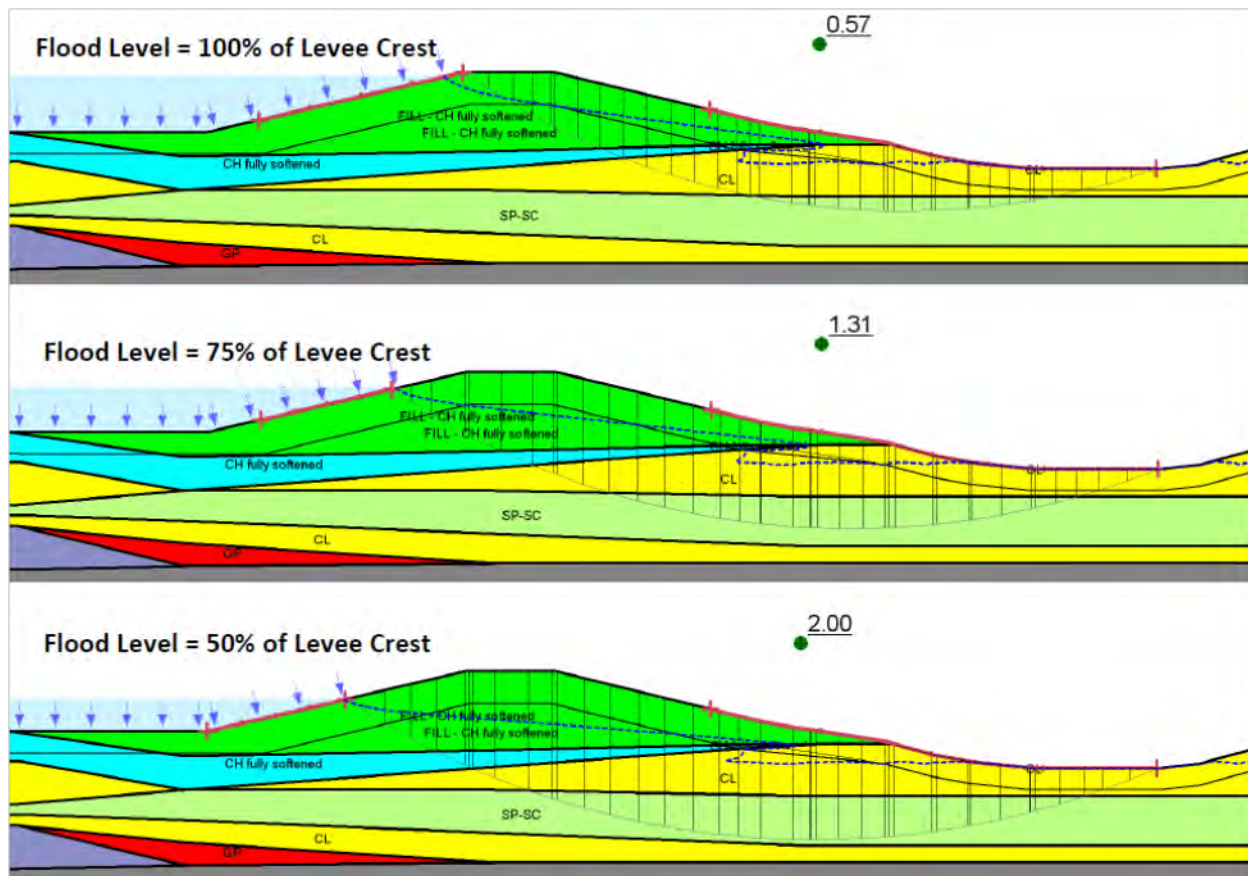
**Figure 45 - Stability analysis results performed on the section at STA 74+00 using a low estimate of permeability for the CL material layer ( $8.6e-6$  ft/hr) under the load of varying flood heights equal to 100, 75, and 50% of the levee crest elevation.**

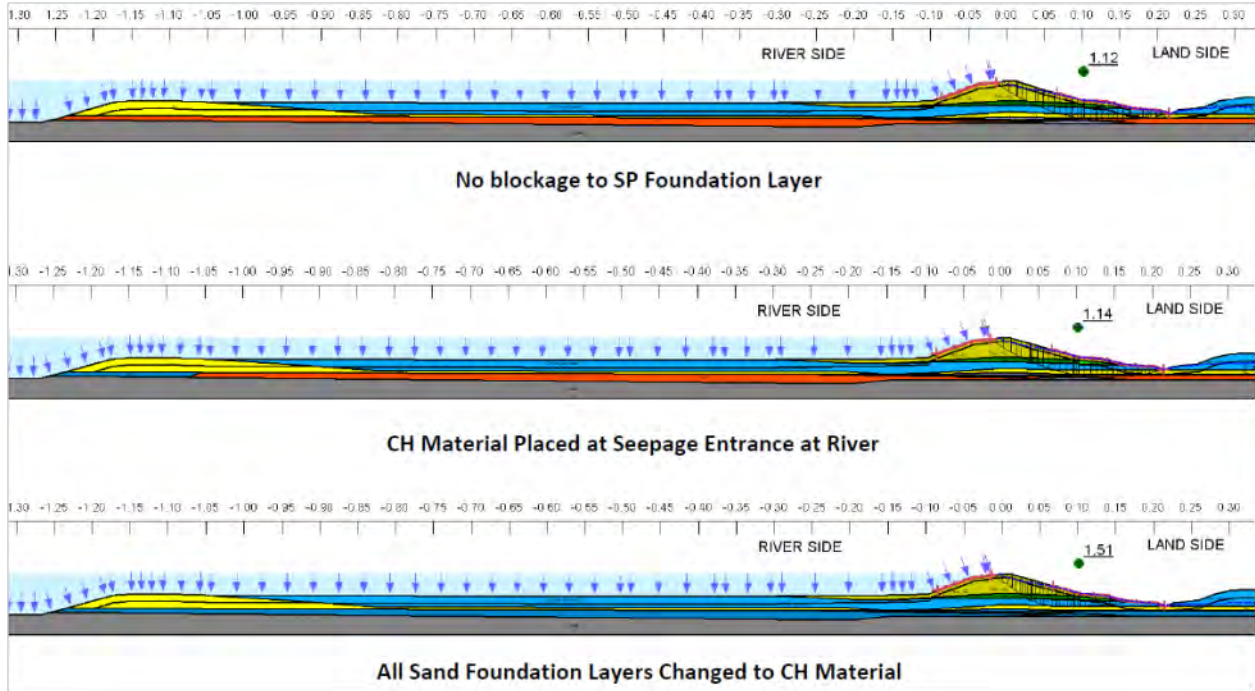
Figure 46 - Stability analysis results showing varying blockages to seepage in the foundation of the section.
