APPENDIX C
BASE CONDITION RISK ASSESSMENT

PART I
RISK ASSESSMENT
TRINITY RIVER CORRIDOR

Trinity River Corridor Dallas Floodway near Dallas, TX

7 September 2012

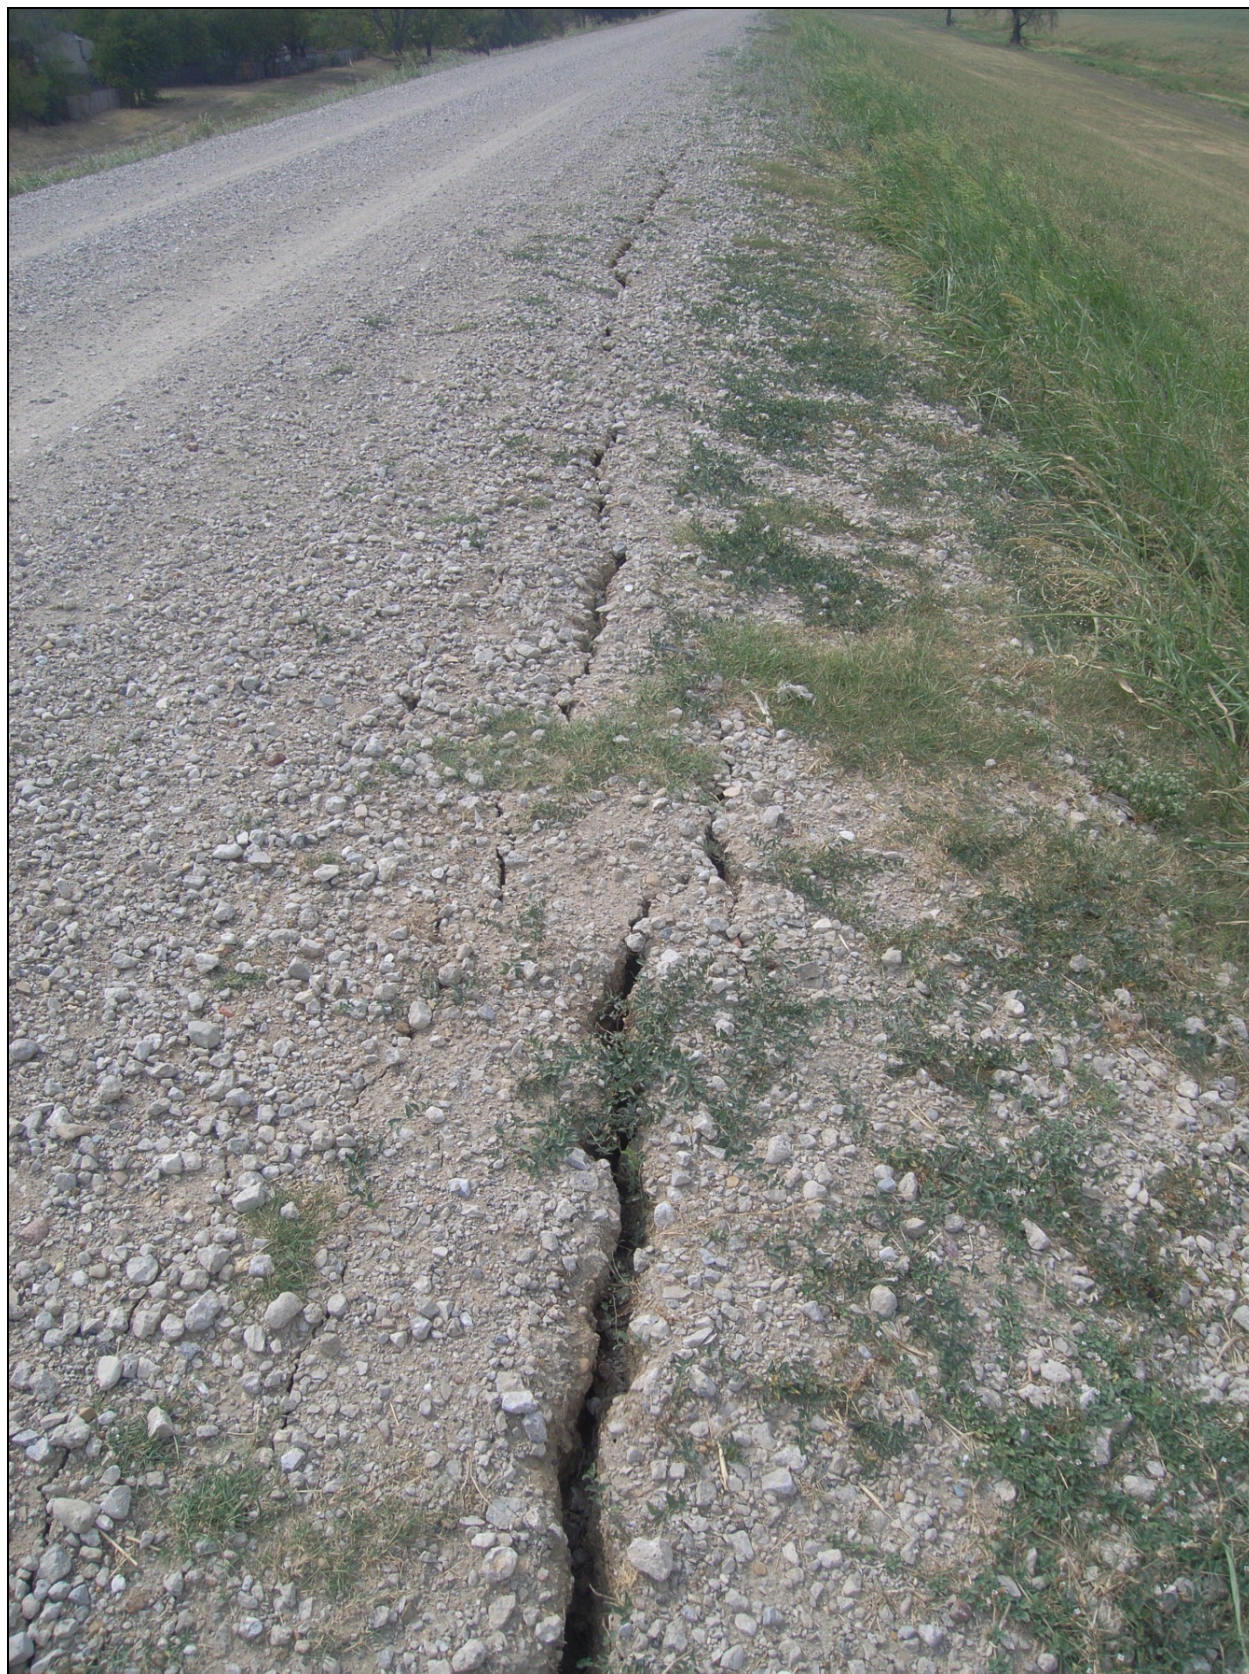
Depth of longitudinal cracking in the crest of the embankment.

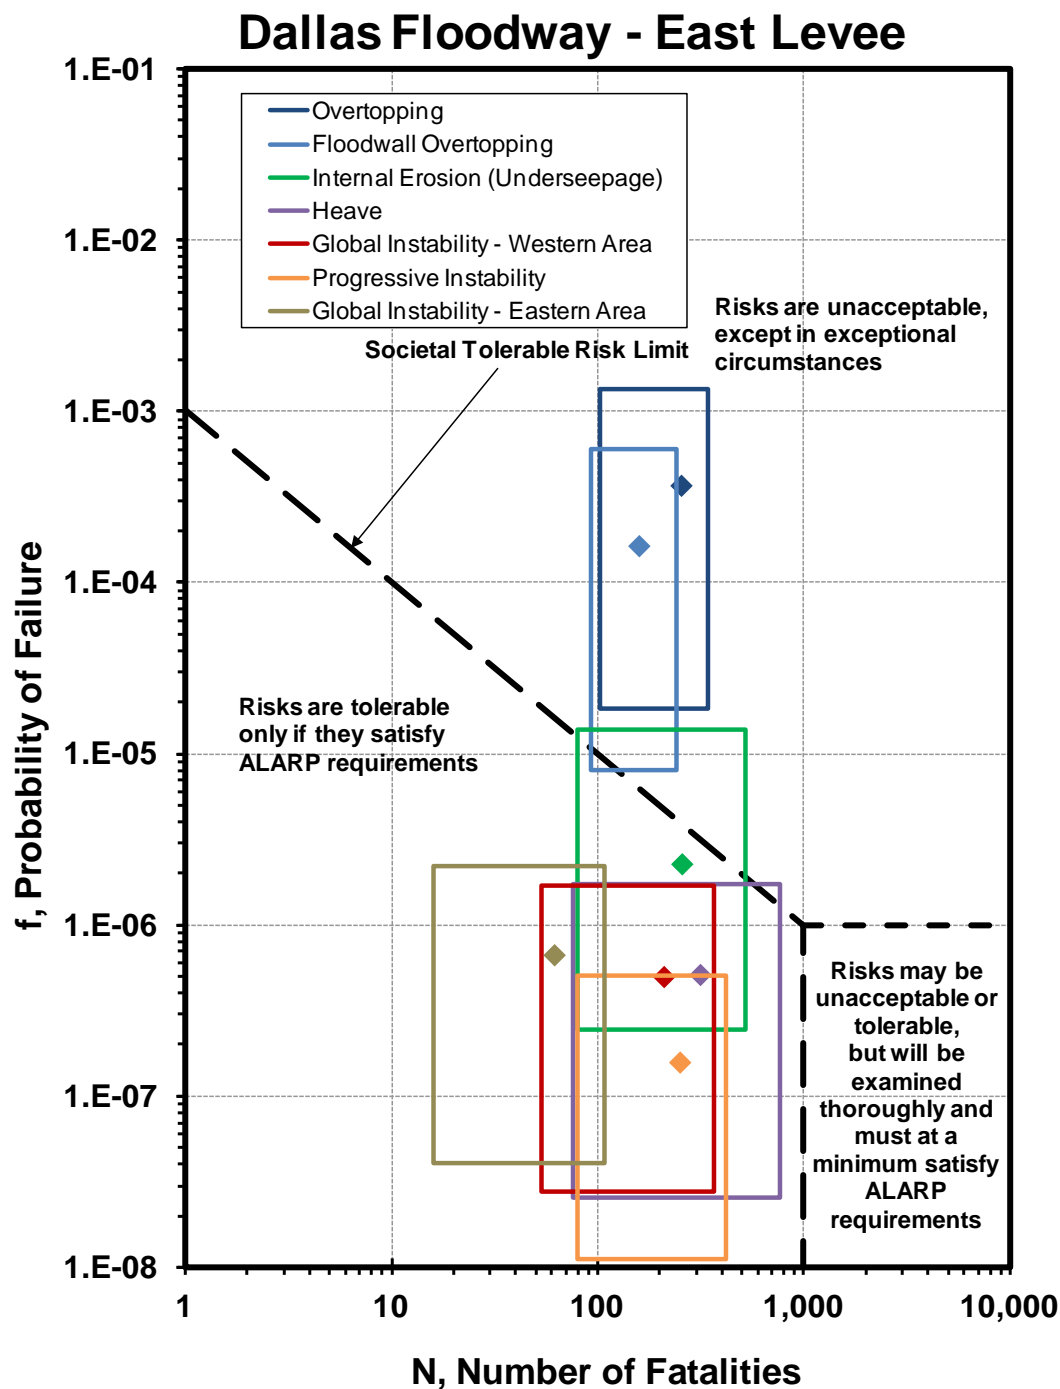
Figure 30 – f-N plot for the East Levee System. Points represent mean risk estimates. Boxes represent uncertainty of those mean estimates and roughly correspond to 5th and 95th limits.

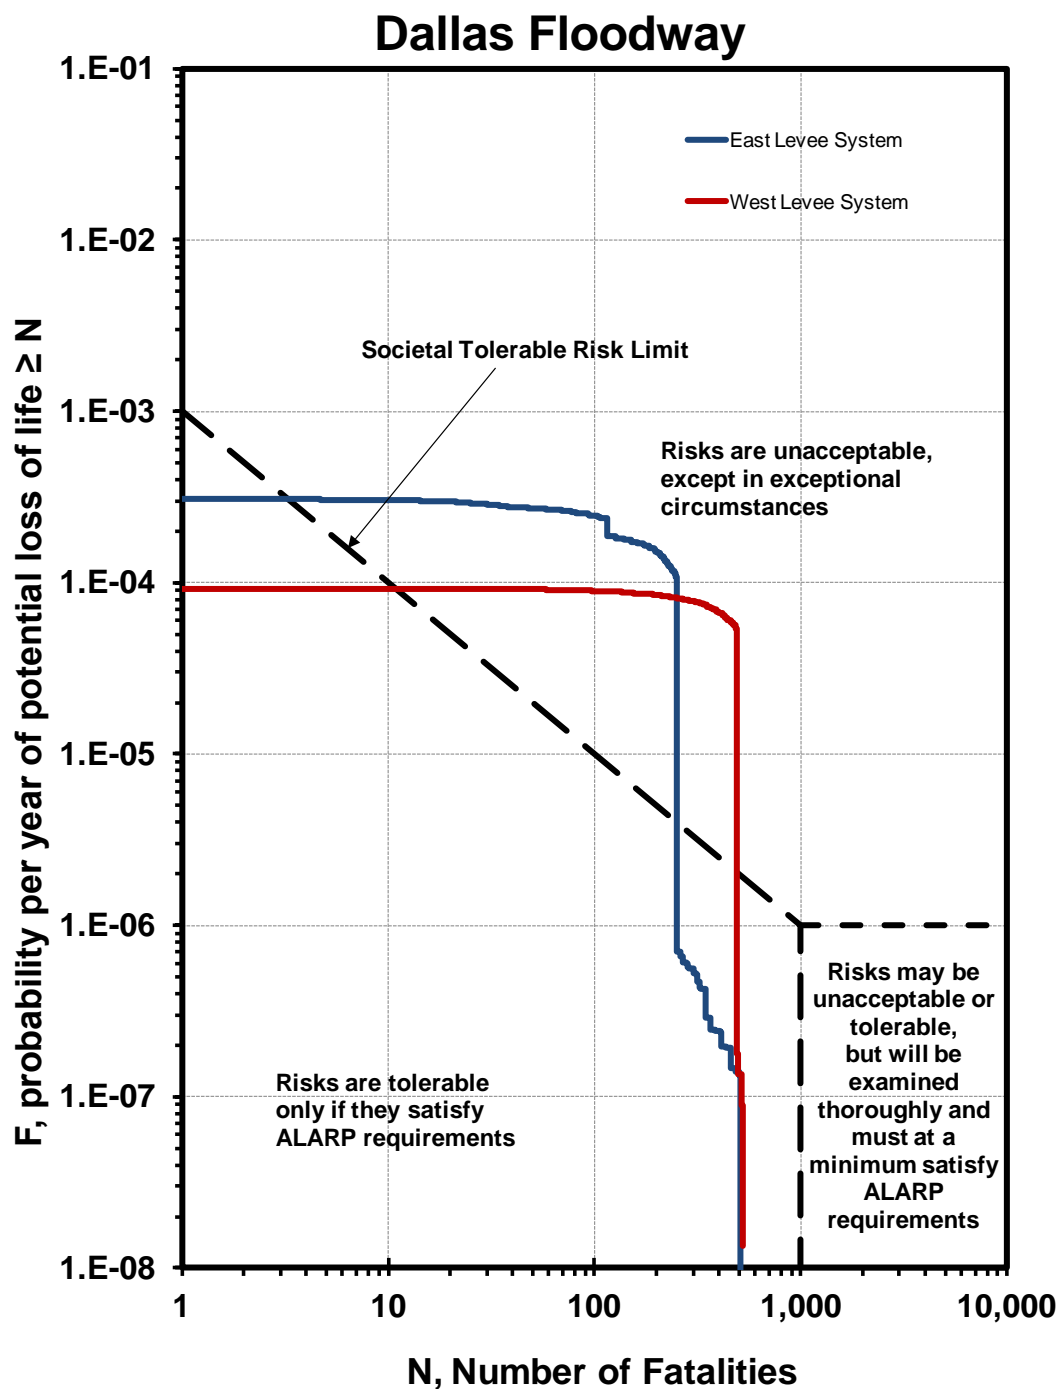
Figure 32 - F-N plot of the East and West Levee Systems. Curves represent total risks posed by each system from all failure modes.

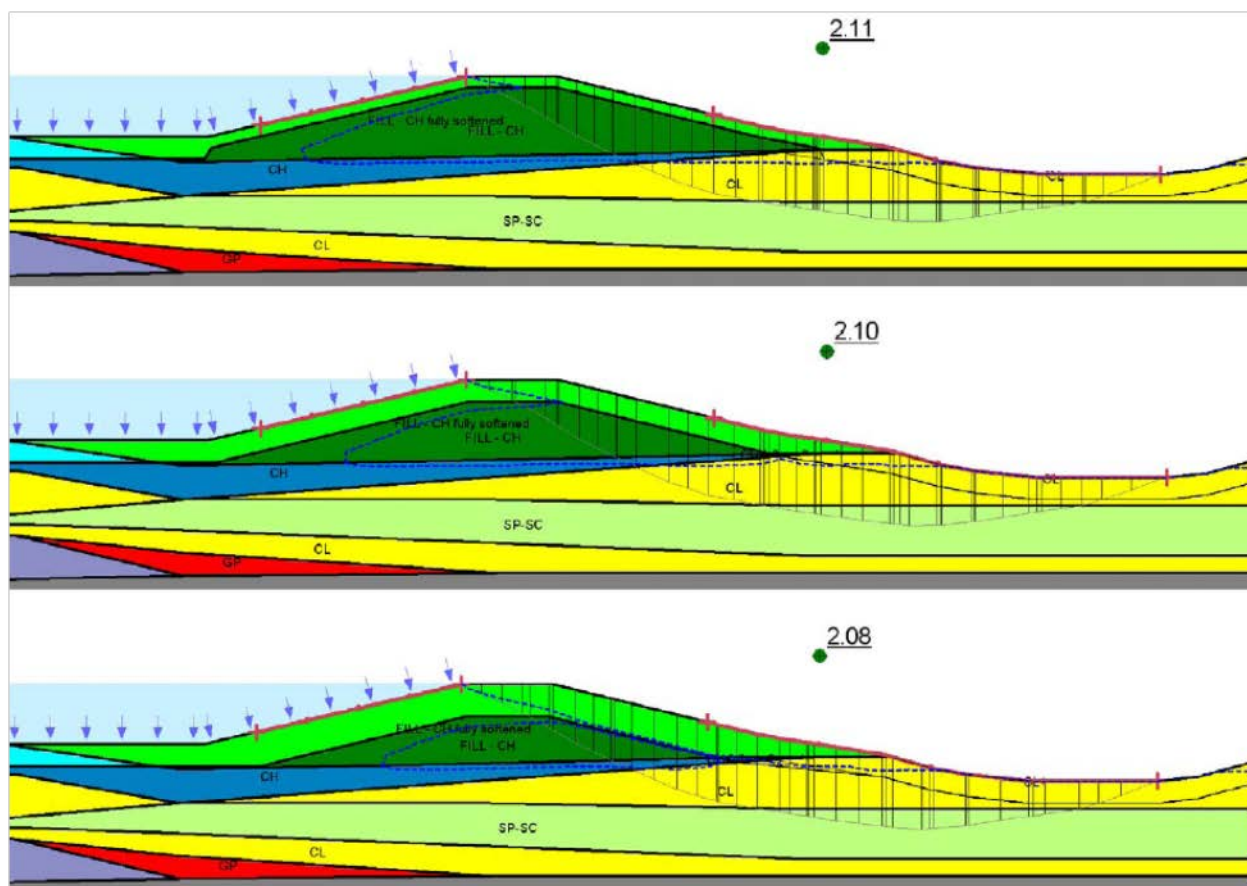
Figure 40 - Stability analysis results showing a 5-ft depth of desiccation on the top figure, 10 ft on middle figure, and 15 ft on the bottom figure. The bright green layer on the top of the levee section and the light blue at the left of the figures represent the desiccated soil.

5, 10, and 15 ft. They have mean factors of safety of 2.18, 2.16, and 2.13, respectively. All the analyses used the best estimates of permeability and flood loads corresponding to 100% of the levee height. Due to the relatively low permeability of the intact high plasticity clay, the transient seepage analyses indicate that the piezometric surface will penetrate the desiccated soils completely but won't penetrate into the intact clay core of the levee. This does little to impact stability because the effective overburden stress is only reduced near the surface of the levee where the transient seepage analysis indicates excess pore pressures are present and where overburden stress was already low. This only serves to further reduce the shear strength in an area that offered little contribution to the overall stability to the levee anyway. Any failure surface that would result in a loss of the levee crest (a critical condition as it would not be able to retain a flood) passes through the core of the levee. Desiccation does not penetrate into the intact clay of the levee core so neither does the piezometric surface during a flood event. Since the pore pressures did not significantly increase, the shear strength of the levee material in this area did not change and the stability of the section remains largely unaffected.

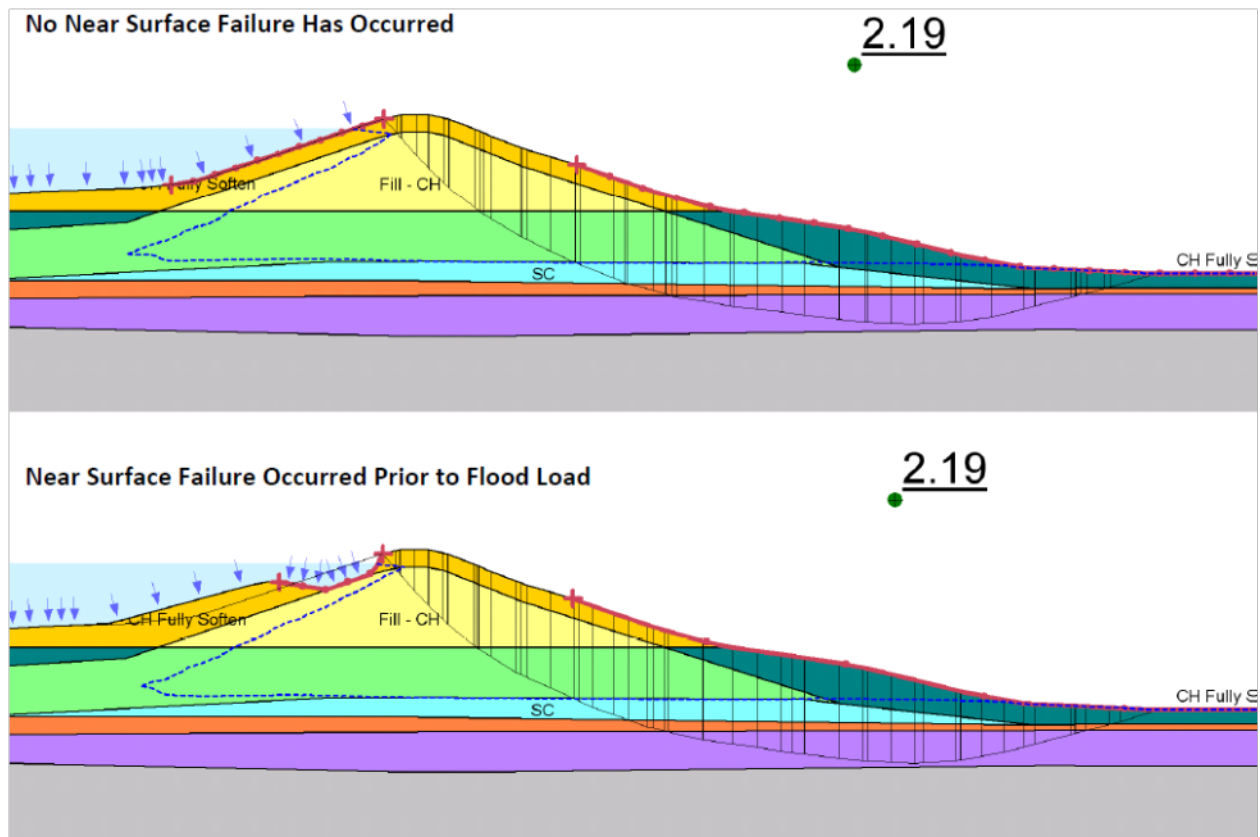
In the Dallas Floodway stability investigation, the factor was initially set to 0.5 in both the CH Fill material and the Fully Softened CH Fill material in order to model the groundwater level at or near the surface of the levee. It was assumed during the risk assessment that the factor of safety had to be close to unity for the near-surface failure to occur so further stability runs were executed while the R_u factor was incremented up or down in order to achieve a final factor of safety of one. Ultimately it was determined that an R_u of 0.46 results in a factor of safety of one. The resulting near-surface failure penetrated approximately 5 ft into the levee. Seepage analyses were then performed on the levee section accounting for the lost material due the movement of the failure mass. The best estimates of permeability for all materials were used for these analyses. Figure 44 shows the results of the two stability analyses on the section located at station 410+00 on the east alignment: the top figure shows the results of the fully intact levee at the peak of the May 1990 flood event scaled to the crest of the levee and bottom figure depicts the results of an analysis assuming a near surface slide has occurred immediately before the same flood load was applied. The figure shows that the piezometric grade line on each picture changes very little indicating there was little change in the pore water pressure induced by the flood load in the levee. This was due to the fact that near-surface failure mass did not penetrate past the desiccated zone into the low permeability core of the levee so the primary portion of the levee remained intact. As a result, the factor of safety against stability failure remained at 2.19.

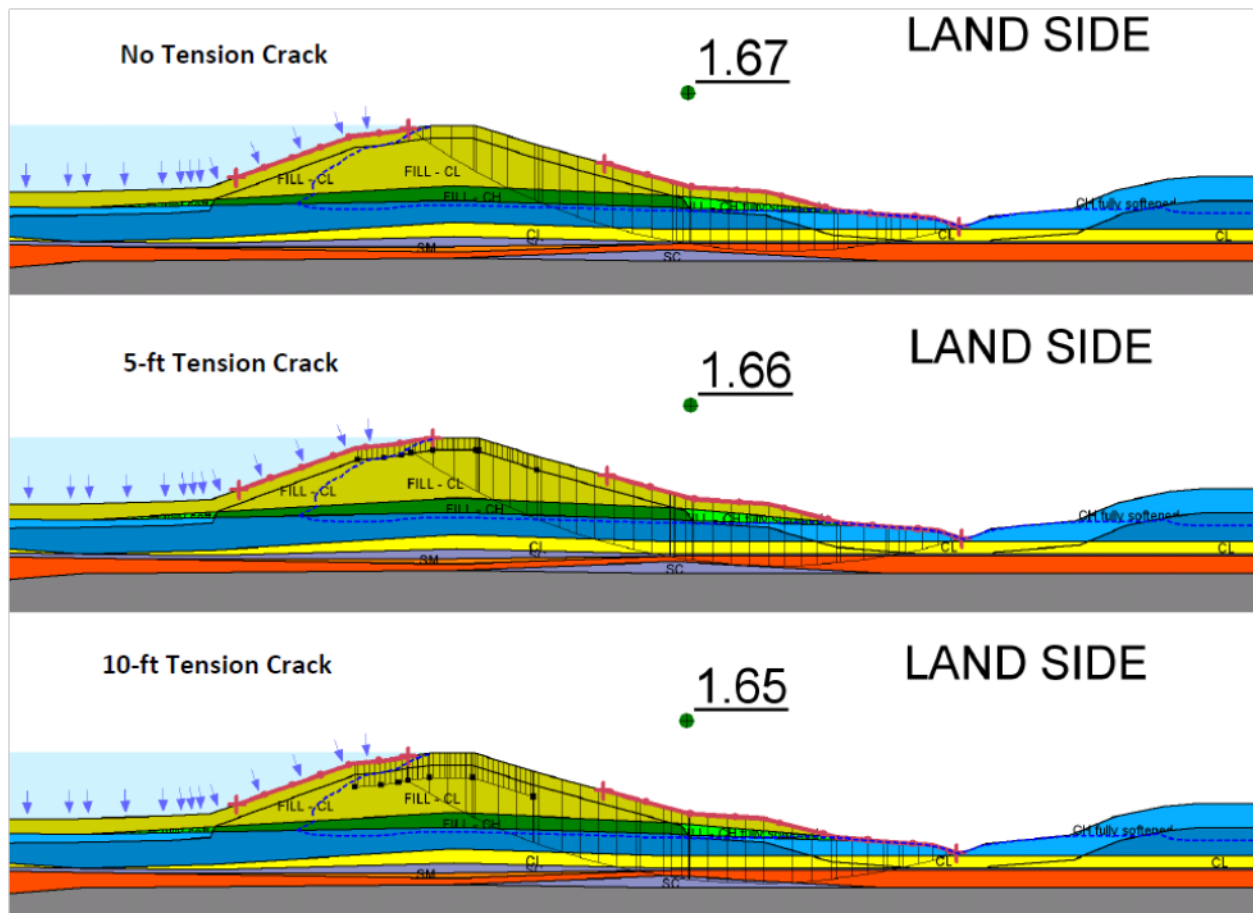
Figure 43 - Stability analysis results showing varying tension crack depths.

soil is nominal. This results in a minimal effect on factor of safety against stability failure as compared to a section with no tension cracks.

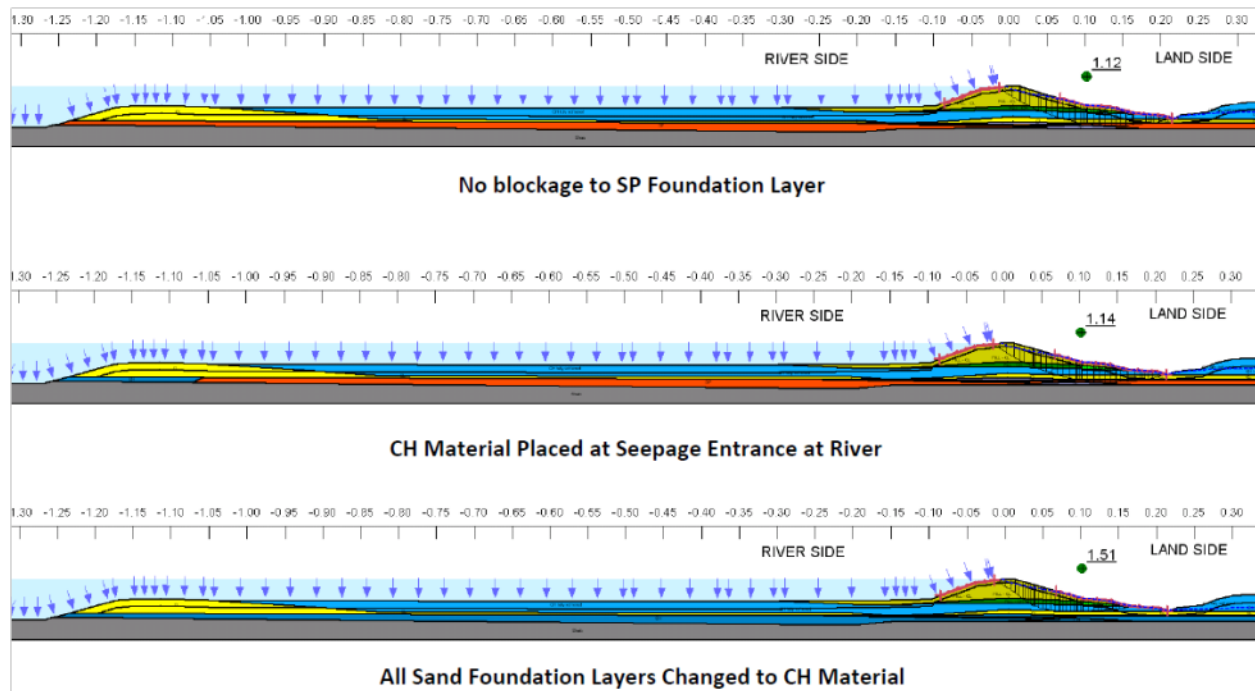
Figure 46 - Stability analysis results showing varying blockages to seepage in the foundation of the section.

Section 220+00 modeled with the high estimate of material permeabilities and a fully desiccated foundation layer was selected as the base case of the problem. This section has a mean factor of safety of 1.16 against stability failure. In order to give greater influence to the desiccated layer, first the primary seepage entrance to the foundation sand was blocked. This was done by replacing the first 180 ft of the 5-ft thick poorly graded sand (SP) with a fully-intact high plasticity clay (CH), eliminating the open pathway to the primary river channel. This marginally increased the mean factor of safety from 1.16 to 1.18. It appears that the increase was only slight because seepage could still penetrate through the desiccated foundation layer that overlies the sand layer in the free-field area between the river thalweg and the flood-side toe of the levee. To further modify the problem, the subsurface sand layers were made less permeable. This was done by modeling all the sand layers in the section as fully-intact high plasticity clay. This significantly improved the stability of the section to a mean factor of safety of 1.66. The primary difference between the first two iterations (base case and blocked entrance) and the last was that seepage pressures could still stack up under the levee in the sand layers in the first two runs, reducing the effective stress and subsequently reducing the available shear resistance. However, when the sand layers were replaced with CH material, seepage pressures could not build up to the same extent (total head in the sand layers decreased by 10 ft) and more shear resistance became available. This further supports the finding that material permeability has the largest influence on stability.
