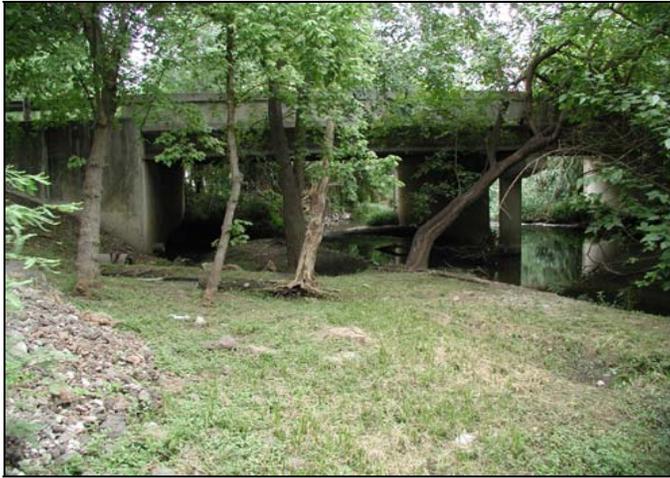
Photo P1. Upper limit of Park Reach at Hildebrand Avenue.

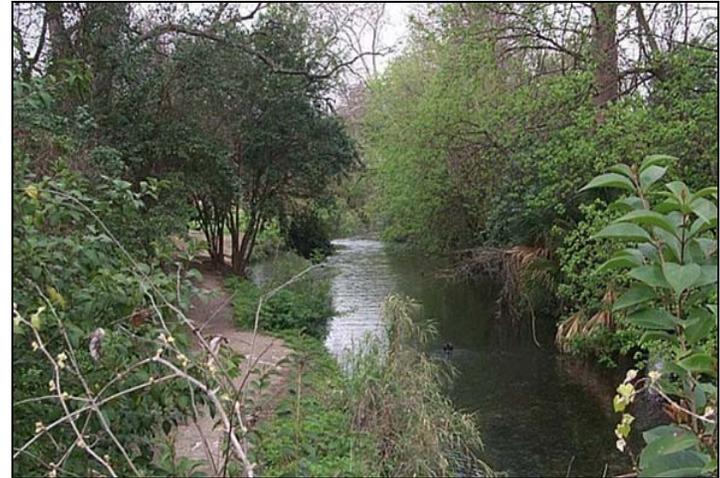
Photo P2. San Antonio River in Brackenridge Park.

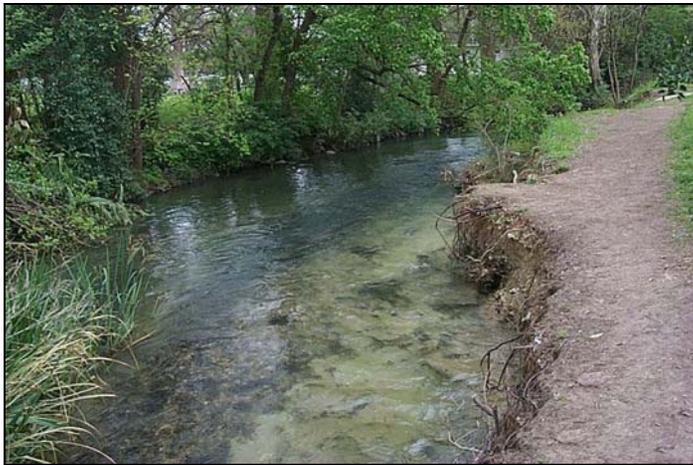
Photo P3. Bank Erosion in upper portion of Park Reach.

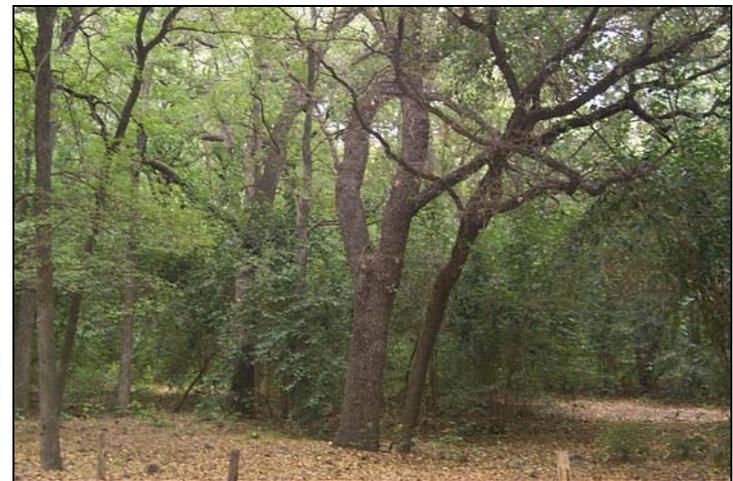
Photo P4. Forest has many invasive species.

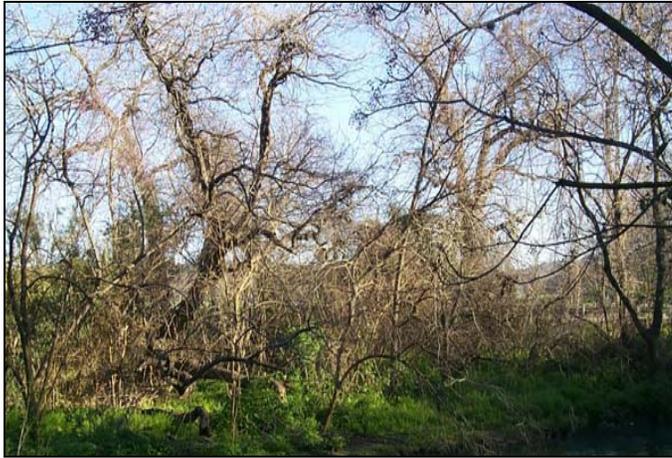
Photo P5. Degraded riparian vegetation within Park Reach.

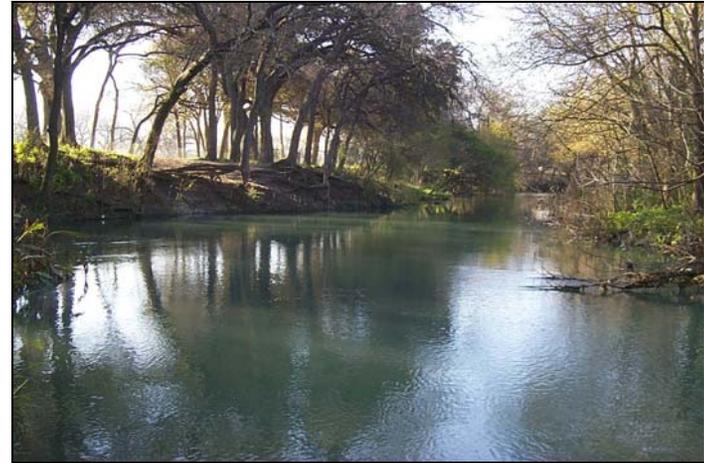
Photo P6. Good quality riparian habitat within Park Reach.

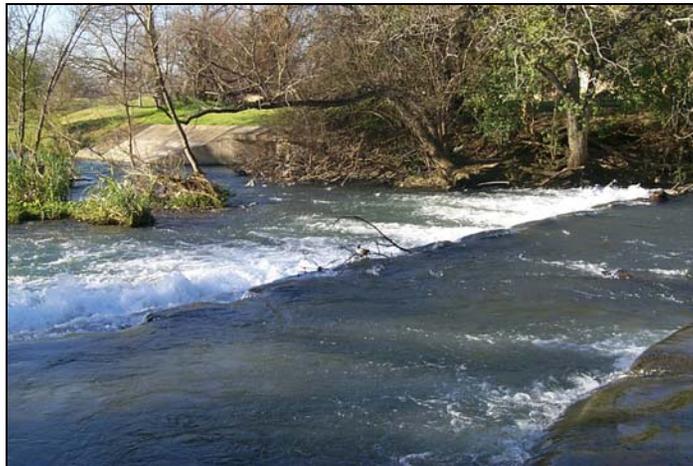
Photo P7. Drop Structure in Brackenridge Park.

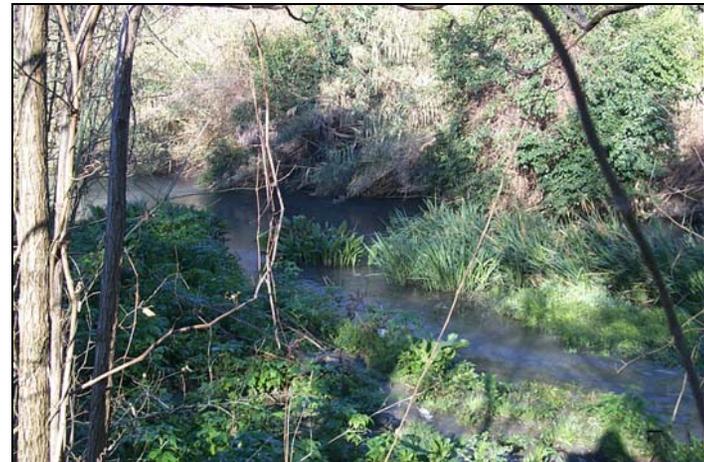
Photo P8. Sediment buildup with in-stream vegetation in Park Reach.

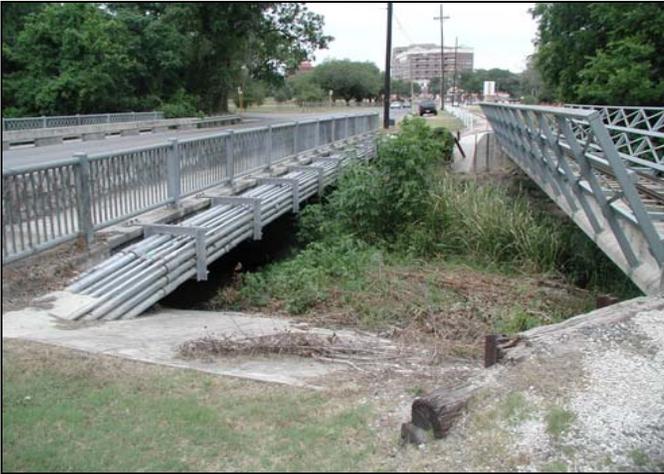
Photo P9. Mulberry Avenue bridge and iron railroad bridge.

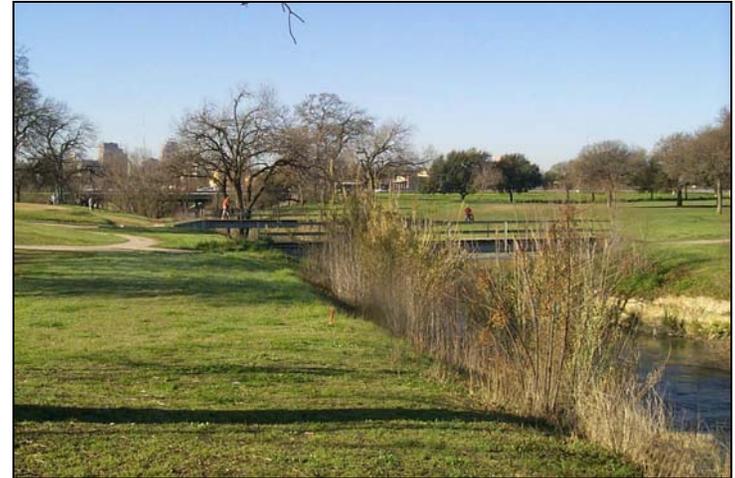
Photo P10. Sparse riparian vegetation through golf course.

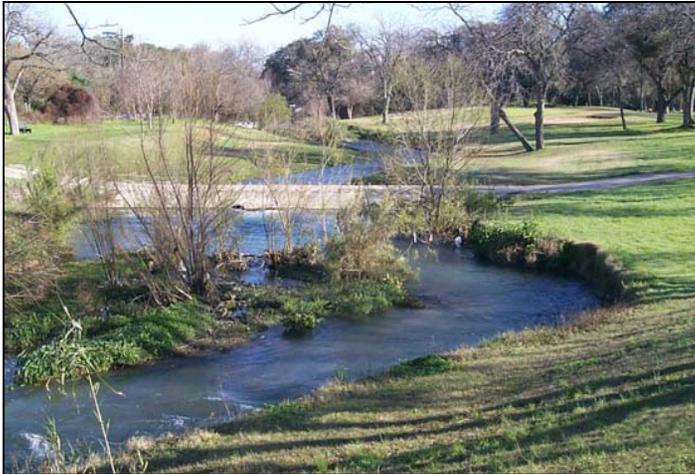
Photo P11. San Antonio River in Brackenridge Golf Course.

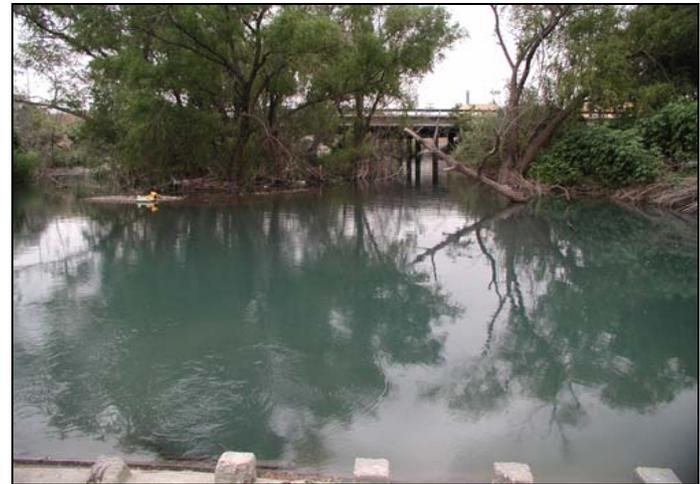
Photo P12. Southern end of Park Reach at U.S. Highway 281.

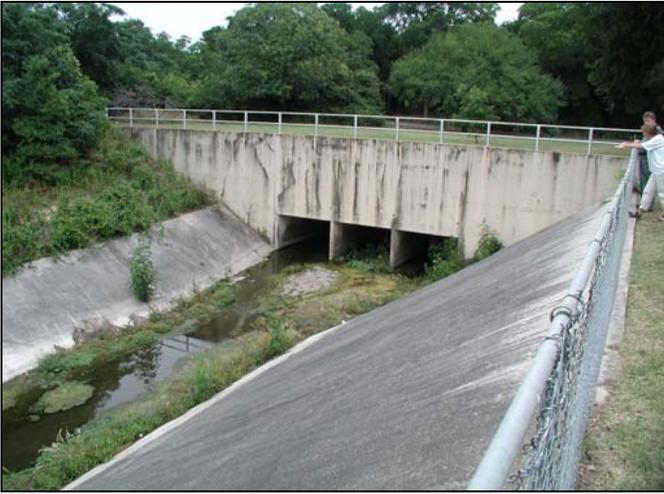
Photo P13. Northern limit of Catalpa-Pershing Channel.

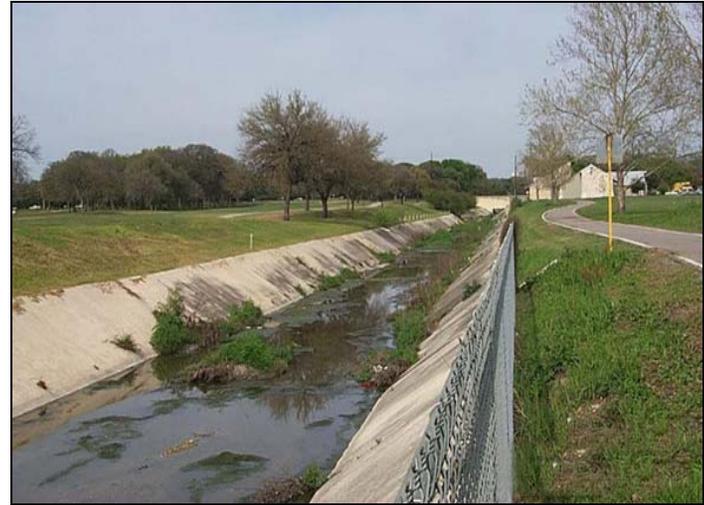
Photo P14. Catalpa-Pershing Channel.

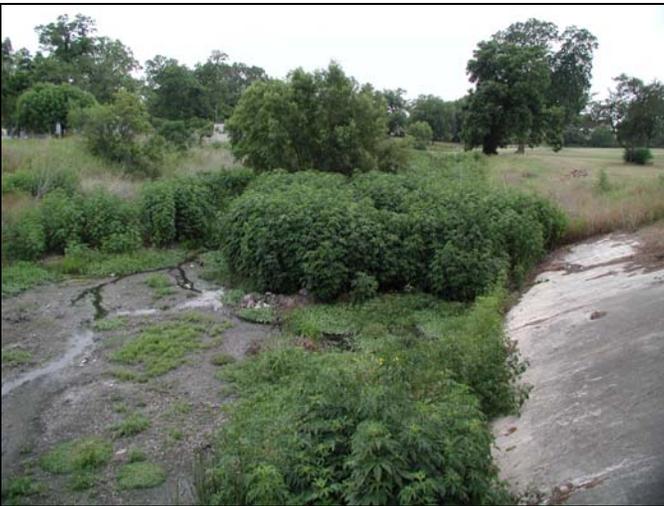
Photo P14. Transition from concrete to grass-lined channel.

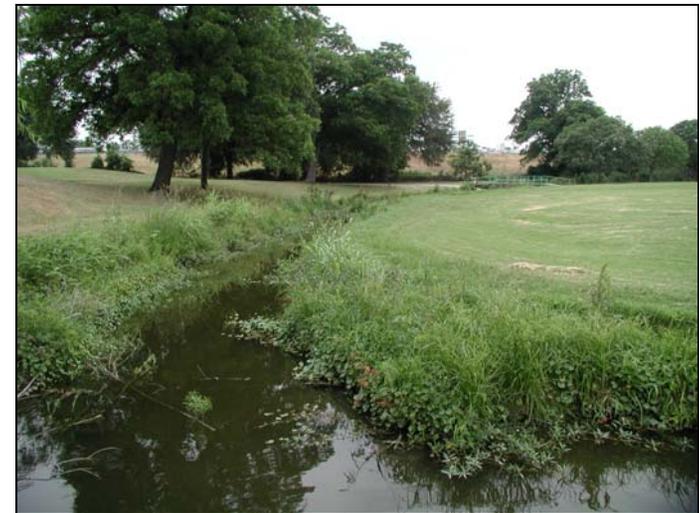
Photo P15 Catalpa-Pershing in Brackenridge Golf Course.

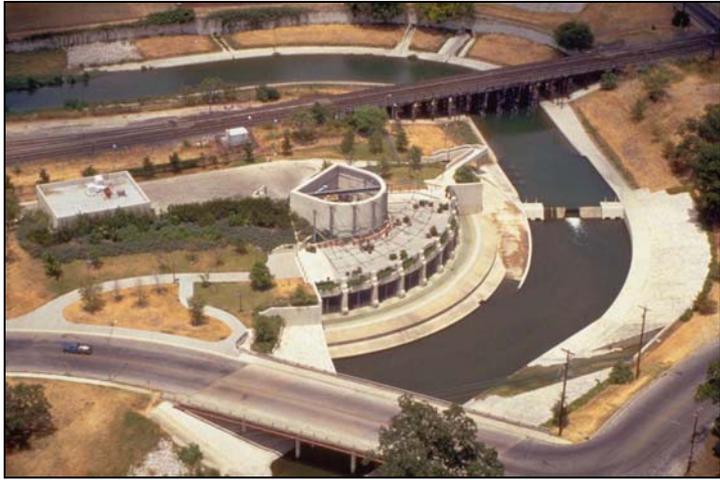
Photo M1. Oblique – SART outlet.

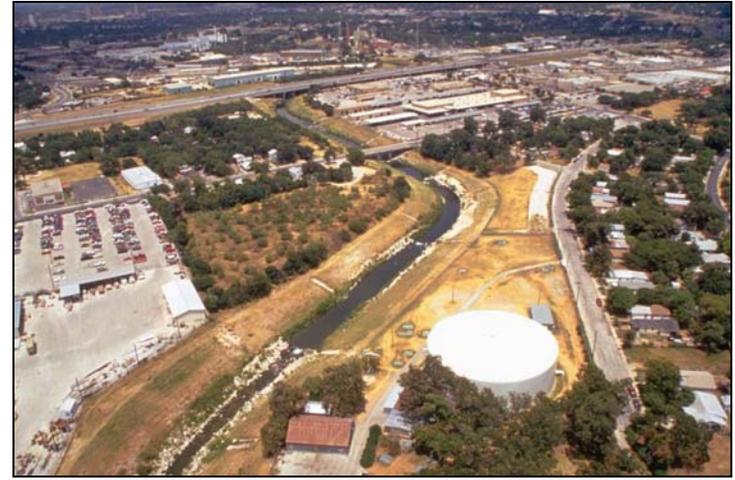
Photo M2. Oblique – North of Confluence with San Pedro.

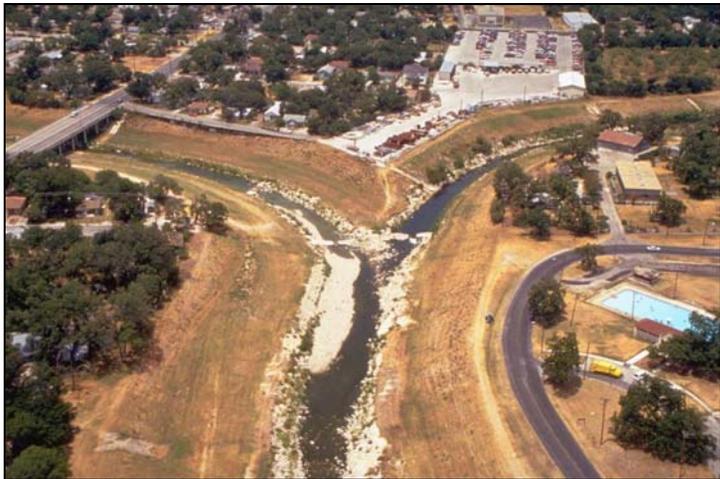
Photo M3. Oblique – Confluence with San Pedro

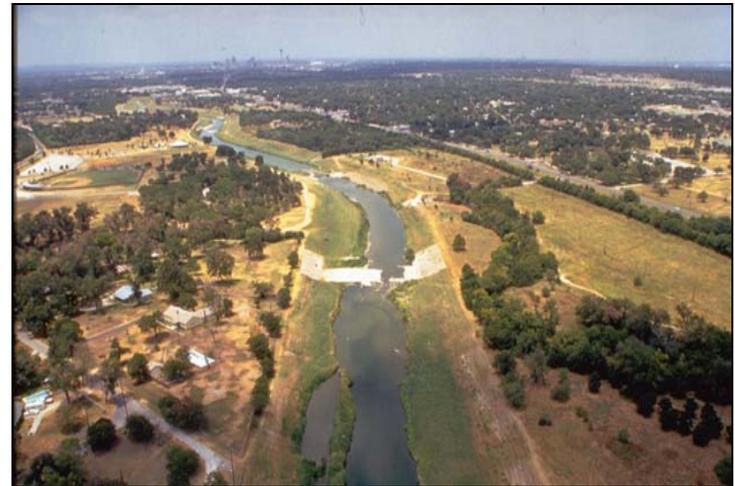
Photo M4. Oblique - Old San Juan Dam.

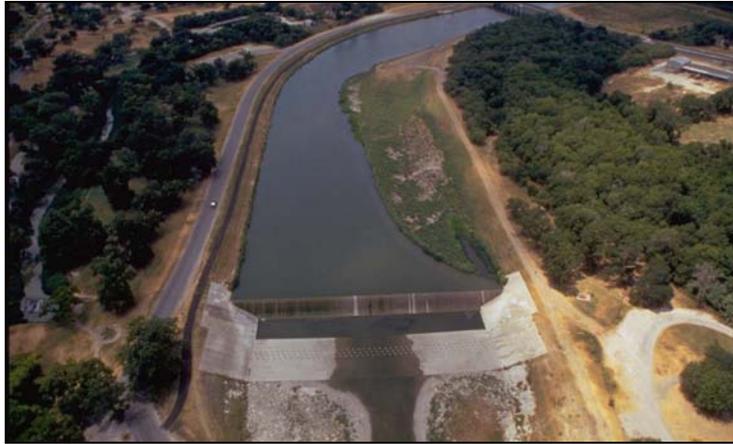
Photo M5. Oblique – Espada Dam.

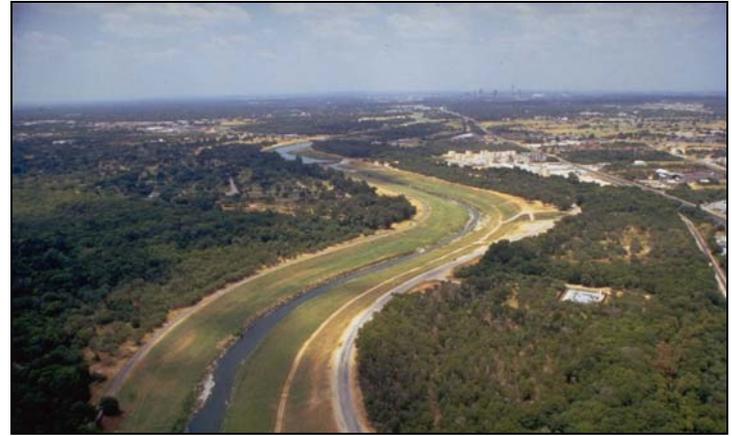
Photo M6. Oblique – North of Ashley Road.

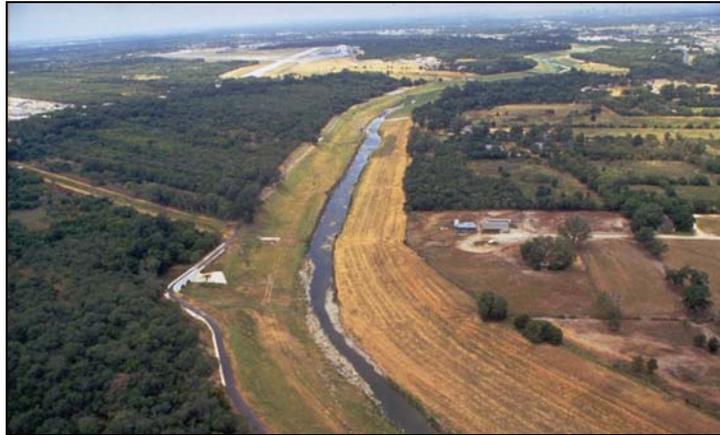
Photo M7. Oblique – North of I.H. 410.

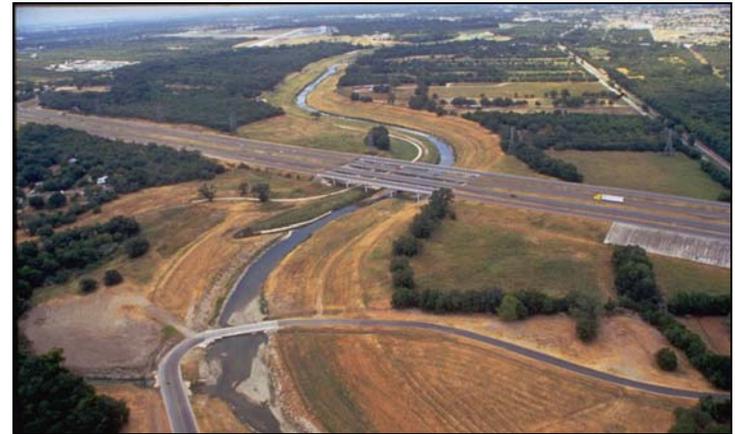
Photo M8. Oblique – I.H. 41.

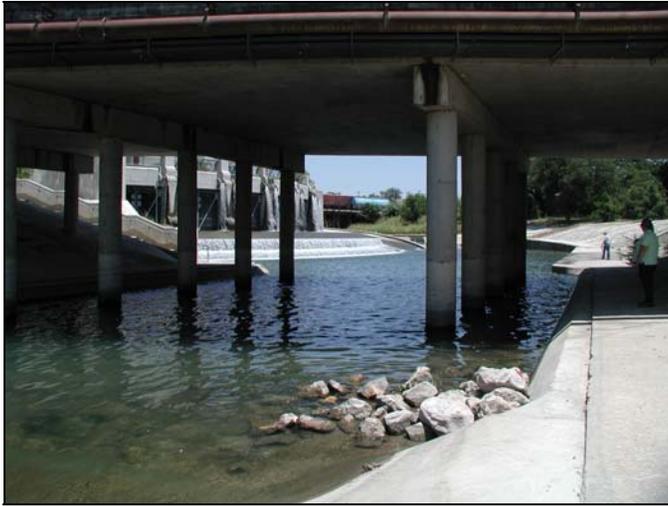
Photo M9. Upper limit of Mission Reach at Lone Star Blvd.

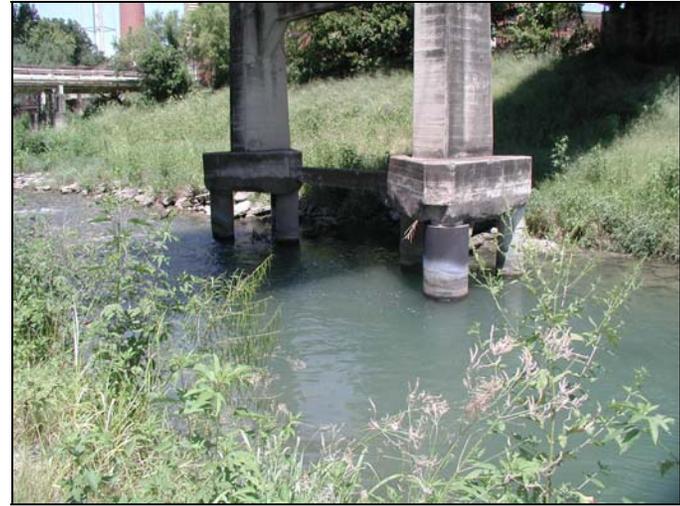
Photo M10. Near City Public Services bridge (Sta. 2101.60).

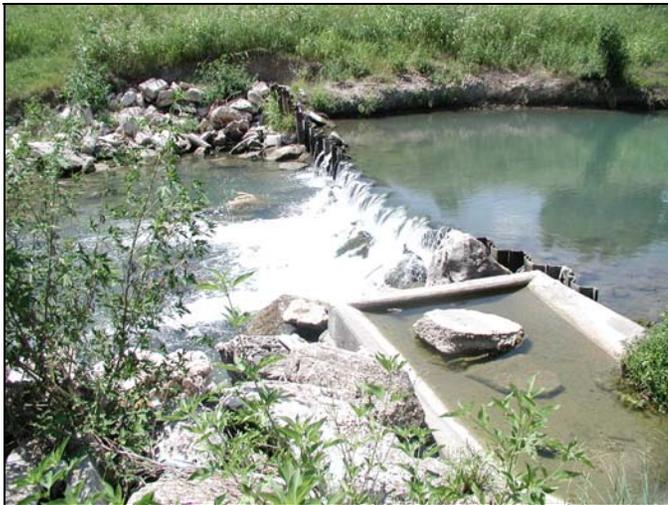
Photo M11. Sheet pile check dam #3 (Sta. 2075+80).

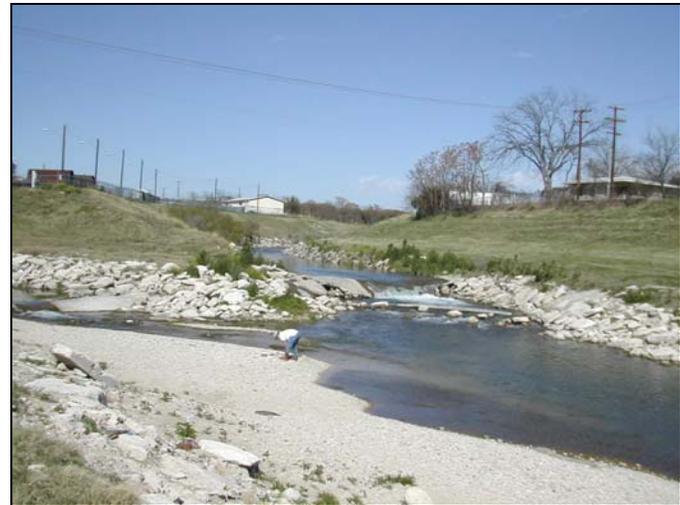
Photo M12. Confluence with San Pedro Creek (Sta. 2060+50).

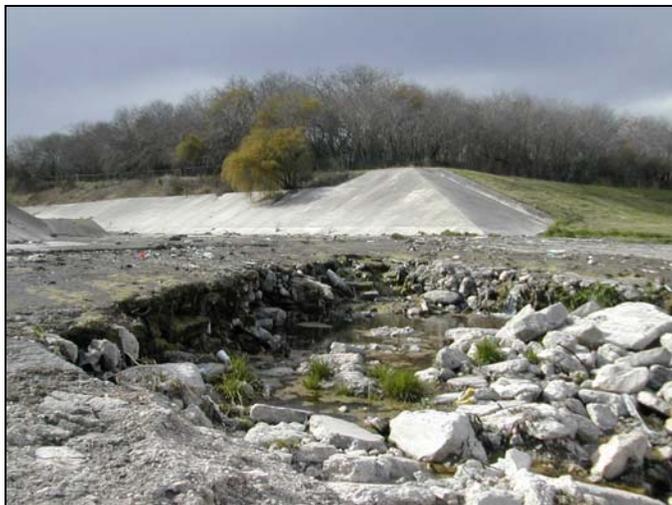
Photo M13. Active head cutting near Sta. 2044+00.

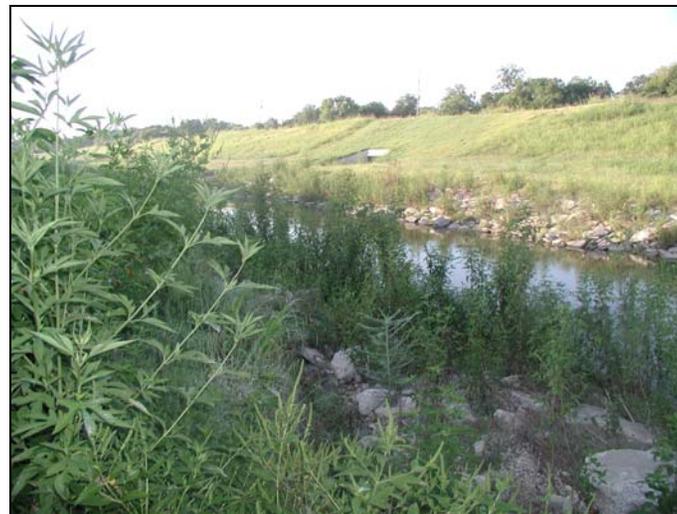
Photo M14. Invasive vegetation near Sta. 2024+40.

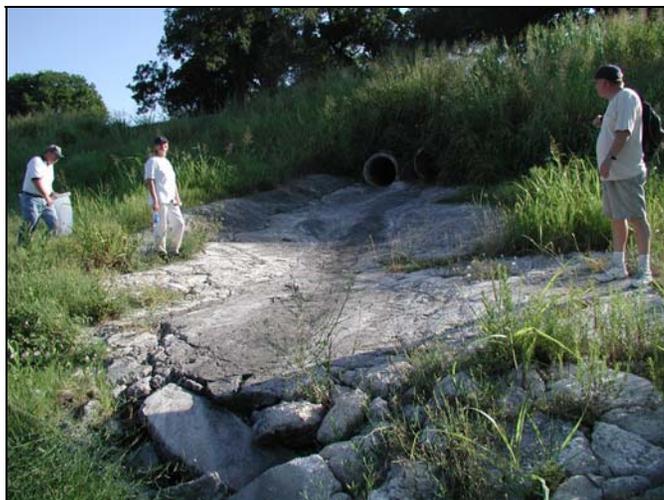
Photo M15. Storm drain near Sta 1996+00

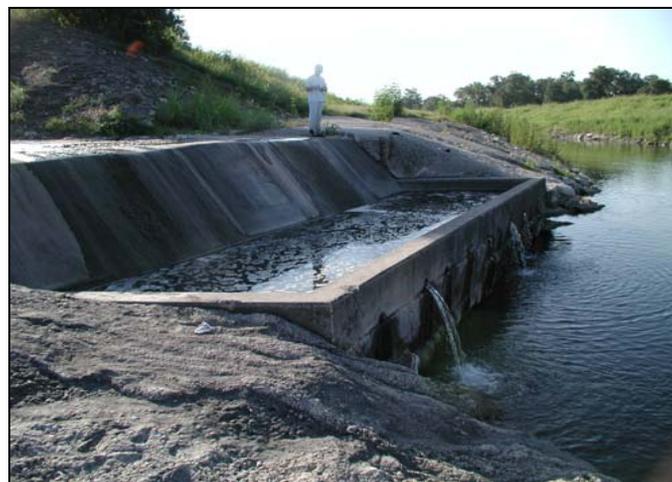
Photo M16. Golf course storm drain [west] (Sta. 1993+30)

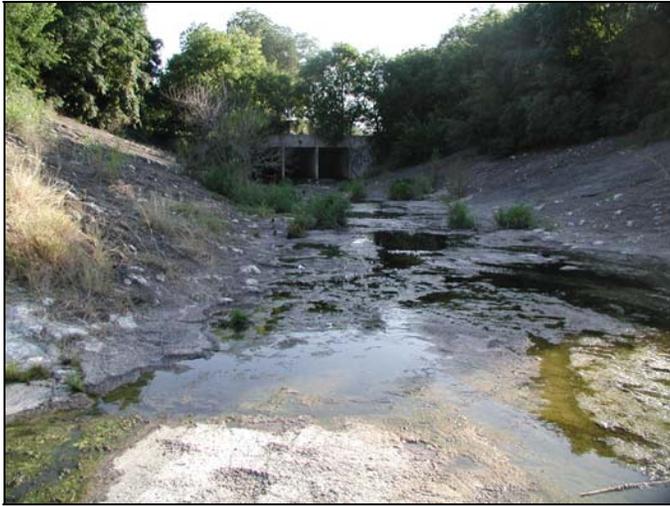
Photo M17. Storm drain [east] from golf course (1993+20).

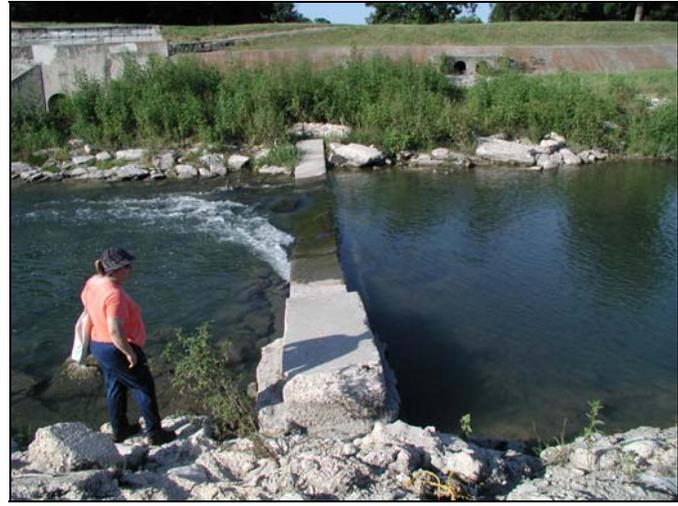
Photo M18. Concrete sill grade structure (Sta. 1978+70).

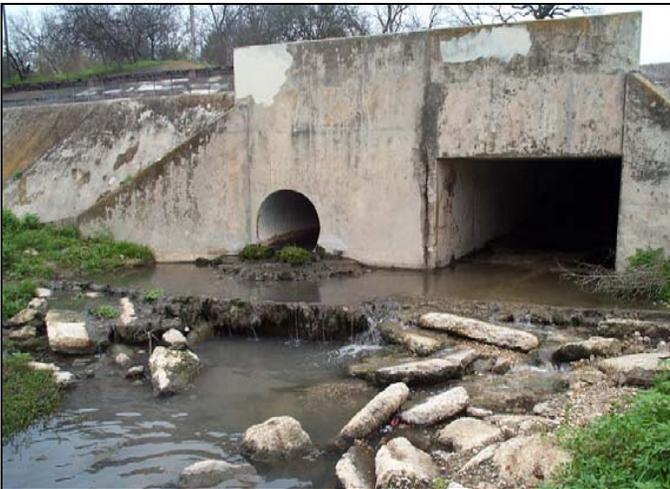
Photo M19. Storm drains near Sta. 1978+00.

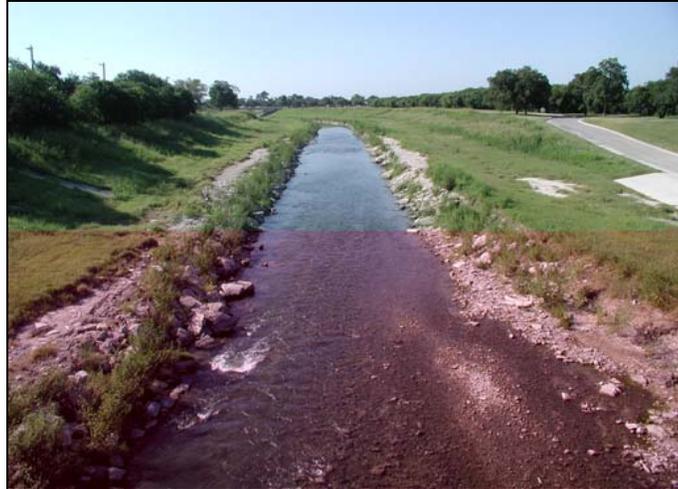
Photo M20. Floodway downstream of Southcross St.

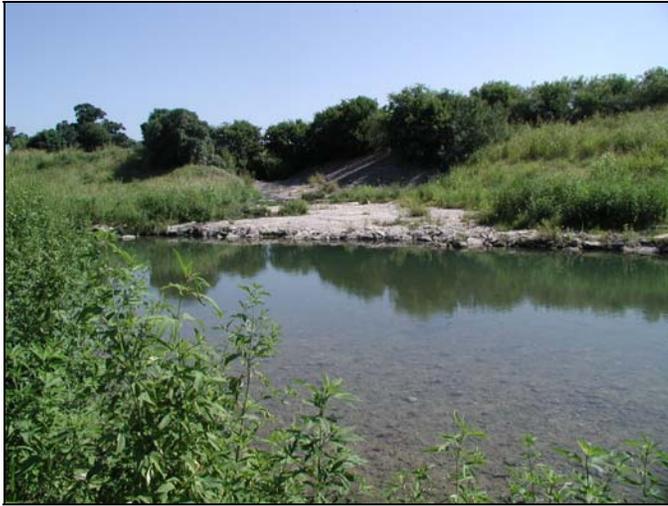
Photo M21. Storm outlet near Sta. 1937+00.

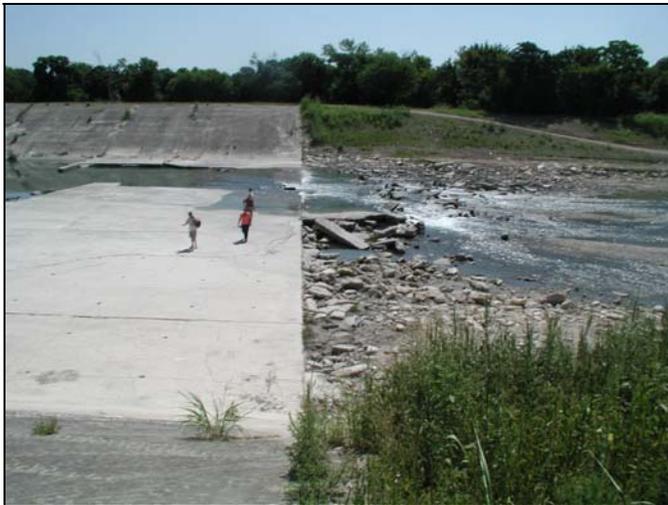
Photo M22. North end of Old San Juan Dam (Sta. 1900+20).

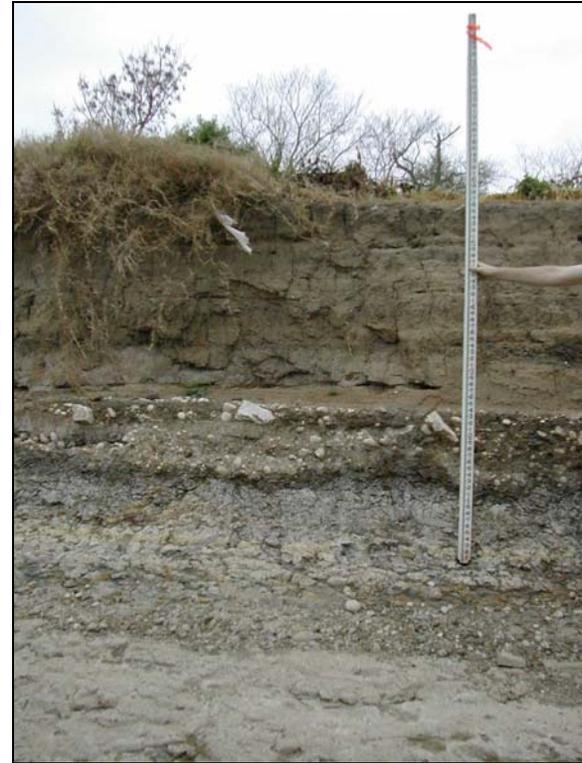
Photo M23. Eroding bank below the Old San Juan Dam near Sta. 1894+20.

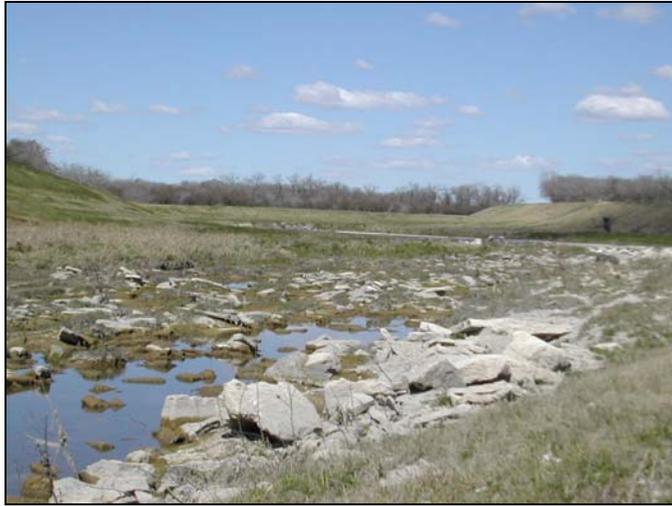
Photo M24. A dewatered segment upstream of Six Mile Creek

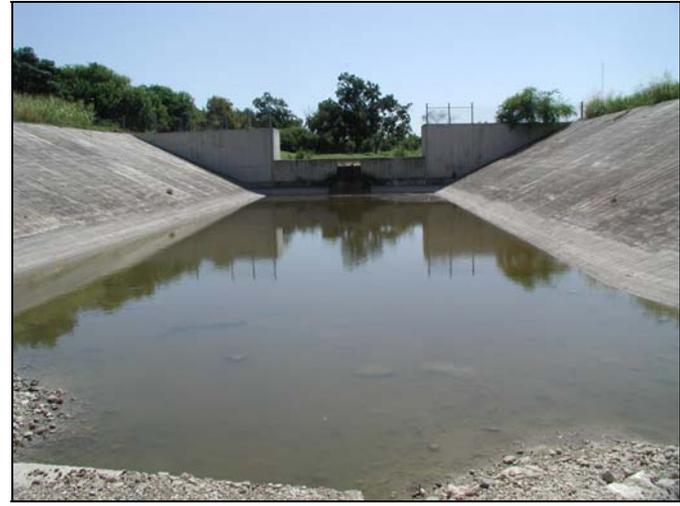
Photo M25. Dam grade structure near Sta. 1877+00.

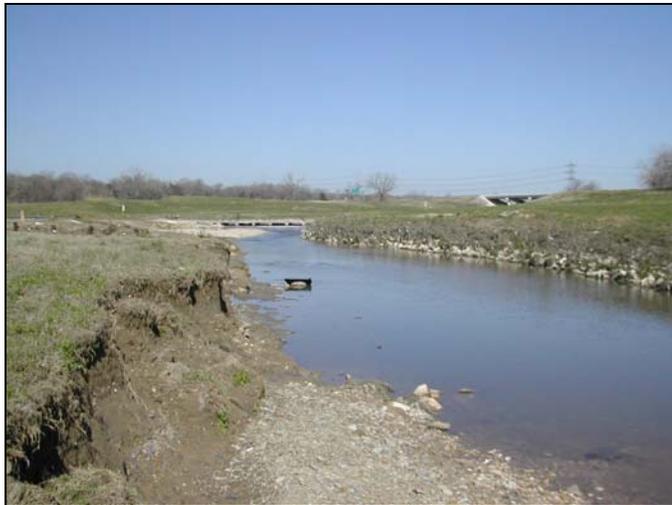
Photo M26. Erosion near I.H. 410 bridge (Sta. 1741+00).

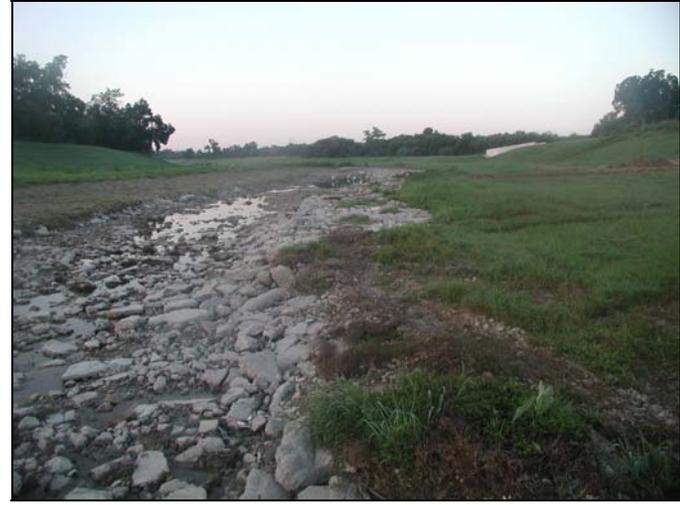
Photo M27. Downstream of Six Mile Creek bypass.

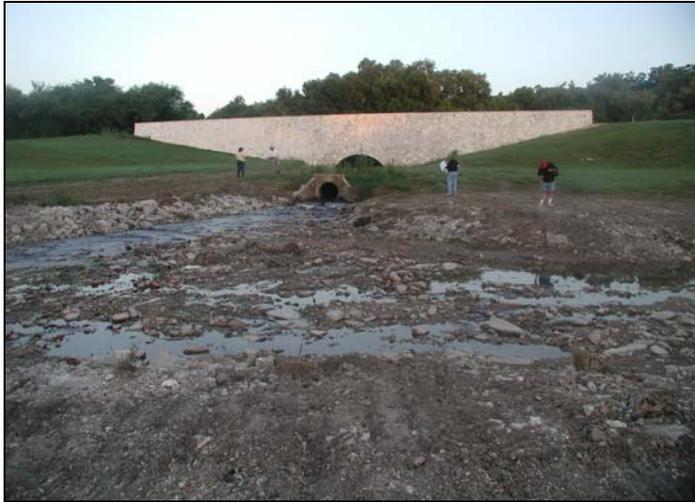
Photo M28. Pedras Creek outfall (Sta. 1783+40).

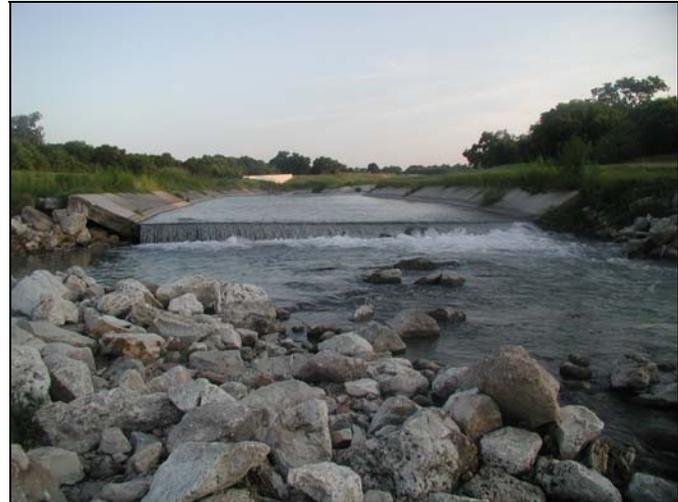
Photo M29. Return of old river channel (Sta. 1774+60).

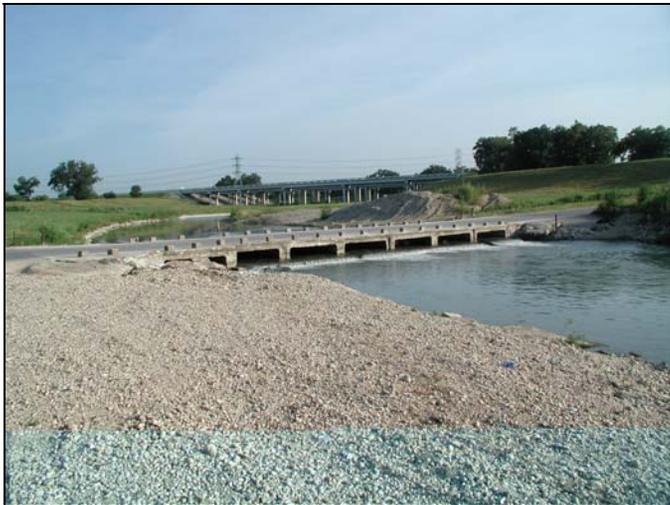
Photo M30. Camino Coahuilteca crossing (Sta. 1727+60)

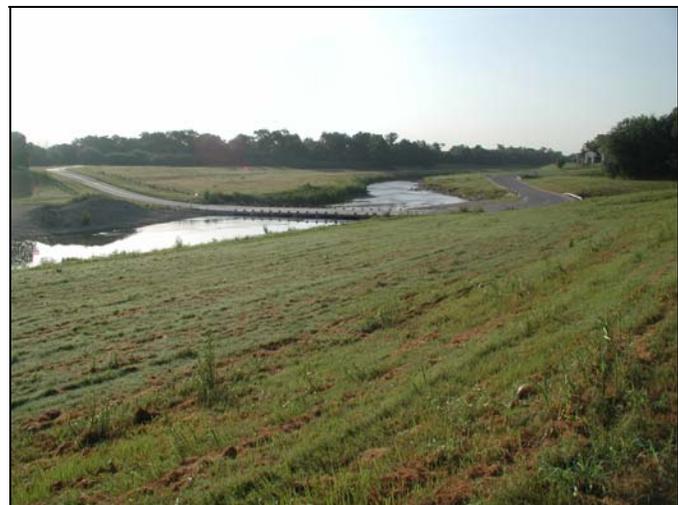
Photo M31. Maintained floodway of SACIP.

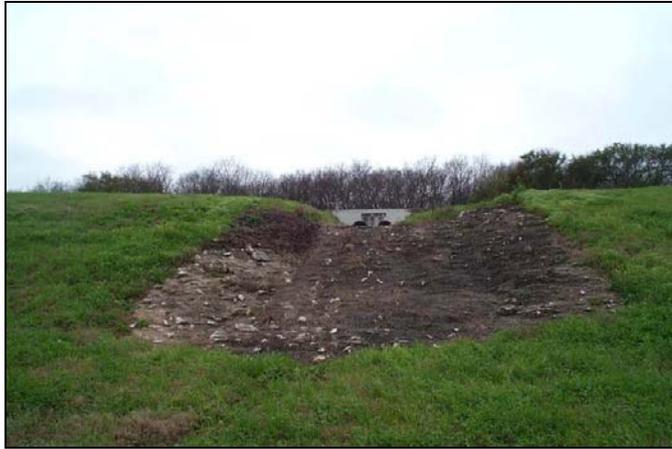
Photo M32. Eroded bank slope of floodway.

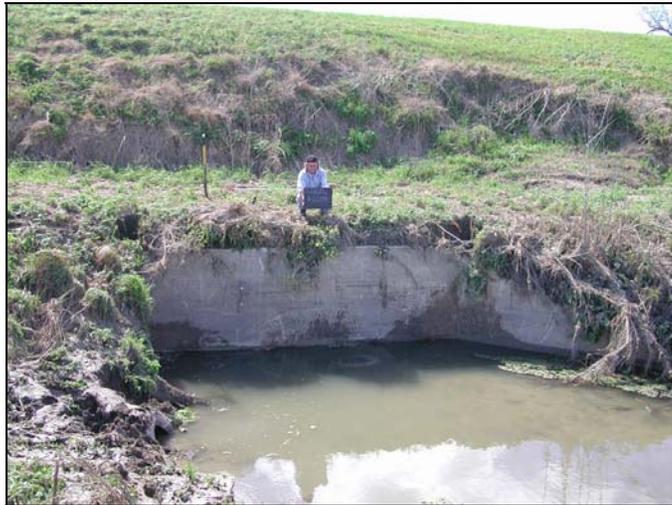
Photo M33. Unidentified storm drain.

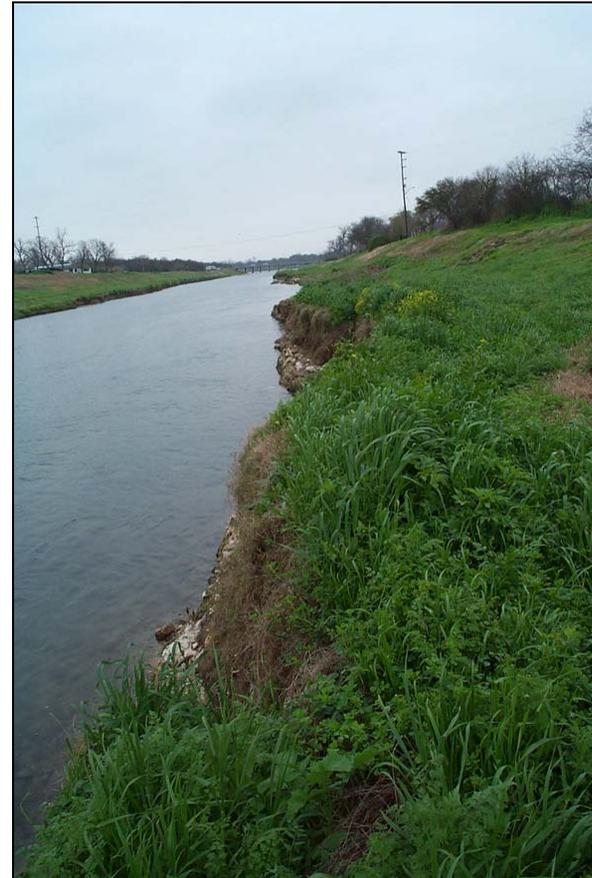
Photo M34. Headcutting and scour.

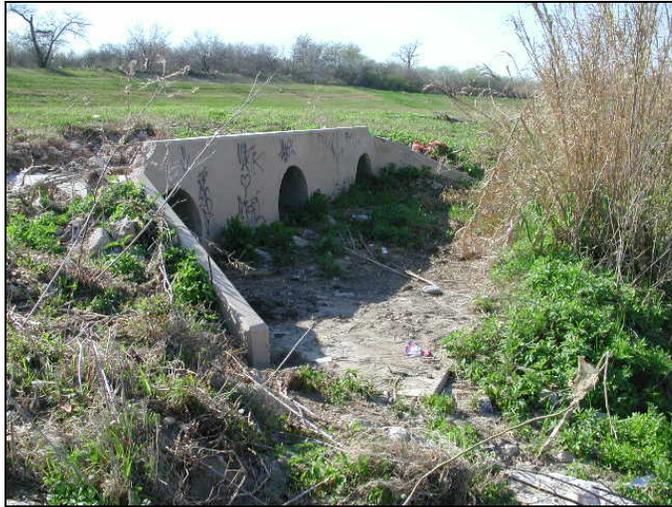
Photo M35. Unidentified storm drain.

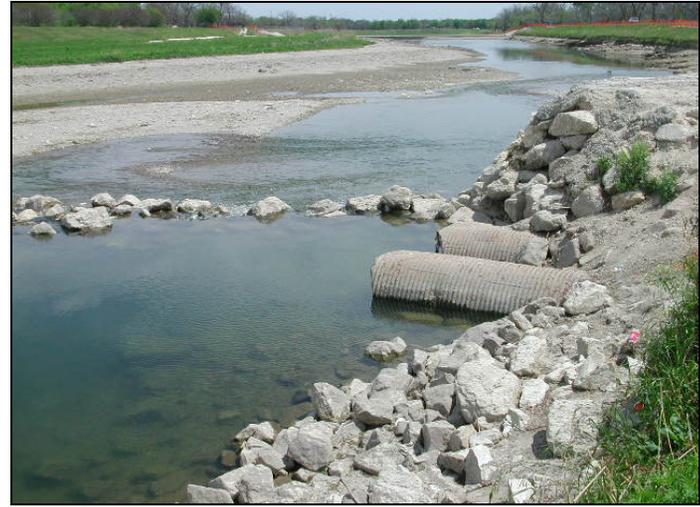
Photo M36. Unidentified storm drain.

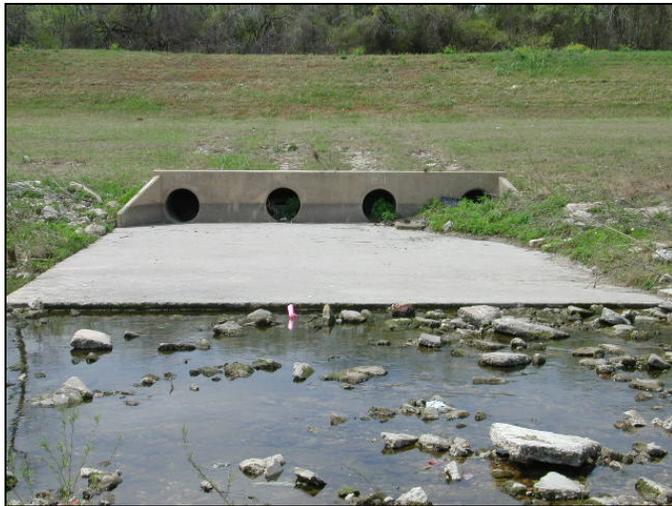
Photo M37. Unidentified storm drain.

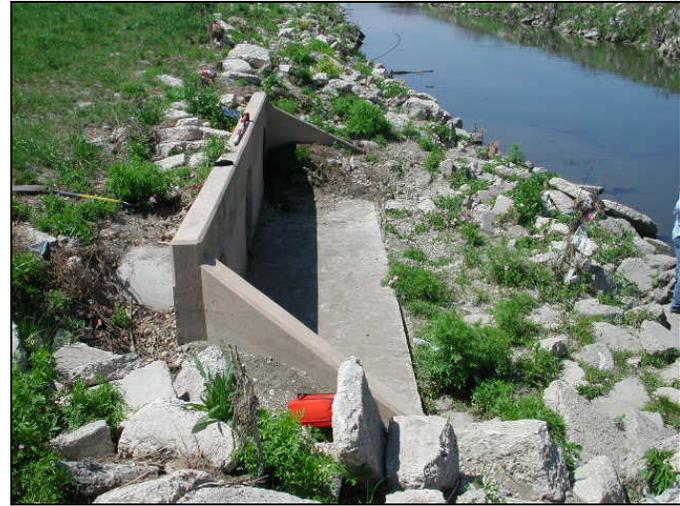
Photo M38. Unidentified storm drain.
