CITY OF DALLAS INTERIOR LEVEE DRAINAGE STUDY WEST LEVEE – PHASE II

VOLUME 2 of 2 – PUMP STATION ASSESSMENTS

January 2009

Large Able (LAX) Pump Station

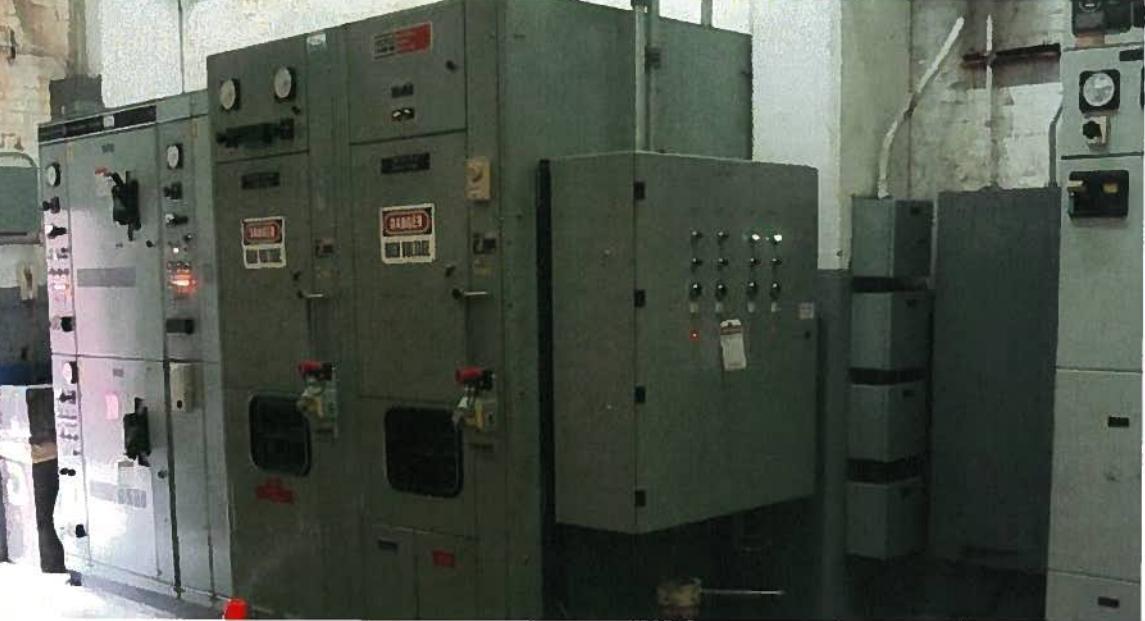
In the event of SCADA System failure, personnel are able to manually operate this station from the cabinet at the south end of the switchgear by switching controls from remote to local and selecting the start or stop switch. (Photo 3.1)

Photo 3.1 – LAX Switchgear and Pump Controls

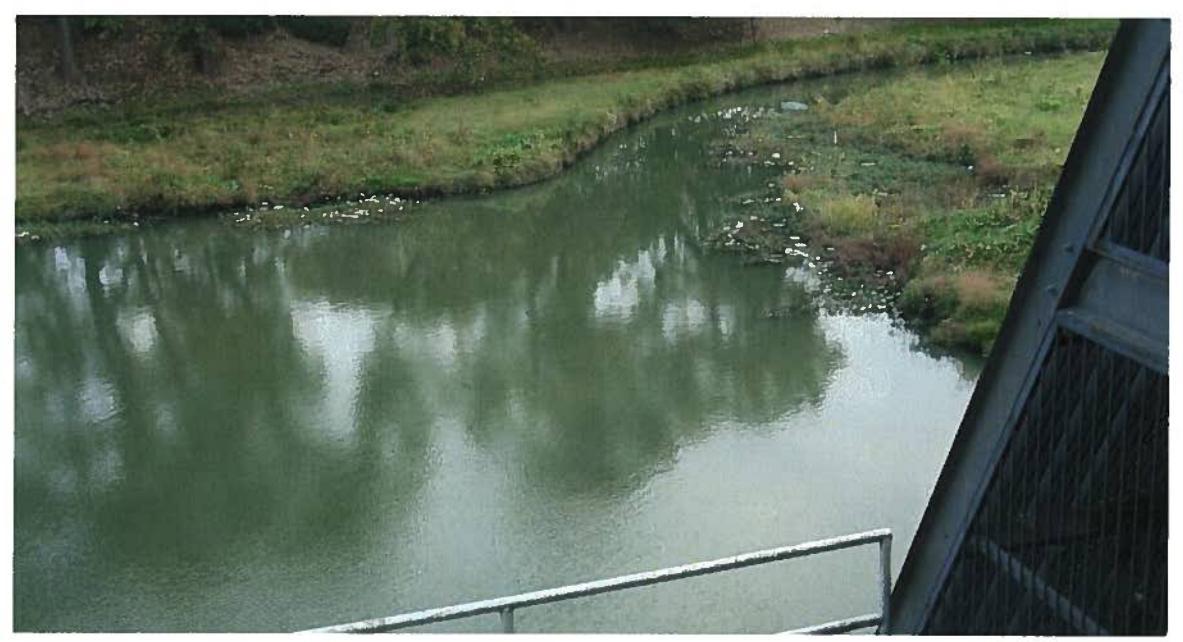
Photo 3.6 - SAX Sump Inflow from the South

As mentioned above, the screens do not show any damage. However, this site is more vulnerable to impacts by large objects due to the flow pattern of incoming flood water maintaining some velocity. (Photos 3.5 & 3.6)

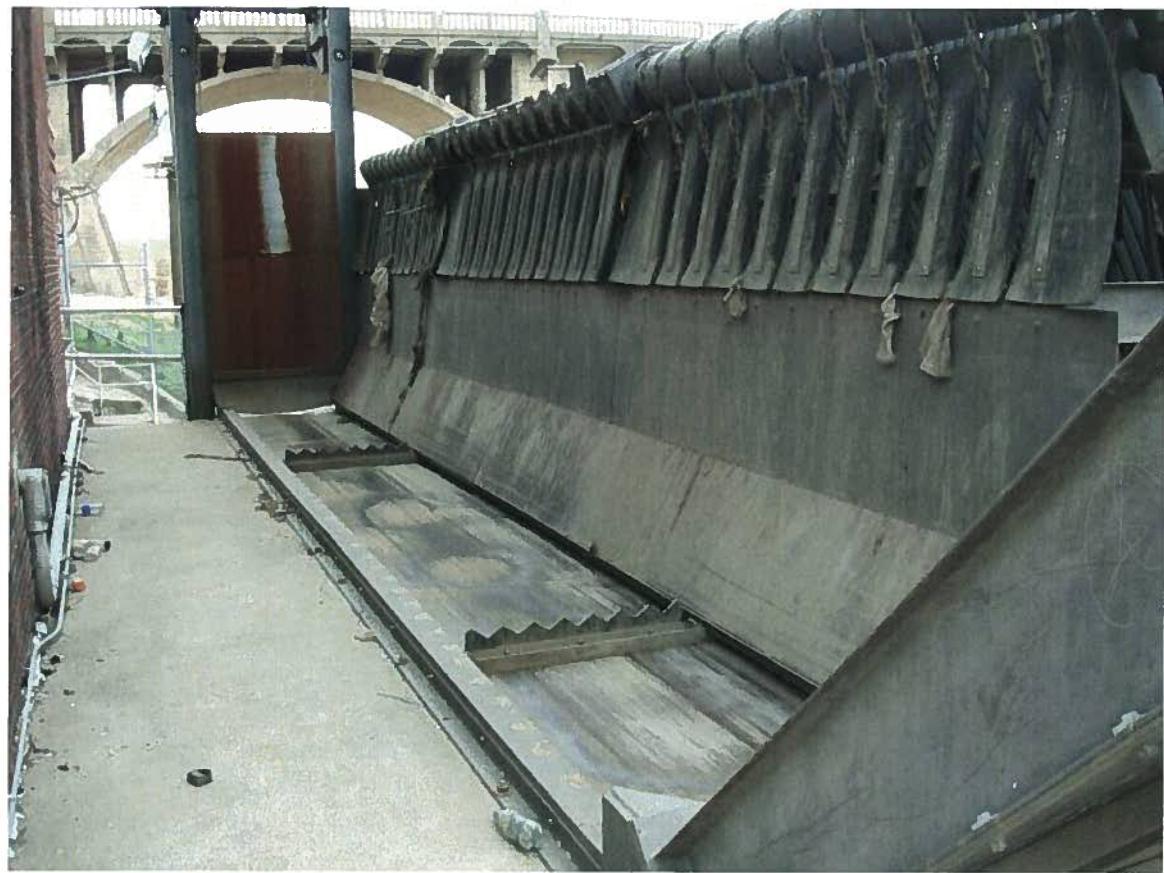
Photo 3.7 - LAX Conveyor System

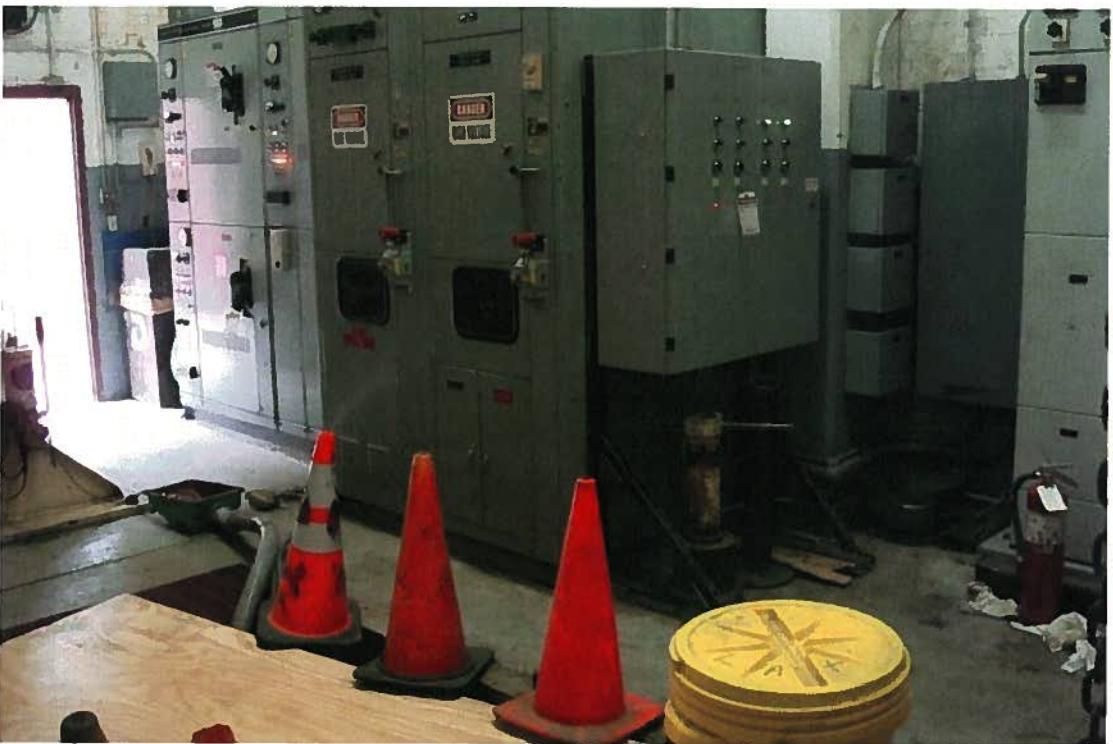
LAX is a poorly laid out pump room with little available space for working on its equipment. As mentioned above, the pumping units are very close to the switchgear. Personnel attempting to carry tools and/or equipment would have to be careful not to bump into either unit while walking between them. There are three main pumping units and one low flow pump. Two units are out of service and sent in for overhauls. There is nowhere to store the removed parts, making an already cramped space more hazardous. (Photo 3.12)

Photo 3.12 - LAX Pump Room, #2 Removed

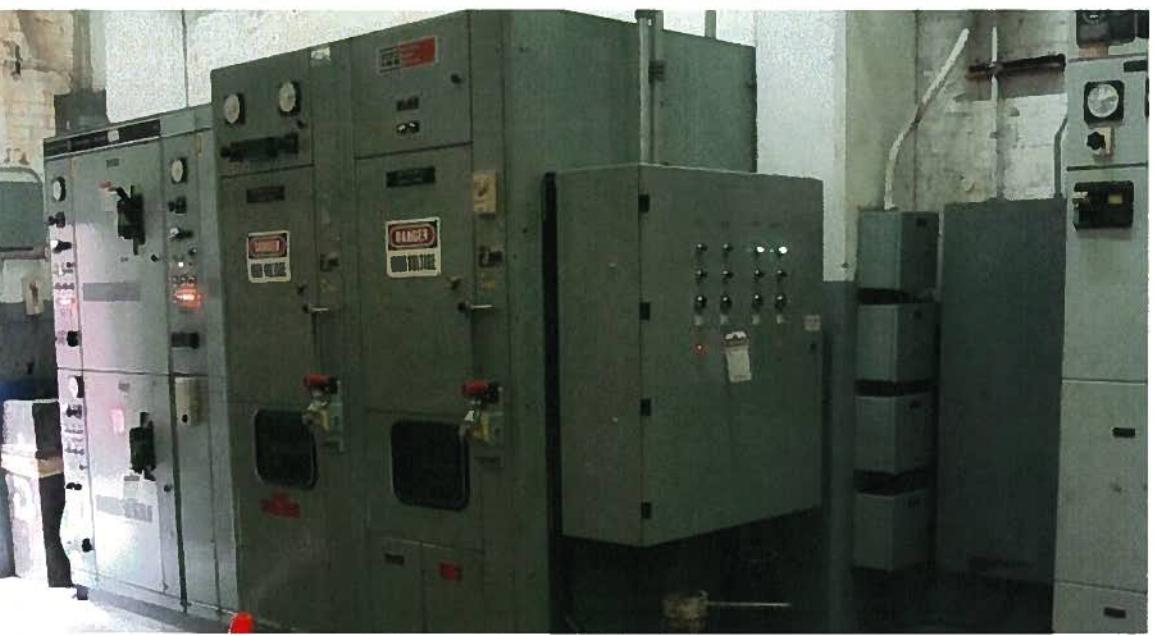
Photo 3.17 - LAX Switchgear

This equipment is at or past its expected service life. Its alarm relays are minimal, requiring on-site personnel to set and reset alarm flags. By comparison, modern electronic protection offers dial-in capabilities, event recordings, warning and alarm conditions, programmable features, etc.

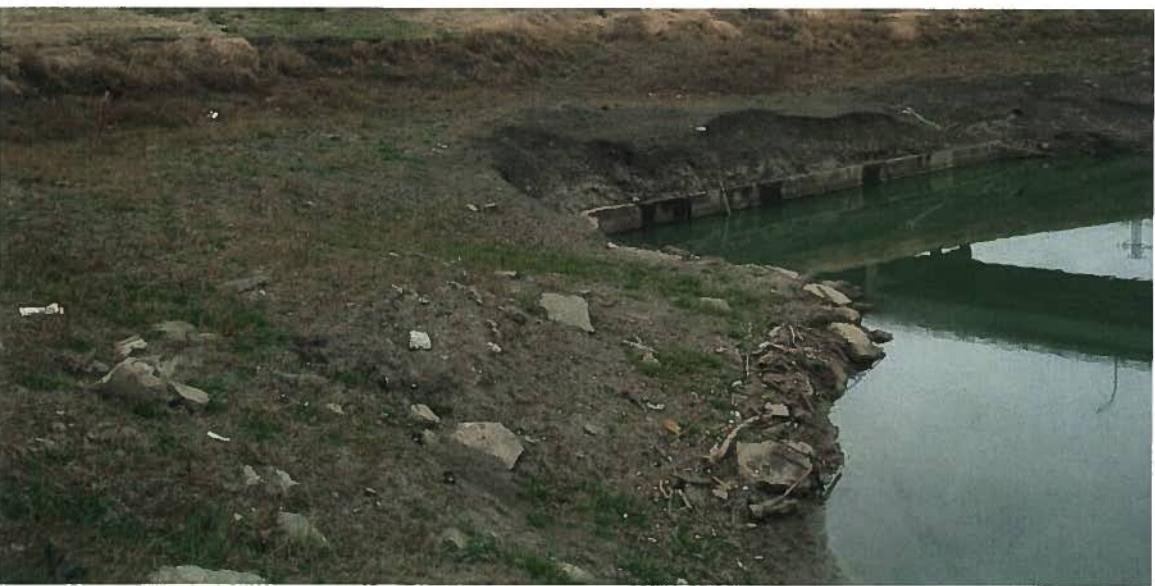
Photo 3.24 - LAX Outfall structure Shared with SAX

The area surrounding the outlet structure is lightly vegetated dropping off to loose soil just above the structure. (Photo 3.24) There are no signs of previous rip-rap. Although there had not been significant rainfall at the time of observation, there were signs of water leeching from the soil above the structure. The loose soil appears to be very unstable and it is likely to continue washing down in front of the structure into the outfall area until the area is stabilized. The outlets are beneath the water's level and the water is too murky to determine any existing conditions below the water line. The exposed portion is in excellent condition.

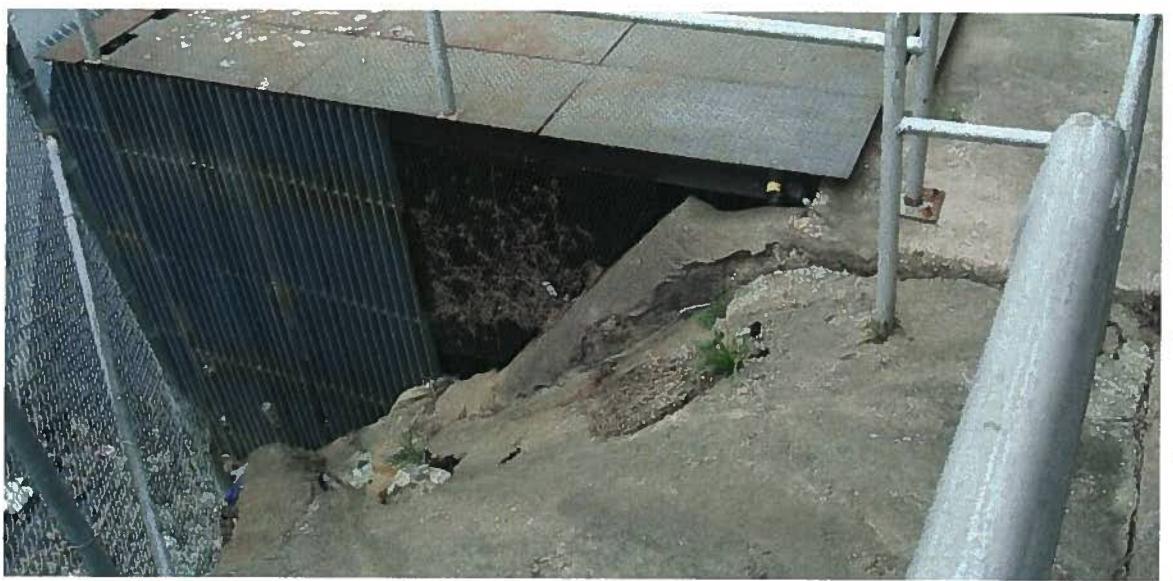
carries off drainage from the North side of the structure. This is not a structural concern but should be replaced in the next available contract. (Photo 3.7)

Photo 3.7 - SAX Drainage on North End of Screens

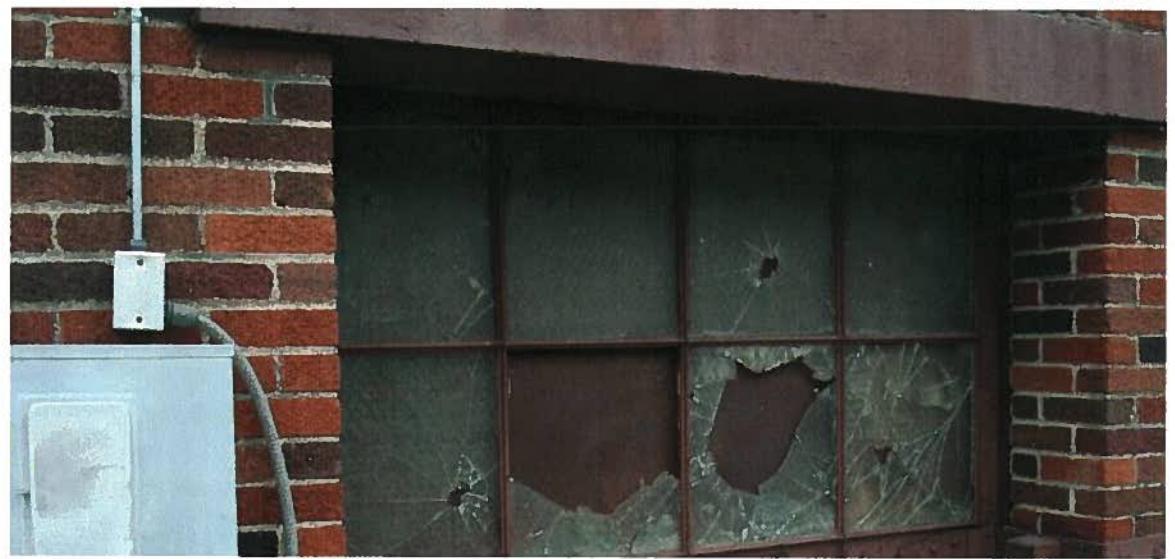
Photo 3.11 - SAX Vandalized North End of Building

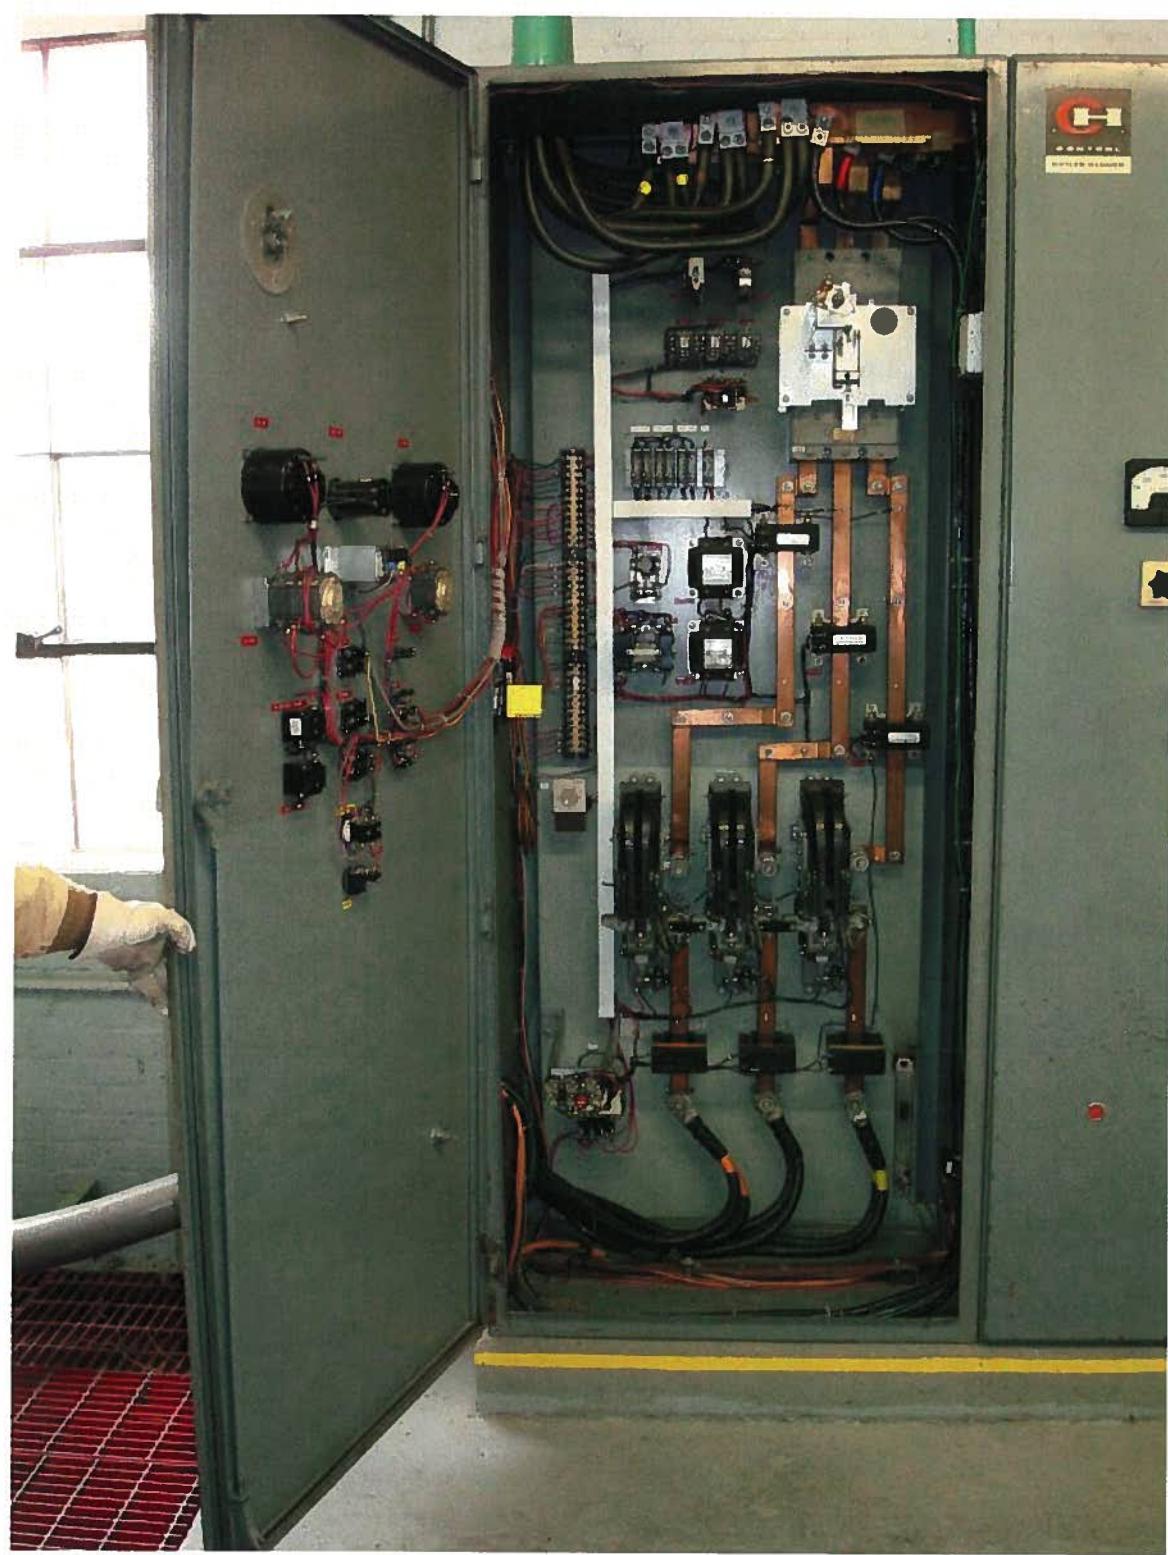
The switchgear itself is in good operational order. (Photo 3.13) As in other stations, its age makes acquiring parts difficult and the protection devices are the old mechanical type and meters are out of calibration. The relays are minimal, requiring on-site personnel to see and reset alarm trips. By comparison, modern electronic protection offers dial-in capabilities, event recordings, warning and alarm conditions, programmable features, etc. The switchgear was replaced in 1990. Now is a good time to consider the future role of this station before equipment is at or past its expected service life.

Photo 3.13 - SAX Switchgear Interior view #4 Unit

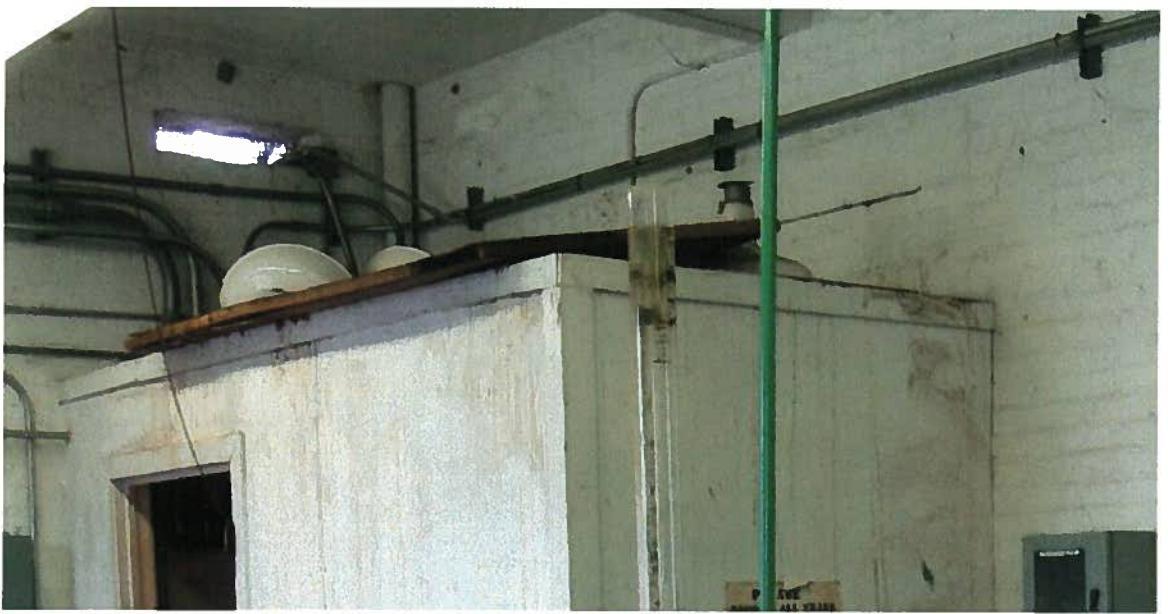
The Remote Terminal Unit (RTU) that controls this station on-site is located in a room within the pump room. This was built in-house to protect the equipment. (Photo 3.14) The walls of this room are stained from water entering the station. This could be through the equipment hatch, ventilation shaft, the penetration around the roof's drain line or the opening in the upper west corner of the south wall. Someone has placed a panel on top of this room to direct the water away from the room suggesting this is a known problem. The City of Dallas' EBS Department maintains and repairs roofs on city owned facilities.

Photo 3.14 - SAX RTU Room, Roof Leak in This Area

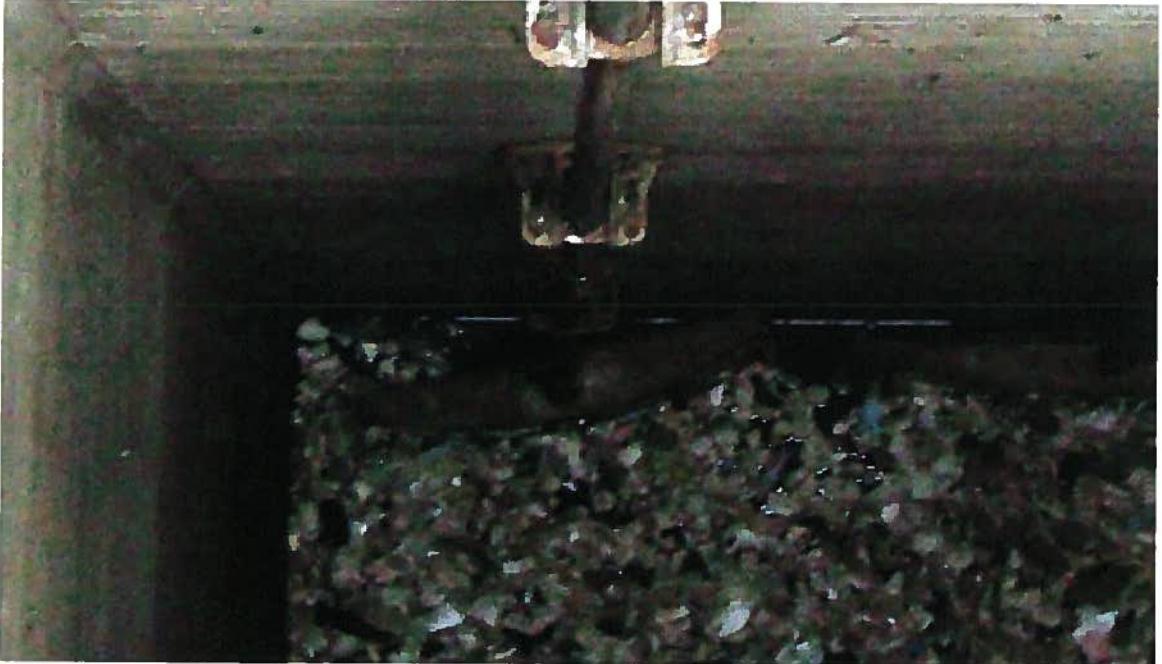
There are two electrically operated sluice gates at the end of the structure. Their operators and upper valve stems are well maintained. The north gate is locked and tagged out of service. The shafts extending down into the vault are straight but have visible corrosion show along their lengths. The wall mounted shaft supports appear to be secure but are also showing signs of corrosion. It is suggested that the nuts and bolts be changed out during the next maintenance period. (Photo 3.20)

Photo 3.20 - SAX Sluice Gates, North Gate Out of Slides

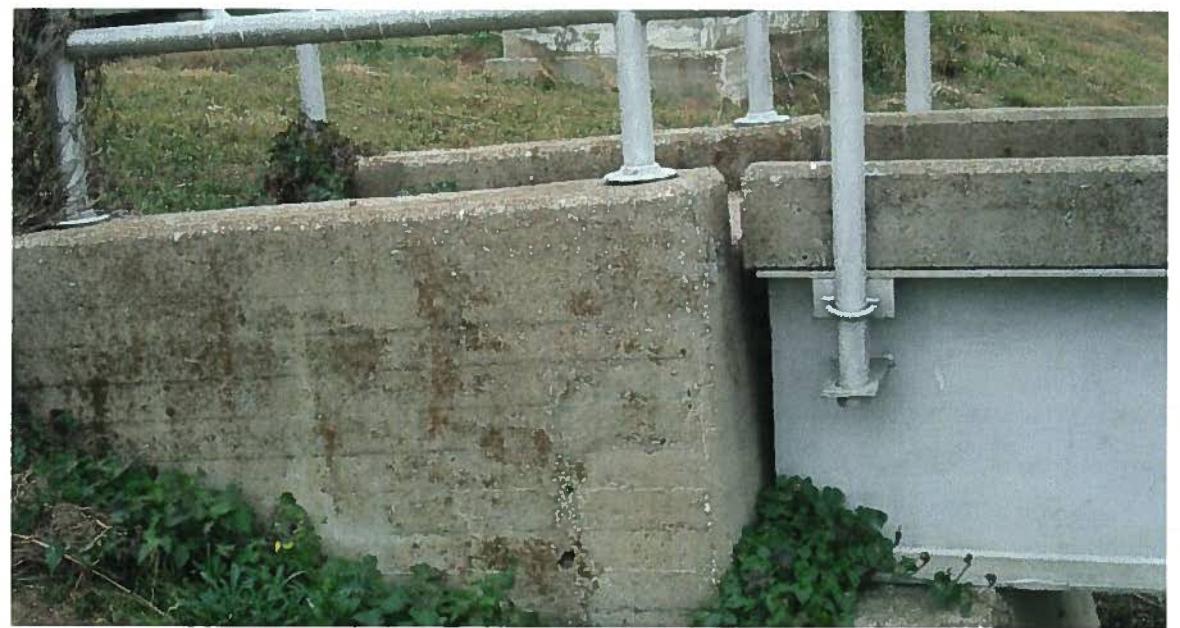
On the opposite end of this structure, the landing at the levee end of the bridge has dropped on the east end about two inches. This does not affect the bridge or its supports. This landing is a separate element. It is suggested that no attempt to re-level be done at this time. It should be watched to see if the conditions changes. (Photo 3.21)

Photo 3.21 - SAX Bridge Landing

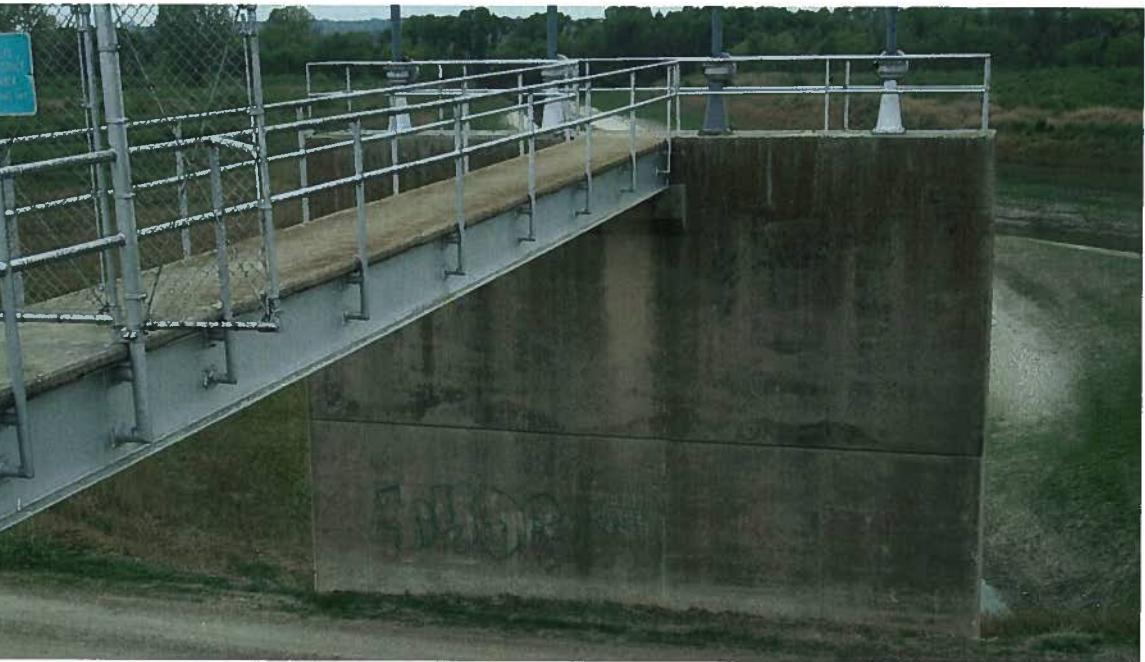
• The outfall structure (Photos 3.19, 3.20 & 3.21) has one visible structural defect on the Northwest point where the bridge anchors to the main structure. This appears to have been patched in the past. There is a slight misalignment being caused by movement between the structure and the landing on the levee. Because of the weight bearing down on this support and the fact that this is a reoccurring problem, it would be advisable to have a structural engineer inspect this and determine what action is needed.

Photo 3.19 - Old Baker Outfall Structure

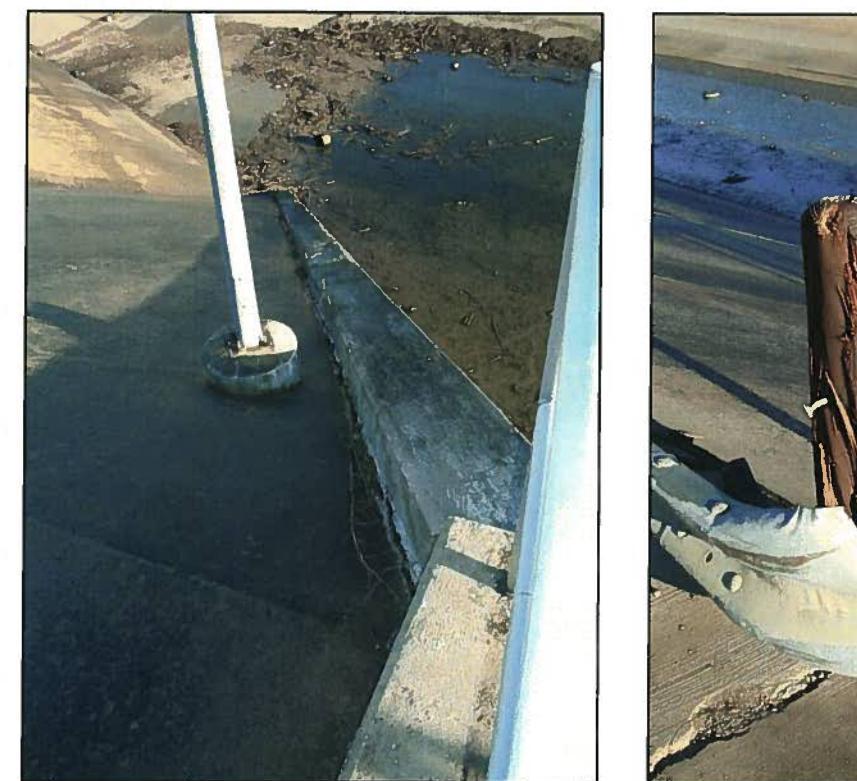
Photo 3.5 NBX North Wing Wall Sealant Failure Photo 3.6 - NBX Bent Rail and Bollard

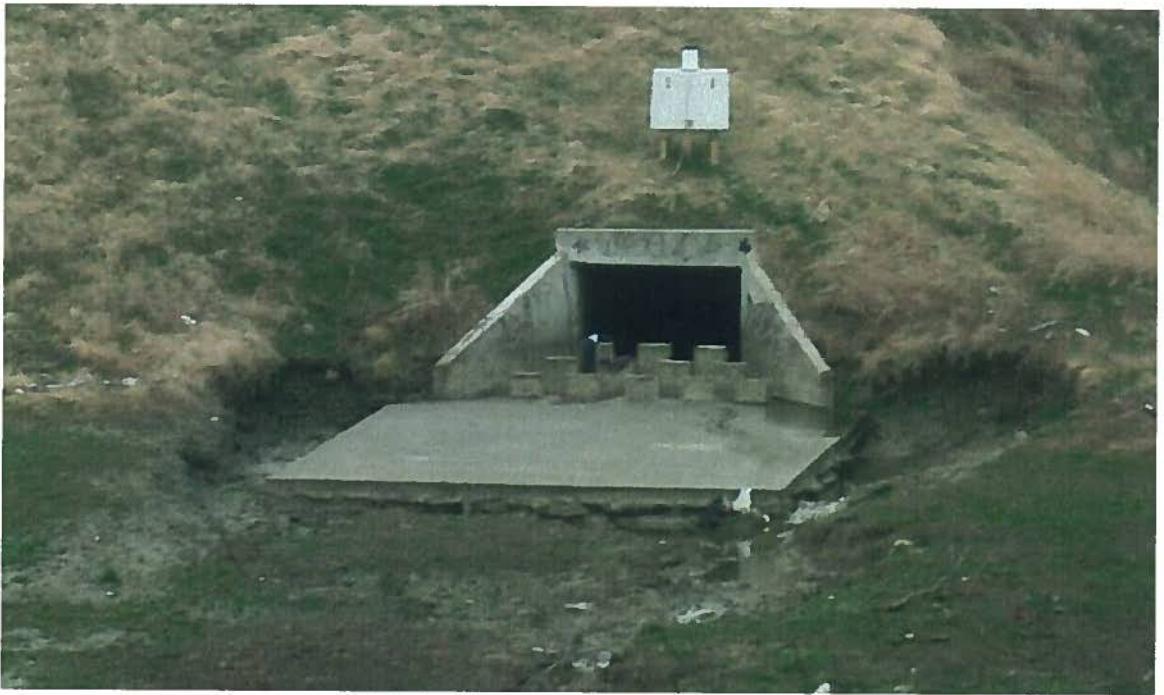
The discharge structure on the West bank of the sump area was a recent improvement. There are erosion problems occurring with soil washing out on both wing walls and soil is being undermined from under the connecting concrete slab. The flow dissipaters appear to be directing water to the end of the wing walls and washing away the embankment. There is also undermining of the pad's perimeter. If this was done under contract, the responsible engineering firm should be contacted, notifying them of the malfunction. This will require resolution before there is irreparable damage. (Photo 3.8)

Photo 3.8 - DX Sump Discharge Structure, West Bank

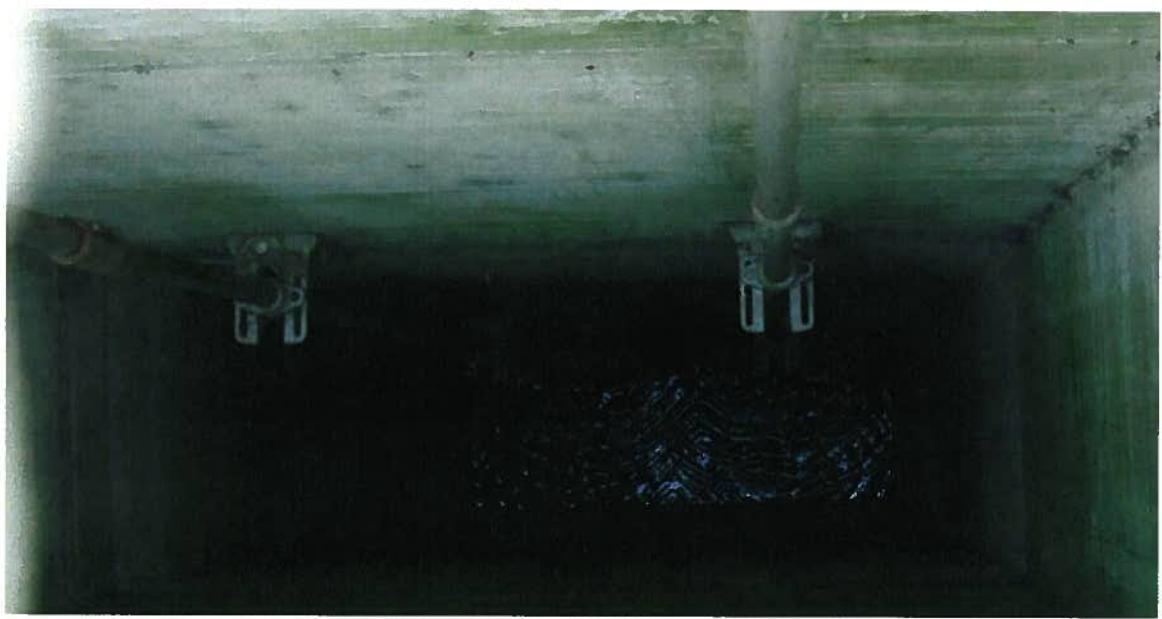
Photo 3.33 - DX Outlet Sluice Gates, Mild Corrosion on Brackets and Shafts

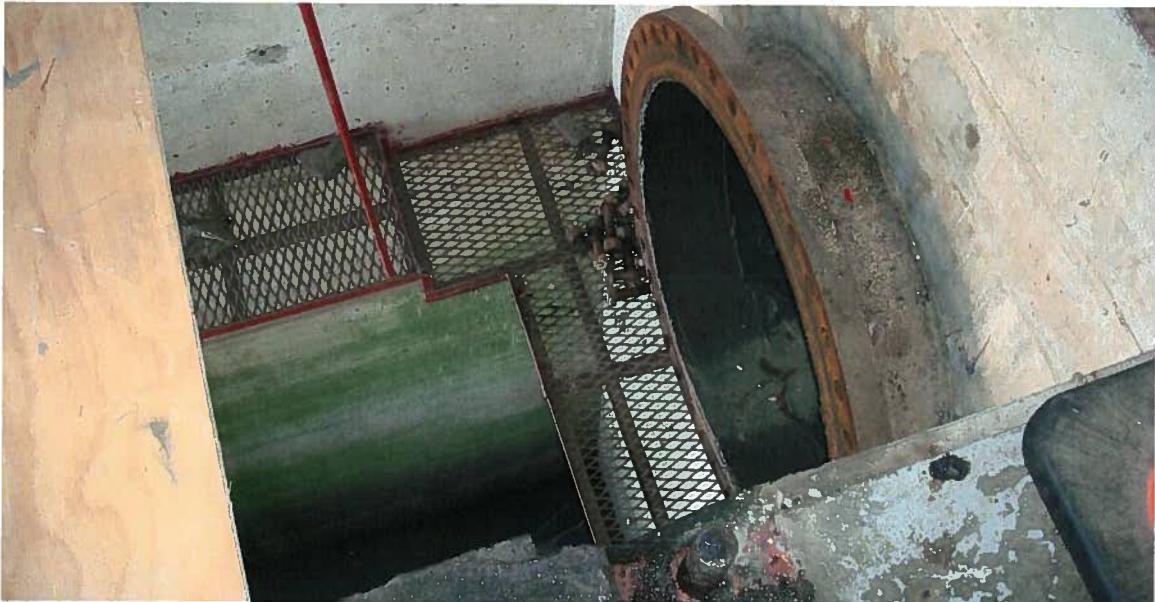
For the safety of personnel, more sufficient barricading should be provided when pumps are removed. The possibility and potential consequences of someone getting injured call for a more substantial safeguard surrounding the worksite. (Photo 3.3)

Photo 3.3 - OHX Pump Pit #2, Plywood Cover Not Adequate or Large Enough To Cover Entire Opening

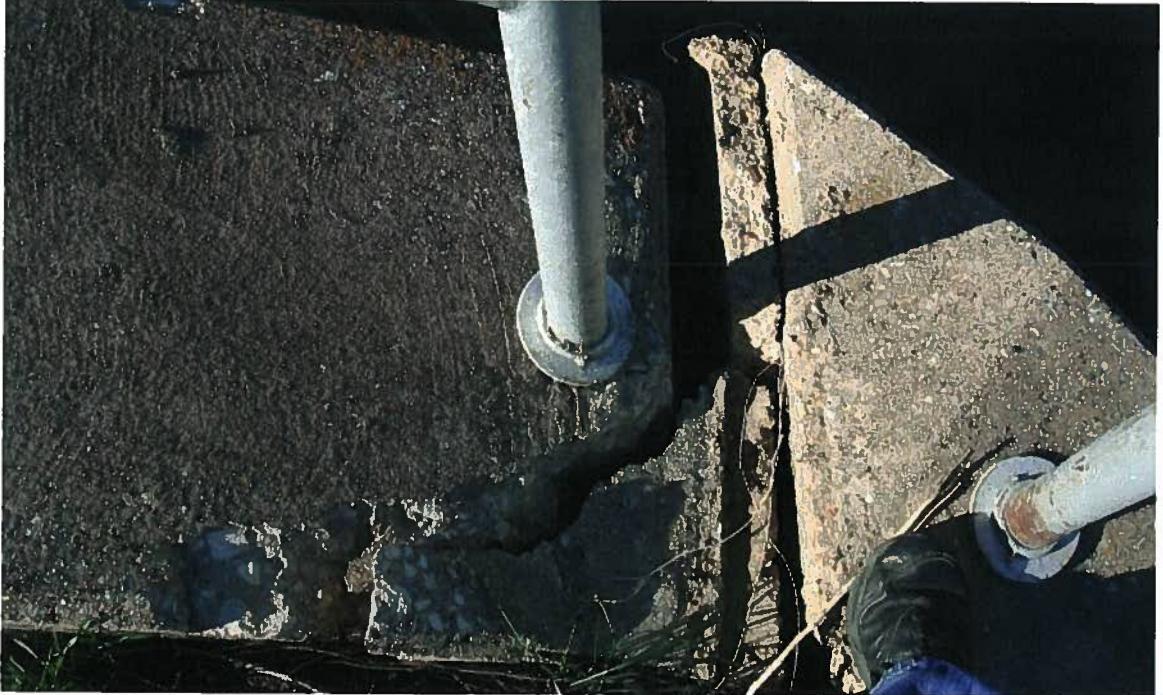
There is concern about the integrity at OHX's north and south wing walls. There is a noticeable movement and damage at two of the joints. A Structural Engineer should make a closer examination to determine if repairs are necessary. (Photos 3.6 & 3.7)

Photo 3.7 - OHX, South Wing Wall, First Joint Showing Movement and Crack, See Shoe Lower Right for Scale

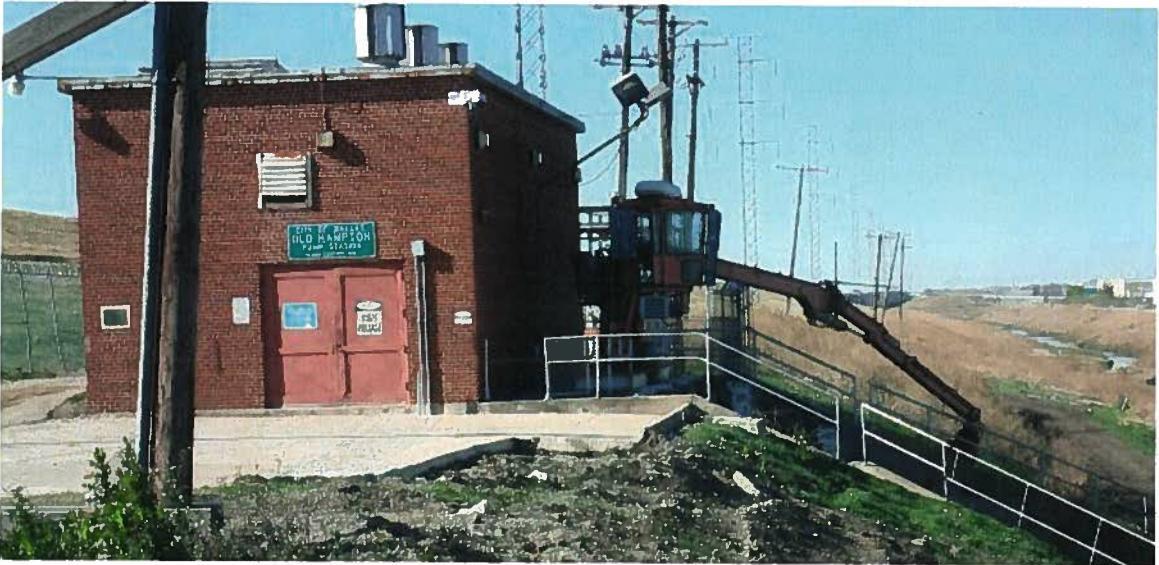
Photo 3.9 - OHX, braced pole in foreground, repairs cut in paving in middle of picture

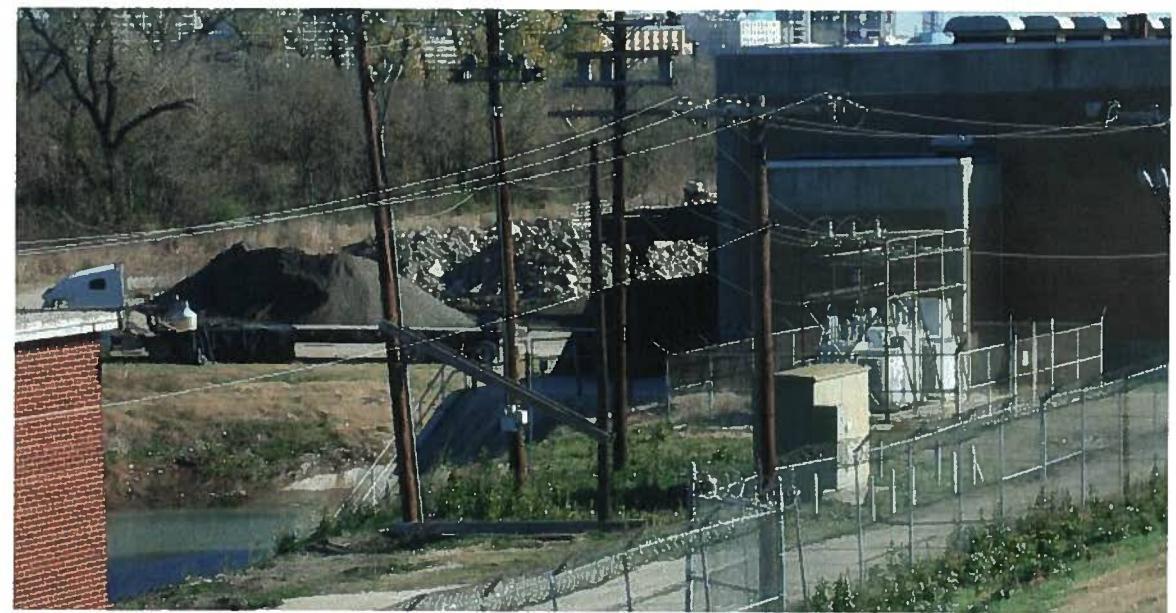
Numerous indications of unstable conditions can be seen along the west bank of the sump area at the OHX site including the damage and movement of the wing walls, on-going repairs to the parking area along the Sump's west bank, (Photo 3.8) and tilting telephone poles along this same bank. (Photo 3.9) Additionally, one pole between OHX and NHX required a secondary pole be installed to support and brace a power pole that has a severe tilt. (Photo 3.10)

Photo 3.10 - OHX, braced power pole

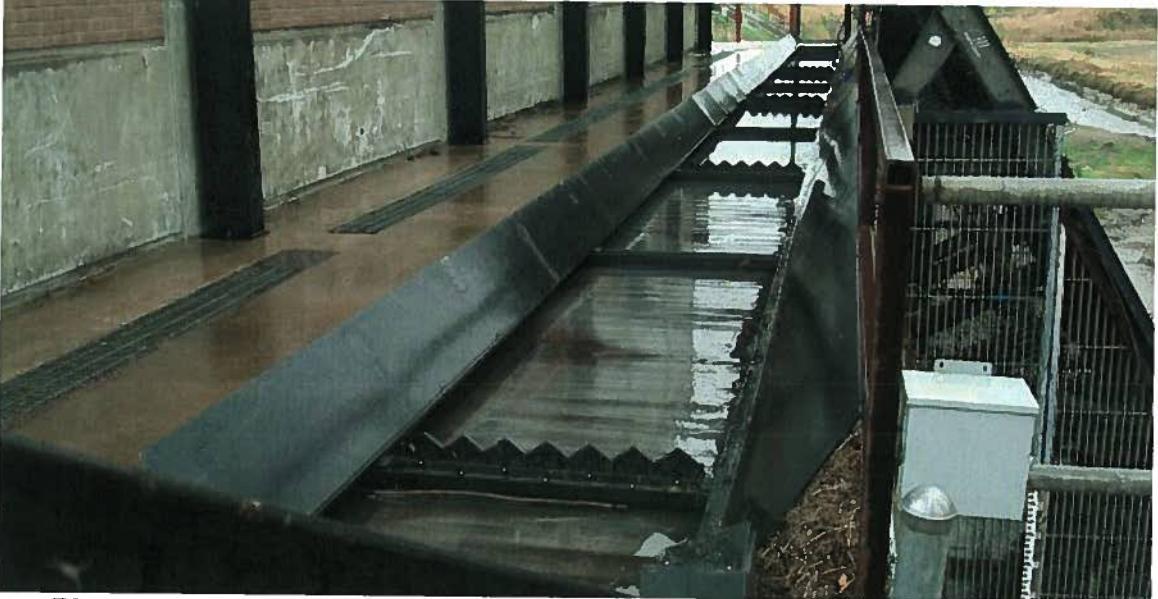
Photo 3.4 - Conveyor System, Problem Area at Incline Shown in Lower Left

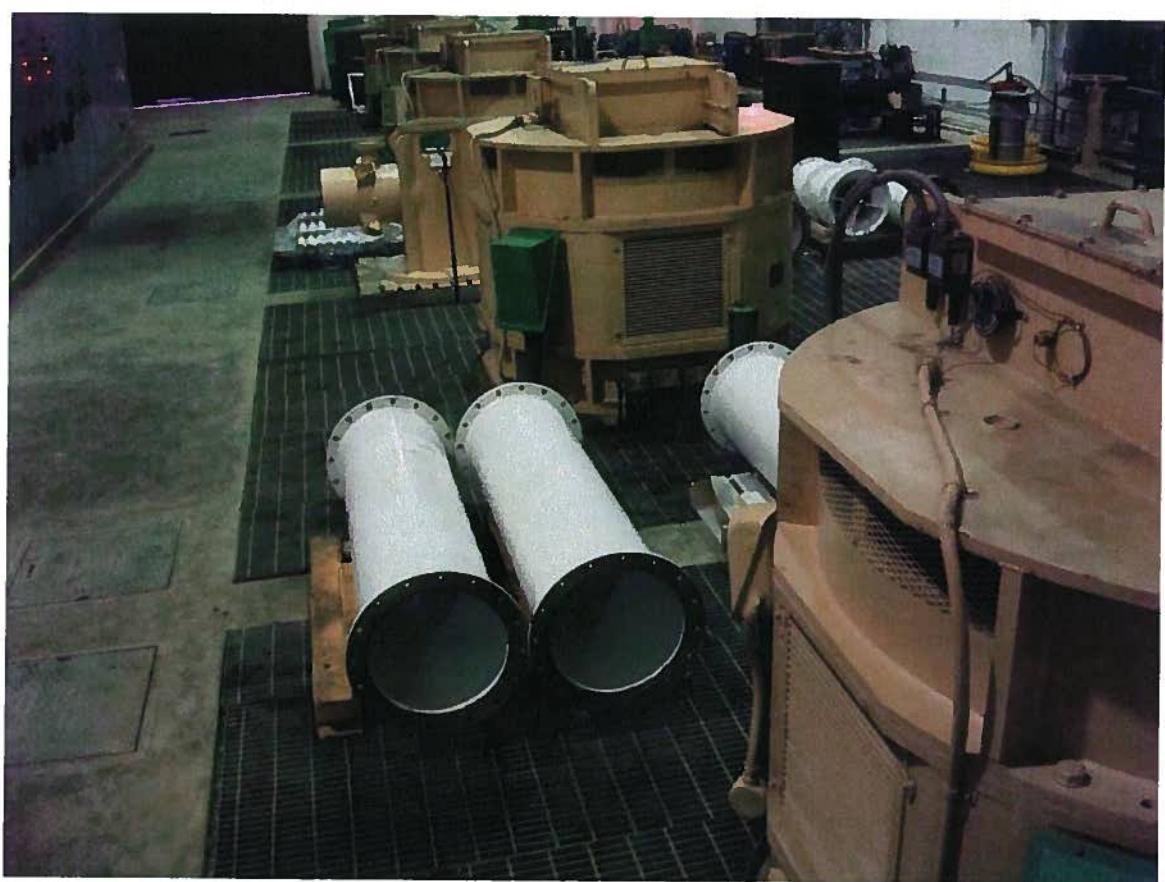
Photo 3.11 - NHX Storage Concerns

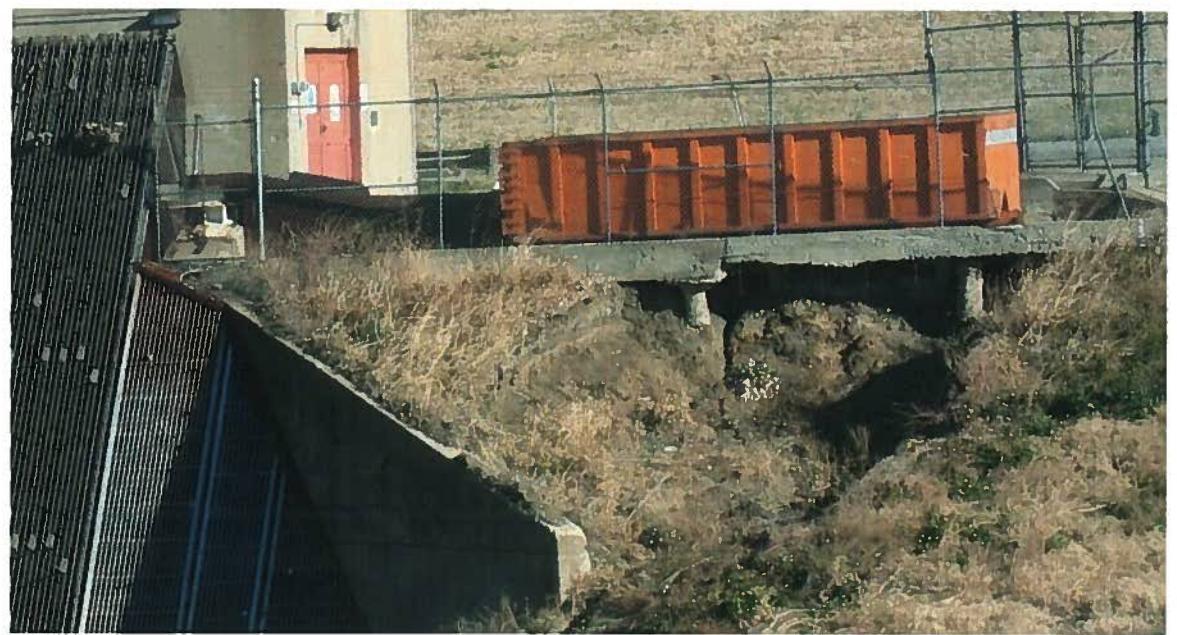
Photo 3.7 - DX, slippage "prior to repairs" on north side of screens

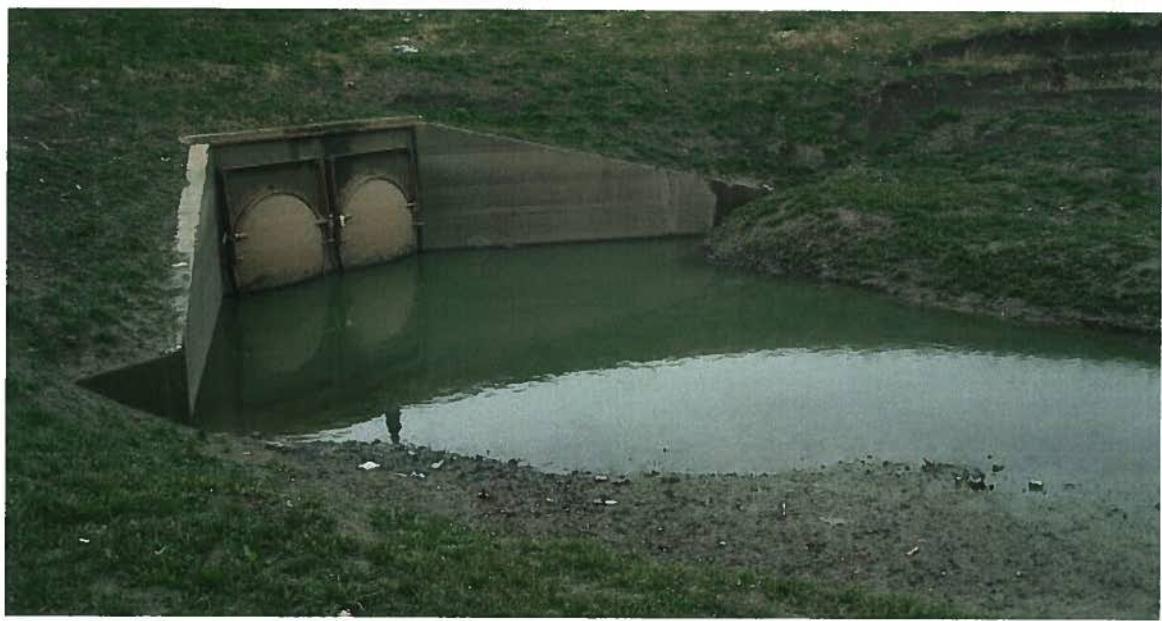
Photo 3.25 - PX Outfall Silt Build-up
