FINAL Site Inspection Report Hammond Bombing and Gunnery Range Tangipahoa Parish, Louisiana

FUDS Project No. A06LA030901
Contract: W912DY-04-D-0005
Task Order: 0009

**Site Inspection Report
Hammond Bombing and Gunnery Range
Tangipahoa Parish, Louisiana**

FUDS Project Number A06LA030901

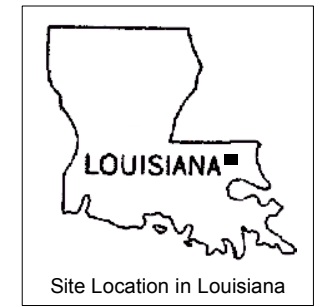
- 9 ● Munitions Debris Location
- 1 ● Other Field Observation Location
- ▲ Groundwater Sample Location
- Qualitative Reconnaissance Track
- Decision Unit
- Bombing Target
- Gunnery Range
- Multiple Use Target (as shown in ASR Supplement)
- Rifle Range
- FUDS Property Boundary
- Adjusted Location of Multiple Use Target Based on Stakeholder Information
- Area of Potential Cratering AOI

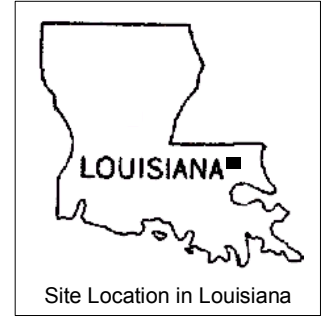
- Groundwater Sample Location
- Qualitative Reconnaissance Track
- Decision Unit
- Bombing Target
- Gunnery Range
- Multiple Use Target (as shown in ASR Supplement)
- Rifle Range
- FUDS Property Boundary
- Adjusted Location of Multiple Use Target Based on Stakeholder Information
- Area of Potential Cratering AOI

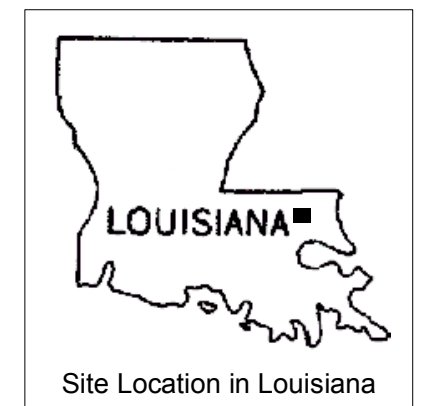
- Surface Soil Sample Location (Decision Unit)
- ▲ Groundwater Sample Location
- Qualitative Reconnaissance Track
- Bombing Target
- Gunnery Range
- Multiple Use Target
- Rifle Range
- FUDS Property Boundary
- Area of Potential Cratering AOI
- Wetland (Obtained from U.S. Fish & Wildlife Service)
