APPENDIX D-

FISH AND WILDLIFE COORDINATION ACT REPORT

This letter provides planning assistance for the Onion and Williamson Creeks Interim Feasibility Study within Travis and Hays counties, Texas. The purpose of this letter is to identify and describe existing fish and wildlife resources within the proposed project areas.

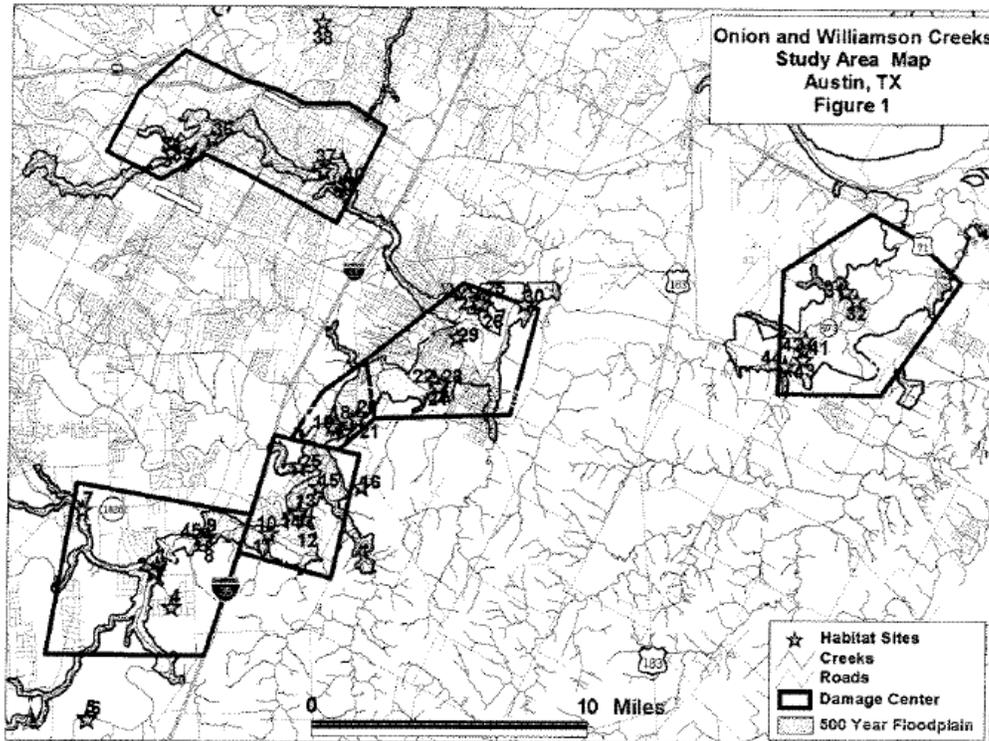
The study area is located in Travis and Hays counties, Texas and the watershed is entirely within the Lower Colorado River Basin. The Onion Creek watershed includes Williamson, Slaughter, Bear, Little Bear and Onion Creeks. The headwaters of the Onion Creek watershed are located in Hays, Blanco, and Travis counties, Texas. Six specific damage areas have been identified for study within the Onion and Williamson Creek subwatersheds (Figure 1).

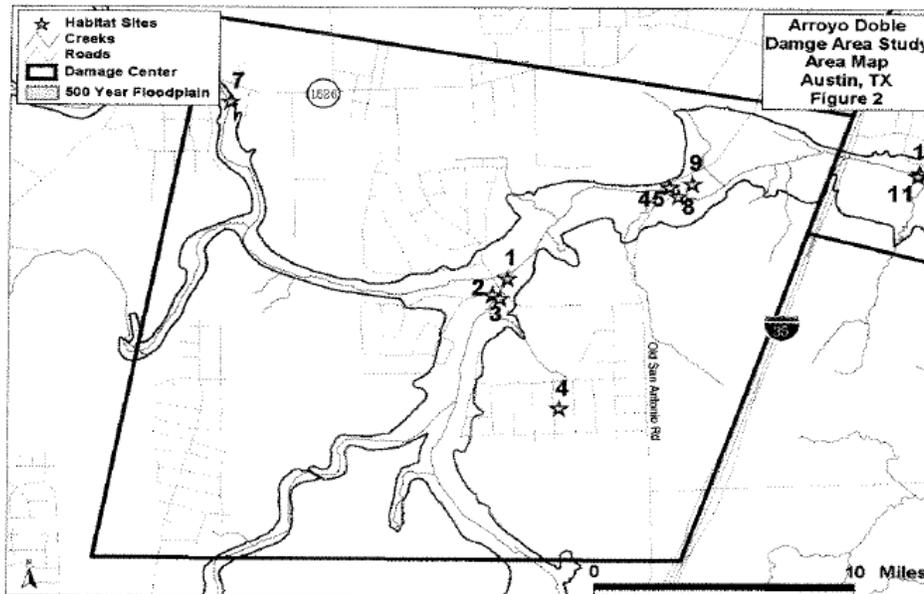
The Arroyo Doble Damage Area is located near the confluence of Bear Creek and Onion Creek west of Interstate Highway 35 (Figure 2). There are several older neighborhoods built on the isthmus between these two streams and on the banks of both streams. The riparian zone here is starting to take on more of an Eastern character, like the Blackland Prairie, with flatter topology, soil/clay banks and large deciduous trees. The understory for at least 20 meters on either side of Onion Creek in this area is well established and diverse. The canopy is dense, consisting of primarily pecan, walnut, and cedar elm. The extent of the riparian zone for both streams is about 75 meters on either side of the stream (150 meters total), but is encroached upon regularly by residential development. Outside the 75 meters riparian zones there is a mix of upland juniper and live oak, residential development and light cultivated agriculture and pastureland.

Several low water dams in this damage area have greatly altered the natural channel of Onion Creek within the damage area. Above the upstream dam (about 1/4 mile above Twin Creeks road) the channel is flat and filled in with cobble and gravel. The gradient of Onion Creek from the top of the damage area to the dam is very low. Water willow and emergent vegetation are dominant in this wide, flat section of the stream. Stream flow through this section typically goes subsurface by July with water found only in several deep pools throughout the damage area.

The second low water dam in this damage area is formed by the old low water crossing of the original San Antonio road (now at Twin Creeks road). This old bridge is just upstream from the confluence of Bear Creek and Onion Creek. Onion Creek is a bedrock channel in this section of stream. The bridge creates a deep pool upstream and is a popular fishing spot. The pool probably holds water throughout most years. The bridge does act to back water up and the culverts beneath the bridge routinely clog with woody debris.

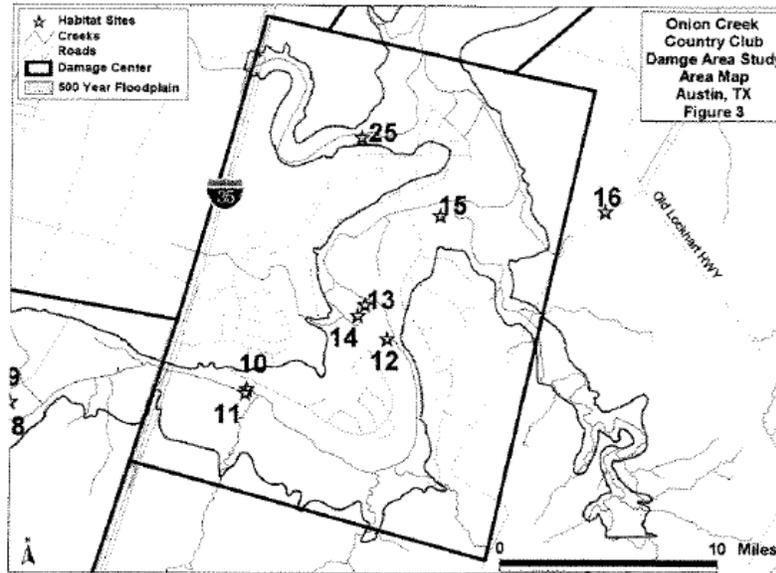
The Onion Creek Country Club Damage Area begins just upstream of Interstate Highway 35 (Figure 3). The small stretch of Onion Creek upstream of the highway is accented with a diverse and healthy riparian area. The area downstream of the highway includes a large residential development and 3 golf courses that dominate this section of Onion Creek. The riparian zone in this reach is extremely narrow (less than 30 meters) and relatively non-functional, particularly within the Onion Creek Country Club, where the understory and much of the canopy cover has been cleared. The riparian area on the opposite side of the streambank from the golf course does contain some dense, healthy habitat. In addition to the clearing of riparian habitat, large growths of algae were noted along the stream. The algae can be detrimental to life in the stream because they decompose after growth periods and consume most of the stream's dissolved oxygen. The golf course uses wastewater effluent for irrigation and the high nutrient load may be acting synergistically with the increased sunlight from the cleared canopy to promote high levels of algae growth. This area needs an active riparian management strategy to reclaim the high potential habitat value for riparian species.

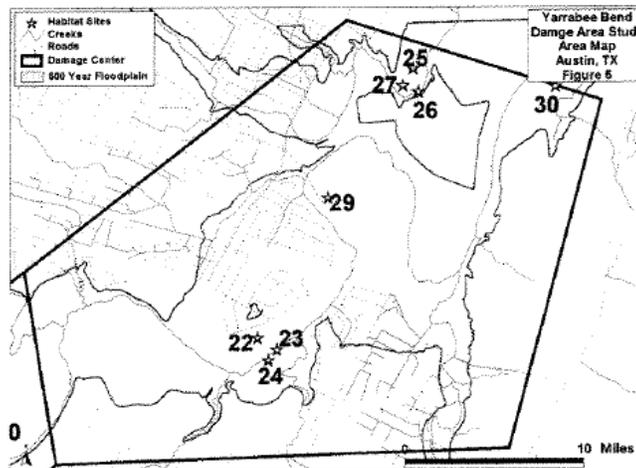
Spotty, but dense, residential and commercial developments characterize this section of Onion Creek (Figure 5). The riparian zone is relatively wide and healthy in some places (greater than 200 meters) and entirely absent in others. Again, due to the deep Blackland Prairie soils and clay banks in this lower section of Onion Creek, there are significant erosion problems in this reach where the riparian zone has been degraded. The canopy in the established riparian areas is dense, high and dominated by pecan, elm, and in some places cypress. In general, the riparian zone in this reach is in fair to moderate condition and relatively intact, with some exceptions on both ends of the spectrum. In the lower end of this reach there is a golf course and abandoned sludge tanks that have historically caused water quality problems on both Williamson and Onion creeks.

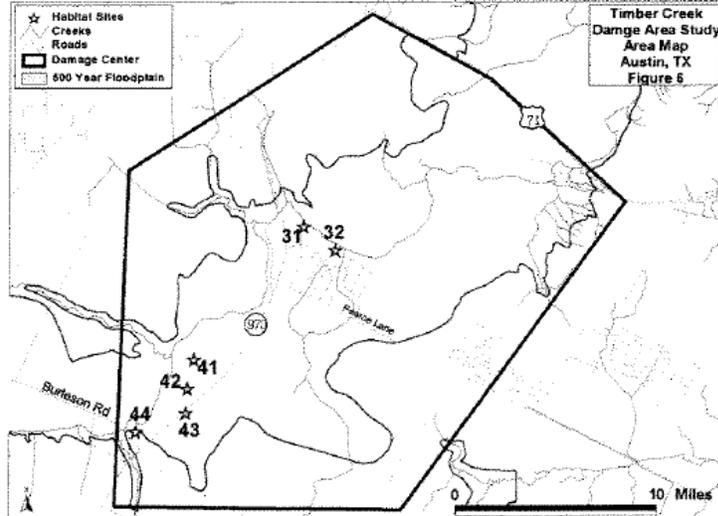
This area in the lower end of the Onion Creek watershed has been extensively farmed/grazed and has little forest cover except along the riparian zone of Onion Creek (Figure 6). This reach has high soil/clay banks typical of the blackland prairie ecoregion and a large deciduous canopy where it has been left alone. There are several sections of this stream where row-crops have been planted right up to the edge of the stream and there is virtually no riparian zone. In other areas the riparian zone is large (more than 200 meters), dense and intact. In general this reach is highly degraded from agricultural and grazing activities and appears to have many areas susceptible to erosion due to a non-continuous and low-quality riparian zone.

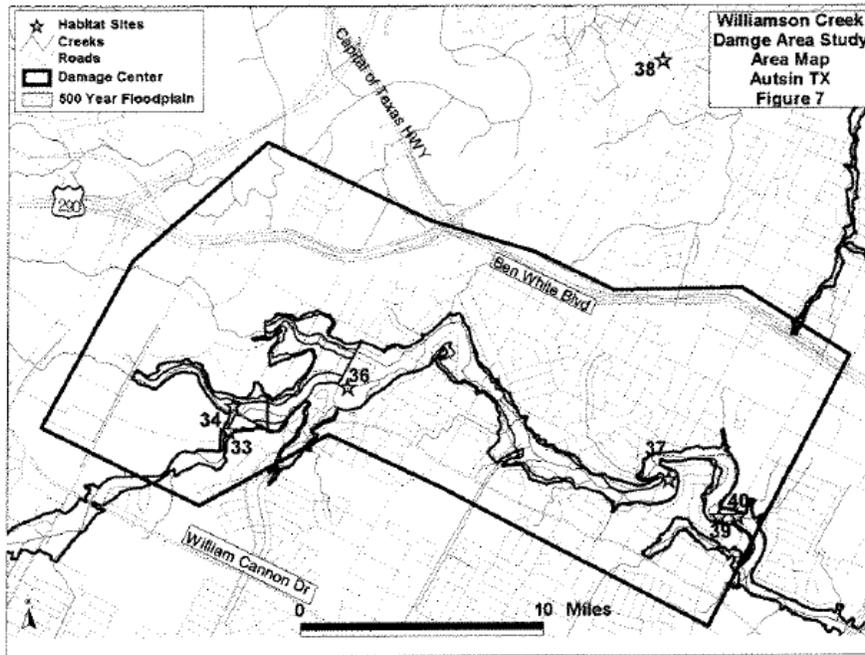
This area is in the Williamson Creek watershed (Figure 7) and is densely developed with residential and commercial land uses (~20% impervious cover). The upper portion of the damage area is located in the recharge zone for the Barton Springs segment of the Edwards Aquifer. A small area downstream of the recharge zone is classified as a contributing zone because water flowing from this area actually flows into the recharge zone. The lower portion of the damage area is in the artesian zone and does not contribute water to the Edwards Aquifer.

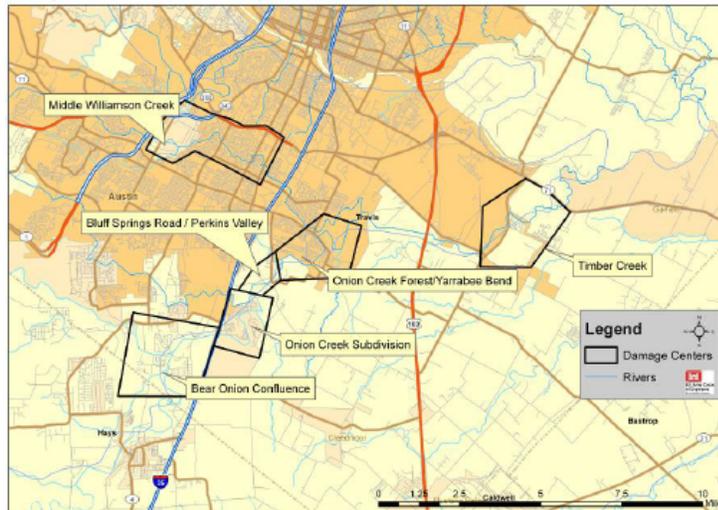
Figure 2 (Figure 2.2 from the EA)

Areas of interest in the Williamson Creek segment are shown in the following figure from the EA:

Designated Areas of Interest Figure 2.2

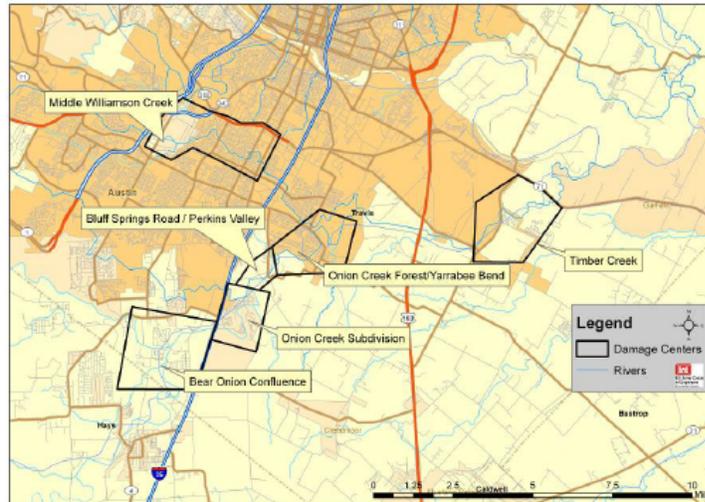
Figure 2 (Figure 2.2 from the EA)

Areas of interest in the Williamson Creek segment are shown in the following figure from the EA:

Designated Areas of Interest Figure 2.2
