## Executive Summary

This draft technical memorandum provides a summary of findings to support preliminary design of the San Antonio River Improvements Project. This document mainly focuses on the geomorphic assessment and sediment transport analyses that are supported by historic channel assessment and hydrology & hydraulics sections. The final section of this memo provides preliminary design criteria for the South Reach of the San Antonio River.

## Geomorphic & Sediment Transport Technical Memorandum Mission Reach/ S.A.R.I.P

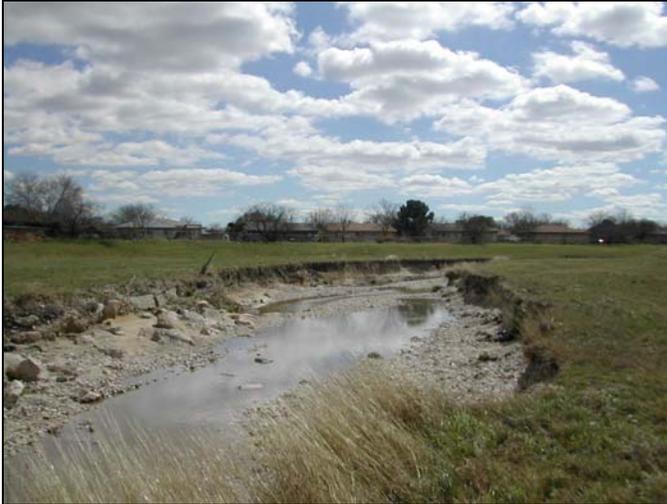
**Photo G.1** Zarzamora Creek downstream from the Ingram Road Bridge shows active bank and bed instability, bed incision, and channel widening.

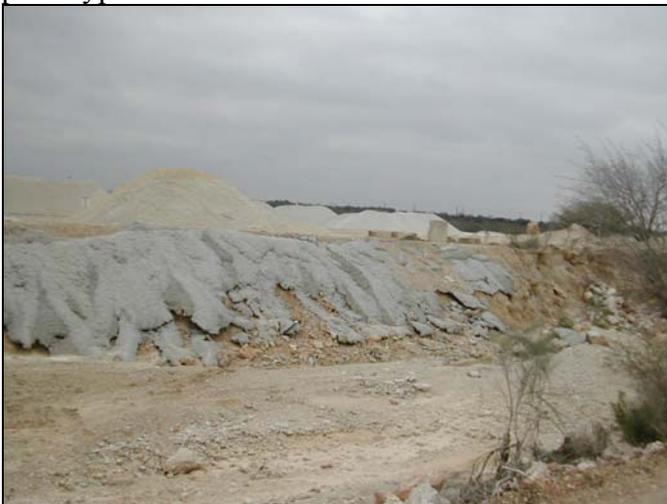
**Photo G.3** An ephemeral segment of Olmos Creek adjacent to active gravel mines and quarries upstream of Huebner Road north of San Antonio.

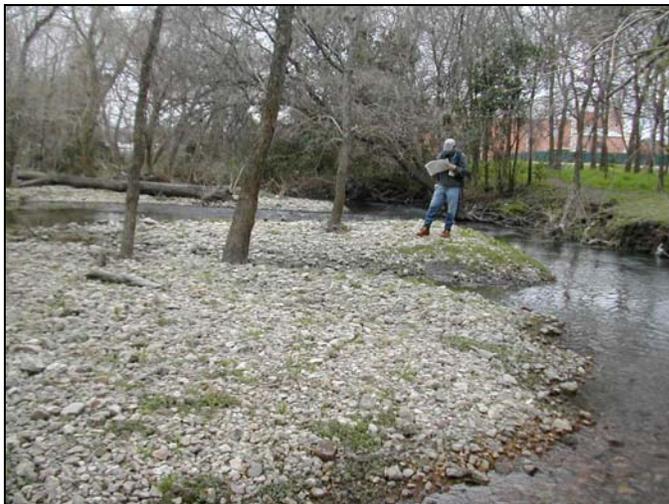
**Photo G.6** As a result of poor sediment conveyance and aggradation, a large mid-channel bar has formed at the confluence of Olmos Creek and the headwaters springs of the San Antonio River.

At the confluence with the San Antonio River and Olmos Creek at 200 Patterson Condominiums (Sta.2476+00), over 5 feet of channel aggradation was observed by local residents and employees after the 1998 flood. Where Olmos Creek meets the San Antonio River, a large mid-channel gravel bar deposit has formed, a likely remnant 1998 flood deposit derived from Olmos Creek (Photo G.6). Adjacent banks are well vegetated with woody species along non-developed segments. A condominium apartment complex maintains a turf grass and concrete-bag revetment wall along the channel margin on the left bank upstream from the converging drainages. Farther upstream, contributing flows from spring-fed PVC pipe outlets are frequent. Well-vegetated mid-channel bars and vegetated islands are also abundant, forming split flows having an anastomosed channel pattern. Infrastructure including pedestrian asphalt pathways, storm outlets, floodwalls, and bridges laterally constrains the channel to a narrow floodplain corridor (< 80 feet).

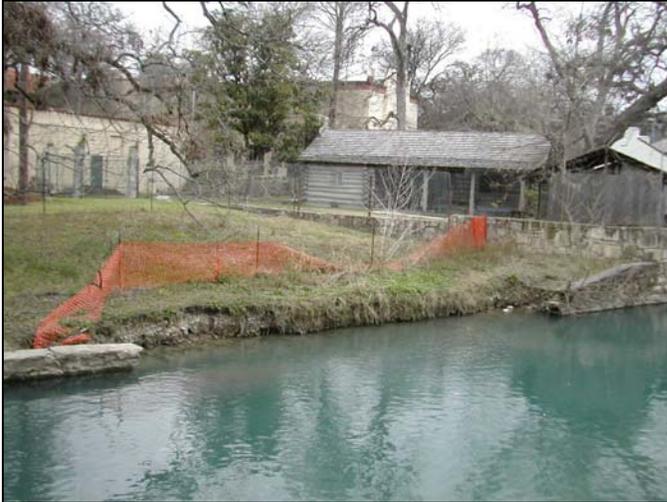
**Photo G.7** WPA wall failure along the left channel margin through the Park 1 sub-reach.

(northward) as the river. Through this reach, mason WPA limestone rock walls confine the low flow channel. These vertical mortared walls form the active channel margin. Local instability and wall failure is common (Photo G.7). Deposits of fine sediment and organics form inset point and side bars with a maximum height of about 4 feet from the channel bed. The low flow channel meanders laterally from one wall boundary to the other (Photo G.8).

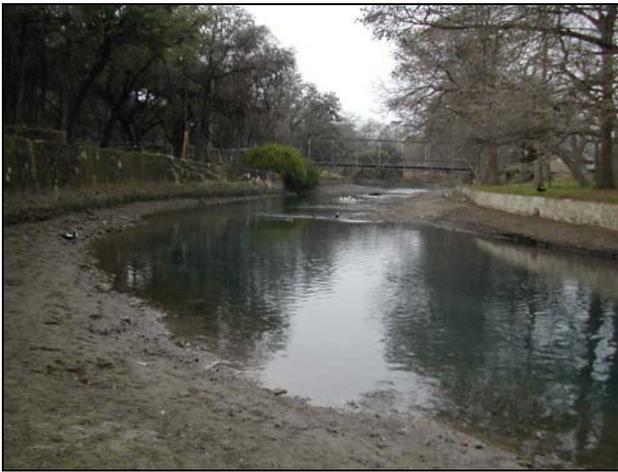
**Photo G.8** Base flow of San Antonio River channel with side and point bar deposits of organics and fine material confined by vertical wall margins.

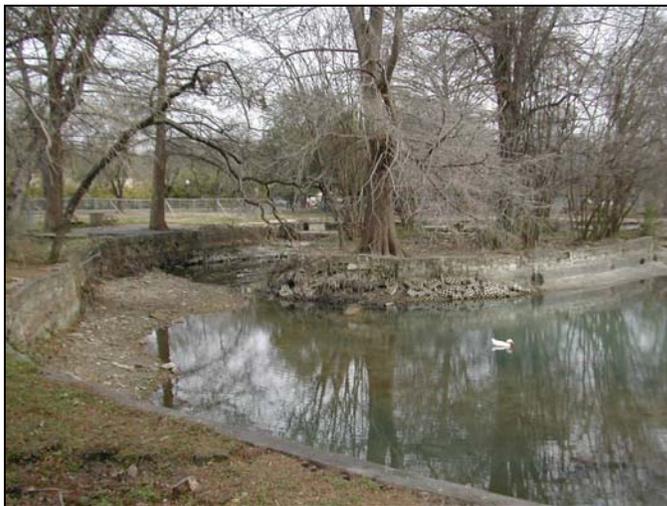
**Photo G.9** A tight meander bend and local hydraulic forces near Sta. 2411+00 cause local instability and degraded channel and floodplain conditions.

Design considerations should consider high stream power and complex hydraulics associated with infrastructure and a tight bend configuration near Sta. 2411+00. Flood flows outside the boundaries of the active channel (floodwalls) provide sufficient hydraulic force to pluck and entrain large quantities of walkway/patio bricks. In addition, evidence of recent hydraulic scour around the tree trunks located 10-15 feet above the channel bed was observed. Bank and floodplain treatments to improve stability and aesthetics must consider high shear values well beyond the walled confines of the active base flow channel.

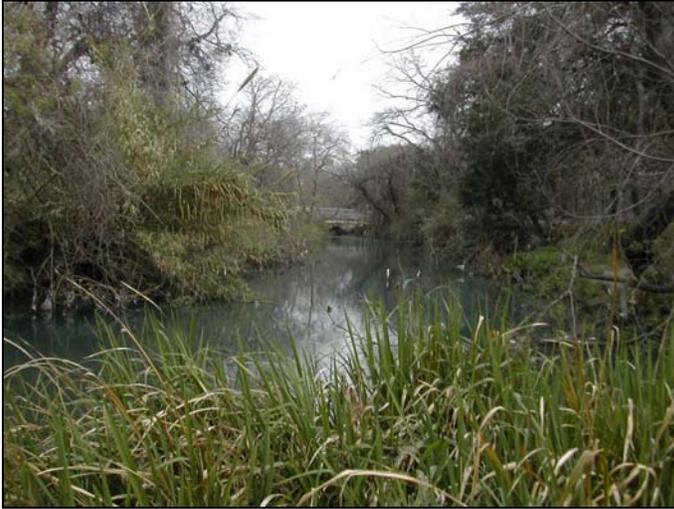
**Photo G.10** San Antonio River looking upstream towards Mulberry Street bridge in the background.

Active floodplain development is occurring along channel margins through this reach. The historic terrace on the right bank constrains the channel while an inset floodplain surface is developing, often creating additional backwater lagoon habitat of emergent wetland plants and cattails. Aggrading bars appear to be the result of local, short-term sediment transport and storage conditions. Relatively frequent rainstorm events are associated with an effective discharge responsible for transporting the greatest volume of sediment on an annual basis. Sediment deposition on the receding limb of these frequent floods form transient side bars, which promote floodplain development and a growing medium for emergent wetland and riparian plant communities. Channel shading from riparian cover is high (Photo G.10).

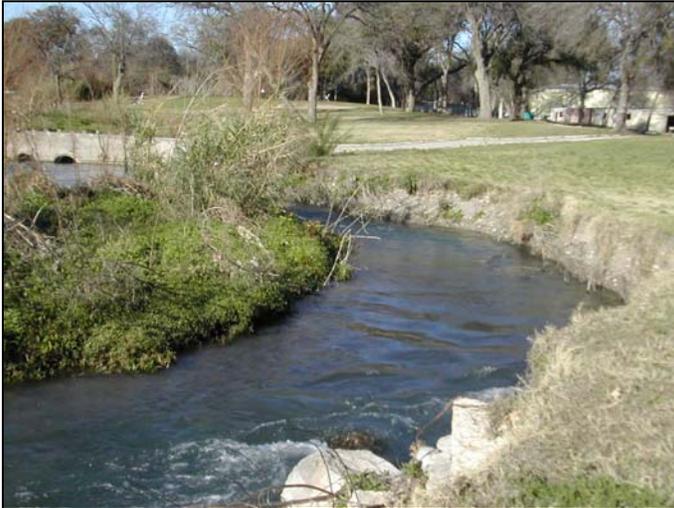
**Photo G.11** Incised channel and eroding bank conditions along the golf course segment upstream of McAllister Freeway.

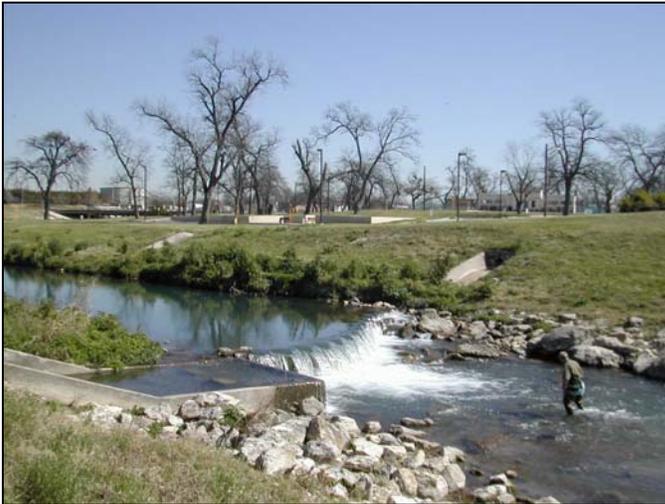
**Photo G.18** Check dam grade control structures built from metal sheet pile maintain channel stability and grade through the Below Outlet sub-reach.

Vertical grade control structures- check dams 10 (Sta. 2116+50) and 9 (2113+00) are comprised of metal sheet pile embedded in the channel and supported by riprap along the bank margins. Bed elevation change at each structure is about 2 to 4 feet. Check dam 9 is partially failed, with the sheet pile bowing downstream due to the weight and hydraulic forces exerted from upstream. Thus, at flood stage flow is being directed towards the banks, increasing shear forces. Despite the improper alignment of the sheet pile, lateral bank erosion is minimal due to high volumes of riprap below the structure and adjacent to storm outfalls. As outlined in the Master Plan, land acquisition on the left floodway, downstream of Roosevelt Park, offers potential to open up the floodplain and improve flood retention values (Sta. 2140+00 to 2110+00).

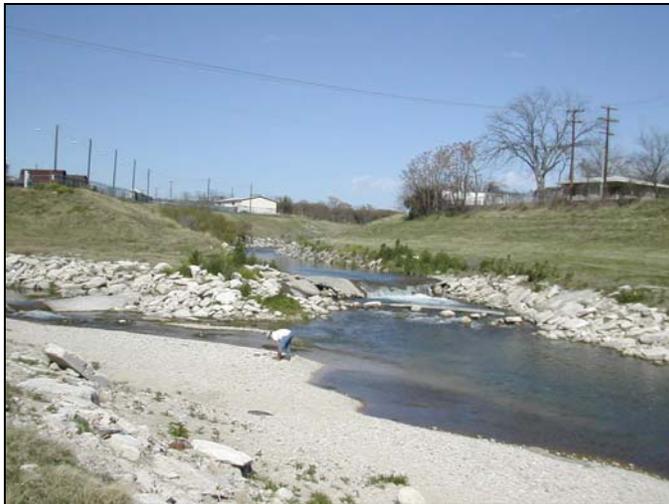
**Photo G.20** Confluence of San Pedro Creek (left) and the San Antonio River.

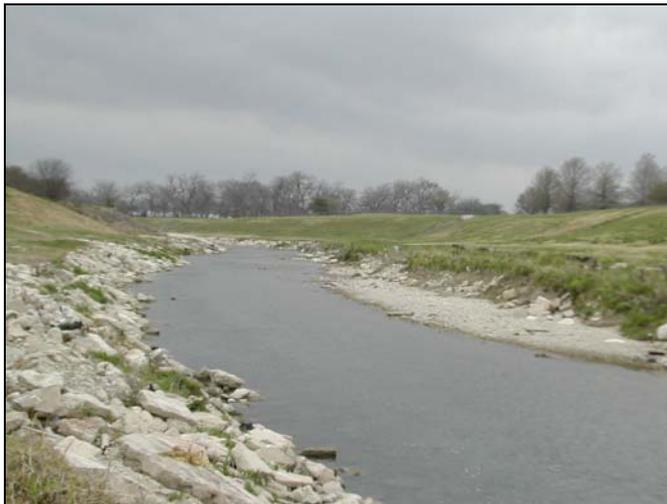
**Photo G.23** A typical pilot channel and floodway segment of the Mission reach.

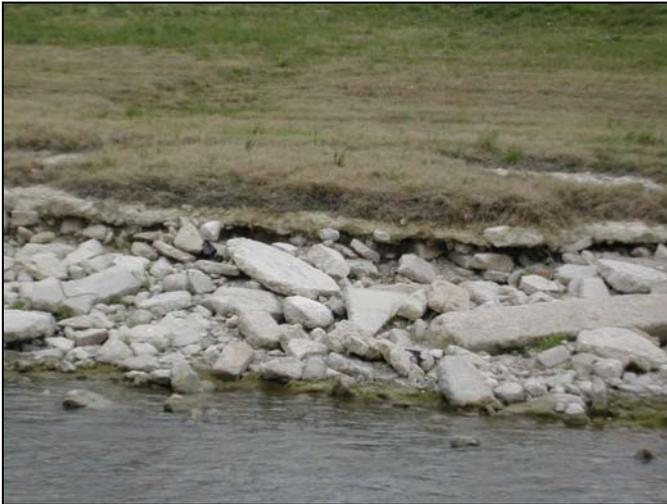
**Photo G.24** Large volumes of concrete riprap, periodically capped with topsoil, pose high cost and effort to remove and replace with more aesthetic bank protection.

The volume of concrete riprap slabs and poured concrete on the floodplain and banks poses design challenges and high costs to remove and/or replace with properly sized native rock materials. Past operation and maintenance efforts include capping the floodplain with topsoil and reseeding with grass (Photo G.24). Scoured floodplain segments are evident where capped soil and sod have been ripped and plucked from the floodway surface, exposing the layers of poured concrete that inhibit further scour and erosion. These segments serve as explicit indicators of high stream power and shear stress outside the pilot channel on the floodplain/floodway bench.

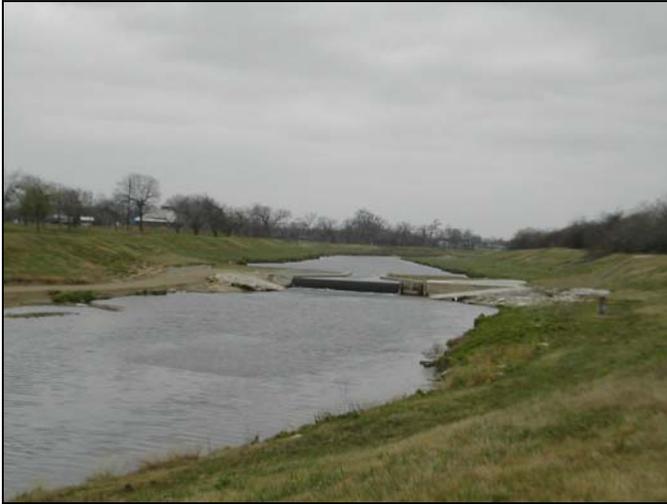
**Photo G.25** Looking upstream at the San Juan Diversion structure.

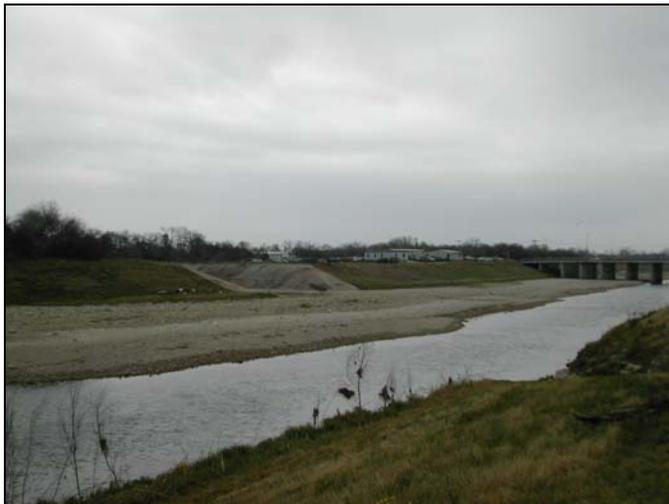
**Photo G.27** Looking downstream at Asylum Creek confluence and S.E. Military Drive with extensive side bar deposit that extends to Espada Dam.

The remnant, historic San Antonio River channel re-enters the main pilot channel at Sta. 1880+00 on the right bank, and the Asylum Creek confluence is at Sta. 1877+00 on the left bank. Asylum Creek is a large tributary with a concrete side slopes/apron and a concrete dam grade structure at the mouth. Asylum Creek is a trapezoidal concrete-lined inset channel with mowed grass floodway for an undetermined distance upstream. Beginning at approximately Sta. 1883+00, a mid-channel bar deposit forms diagonally across the channel. Through this segment, a well developed side gravel bar deposit on the inside, convex left bank margin extends from well above Asylum Creek, under the S. E. Military Drive Bridge to the upper end of the Espada Dam structure, about 3,200 feet in length (Photo G.27). The bar extends from the distal side of the left floodway to the base flow channel. The base flow channel's left margin is well defined by an abrupt and steep submerged ledge. Channel maintenance, sediment dredging and removal above Espada Dam likely are likely responsible for this bank feature anomaly.

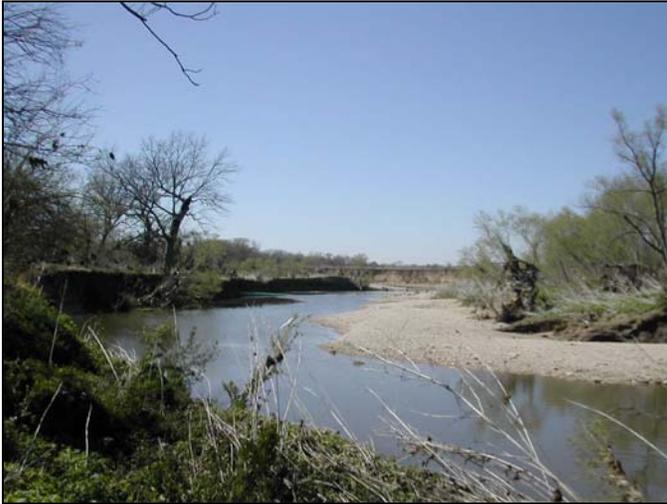
**Photo G.32** Downstream from the project reach and ACOE floodway, the San Antonio River remains a more natural system with a riparian corridor, local sediment supply, meandering pattern, and more accessible floodplain.
