**PLANNING DESIGN REPORT
AND
ENVIRONMENTAL ASSESSMENT**

**OLMOS CREEK SECTION 206 AQUATIC ECOSYSTEM RESTORATION PROJECT
BEXAR COUNTY, TEXAS**

**U.S. ARMY CORPS OF ENGINEERS
FORT WORTH DISTRICT
819 TAYLOR STREET
FORT WORTH, TEXAS 76102-0300**

NOVEMBER 2006

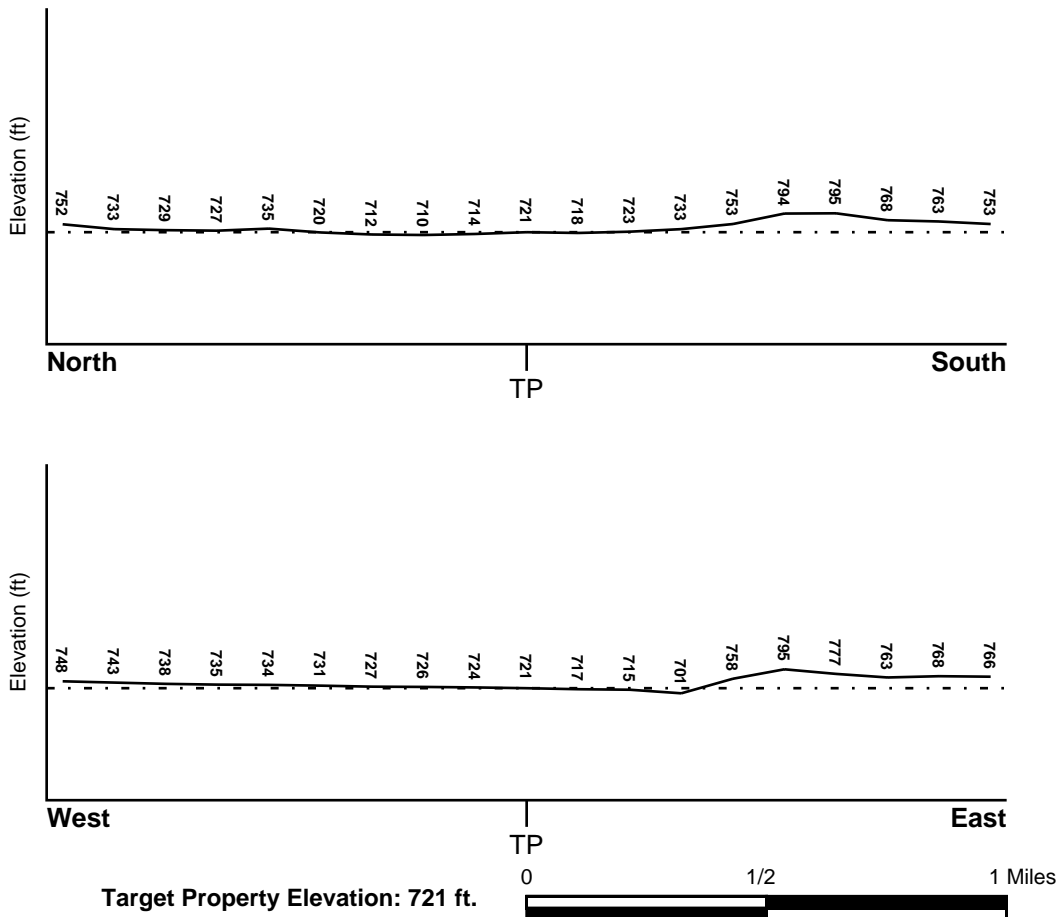
SURROUNDING TOPOGRAPHY: ELEVATION PROFILES

Source: Topography has been determined from the USGS Digital Elevation Model and should be evaluated on a relative (not an absolute) basis. Relative elevation information between sites of close proximity should be field verified.

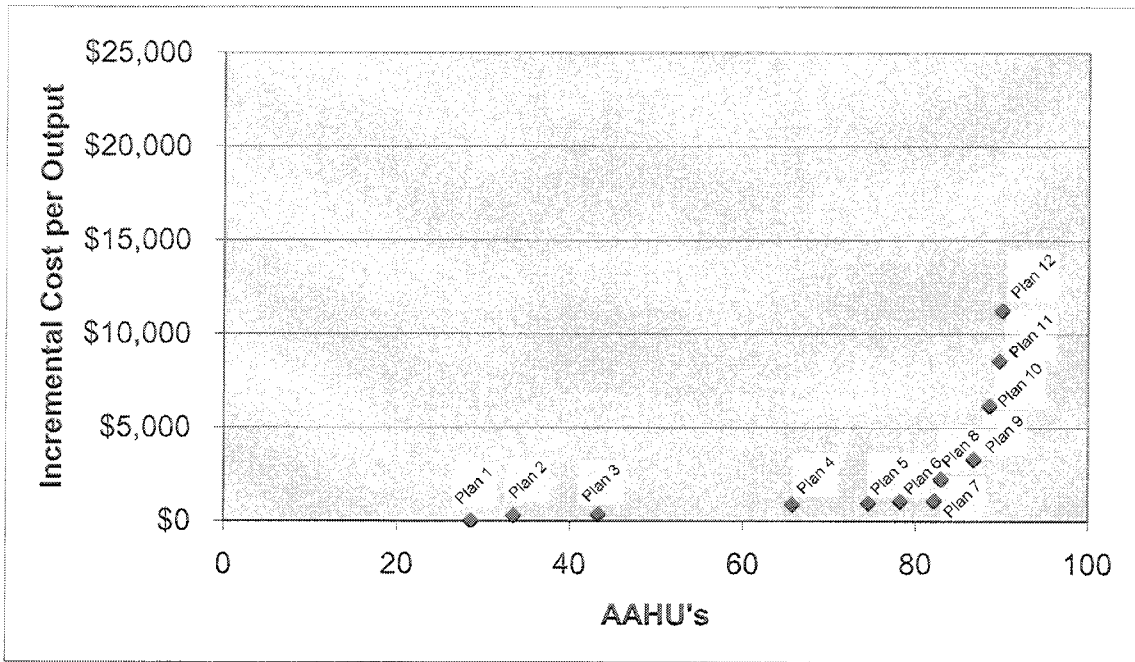
Incremental Cost per AAHU Of Best Buy Plans

* Note: Plan 13 is not shown on the above graph due to its extremely high incremental cost per output value.

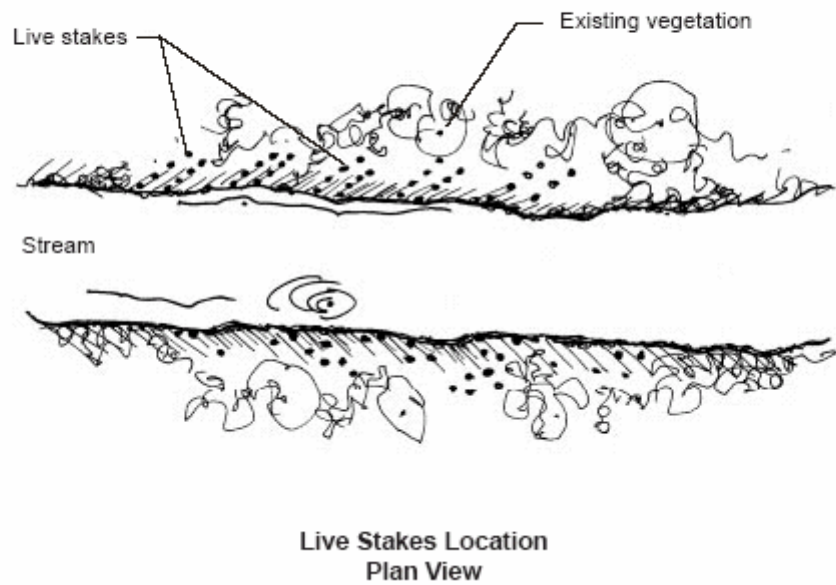
Diagram 1. Plan View of Live Stake Arrangement for Erosion Control (Source: Stream Corridor Restoration Handbook, USDA; Engineering Field Handbook, NRCS).

Alternative 4. Alternative 3 with the replacement of flow baffles with live willow stakes for erosion control in Area One. Live staking would occur on approximately 3,000 square feet near the terminus of the concrete-lined storm drain located in Area One. Staking would occur at three stakes per four square feet. Live staking provides benefits to the terrestrial environment as well as the aquatic environment. This alternative would provide an additional 2.33 AAHU's over the project life period as compared to Alternative 3. However, AAHU's would still decrease over the project life from 56.87 to 43.30.

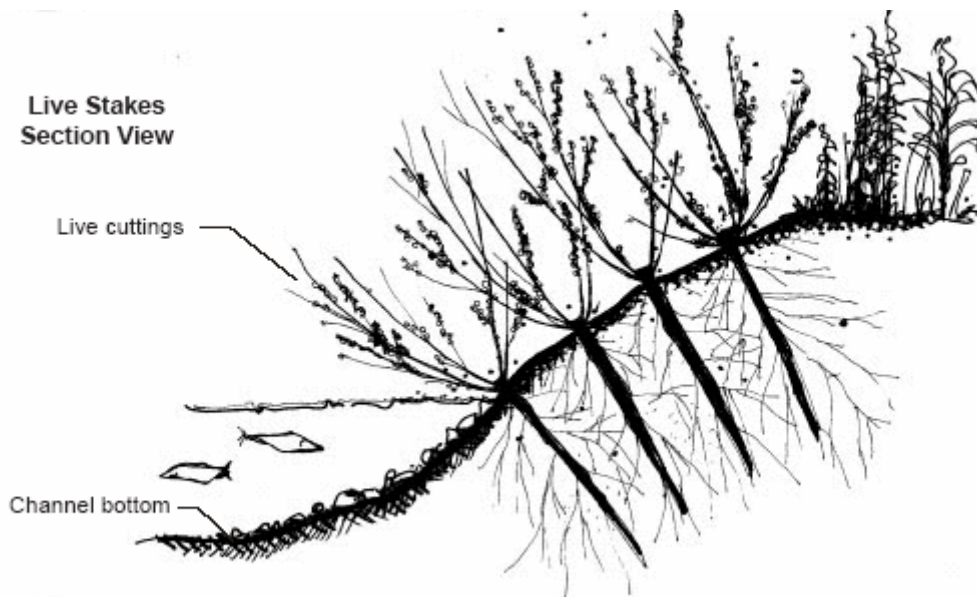
Diagram 2. Section View of Live Stake Arrangement for Erosion Control (Source: Stream Corridor Restoration Handbook, USDA; Engineering Field Handbook, NRCS).

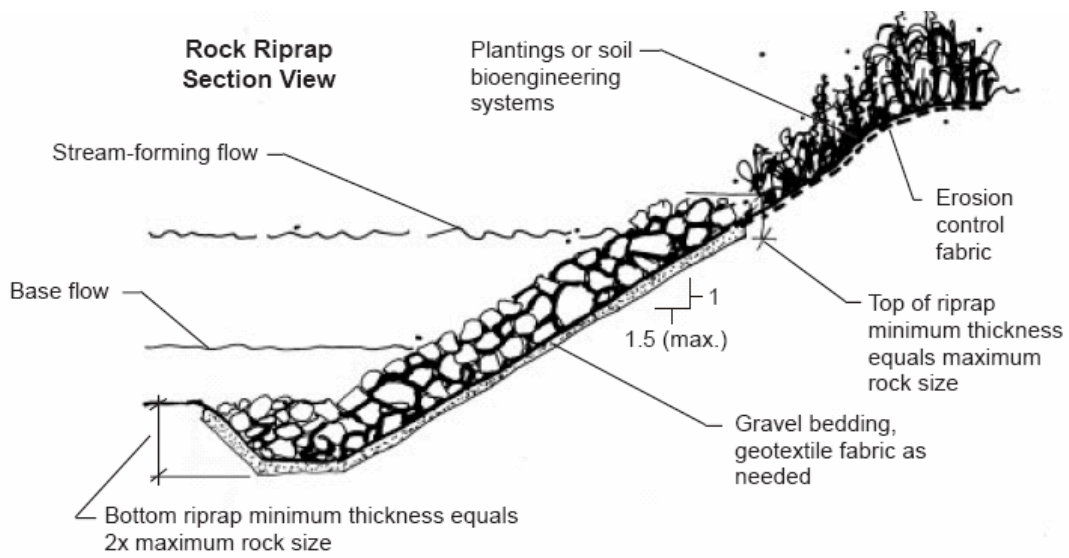
Diagram 3. Section View of Riprap used for Erosion Control
 (Source: Stream Corridor Restoration Handbook, USDA; Engineering Field Handbook, NRCS).

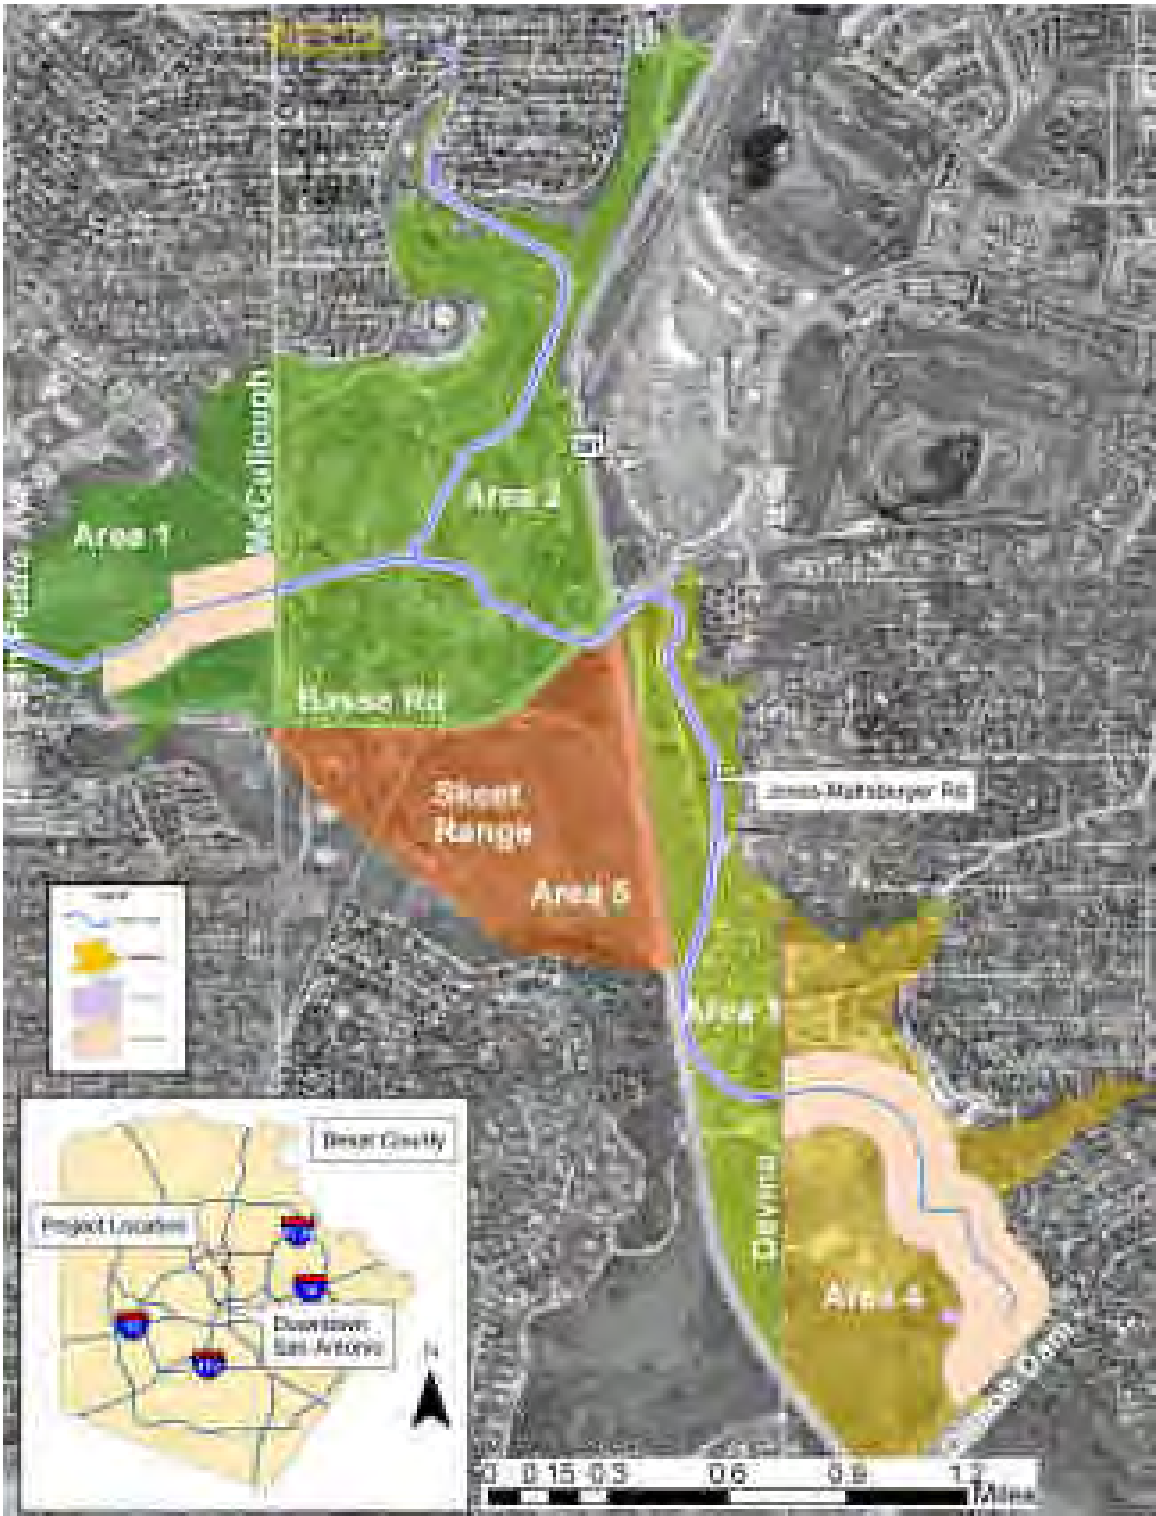
Figure One. Study Area for Olmos Creek Aquatic Ecosystem Restoration Project in San Antonio, Bexar County, Texas.

The study area is located in San Antonio, Bexar County, Texas and is entirely within the San Antonio River watershed (Figure 1). The study area was divided up into five areas that were different habitat types. Area One is a grassland that borders both sides of the stream. In Area Two the stream runs through a golf course. Area three runs through Olmos Basin Park. Area four is also in the park but in a less developed portion and is bounded at the lower end by Olmos Dam. Area five is a grassland located just west of Highway 281 and adjacent to a skeet shooting range.

The study area was divided into five project areas (Figure 1.) based on habitat type and land use. Below is an analysis of the fish and wildlife habitat conditions for each area.

Area Four is located between the second crossing of Devine Road and Olmos Dam (Figure 1). This area is a thickly vegetated riparian bottomland hardwood and is subject to flooding. Riparian woodland habitat was assessed at seven sites in Area Four (6-12). The HEP/HSI information is summarized in Table 7.

Area Five is located between Highway 281 and the Olmos Basin Shooting Range (Figure 1). This area is a forb-dominated grassland and one site (18) was sampled in this grassland. The HEP/HSI information is summarized in Table 8.

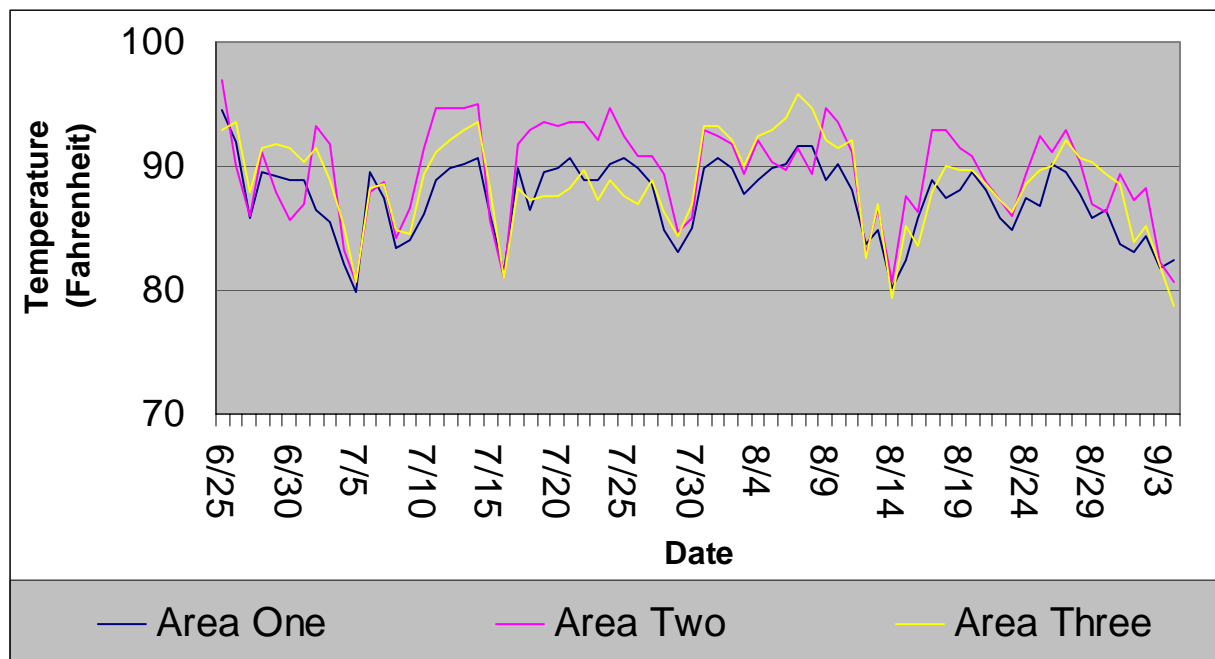
Figure Two. Olmos Creek Maximum Daily Temperatures June 25 to September 4, 2003.

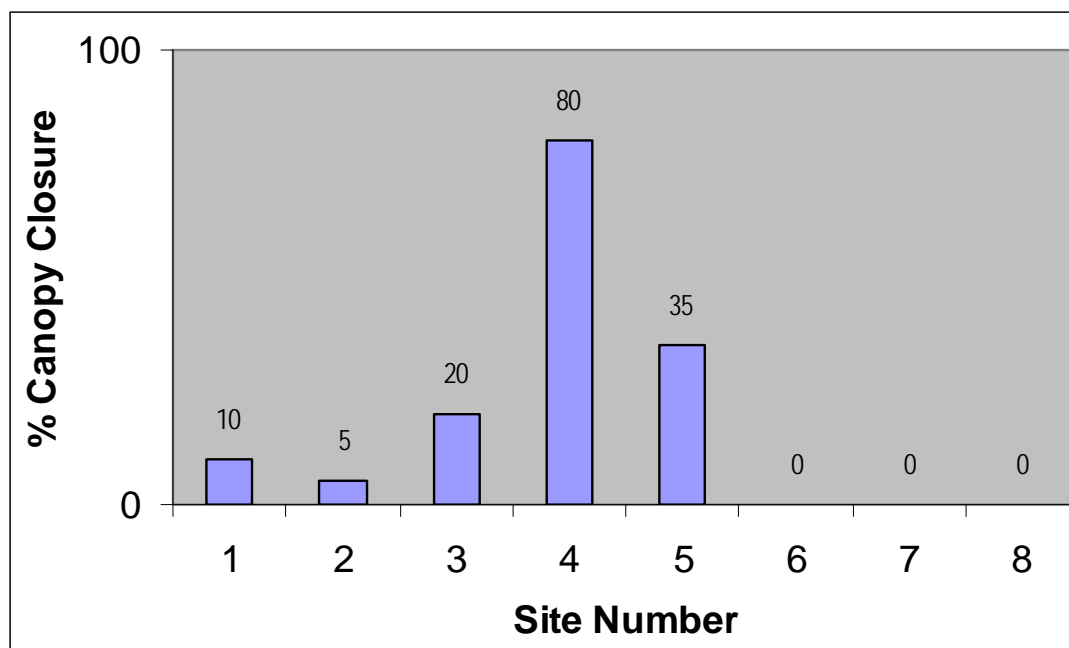
Figure 3. Olmos Creek canopy closure in Area One of the Olmos Creek Restoration Project.

The aquatic habitat within Area One is not in optimal condition. It appears that springs may be present in the downstream portion of this area. The stream lacks shade and riparian habitat in the streamside zone. An analysis of stream shade was conducted along this stretch of Olmos Creek (Figure 3). Overall, the canopy is very poor, with little to no shade along most of the stream. One or two areas along this section have some dense pockets of stream shade. The lack of stream shade probably has a great impact on stream water temperature.

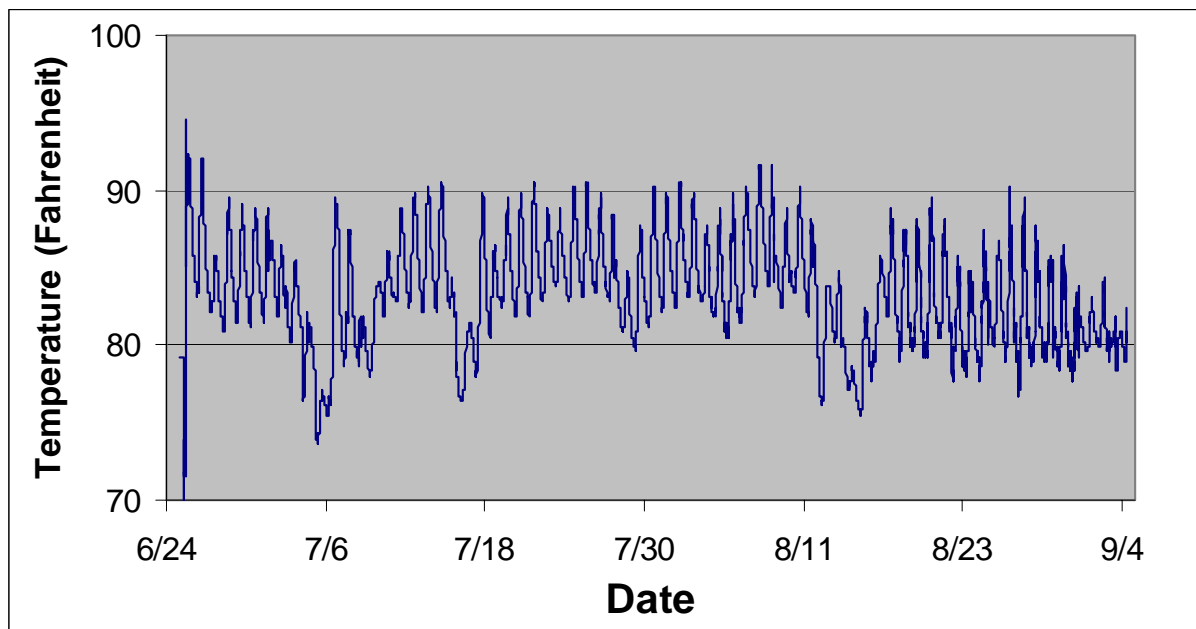
The temperature was measured continuously from June 25 to September 4, 2003 (Figure 4). Water temperature was mostly between 80°F (26°C) and 90°F (32°C) but spiked to 95°F (35°C) in late June. The temperatures above 80°F (26°C) and 90°F (32°C) indicate low water flow and high solar input. Temperature is also greatly influenced by storms that drove stream temperatures below 80°F (26°C). The lack of stream shade and the high summer water temperatures probably limit the aquatic productivity of this stream section.

Figure 4. Olmos Creek water temperature in Area One of the Olmos Creek Restoration Project.

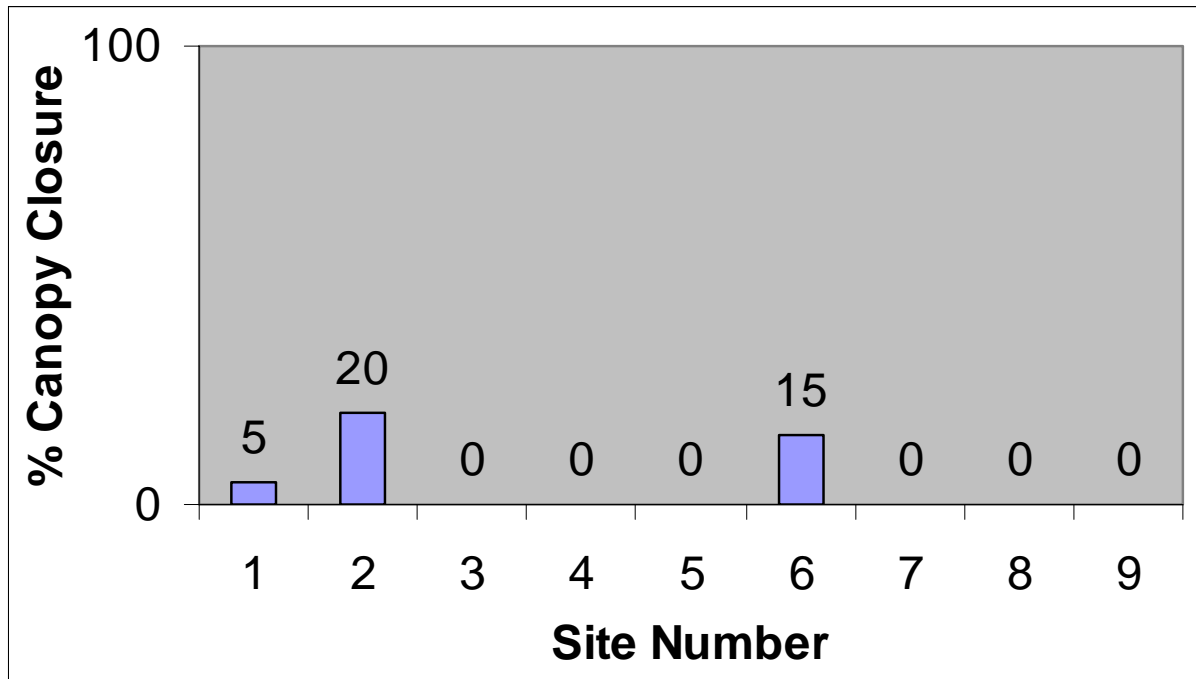
Figure 5. Olmos Creek canopy closure in Area Two of the Olmos Creek Restoration Project.

The aquatic habitat within Area Two is not in optimal condition. While this area may have small springs and seeps along the stream, there is little to no streamflow, except during rain events. The stream lacks shade and riparian habitat in the streamside zone. An analysis of stream shade was conducted along this stretch of Olmos Creek (Figure 5). Overall the canopy is very poor, with little to no shade along most of the stream. One or two areas along this section have some pockets of stream shade. The lack of stream shade probably has a great impact on stream water temperature.

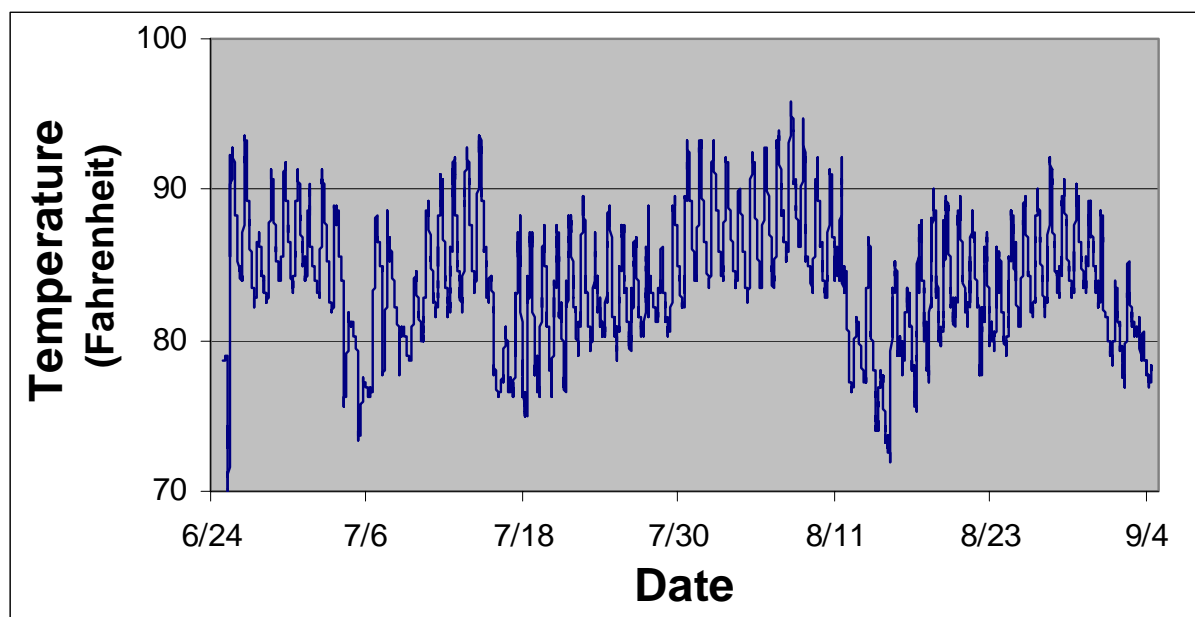
The temperature was measured continuously from June 25 to September 4, 2003 (Figure 6). Water temperature was mostly between 80°F (26°C) and 90°F (32°C) but spiked to 95°F (35°C) in late June. The temperatures above 80°F (26°C) and 90°F (32°C) indicated low water flow and high solar input. Temperature is also greatly influenced by storms that drove stream temperatures below 80°F (26°C). The lack of stream shade and the high summer water temperatures probably limit the aquatic productivity of this stream section.

Figure 6. Olmos Creek water temperature in Area Two of the Olmos Creek restoration project.

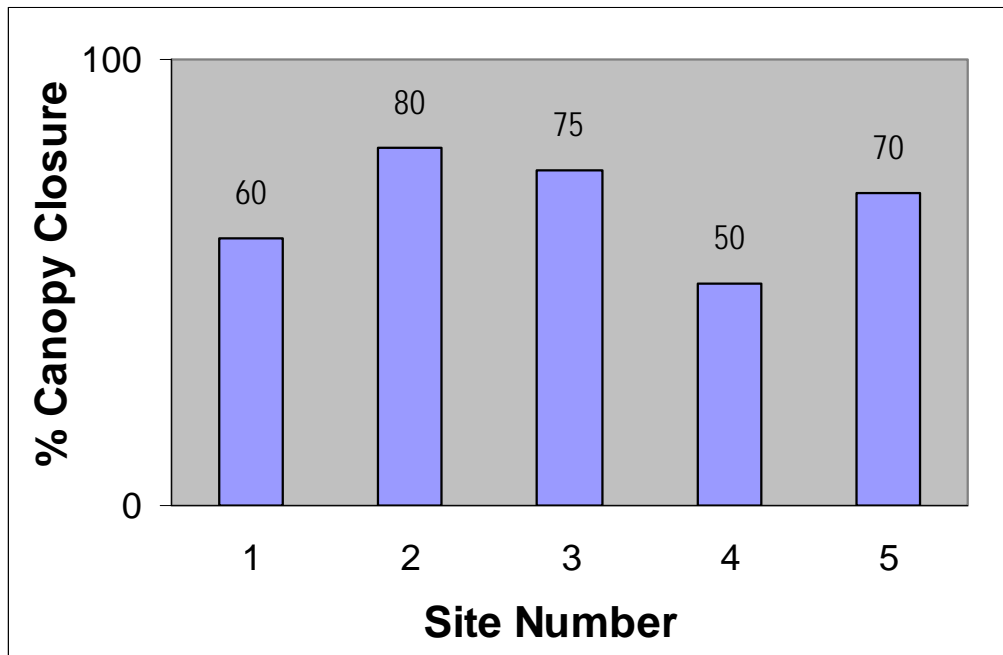
Figure 7. Olmos Creek canopy closure in Area Three of the Olmos Creek Restoration Project.

The aquatic habitat within Area Three is in fairly good condition. While this area goes dry during the summer, it provides an important link between downstream pools and upstream permanent water. The creek has good streamside shade and fair riparian habitat. An analysis of stream shade was conducted along this stretch of Olmos Creek (Figure 7). Overall, the canopy is very good, with adequate shade along most of the stream.

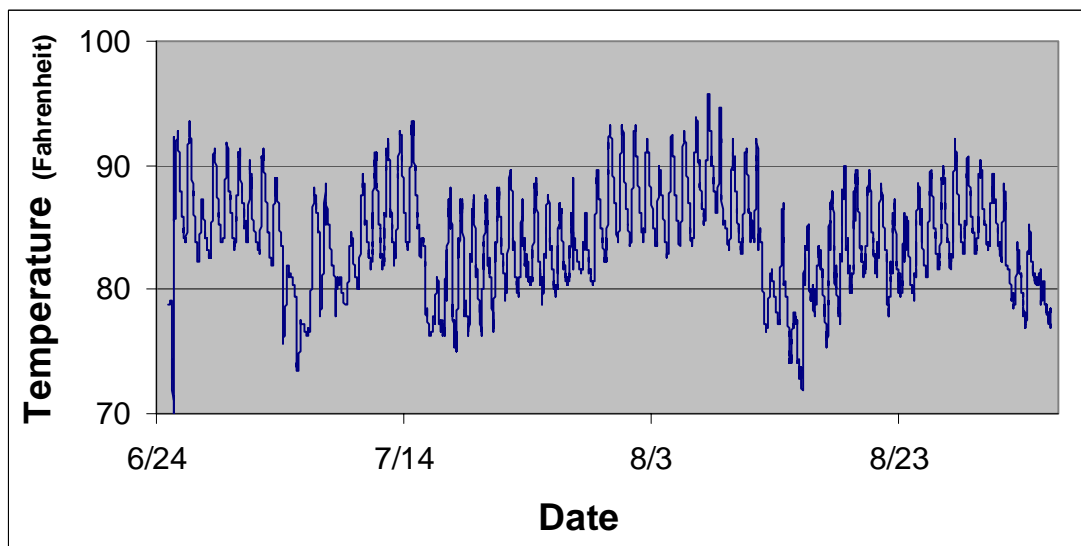
The temperature was measured continuously from June 25 to September 4, 2003 (Figure 8). Water temperature was mostly between 80°F (26°C) and 90°F (32°C). The temperatures above 80°F (26°C) and 90°F (32°C) indicated low water flow. Temperature is also greatly influenced by storms that drove stream temperatures below 80°F (26°C). The high summer water temperatures probably limit the aquatic productivity of this stream section.

Figure 8. Olmos Creek water temperature in Area Three of the Olmos Creek Restoration Project.

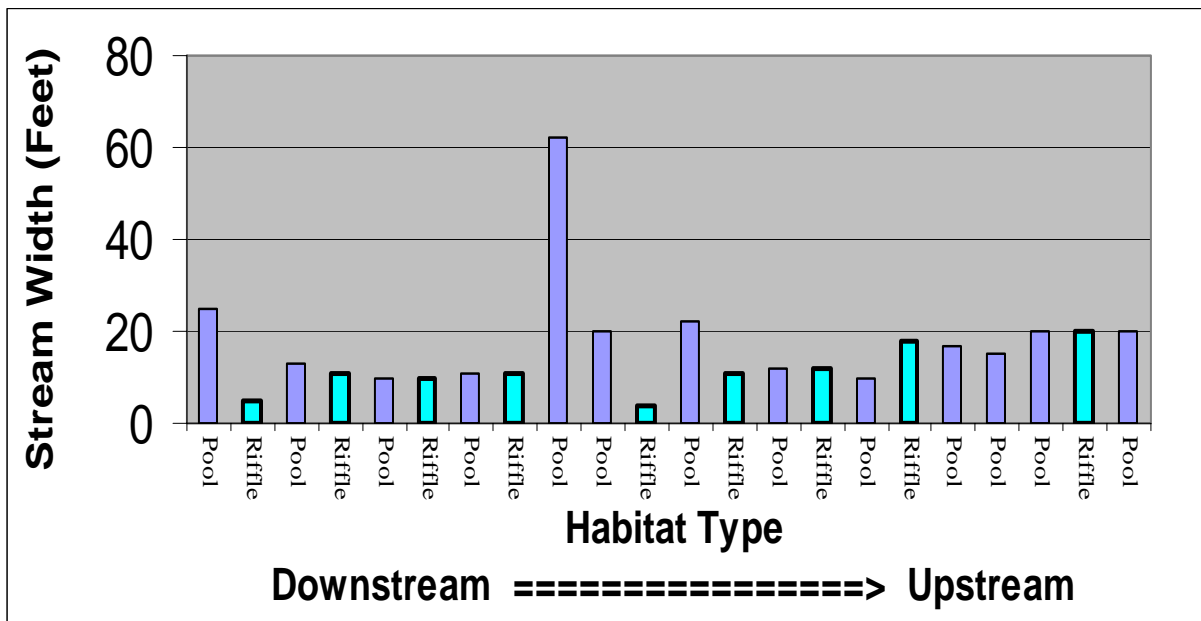
Stream width can also be used as an indication of the habitat condition within the stream (Figure 9). Olmos Creek, through this stream section, has been widened by past management activities. Based on our observations and measurements, this stream section should have an average stream width between 10 and 15 feet (3 and 5 meters). The riffle habitat was within this range having an average stream width of 11 feet (3 meters), with a minimum width of 4 feet (1 meter) and a maximum width of 20 feet (6 meters). However, the pool habitat was considerably wider with an average width of 20 feet (6 meters), a minimum width of 10 feet and a maximum width of 62 feet (19 meters). For the most part, each pool width measurement that exceeded about 15 feet (5 meters) was in response to a man-made structure. Two bridges, three utility (sewer) lines, one abandoned utility crossing, and one abandoned concrete crossing directly impact stream width through the park section of Olmos Creek. Reduction of these impacts would benefit the aquatic habitat by reducing stream width and increasing stream depth. This change in stream channel dimensions would serve to improve habitat conditions by moderating stream temperature and reducing the amount of pool habitat within the stream. In addition, riffles, the food production habitat, would probably increase.

Figure 9. Stream width of each habitat unit in Olmos Creek within Area Three. Area Three is between the first and second stream crossing of Olmos Creek and Devine road in Olmos Basin.

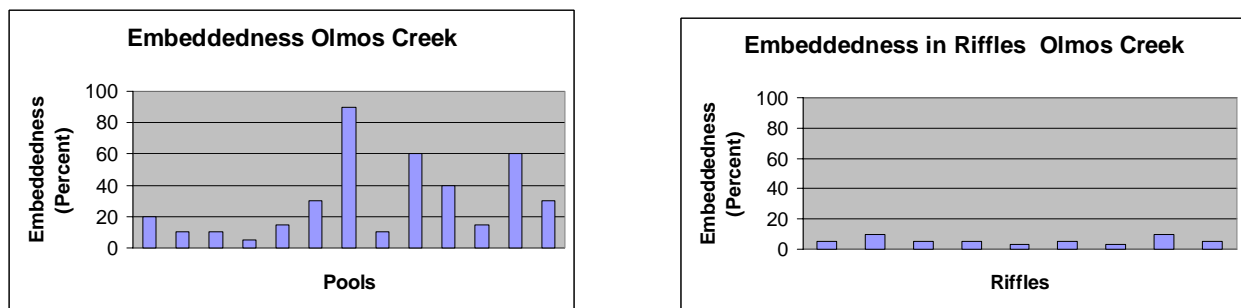
The level of embeddedness (pools = 30 and riffles = 6) is fairly low and indicates a light silt load (Figure 10). The stream receives a large amount of scouring streamflow during most storm events. While individual sources of streambank erosion were noted, overall stream sedimentation does not appear to be a major issue in Olmos Creek.

Figure 10. Embeddedness or the percent to which the substrate is embedded in fine silt, for Olmos Creek within Area Three. Area Three is between the first and second stream crossing of Olmos Creek and Devine road in Olmos Basin.

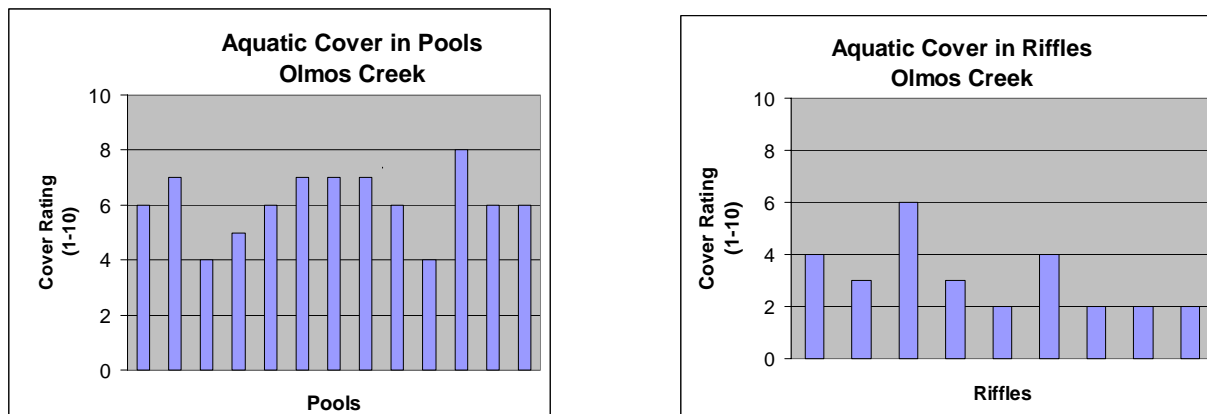
Aquatic habitat cover scores (pools = 6 and riffles = 3) were fair to good (Figure 11). The stream could benefit from the introduction of boulders to provide additional cover for aquatic species. Most benefits would be gained from introducing these habitat elements in the pools. With the scouring flows that the stream receives, boulder introduction may be the only feasible way to introduce cover that will stay in place.

Figure 11. Aquatic cover, or a rating of the hiding and resting cover, for Olmos Creek within Area Three. Area Three is between the first and second stream crossing of Olmos Creek and Devine road in Olmos Basin.

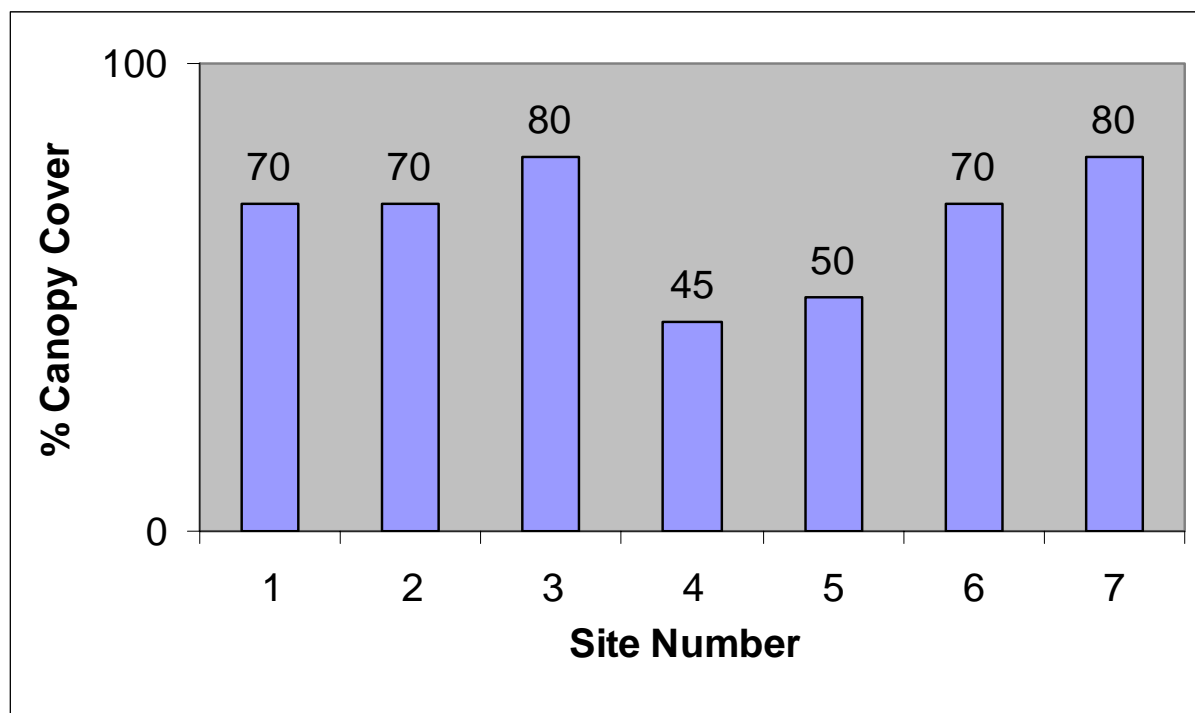
The aquatic habitat within Area Four, while not perennial is in good condition. Deep pools and a shady stream provide good aquatic habitat. While this area goes dry during the summer, it provides an important link between downstream pools and upstream permanent water. The creek has good streamside shade and fair riparian habitat. An analysis of stream shade was conducted along this stretch of Olmos Creek (Figure 12). Overall the canopy is very good, with dense shade along most of the stream.

Figure 12. Olmos Creek canopy closure in Area Four of the Olmos Creek Restoration Project.
