**Hydrology and Hydraulics Appendix C**  
**Integrated Planning and Design Analysis and Environmental**  
**Assessment**  
**Waco Metropolitan Area Regional Sewerage System Treatment Plant**  
**Waco and McLennan County, Texas**  
**Brazos River**  
**Section 14 Emergency Streambank and Shoreline Protection**

May 2021

**US Army Corps**  
**of Engineers®**  
Fort Worth District

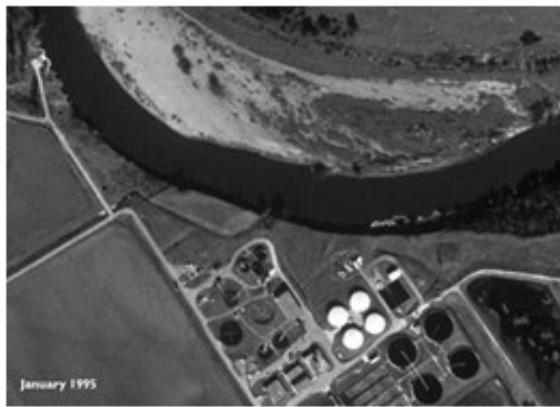
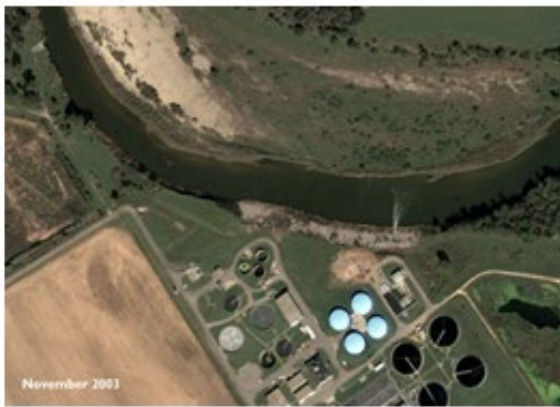
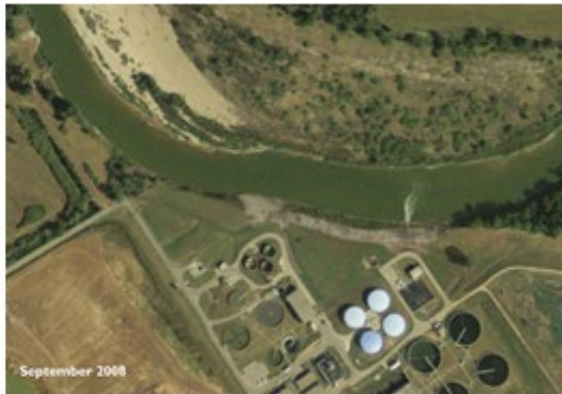
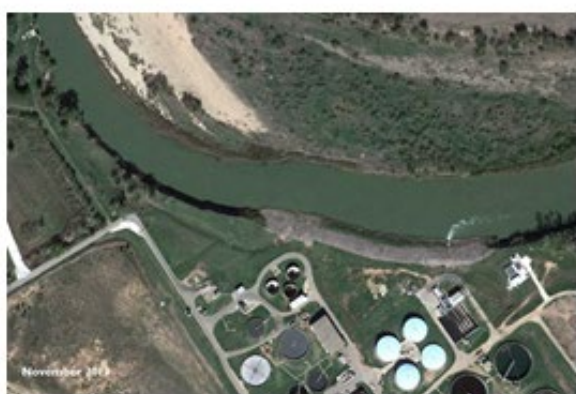
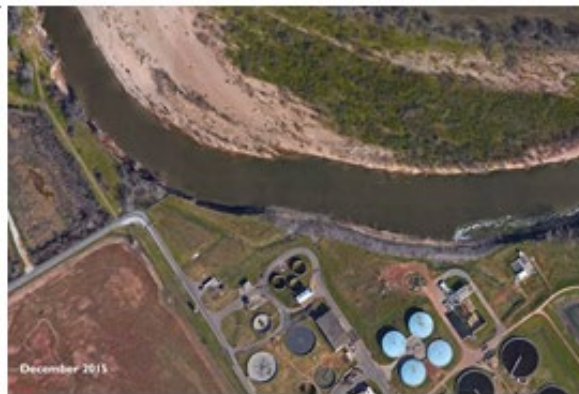
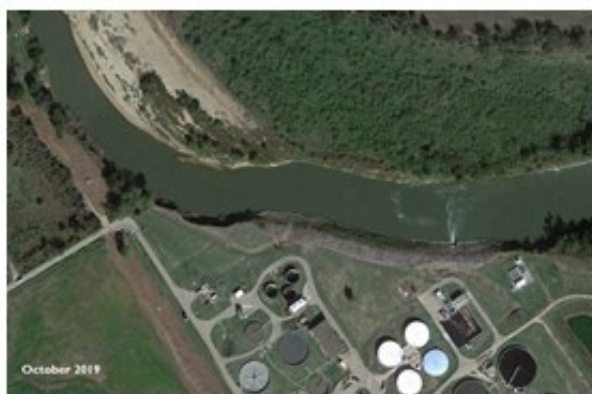
**Figure I-2.** Study Area Erosion 1995 - 2019

**1.1 Problem Identification.** The right bank of the Brazos River, adjacent to the WMARSS Central Wastewater Treatment Plant, has been steadily eroding during the past several years. The erosion, if allowed to continue, will impact three critical infrastructure facilities: WMARSS Central Wastewater Treatment Plant, city of Robinson water intake (located about 1,000 feet upstream), and the Sandy Creek power plant intake structure (located within the WMARSS Central Wastewater Treatment Plant facility). A chronological display of the erosion from 1995 – 2019 is shown in Figure I-2. A ground view of the erosion is shown in Figure I-3.

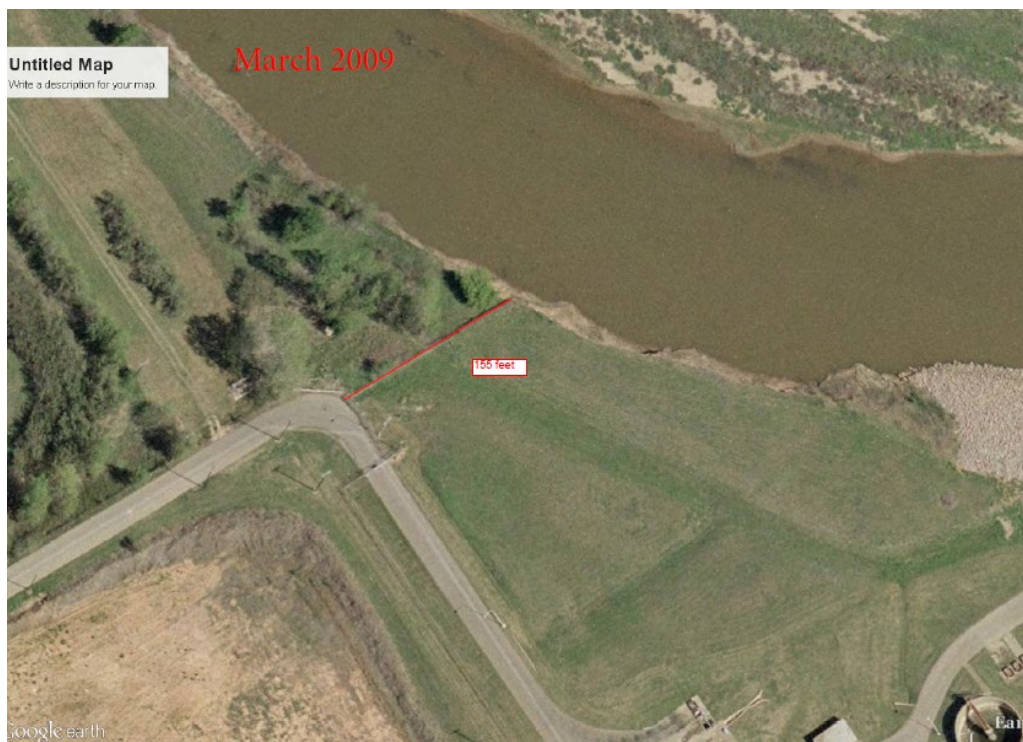
**Figure I-4. Erosion Measurement Point**

**I.1.1 Rate of Erosion.** The rate of erosion of the Brazos River right bank was estimated by the Civil Design Section using aerial photographs over a 24-year time period and by measuring the distance from the riverbank to the corner point of the WMARSS Central Wastewater Treatment Plant access road. Table I-1 shows the results of the measurements. Figure I-4 shows a typical measurement point.

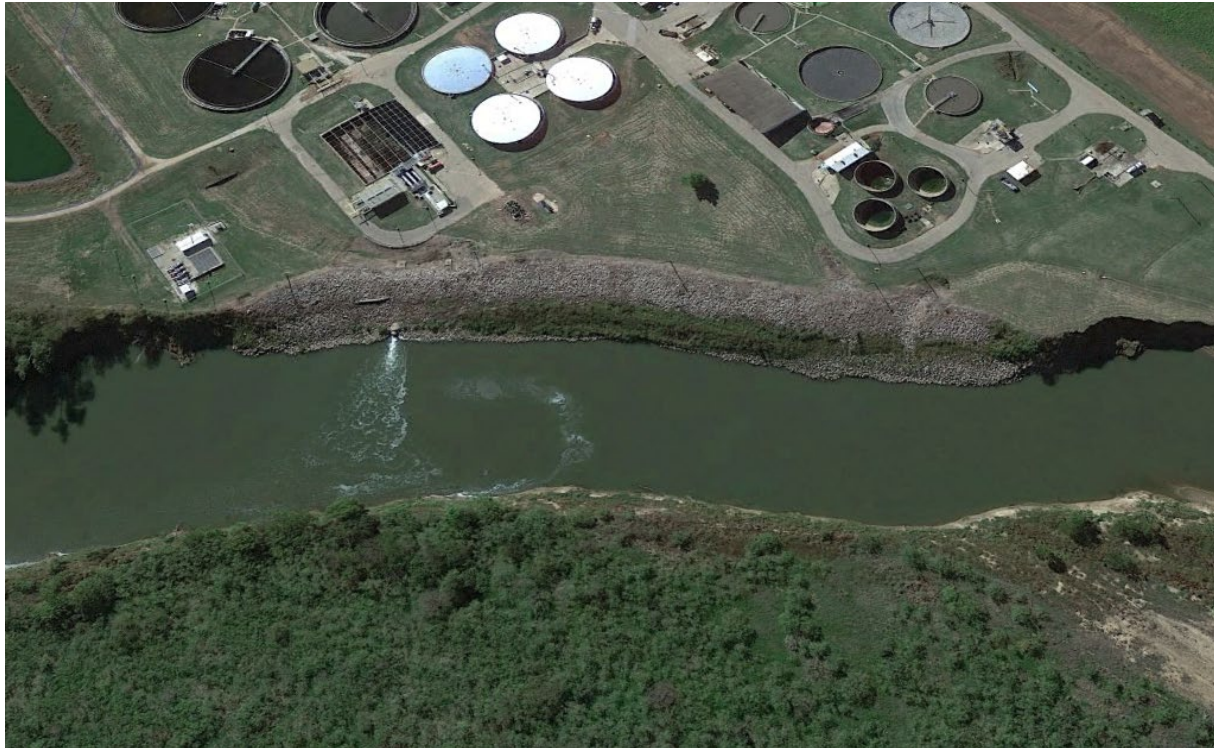
**Figure I-5.** Existing Streambank Protection Project

**I.3 Existing Improvement.** There is an existing U. S. Army Corps of Engineers Section 14 civil works project located at the WMARSS Central Wastewater Treatment Plant. The project consists of about 900 feet of streambank protection (24-inches of stone riprap over 9-inches of bedding). The project was completed in 2002. The project was constructed to repair erosion along the right bank of the Brazos River. The project is annually inspected by the Fort Worth District. The city of Waco is the Local Sponsor and is responsible for maintenance. Figures I-5 to I-7 show the existing project.

**5.2 Selected Plan Justification.** The Selected Plan design is similar in design to the existing U. S. Army Corps of Engineers Section 14 civil works project located at the WMARSS Central Wastewater Treatment Plant. The project consists of about 900 feet of streambank protection (24-inches of stone riprap over 9-inches of bedding). The project was completed in 2002. This project has been functioning as designed for 18 years. The Selected Plan will extend the stone riprap of similar size for 1,300 feet upstream and 300 feet downstream of the existing stone riprap, thereby creating a long (+2,500 feet), armored bank protection system. The length of the protection system will solve the current erosion issue, i.e., protect the existing infrastructure along the Brazos River, at a cost that is the least of the three alternatives considered. The length of the protected section of the riverbank at 1,300 feet also envelopes the curvature of the riverbank, which is one of the contributory factors to the erosion potential. The Selected Plan will be maintained by the city of Waco, as they have been doing for the existing Section 14 project and will not present new or unique maintenance challenges for the city.

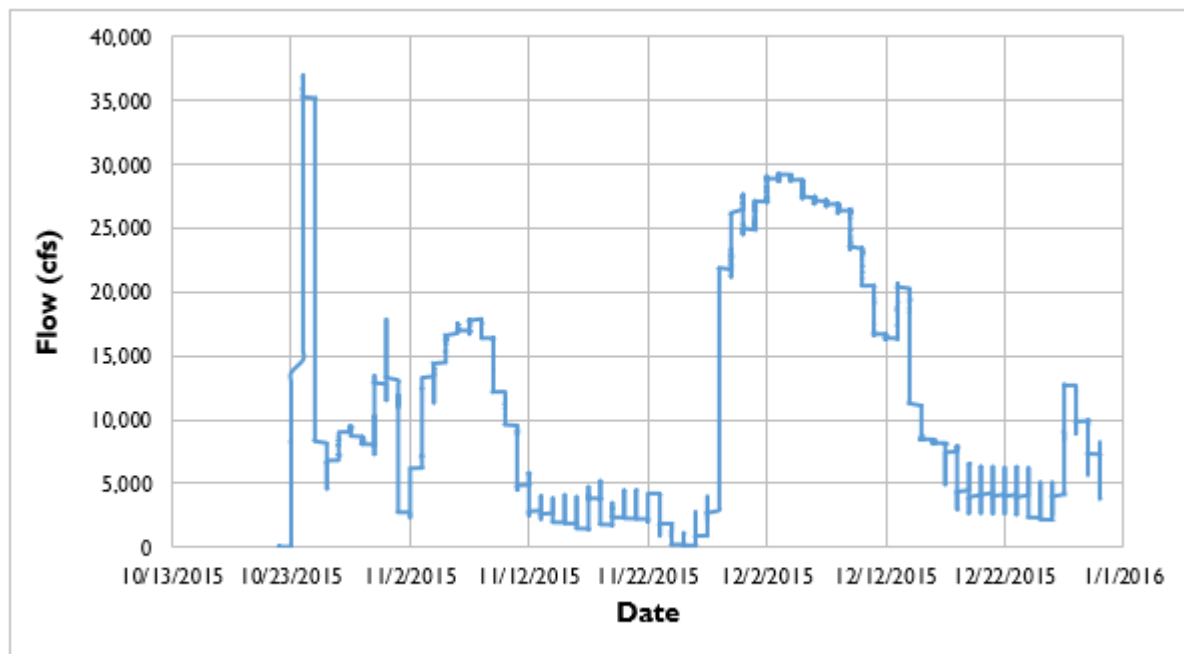
**Figure 2-2.** October - December 2015 Hydrograph at Brazos River at Waco Gage

Figure 2-2 shows the October 2015 hydrograph at the Brazos River at Waco Gage and the peak flow of 37,000 cfs. The hydrograph shows the flow peaked and receded quickly. Later in the year smaller flow peaks occurred in November and December. Quickly rising and falling river levels will impact the condition of the riverbanks as well as smaller, longer duration flows.

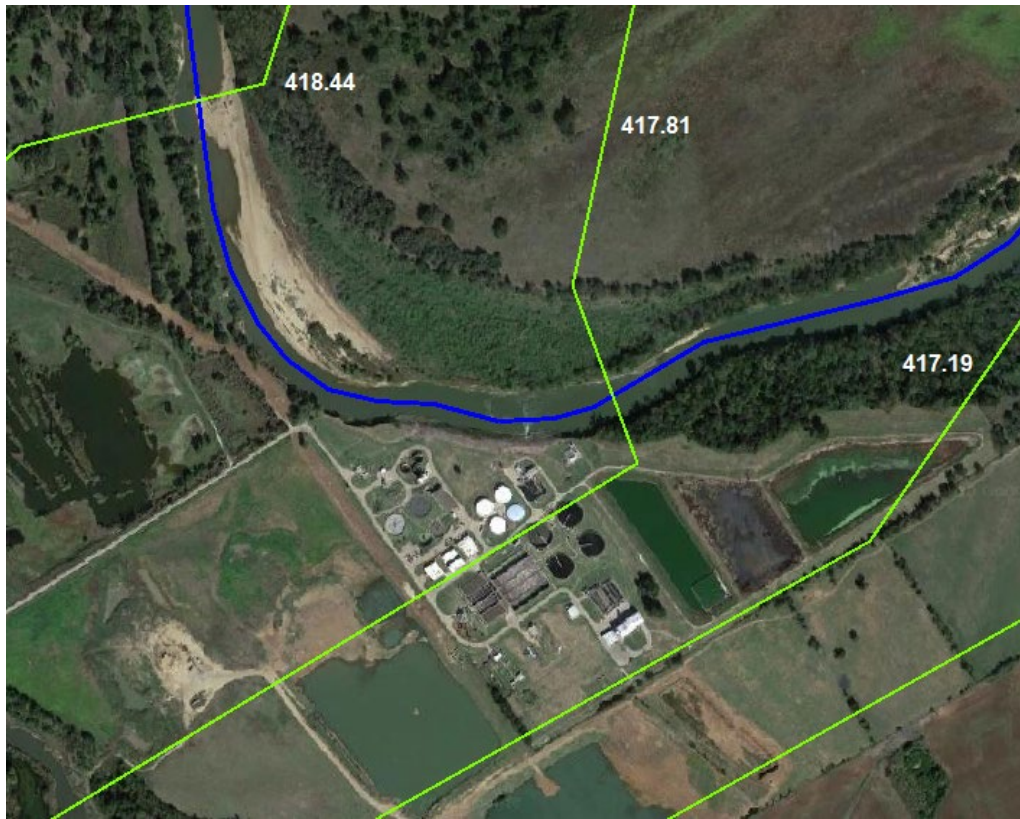
**Figure 3-1.** HEC-RAS Cross-sections at the WMARSS Central Wastewater Treatment Plant

**3.0.2. Result of Analysis.** The Brazos River HEC-RAS model cross-section in the vicinity of the WMARSS Central Wastewater Treatment Plant is shown in Figure 3-1. The flood event water surface elevations are shown in Table 3-1.

Flood Event	Q Total (cfs)	W.S. Elev. (ft)	Depth (ft)
2-year	21,400	369.3	24
5-year	34,500	372.8	28
10-year	43,400	374.4	29
25-year	59,700	377.2	32
50-year	75,700	379.5	35
100-year	99,400	381.8	37
250-year	126,000	383.5	38
500-year	200,000	385.1	40

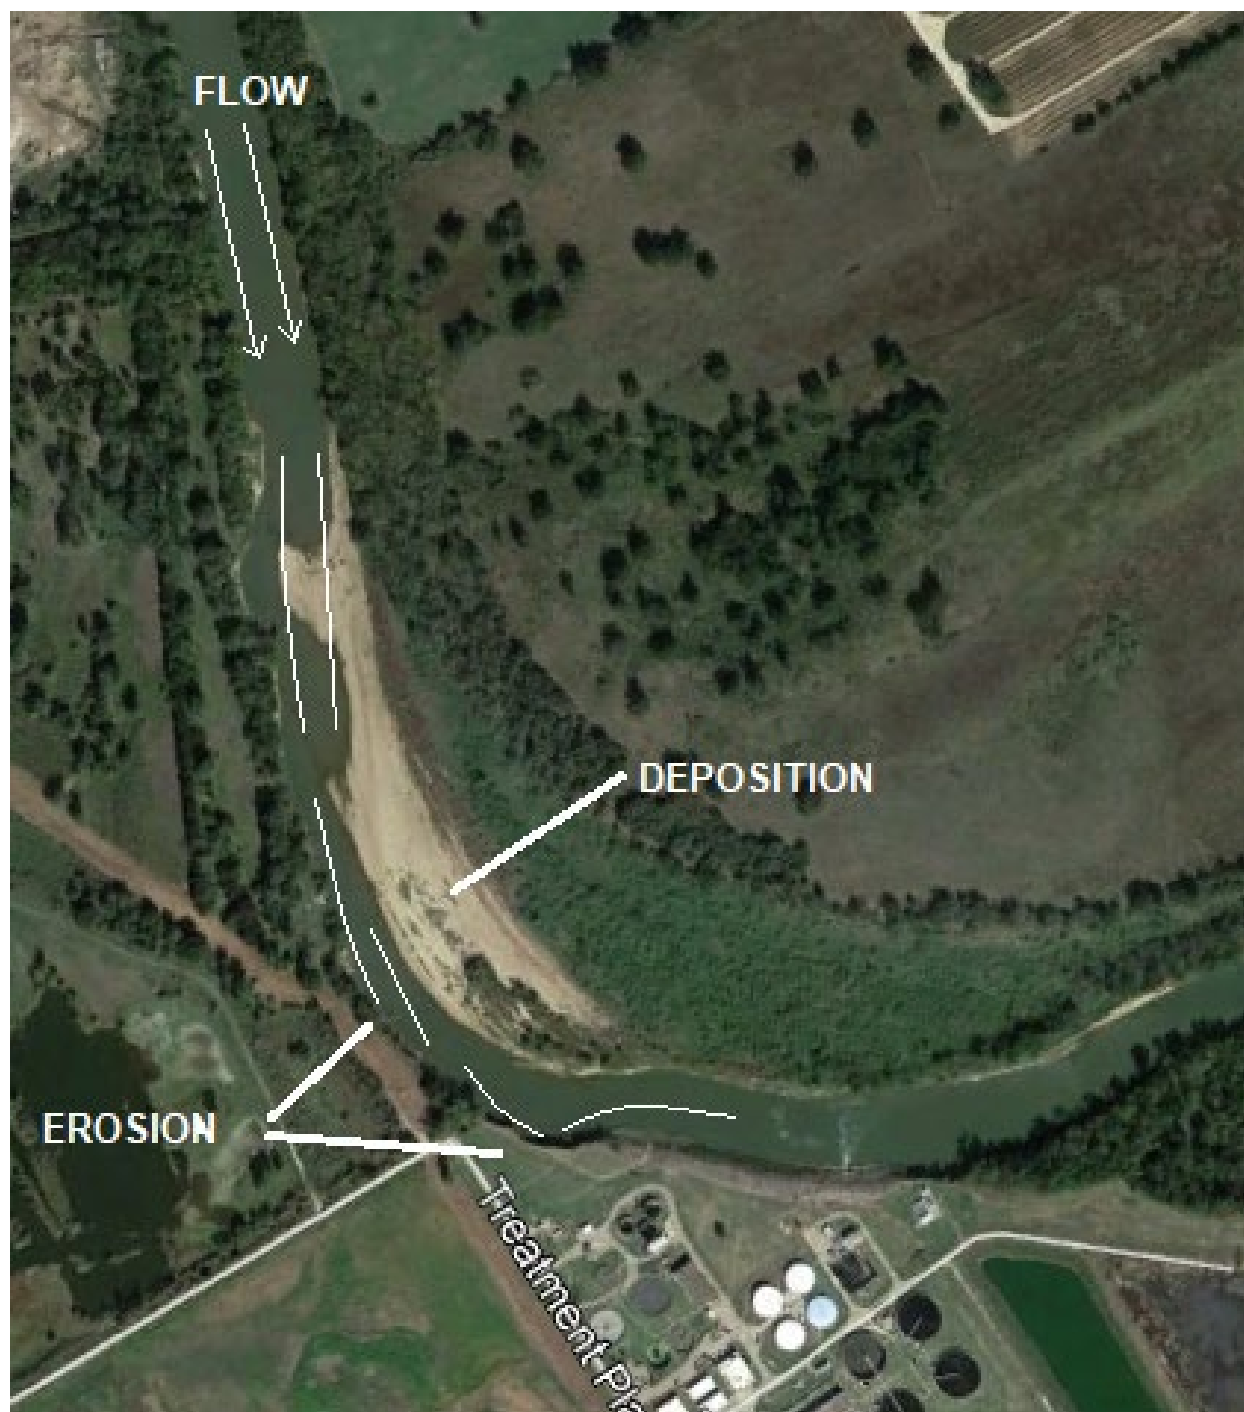
**Figure 3-3.** Brazos River Alignment in the Study Area

The Brazos River flows in a straight alignment for about 0.75 miles from the upstream SH 6 bridge before it bends as it approaches the WMARSS Central Wastewater Treatment Plant. The major part of the Brazos River right bank erosion in the study area is located at this bend in the river (approximate radius of 1,000 feet). The erosion adjacent to the WMARSS Central Wastewater Treatment Plant is occurring at the outside bend of the river, while sediment deposition is occurring on the opposite inside bend of the river. The flow of the Brazos River is directed towards the outer bank. Over time, this outer bank has continued to erode. It is likely that the river thalweg (the deepest part of the river channel) is located adjacent to the right bank. Figure 3-3 shows the Brazos River alignment in the study area. The hydraulic forces on the right bank appear to be the predominant cause of the erosion.

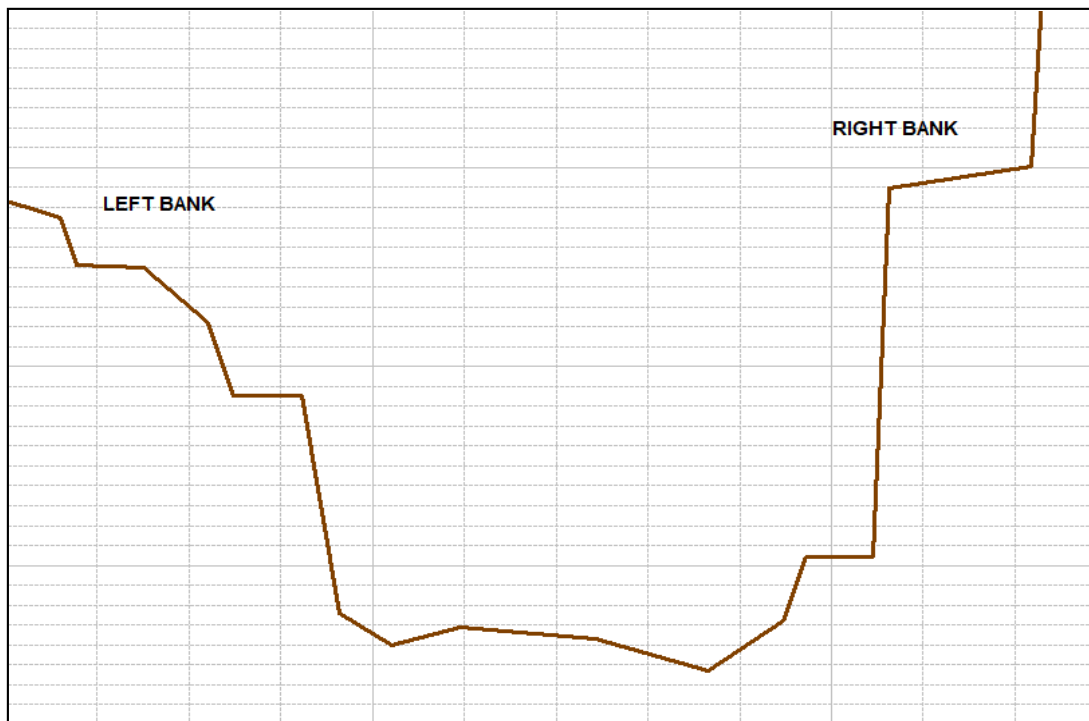
**Figure 3-4.** Brazos River Channel Geometry Cross-section 417.81

The Brazos River channel geometry from HEC-RAS model at cross-section 417.81 is an approximation based on known channel geometry from upstream and downstream bridges. The channel geometry is shown in Figure 3-4. The river channel velocities as computed from the Brazos River HEC-RAS model are shown in Figure 3-5.
