**ENVIRONMENTAL ASSESSMENT
LONE STAR LODGE AND MARINA
RAY ROBERTS LAKE
PILOT POINT, DENTON COUNTY, TEXAS**

**United States Army Corps of Engineers
Fort Worth District**

July 2020

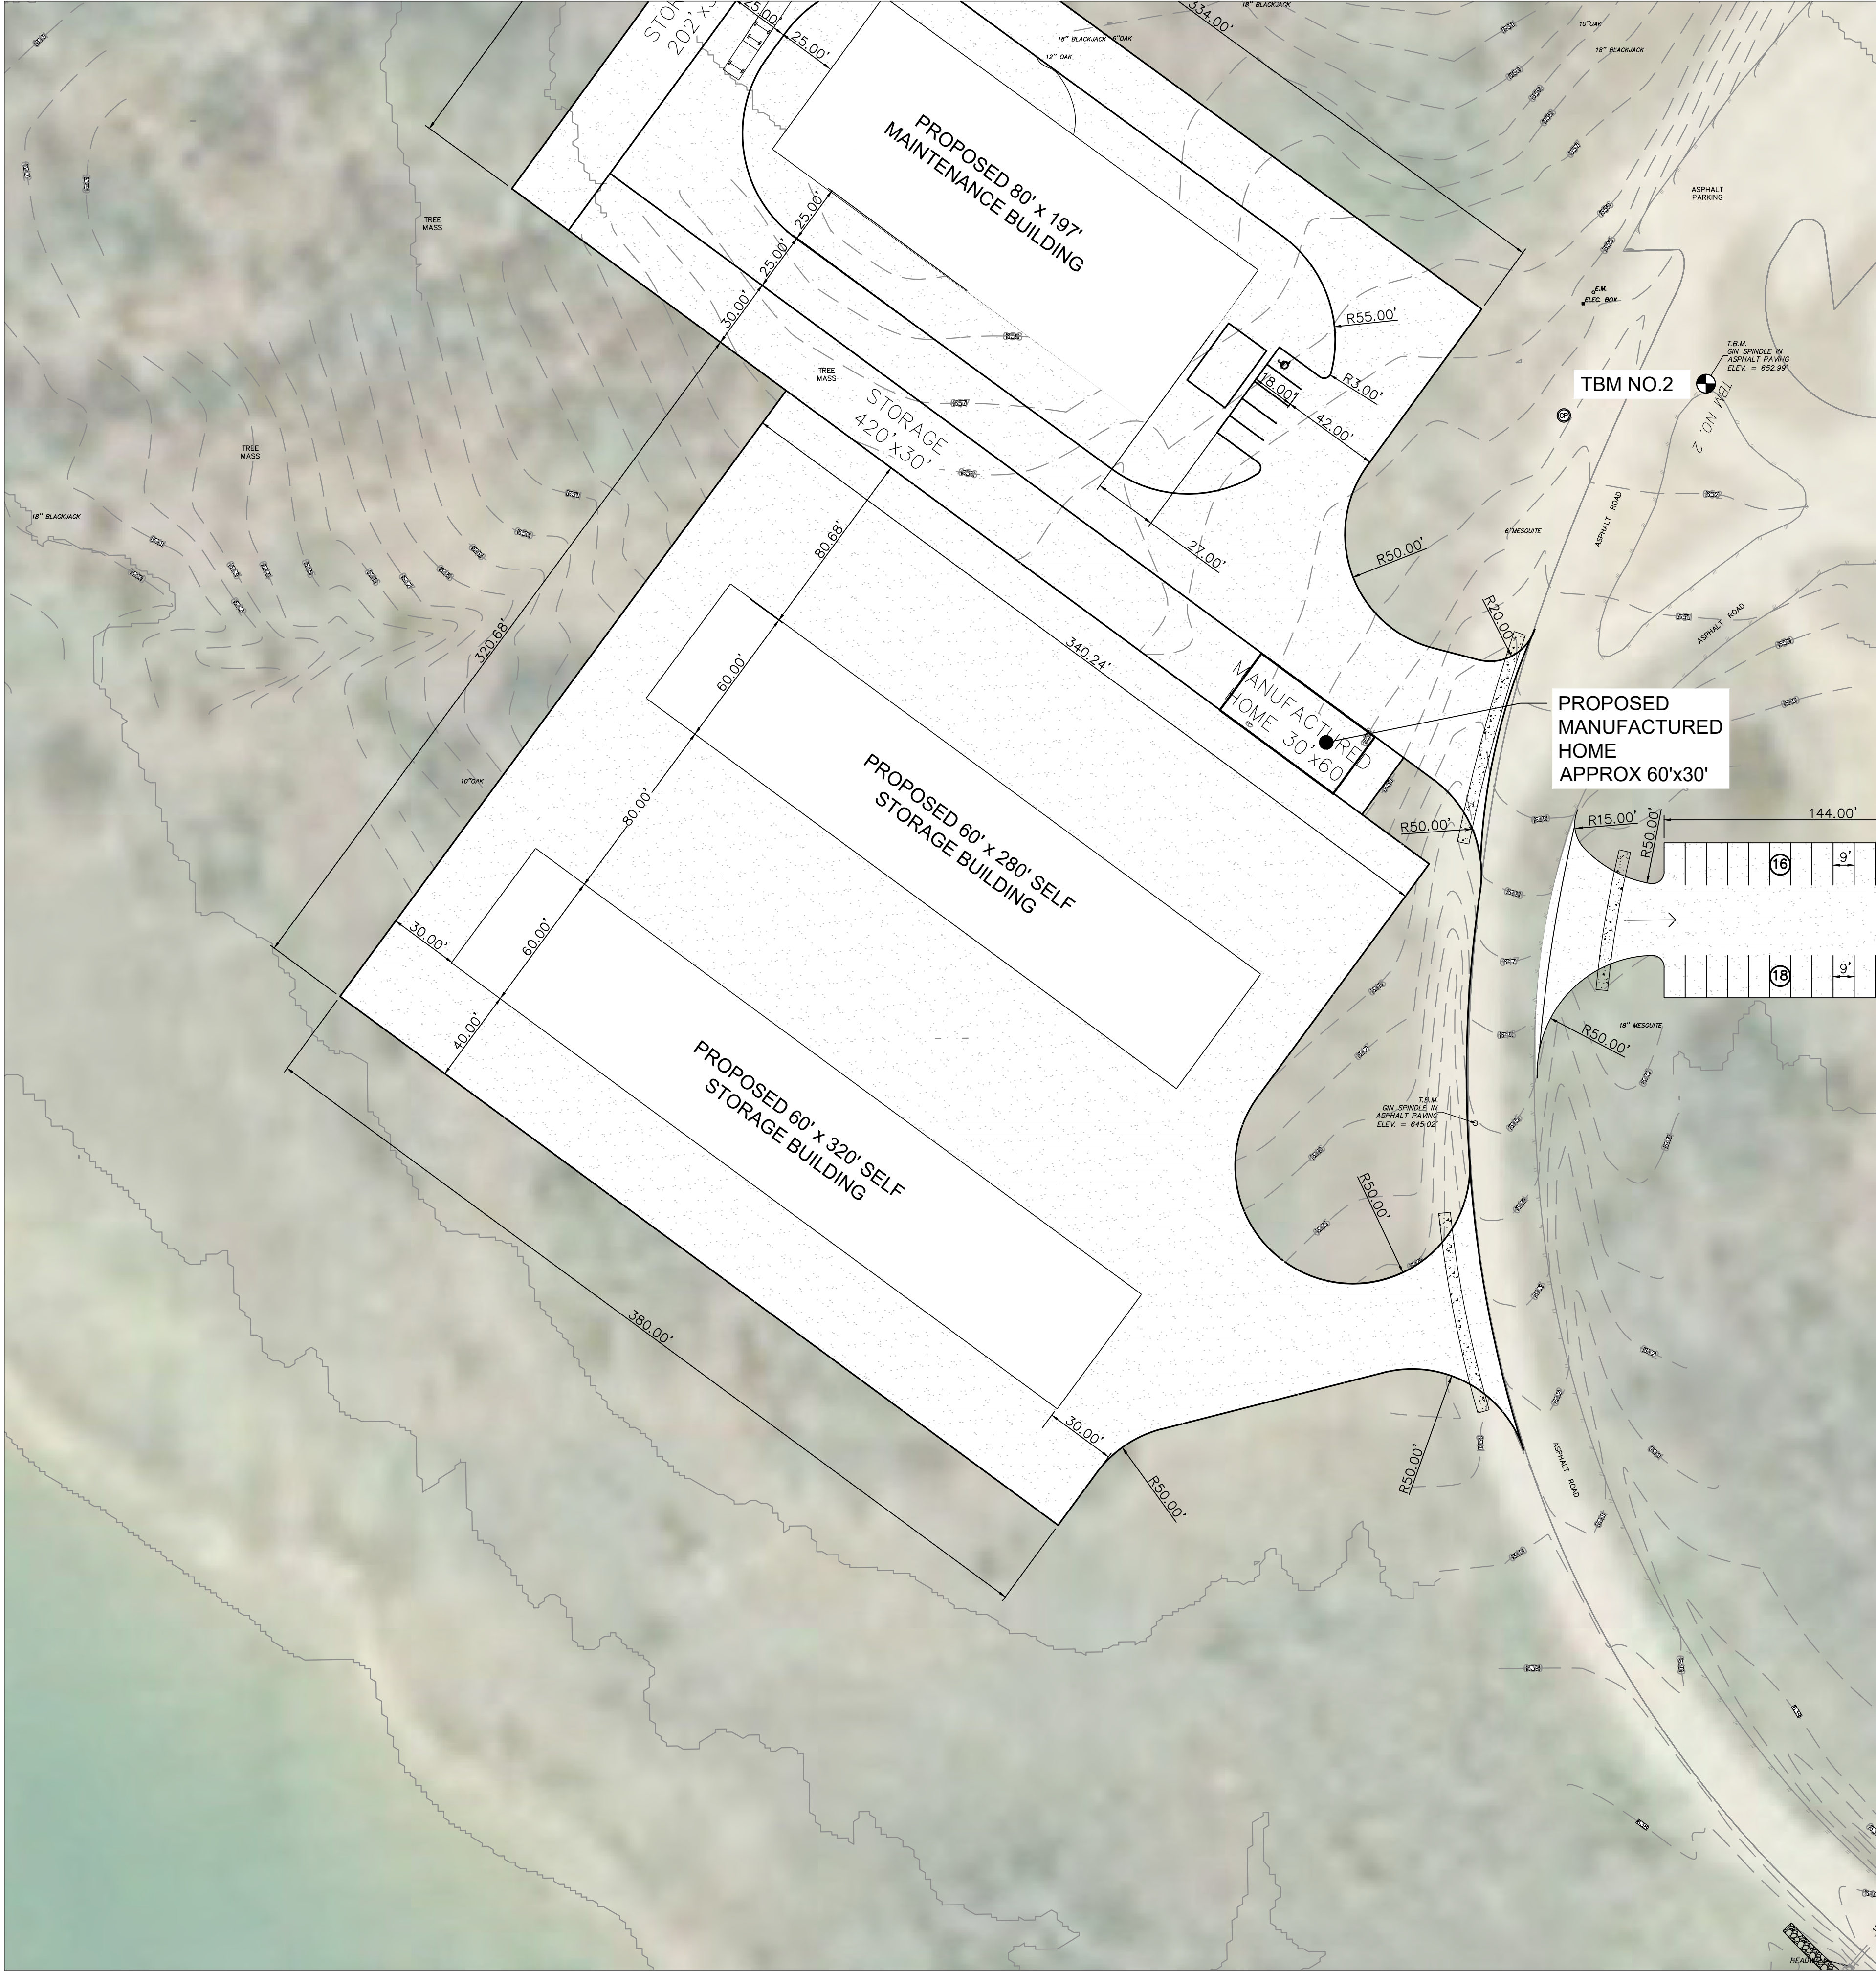
DATE: 10/23/2019	SHEET:
DRAWN BY: MAP/MLL	Exhibit - 2.5
CHECKED BY: KJW	
SCALE: AS NOTED

SELF STORAGE BUILDINGS

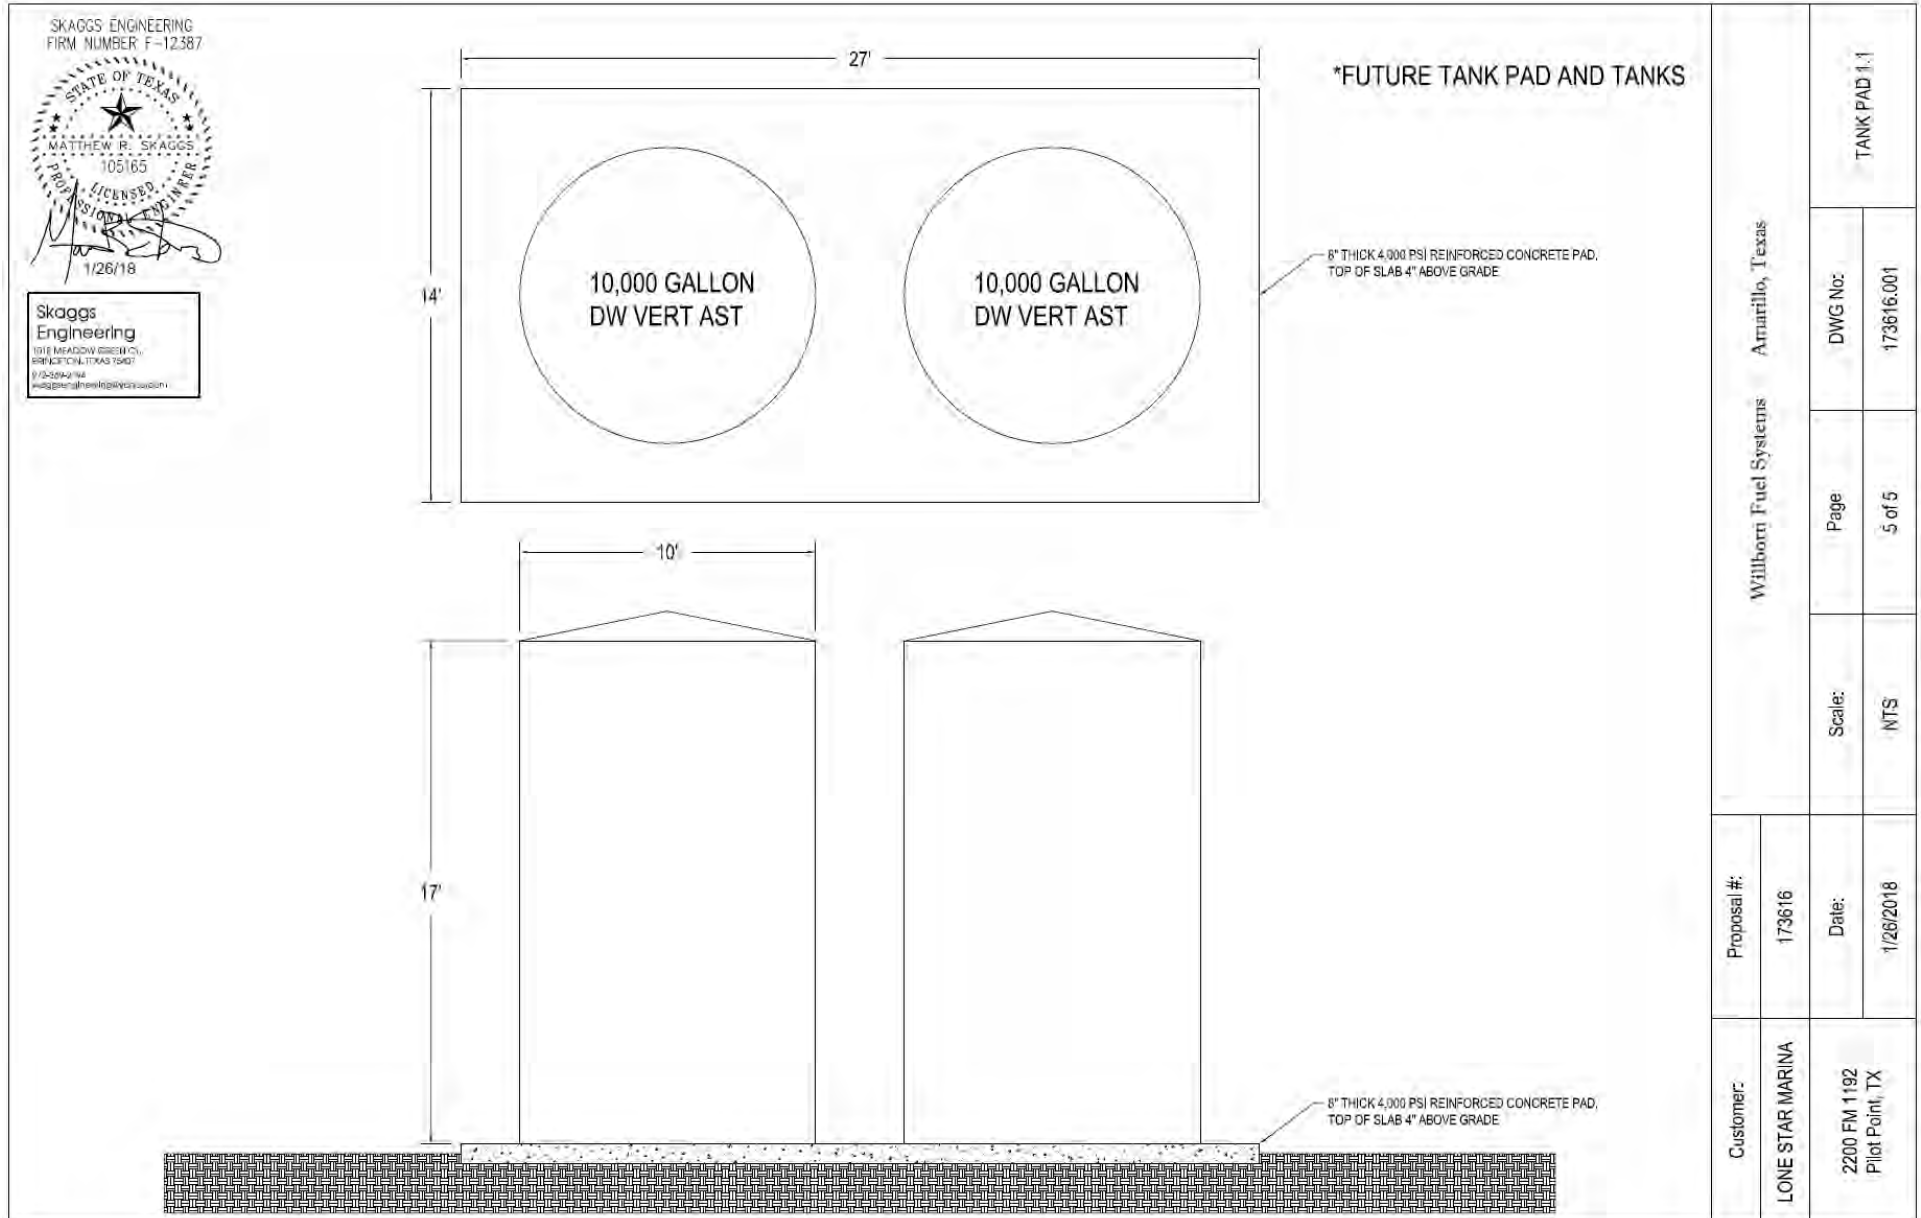
Attachment 5.4 (Willborn Fuel Systems)

This depicts a future expansion for two 10,000-gal AST(s) if ever needed. They would replace the current Convault tank that is in use now.

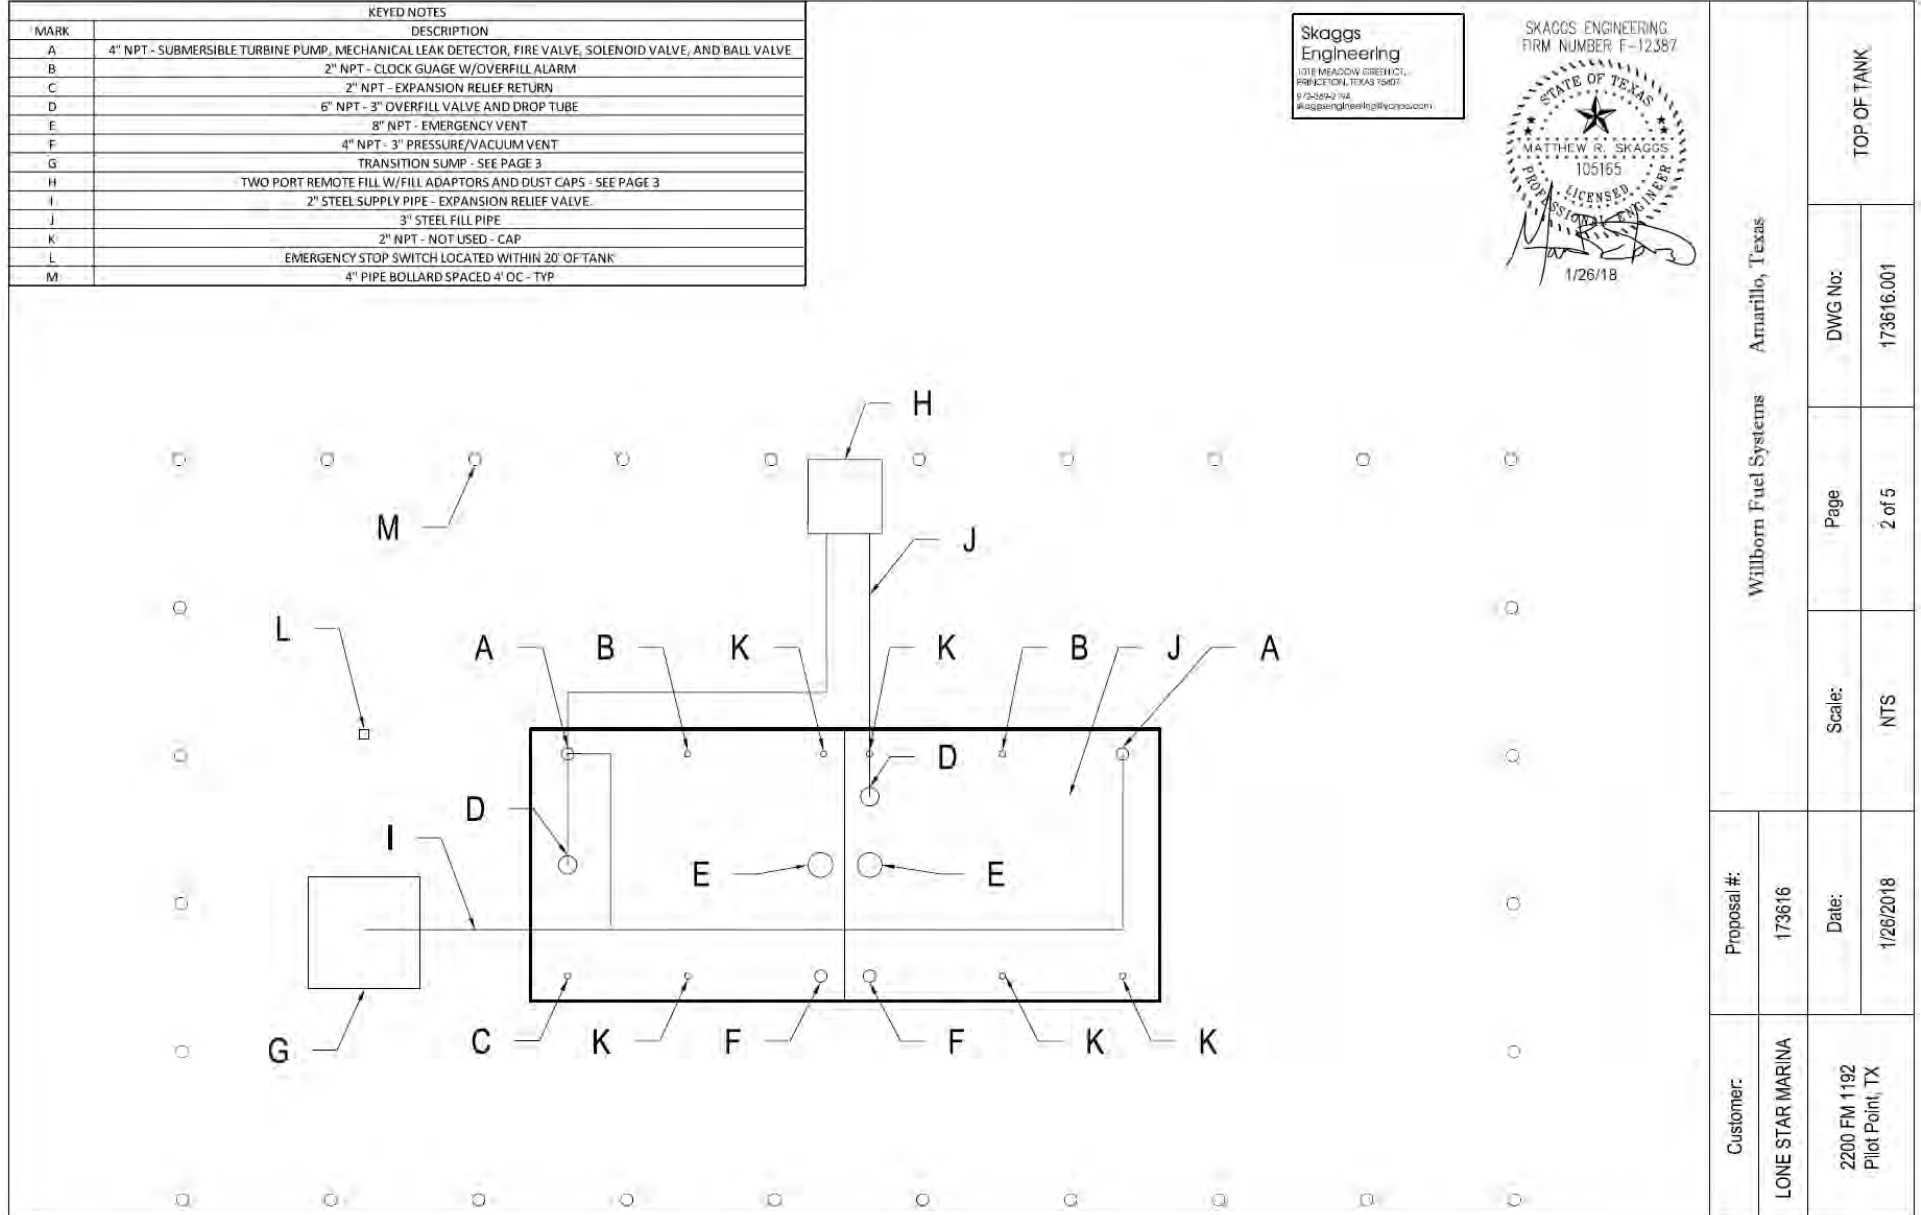
Attachment 5.5 (Willborn Fuel Systems)

This depicts the top of the current 6,000-gal AST in use and where items are located on the tank. (Pipes, valves, etc.)

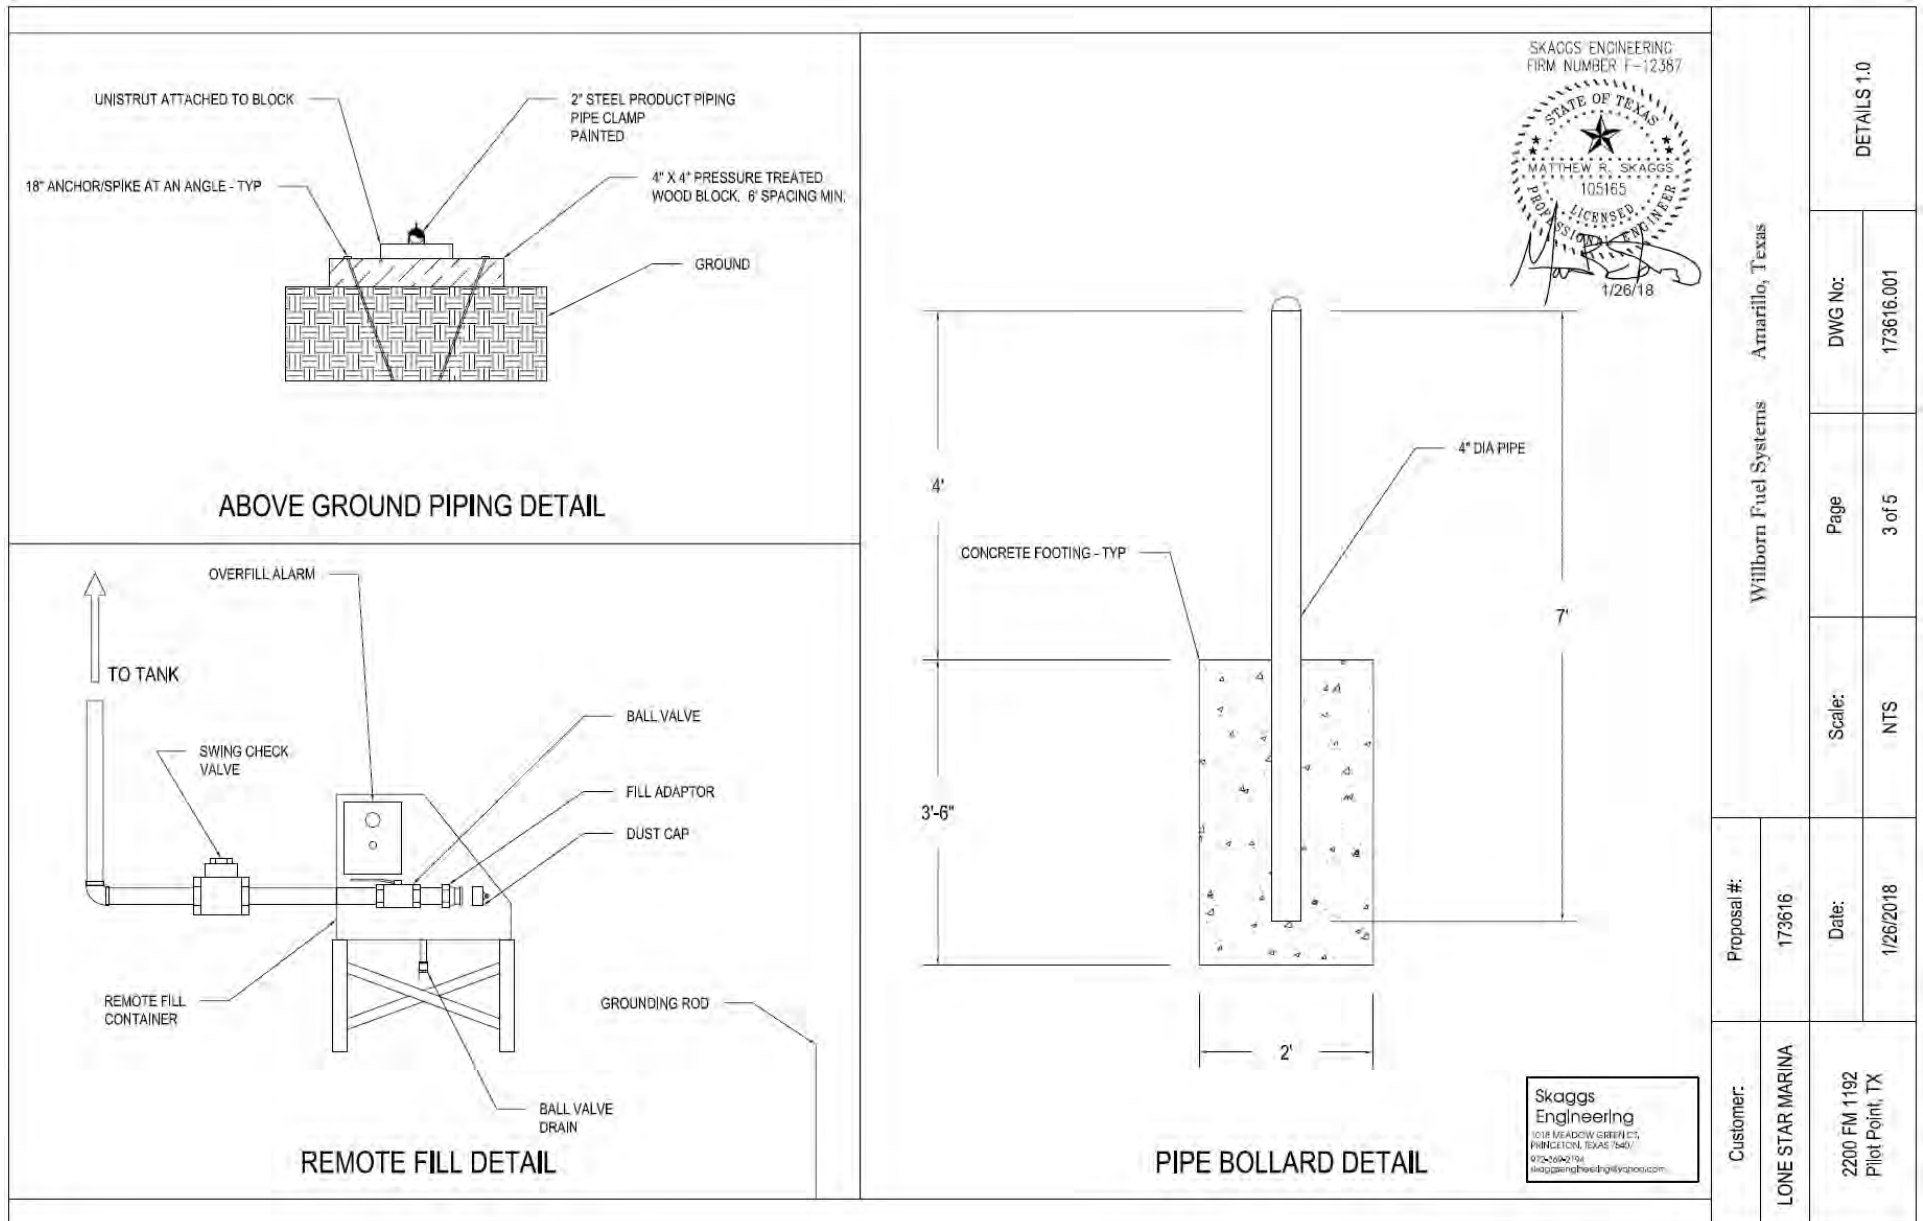
Attachment 5.6 (Willborn Fuel Systems)

This depicts the piping details of the above ground pipe and the remote fill unit.

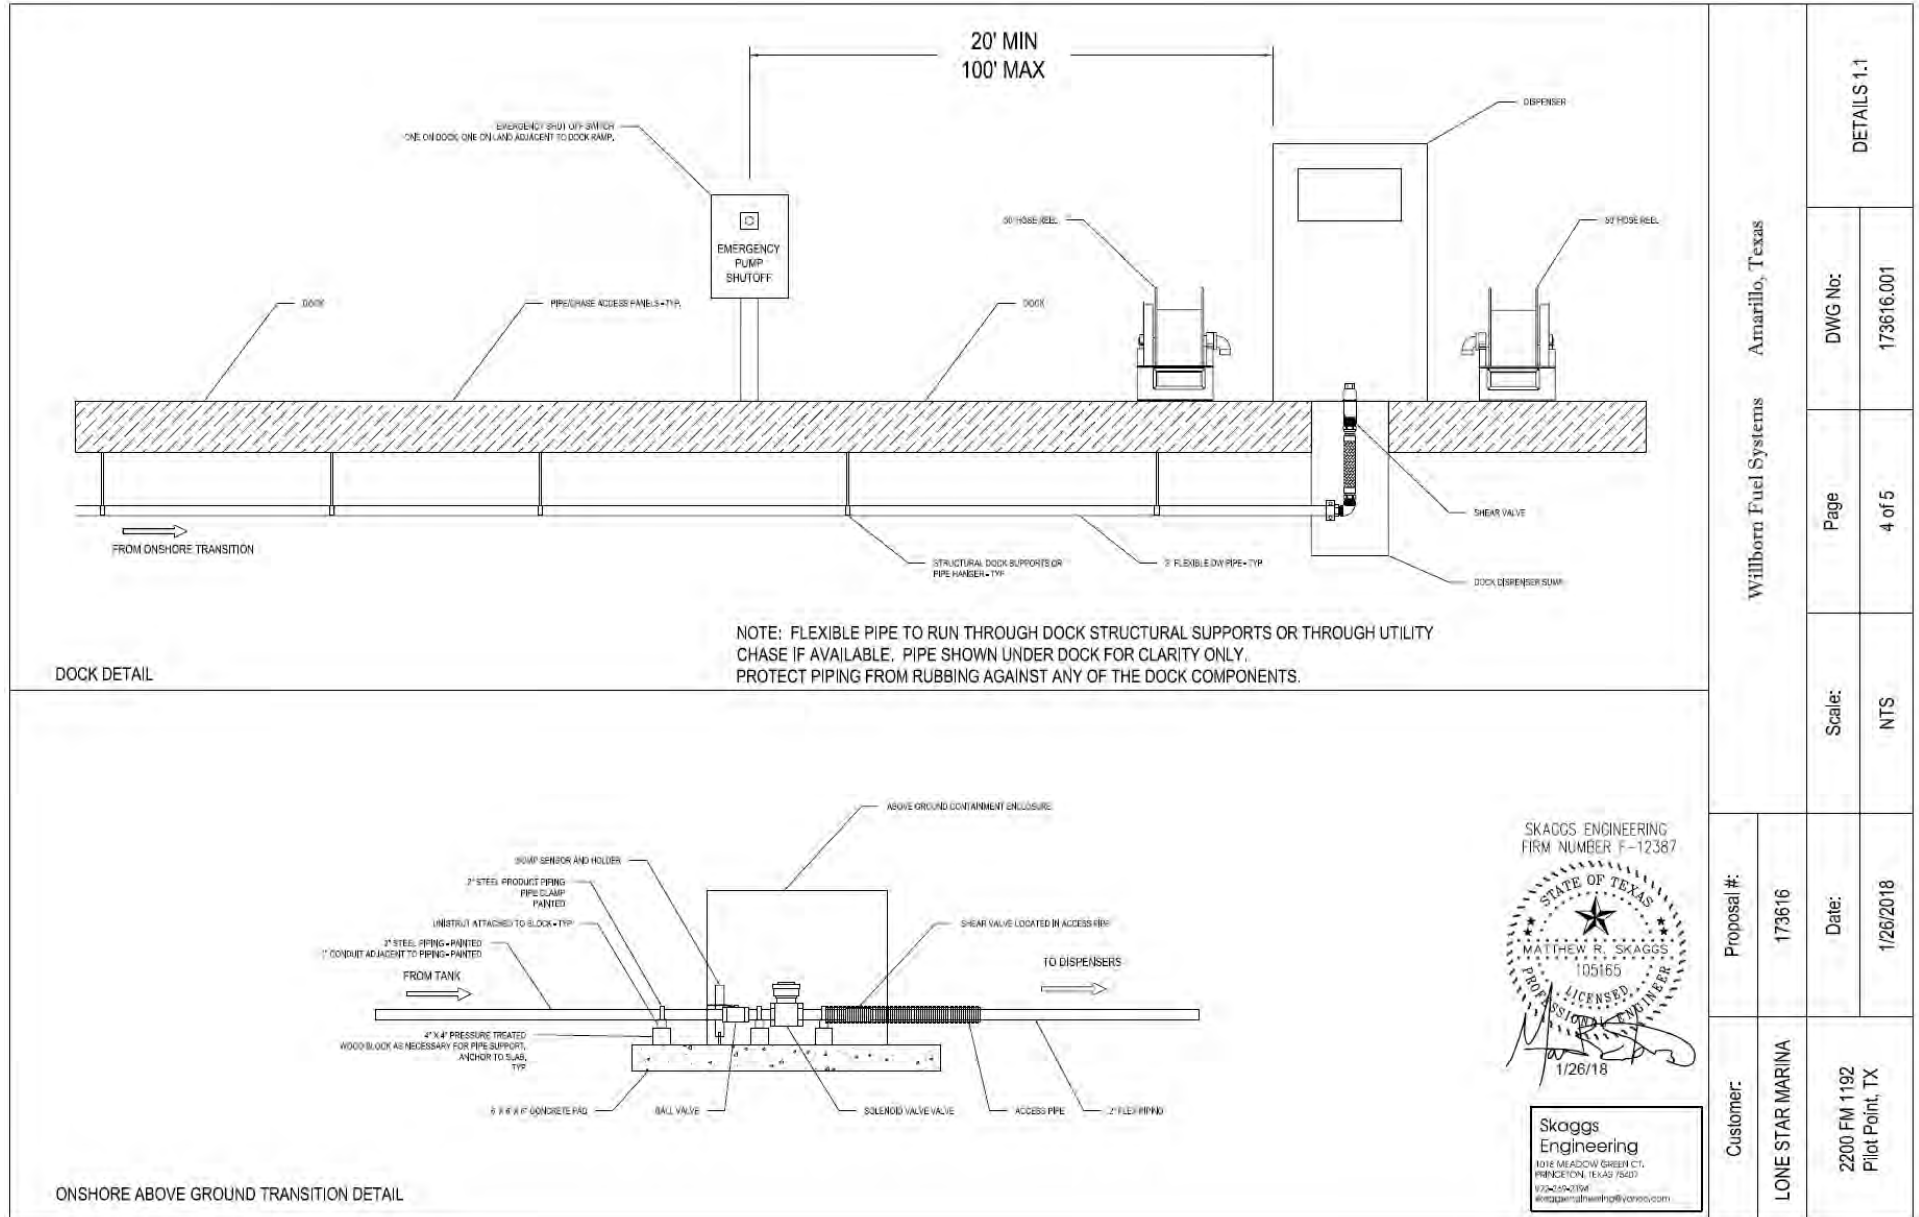
Attachment 5.7 (Willborn Fuel Systems)

This depicts the current pump setup on the dock, and the onshore above-ground transition.

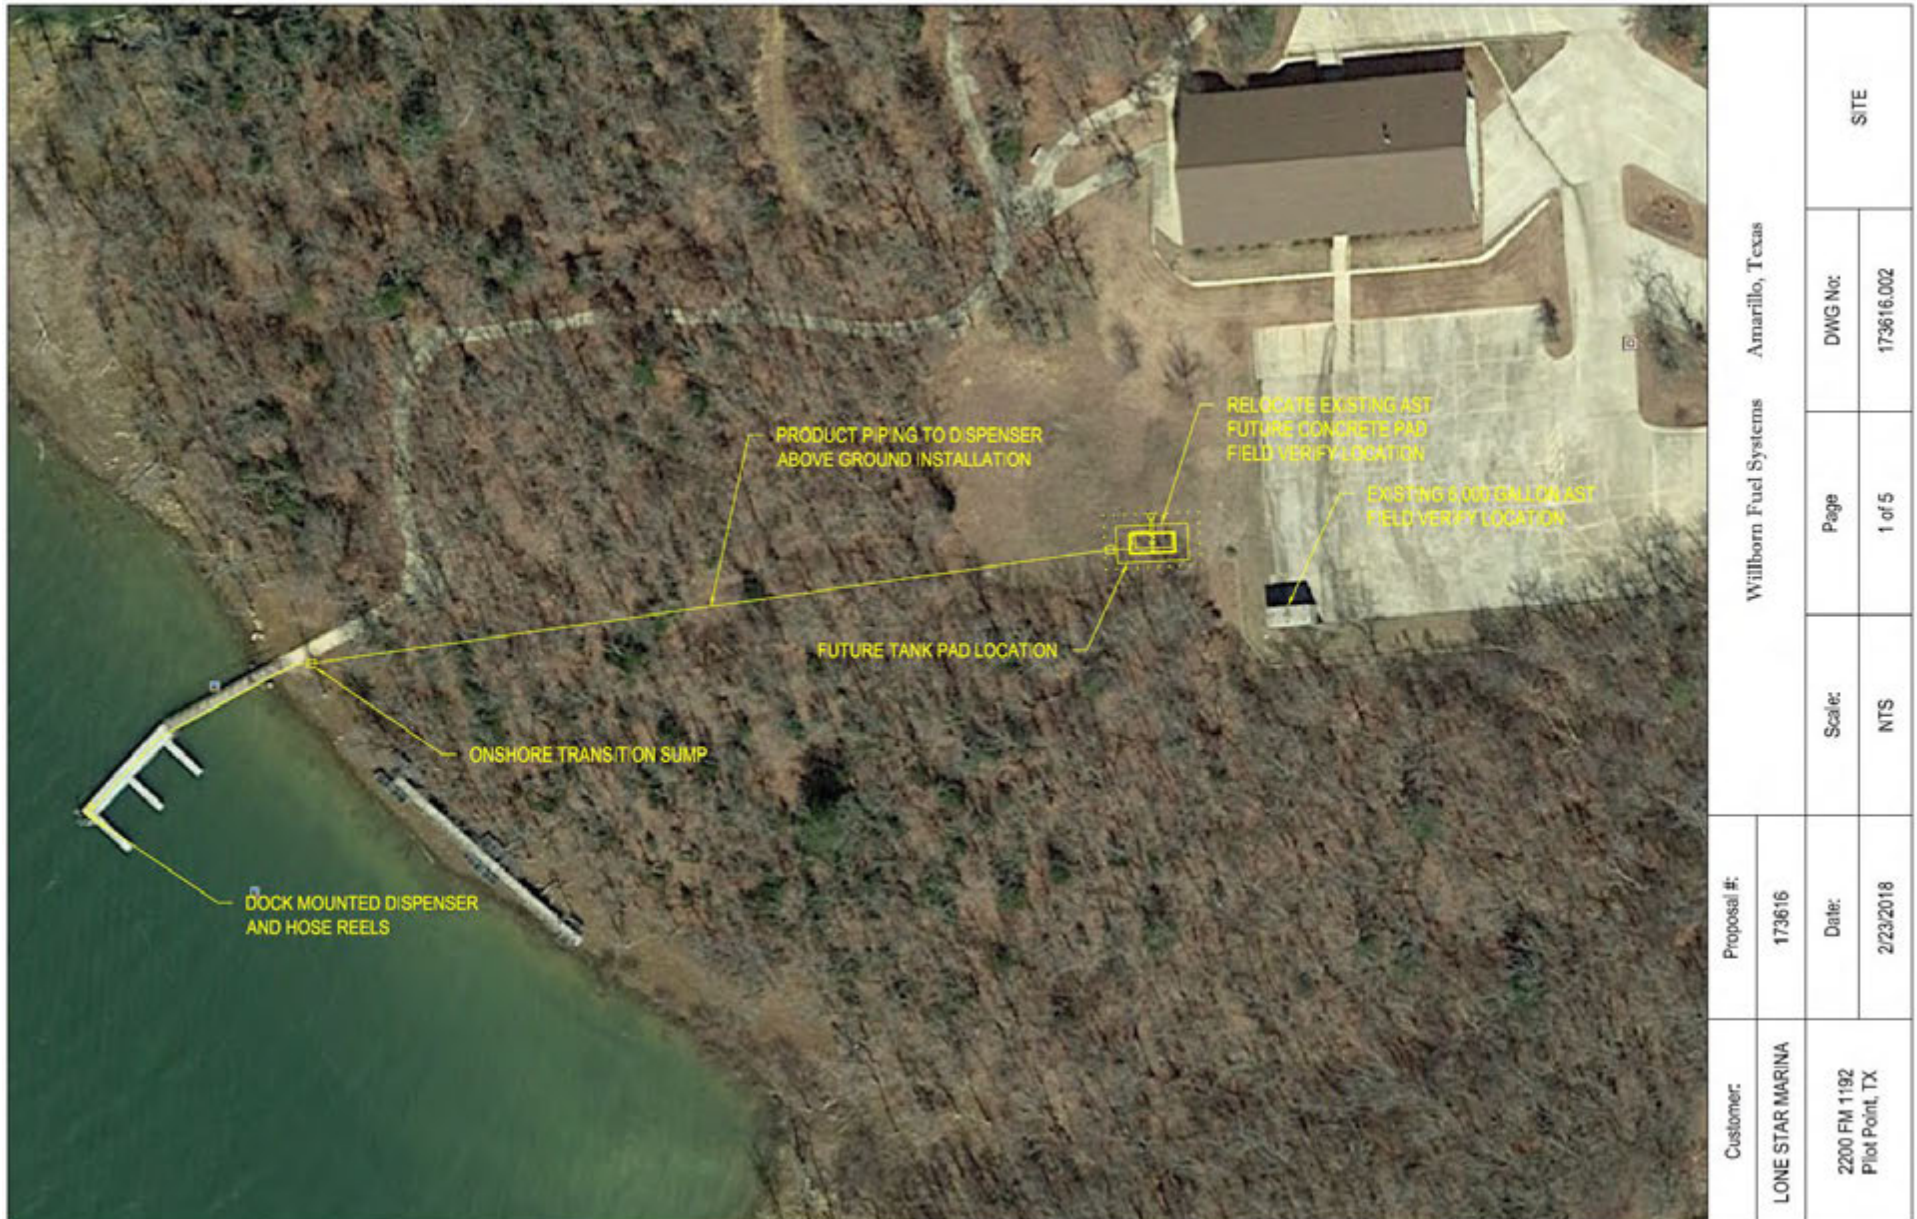
The same hose reel system be used on the new marina an additional 4 dispenser pumps will be added in the future, if needed.
