21420-2008-FA-0248

**EXISTING HABITAT CONDITIONS PLANNING AID REPORT
FOR THE
BRAZOS SYSTEMS ASSESSMENT – INTERIM FEASIBILITY STUDY
BRAZOS RIVER BASIN PHASE II
AQUILLA LAKE STORAGE REALLOCATION**

**EXISTING HABITAT CONDITIONS PLANNING AID REPORT
FOR THE
AQUILLA LAKE WATER REALLOCATION INTERIM FEASIBILITY STUDY
(BRAZOS RIVER BASIN SYSTEMS ASSESSMENT INTERIM FEASIBILITY
STUDY, PHASE II)**

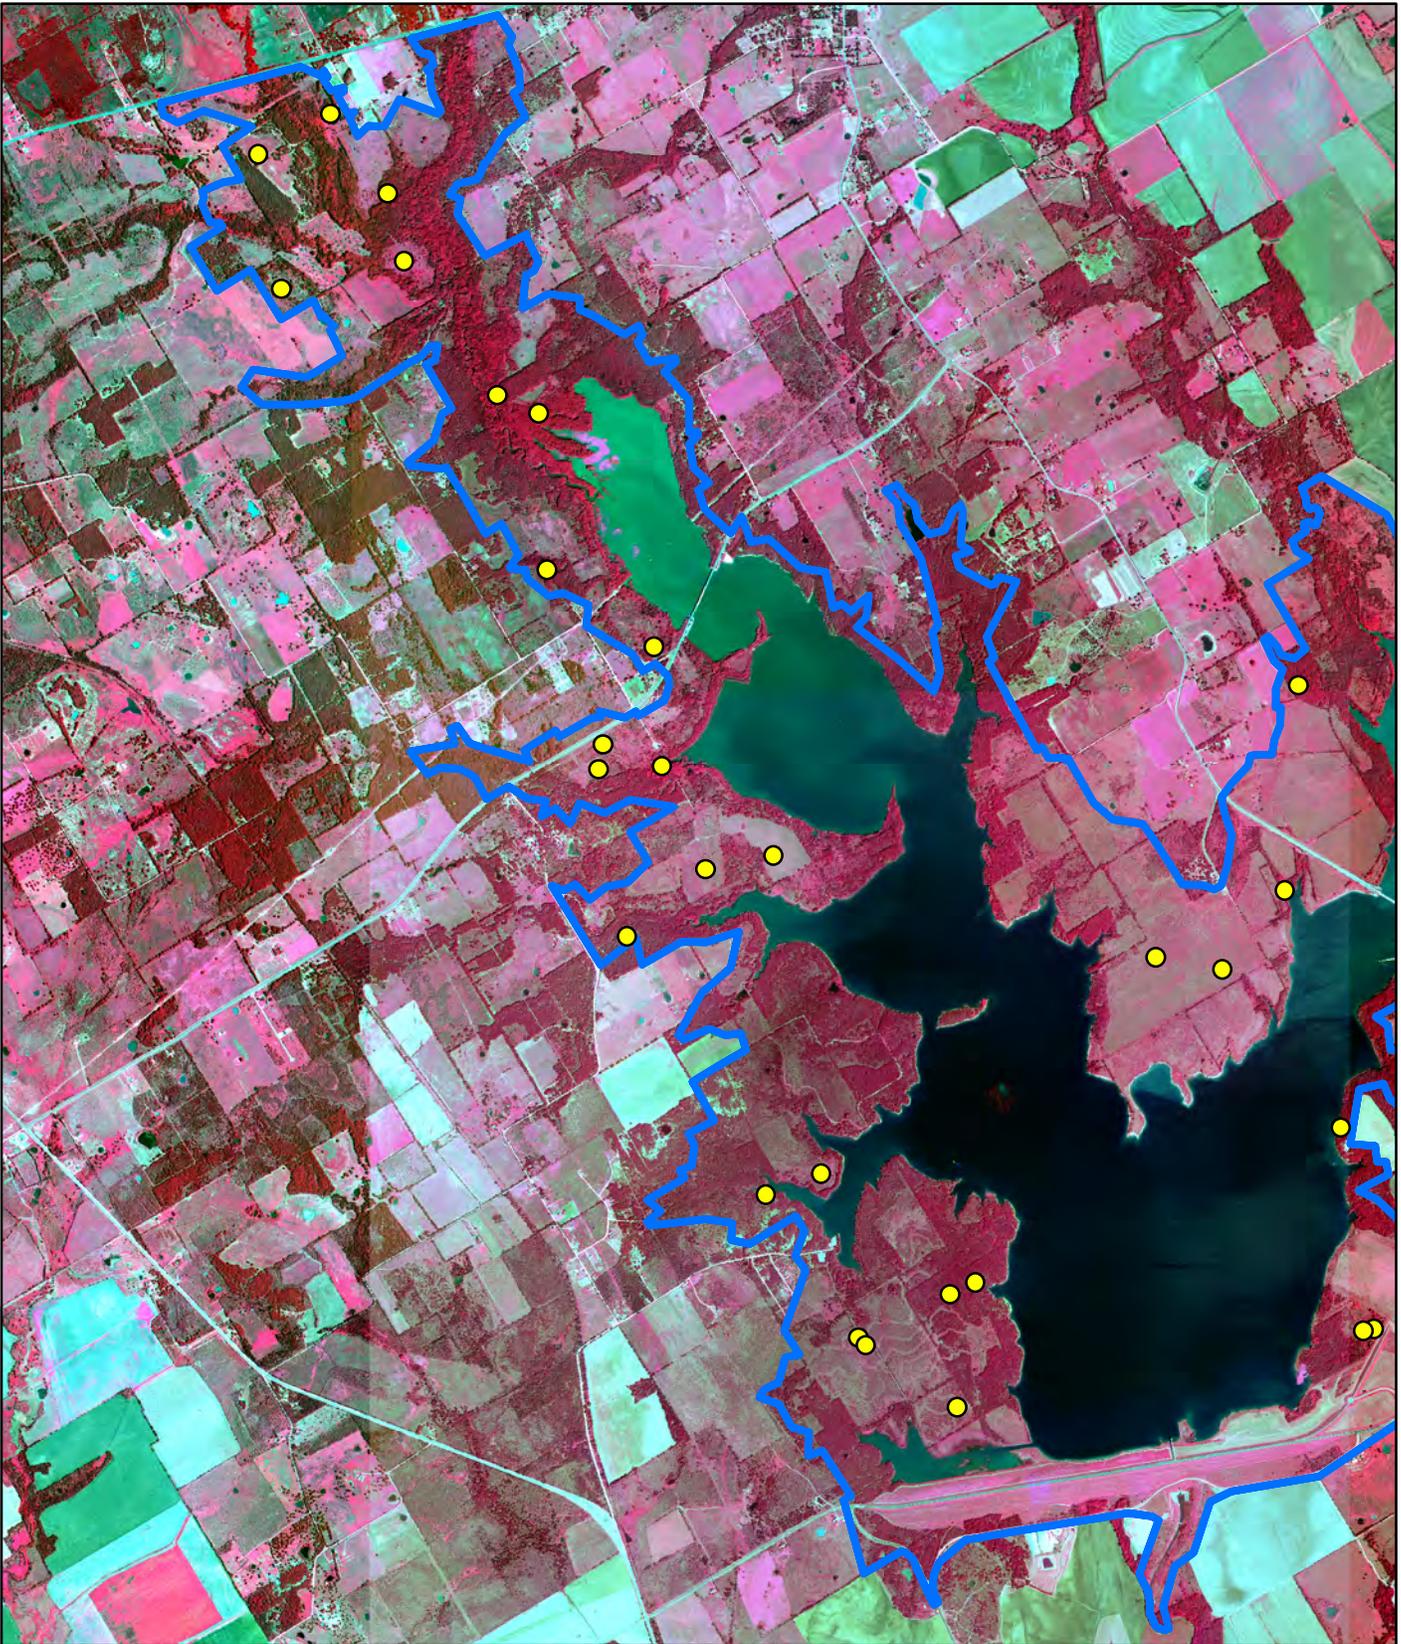
Appendix D1: Aerial photograph Aquilla Lake study area with HEP sites, western half

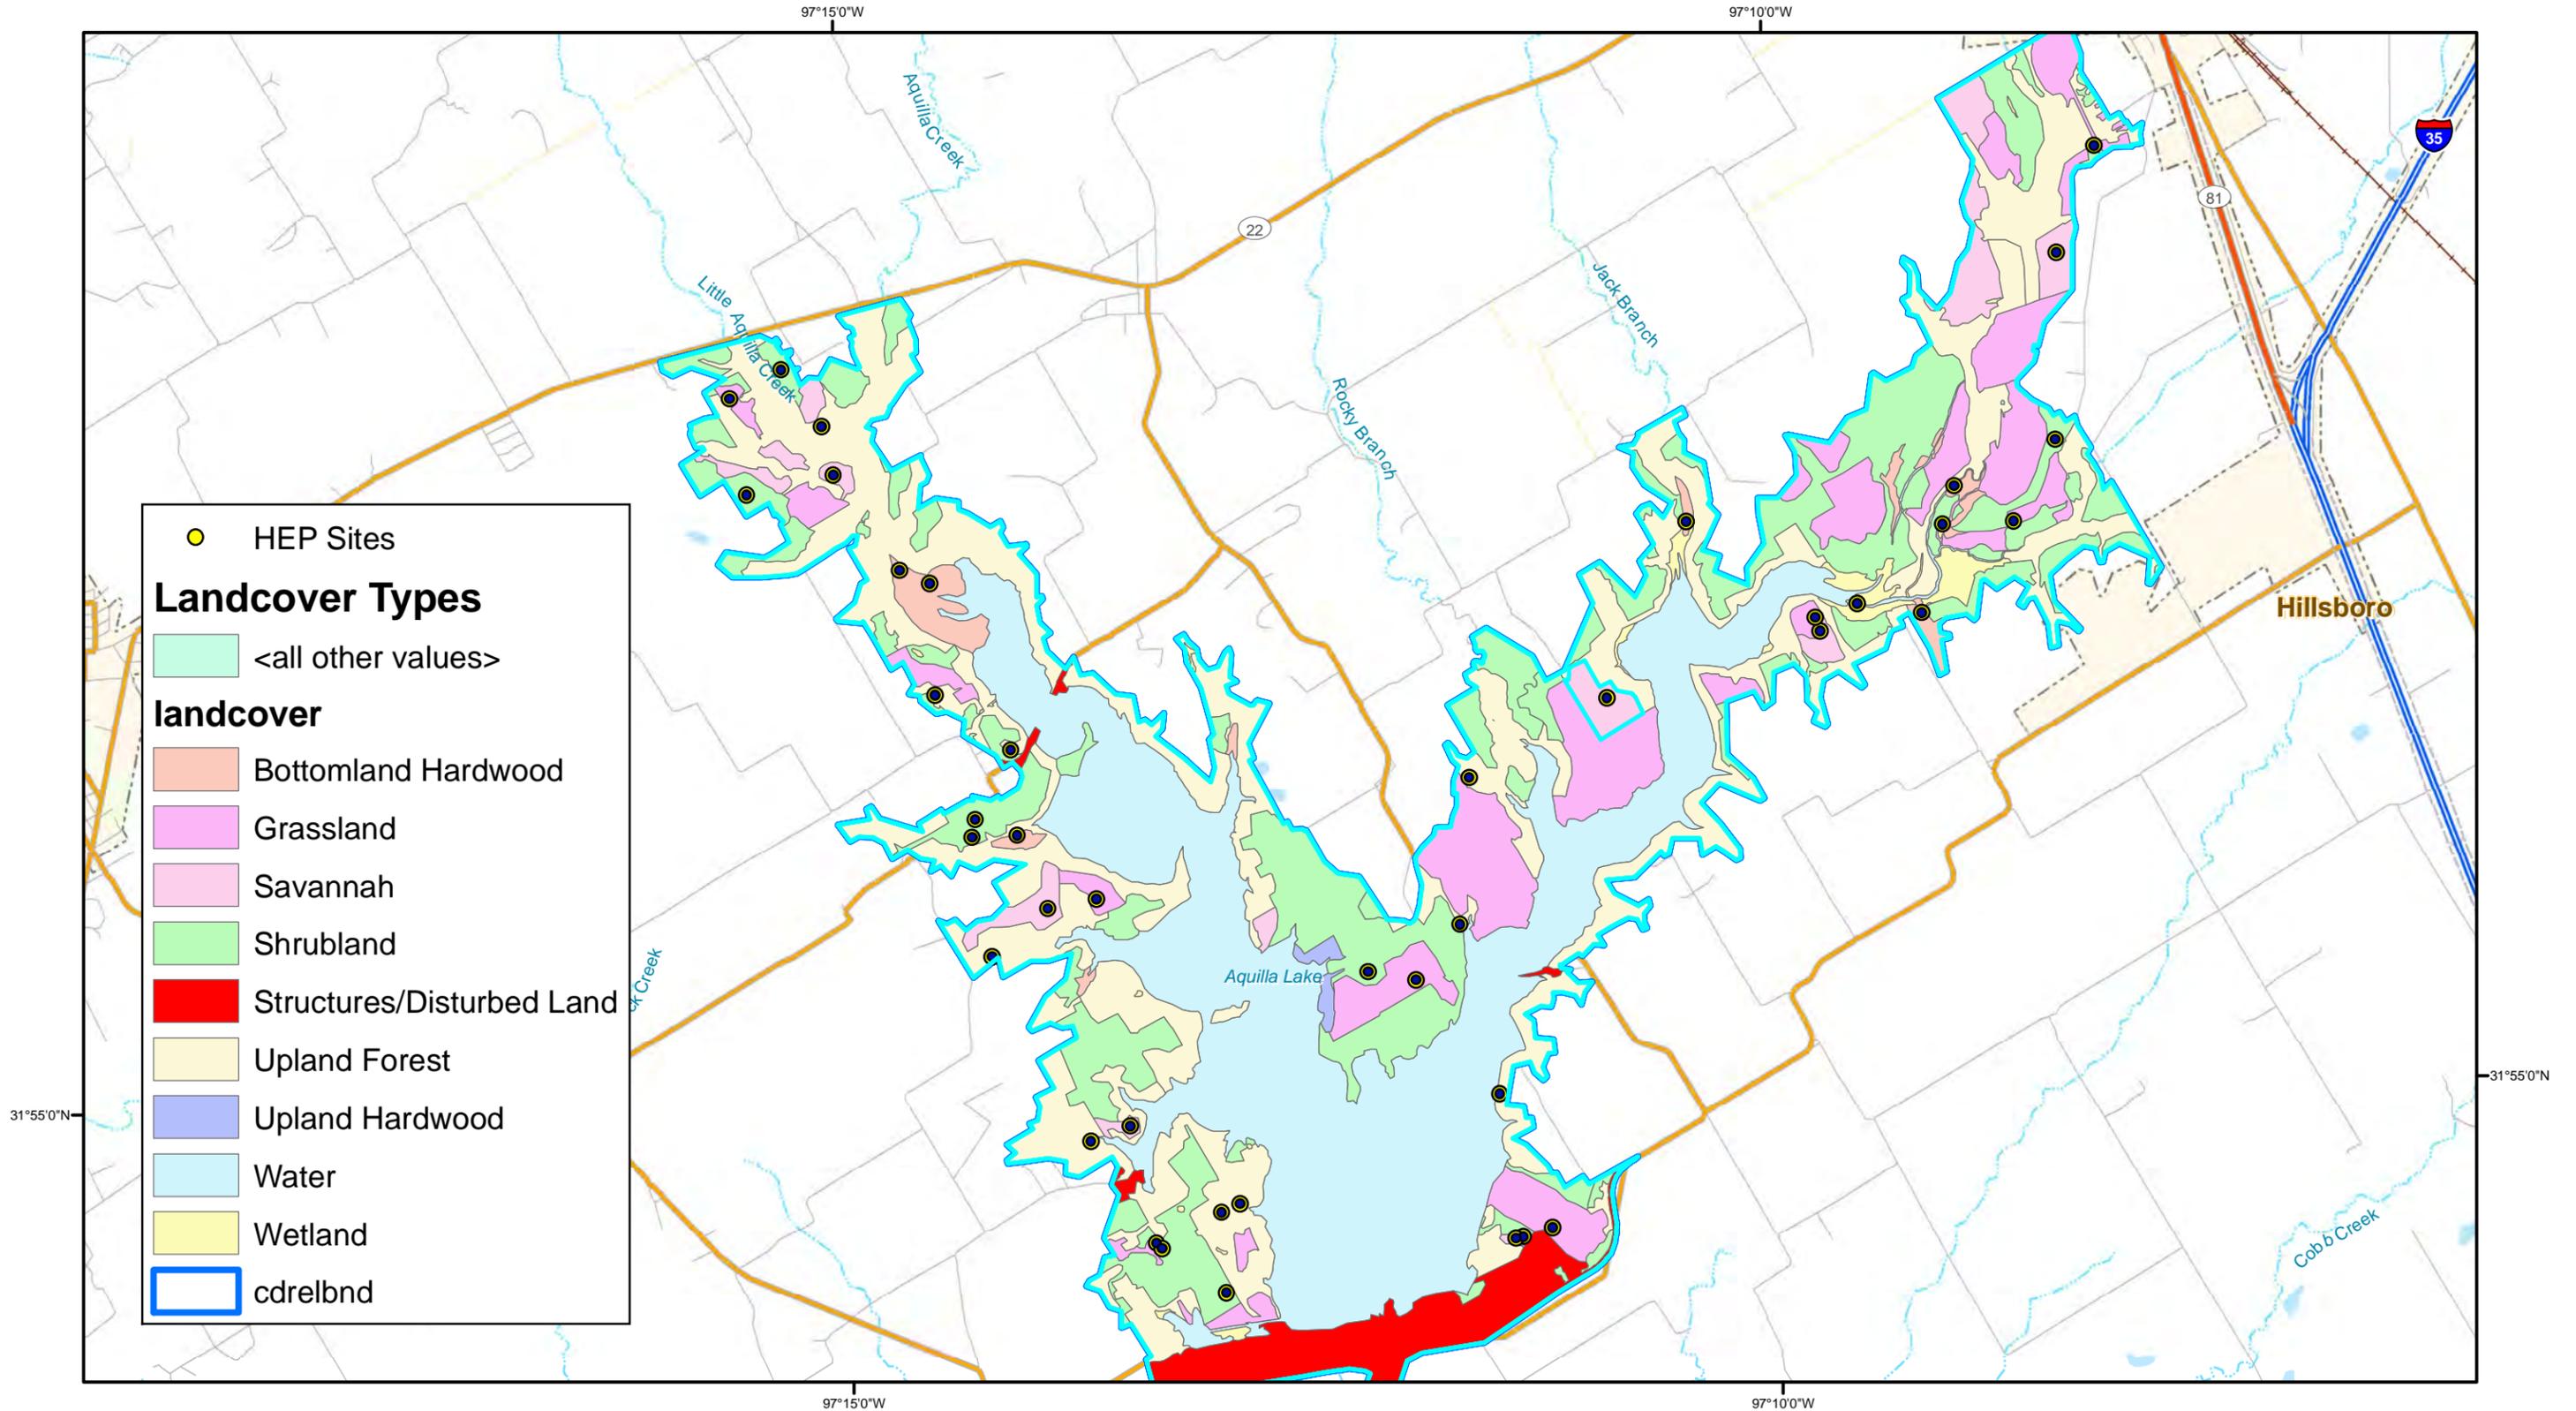
Appendix E: Aquilla Lake study area landcover types

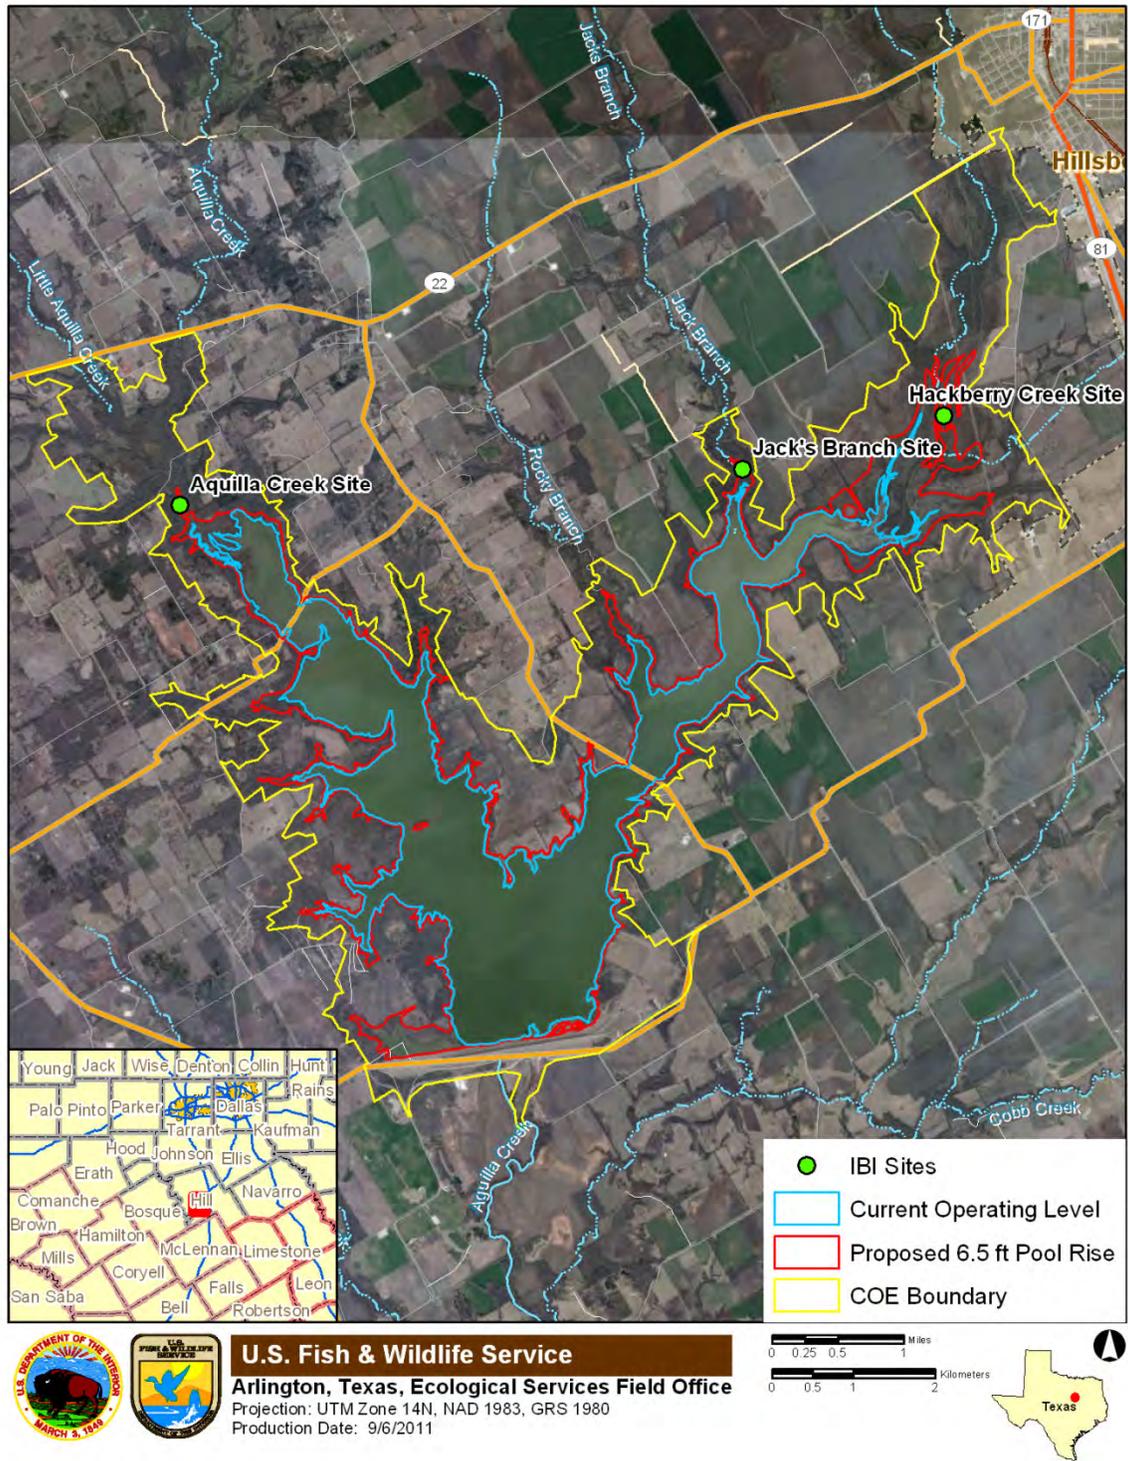
Figure 1: Location of Aquilla Creek, Jack's Branch, and Hackberry Creek sampling sites.

Fish-community structure was assessed at one site on each tributary (Aquilla Creek, Jack's Branch, and Hackberry Creek) in Hill County, Texas by USFWS and USACE personnel to determine baseline conditions (Table 1 and Figure 1). The three sites were located in areas that would be directly impacted by activities associated with the proposed project; specifically, between the reservoir's current normal conservation pool elevation of 163.8 meters (537.5 feet) above sea level and the proposed 2-meter (6.5-foot) pool rise. Rocky Creek, a tributary of Aquilla Lake located approximately 2.5 kilometers (1.5 miles) southwest of Jack's Branch, was not sampled due to being completely dry during the sampling period.

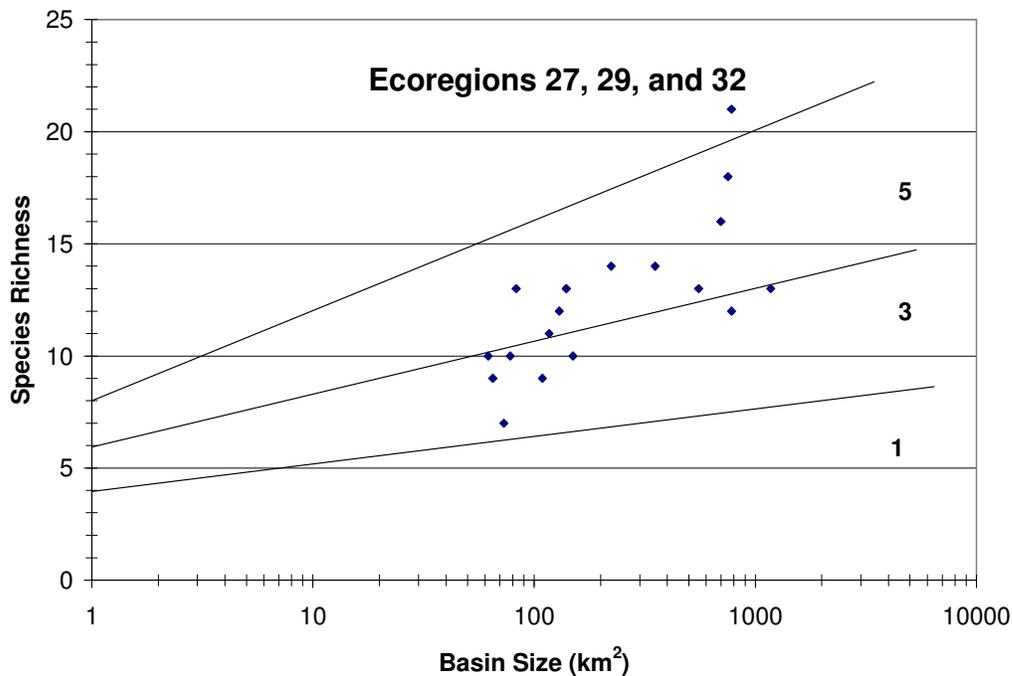
Figure 2. Fish species richness versus drainage basin size for the Subhumid Agricultural Plains (Ecoregions 27, 29, and 32) from Linam *et al.* (2002).

Metric	Scoring Criteria		
	5	3	1
1. Total number of fish species	See figure 2		
2. Number of native cyprinid species	>3	2-3	<2
3. Number of benthic invertivore species	>1	1	0
4. Number of sunfish species	>3	2-3	<2
5. % of individuals as tolerant species (excluding western mosquitofish)	<26%	26-50%	>50%
6. % of individuals as omnivores	<9%	9-16%	>16%
7. % of individuals as invertivores	>65%	33-65%	<33%
8. % of individuals as piscivores	>9%	5-9%	<5%
9. (a) Number of individuals/seine haul	>87	36-87	<36
9. (b) Number of individuals/minute of electrofishing	>7.1	3.3-7.1	<3.3
10. % of individuals as non-native species	<1.4%	1.4-2.7%	>2.7%
11. % of individuals with disease or other anomaly	<0.6%	0.6-1%	>1%
