I. ADMINISTRATIVE INFORMATION

ORM Number: SWF-2021-00067

Review Area Location¹: State/Territory: TX City: Leon Valley County/Parish/Borough: Bexar

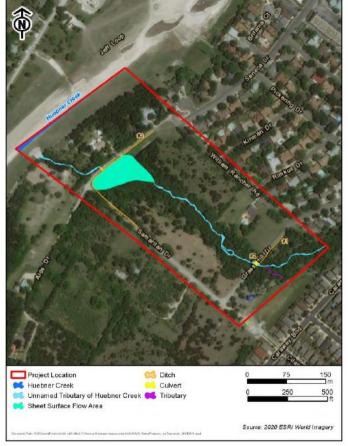
Figure 8. Results of the delineation.

Tributaries ((a	Tributaries ((a)(2) waters):				
(a)(2) Name	(a)(2) Size		(a)(2) Criteria	Rationale for (a)(2) Determination	
Huebner Creek	752	linear feet	(a)(2) Intermittent tributary contributes surface water flow directly or indirectly to an (a)(1) water in a typical year.

Excluded waters ((b)(1) - (b)	(12)):4		
Exclusion Name	Exclusion	Size	Exclusion ⁵	Rationale for Exclusion Determination
Unnamed tributary of Huebner Creek	1982	linear feet	(b)(3) Ephemeral feature, including an ephemeral stream, swale, gully, rill, or pool.	Four pools of water were observed within the unnamed tributary of Huebner Creek. The observed pools were small in size and had no flow. The water appeared to be dark and stagnant and no aquatic species or vegetation was observed in the water indicating that the water was no present for long periods. Although the APT indicates that the October 2020 and November 2020 were dryer than normal compared to the last 30 years, December 2020 was determined to be a normal month. This tributary only have surface flow after rain events. The observed small pools within the unnamed tributary of Huebner Creek are remnants of recent rain events and the water collected in the lowest areas of the tributary. The lack of aquatic species and vegetation in the pools provide further evidence that the tributaries are ephemeral. There were no signs of inundation by flooding such as the presence of water marks and sediment and drift deposits. This tributary is not flooded by another WOTUS in a typical year. The project area is adjacent to Huebner Creek, a jurisdictional WOTUS, but due to improvements to Huebner Creek including making the floodway over 350 feet wide and the construction of high banks on each side of the creek, it is unlikely the project area would be flooded by Huebner Creek in a typical year. Also, the project area is five to forty-five feet higher in elevation than Huebner Creek indicating that the project area does not get flooded by Huebner Creek in a typical year. Review of aerial photography dating from 1995 to 2020 does not

Sheet Surface Flow Area	1.1	acres	(b)(4) Diffuse stormwater run- off over upland or directional sheet flow over upland.	A sheet surface flow area exists in between where the OHWM of the unnamed tributary of Huebner Creek ends and Ditch #3 along Aids Drive. No OHWM exists within this area. The entire area was slightly scoured and consisted of clay with no herbaceous vegetation. This area occurs in an upland. Therefore, since this sheet surface flow area is not a tributary under (a)(2), exclusion (b)(4) applies.
