**U.S. ARMY CORPS OF ENGINEERS
REGULATORY PROGRAM
APPROVED JURISDICTIONAL DETERMINATION FORM (INTERIM)
NAVIGABLE WATERS PROTECTION RULE**

ORM Number: SWF-2017-00148

Altura Homes
Meadows at Morgan Creek – 100.879 Acres
Farm to Market Road 2453
Royse City, Rockwall County, TX

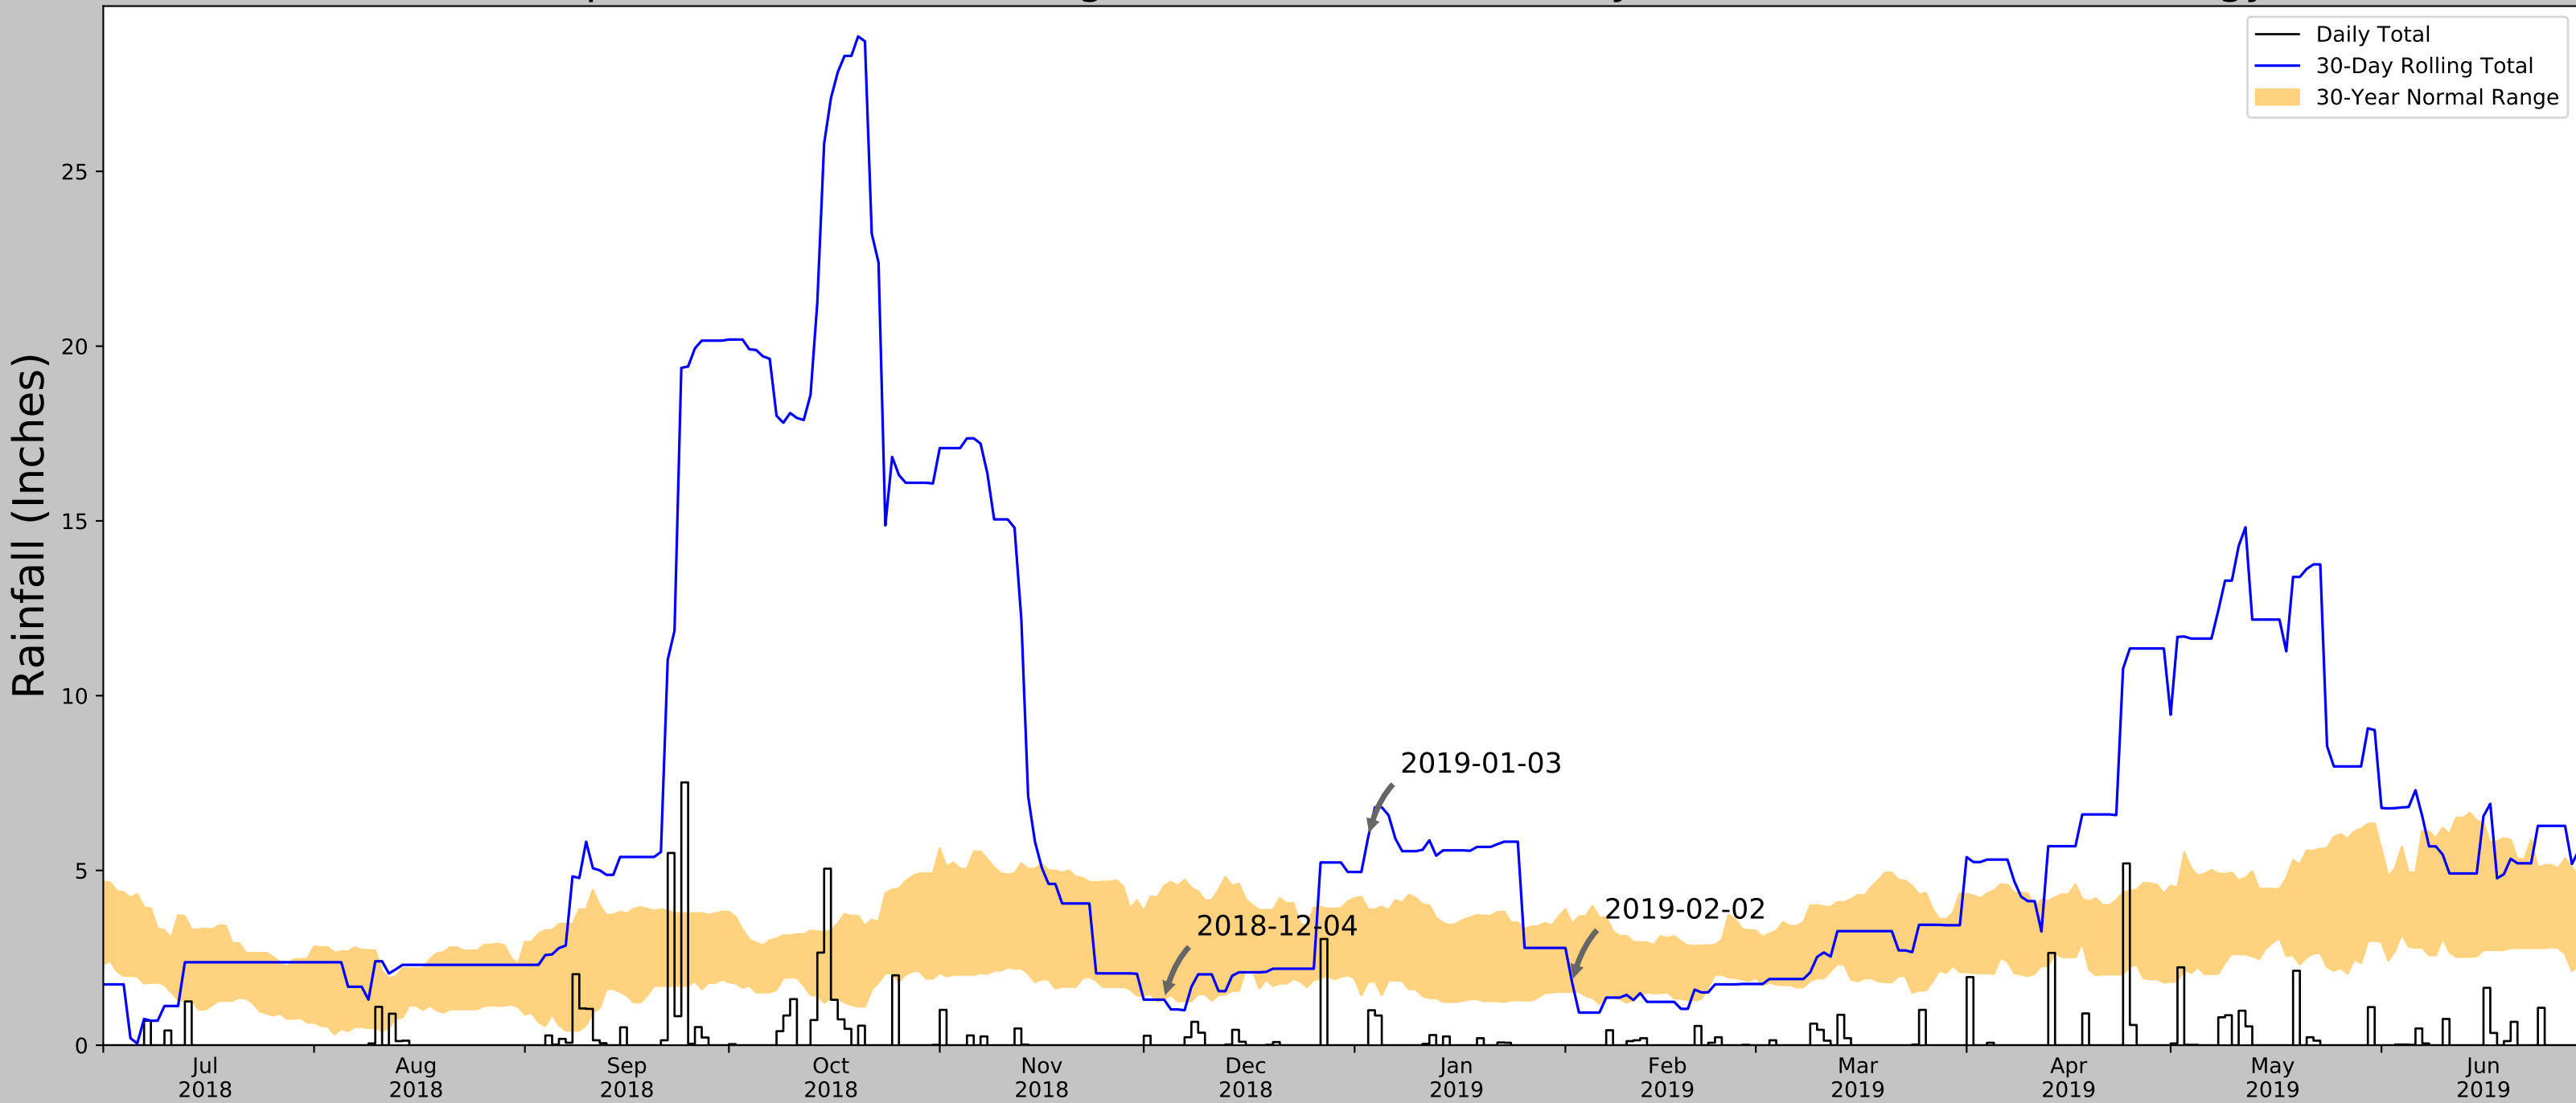
Antecedent Precipitation vs Normal Range based on NOAA's Daily Global Historical Climatology Network

Coordinates	32.9679, -96.31
Observation Date	2019-02-02
Elevation (ft)	542.53
Drought Index (PDSI)	Severe wetness
WebWIMP H ₂ O Balance	Wet Season

30 Days Ending	30 th %ile (in)	70 th %ile (in)	Observed (in)	Wetness Condition	Condition Value	Month Weight	Product
2019-02-02	1.526378	3.464961	1.783465	Normal	2	3	6
2019-01-03	1.818898	3.885039	5.956693	Wet	3	2	6
2018-12-04	1.326772	4.559843	1.30315	Dry	1	1	1
Result							Normal Conditions - 13

- B. Typical year assessment(s):** The APT tool was run for February 2, 2019, when the consultant performed a site visit to delineate the resources on site and take photographs, and conditions were drier than normal during the wet season. It is the Corps' determination through an assessment of all available information that Pond 1 and Trib 1 are non-jurisdictional and only exhibit surface water flowing or pooling in direct response to precipitation.
- C. Additional comments to support AJD:** Evidence of the presence of water within the confined drainage area of Trib 1 by using Google Earth Imagery was observed during more recent years (years viewed: 1996, 2005, 2010, 2012, 2014, and 2018), but appears only when the pond has been filled, indicating overflow into an ephemeral drainage.

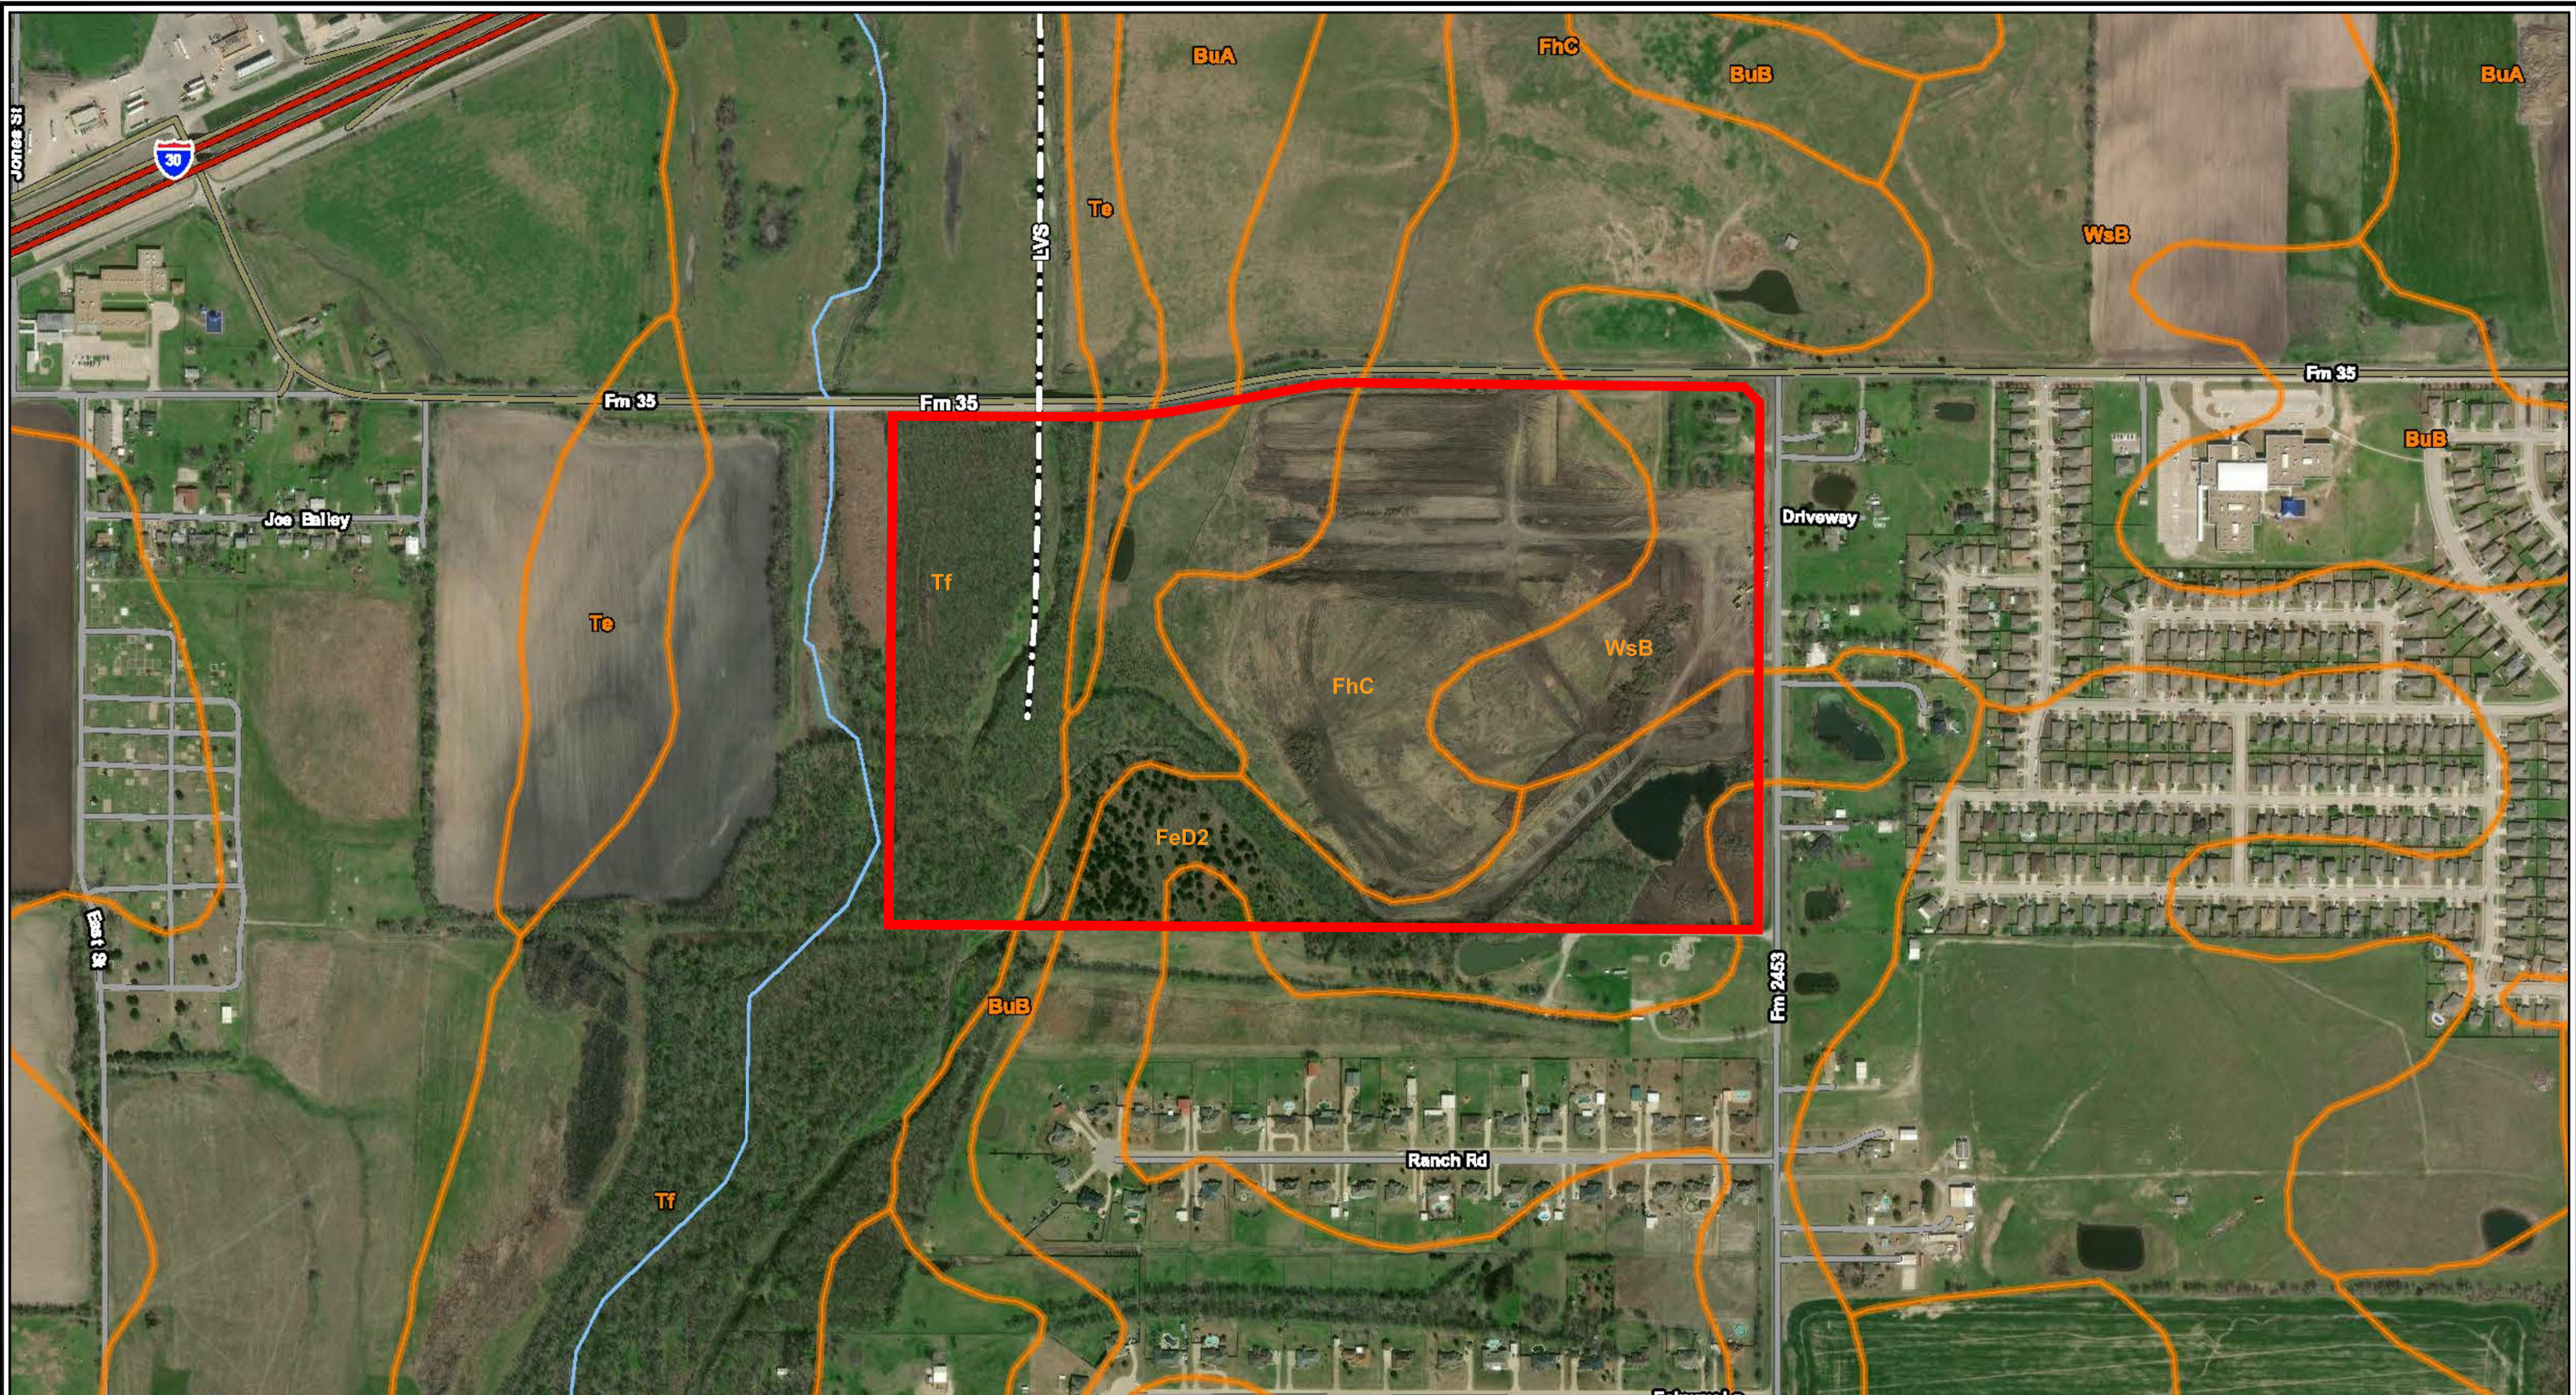
FIGURE 3

SOURCE: USDA NATURAL RESOURCE CONSERVATION SERVICE; WEB SOIL SURVEY, SOIL MAP - HUNT COUNTY, TEXAS, VERSION 17, SEPTEMBER 14, 2018 & KAUFMAN AND ROCKWALL COUNTIES, TEXAS, VERSION 15, SEPTEMBER 14, 2018.

SOILS MAP
MEADOWS AT MORGAN CREEK
SW CORNER OF FM 35 AND FM 2453
CITY OF ROYSE CITY, ROCKWALL COUNTY, TEXAS

Data Source (select)	Name and/or date and other relevant information
USGS Sources	N/A.
USDA Sources	USDA NRCS Web Soil Survey Map, Figure 3 "Soils Map"
NOAA Sources	N/A.
USACE Sources	N/A.
State/Local/Tribal Sources	N/A.
Other Sources	N/A.

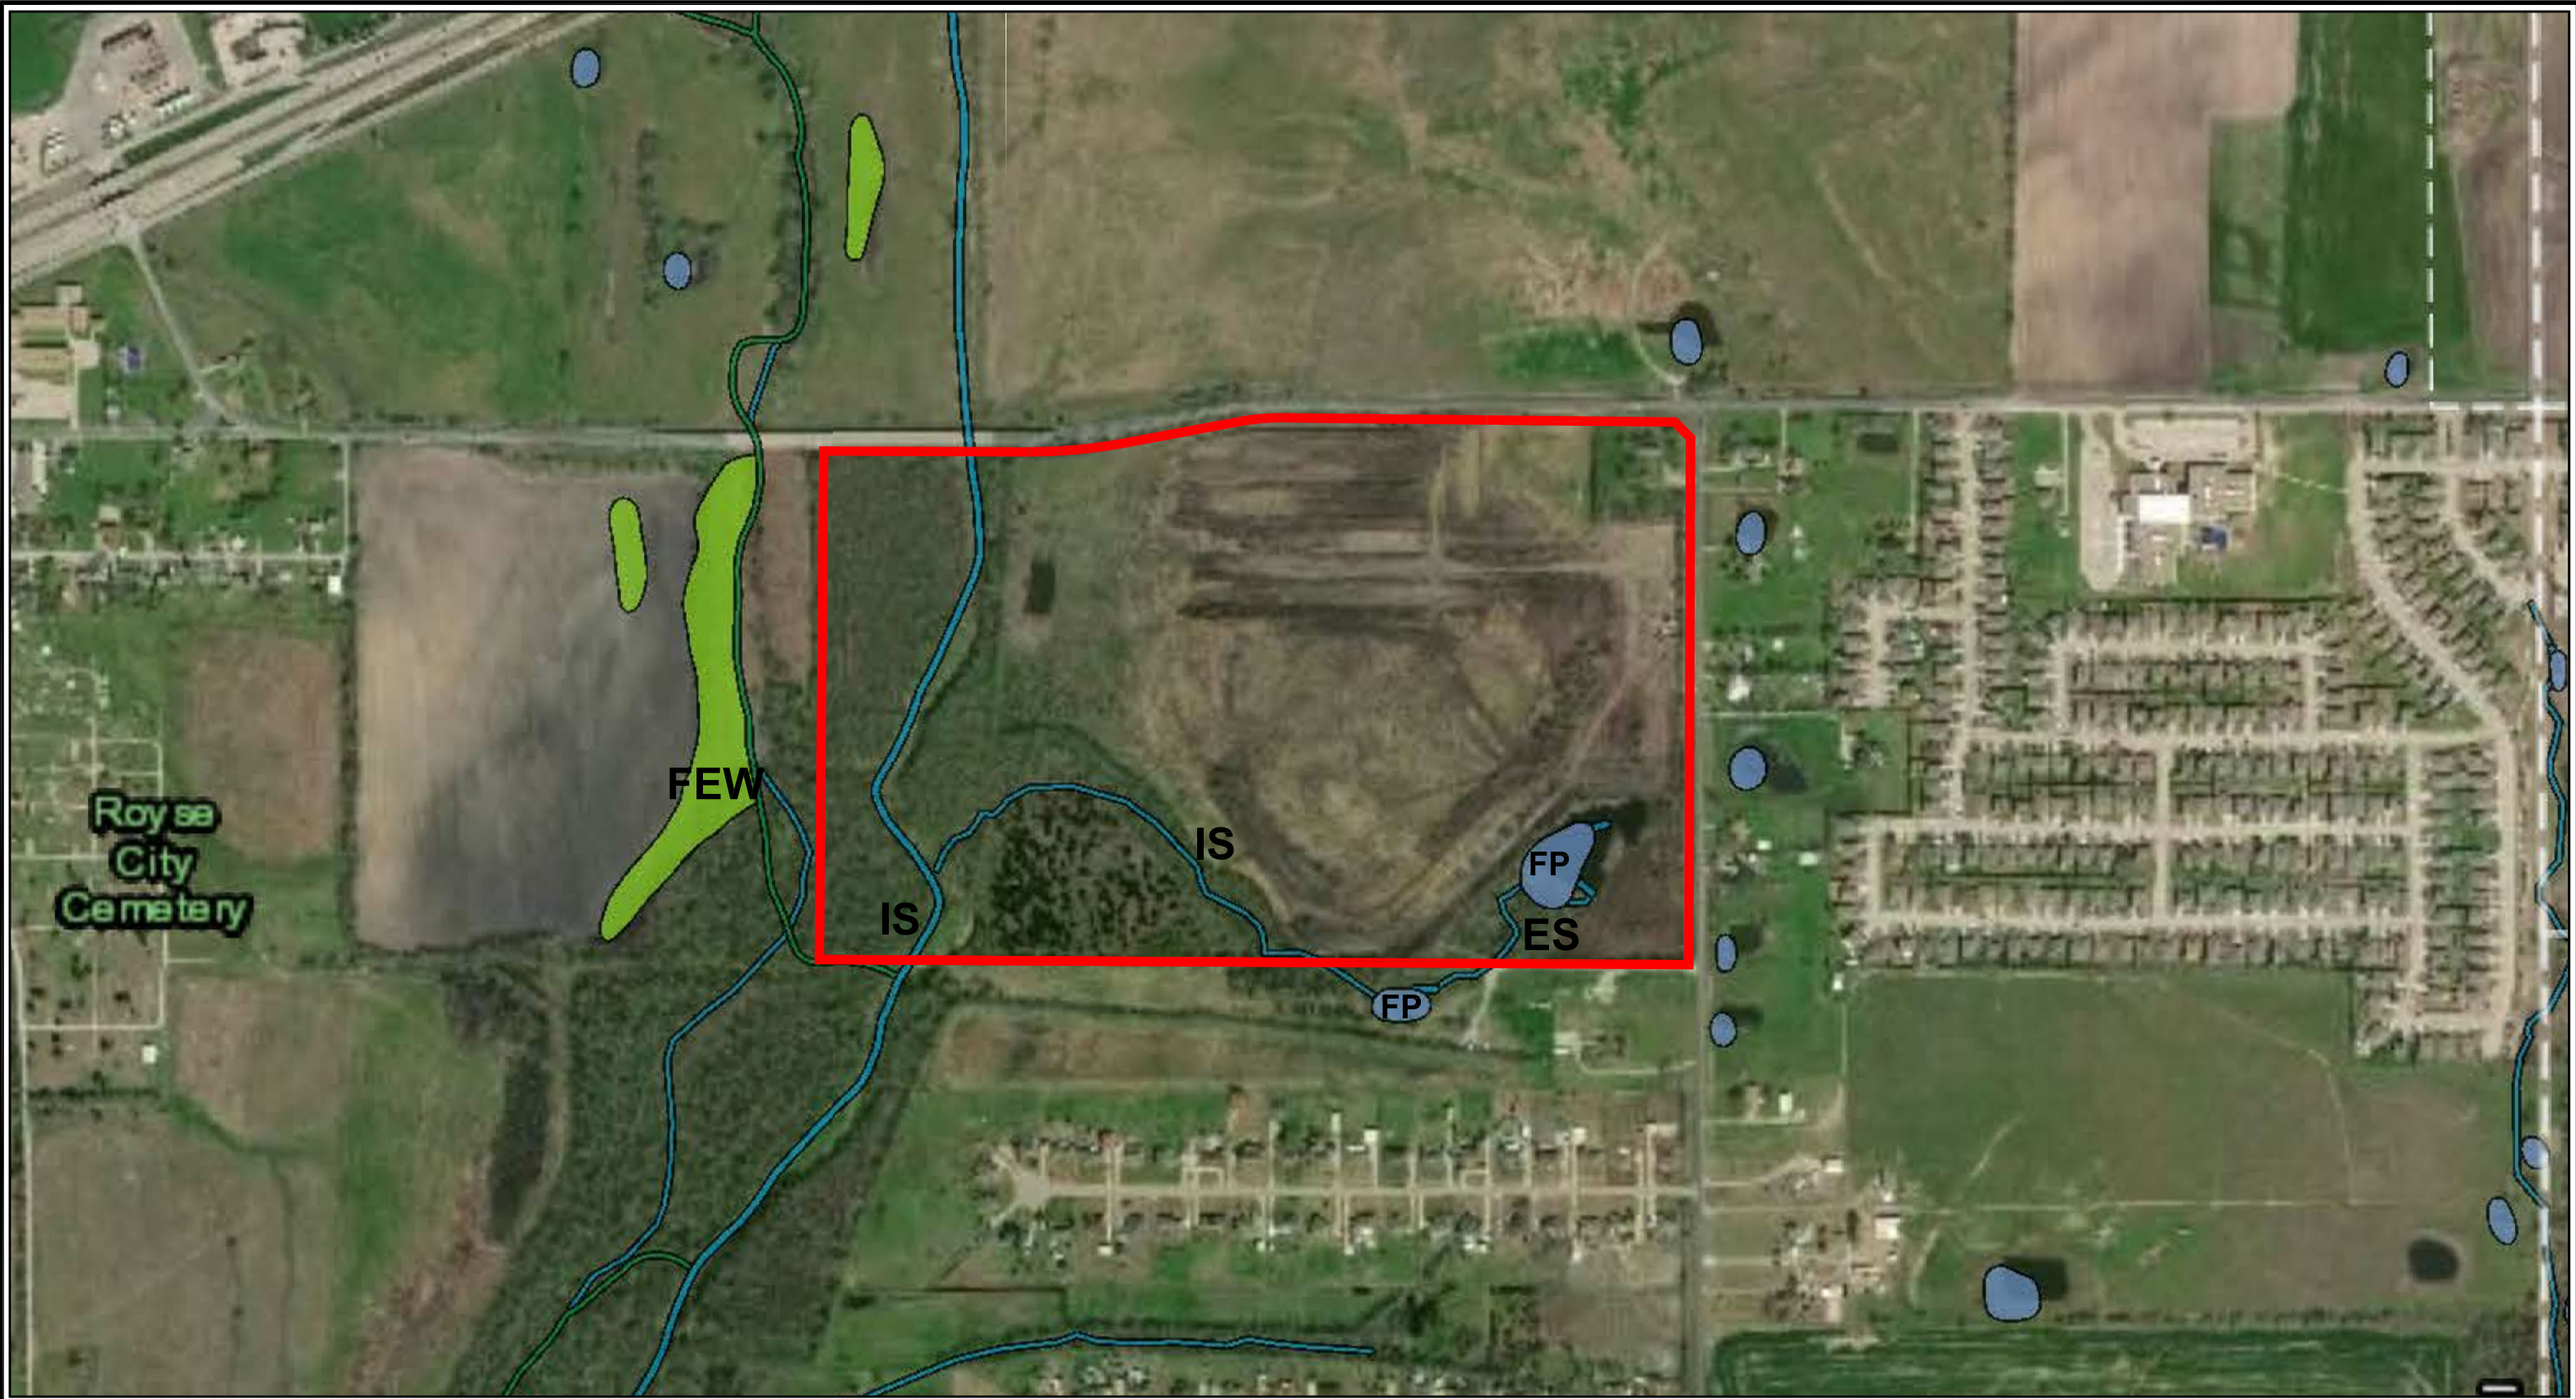
FIGURE 4

SOURCE: US DEPARTMENT OF INTERIOR, NATIONAL WETLANDS INVENTORY; ROYSE CITY, TEXAS; 1992.

WETLANDS MAP
MEADOWS AT MORGAN CREEK
SW CORNER OF FM 35 AND FM 2453
CITY OF ROYSE CITY, ROCKWALL COUNTY, TEXAS

- Information submitted by, or on behalf of, the applicant/consultant: *Figure 8, Delineation Map.*
This information is sufficient for purposes of this AJD.
Rationale: *N/A*
- Data sheets prepared by the Corps: *N/A*
- Photographs: (*aerial and other*) *Figure 6, Aerial Photograph, Figure 7, Aerial Photograph - 2018, Figure 9 - Photo Location Map, & Photographic Log, photos #7-10.*
- Corps Site visit conducted on: *April 25, 2017 – site visit was not associated with the resources summarized in this report.*
- Previous Jurisdictional Determinations (AJDs or PJDs): *N/A*
- Antecedent Precipitation Tool: *detailed discussion provided in Section III.B.*
- USDA NRCS Soil Survey: *N/A*
- USFWS NWI maps: *Figure 4, Wetlands Map*
- USGS topographic maps: *Figure 1, Topographic Map, TX 2016*

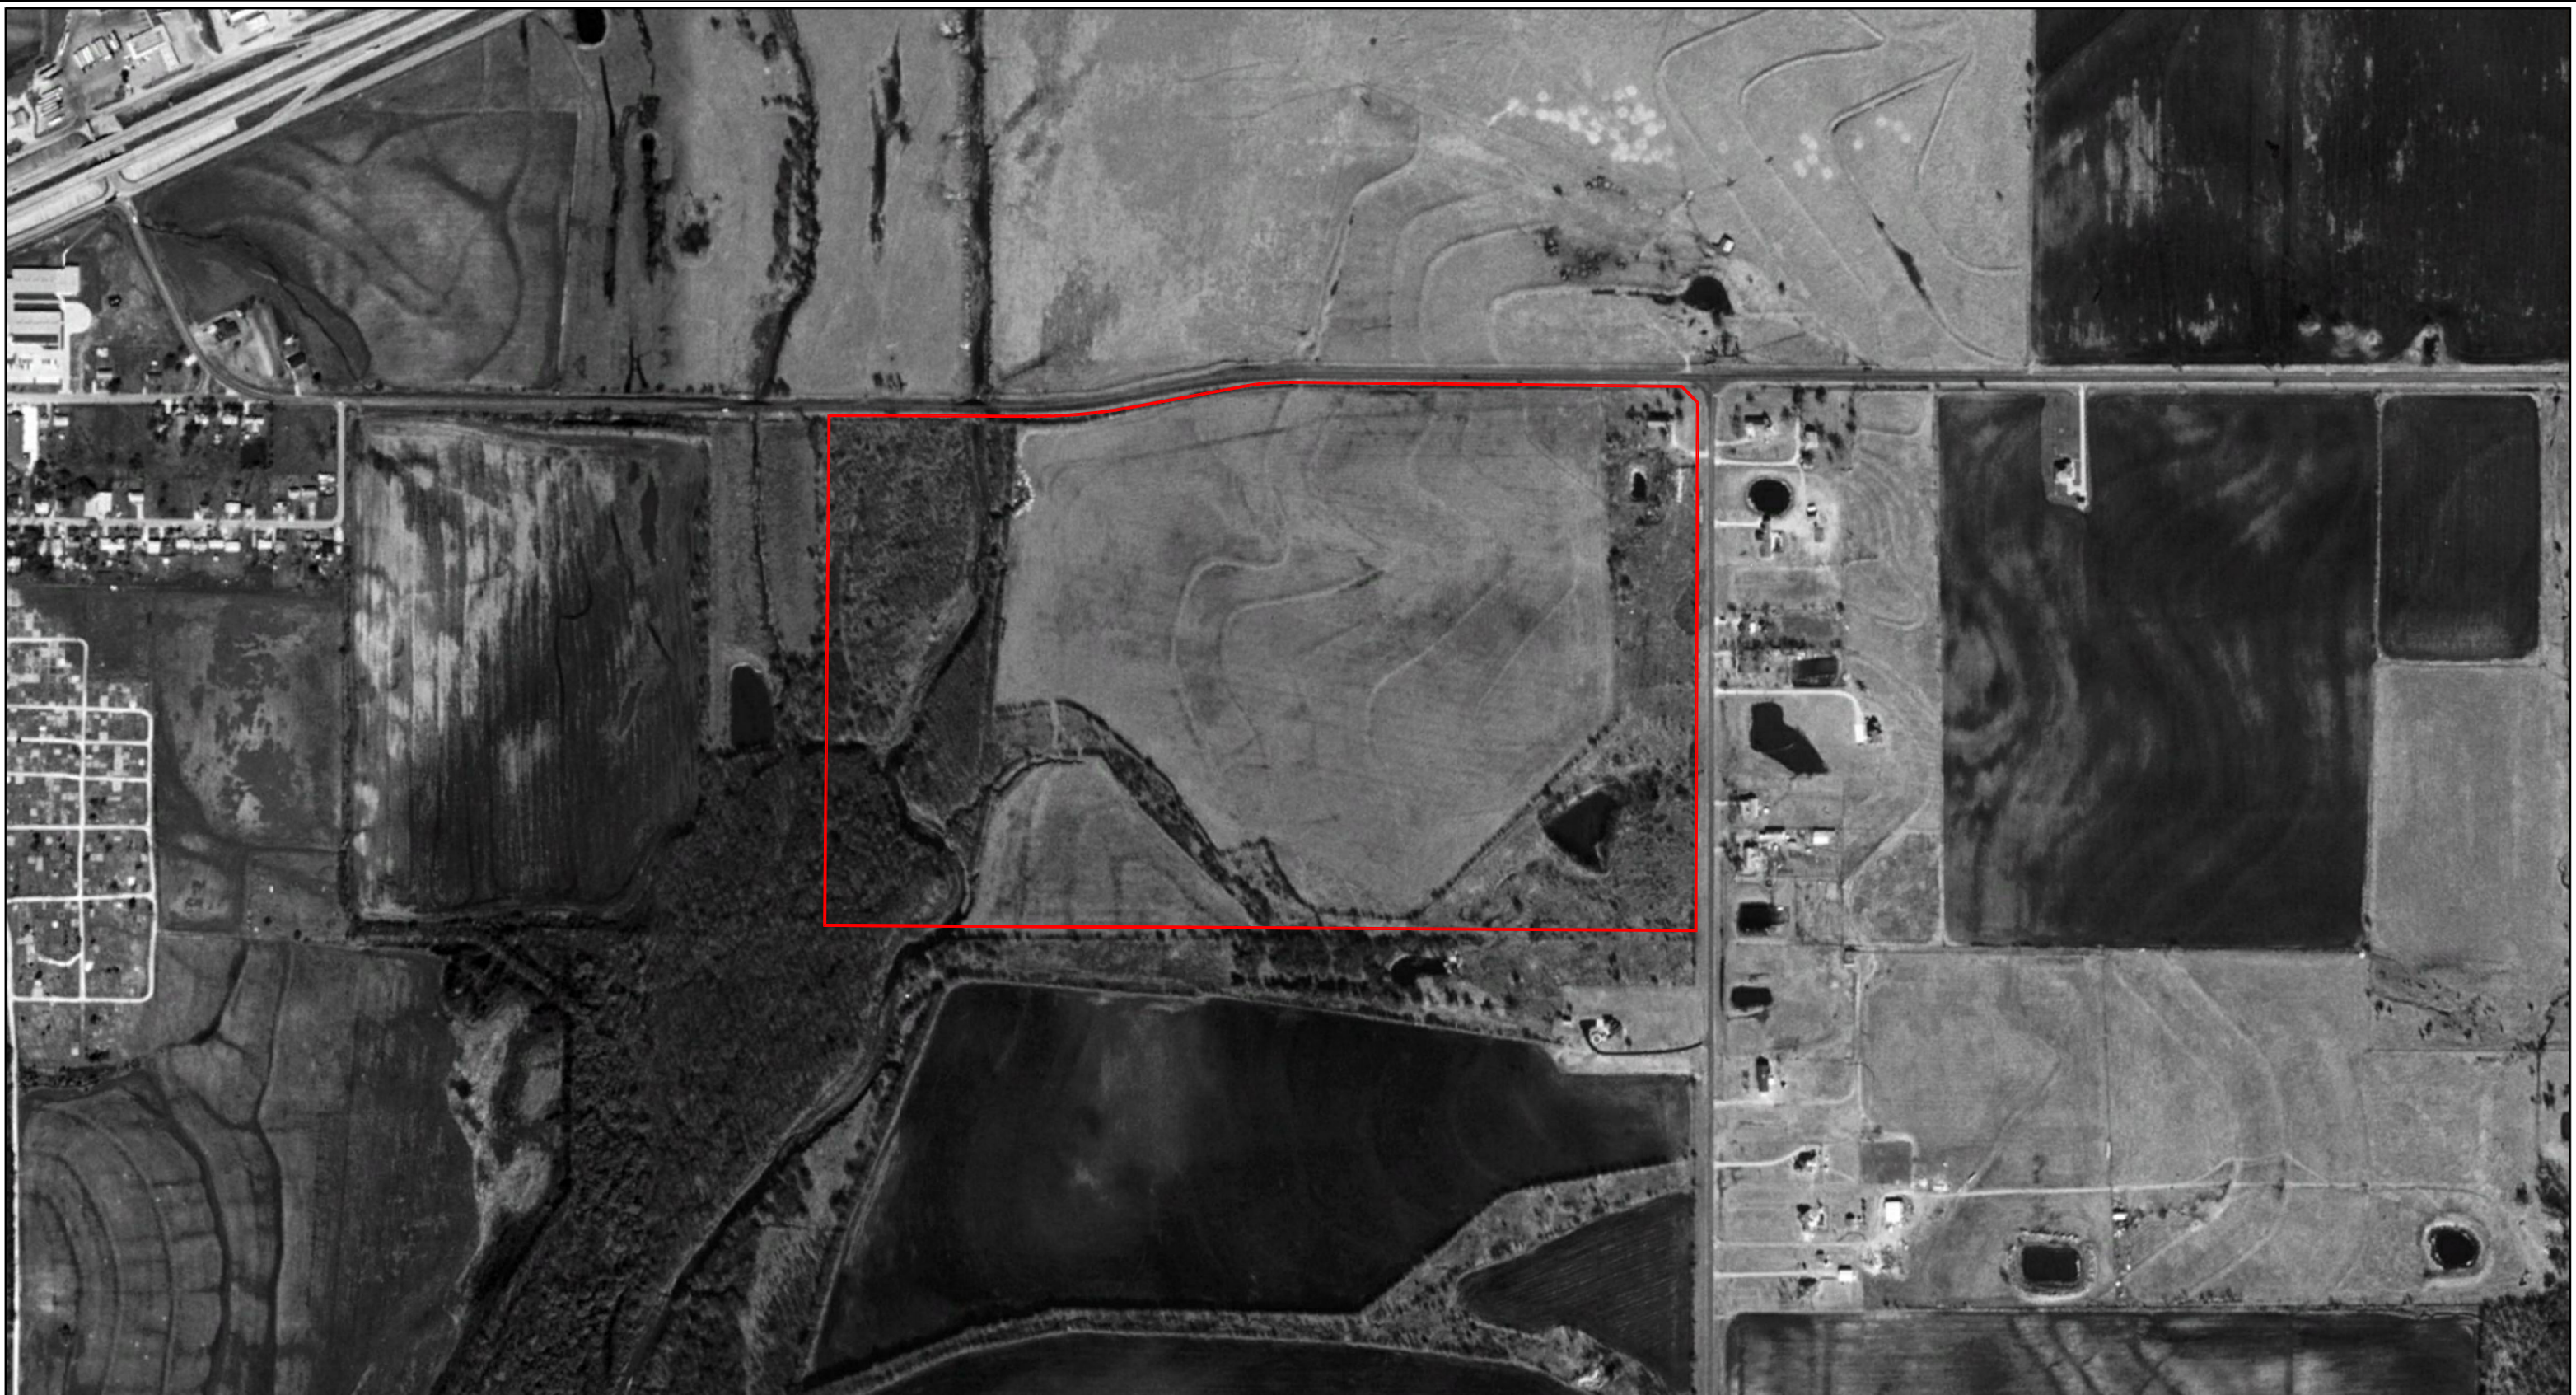
FIGURE 6

SOURCE: TEXAS NATURAL RESOURCE INFORMATION SYSTEM; TEXAS ORTHOIMAGERY PROGRAM; 1/4 USGS QUADRANGLE; 1996.

AERIAL PHOTOGRAPH - 1996
MEADOWS AT MORGAN CREEK
SW CORNER OF FM 35 AND FM 2453
CITY OF ROYSE CITY, ROCKWALL COUNTY, TEXAS

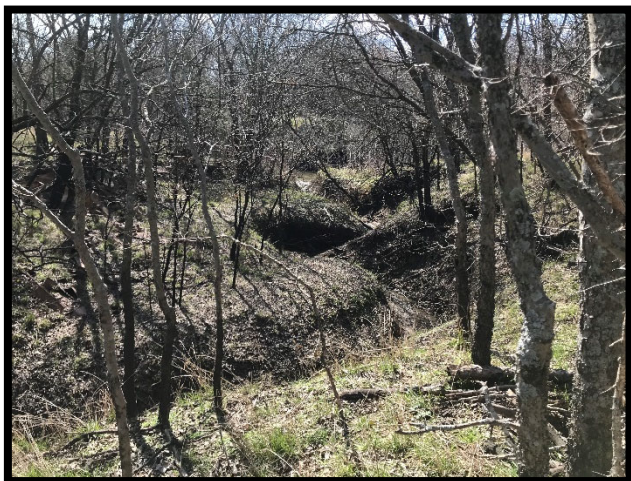
Photo 1 - View of discharge location into Sabine Creek. See Photo Location Map

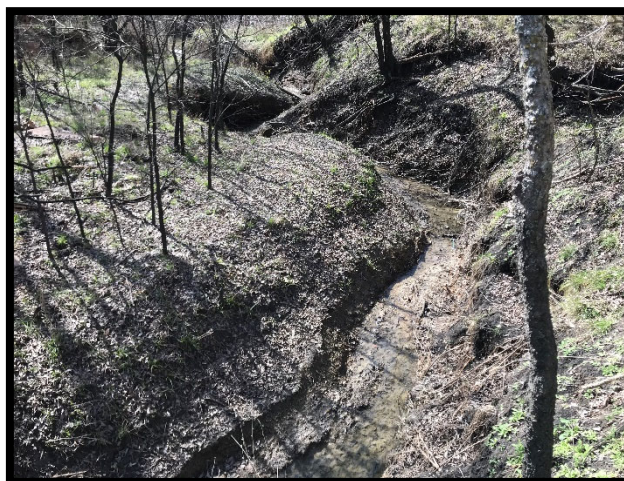
Photo 2 - View of T-1 Location. See Photo Location Map for location.

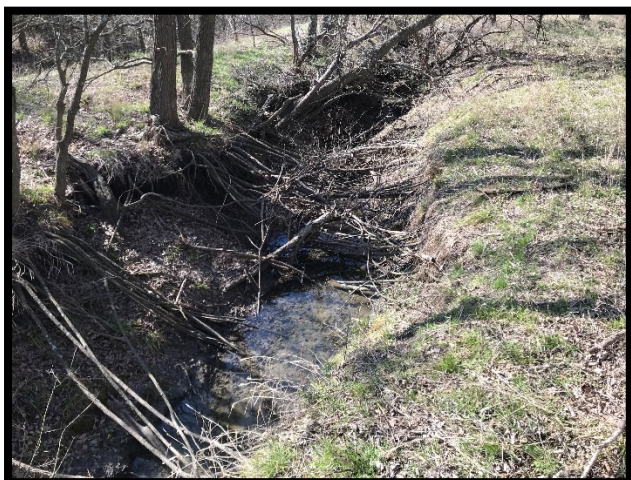
Photo 3 - View of T-2 Location. See Photo Location Map.

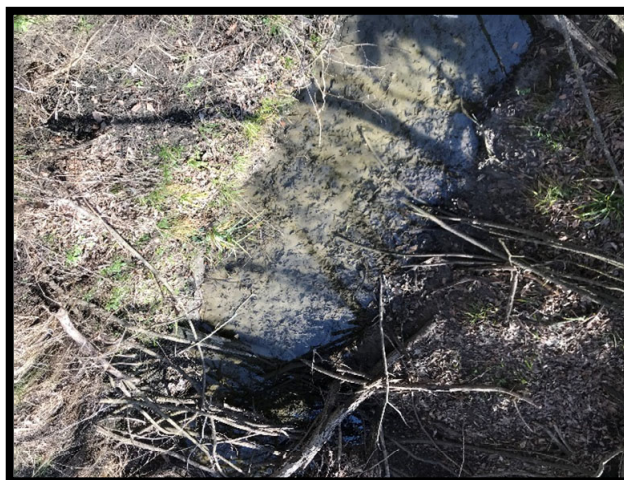
Photo 4 - View of T-2 Location. See Photo Location Map.

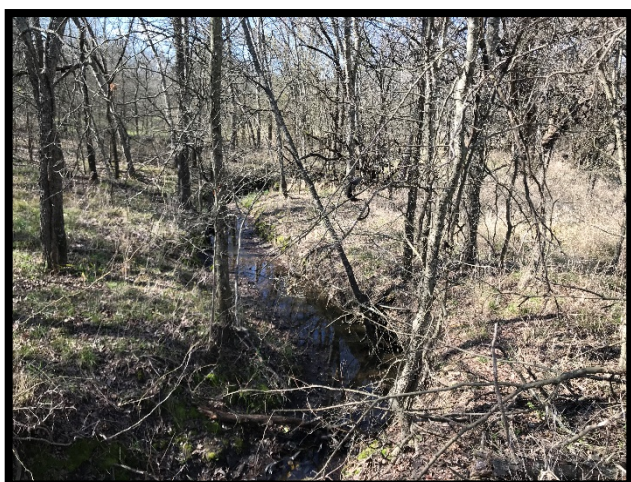
Photo 5 - View of T-3 Location. See Photo Location Map for location.

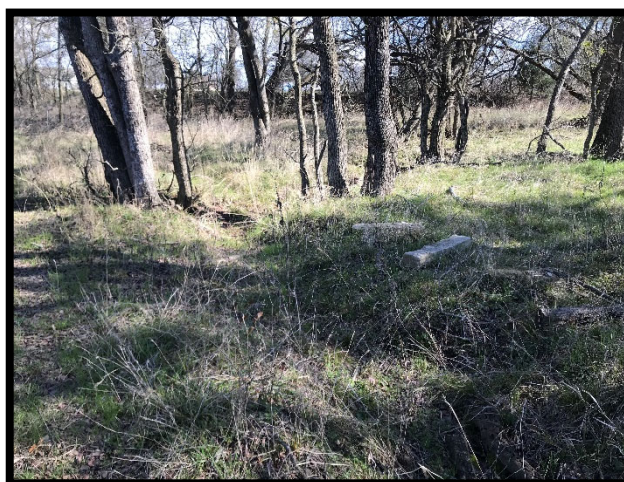
Photo 6 - View of T-4 Location, below Pond-2. See Photo Location Map for location.

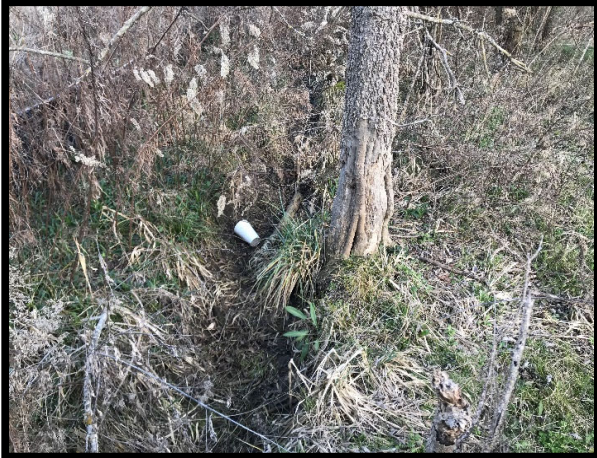
Photo 7 - View of drainage channel from Pond-1. See Photo Location Map for location.

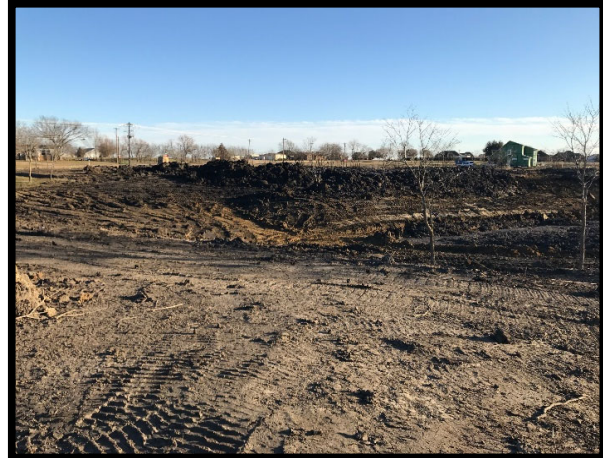
Photo 8 - View of Pond-1 during removal of silt. See Photo Location Map.

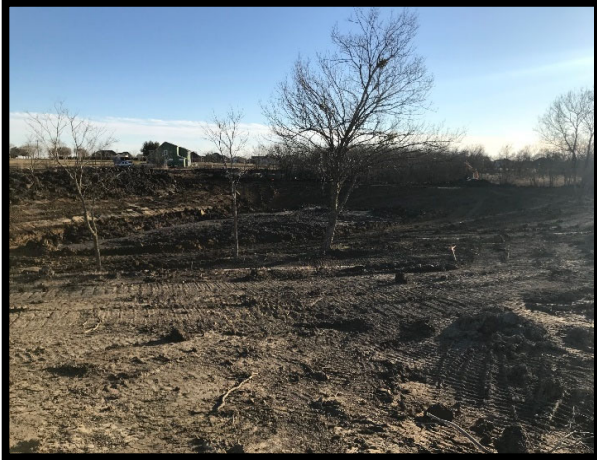
Photo 9 - View of Pond-1 during removal of silt. See Photo Location Map for location.

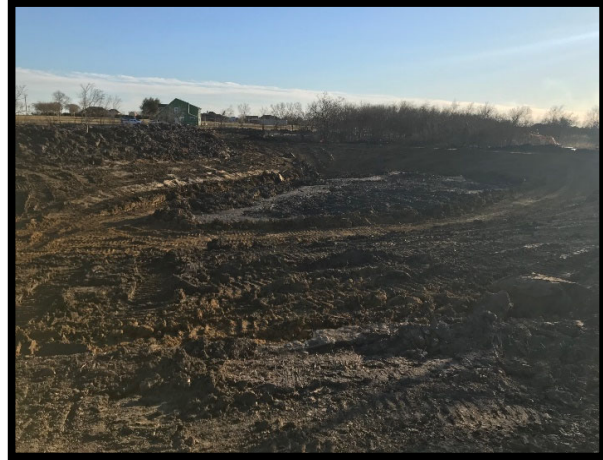
Photo 10 - View of Pond-1 during removal of silt. See Photo Location Map.
