**U.S. ARMY CORPS OF ENGINEERS  
REGULATORY PROGRAM  
APPROVED JURISDICTIONAL DETERMINATION FORM (INTERIM)  
NAVIGABLE WATERS PROTECTION RULE**

ORM Number: SWF-2020-00424

**Mapped Photo Log  
 for Saddleback at Santa Rita  
 Ranch  
 SWF-2020-00424**  
 Page 1 of 16

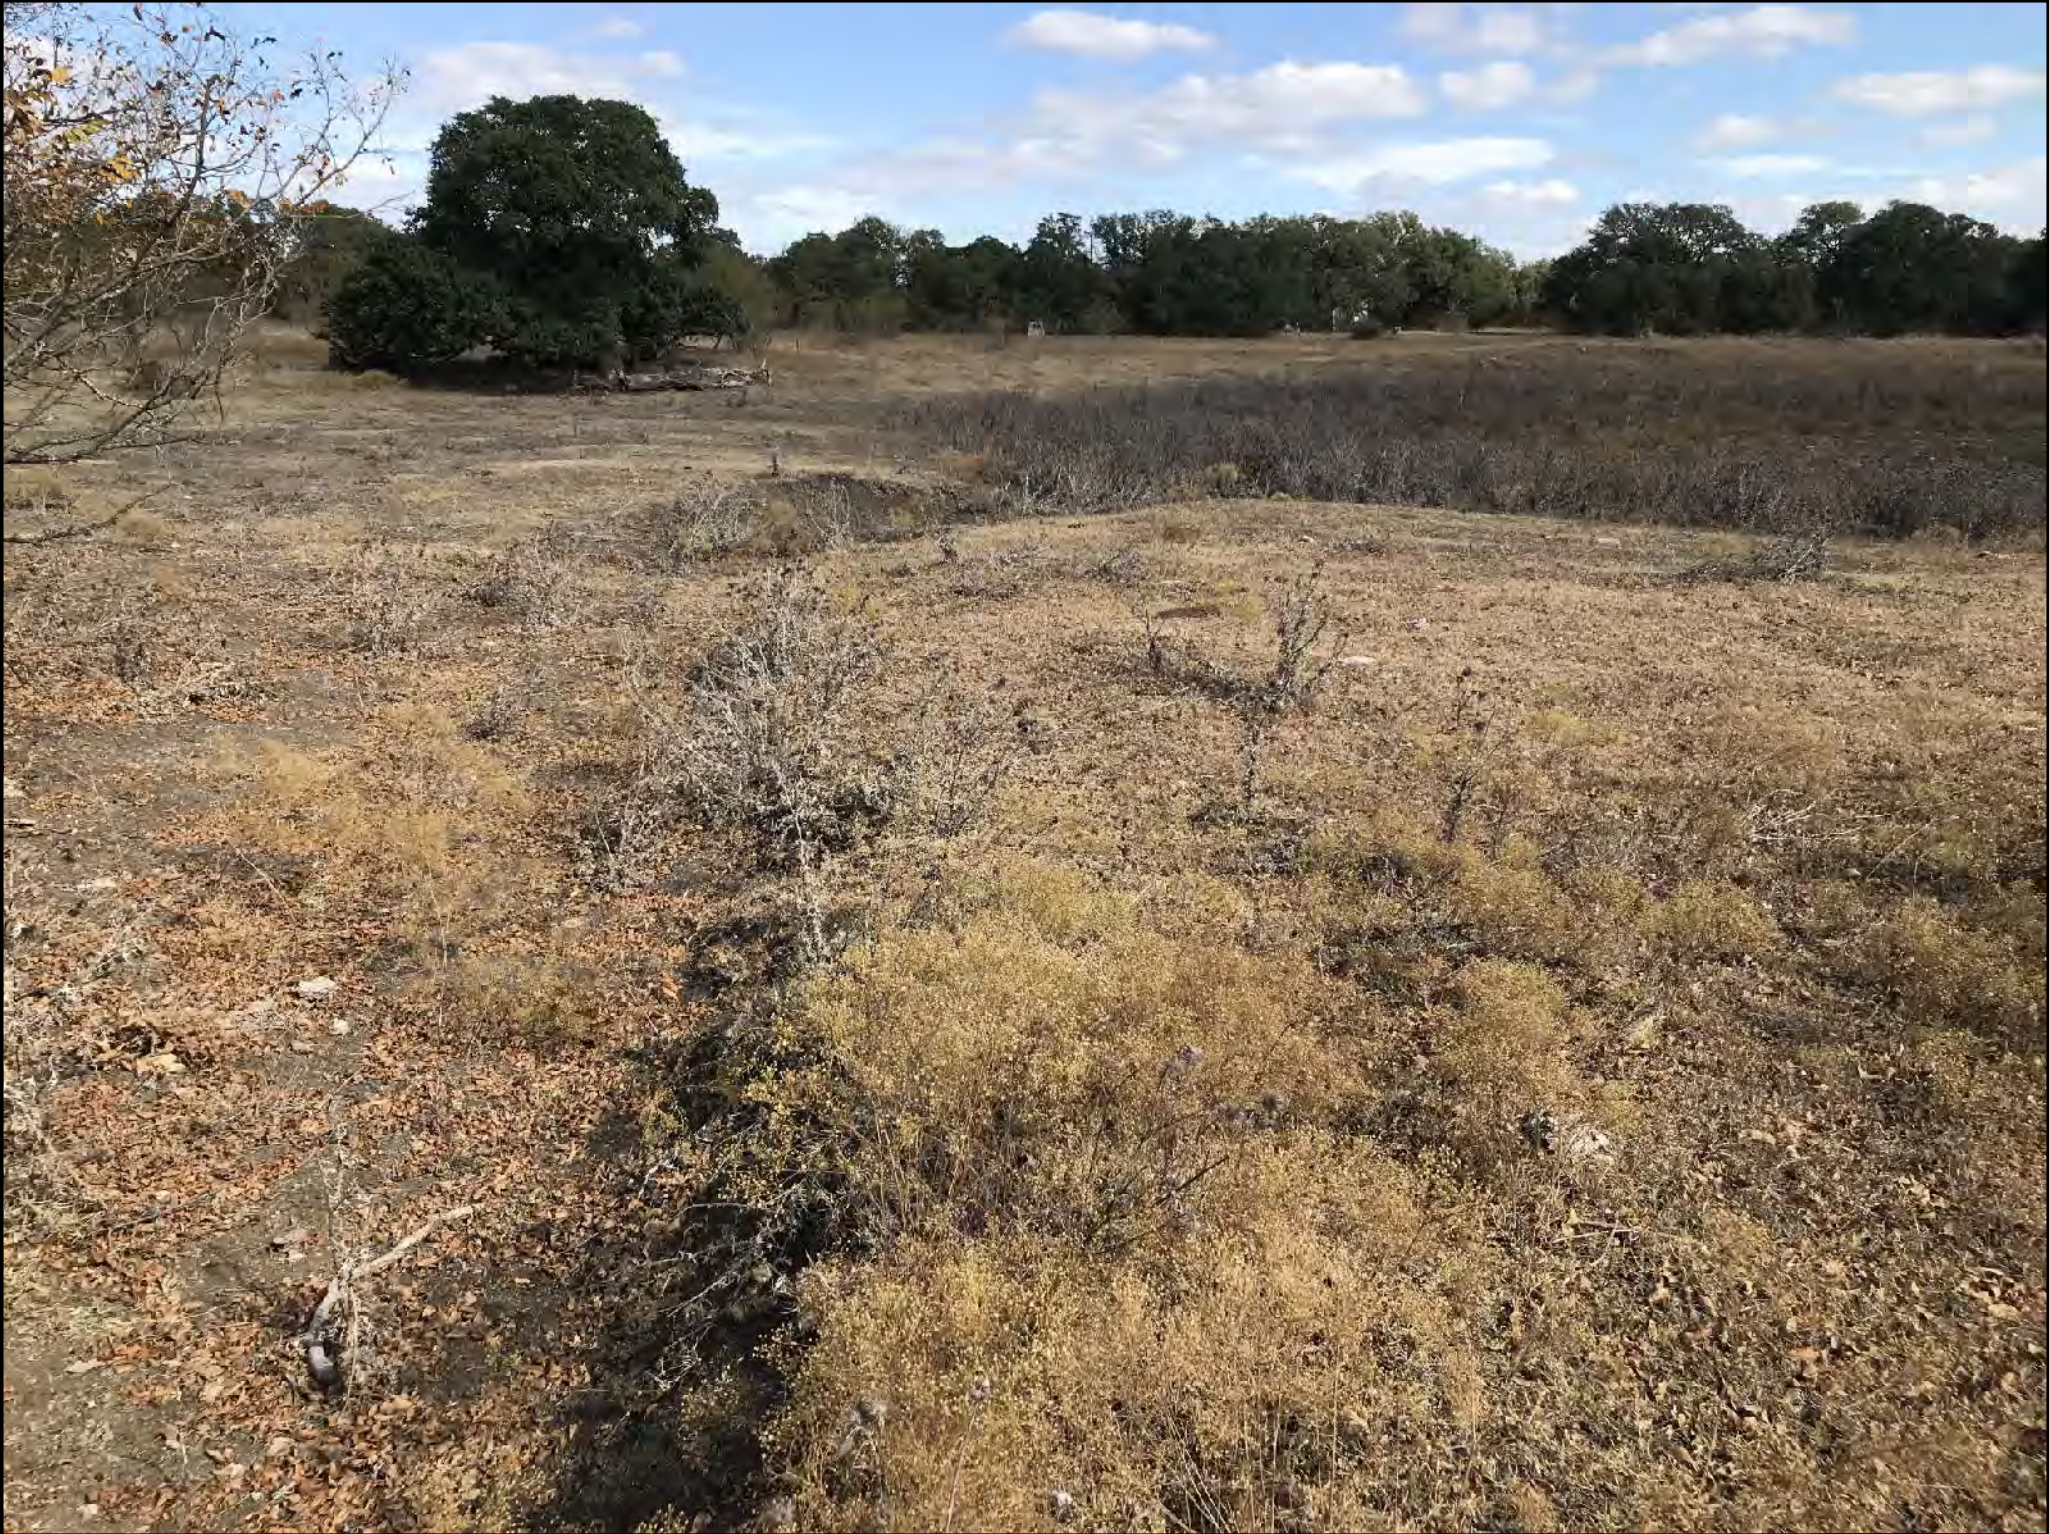
Description:  
 View of the swale above the pond.

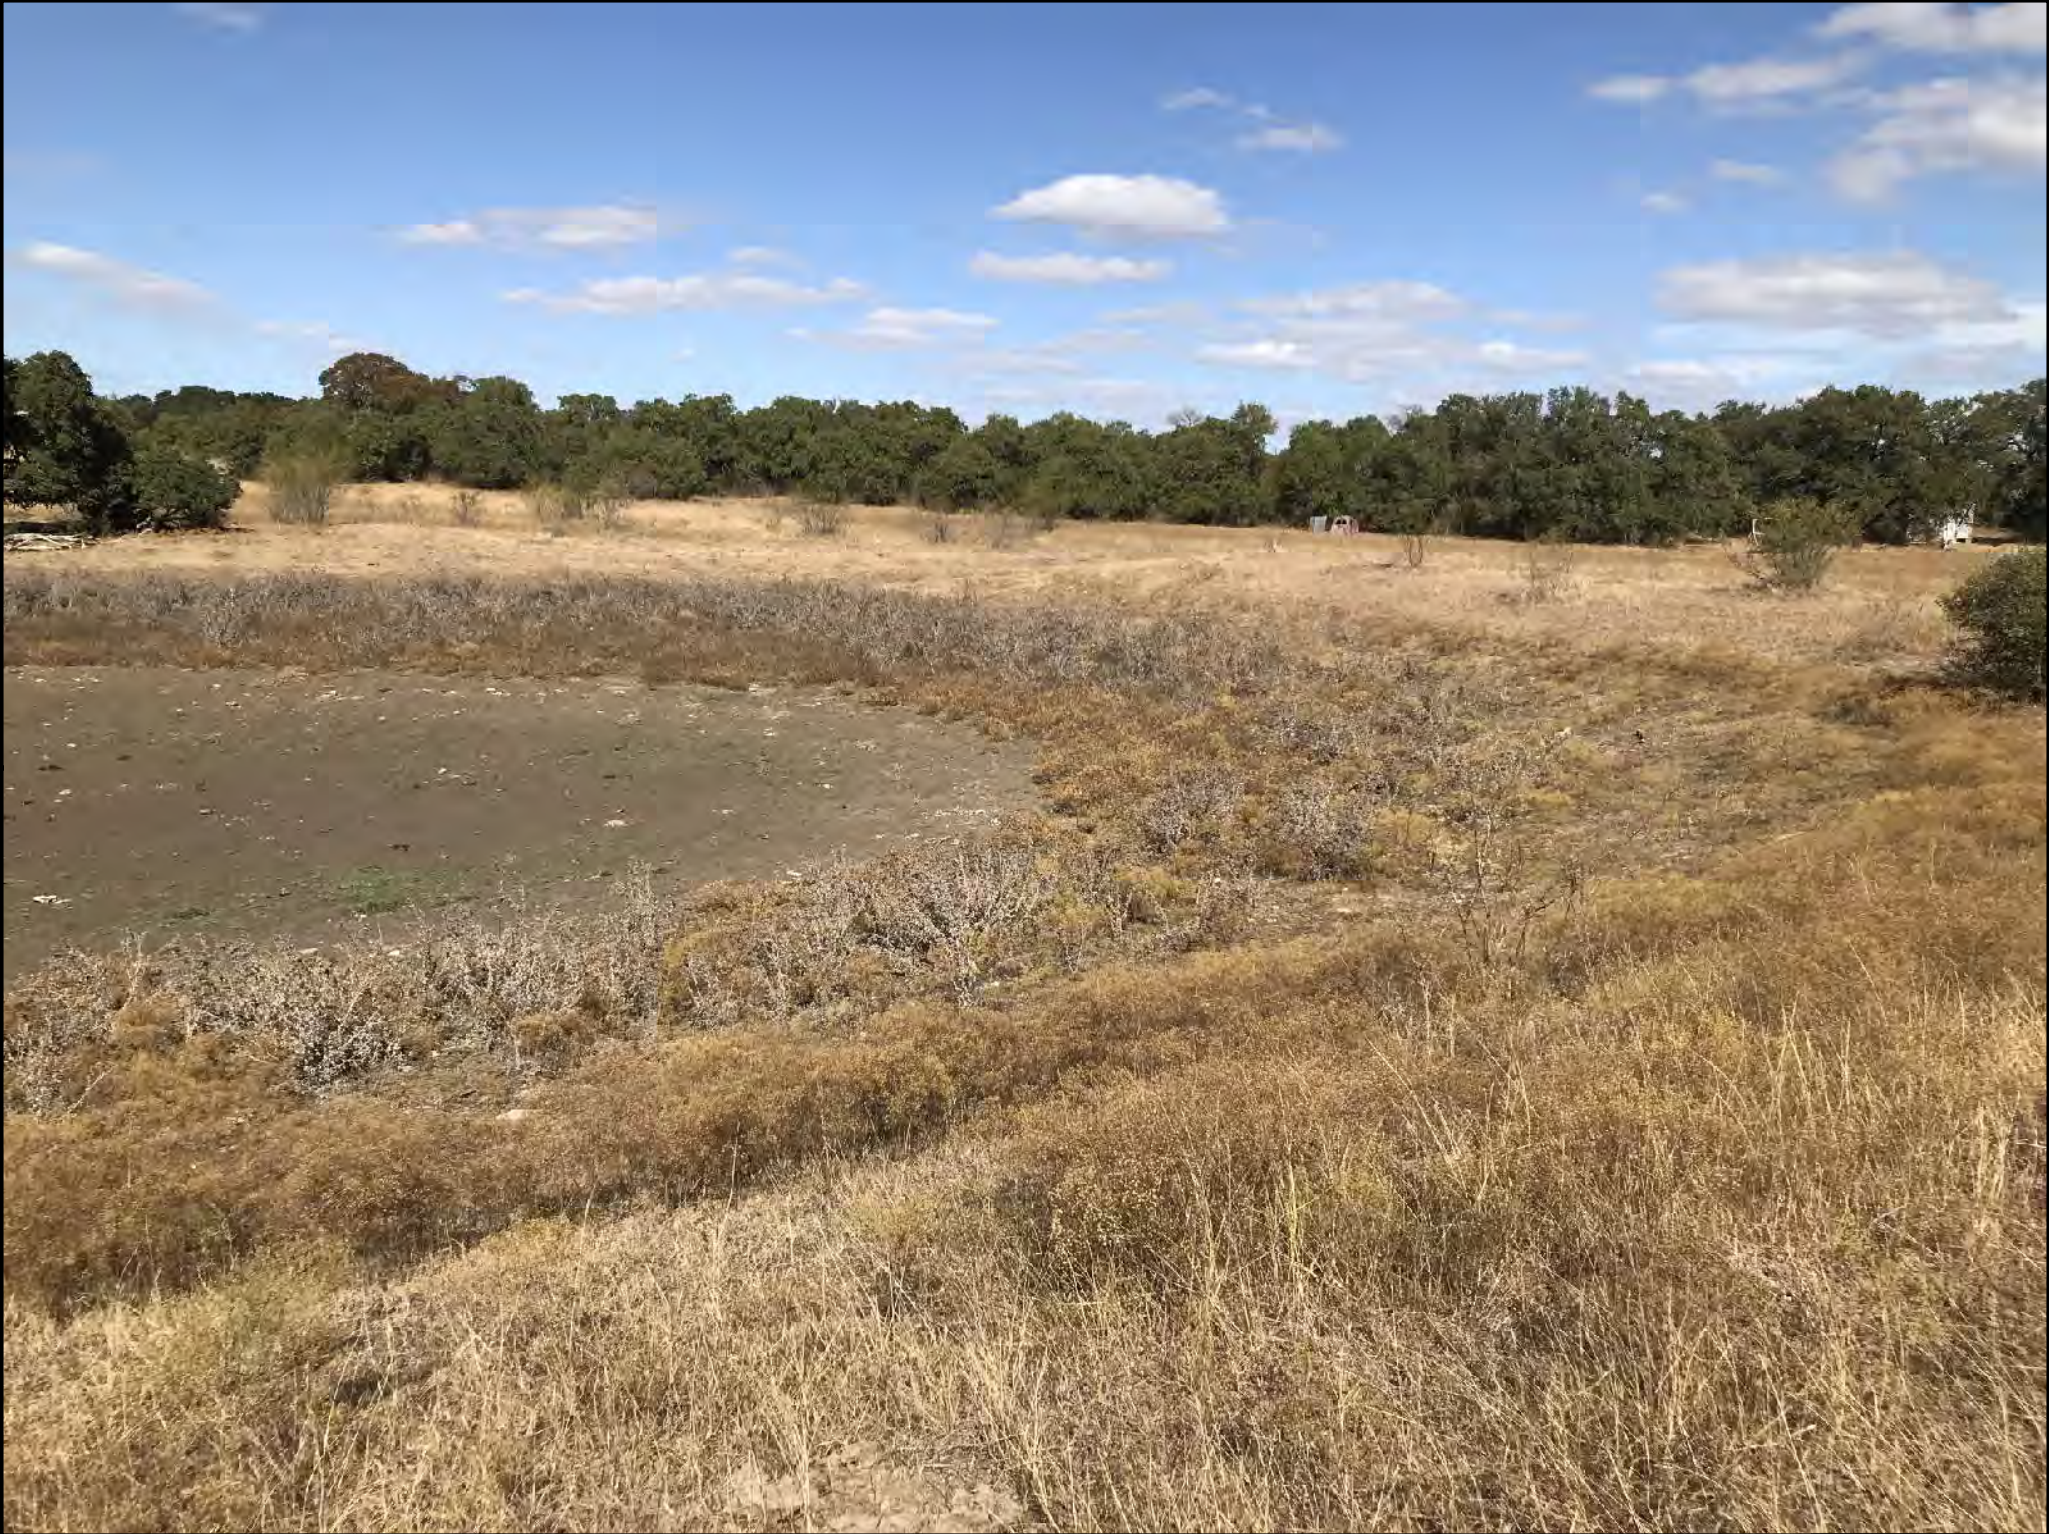
**Mapped Photo Log  
 for Saddleback at Santa Rita  
 Ranch  
 SWF-2020-00424**  
 Page 2 of 16

Description:  
 View of pond 1.

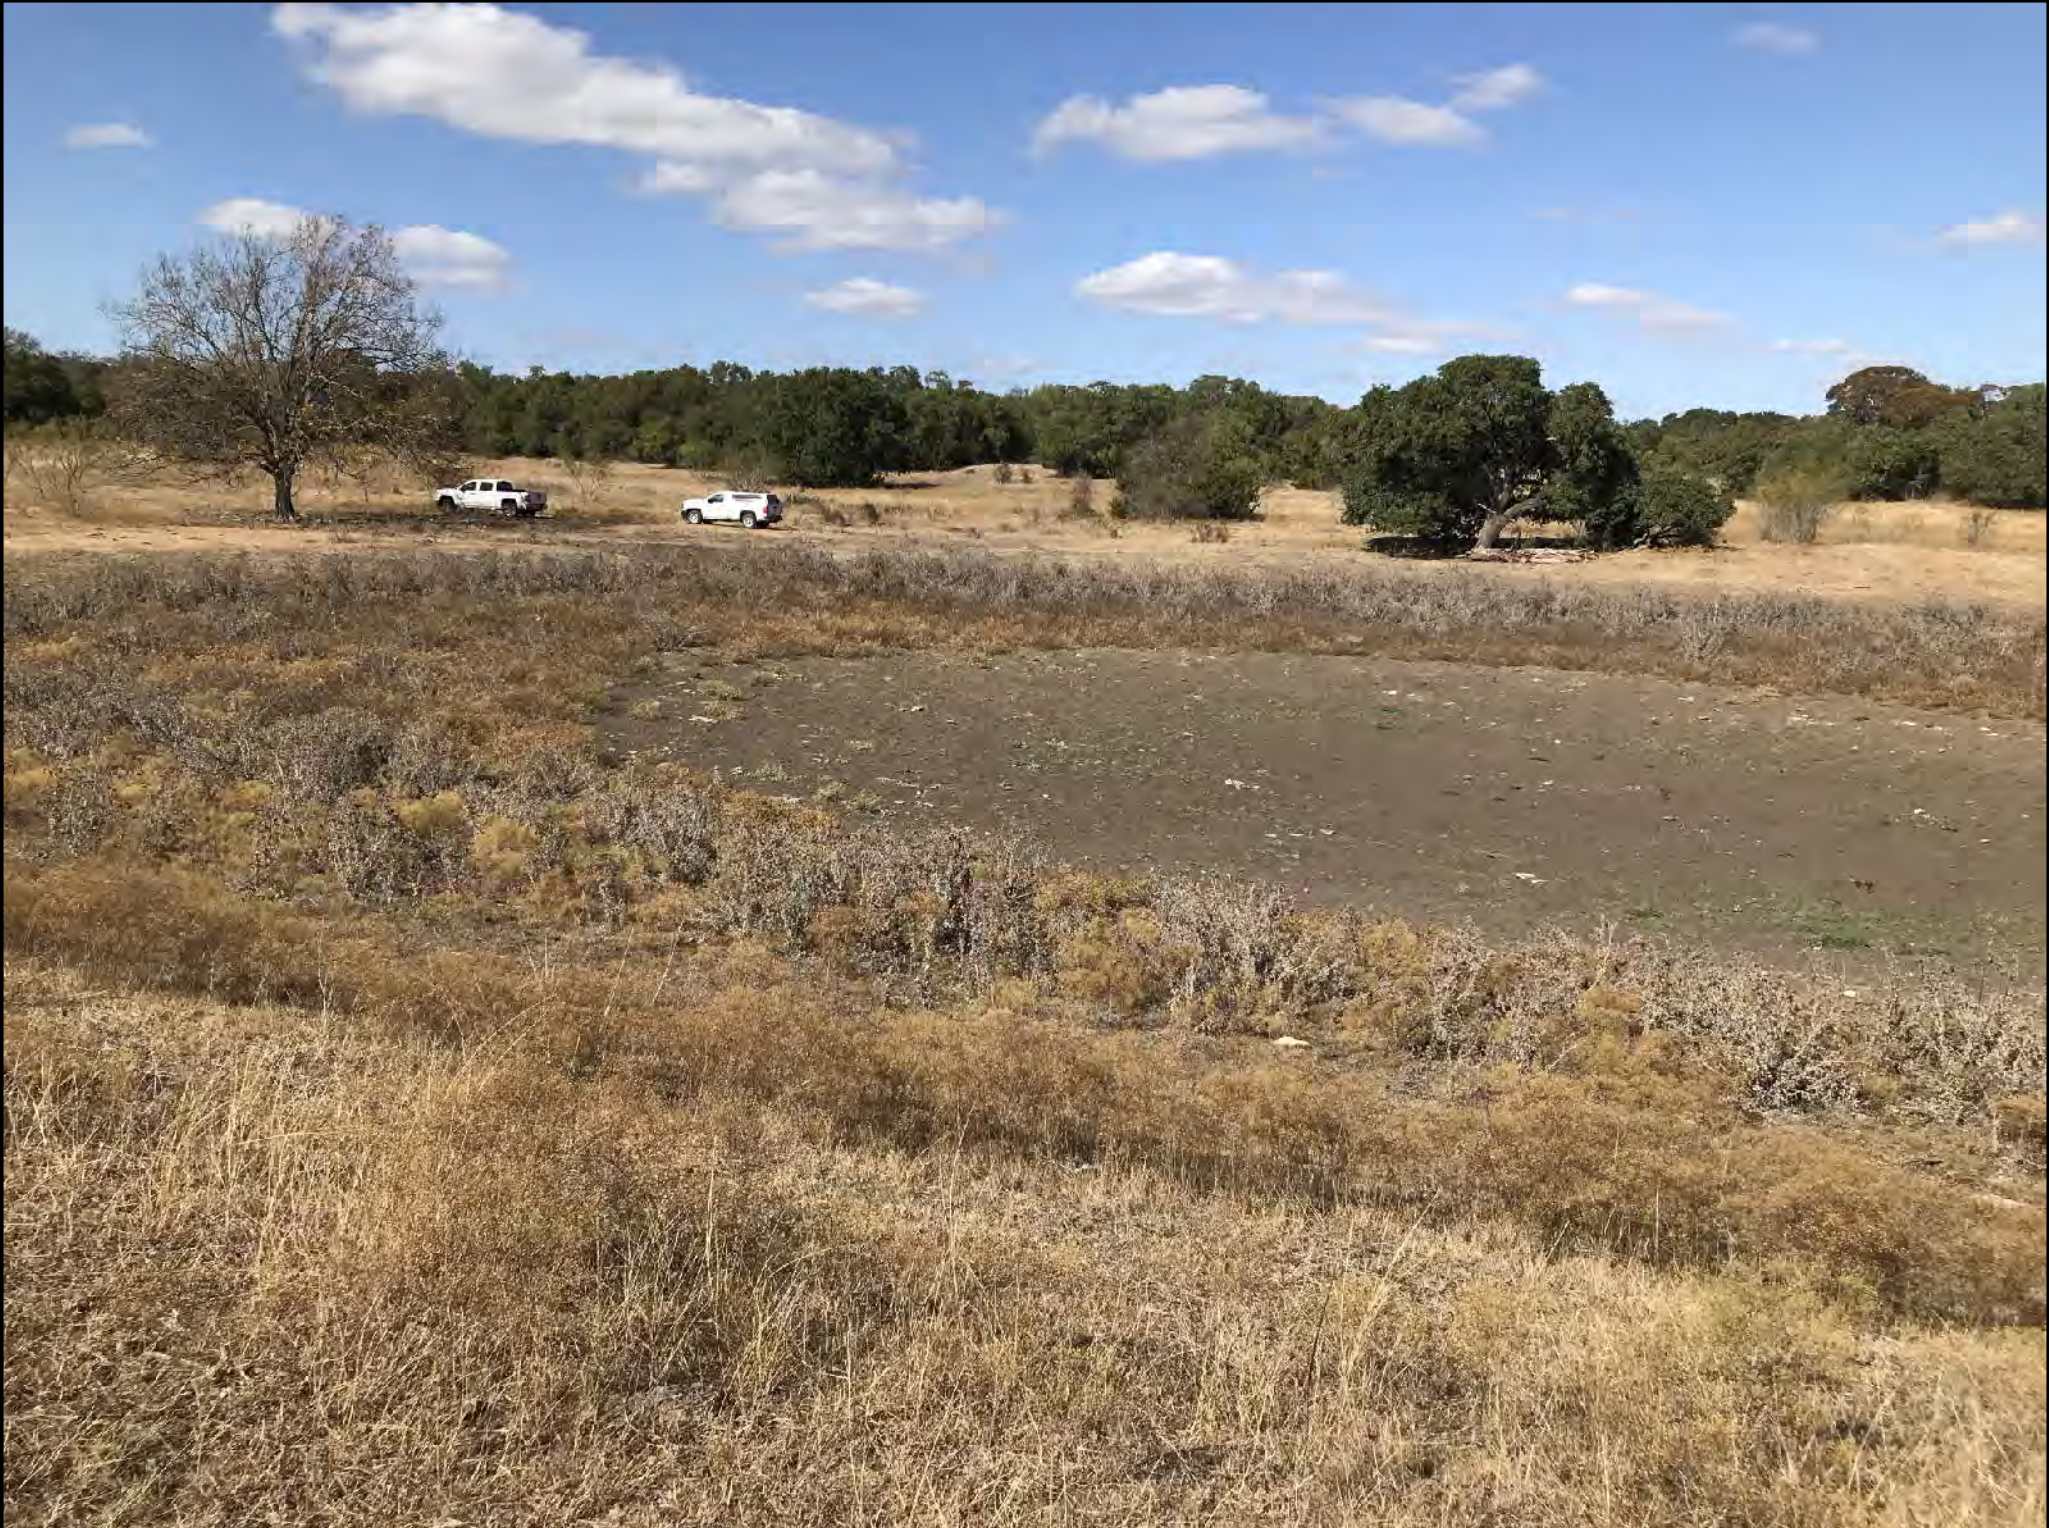
**Mapped Photo Log  
 for Saddleback at Santa Rita  
 Ranch  
 SWF-2020-00424**  
 Page 3 of 16

Description:  
 View of pond 1.

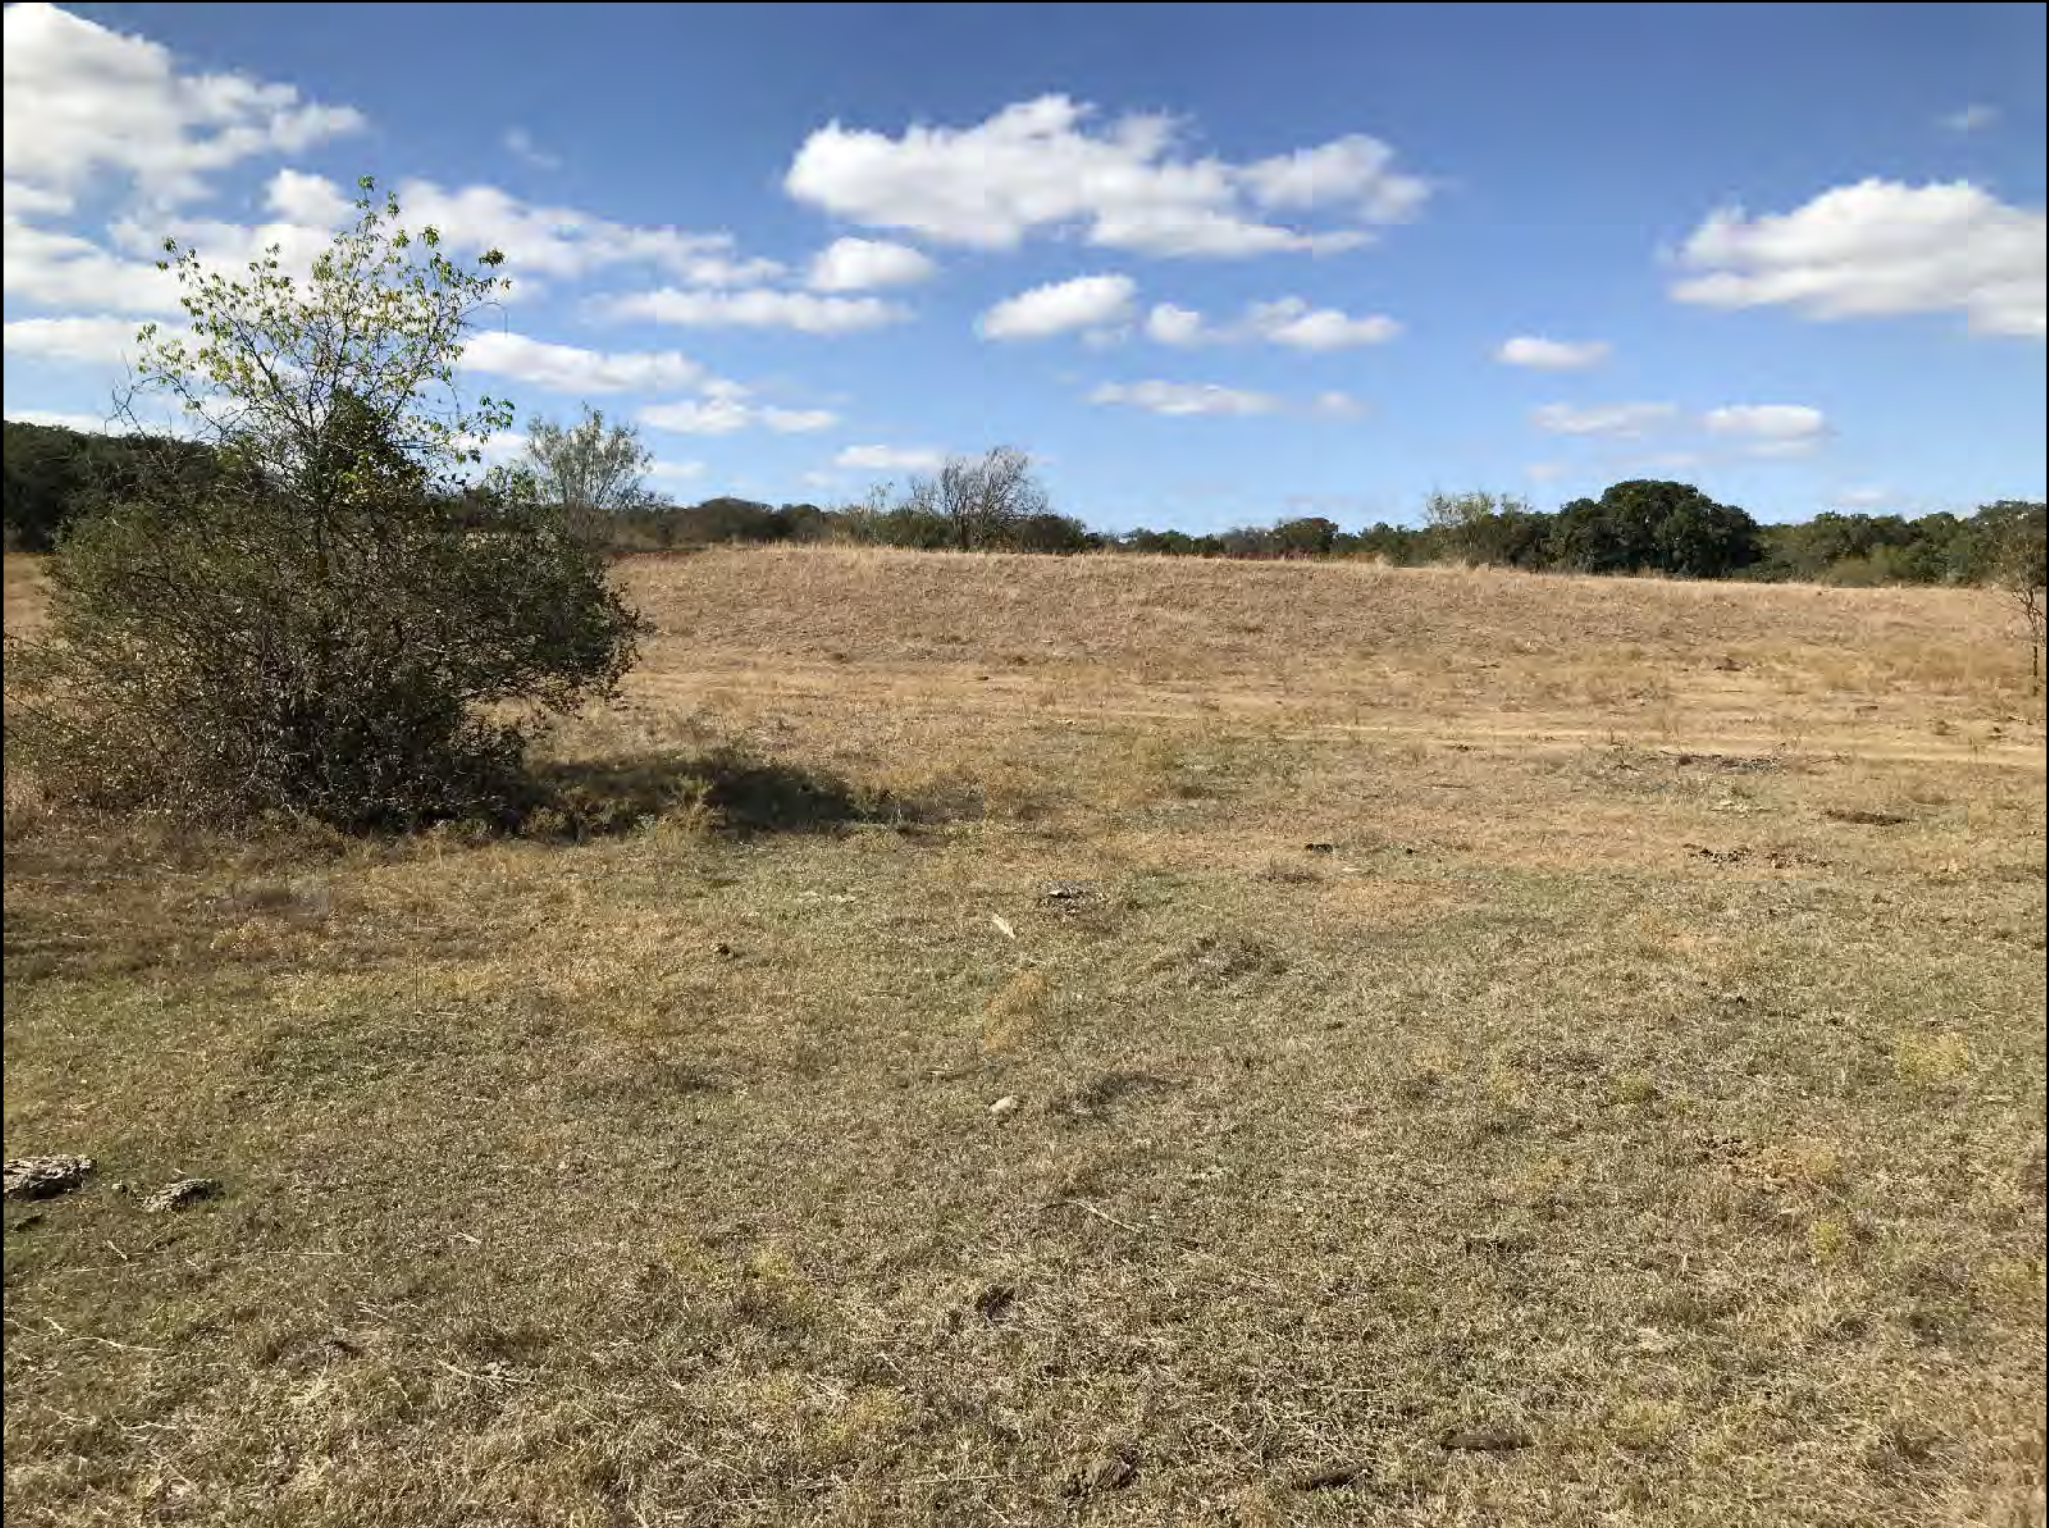
Page 4 of 16

View of drainage area below the dam of pond 1.

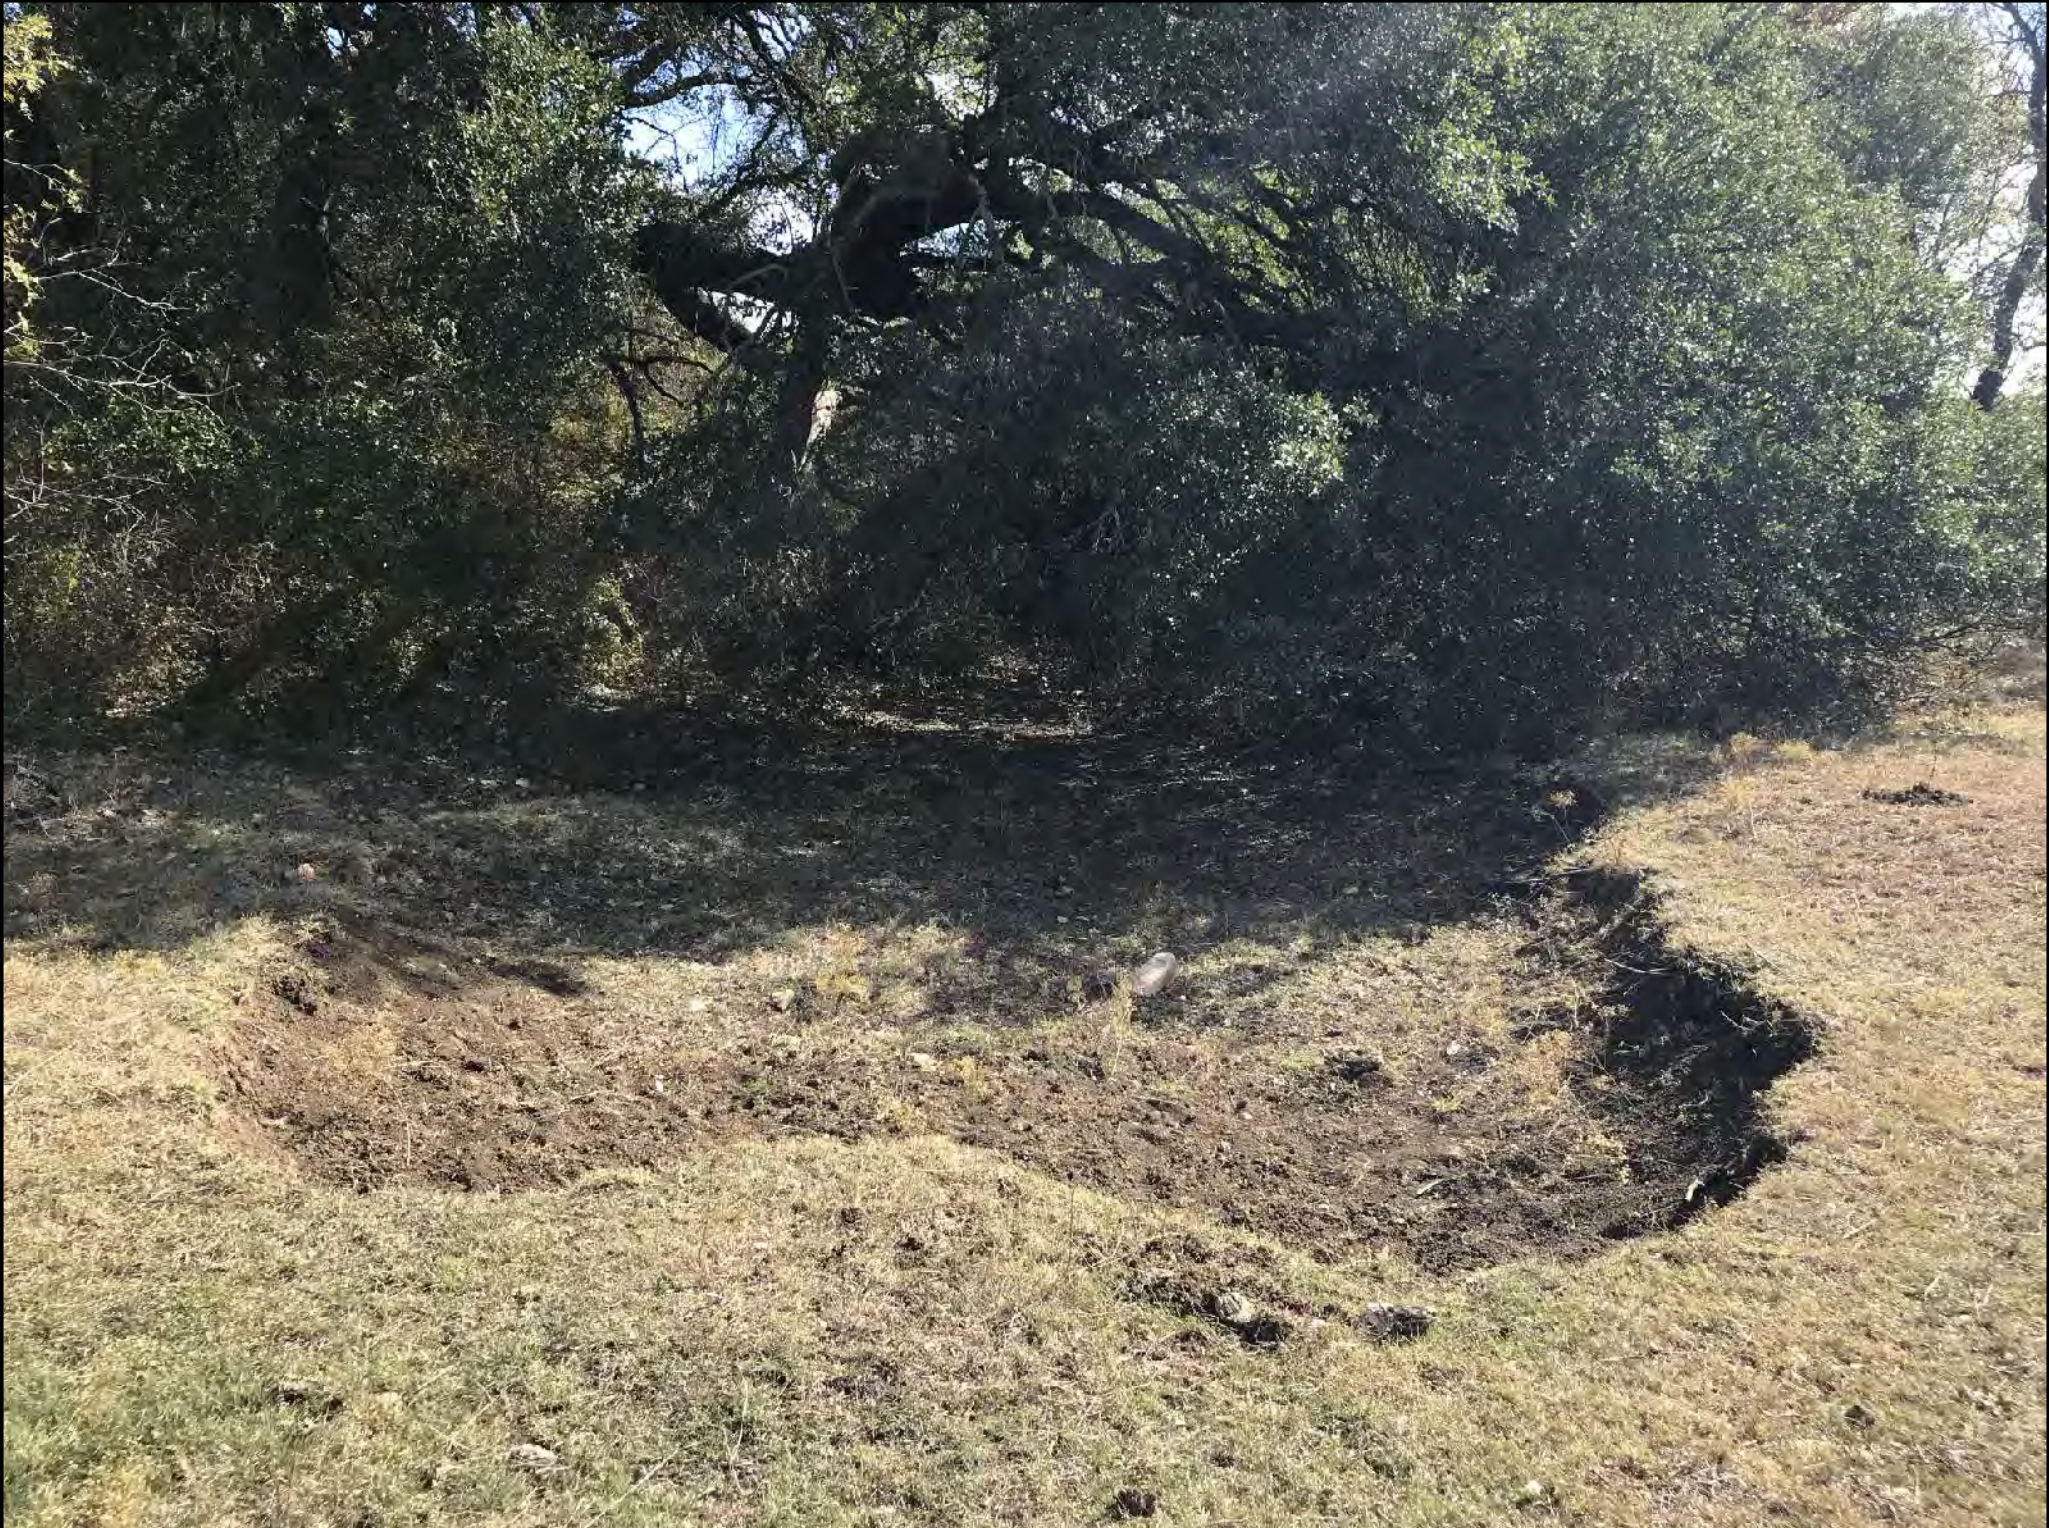
**Mapped Photo Log  
 for Saddleback at Santa Rita  
 Ranch  
 SWF-2020-00424**  
 Page 5 of 16

Description:  
 View of the beginning of the tributary  
 to Sowes Creek.

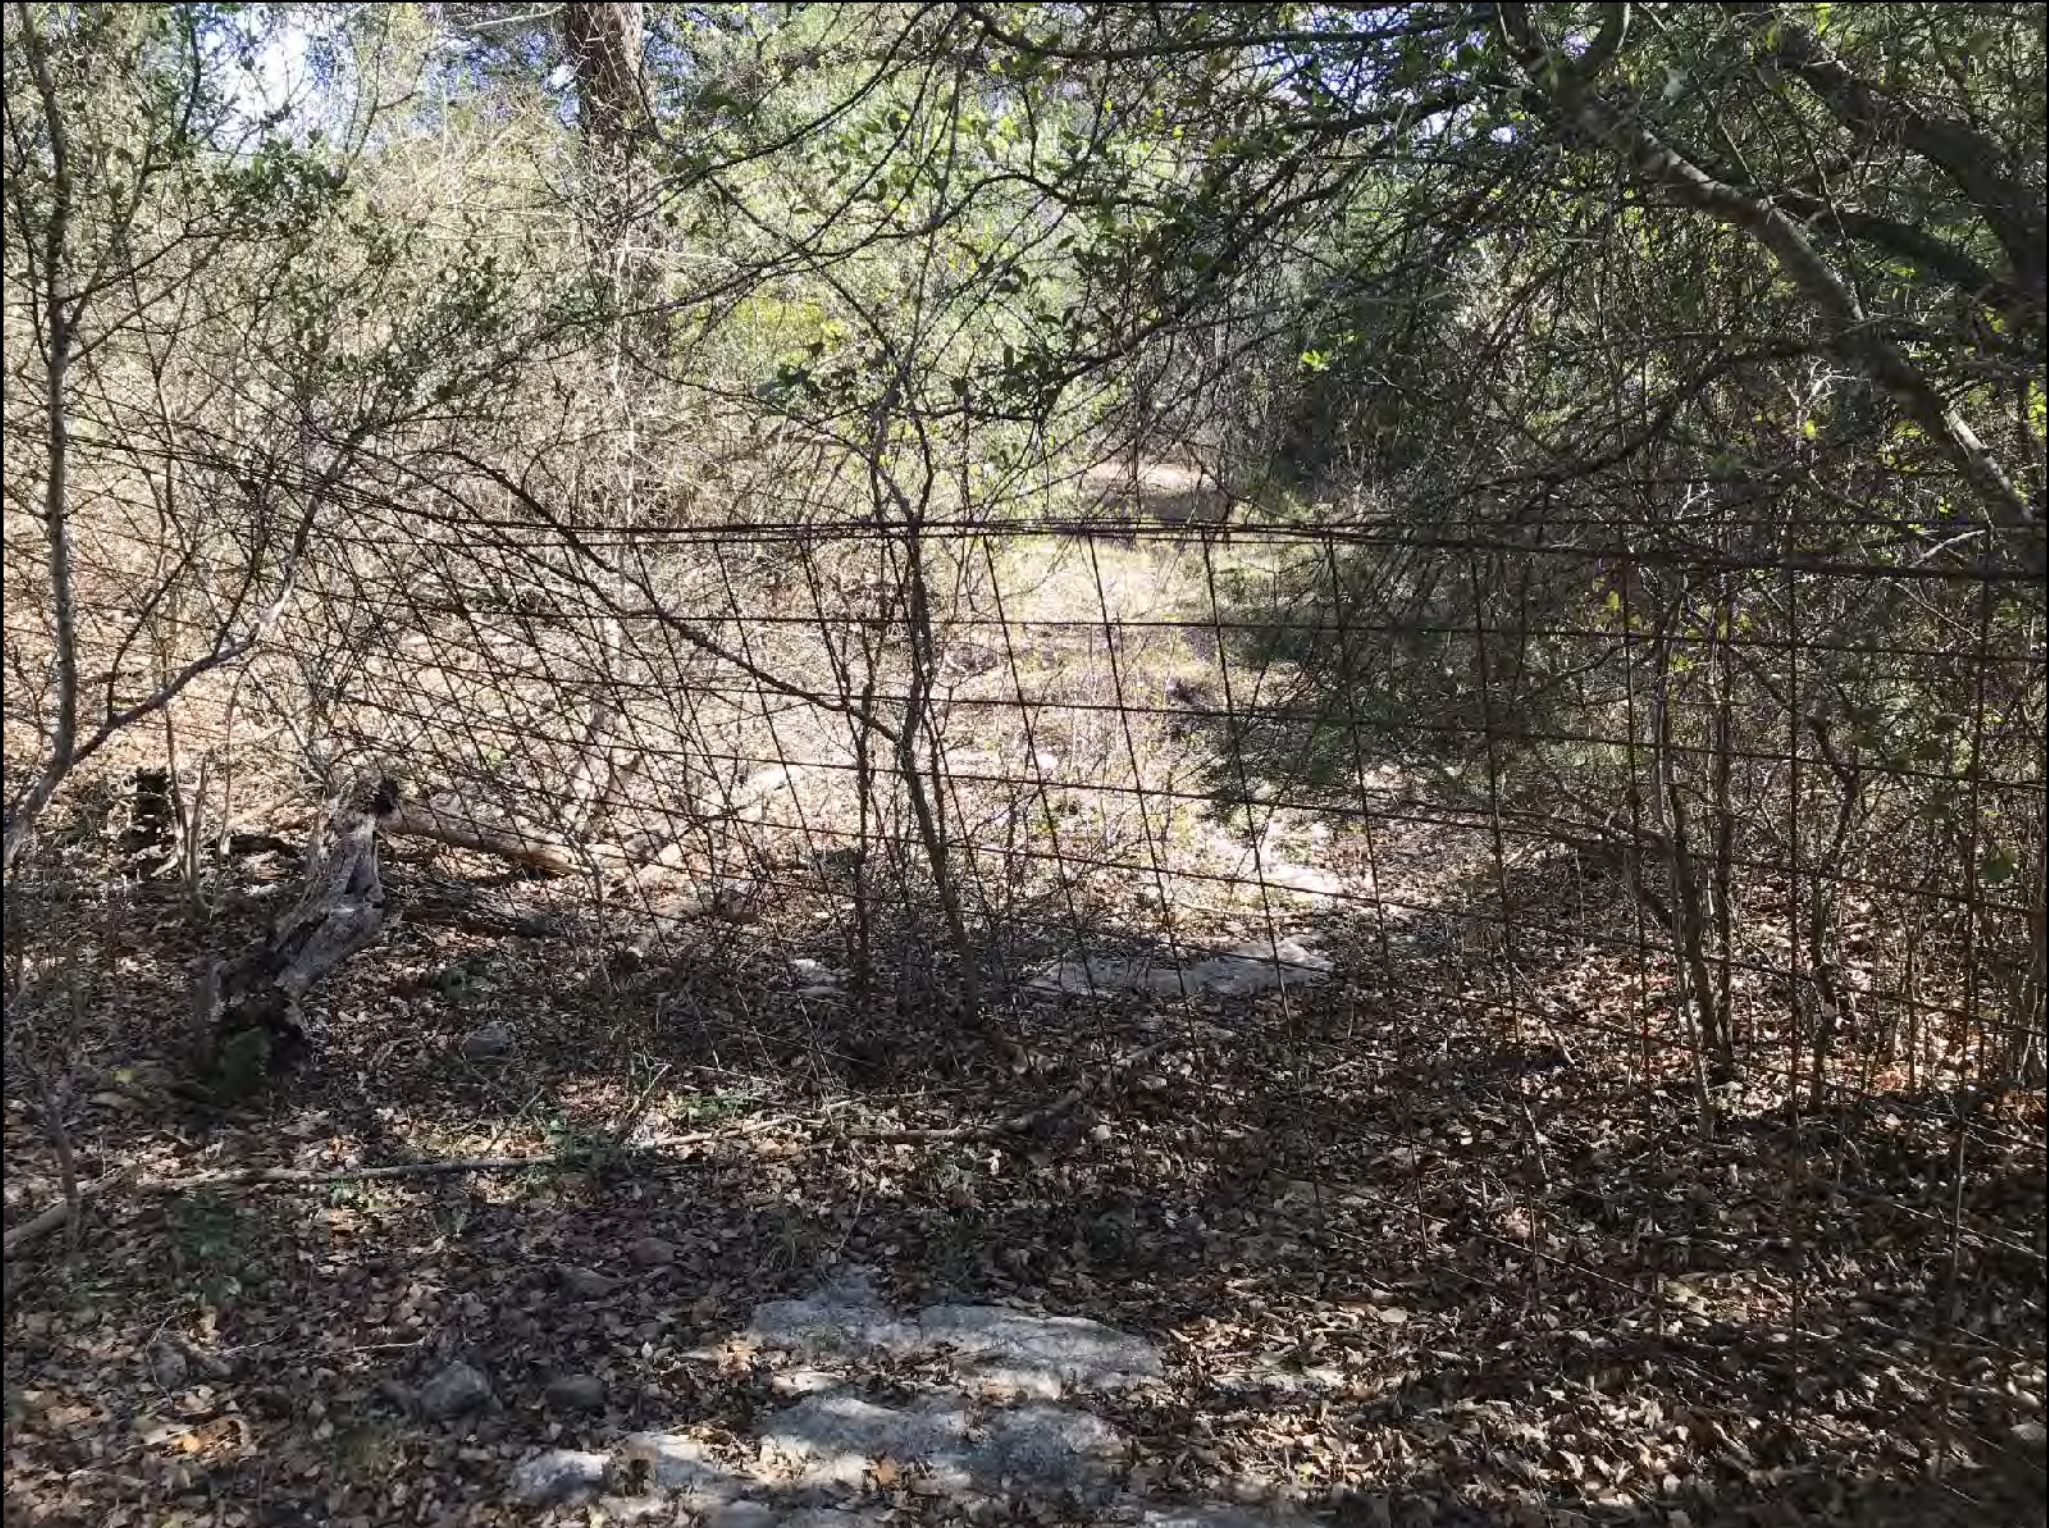
**Mapped Photo Log  
 for Saddleback at Santa Rita  
 Ranch  
 SWF-2020-00424**  
 Page 6 of 16

Description:  
 View of the tributary to Sowes Creek.

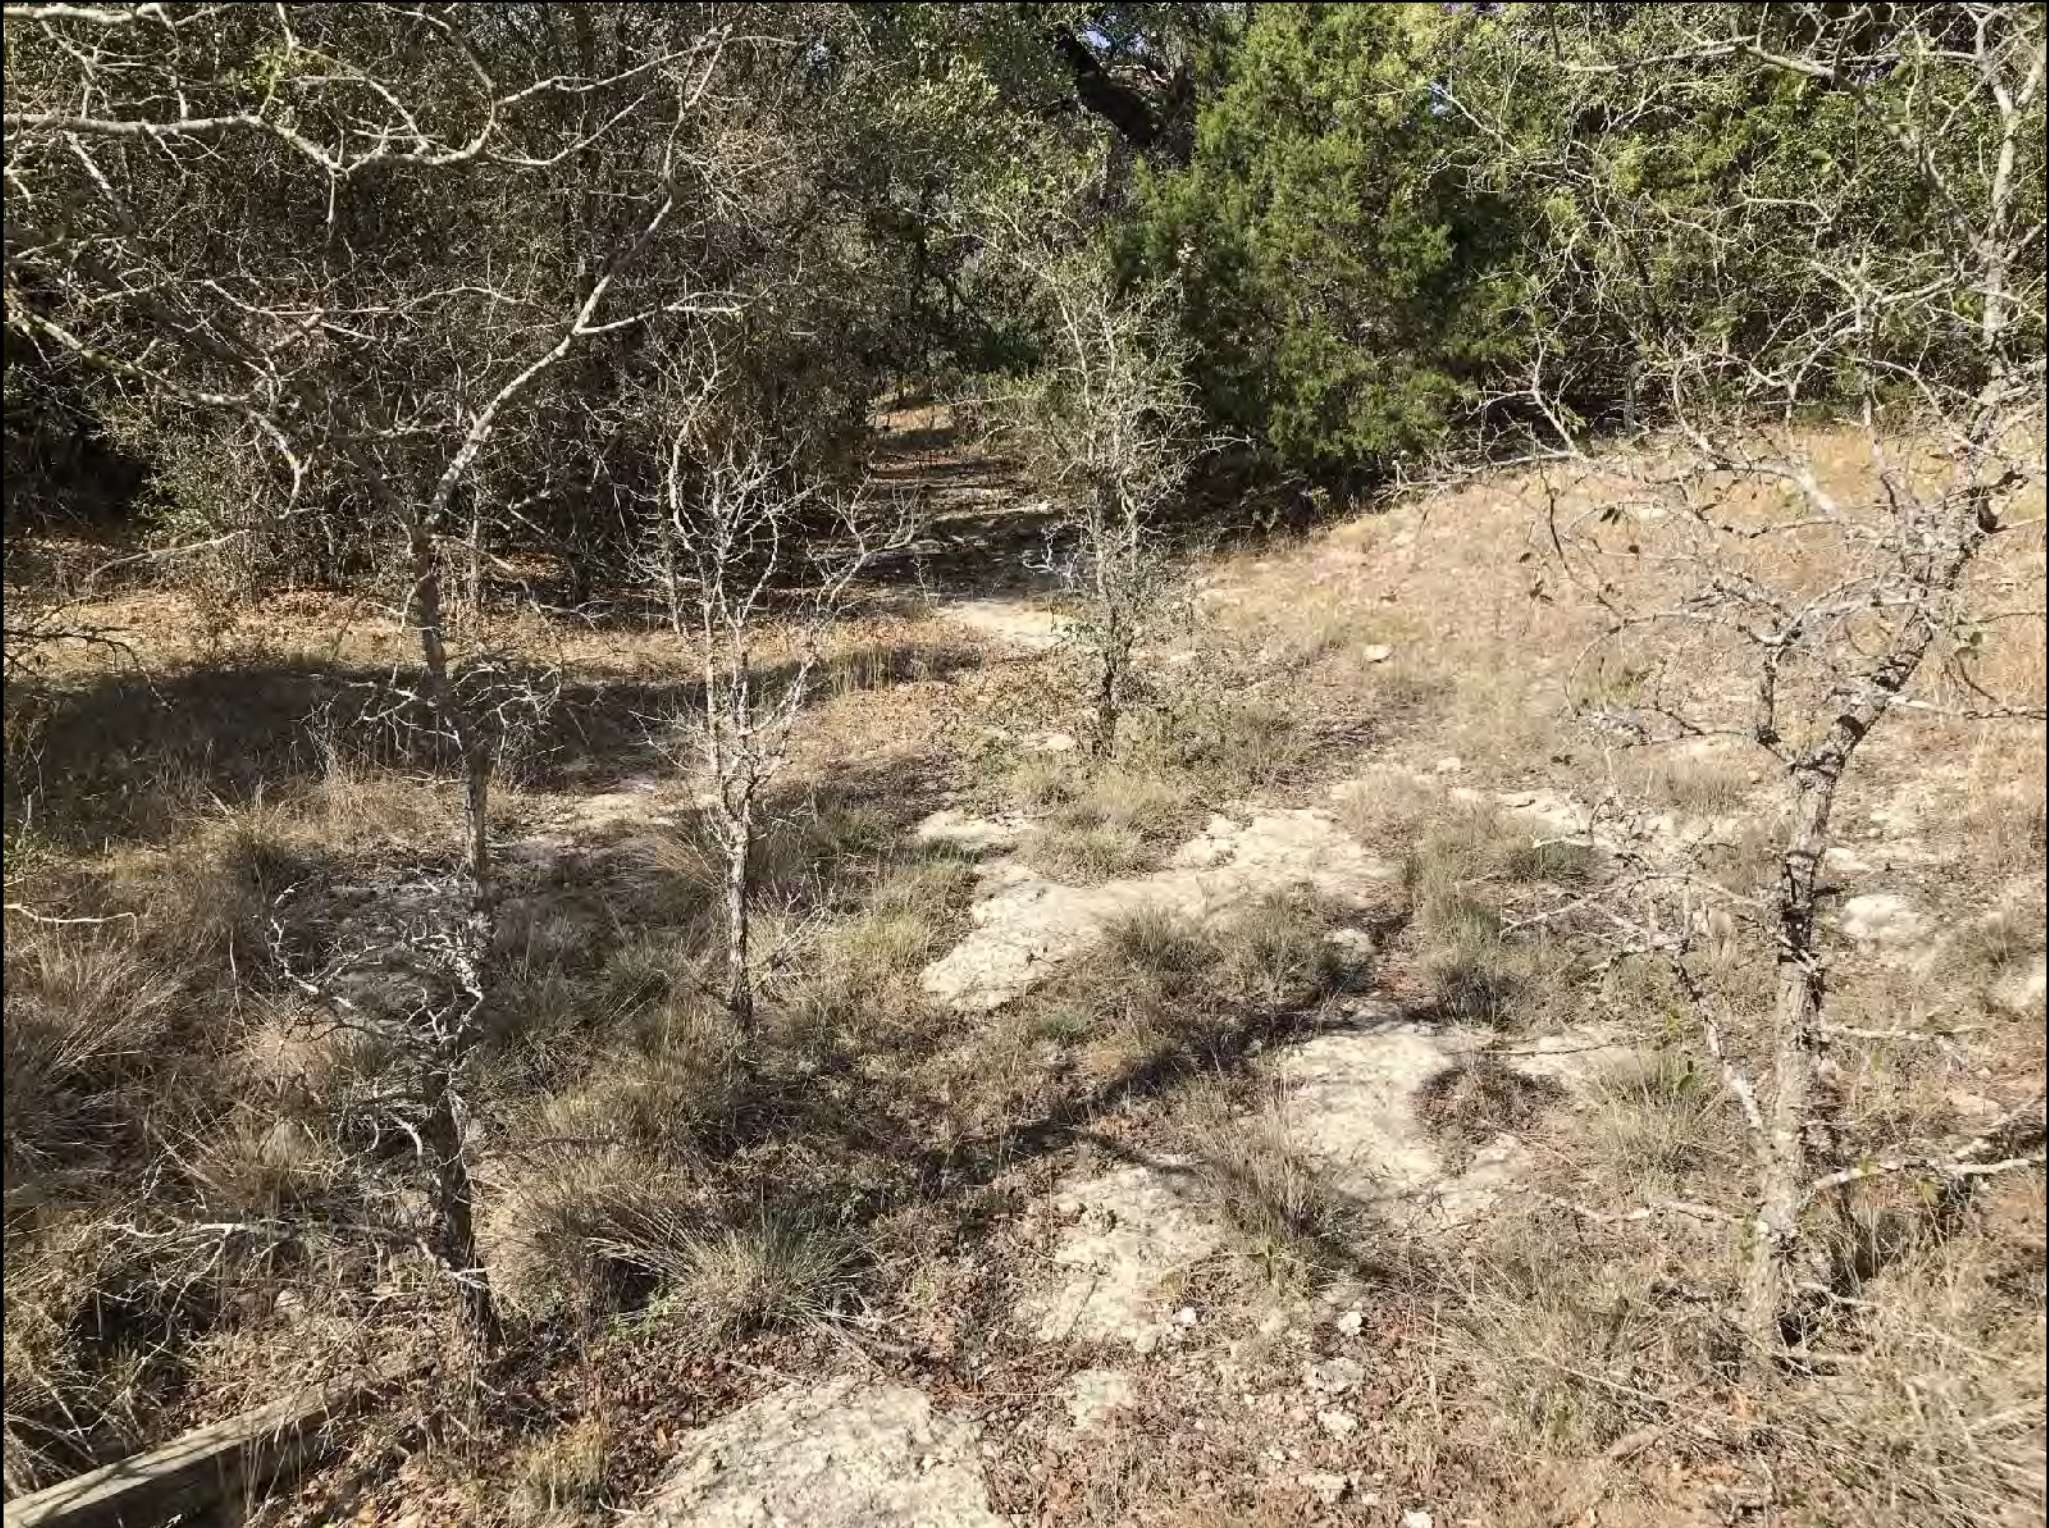
Page 7 of 16

Description:  
 View of the tributary to Soves Creek.
