**U.S. ARMY CORPS OF ENGINEERS  
REGULATORY PROGRAM  
APPROVED JURISDICTIONAL DETERMINATION FORM (INTERIM)  
NAVIGABLE WATERS PROTECTION RULE**

ORM Number: SWF-2020-00424

**Mapped Photo Log  
 for Saddleback at Santa Rita  
 Ranch  
 SWF-2020-00424**  
 Page 1 of 16

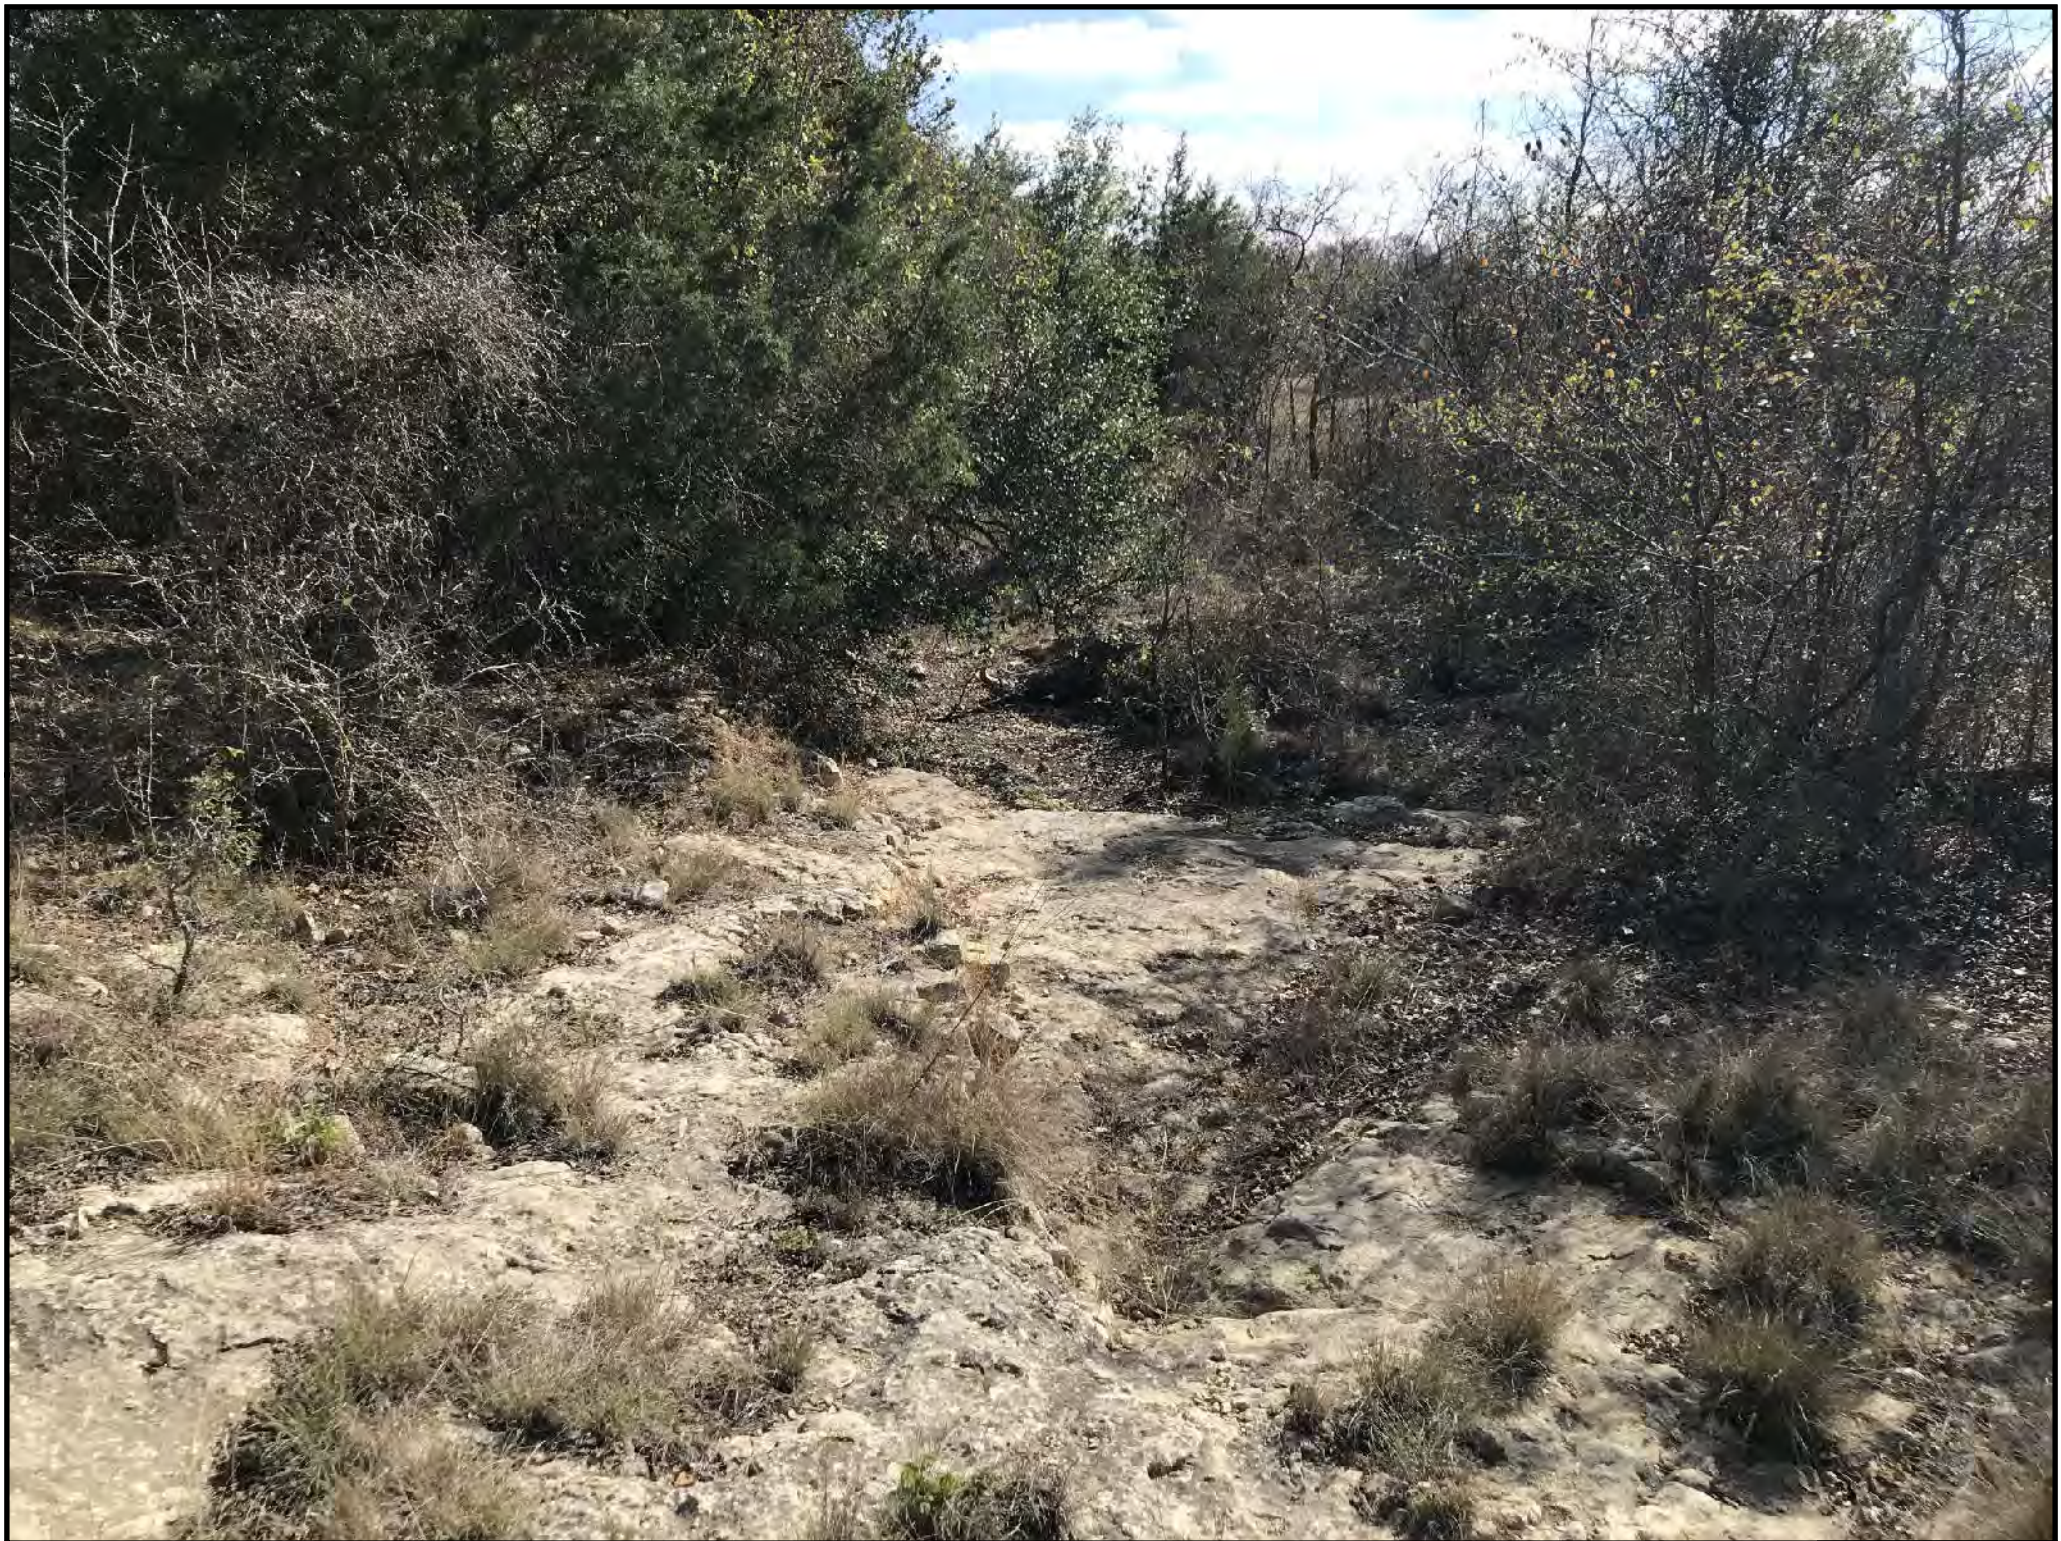
**Mapped Photo Log  
 for Saddleback at Santa Rita  
 Ranch  
 SWF-2020-00424**  
 Page 8 of 16

Description:  
 View of the tributary to Sowes Creek.

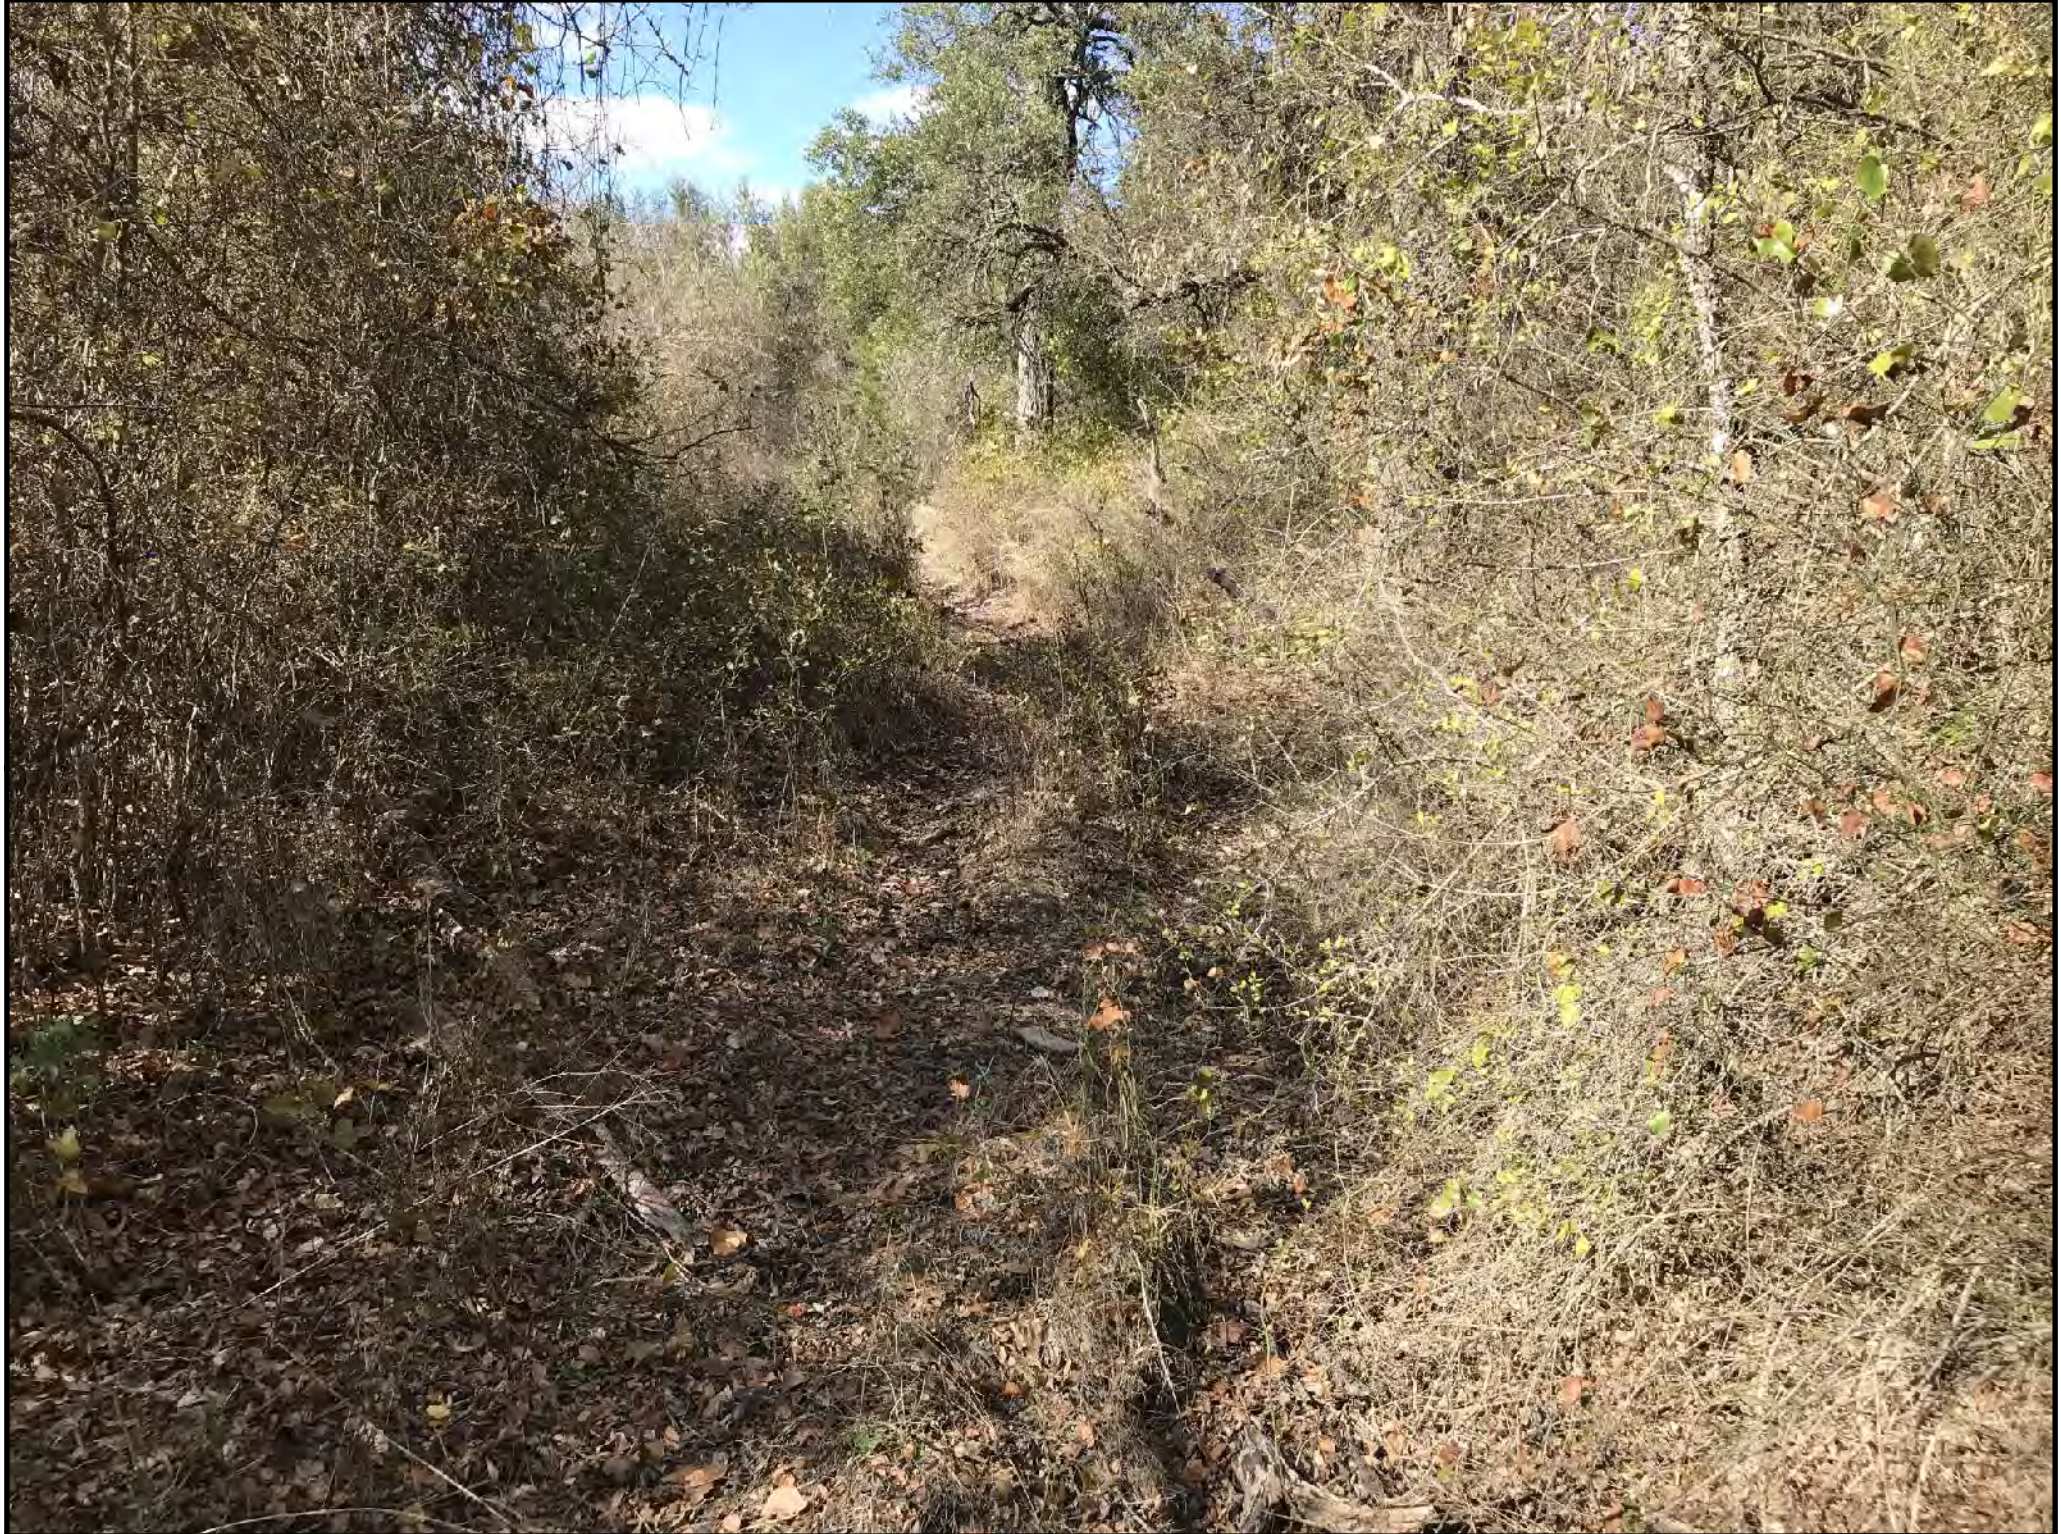
**Mapped Photo Log  
 for Saddleback at Santa Rita  
 Ranch  
 SWF-2020-00424**  
 Page 9 of 16

Description:  
 View of the tributary to Sowes Creek.

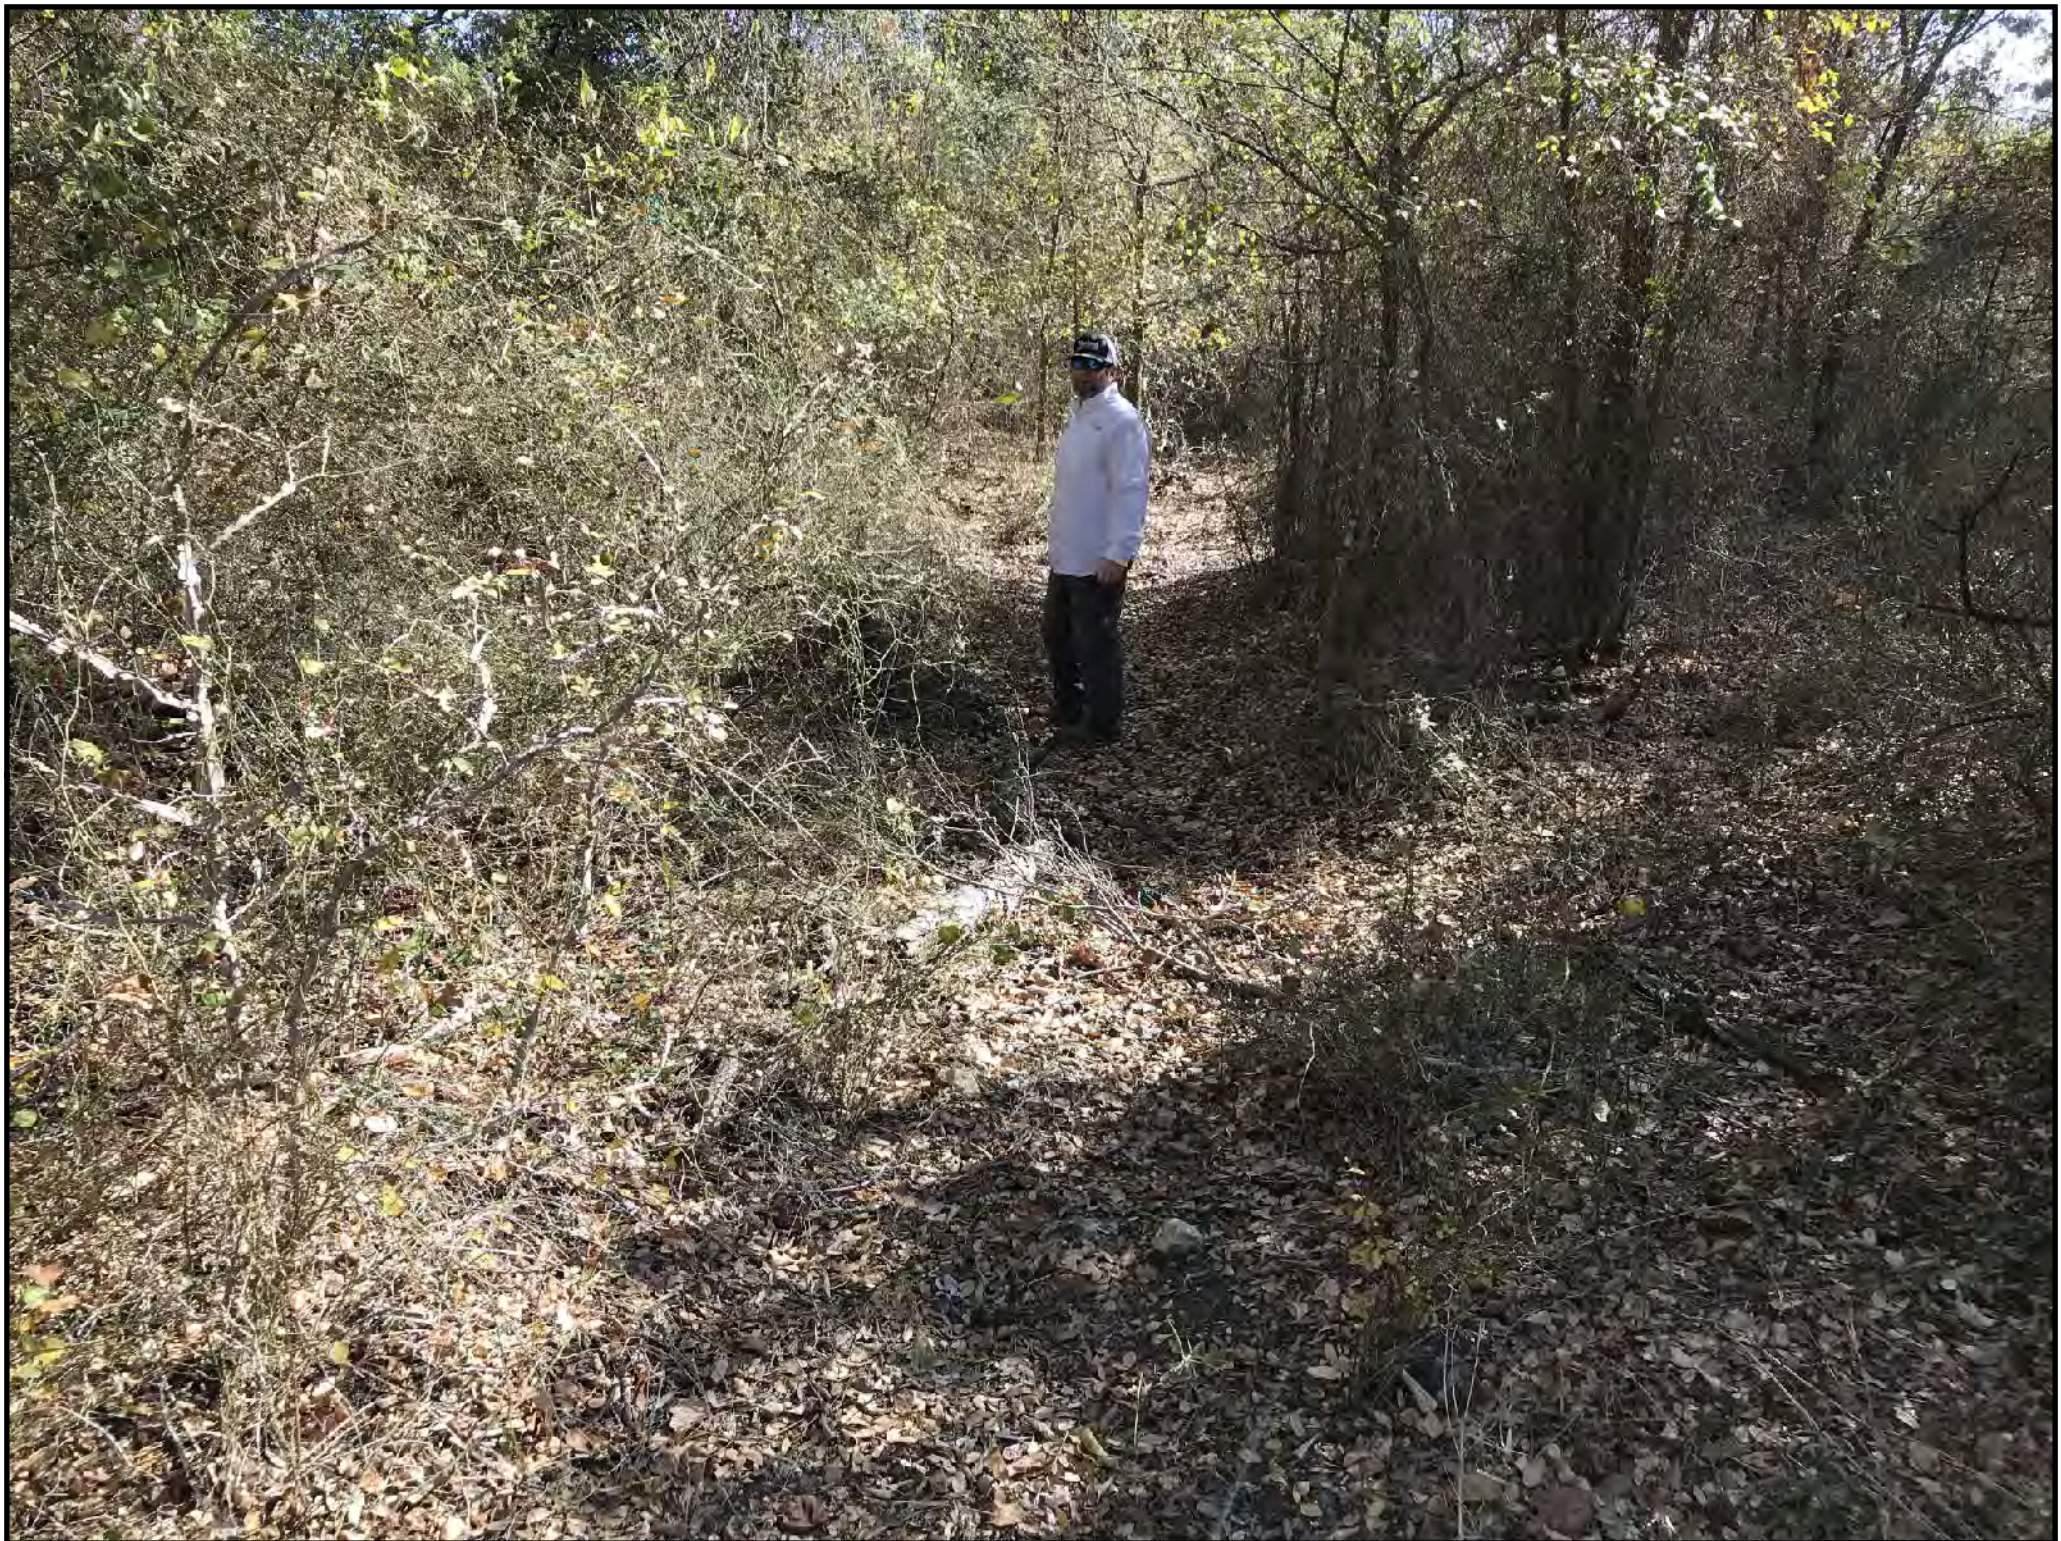
**Mapped Photo Log  
 for Saddleback at Santa Rita  
 Ranch  
 SWF-2020-00424**  
 Page 10 of 16

Description:  
 View of the tributary to Sowes Creek.

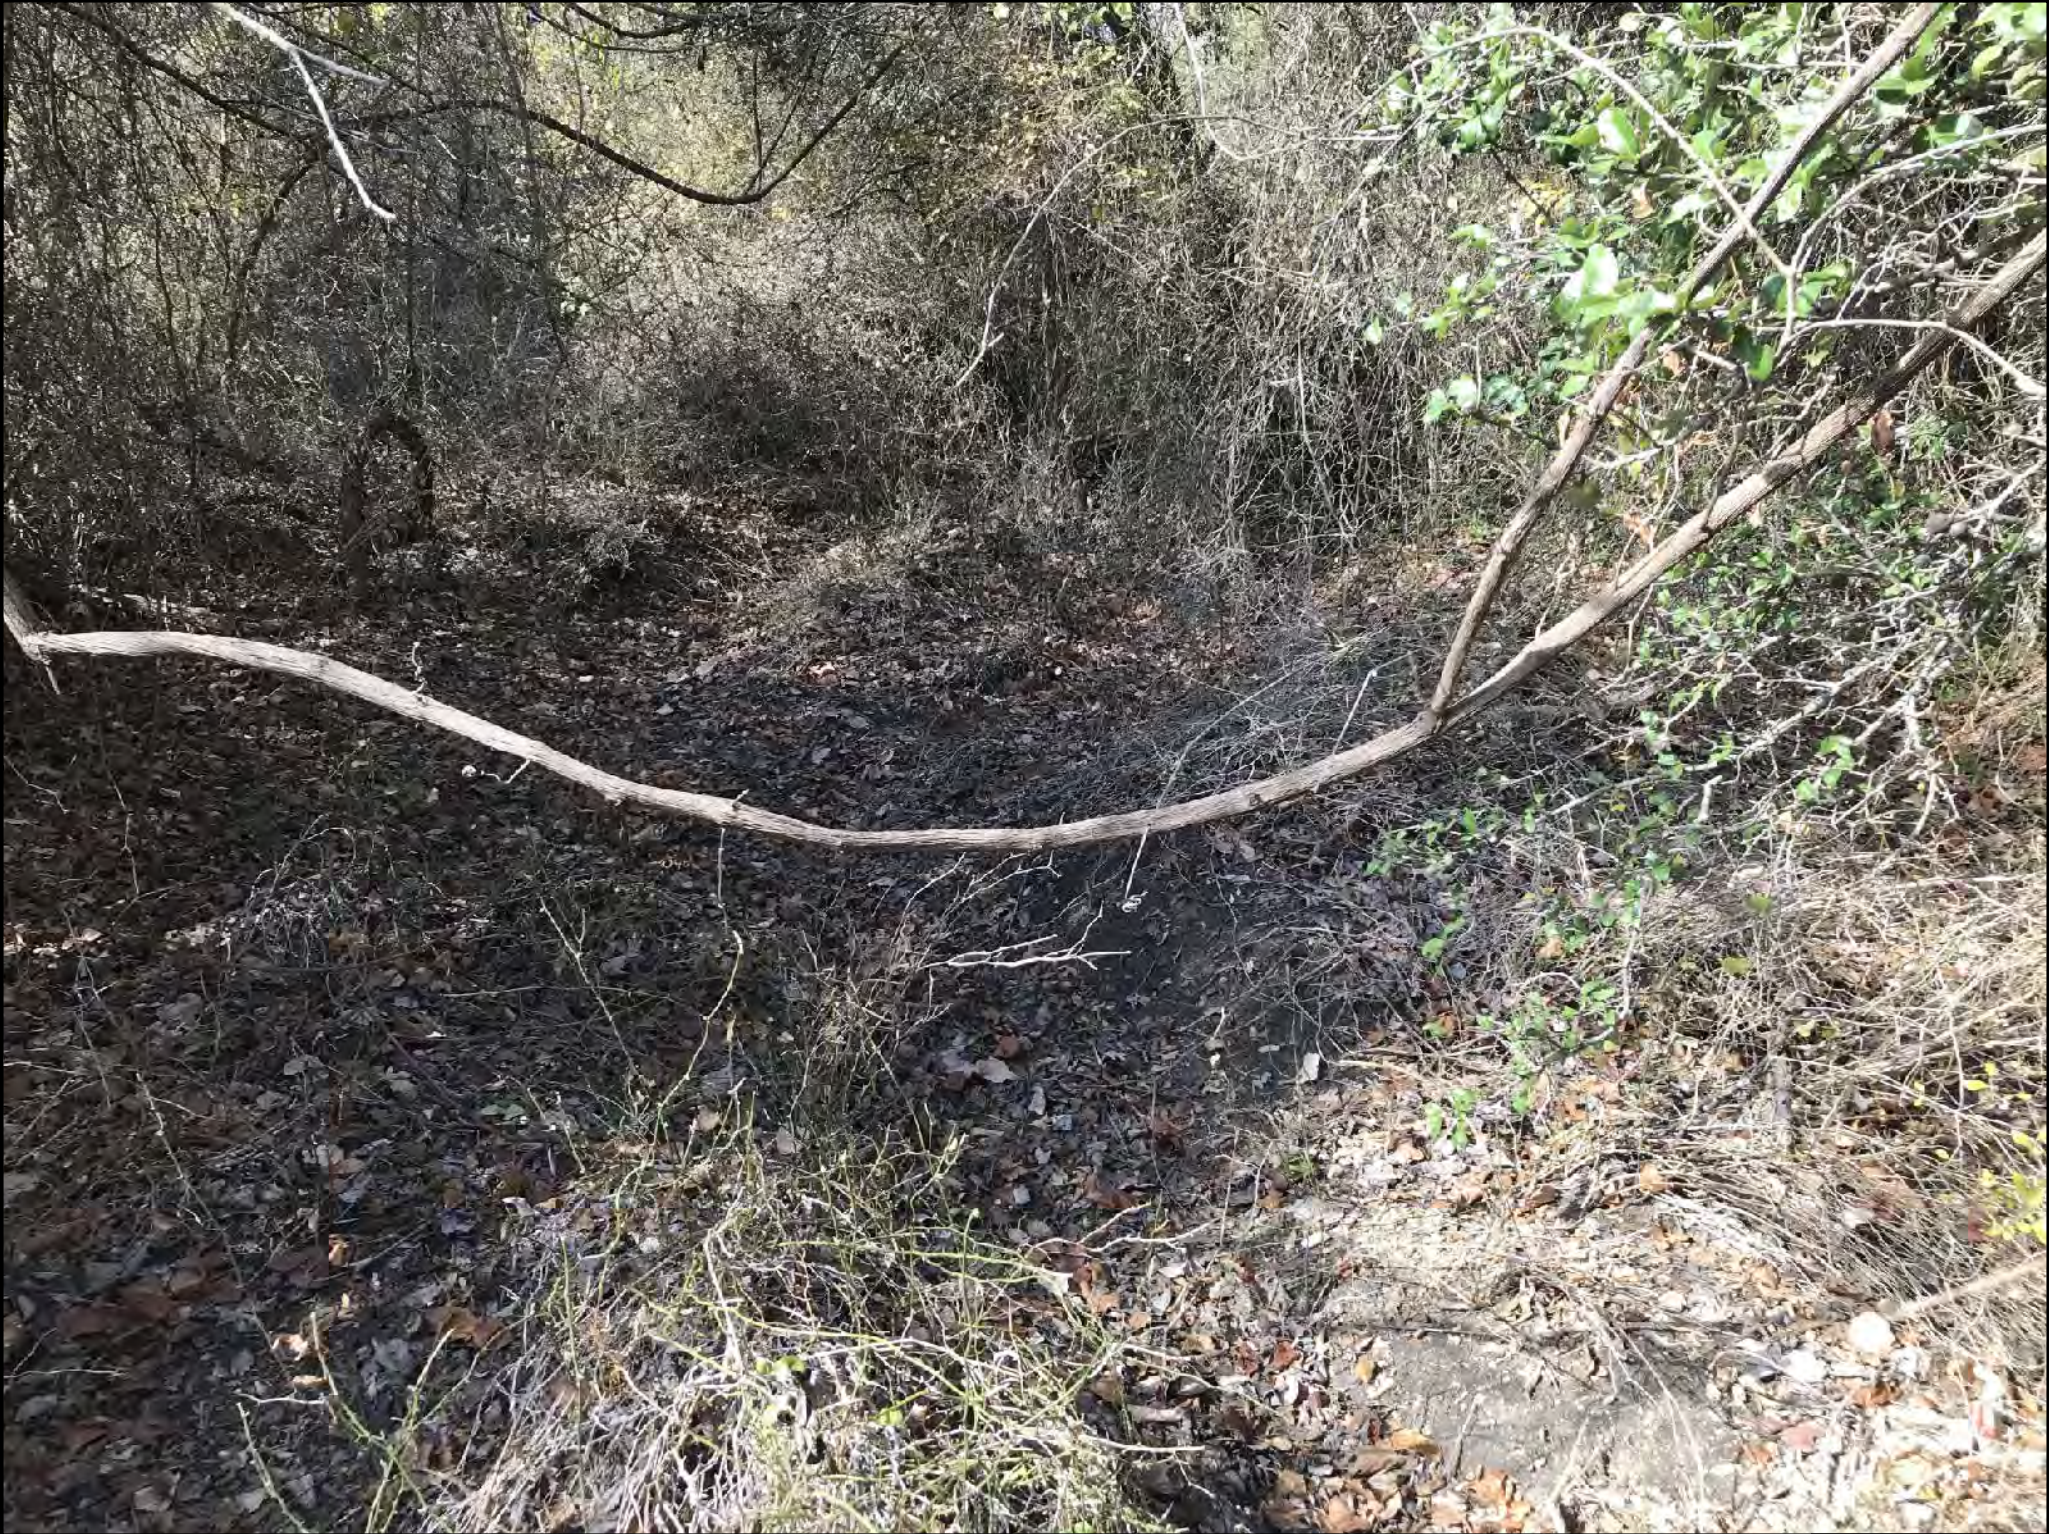
**Mapped Photo Log  
 for Saddleback at Santa Rita  
 Ranch  
 SWF-2020-00424**  
 Page 11 of 16

Description:  
 View of the tributary to Sowes Creek.

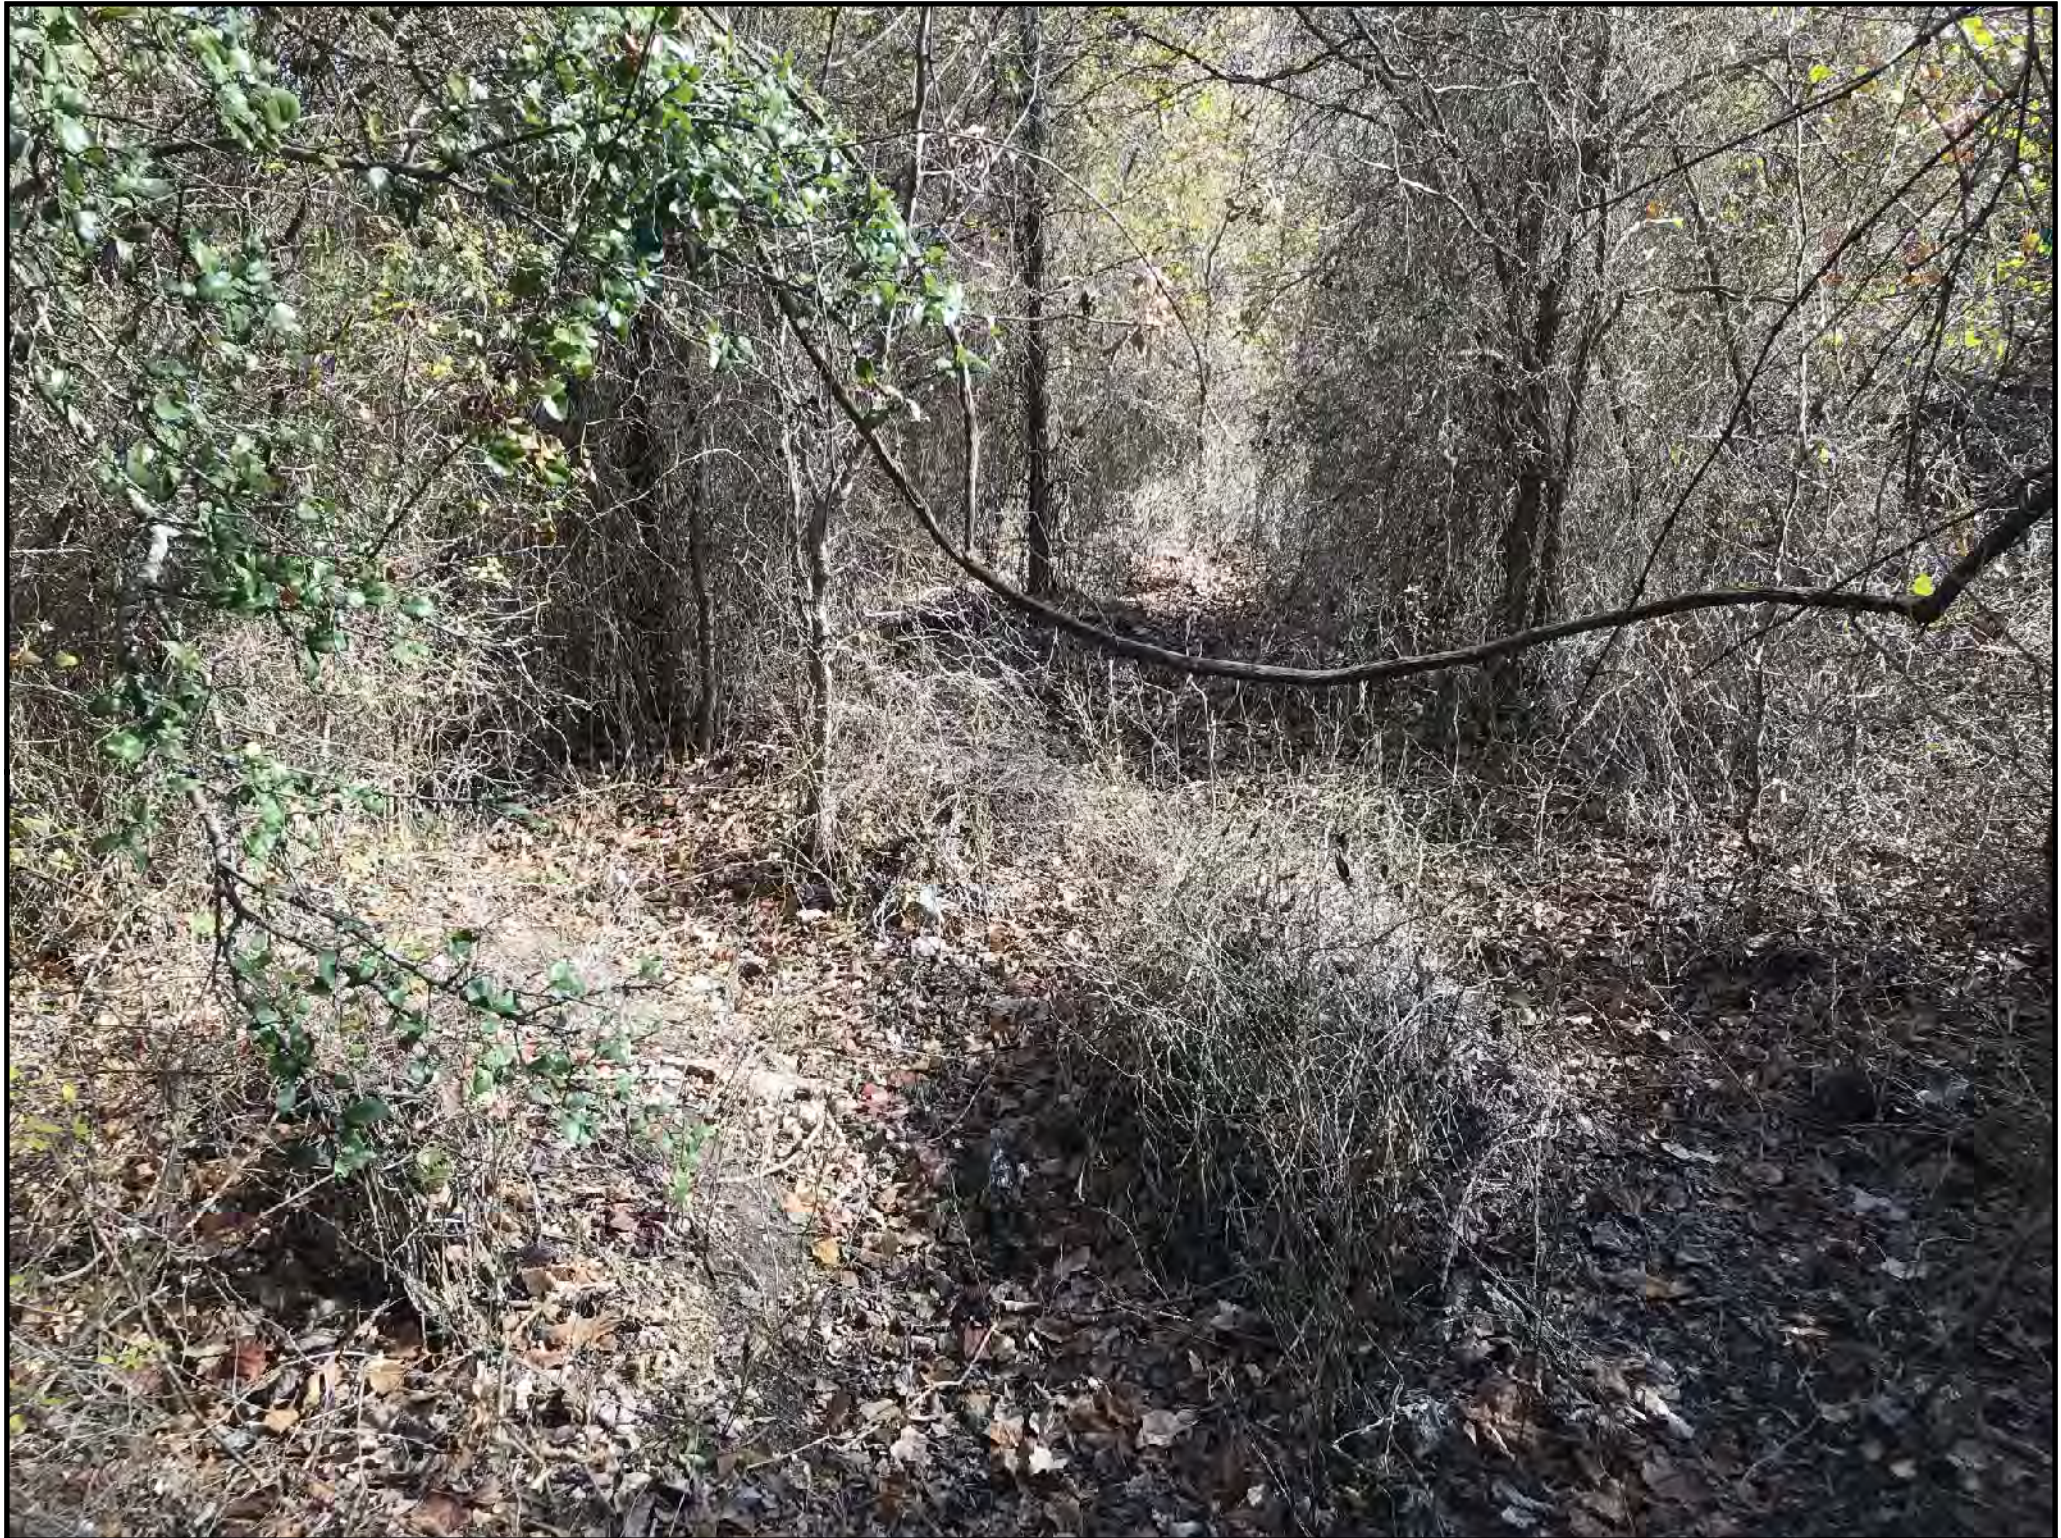
**Mapped Photo Log  
 for Saddleback at Santa Rita  
 Ranch  
 SWF-2020-00424**  
 Page 12 of 16

Description:  
 View of the Tributary to Sowes Creek.

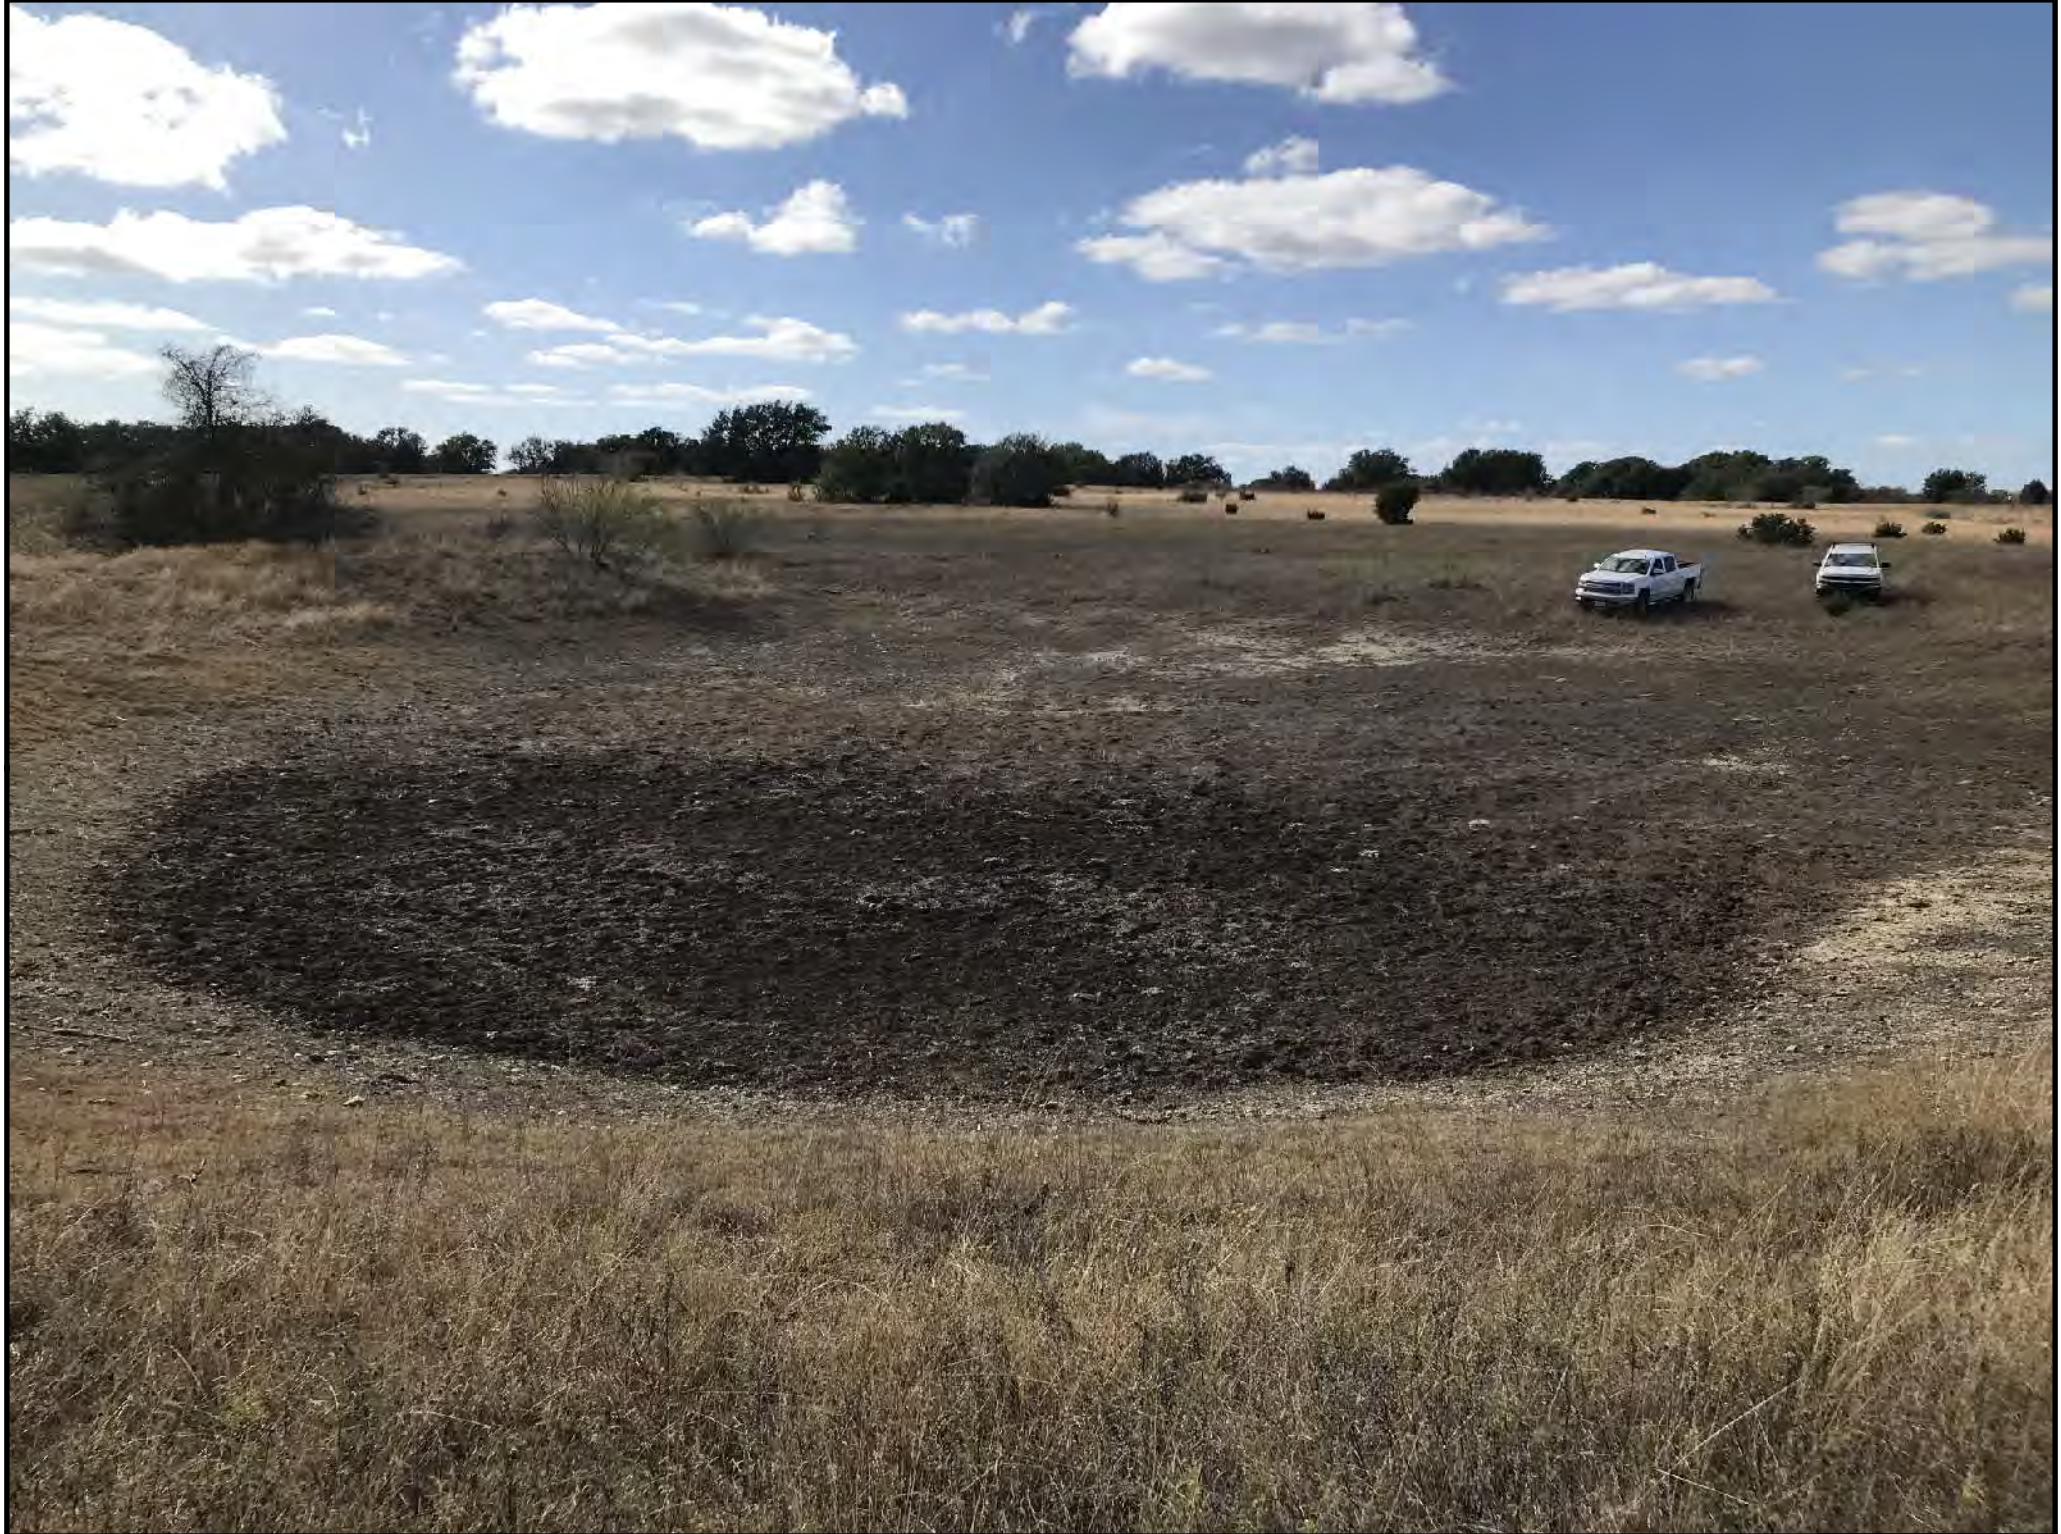
**Mapped Photo Log  
 for Saddleback at Santa Rita  
 Ranch  
 SWF-2020-00424**  
 Page 13 of 16

Description:  
 View of pond 2.

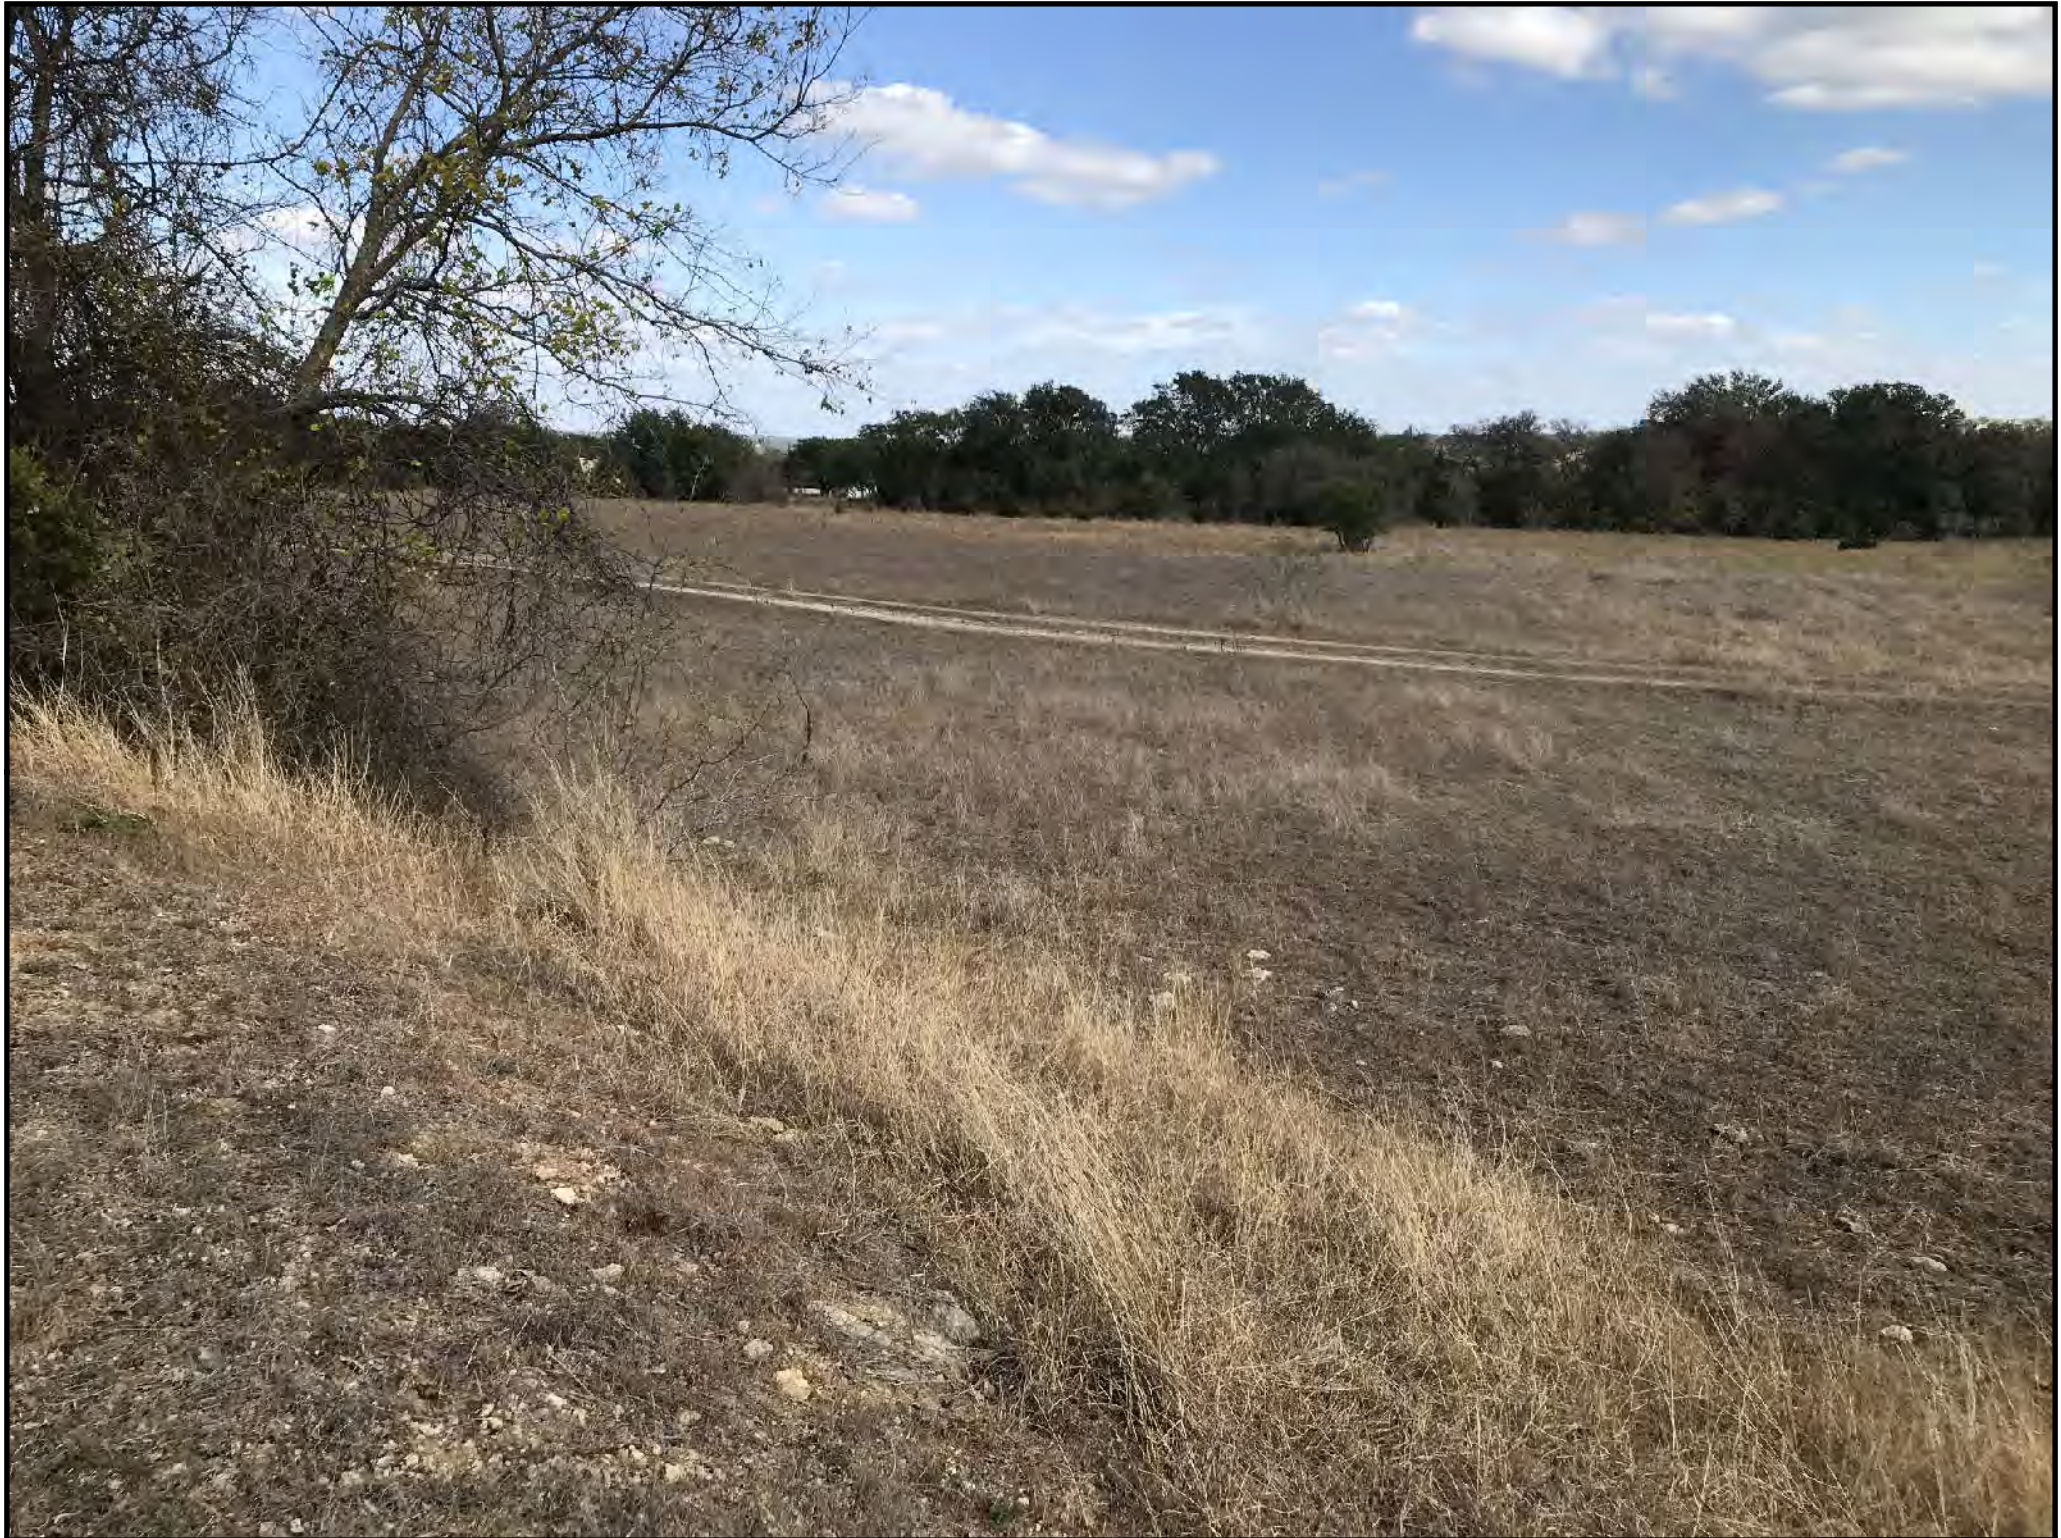
**Mapped Photo Log  
 for Saddleback at Santa Rita  
 Ranch  
 SWF-2020-00424**  
 Page 14 of 16

Description:  
 View of swale below pond 2.
