**U.S. ARMY CORPS OF ENGINEERS  
REGULATORY PROGRAM  
APPROVED JURISDICTIONAL DETERMINATION FORM (INTERIM)  
NAVIGABLE WATERS PROTECTION RULE**

ORM Number: SWF-2020-00424

**Mapped Photo Log  
 for Saddleback at Santa Rita  
 Ranch  
 SWF-2020-00424**  
 Page 1 of 16

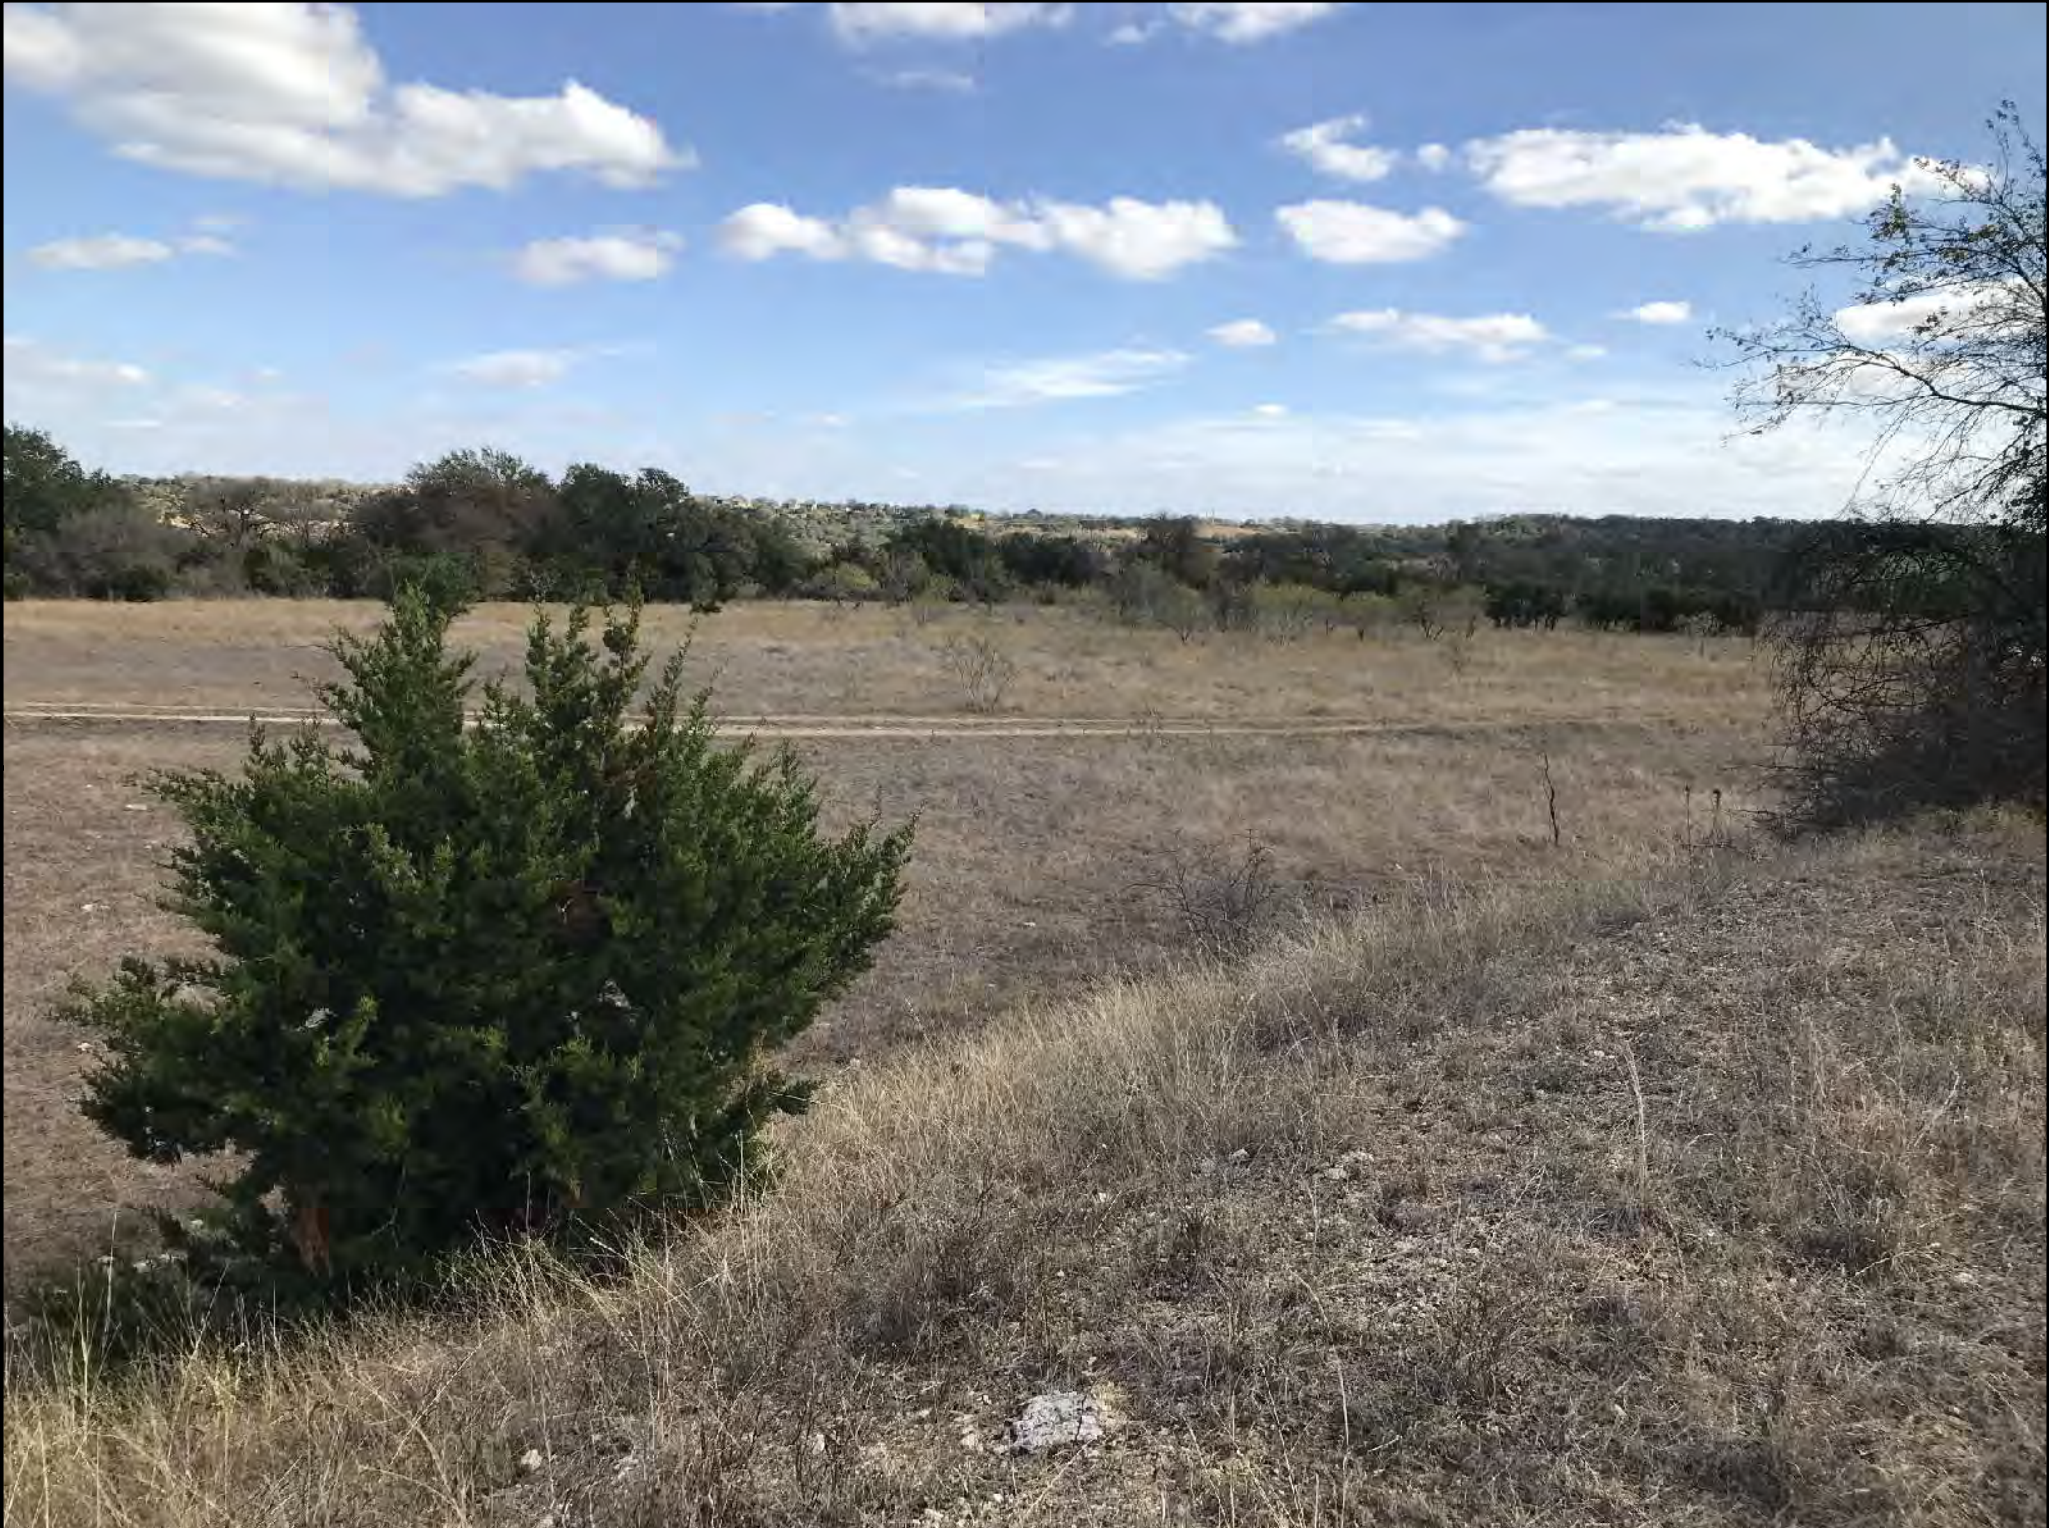
**Mapped Photo Log  
 for Saddleback at Santa Rita  
 Ranch  
 SWF-2020-00424**  
 Page 15 of 16

Description:  
 View of swale below pond 2.
