**FIGURE 6: DELINEATED OPEN WATERS
PROPOSED LAKE RALPH HALL
SUPPLEMENTAL JURISDICTIONAL DETERMINATION**

USACE PROJECT NO.:
SWF-2003-00336

PREPARED BY:
ALAN PLUMMER ASSOC., INC.

WETLAND DETERMINATION DATA FORM – Great Plains Region

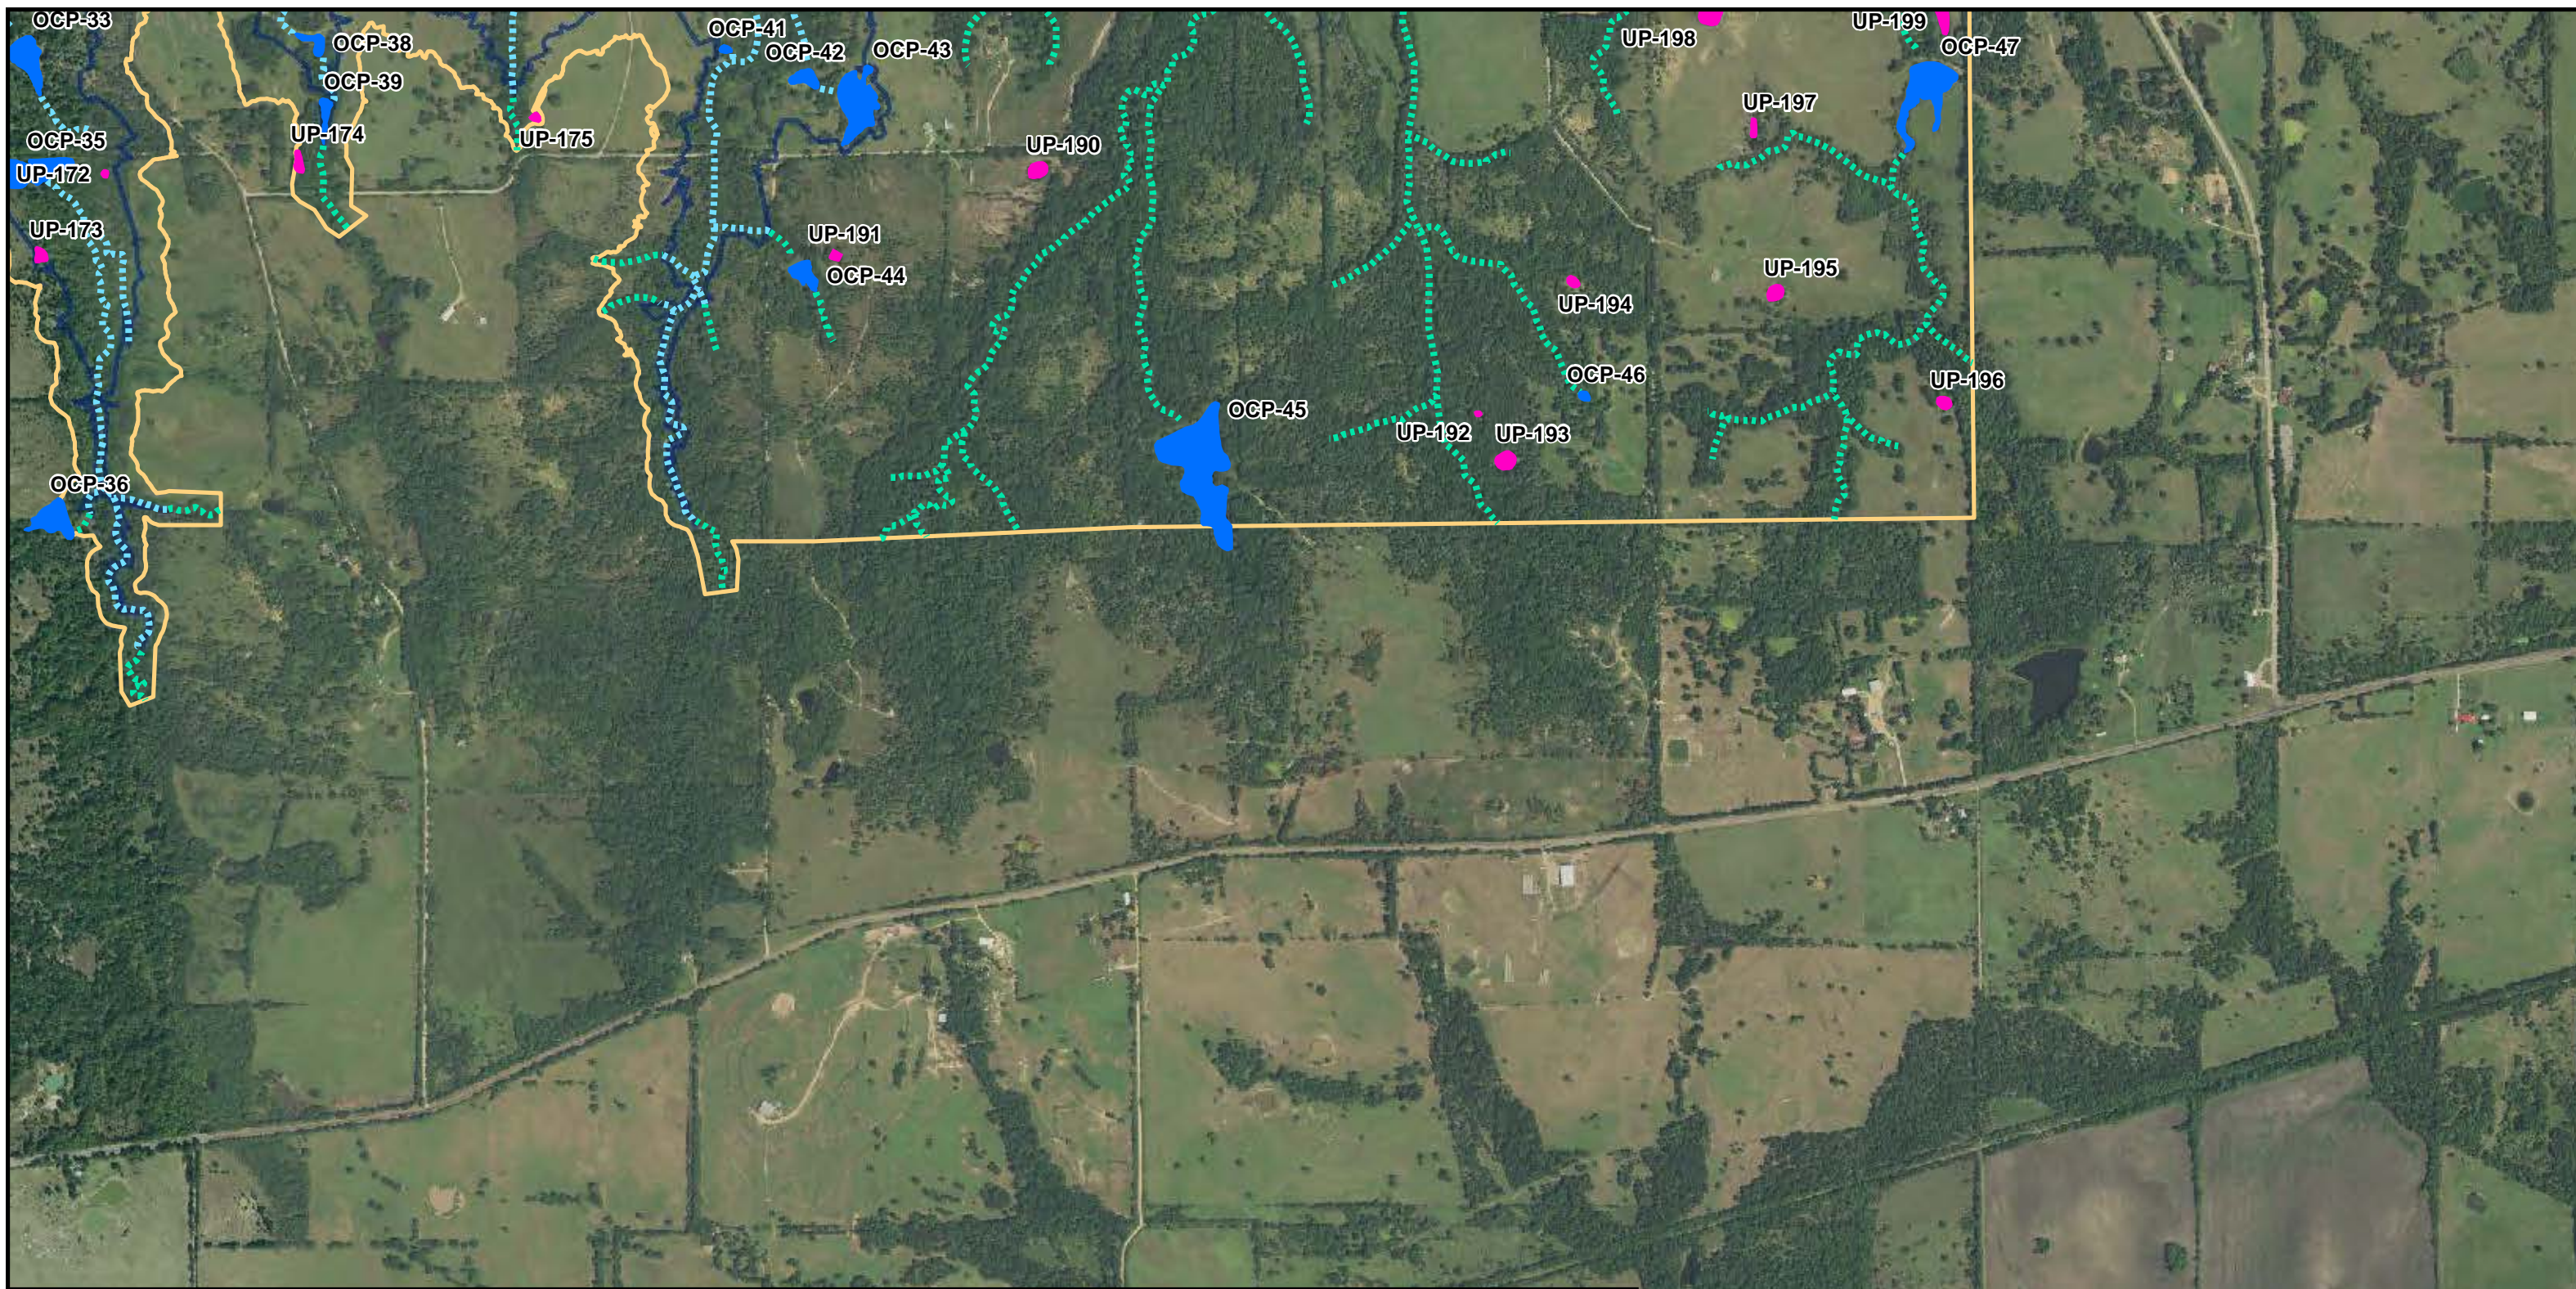
JURISDICTIONAL OPEN WATERS	NON-JURISDICTIONAL OPEN WATERS	STREAM LOCATION	SJD ASSESSMENT AREA
ON-CHANNEL IMPOUNDMENT	UPLAND POND	CONSERVATION POOL, DAM, SPILLWAY	CONSERVATION POOL
		ASSESSMENT AREA OUTSIDE OF CONSERVATION POOL

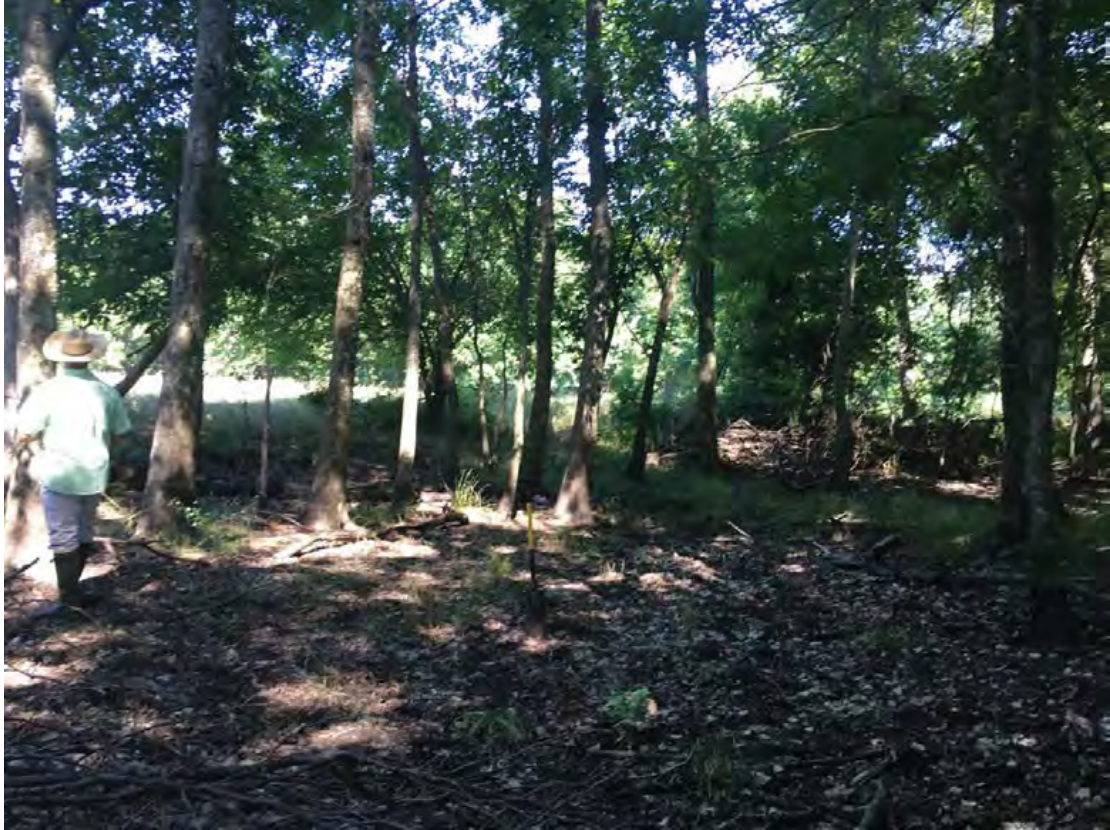
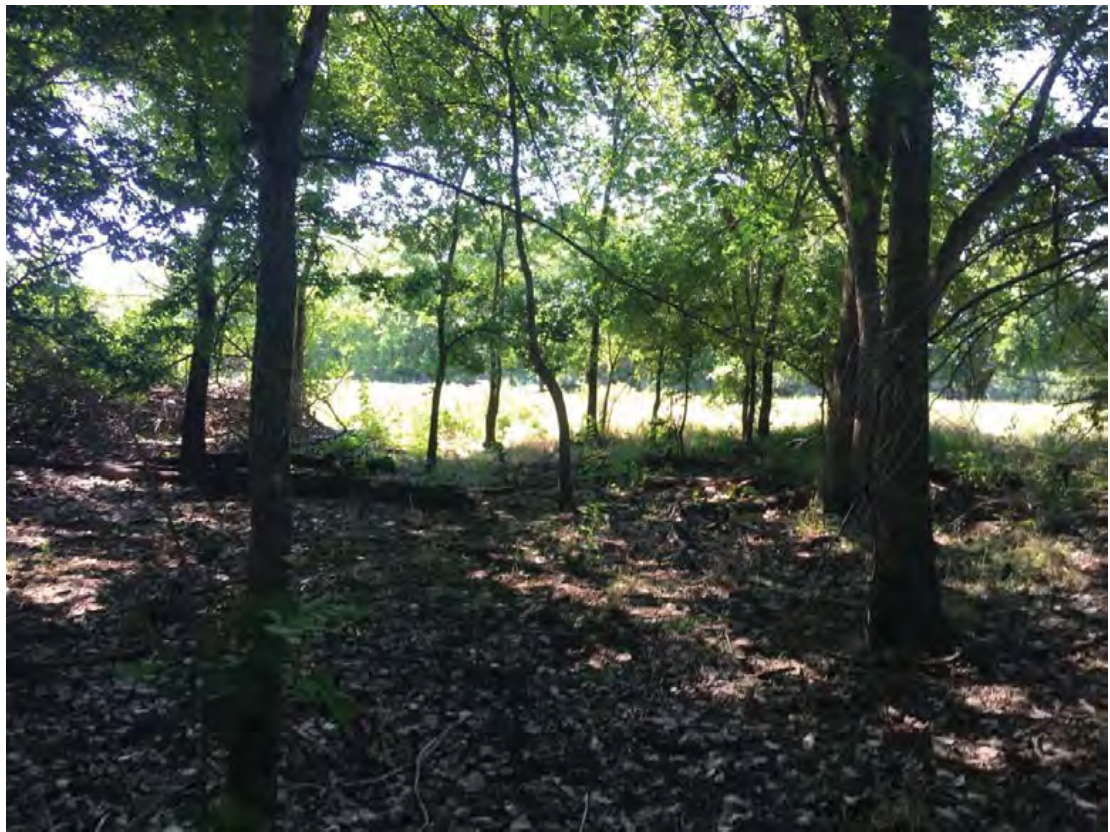
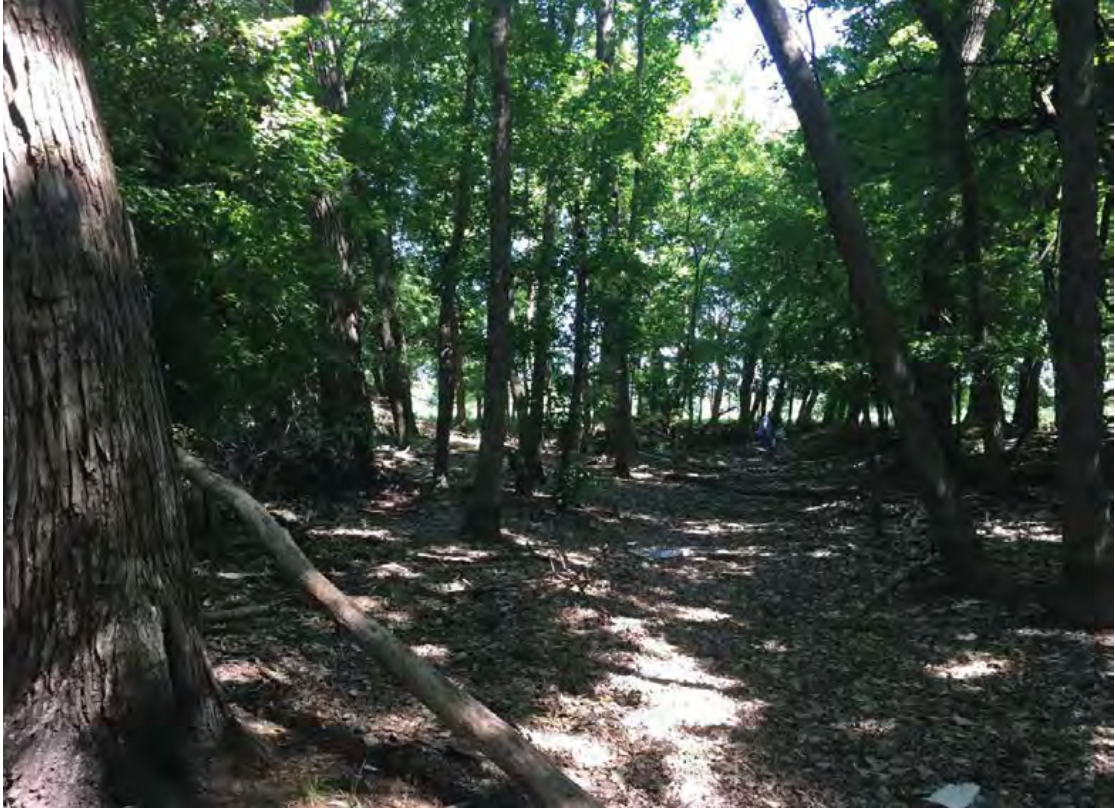
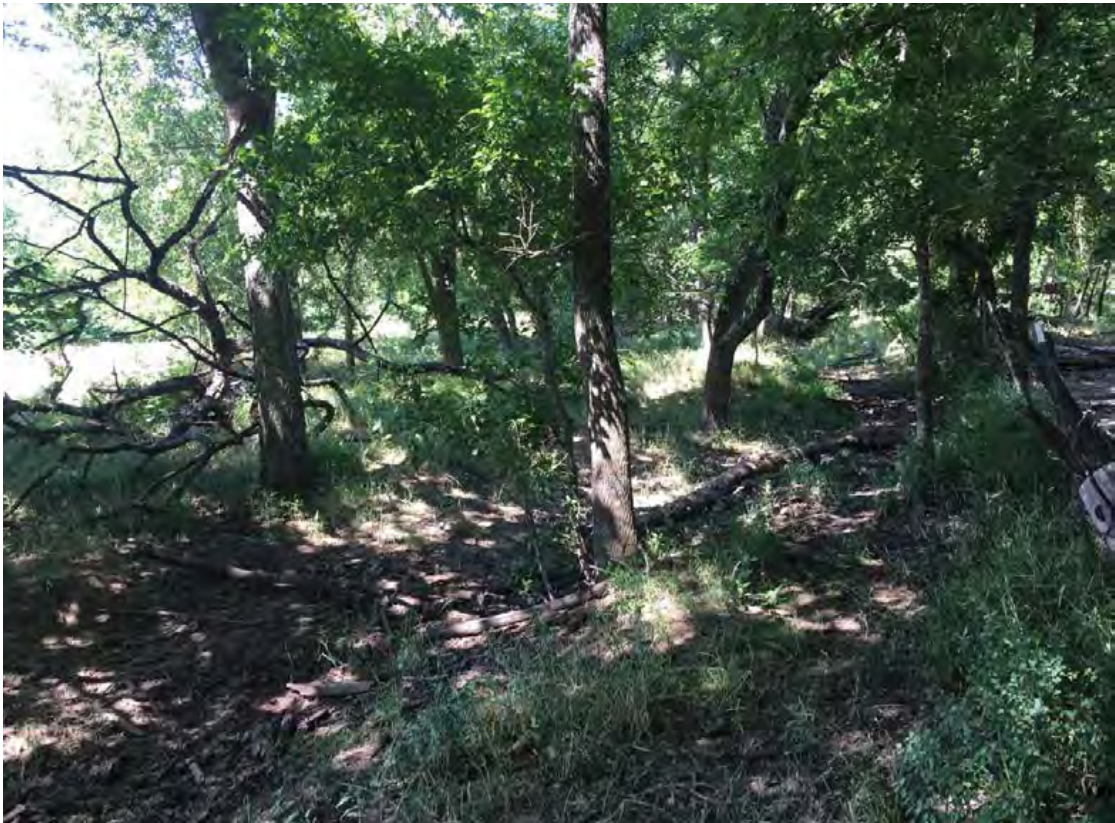
Project/Site: Lake Ralph Hall Supplemental JD City/County: Ladonia/Fannin Sampling Date: 5/30/17
 Applicant/Owner: Upper Trinity Regional Water District State: TX Sampling Point: WP4
 Investigator(s): Jason Voight, Andrew Sample Section, Township, Range: _____
 Landform (hillslope, terrace, etc.): Valley Local relief (concave, convex, none): Concave Slope (%): 0-1%
 Subregion (LRR): Southwest Prairies Lat: 33.45900 Long: -95.89973 Datum: NAD83
 Soil Map Unit Name: Tinn Clay, Occasionally Flooded NWI classification: none

Depth (inches)	Matrix		Redox Features				Texture	Remarks
	Color (moist)	%	Color (moist)	%	Type ¹	Loc ²		
0-18	10 YR 3/1	100					Clay

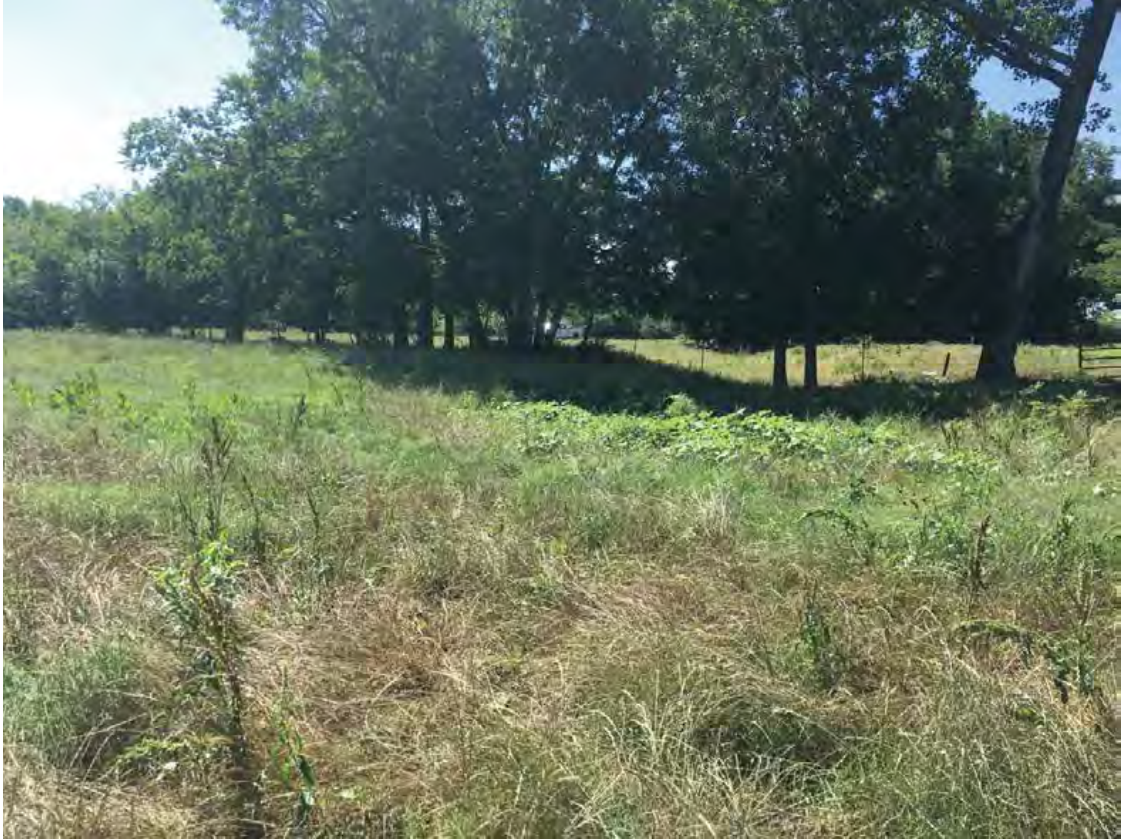
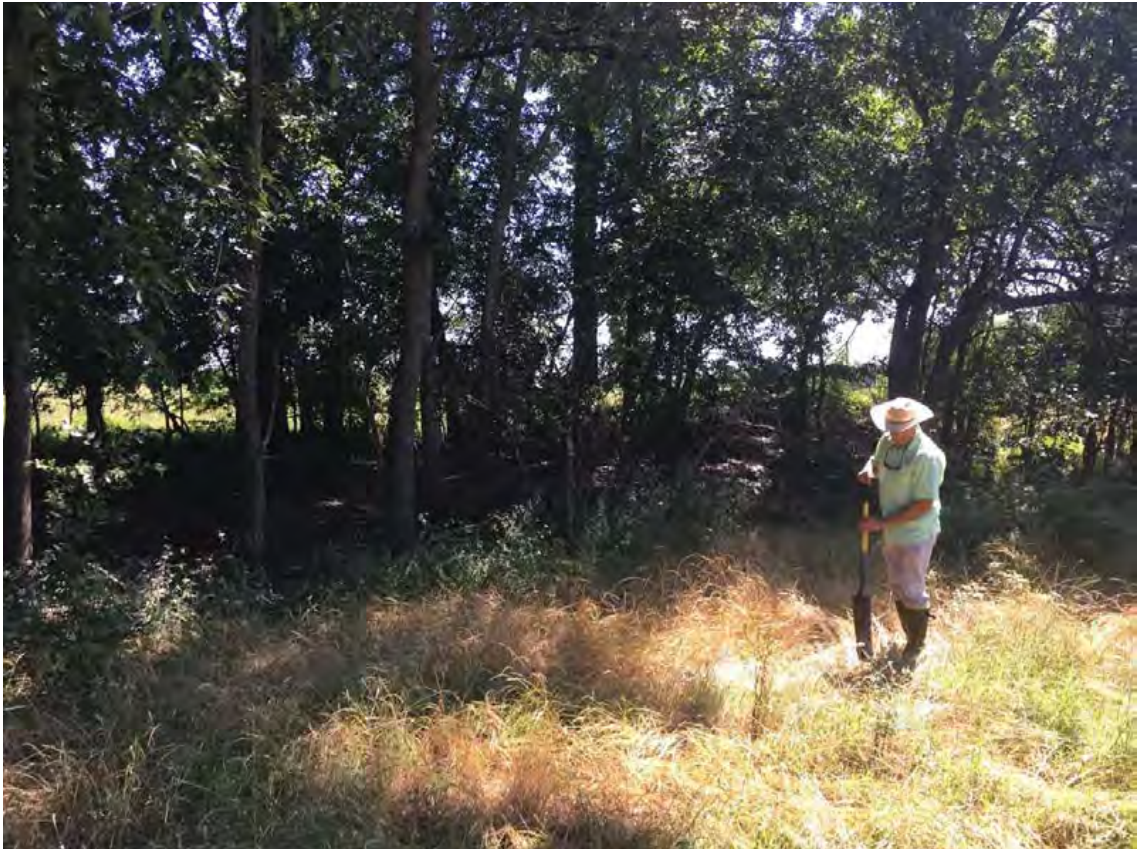
Project/Site: Lake Ralph Hall Supplemental JD City/County: Ladonia/Fannin Sampling Date: 6/2/2017
 Applicant/Owner: Upper Trinity Regional Water District State: TX Sampling Point: WP5
 Investigator(s): Jason Voight, Andrew Sample Section, Township, Range: _____
 Landform (hillslope, terrace, etc.): Valley Local relief (concave, convex, none): Concave Slope (%): 0-1%
 Subregion (LRR): Southwest Prairies Lat: 33.45254 Long: -96.01153 Datum: NAD83
 Soil Map Unit Name: Tinn Clay, Occasionally Flooded NWI classification: none

Depth (inches)	Matrix		Redox Features				Texture	Remarks
	Color (moist)	%	Color (moist)	%	Type ¹	Loc ²		
0-18	10 YR 3/1	100					Clay

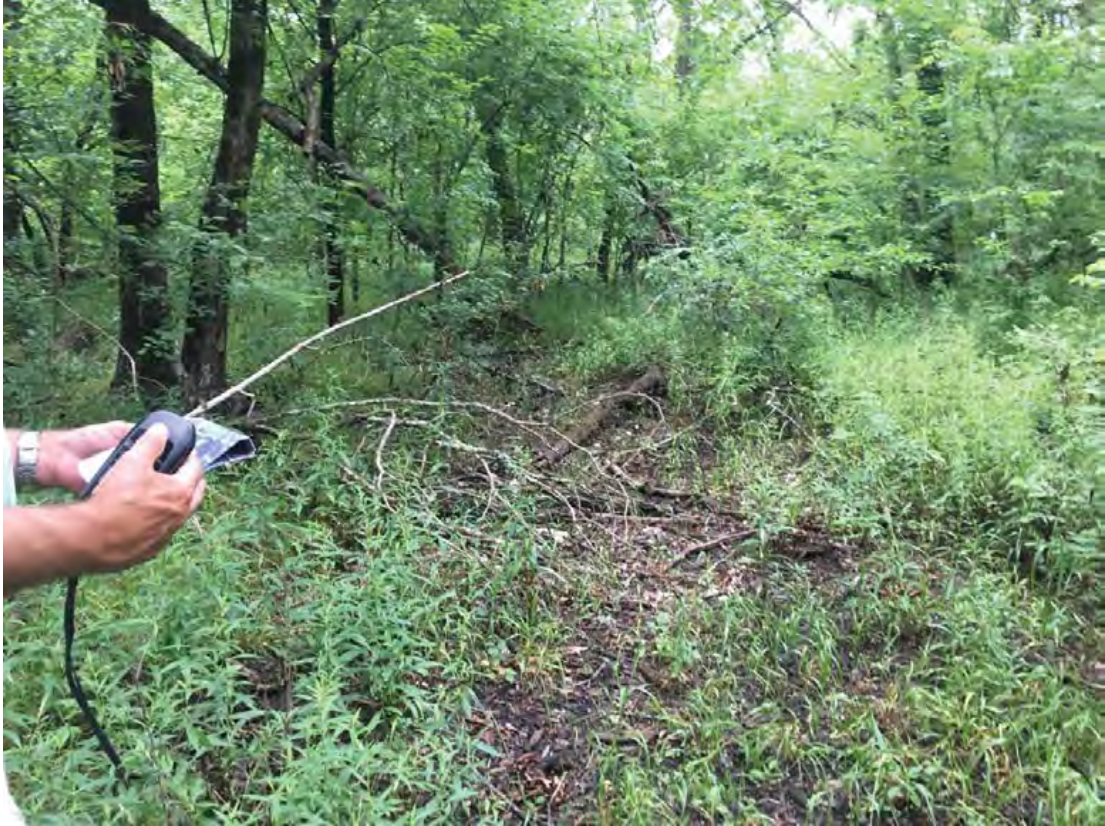
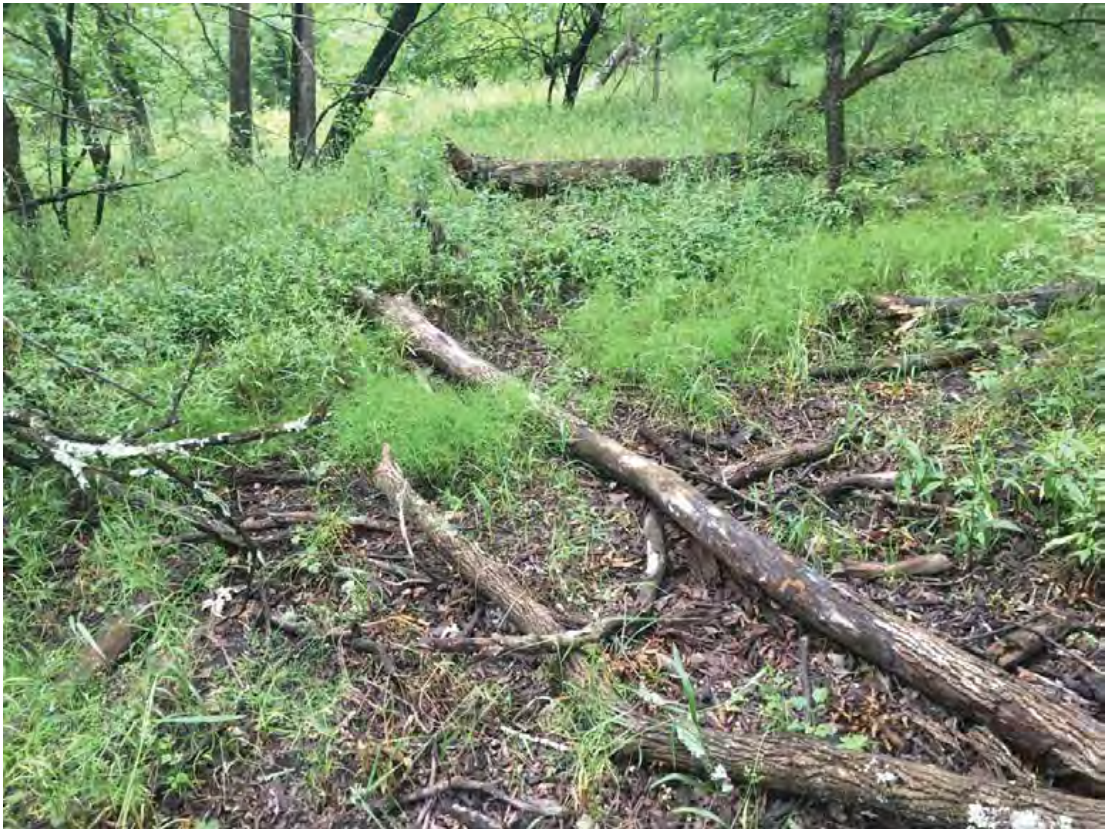
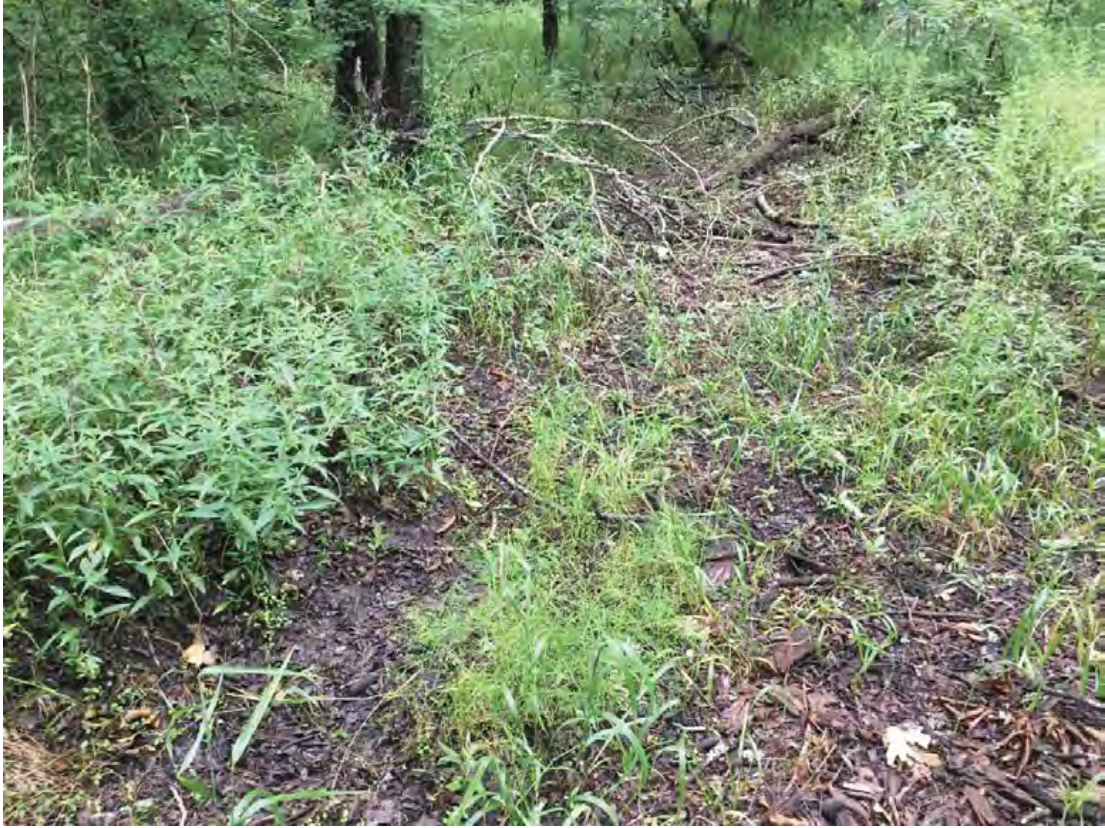
Project/Site: Lake Ralph Hall/Supplemental JD City/County: Ladonia/Fannin Sampling Date: 6/2/2017
 Applicant/Owner: Upper Trinity Regional Water District State: TX Sampling Point: WP6
 Investigator(s): Jason Voight, Andrew Sample Section, Township, Range: _____
 Landform (hillslope, terrace, etc.): Valley Local relief (concave, convex, none): Concave Slope (%): 0-1%
 Subregion (LRR): Southwest Prairies Lat: 33.45295 Long: -96.01133 Datum: NAD83
 Soil Map Unit Name: Tinn Clay, Occasionally Flooded NWI classification: none

Depth (inches)	Matrix		Redox Features				Texture	Remarks
	Color (moist)	%	Color (moist)	%	Type ¹	Loc ²		
0-2	10 YR 3/1	100					Clay	
2-18	10 YR 3/1	95	10 YR 5/4	5	C	M	Clay

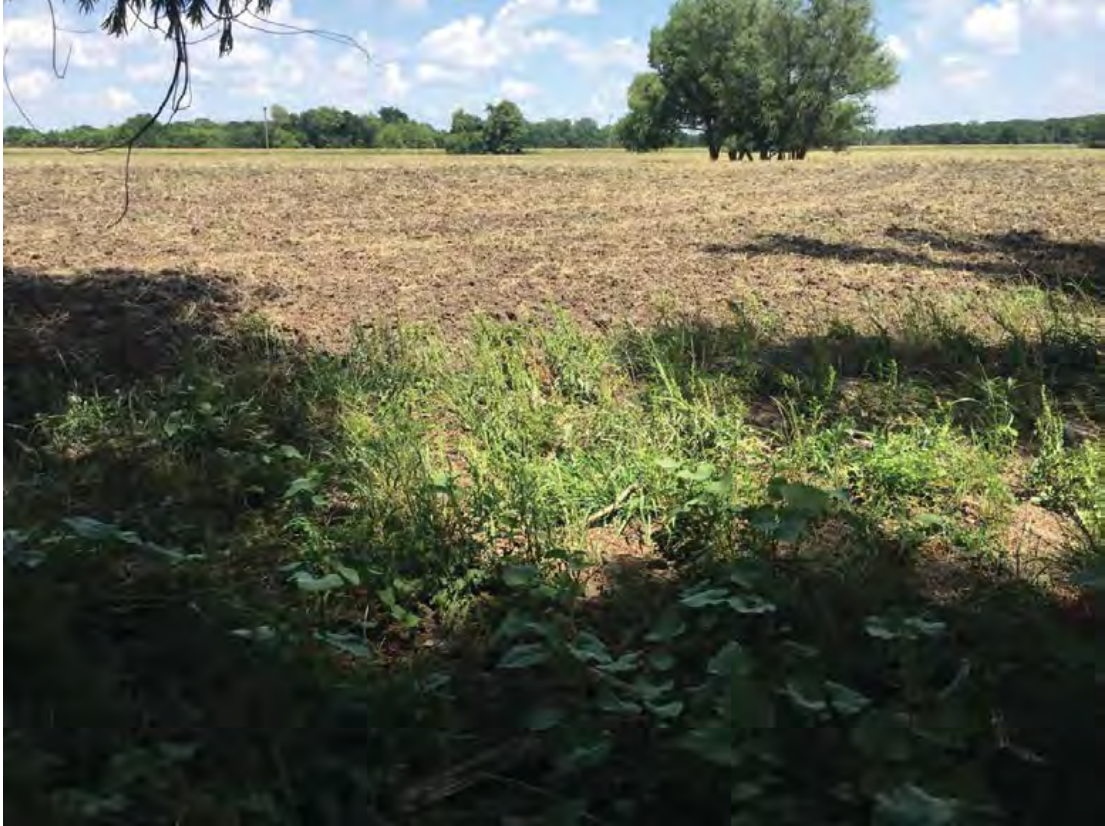
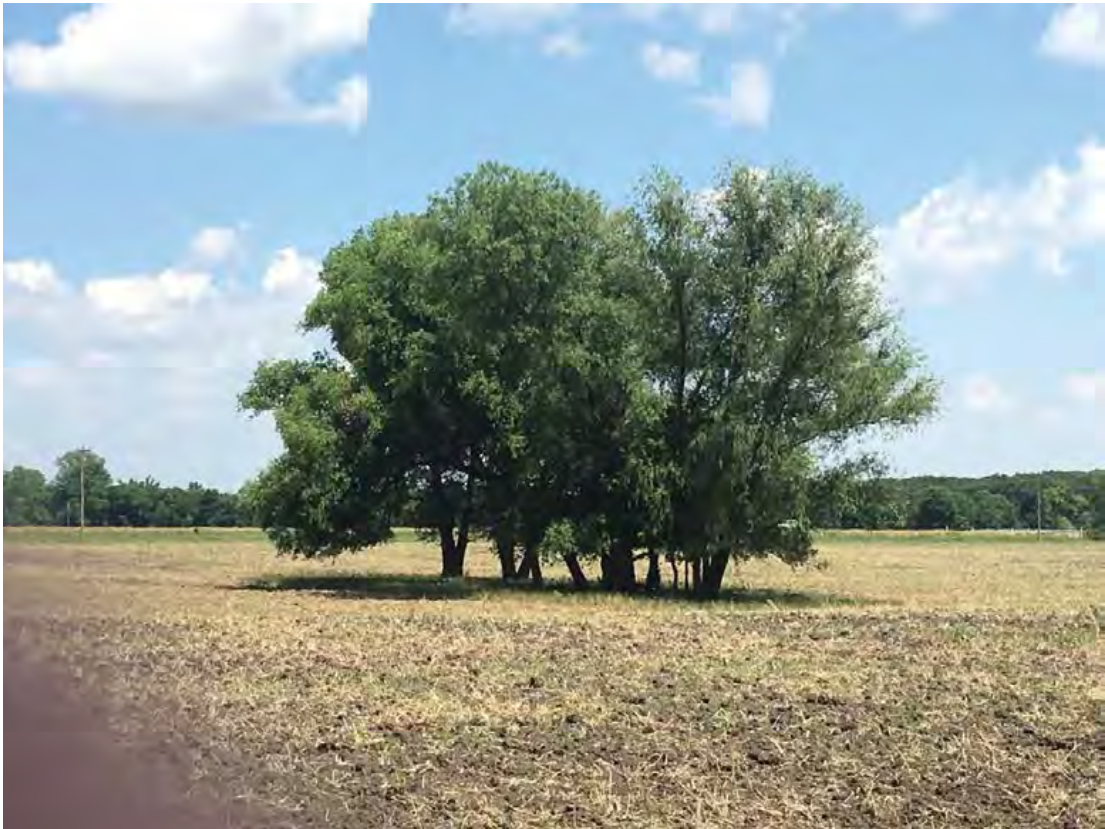
No redox features observed; Tinn clay, occasionally flooded is nationally listed hydric soil; naturally dark soil

Remnant former North Sulphur River channel west of SH 34; previously filled but still depressional

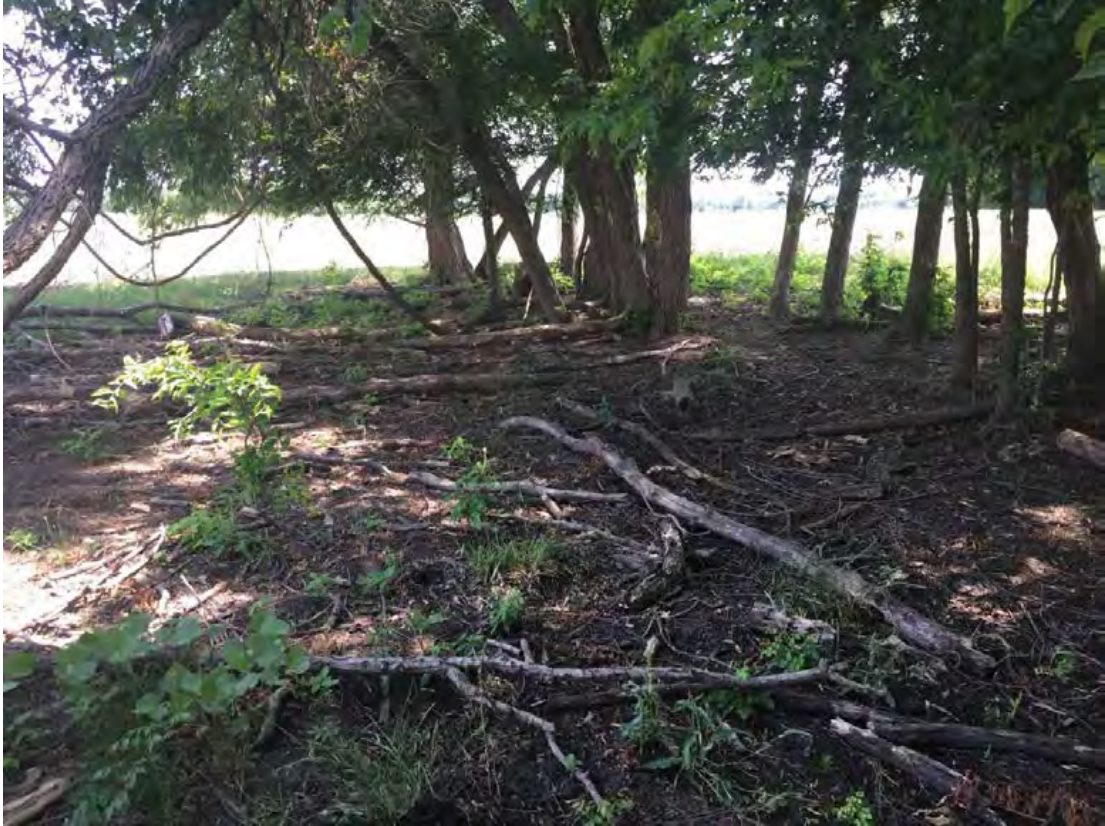
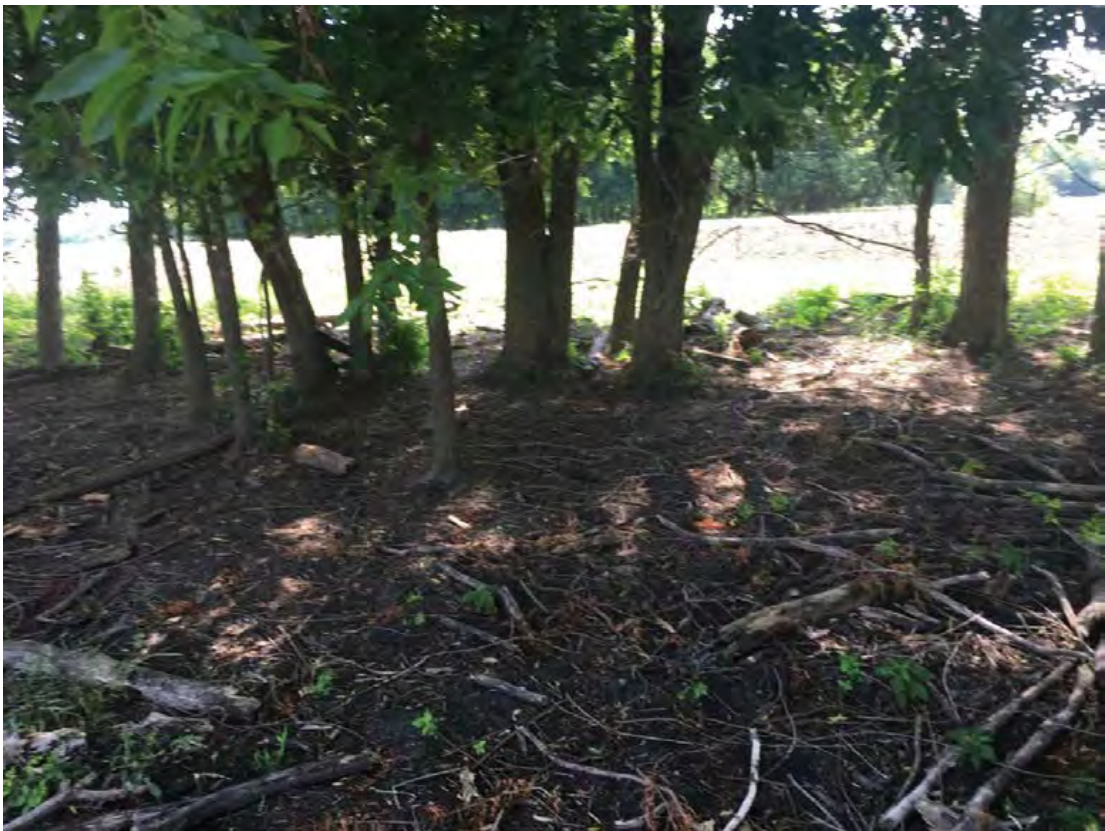
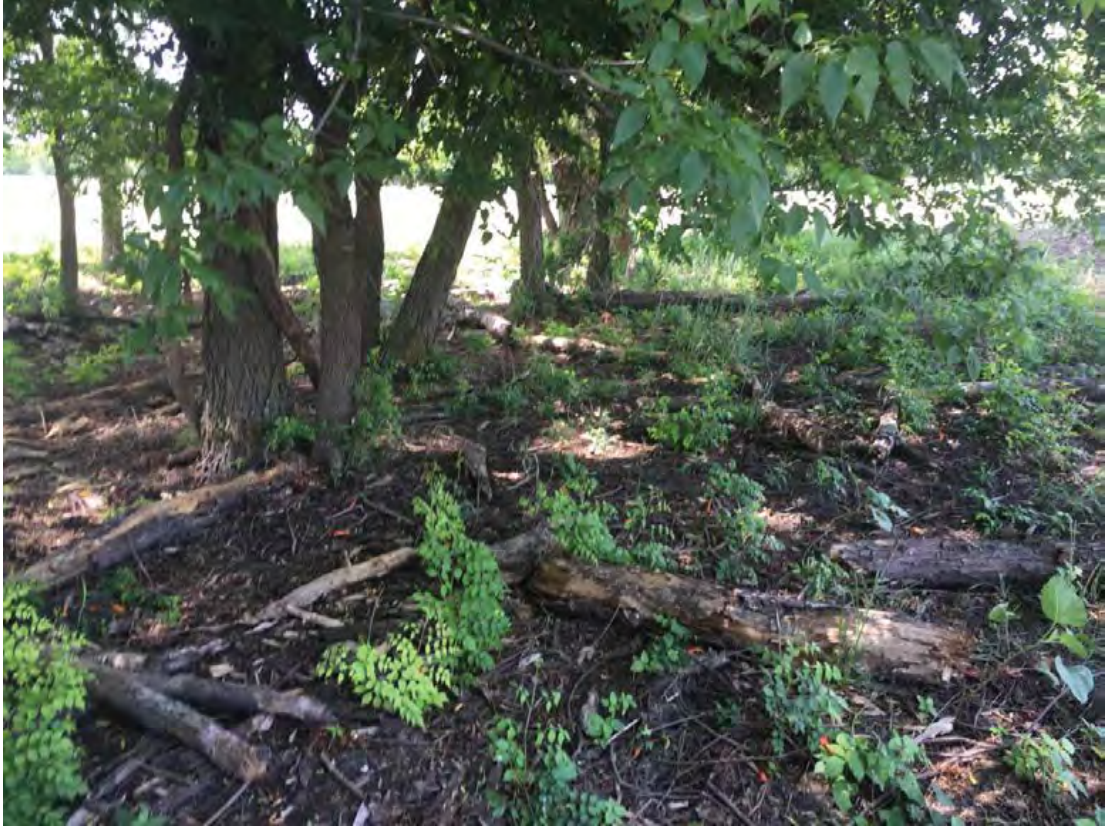
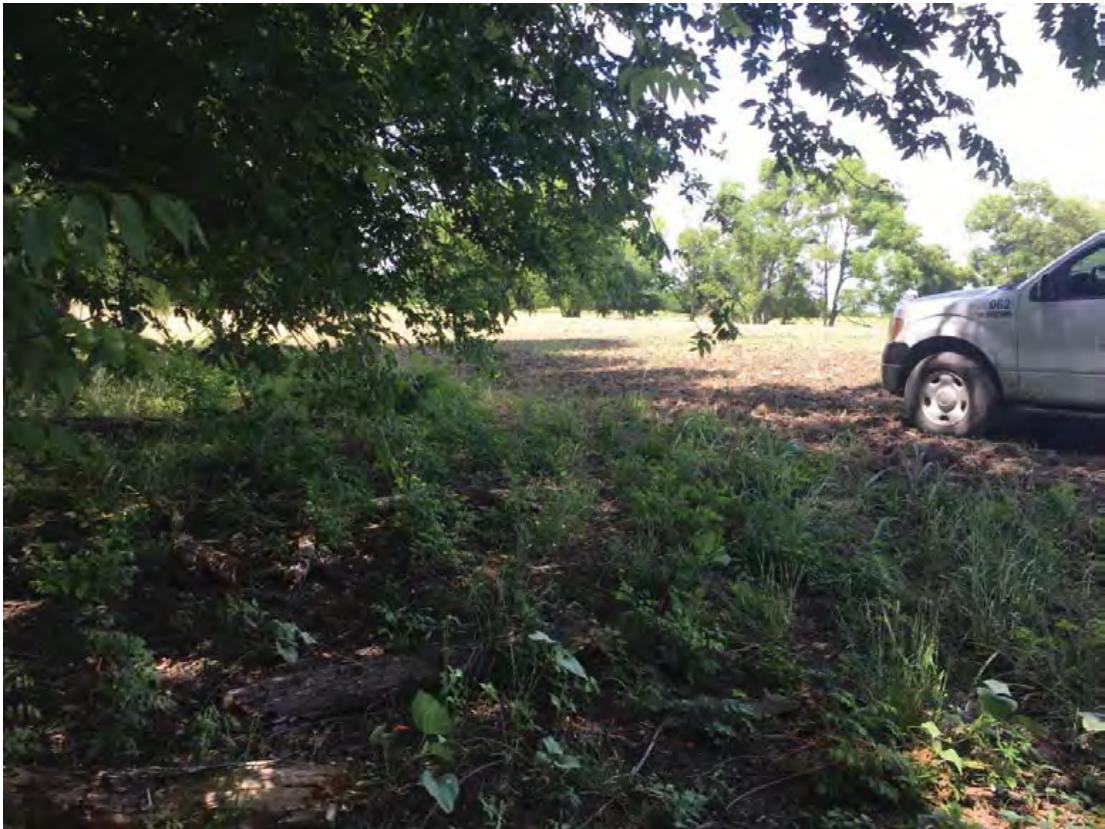
No redox features observed; Tinn clay, occasionally flooded is nationally listed hydric soil; naturally dark soil

Remnant former North Sulphur River channel west of SH 34; previously filled but still depressional

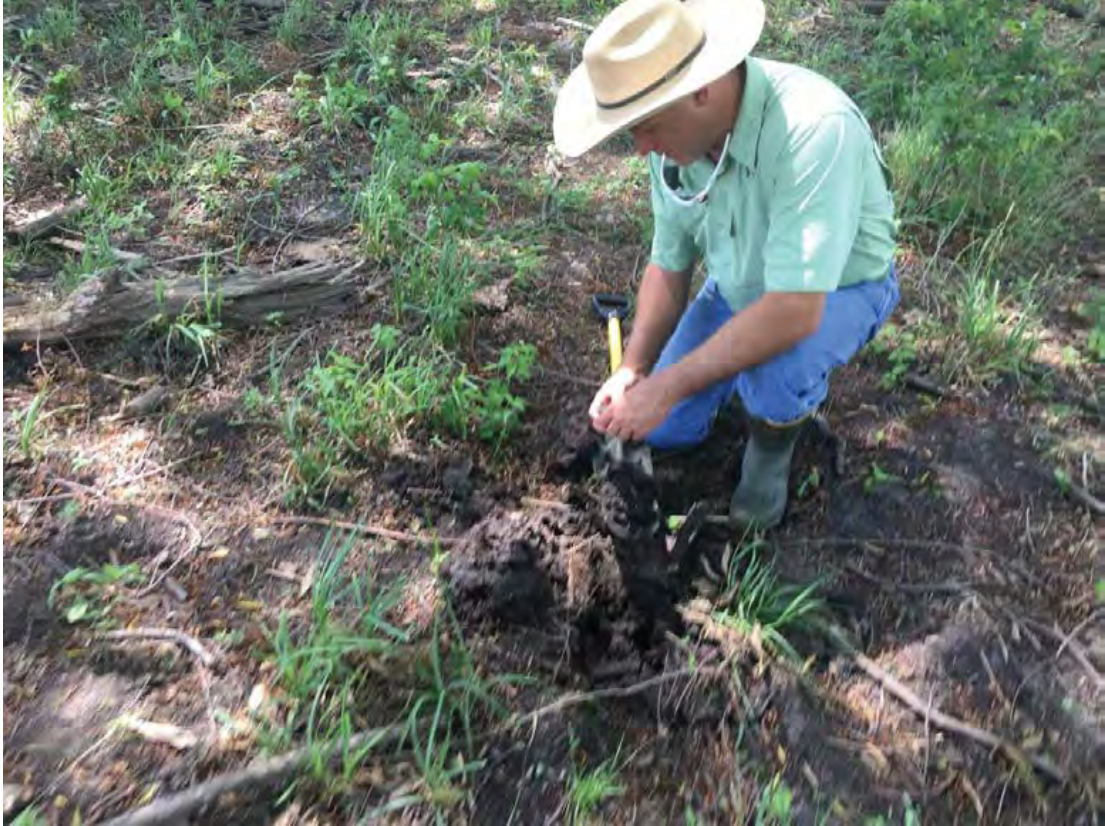
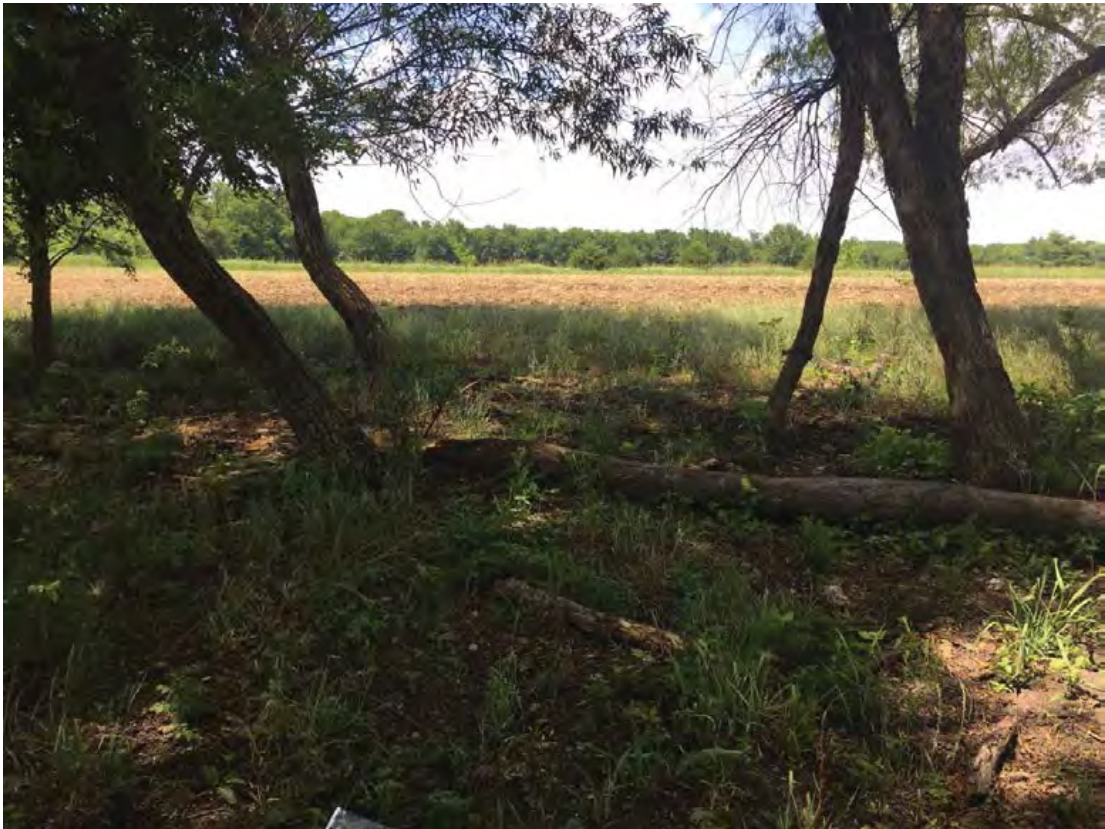
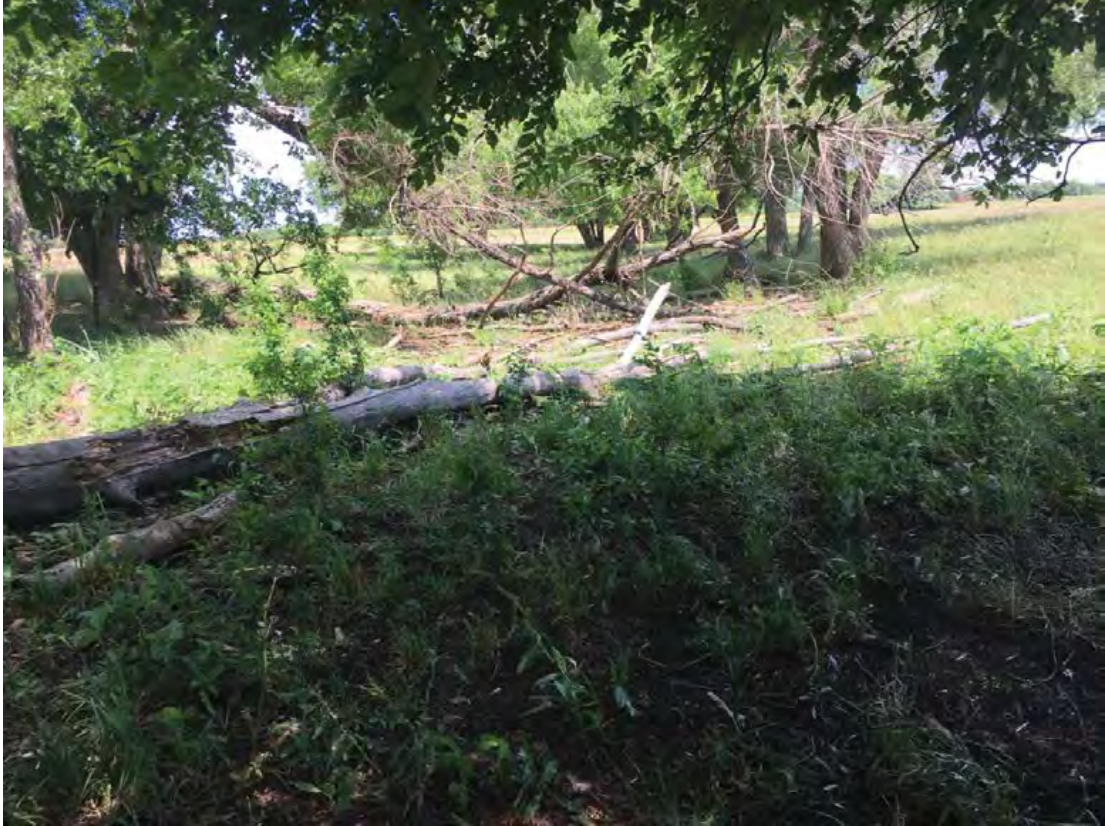
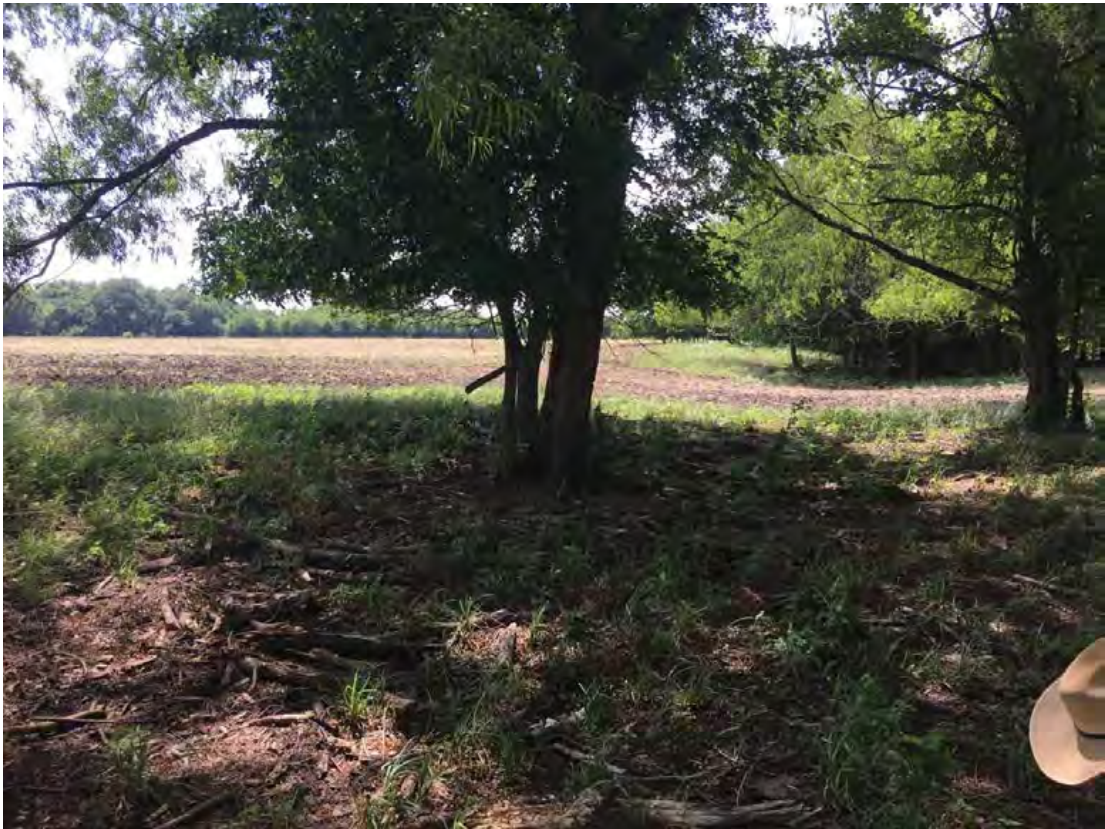
No redox features observed; Tinn clay, occasionally flooded is nationally listed hydric soil; naturally dark soil

Remnant former North Sulphur River channel west of SH 34; previously filled but still depressional
