**FIGURE 6: DELINEATED OPEN WATERS
PROPOSED LAKE RALPH HALL
SUPPLEMENTAL JURISDICTIONAL DETERMINATION**

USACE PROJECT NO.:
SWF-2003-00336

PREPARED BY:
ALAN PLUMMER ASSOC., INC.

WETLAND DETERMINATION DATA FORM – Great Plains Region

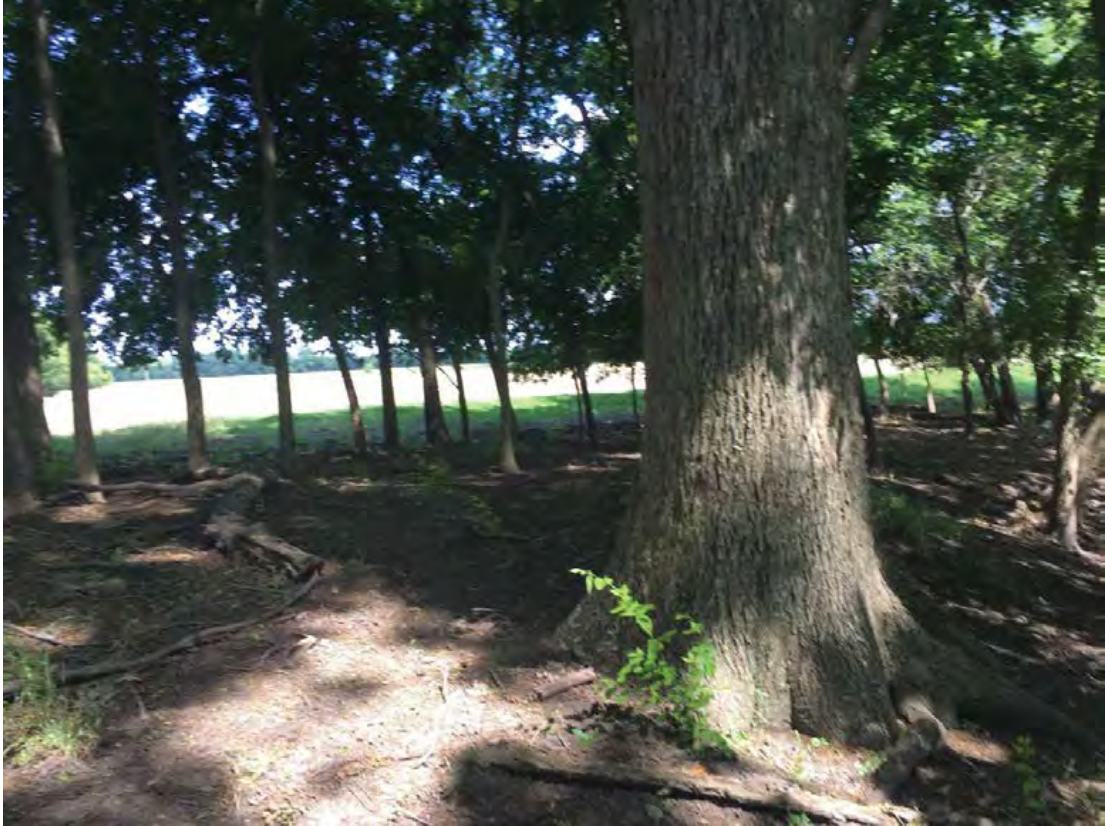
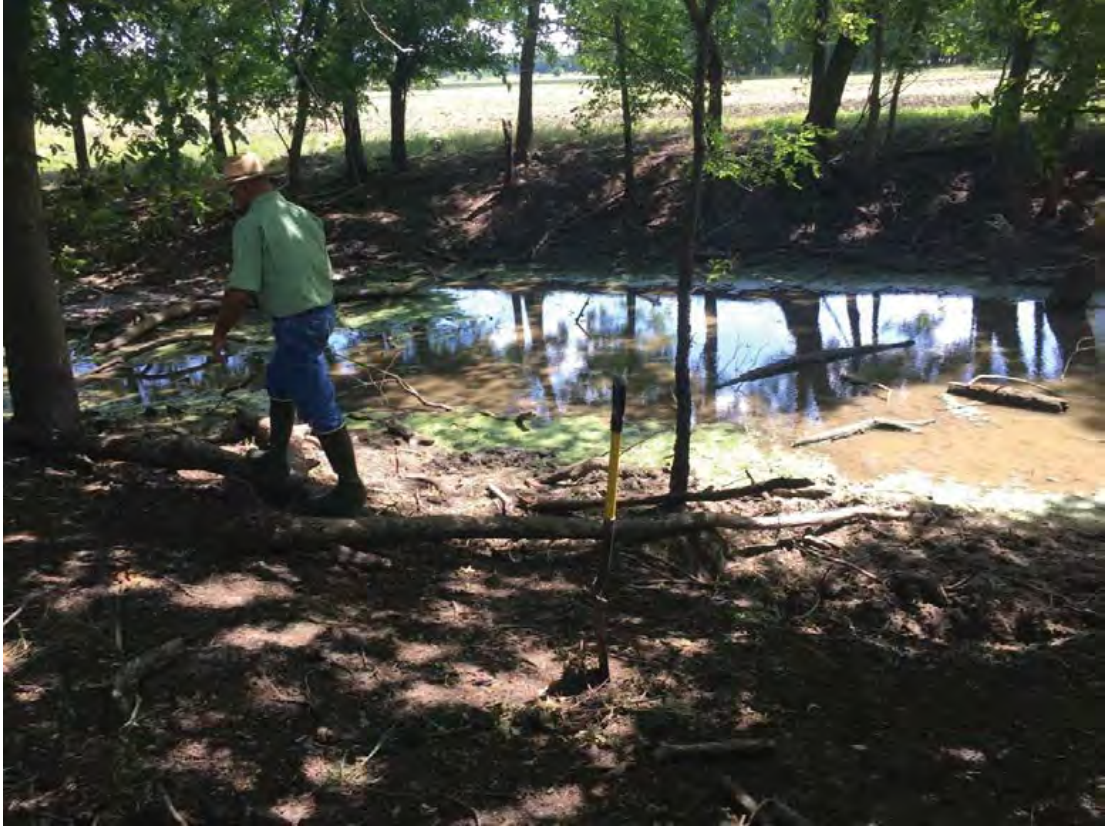
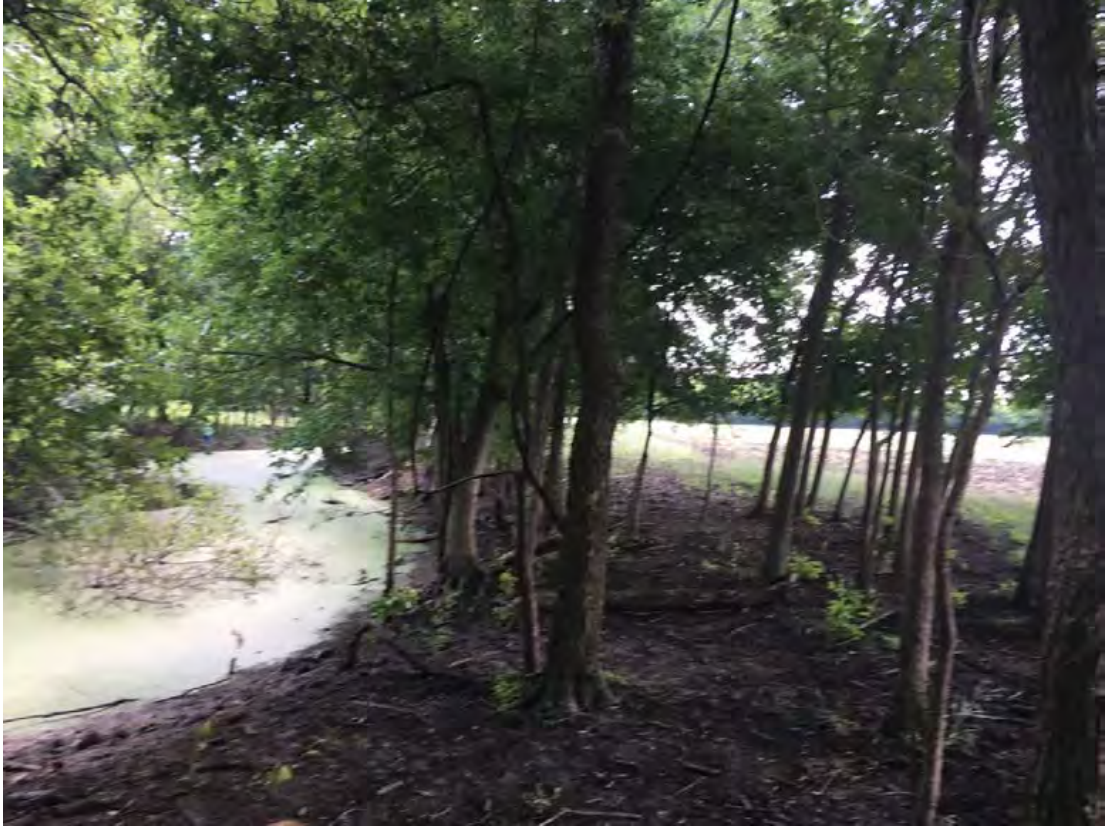
Outside edge of forested wetland within remnant former North Sulphur River channel west of SH 34

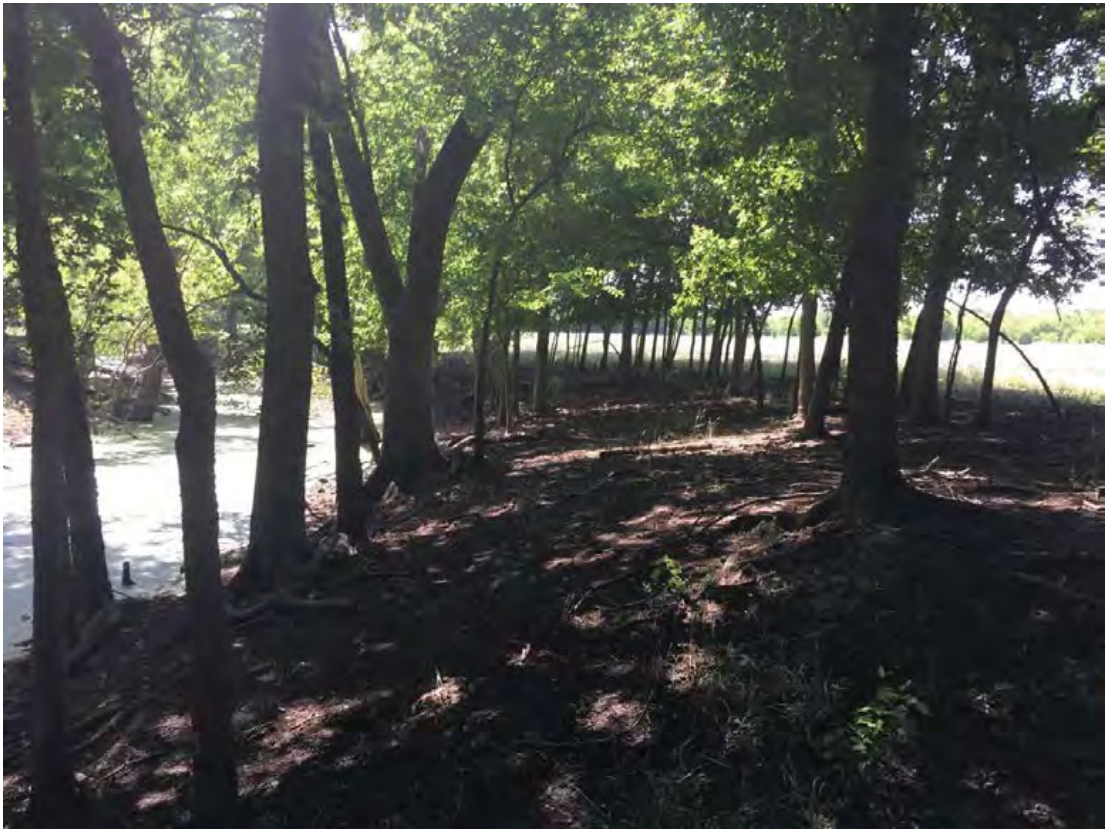
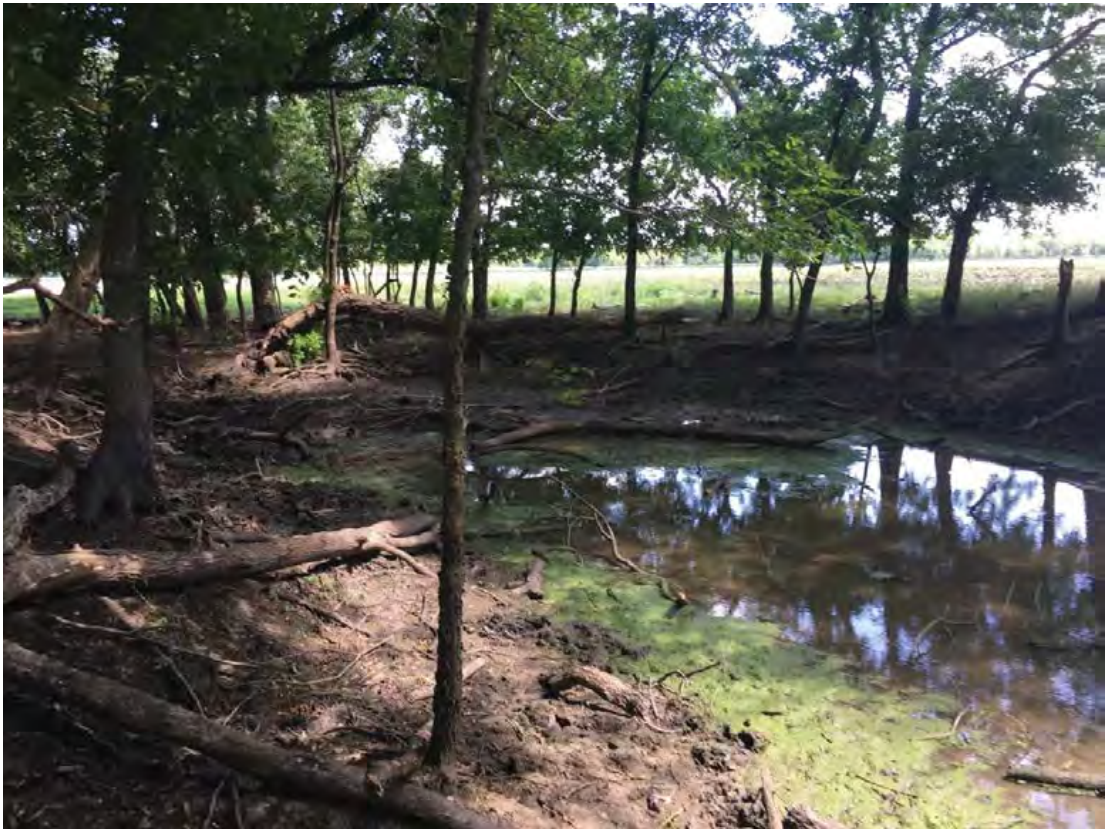
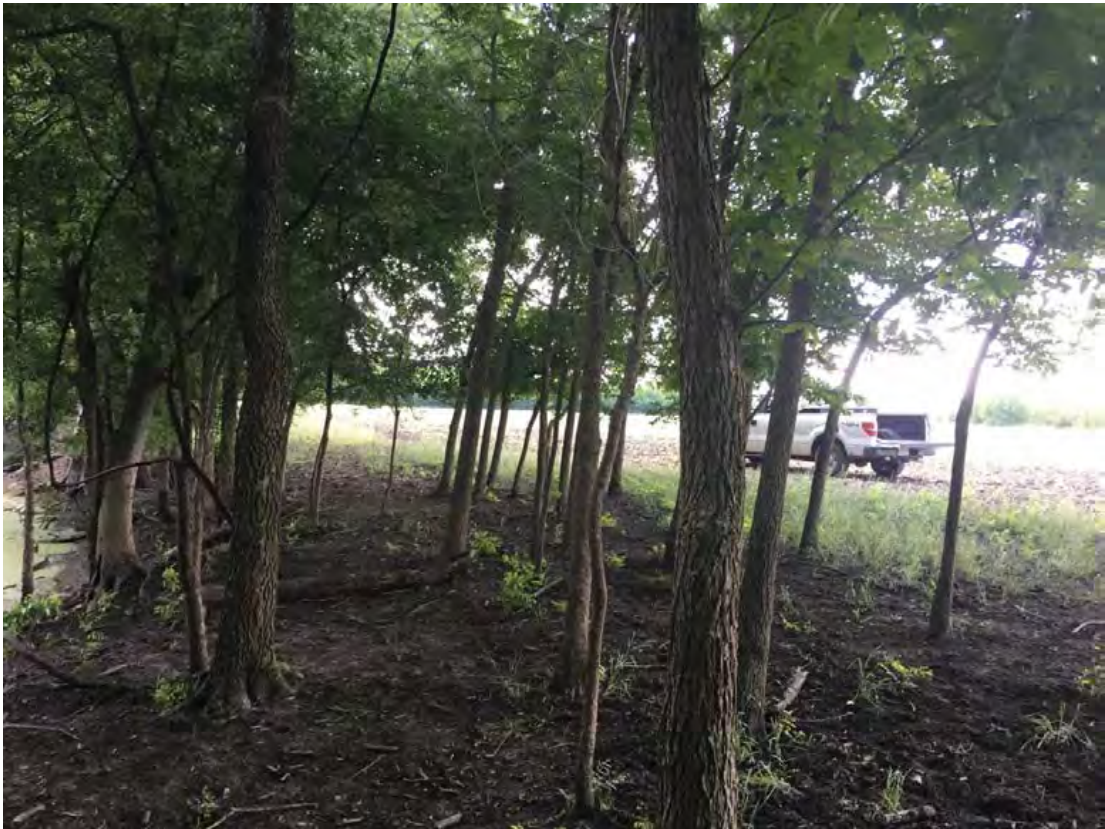
Insufficient redox features observed; Tinn clay, occasionally flooded is nationally listed hydric soil; naturally dark soil
