Public Notice

Applicant: Town of Flower Mound / Clay Riggs

Project No.: SWF-2019-00038

SUBJECT: Application for a Department of the Army Permit under Section 404 of the Clean Water Act (CWA) to discharge dredged or fill material into waters of the United States associated with the East Waketon Road Drainage Improvements Project located on property adjacent to and northeast of the intersection of Waketon Road and Long Prairie Road (FM 2499) in the Town of Flower Mound, Denton County, Texas.

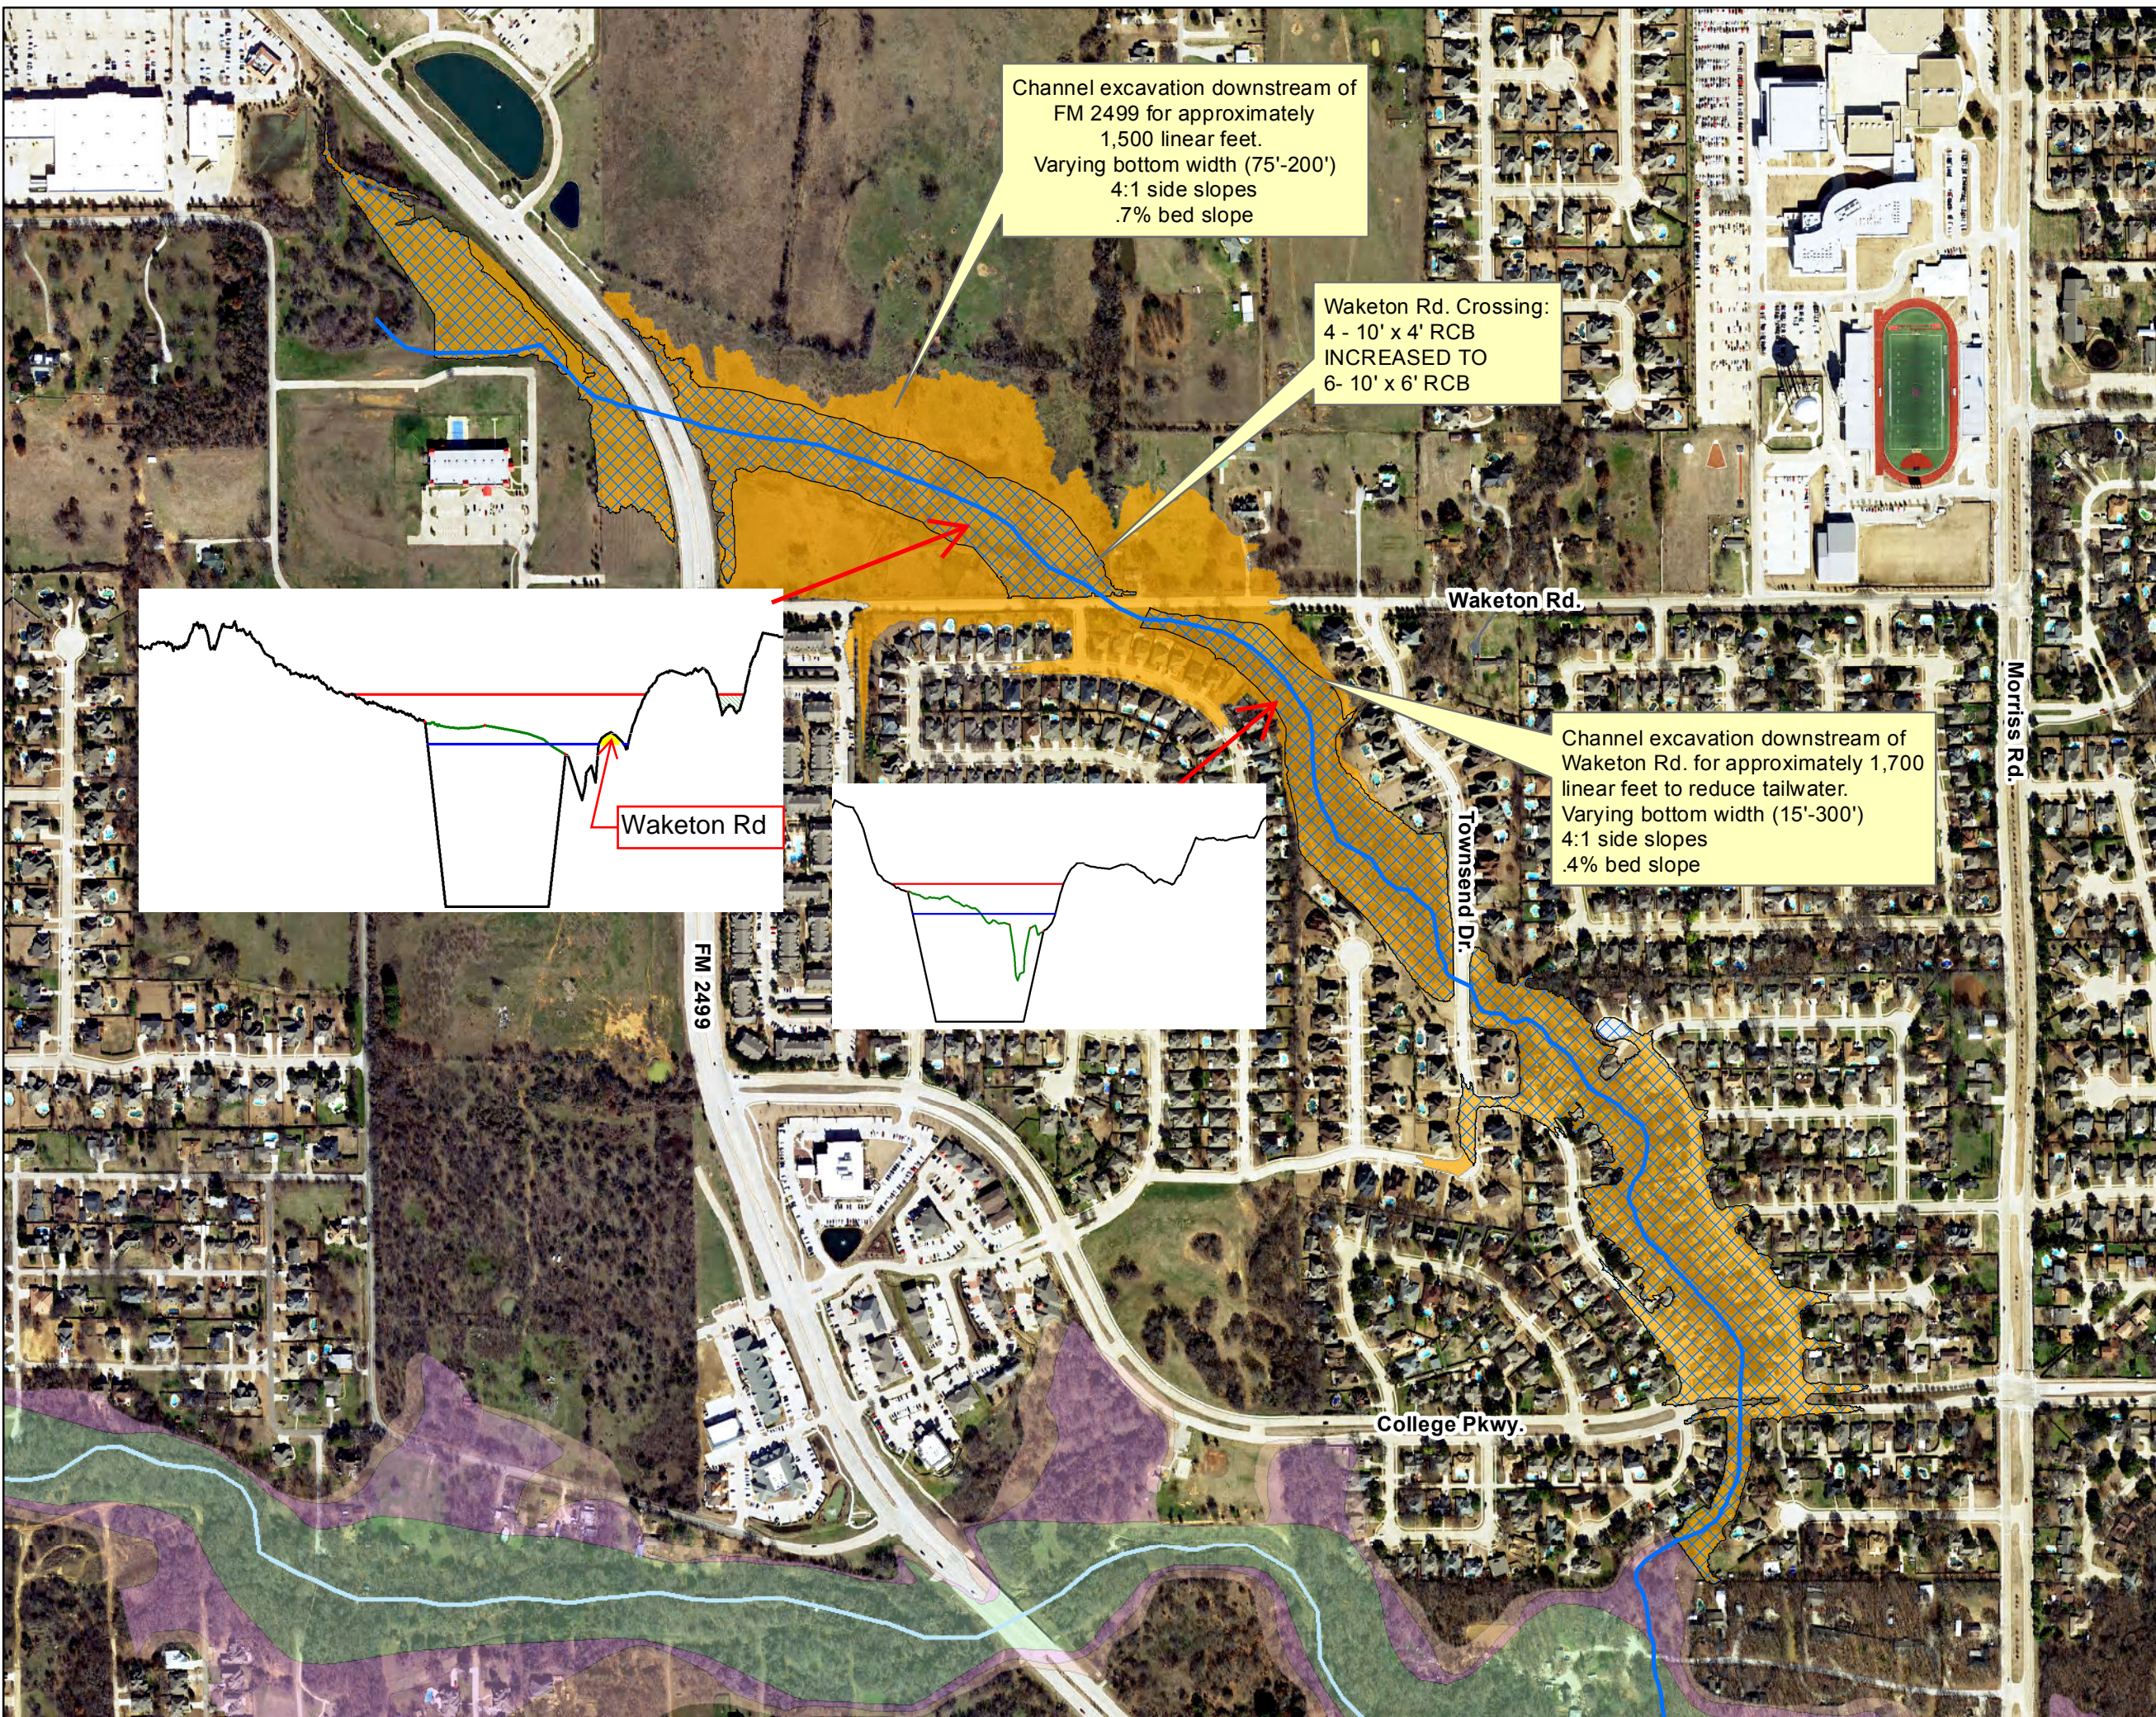
FIGURE F-5: Alternative #3

Channel excavation downstream of FM 2499 for approximately 1,500 linear feet.
Varying bottom width (75'-200')
4:1 side slopes
.7% bed slope

Waketon Rd. Crossing:
4 - 10' x 4' RCB
INCREASED TO
6- 10' x 6' RCB

Channel excavation downstream of Waketon Rd. for approximately 1,700 linear feet to reduce tailwater.
Varying bottom width (15'-300')
4:1 side slopes
.4% bed slope

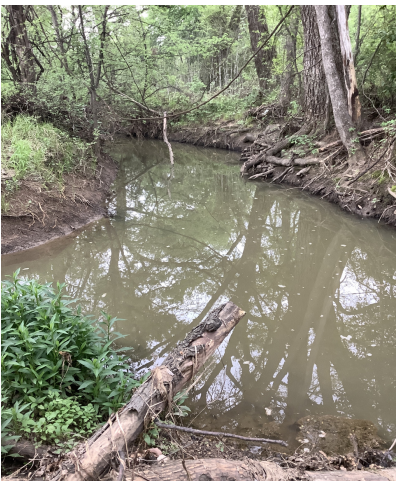
<p>Representative photo of IS-1.1 (SAR-1.1).</p>
---	--

Notes: SAR 1.1 begins at the point of transition between concrete-lined channel, and natural bed and bank. SAR 1.1 has natural bed and bank. Buffer size was slightly increased to accurately depict riparian zone condition.

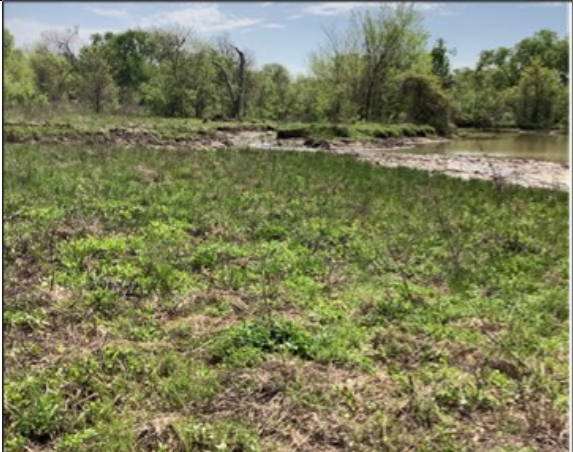
<p>View among the transition of the wetland complex (EW-1) to an open water (OW-3) feature within the complex. View facing southeast of the DP-4 location.</p>
---	--

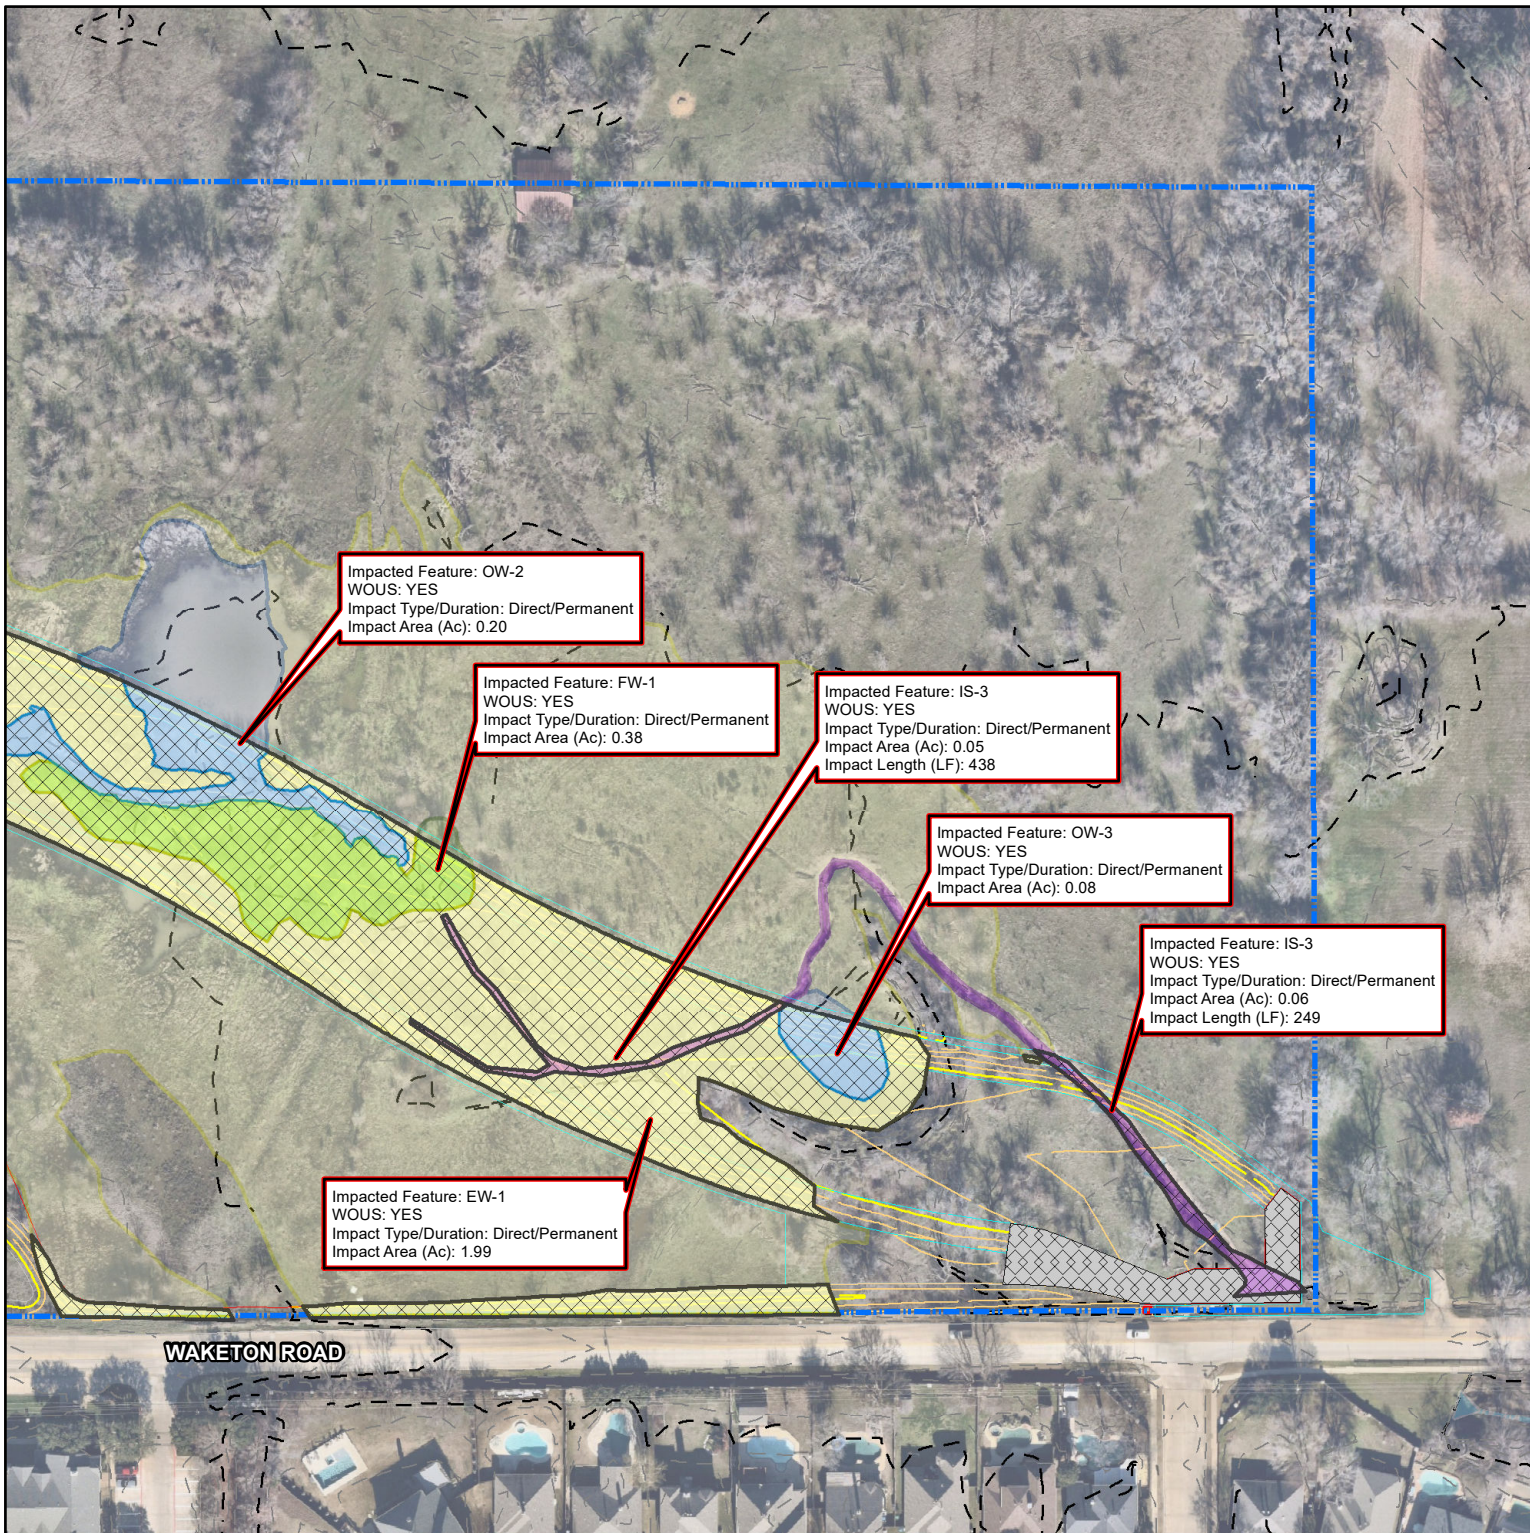
EAST WAKETON ROAD DRAINAGE IMPROVEMENTS PROJECT
Project Number: #SWF-2019-00038
Date: 03/2024 AVO: 35351
PROJECT IMPACT MAP
SHEET 5 OF 8

- STUDY AREA
- DRAINAGE DITCH
- EMERGENT WETLAND
- FORESTED WETLAND
- OPEN WATER
- INTERMITTENT STREAM
- IMPACTS TO AQUATIC FEATURES
- EXISTING MAJOR CONTOUR
- EXISTING MINOR CONTOUR
- Design Data**
- ROCK RIPRAP
- PROPOSED MAJOR CONTOUR
- PROPOSED MINOR CONTOUR

ADVERSE IMPACTS OF THE PROPOSED PROJECT: The proposed project will result in the discharge of fill material through excavation, permanently impacting 2.37 acres of emergent and forested wetland and 1.07 acres of open water. Approximately 687 linear feet of a man-made drainage will be reconfigured by the proposed project.
