14 January 2016

RE: Cultural Resources Survey and Mitigation of Adverse Effects for a USACE Section 408 Request for the Left Bank Development, City of Fort Worth, Tarrant County, Texas

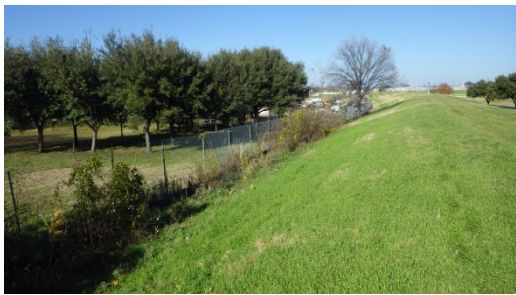
Table 3: Standing Structures within the Direct APE

The footprint of the direct APE was primarily comprised of the sloping, grass-covered surface of a levee pertaining to the TRFCS, which is a historic-aged structure. The property's design characteristics are summarized in **Table 3**. For complete Historic American Building Survey (HABS) equivalent architectural documentation see **Attachment D**. Remaining portions of the APE were located within the footprint of previously demolished buildings and lots that had been recently modified for commercial development.

Property Identification Number	Property Location/Address	Construction Date/Architectural Elements	National Register Status	Photograph of Resource
1	Between the 2100 block of West 7 th Street and the 2100 block of Dakota Street west of the CFTR	c. 1952-1956, part of TRFCS, elements consisted of grass covered earthen levee	Eligible

- 1) **Property 1 (TRFCS)** – The portion of the TRFCS levee within APE was constructed between 1952 and 1956 and was comprised of a grass covered levee. The TRFCS was the first undertaking of the USACE SWF to control the floodwaters of the WFTR and CFTR, which, in turn, had a significant effect on the growth and safety of Fort Worth and its design and construction are characteristic of the period. Past research and SHPO consultation determined the TRFCS is eligible for listing on the NRHP under Criteria A and C.

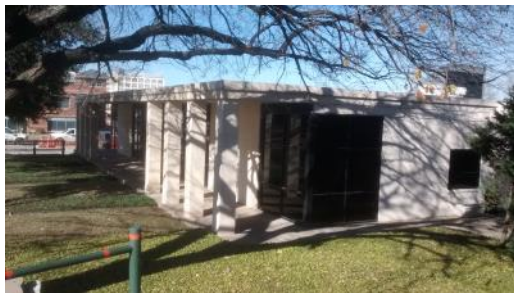
Table 4: Standing Structures within the Indirect APE

The limits of the indirect APE were field verified to ensure that no properties outside this distance could be adversely affected (**Attachment C**). Through the indirect APE survey, one historic-aged property was identified. The property's design characteristics are summarized below in **Table 4** and deed chain of title records are within **Table 5**. The vast majority of the indirect APE was located within areas under construction or within the active CFTR floodway. There were several modern commercial buildings within the indirect APE; however, these structures were not assessed for potential NRHP eligibility as there was low potential any of these properties had achieved historical importance since their construction (36 CFR 60.4[g]).

Property Identification Number	Property Location/Address	Construction Date/Architectural Elements	National Register Status	Photograph of Resource
2	2100 West 7 th Street	c. 1960, single story commercial building, load bearing masonry, flat roof, brick veneer, symmetrical and asymmetrical windows, split colonnade	Not Eligible

- 1) **Property 2 (2100 West 7th Street)** – The property lacked distinctive characteristics of a significant architectural style and was not associated with events that have made a significant contribution to the broad patterns of our history or with the lives of persons significant in our past. As such, the property was not considered eligible for listing under Criteria A, B, or C.

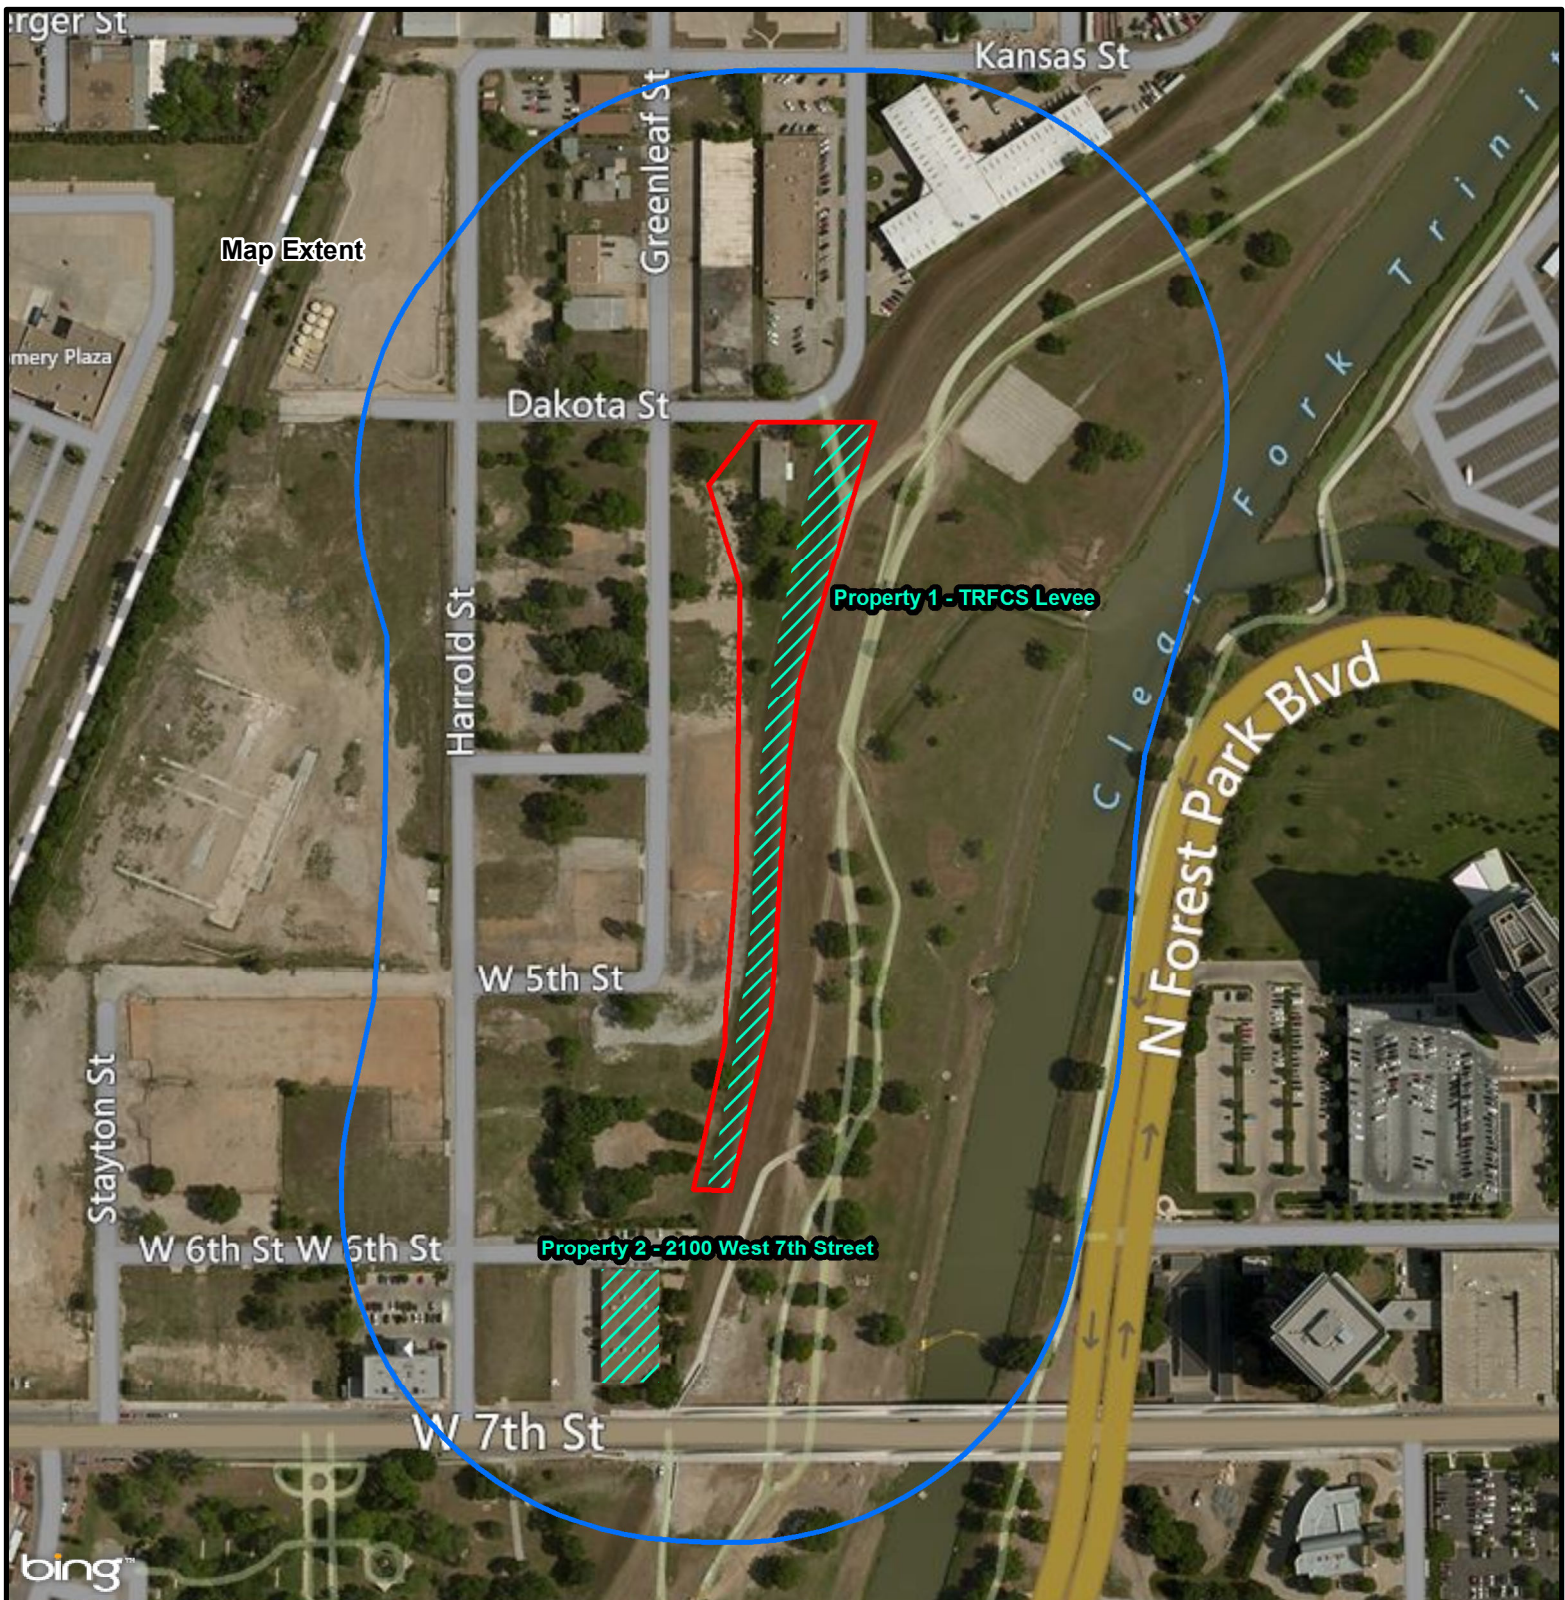
Figure 4
Property Identification Map

During the survey, the existing conditions of each of the previously identified historic-period building/structures were assessed. The survey transpired between the 2100 block of West 7th Street and the 2100 block of Dakota Street. One historic-aged structure was identified during the survey within the direct APE, which pertained to the TRFCS, and one historic-aged building was identified within the indirect APE (**Attachment A, Figure 4**).

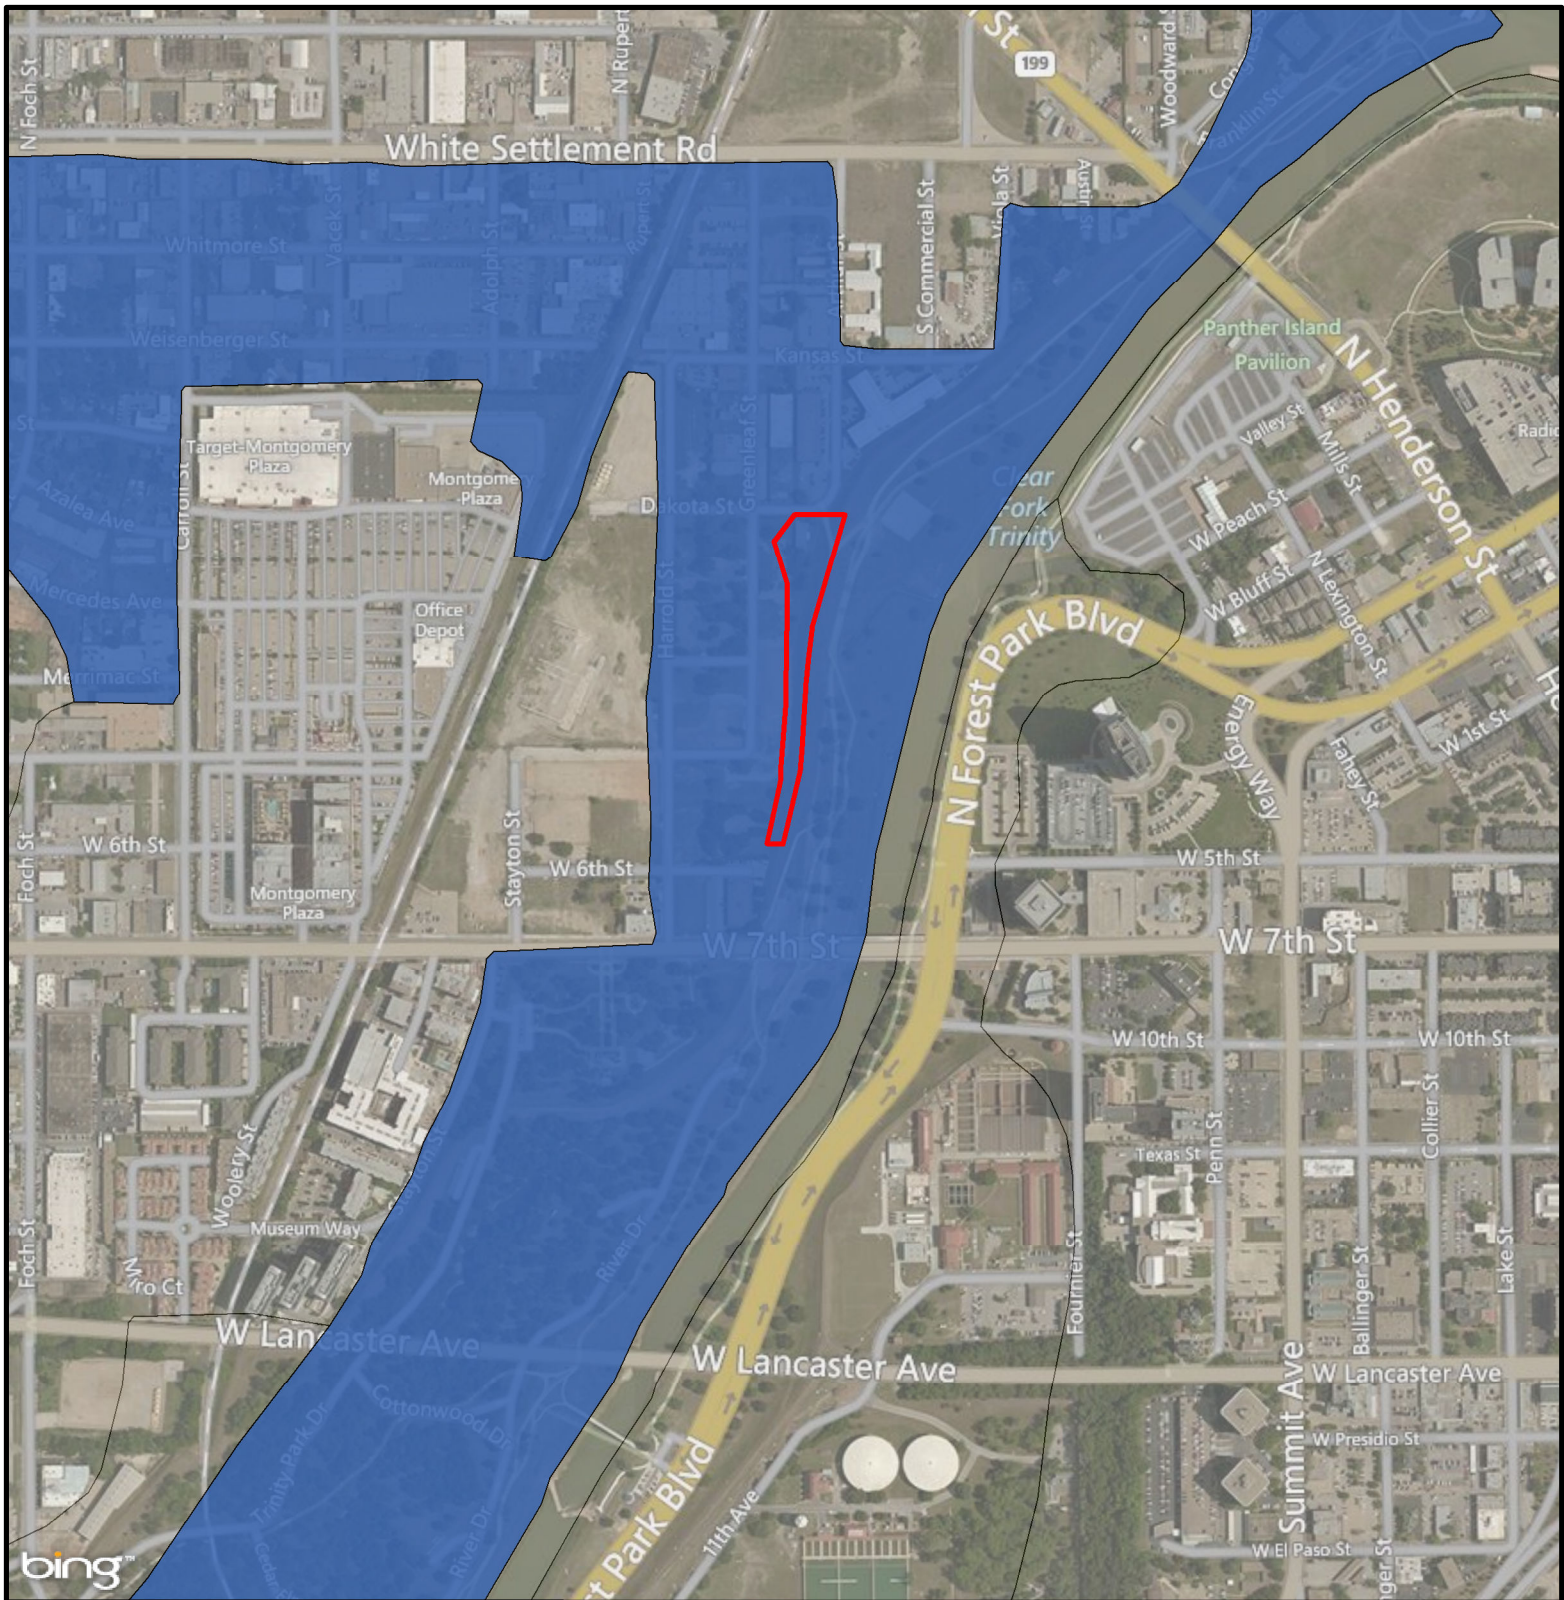
Figure 3
Soils Map

As shown by the *Soil Survey of Tarrant County, Texas*, the APE contains one mapped soil consisting of Frio-Urban land complex, occasionally flooded. This soil is characterized by well drained, silty clay soils located on floodplains derived from mixed source of loamy, Holocene-aged alluvium (Ressel 1981, Web Soil Survey 2015) (**Attachment A, Figure 3**). The Quaternary-aged alluvial soils in this area are underlain by the undivided Cretaceous-aged Washita group comprised of Pawpaw Formation, Weno Limestone, Denton Clay, Fort Worth Limestone, and Duck Creek Formation (McGowen et al. 1966). The Washita group is comprised of alternating beds of limestone and marl, with sandy matrices nearer the top (Baker 1960).
