WESTSIDE CREEKS ECOSYSTEM RESTORATION

Appendix G: Hazardous, Toxic and Radioactive Waste

HAZARDOUS, TOXIC AND RADIOACTIVE WASTE TECHNICAL APPENDIX

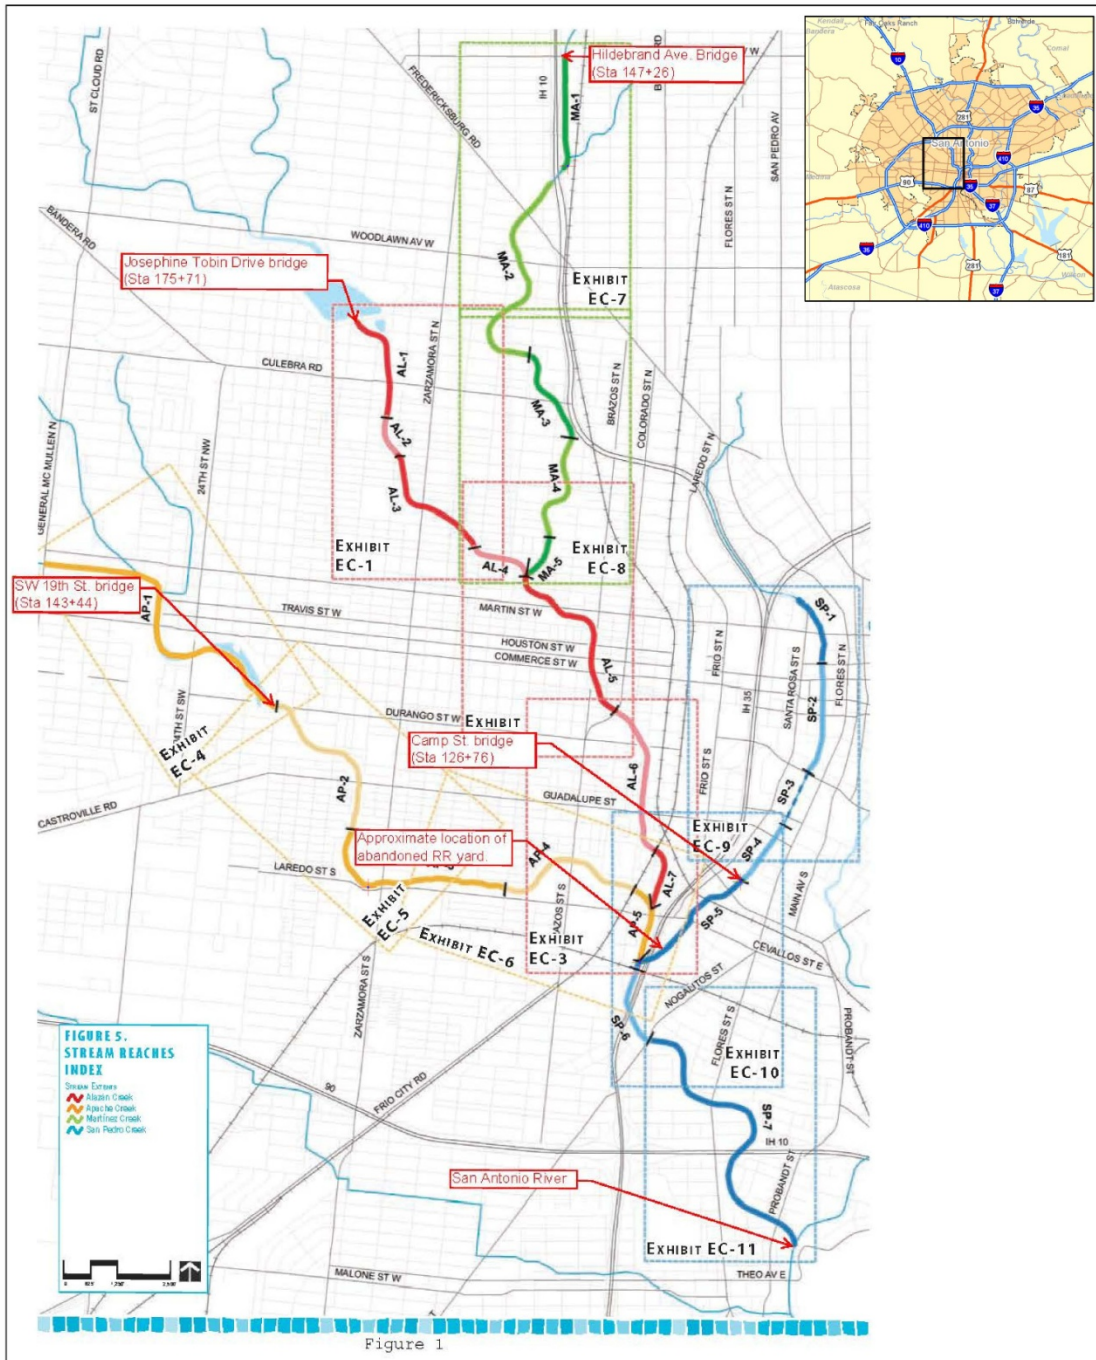
The ESA addressed the following WSC areas, see Figure 1:

Figure 1. Westside Creeks Ecosystem Restoration HTRW Area

San Pedro Creek. The PDT observed a REC on an adjacent property with potential to migrate into the project area, and historical records searched indicated environmental concerns for the subject property. Figure 1 shows the approximate location of this site. Since the WSC project construction will not disturb the east creek bank in the vicinity of the Sloan Market Yard site additional assessment is not recommended.

However, if future activities will disturb the east creek bank it is recommended that an additional assessment for hazardous and toxic substances or waste be conducted focused on characterizing any materials that would be disturbed by such activities. This additional assessment, if required, should focus on soils and potential for affecting impacts from contaminated groundwater (if any) to the stream that might be affected by the activities.
