PART I  
RISK ASSESSMENT  
TRINITY RIVER CORRIDOR

# Risk Assessment

## Trinity River Corridor Dallas Floodway near Dallas, TX

*7 September 2012*

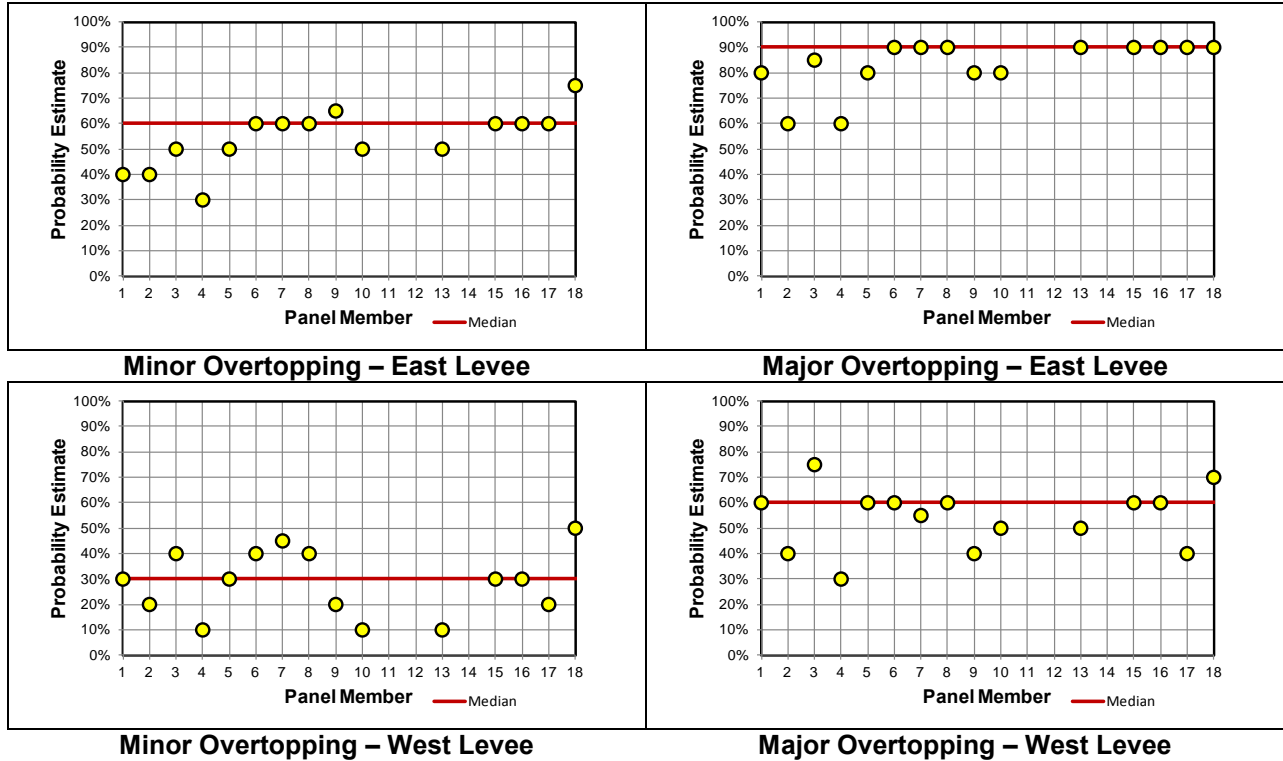
The team discussed adverse and favorable factors related to this node. The clay embankment material is generally erosion resistant, but Johnson grass clumps and desiccation cracks could create nick points for headcutting erosion. In the end, the team focused on the depth and duration of overtopping, both being fairly small for the West Levee and lower flood load range, and both being fairly large for the East Levee and higher flood load range. The estimates generally ranged from generally unlikely for the former to generally likely for the latter, with conditions in between being more uncertain.

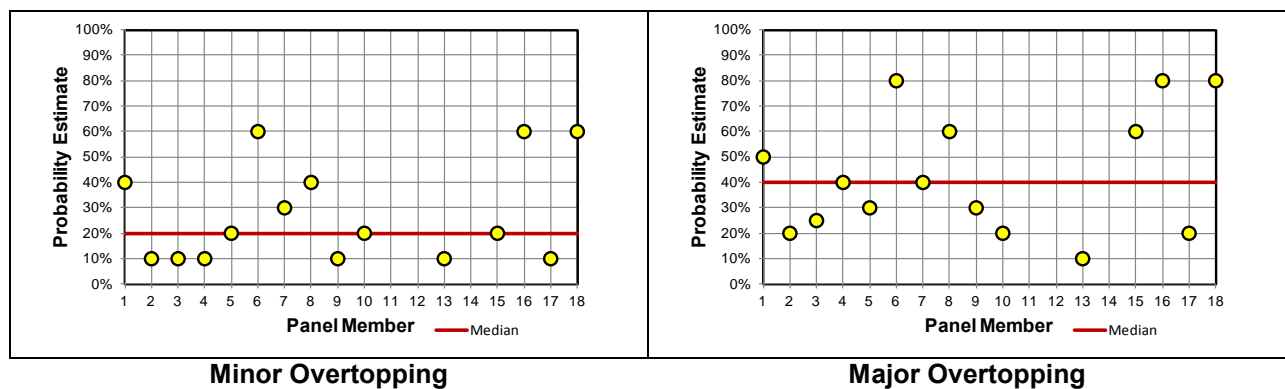
Dumping of large rip-rap stone on the protected side toe of the wall would likely be an effective mitigation strategy to prevent failure by undermining erosion. Nevertheless, the possibility that a large local thunderstorm could move in quickly and overtop the wall before intervention could be taken led to a fair amount of uncertainty in the estimates, especially at the higher flood loading, as summarized in the following table.

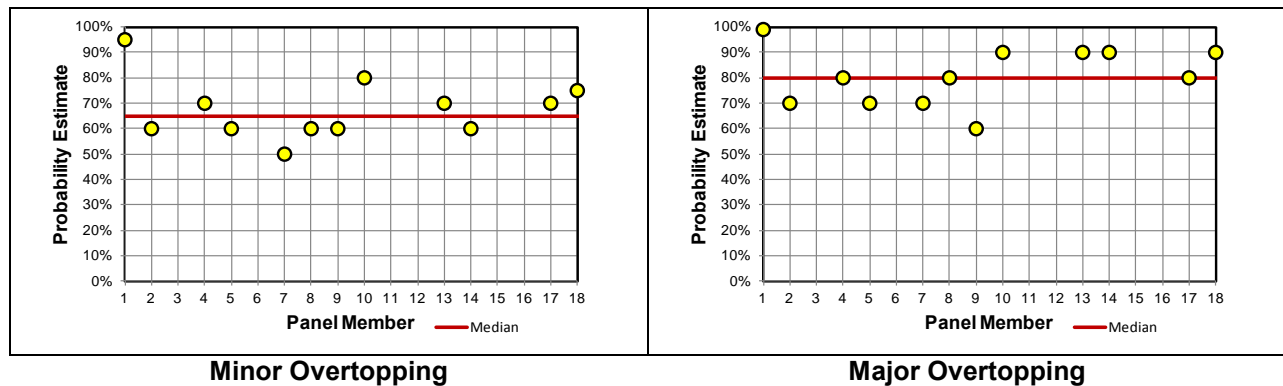
Although a layer of somewhat erosion resistant clay overlies the toe of the wall on the protected side, the team was not confident the wall would survive overtopping of the depths and durations considered, especially at the higher overtopping flows. The main factors contributing to this assessments were related to the wall footing and key which are skewed to the river side, and thus not in a good location to resist erosion. In addition, it was doubtful any sort of tailwater would build up as it would be more likely to flow into the sump away from the wall.

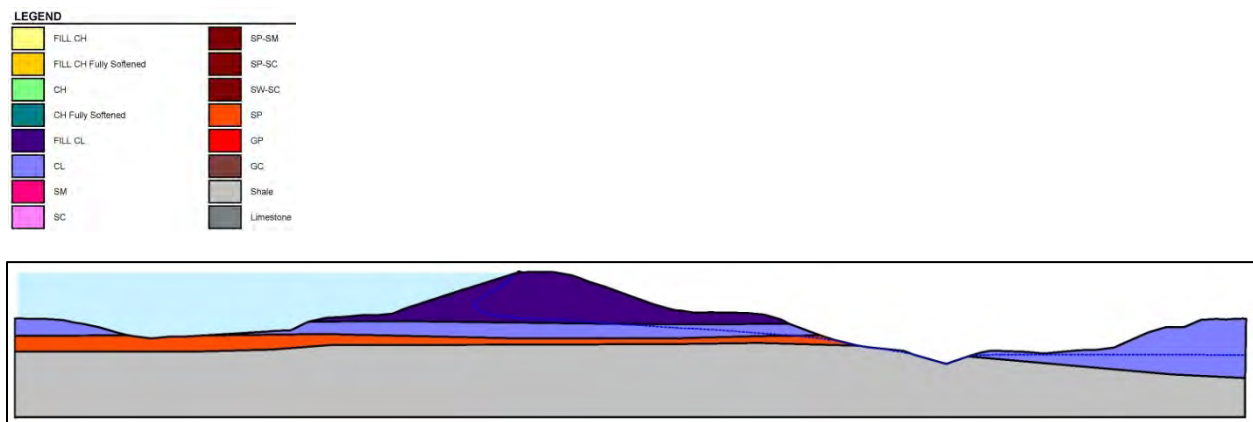
Figure 9 - Levee Section

The team determined that the most likely location for internal erosion to occur is where the basal sand layer exits on a free face on the land side, as interpreted by borings. This will occur in the area having the shortest seepage path and shallowest sand layer elevation, likely in the leveed side sump. Other that have variations in the elevation of the basal sand layer and distance to the river areas would likely have significantly lower risks.

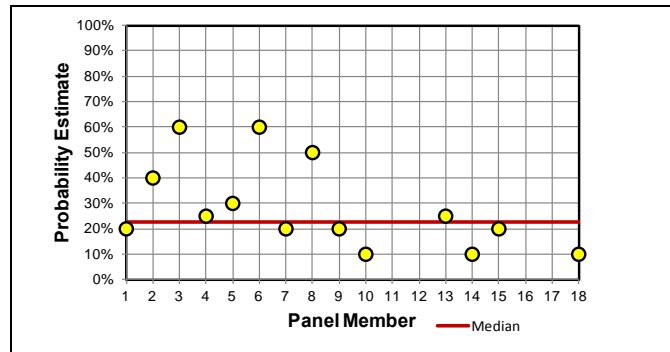
Continuous Sand Layer

Continuity might be more likely where gravel pits were developed and in the location of historical river crossings. The boring logs indicate a clean sand layer may include gravels and clays. Nearby piezometers indicate little response to the river stage. The team determined that continuity was unlikely in the section examined.

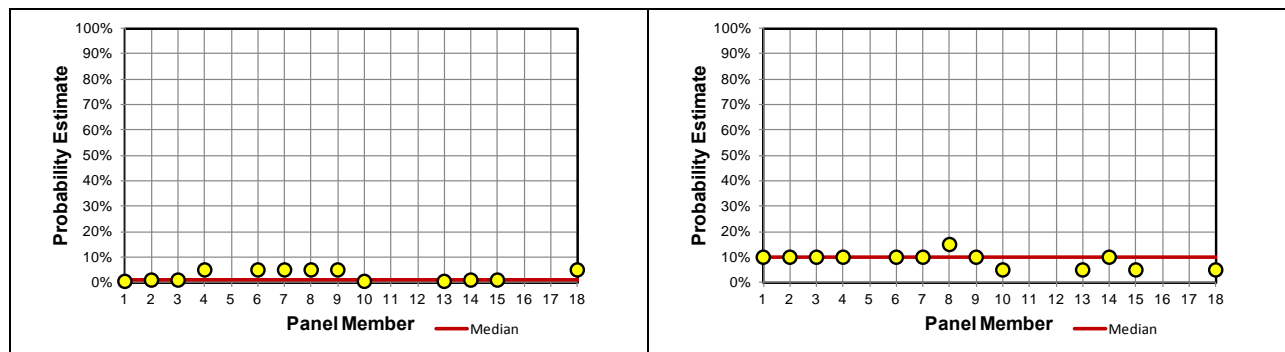
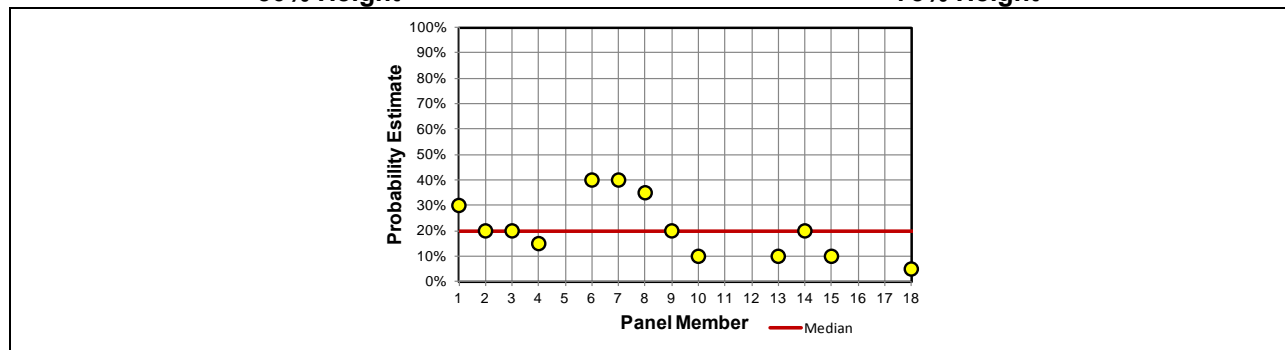
The maximum gradient was calculated at 0.12. The presence of a terrace deposit could result in finer sands being on top of the layer which would be more erodible. However, the sand in the location of study is likely coarse. The critical gradient is 0.6, which is still higher than the calculated gradient of 0.12. The team determined that the sand would be unlikely to very unlikely to erode, but that erodibility is dependent on river stage.

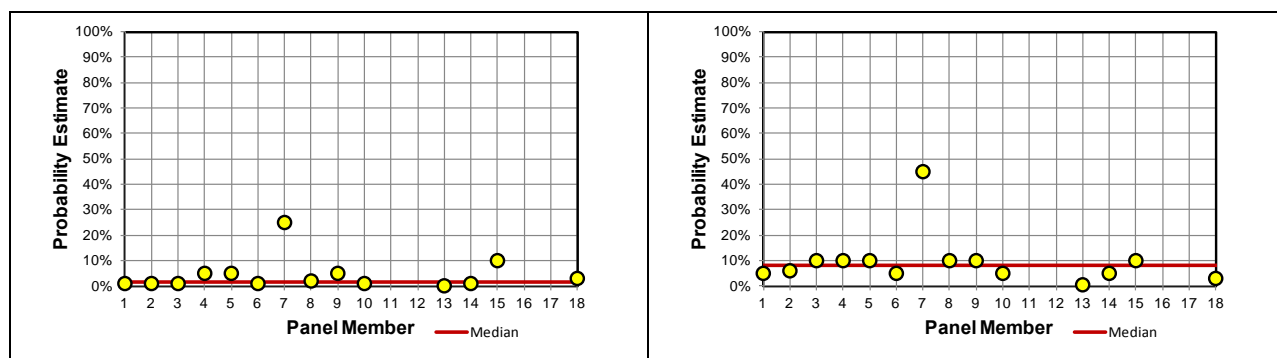
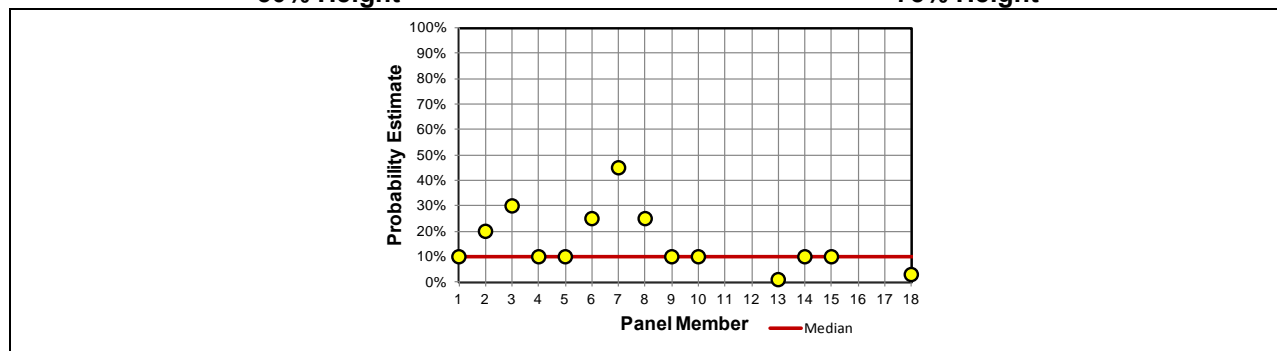
This area is near a pump station making it more likely that anomalous behavior would be observed. There is good access on the land side. If erosion began, it would occur in the side slope of the sump which is more observable. The team felt the ease or difficulties intervening early in the progression of erosion would be similar to PFM#8 and elected to use the same estimates.

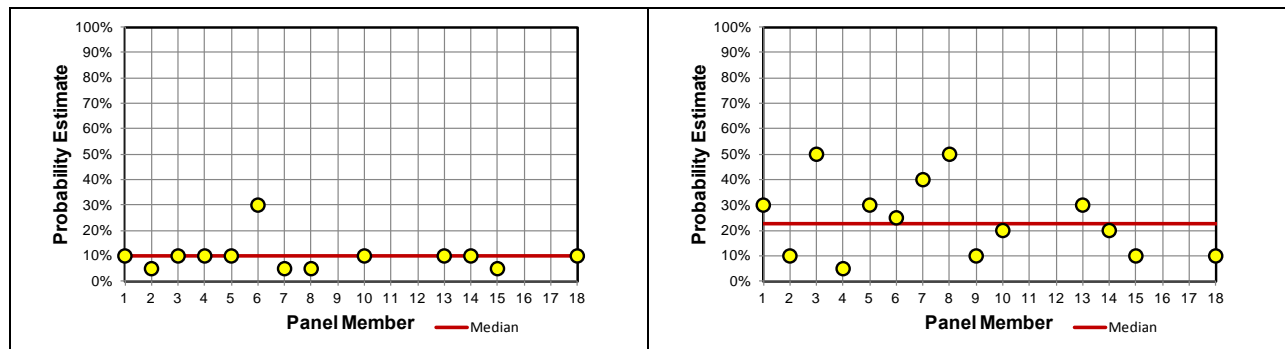
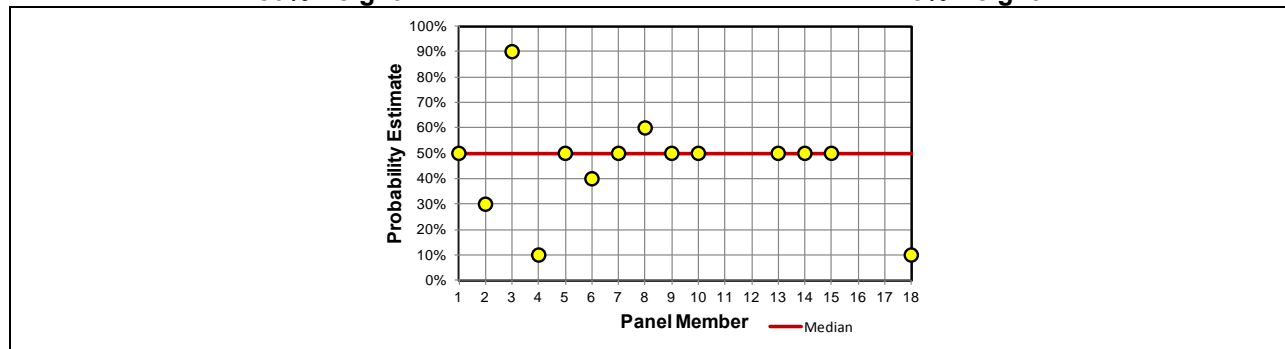
The team compared this location with that of a previous failure mode. Access is better in this location, and it might be possible to take some action on the river-side by dumping material. However, the team elected to use the same estimates as PFM #8 although it was recognized that the values could be slightly lower here.

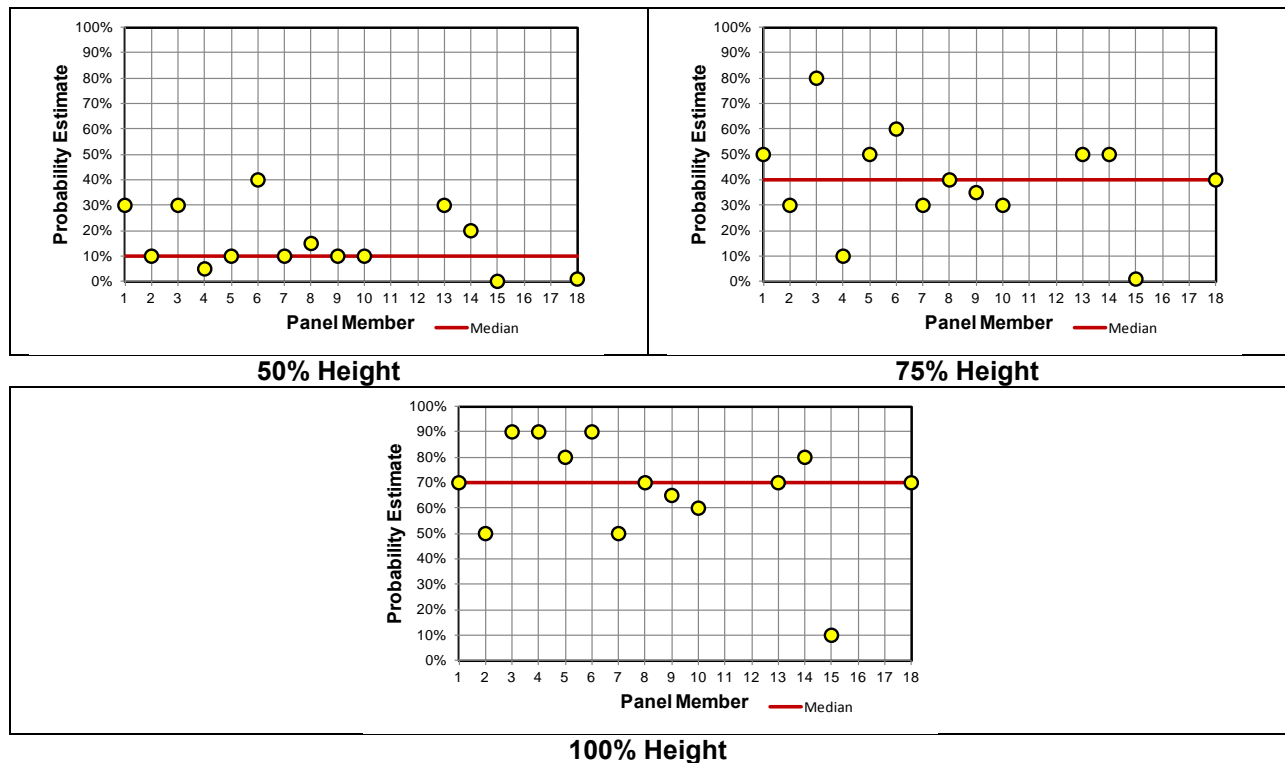
The team compared this location to a location from a previous failure mode. In this location, the sand layer is closer to the embankment and the crest elevation is 1.4 feet lower based on the 2003 survey. However, the sand layer is not as thick in this location. None of these factors were determined to be significant, and the team elected to use the same estimates from PFM #8.

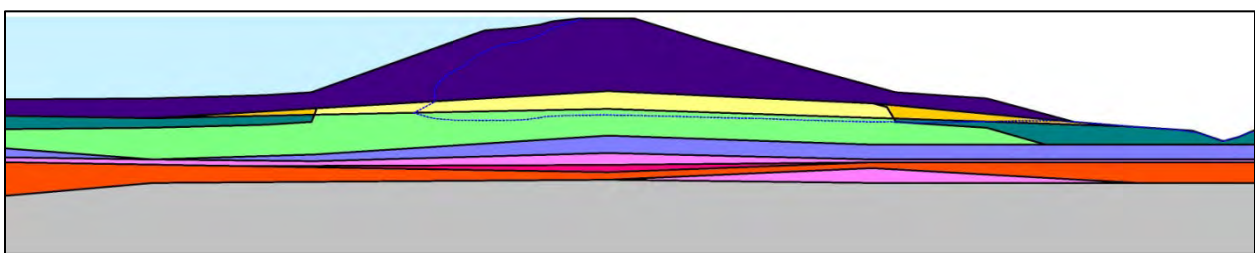
**Figure 13 – East Levee Section**

One of the reasons this particular section was thought to be critical is that the clay blanket is likely one of the thinnest in the system where a basal sand layer exists. Foundation pressures are

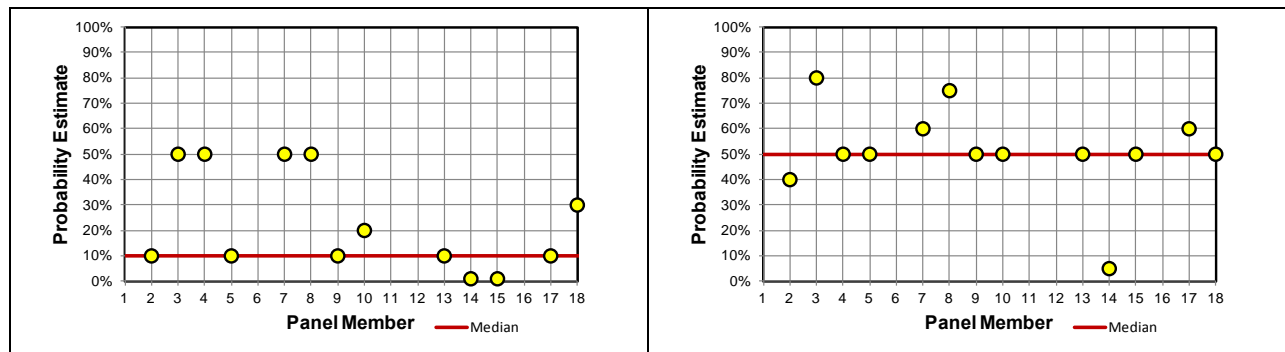
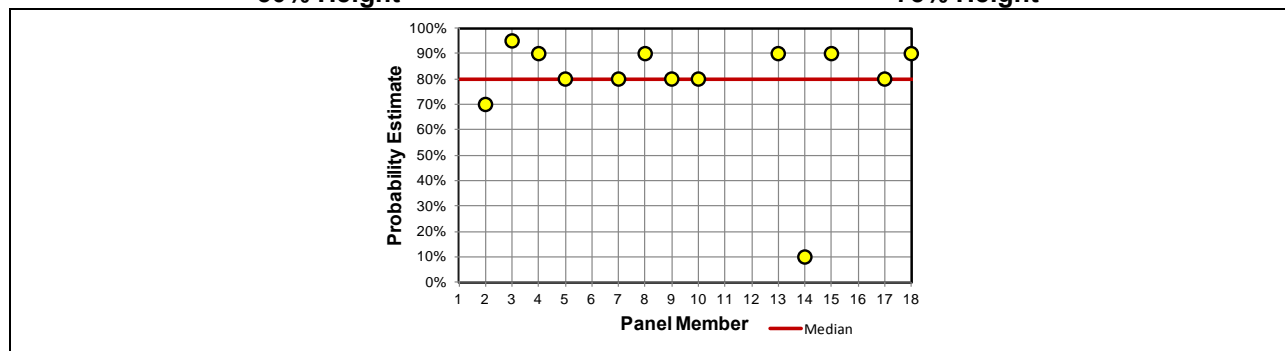
100% Height

The sumps are normally pumped down during flooding, so water on the land side would not be adding to the resisting forces. Historically, the flood loading has come within 2 feet of 50% of the levee height, and no problems such as increased seepage or boils were observed during that event. It's possible than natural drainage would occur in the sand layer. The clay blanket may also be thicker than it was modeled and the clay strength does not factor into the heave calculation. In the end, a lot of weight was put to the seepage analysis results because they are conditional on the continuous sand layer, but the team reduced the estimates somewhat because of the historical behavior.

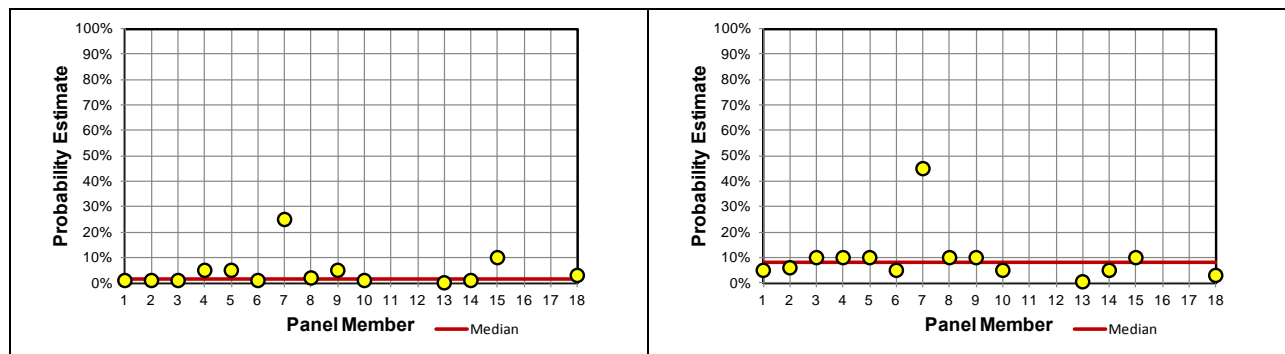
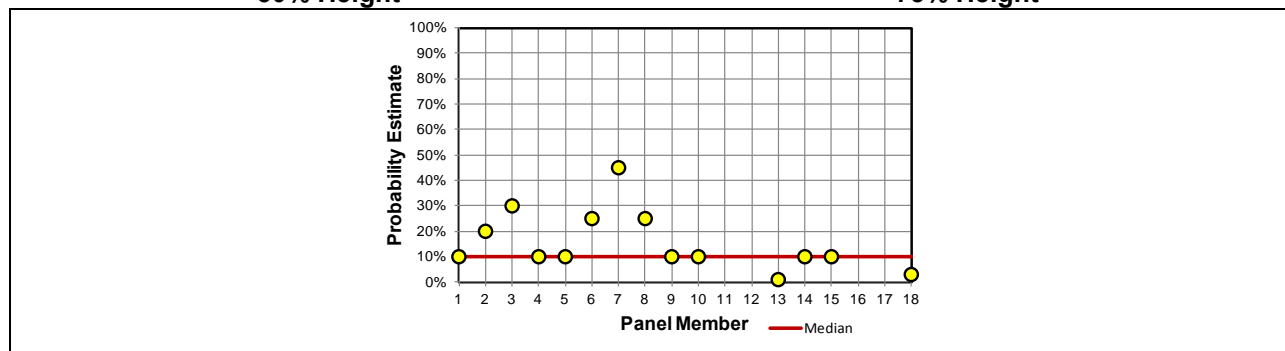
Intervention is likely to be successful at this location. Visual observation of the sumps begins once pumping begins. Mowing operations have increased the visibility at the sumps and the City of Dallas has tracked equipment. Access is excellent at the likely location of this failure mode. There are emergency stockpiles of sand and sandbags that could be used to build sand rings to reduce the gradient. The Corps has seen much success flood fighting sand boils across the country. The heads in this system are not large, so flood fighting should be successful and the boils should be obvious. The flood peak durations are relatively short (hours to days).

Despite these factors, there are other items that might indicate difficulties flood fighting. Treating a boil in one area might cause the pressures to move to another location. Visibility is less at night and vegetation and water could cause the boils to allow erosion to start unnoticed. Vigilant monitoring and abilities and potential success fighting boils were the most influential pieces of information gathered.

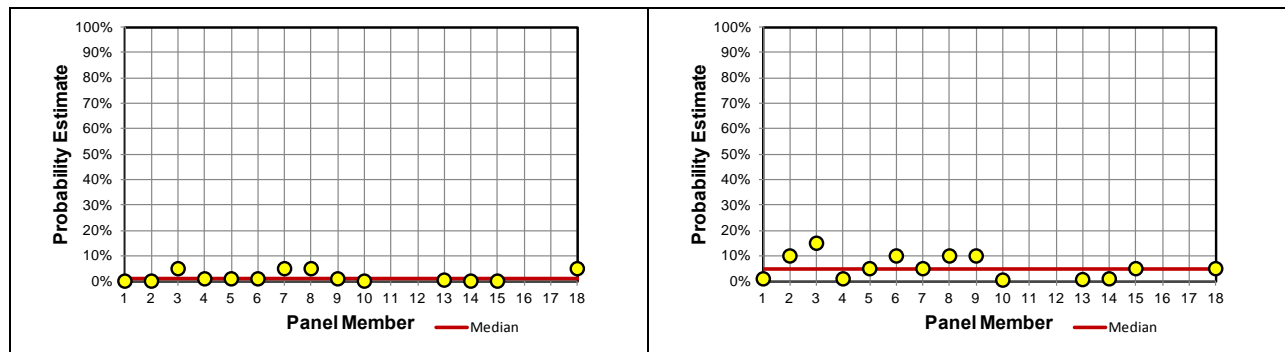
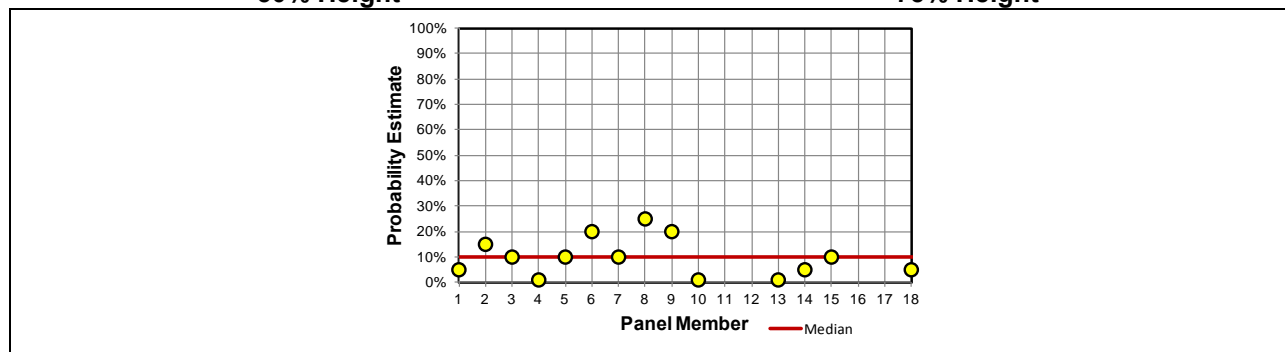
For erosion to progress, enough gradient must exist to begin to move material out of the basal sand layer so that the failure mode can progress. The gradients are unlikely to be high enough to move material at this location. The gradient is approximately 0.03 with water at the full height of the levee. The Coefficient of Uniformity calculations indicate values more than 3.0, with much of the data in the 10.0 to 20.0 range. That means the critical gradient is approximately 0.60. A large amount of sand would need to be moved to connect to the river. The gradient from the upstream toe (in the case where a flaw might exist right at the upstream toe) to the heel is approximately 0.10.

However, some of the fine sand is more erodible than the material that was assumed during the assessment. There could be a shorter seepage path at the bridge pier location and there is a lake on the river side – although the lake is shallow and likely silted in. The low average gradients and high coefficient of uniformity were the critical pieces of information evaluated by the team.

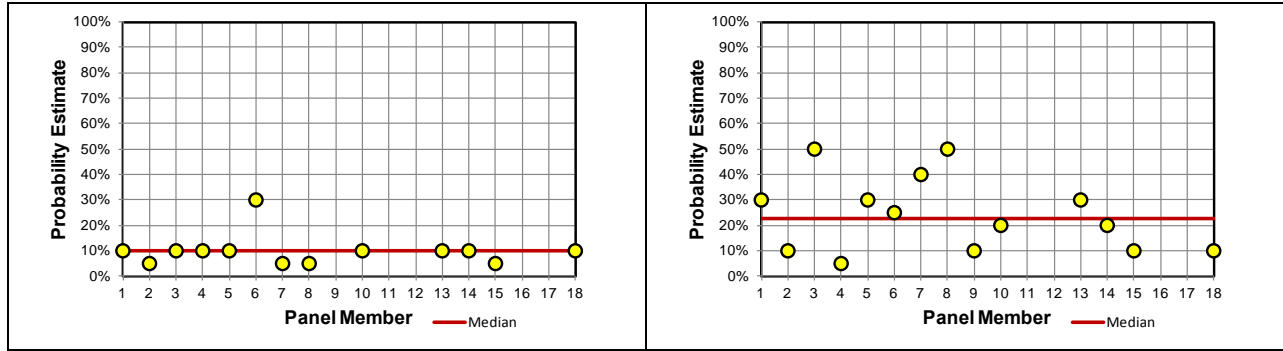
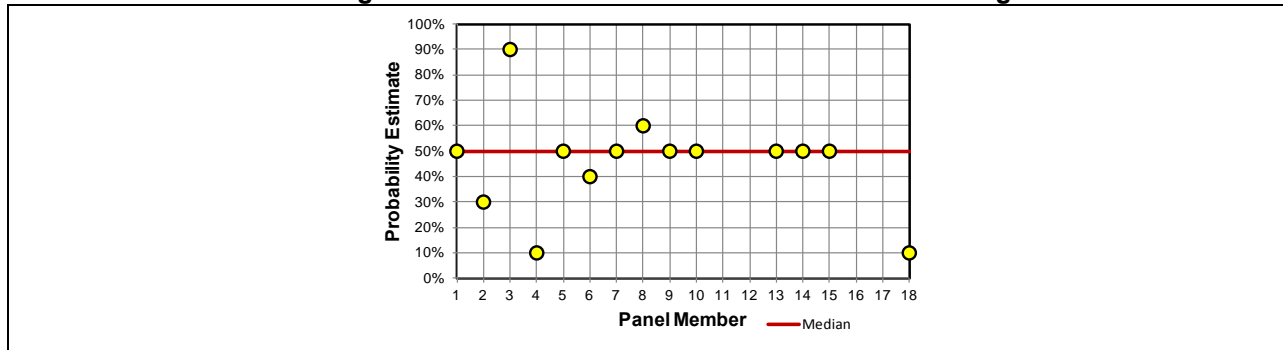
When erosion has progressed and an erosion tunnel has contacted the river, the team examined the potential to intervene and prevent a breach. A seepage berm could be built on the land side. The City of Dallas has material, equipment, and staff to do this. The pumps could be turned off and the sumps could be filled with water to help reduce the gradient. The problem would be pretty obvious and there is good access to the site. There would be no access on the river side where the seepage entrance would be and it make take time to intervene, so the team was not certain regarding the ability to intervene. Overall, the City has the ability to deal with major incidents, but the team was less certain about their potential for success at very high flood levels.

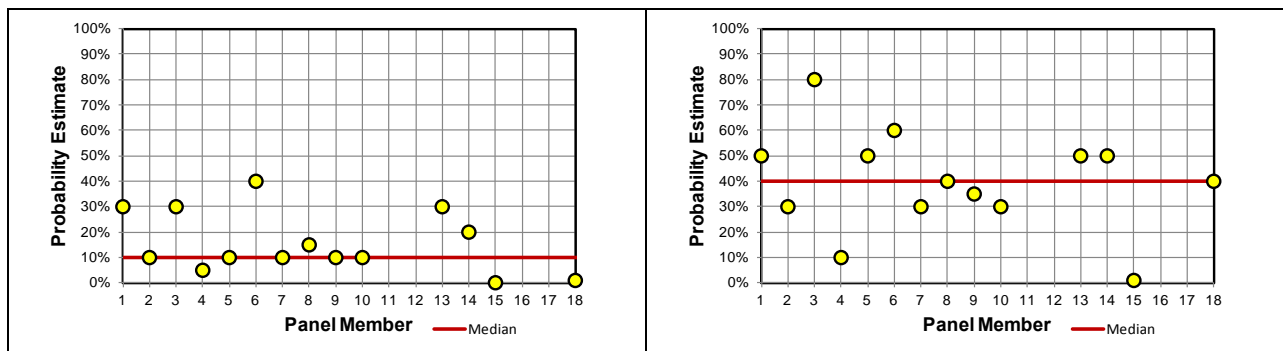
If erosion has progressed and intervention failed, the team examined the likelihood of the levee breaching and catastrophically failing. The levee will likely be loaded for a short duration, the clay erodes slowly, and the smaller the flood, the less likely breach would happen. The sand layer is also relatively thin, which might limit the amount of flow and erosion. The desiccated clay might erode more quickly because of its cracked nature.

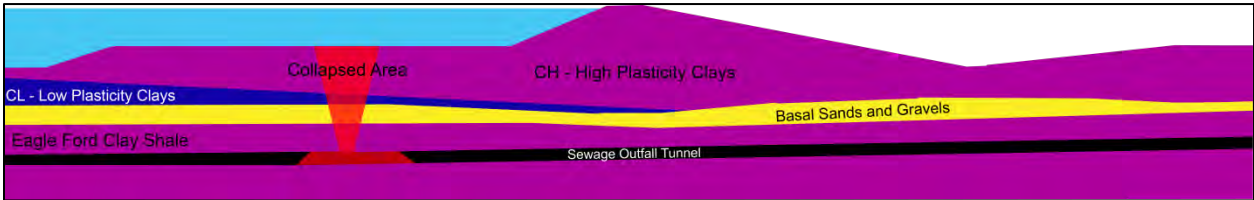
Figure 16 - Levee Section at the collapsed area

The risk assessment team held a teleconference to discuss the impacts of the existing tunnel situation. The team decided to qualitatively assess the risks posed by the existing system. The team felt that there is a significant chance that a void exists below the levee itself. If this void were to lead to a collapse during a flood event, it could cause a 10-15 foot collapse of the crest of the embankment. If the flood was significant – even for storms with less than 100-year recurrence – this could cause the embankment to overtop and breach. The team used the original matrix from the PFMA, which is shown below.

The team believes that the risks posed by the tunnel are at least an order of magnitude higher than any other failure mode evaluated by the team. There is a significant amount of uncertainty with this situation.

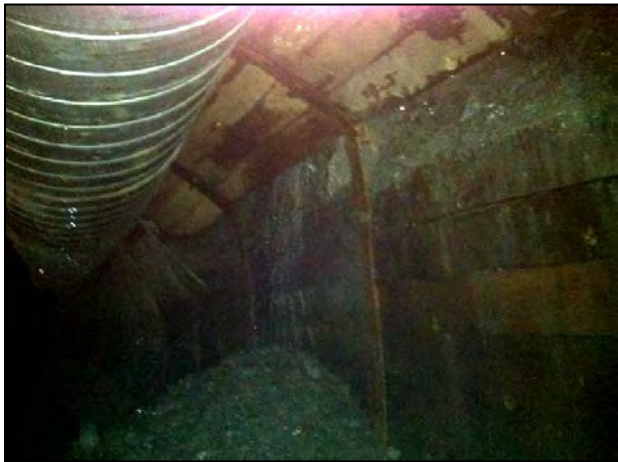
During the risk assessment, a sewage outfall tunnel was being constructed beneath the levee. This failure mode was considered during the PFMA session and determined to be a low risk. However, the team assumed these conduits were built as they were planned using the methods as they were approved. Before completion of the outfall tunnel, on 28 January 2012, a large area of the tunnel collapsed and stopped up to the ground surface near the river side of the levee. Flowable fill was placed into the sinkhole to stabilize the area. 350 to 450 cubic yards of flowable fill were placed in the sinkhole. A remedial grouting operation was immediately begun to fill the void and the collapsed area of the tunnel with low mobility grout.

Piezometers near the collapsed area with tips in the basal sand show regional groundwater dropping significantly at the time of the collapse and rebounding over several days. These instruments also show an identical response approximately one month after the initial collapse with no surface expression of distress. This could indicate a collapsed area, likely between the land-side toe of the levee and the initial collapsed area.

Figure 17 - Photo of the Initial Collapse

Currently, the land side of the collapsed tunnel area is full of water. The City of Dallas is considering options to safely replace the water, re-establish the tunnel, construct the outfall structure, and possibly remediate any damage caused during the collapses.

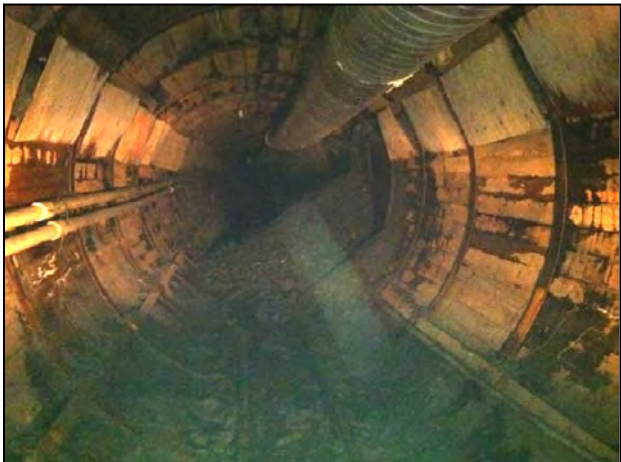
Figure 18 - Photo of the Collapse Progressing

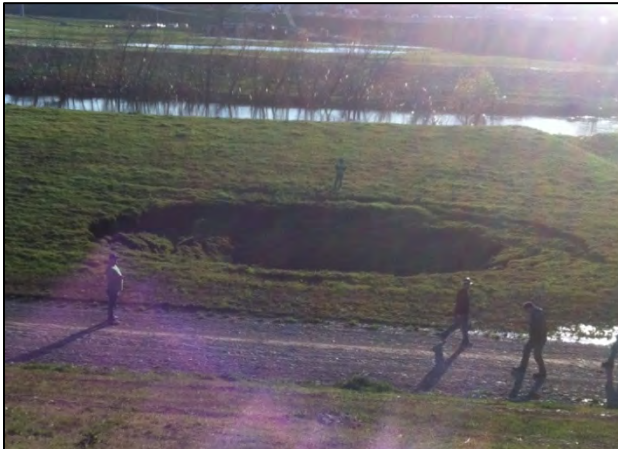
Figure 19 - Photo of the Sinkhole

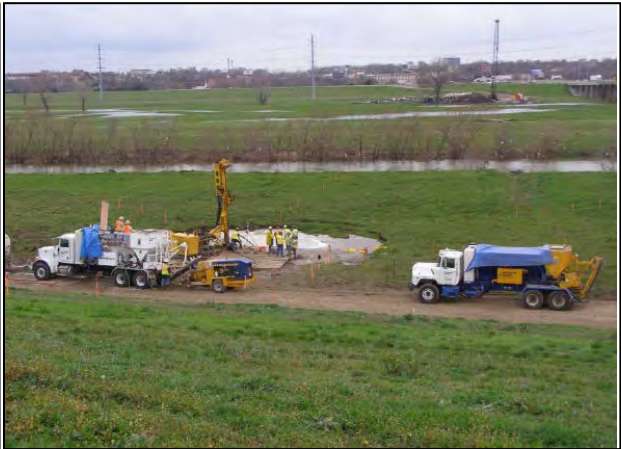
Figure 20 - Photo of the Remedial Grouting

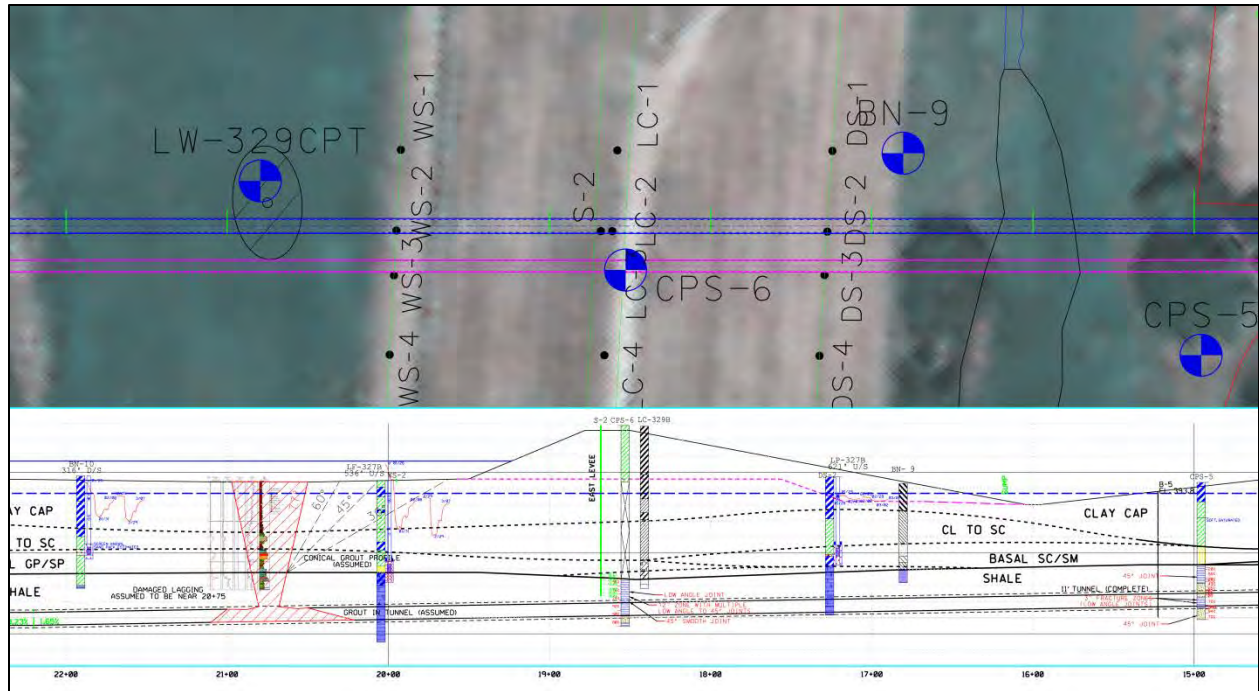
**Figure 21 - Cross-section showing instrumentation and nearby borings.**
