CITY OF DALLAS INTERIOR LEVEE DRAINAGE STUDY WEST LEVEE – PHASE II

VOLUME 2 of 2 – PUMP STATION ASSESSMENTS

January 2009

Large Able (LAX) Pump Station

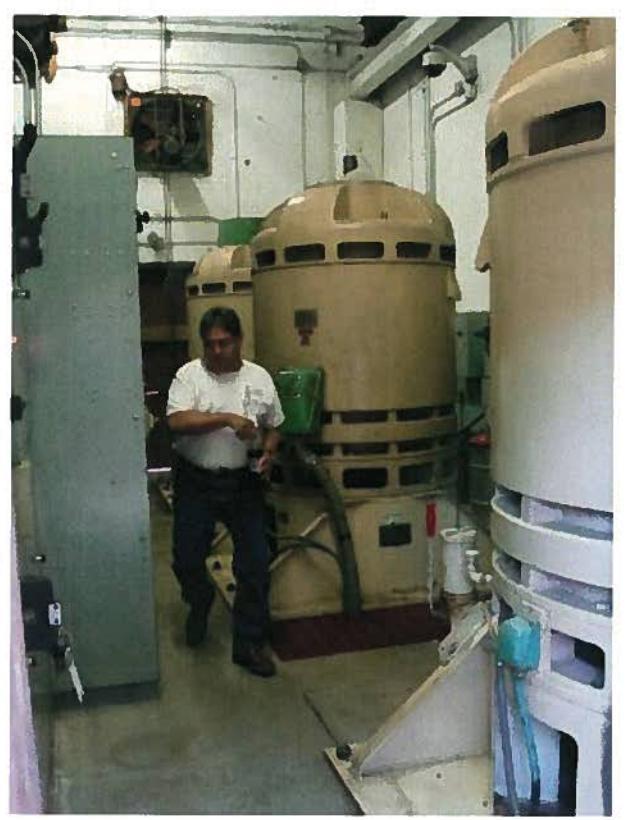
The layout of the station is a concern as it is a compact area with little room to work. The clearance between the pump and switchgear could prove to be unsafe for employees rolling out the switchgear for maintenance activities. (Photo 3.2) When equipment is pulled, its removal leaves a dangerous opening in the floor. (Photo 3.3) This opening needs to be barricaded to prohibit stepping over. Additionally, a temporary

Photo 3.2 - LAX Walk Space

The City of Dallas should consider modifying or replacing this station in order to provide a more safe work environments for their employees.

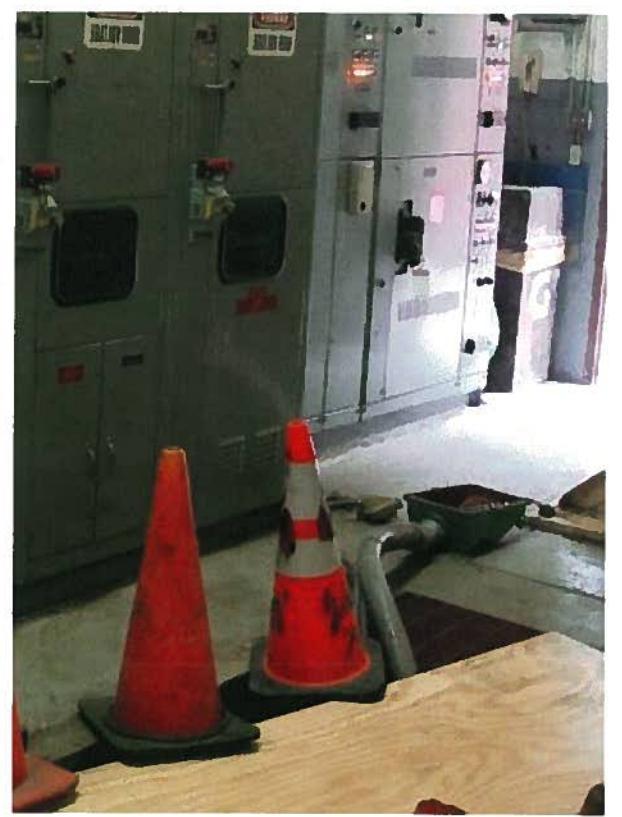
Photo 3.3 - LAX Unit Two Pulled

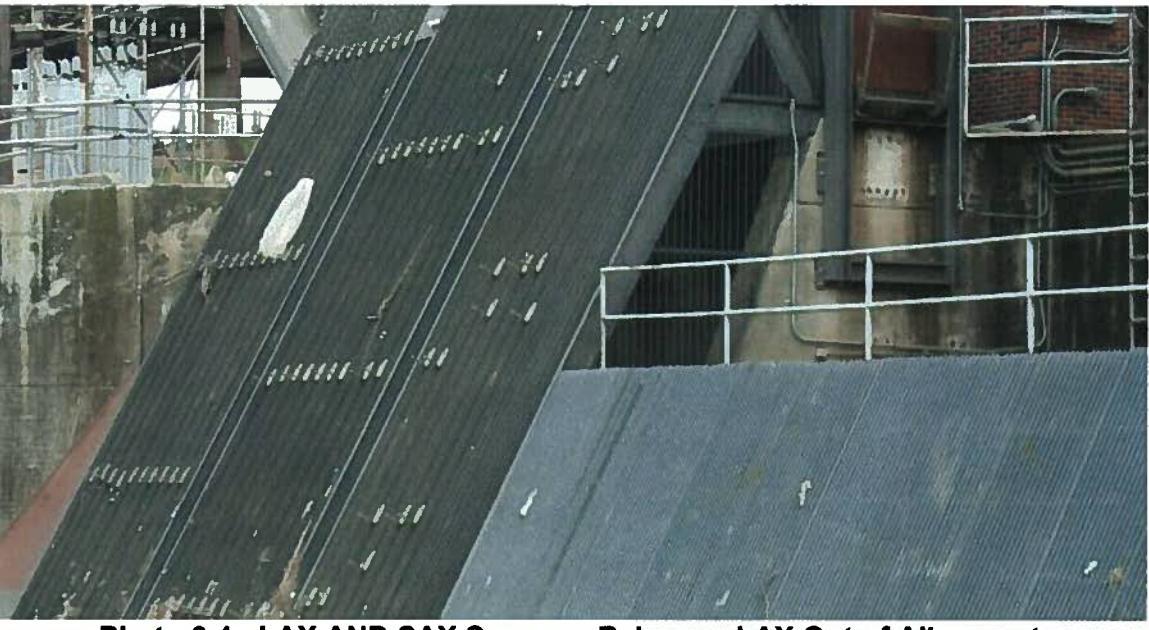
LAX is located to the South of the original Small Able Station (SAX). Both LAX and SAX share operational importance. SAX is included in the pumping sequence, rather than being utilized as a back-up station, as seen at the Baker and Hampton sites. This site location has a shared sump area and the screens for both stations are affixed side by side. There is not any physical damage to the LAX screens, however the rakes are out of alignment. SAX rakes adjoin the LAX screens and do not have an automated rake system. It appears that personnel are required to move debris from SAX to LAX for removal as there is no other suitable method available. Because the LAX rakes were not designed to convey debris from both LAX and SAX, the added load from SAX may exceed the capacity of the LAX rake system. (Photo 3.4)

Photo 3.4 - LAX AND SAX Screens, Rakes on LAX Out of Alignment

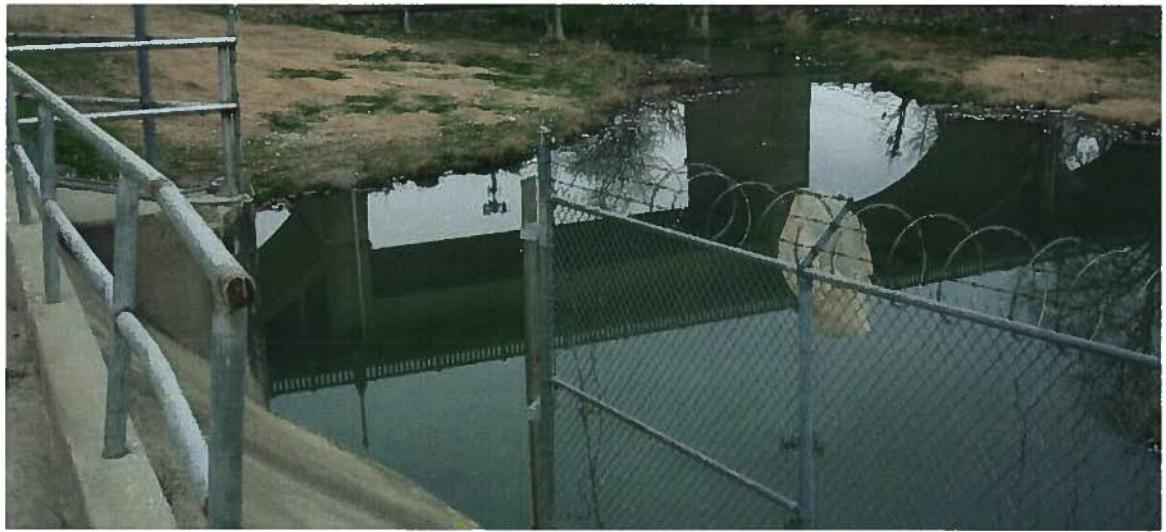
Photo 3.5 - SAX Sump Inflow from the North

As mentioned above, the screens do not show any damage. However, this site is more vulnerable to impacts by large objects due to the flow pattern of incoming flood water maintaining some velocity. (Photos 3.5 & 3.6)

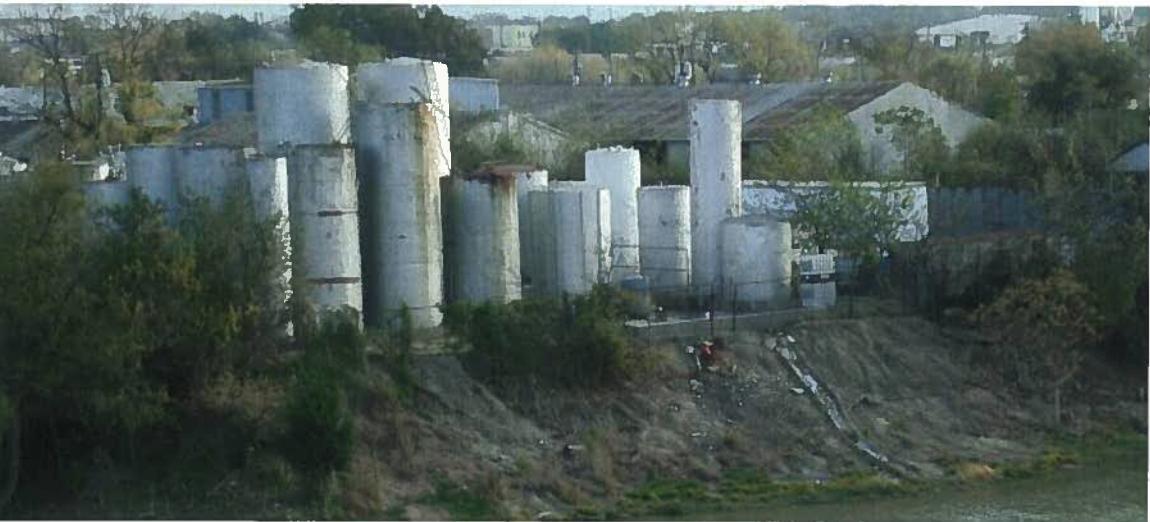
There are numerous businesses and their adjacent parking areas located near the station and any waste coming from these areas flows directly into the sump's channel. The possibility of hazardous waste coming from these businesses is not currently monitored. The debris coming into the site is hauled to a pubic landfill. There are restrictions on what may be deposited at these landfills, and if hazardous material is being spilled into the sump's channel, additional costs could be incurred to properly dispose of this waste. Additionally, all flood waters are discharged into the Trinity River which could cause another potential health concern.

Photo 3.8 - SAX & LAX Channel to Sump Area

The extent of the monitoring of the waste from local business is not currently known, but the City of Dallas has recently created a new Environmental Department and is actively involved in environmental management. It is recommended that the Environmental Department look into this waste to prevent possible environmental repercussions.

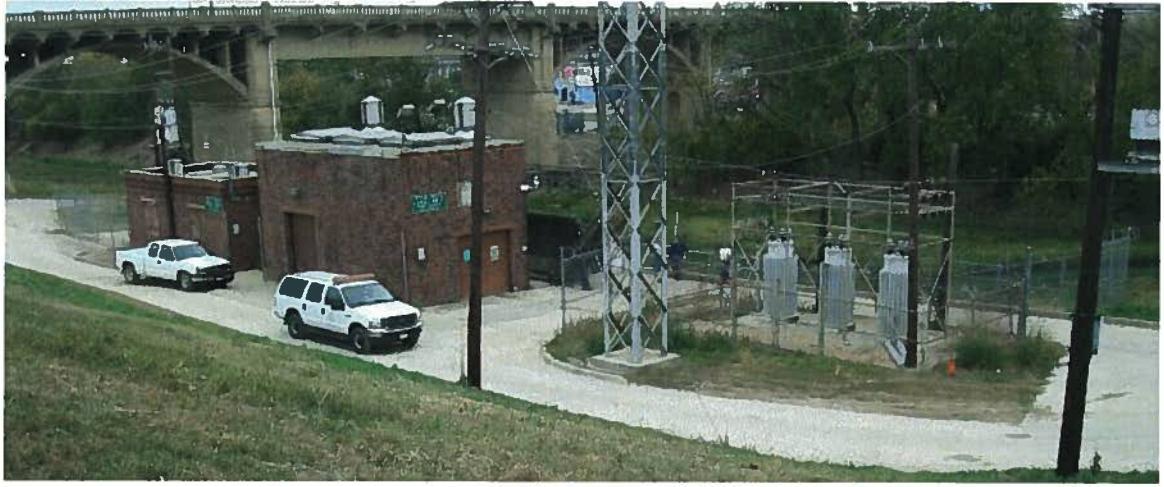
Photo 3.9 - Able Site's Security Fencing

The fencing around the perimeter of Able's site and the gate at the entrance is ineffective as a deterrent to trespassing and vandalism. (Photo 3.9) The gate across the driveway entrance is not intended to stop foot traffic. The gates on the chain link fencing surrounding the site have been pulled off their hinges and left open. In order to maintain the safety of the equipment and personnel, these gates should remain operational.

The turning radius of the driveway on the south end of the site (Photo 3.9) is very confining for large vehicles. The location of the transformer yard makes it difficult to increase the turning radius to accommodate larger vehicles. Pumps and motors are removed from the west side of these stations and may not pose a problem as long as the south end drive is long enough for turning around.

Vandalism has occurred at the pump stations and vagrants are commonly living within the levee area. For the safety of intruders, employees and equipment, it is recommended that security and lighting in and around the site be upgraded per the recommendations above.

- Fence repairs are required to improve security. The gates need to be installed to secure the site. If these gates are a nuisance to maintenance and/or operations, the fence line could be moved to better accommodate activities. The City of Dallas has a price agreement in place for fence repairs and new installation.

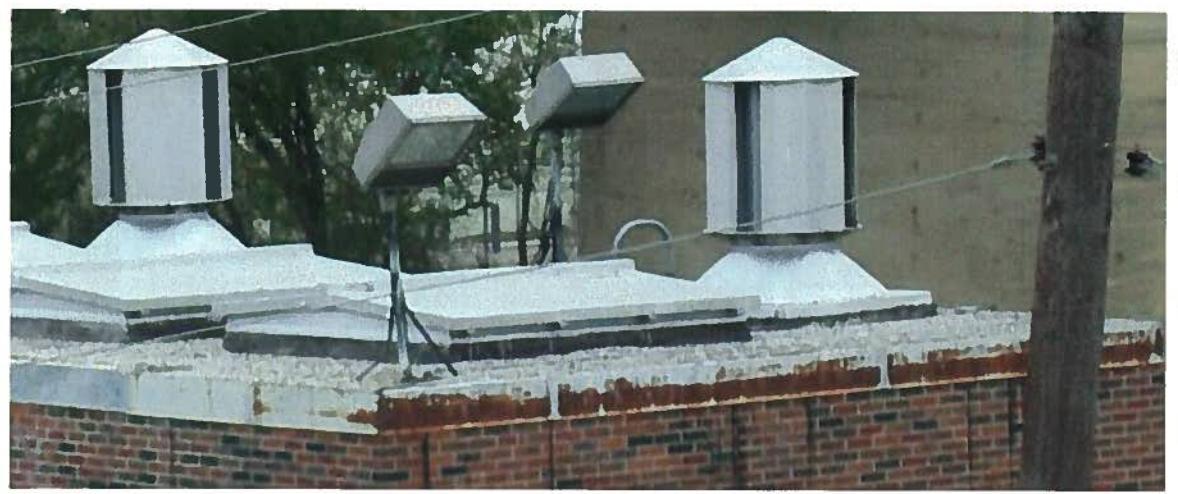
Photo 3.10 - LAX roof Vent Cover, Equipment Hatch and flashing

The roof is poured concrete with a membrane cover and rock overlay. There are no internal signs of leaks from the roof, but the flashing around the roof's perimeter is showing a heavy build-up of corrosion that does require attention. (Photo 3.10) There does not appear to be any physical damage to the metal, however a close inspection from the rooftop was not done.

The two vent covers and three equipment hatches are not showing any signs of corrosion. The equipment hatches are raised several inches above the roof, which prevents standing water from entering the station. This is the most important consideration when altering the hatches on the roof at any facility.

- The flashing around the roof needs to be cleaned and sealed to eliminate the ongoing corrosion.
- There is damage to the brickwork on the south wall at the east corner. This should be looked at by a structural engineer to determine if repairs are necessary.

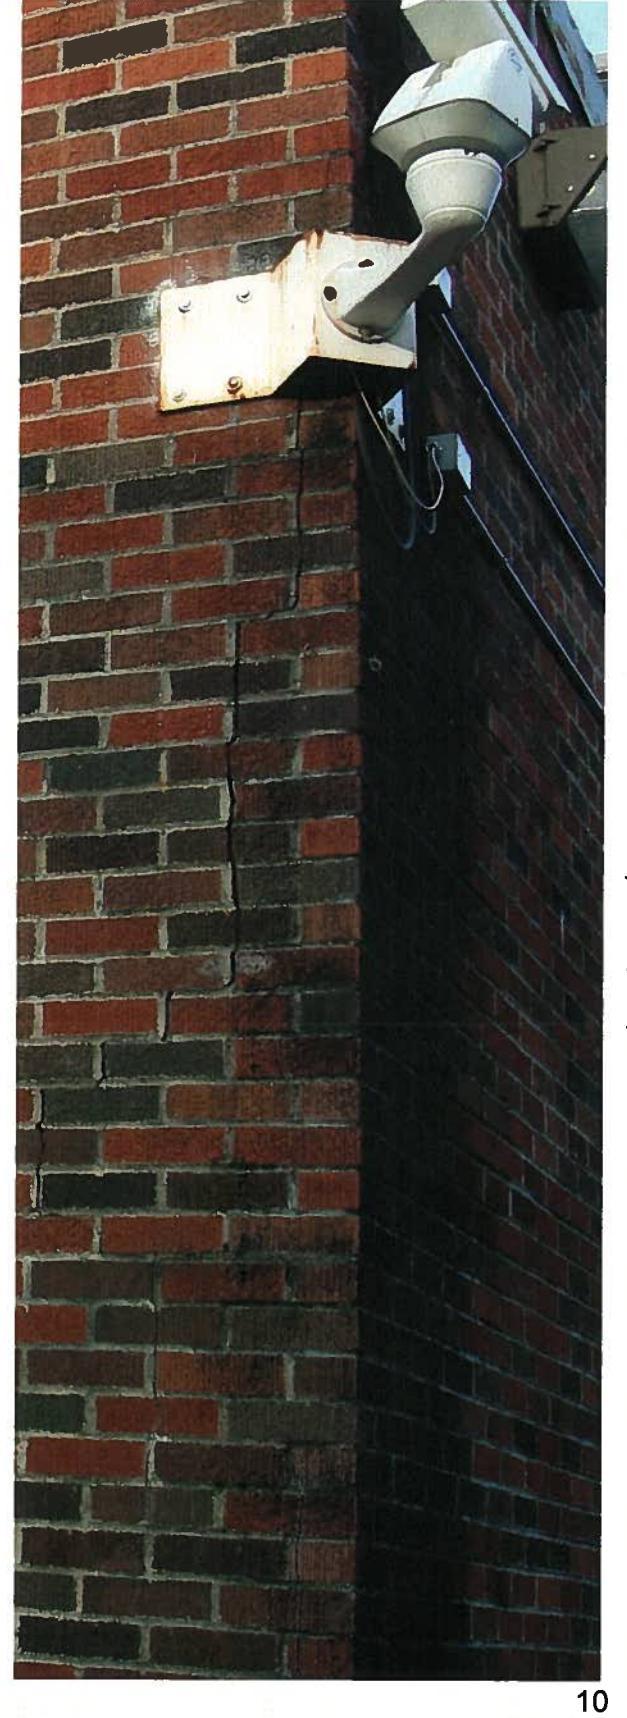
The brick work appears to have been regrouted in the recent past. There also appears to have been repairs or replacement of brickwork on the roll-up door on the west wall. There is a crack running down the exterior of the south wall on its east corner. The crack runs downward through several courses in a straight line breaking bricks in its path, then shifts over a half course, and then continues straight downward again breaking additional bricks along that line in its path. This crack runs over several more courses and down half the height of the building before ending. (Photo 3.11) Though the crack appears minor, but it is recommended that a structural engineer look at the problem to insure there are not any structural problems and to determine what repairs (if any) might be required. No other areas with this type of damaged were observed. This crack could be the result of the hammering and drilling required for mounting the security camera and its related conduits and iunction boxes.

If this building's bricks were not re-sealed at the time of re-grouting, it is recommended that this work be added to the next available contract.

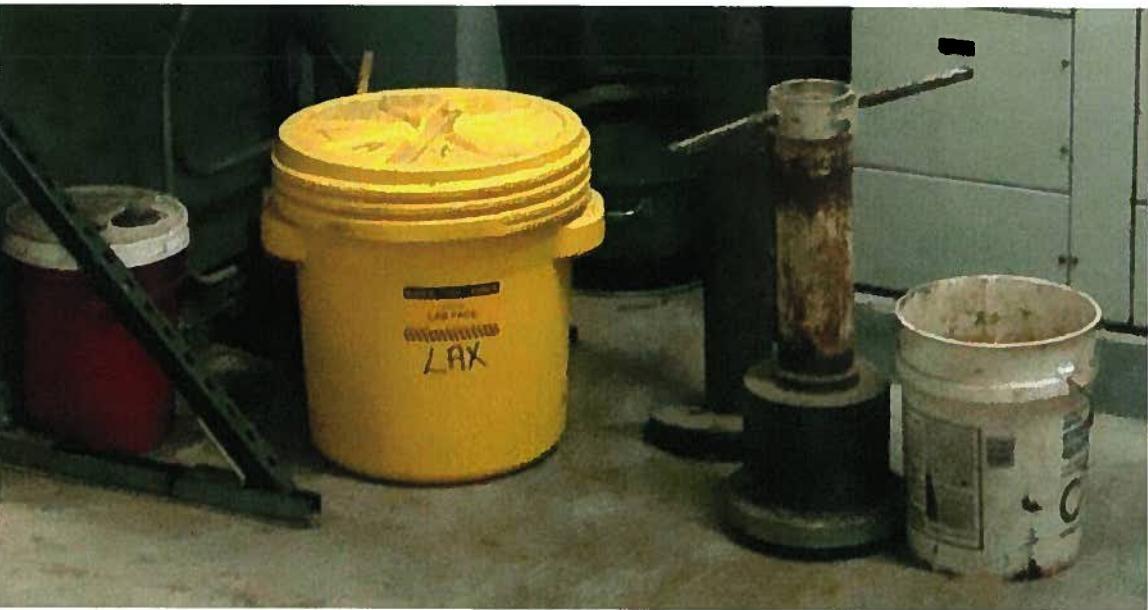
Chemical containers, some not marked, are routinely stored in pump rooms. Depending on the contents of these containers, it is possible that some may require special cabinets and may not be permitted to be stored inside the building. This situation should be investigated by the part division's team assigned to the ecology program. (Photo 3.13)

Photo 3.13 - LAX Chemical Storage

No Material Safety Data Sheets (MSDS) were observed in the station. It is suggested that each building with any chemicals on-site have a MSDS book with an up-to-date listing of all chemicals on the premises. This MSDS book should be clearly displayed and readily available to all employees.

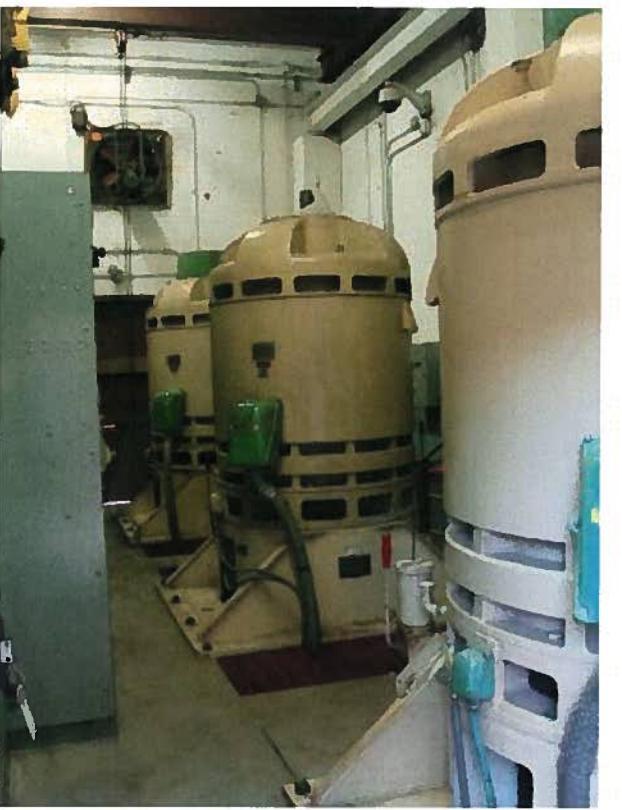
The age of these pumping units is at or past their normal service life. They can continue to be serviced and used, but the cost should be looked at and determined at what point newer more efficient units would be more cost effective. Unfortunately this problem would be compounded cost-wise, because of the limited space and the fact that other stations built in the same time frame will also have aging units. These stations were not designed for future changes or expansion. (Photo 3.14)

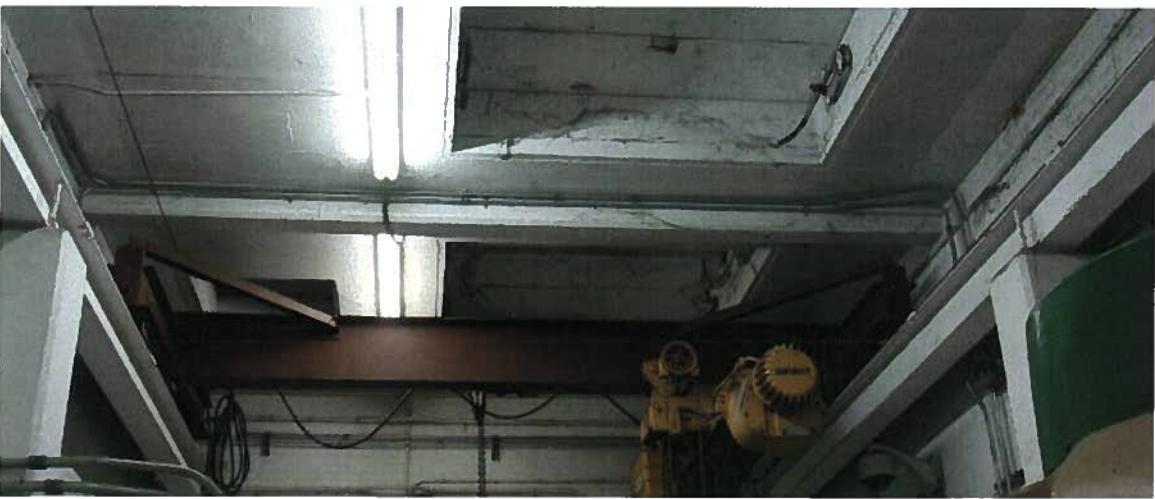
Lighting in the pump room is adequate but could be improved with additional ceiling mounted fluorescent fixtures. These lamps are a little difficult to reach due to the ceiling's height, but a step ladder can be used to install/replace light fixtures. However, the previously discussed limited space does present a challenge. (Photo 3.15)

The roofing structure is poured in place concrete, sealed with paint. There are no signs of leakage. The equipment hatches are raised, with a bi-fold a hatch cover. (Photo 3.15)

Photo 3.15 - LAX Lighting, Hatches & Crane

The pump room has a manually operated rail and dolly with an electrically operated 10ton crane (Photo 3.15) used to pull and install equipment. The bridge travels north – south and the dolly, east – west. All equipment in the main pump room is accessible to the crane. It is in working order and inspected by division personnel. The extraction of a pump requires a rental mobile crane that pulls the units through the roof's equipment hatches. (Photo 3.15)

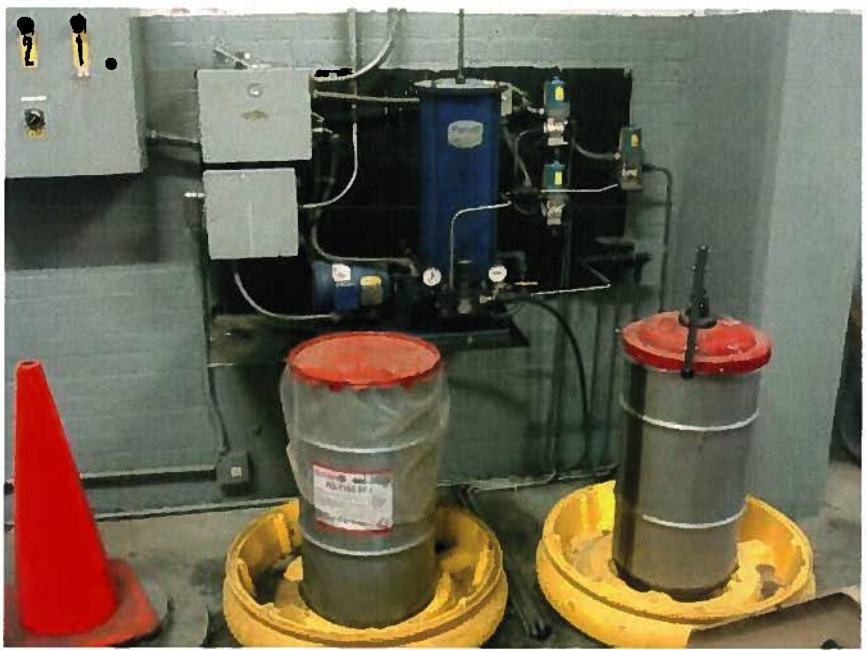
Photo 3.16 - LAX Farval Lubrication System

The Farval lubrication system (Photo 3.16) provides each pump with a measured amount of lubrication at prescribed times. The transfer of grease from the storage container to the Farval's main cylinder has experienced some problems with air pockets. The delivery of grease to the farthest pump is also experiencing some intermittent

difficulties. There are alarms in place that prevent a pump from starting or that take the pump off line if the Farval system fails to operate correctly. These alarms transmit to the SCADA, informing the operator of the problem.

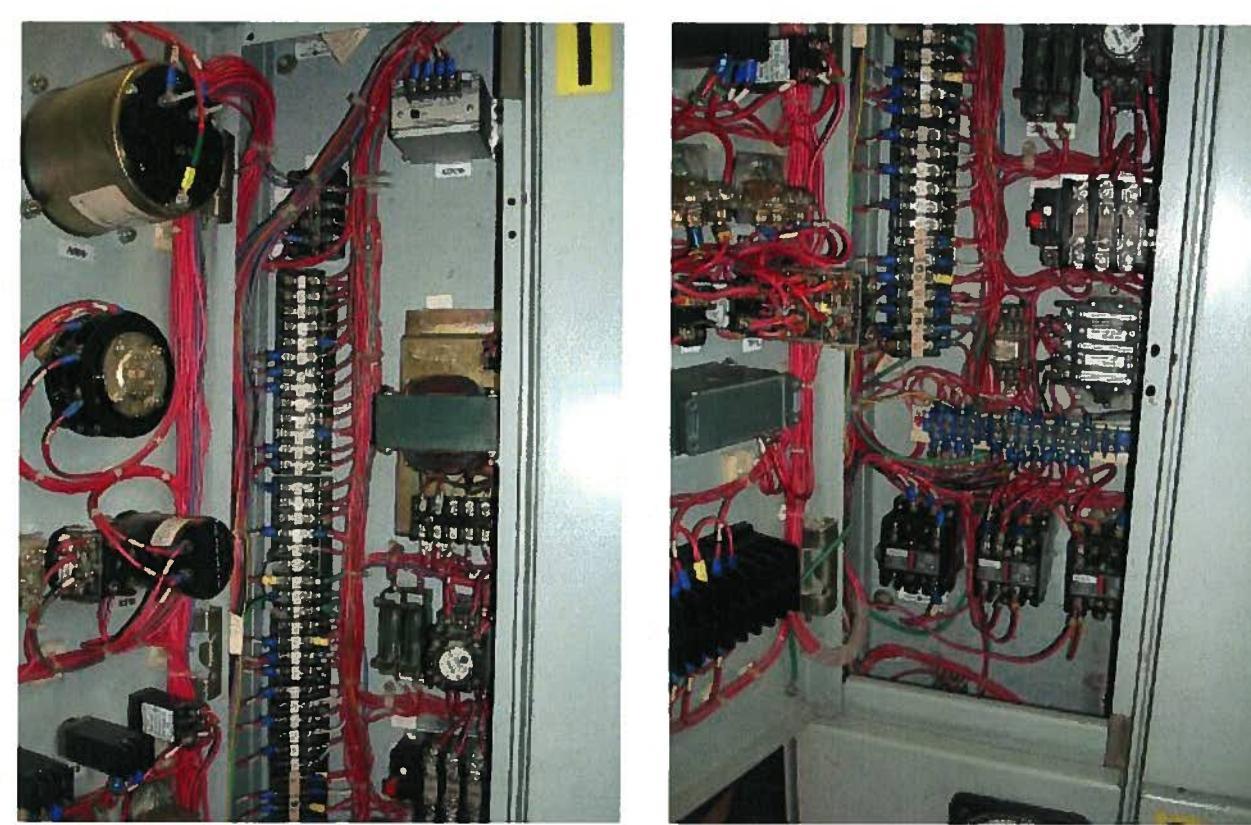
This equipment is at or past its expected service life. Its alarm relays are minimal, requiring on-site personnel to set and reset alarm flags. By comparison, modern electronic protection offers dial-in capabilities, event recordings, warning and alarm conditions, programmable features, etc.

Photo 3.18 - LAX Switchgear

Photo 3.19 - LAX Switchgear

Division's electrical staff is responsible for maintaining and repairing electrical equipment, the majority of which is switchgear. All switchgear is inspected and serviced twice a year. Very minor discrepancies were noticed while inspecting random cabinets.

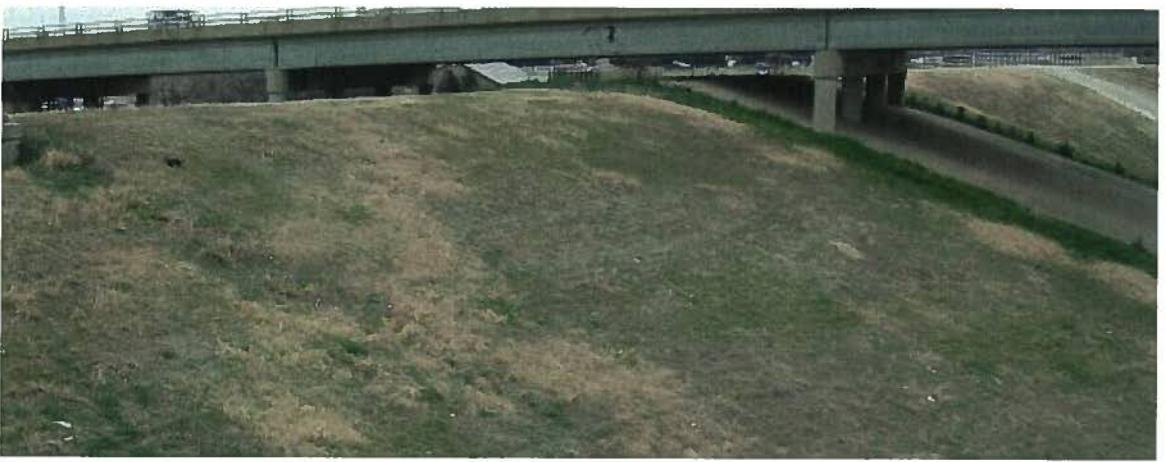
Photo 3.22 - Levee at SAX Looking South

The slope is covered in shallow ruts that were caused during mowing, probably because the ground was wet at the time of mowing. These should level out over time.

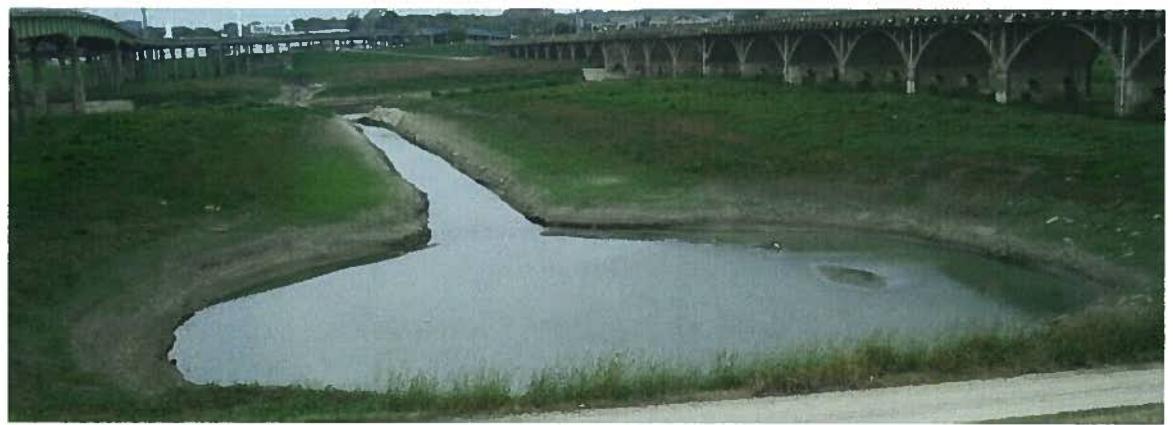
Photo 3.25 - SAX Outlet Pond and Channel

The circular pond of water at the structure's discharge shows heavy silting on the Northwest portion of this area. (Photo 3.25) It appears this could be the soil that washed down from above the outfall structure. It is recommended that the area surrounding this structure be graded down and replaced with the appropriately sized rip-rap.

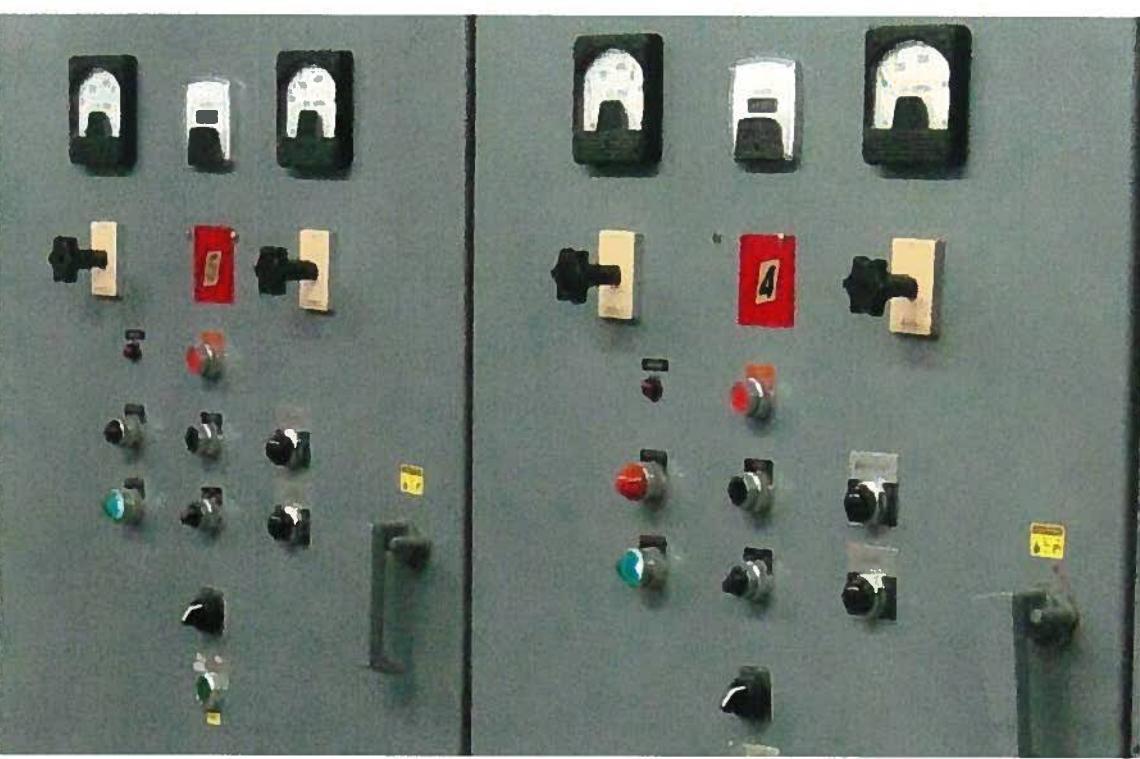
In the event of a SCADA System failure, personnel are able to manually operate this station from the switchgear cabinet, by switching controls from remote to local and selecting the start or stop switch. (Photo 3.1) Indicator lights and instrumentation (Photo 3.2) provide the necessary information to an Operator. An operational chart provides guidelines for when each unit is to be put on-line or off-line.

Photo 3.1 - SAX Manual Controls on Switchgear

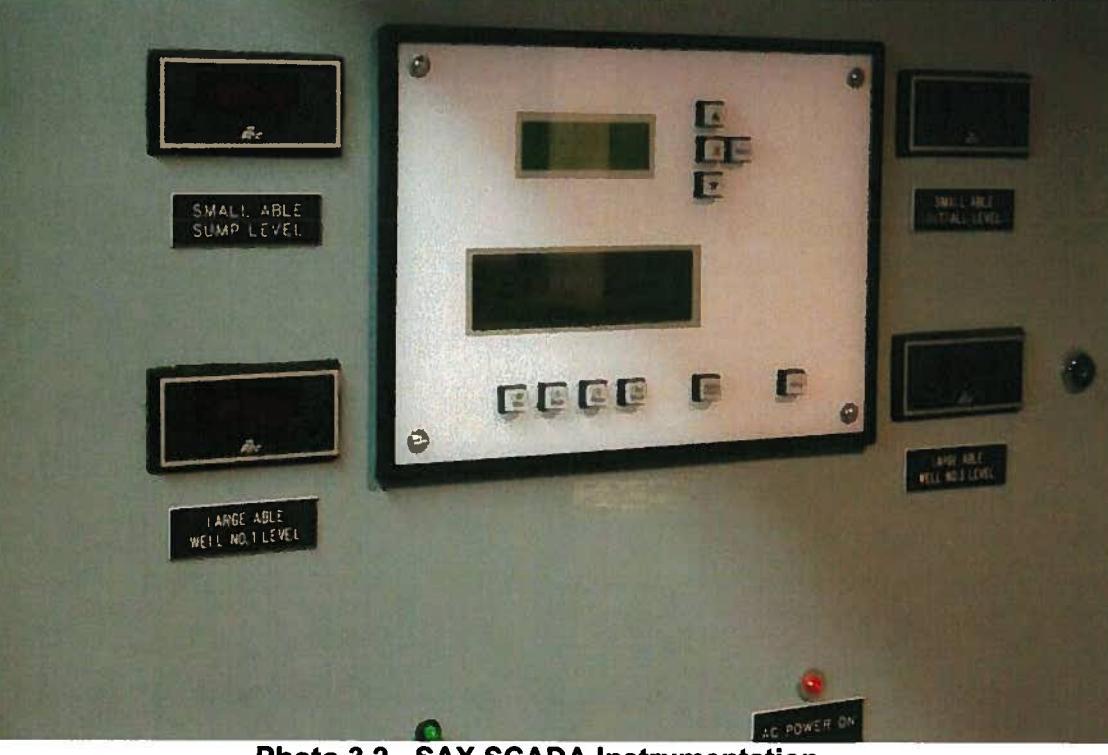
Photo 3.2 - SAX SCADA Instrumentation

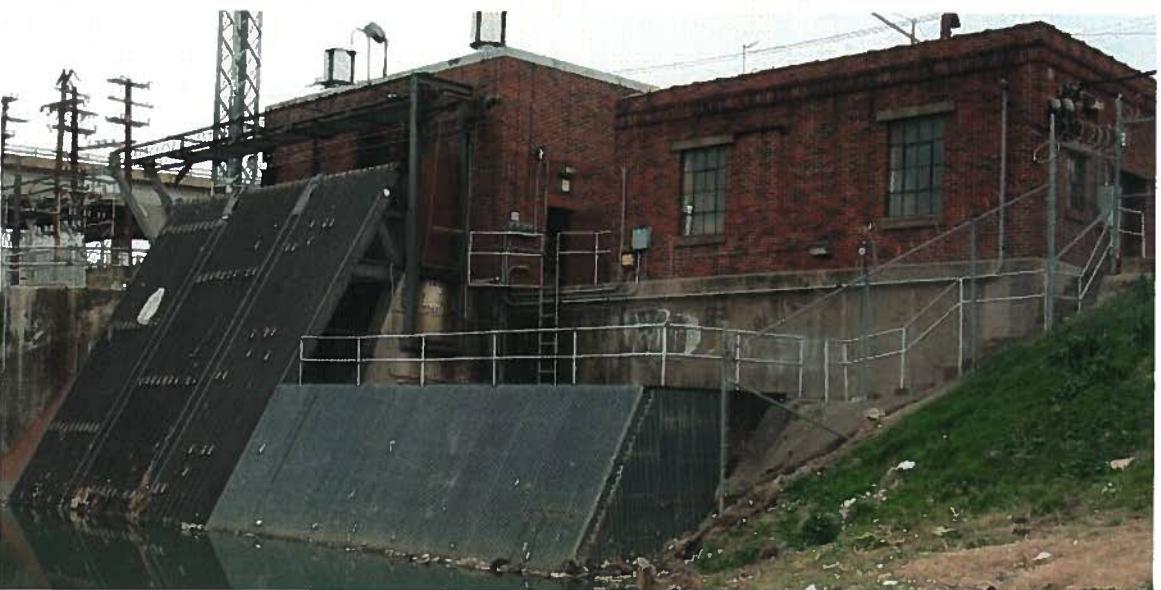
The SAX is located to the North of LAX and shares the same sump area (Photo 3.3). There was no visible damage to the screens, but some of the rakes at LAX had serious misalignment on the section closest to SAX. This could mean the incoming debris exceeds the lifting capacity of the rakes. SAX does not have a trash crane or mechanical rake system. Debris must be manually cleared with long handled rakes. There is no access to the SAX screen's landing to remove the debris. Raking the debris over to the LAX rakes would explain the overloading of the rake system's design.

Photo 3.3 - SAX and LAX Screens

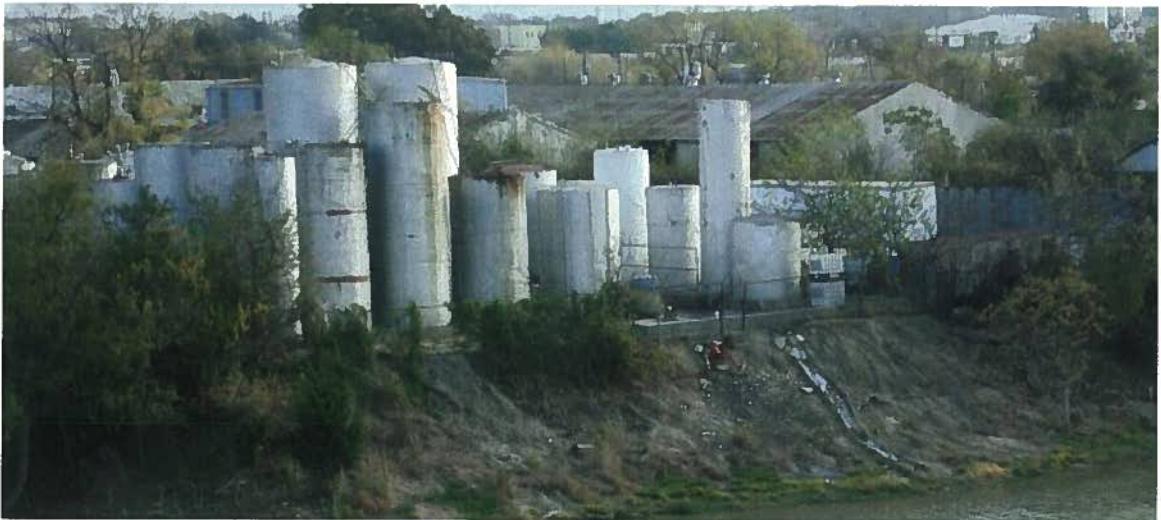
This site has a large accumulation of manmade debris around the sump area. This site is the furthest South on the east levee and closest to downtown industrial areas. Many of these industrial businesses are built right up to the banks of the channel feeding into the sump. (Photo 3.4)

Photo 3.4 - SAX and LAX Channel to Sump Area

There are numerous businesses and their adjacent parking areas located near the station and any waste coming from these areas flows directly into the sump's channel. The possibility of hazardous waste coming from these businesses is not currently monitored. The debris coming into the site is hauled to a public landfill. There are restrictions on what may be deposited at these landfills, and if hazardous material is being spilled into the sump's channel, additional costs could be incurred to properly dispose of this waste. Additionally, all flood waters are discharged into the Trinity River which could cause another potential health concern.

The extent of the monitoring of the waste from local business is not currently known, but the City of Dallas has recently created a new Environmental Department and is actively involved in environmental management. It is recommended that the Environmental Department look into this waste to prevent possible environmental repercussions.

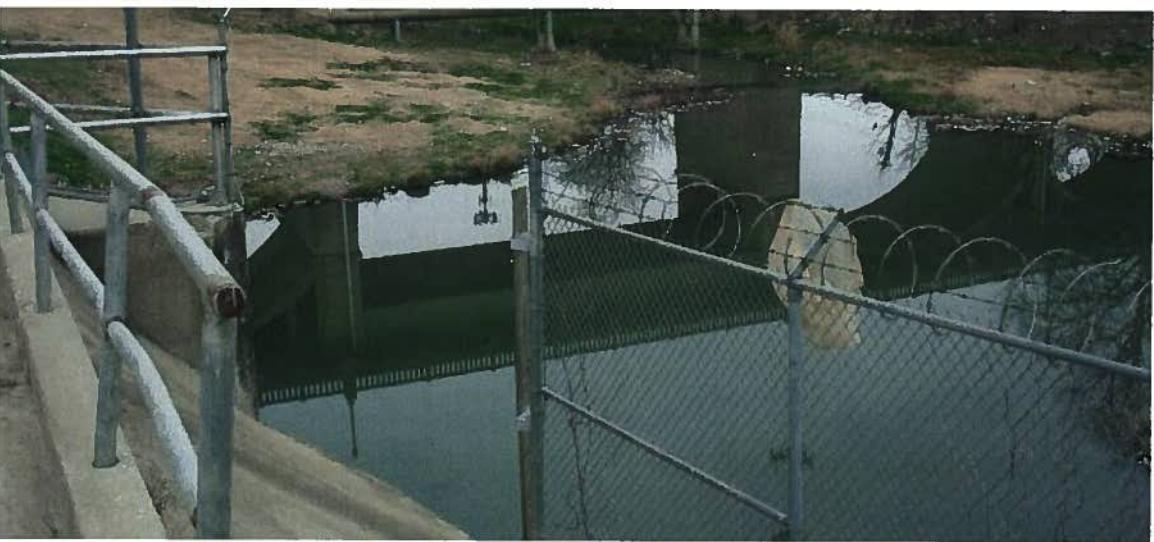
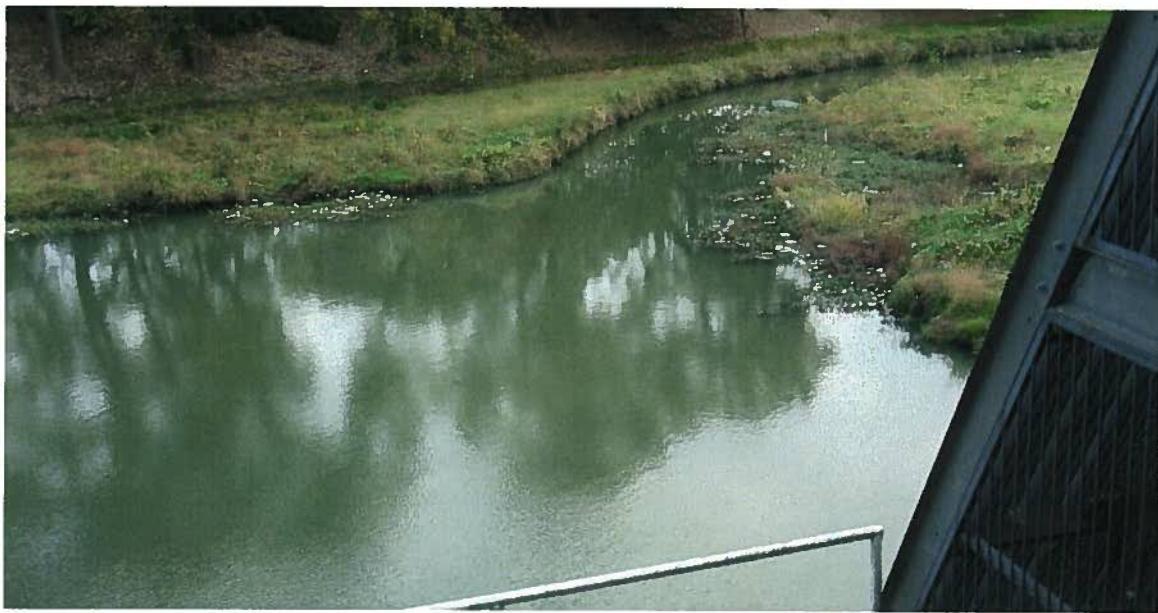
As mentioned above, the screens do not show any damage, but this site is more vulnerable to impacts by large objects due to the flow pattern of incoming flood water maintaining some velocity. (Photos 3.5 & 3.6)

Photo 3.5 - SAX Sump Inflow from the North

Photo 3.6 - SAX Sump Inflow from the South

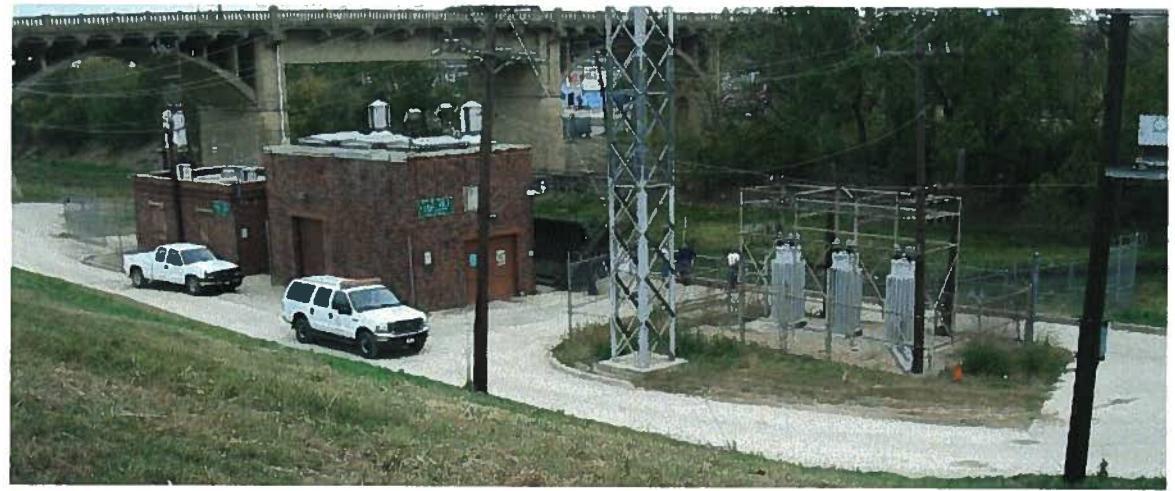
The fencing around the perimeter of Able's site and the gate at the entrance is ineffective as a deterrent to trespassers. (Photo 3.8)

Photo 3.8 - Able Site's Security Fencing

The gate across the driveway entrance is not intended to stop foot traffic. The gates on the chain link fencing surrounding the site have been pulled off their hinges and left open. In order to maintain the safety of the equipment and personnel, these gate should remain operational.

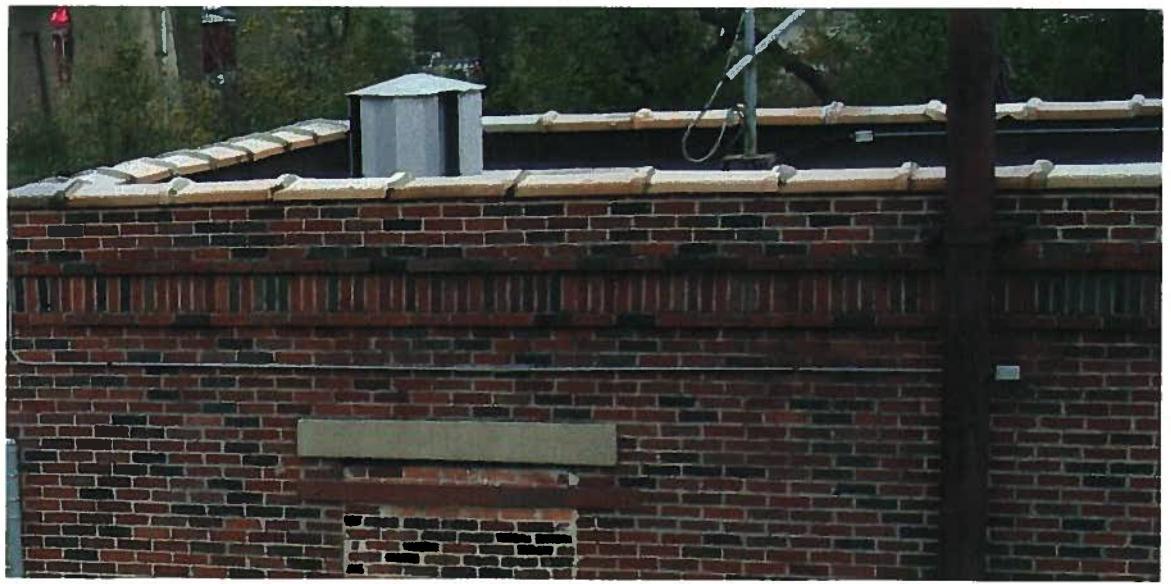
Photo 3.9 - SAX Brickwork and Capstones

The building as a whole appears to be in excellent condition, with only minor repairs needed. The brickwork is in excellent condition, with no signs of cracking or movement, and there are signs that the joints were re-pointed. The joints of the capstones surrounding the roof are poorly grouted and in need of attention. (Photo 3.9)

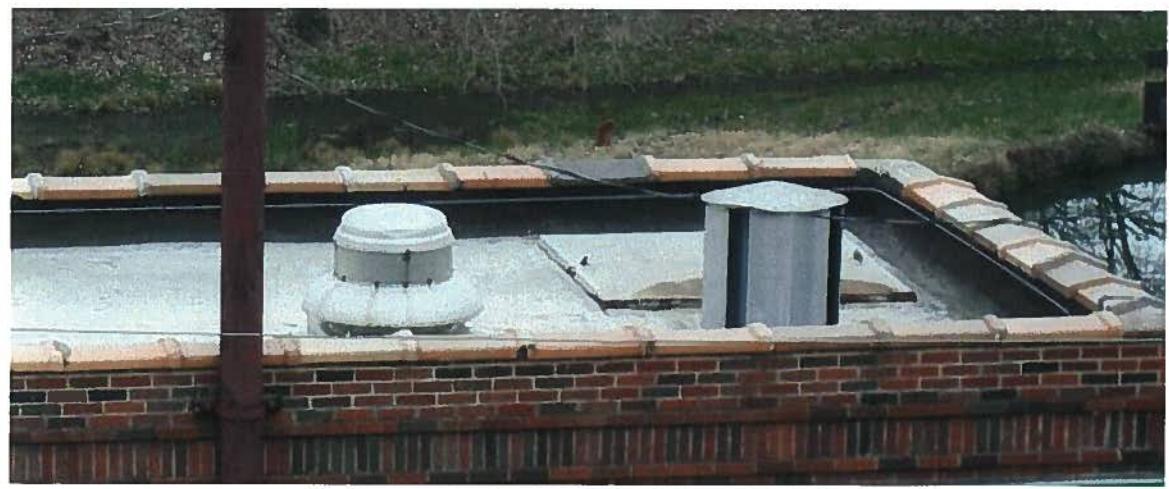
There are signs of the roof leaking on the northeast interior of the building that is also mentioned below in the section covering the interior inspection. The roof is concrete, designed with a large equipment hatch above each pumping unit to allow crane access. (Photo 3.10) These hatch penetrations do not have a sufficient lip height above the roof's surface to prevent water from entering the pump room if the roof does not drain properly. This may be part of the problem. The south hatch has a large amount of corrosion in a circular pattern, indicating the possibility of ponding. This can be seen on the southwest corner of the building's roof, which can be seen in Photo 3.10.

Photo 3.10 - SAX Roof, South End

There is minor corrosion on the North equipment hatch, but only on the edges. Cleaning and painting is all that would be required. The scupper or downspout may be partially blocked and is also leaking at its point of penetration. The roof's surface is clear of any debris and there are no dark areas indicating a ponding problem on the remainder of the roof.

- The equipment hatch penetrations do not extend above the roof's surface sufficiently and allow leakage into the pump room, in the event the roof does not drain properly. A modification extending the lip a minimum of 4" above the roof's surface is suggested. This could be accomplished by adding an internal collar, welded or bolted with a sealant added between the existing and new surfaces.

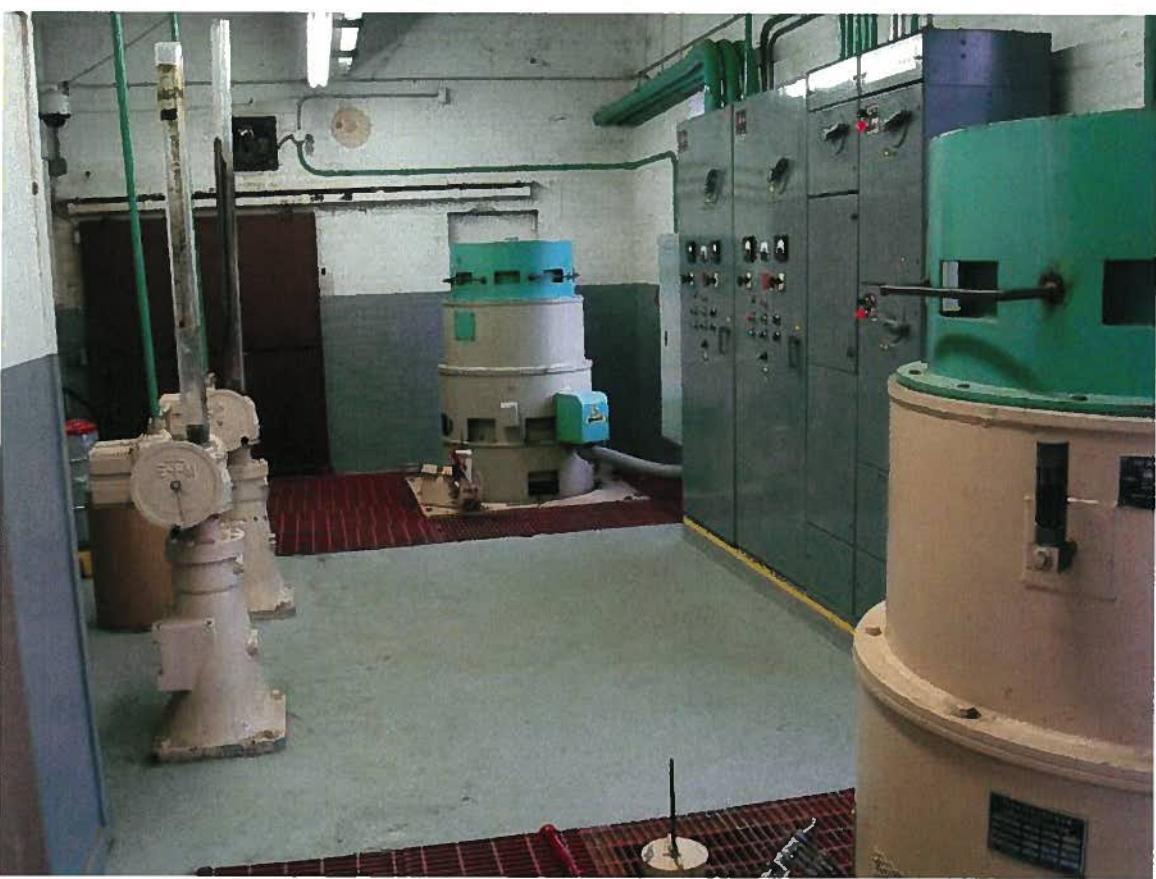
Photo 3.12 - SAX Pump Room's Interior

The electrical cabinets are raised off the floor slab and mounted against the wall. (Photo 3.12) Electrical service enters the building through the upper northeast corner of the building. The electrical service enters the switchgear from the top. Only the motor leads exit from the lower sides of the cabinets, while the remaining runs exit the top of the cabinets through wall-mounted conduits to the circuit panels and breakers. All appear to be in excellent shape. This station was a well laid out design for its day.

Preventative maintenance and most repairs on electrical switchgear and equipment are performed by the Division's Electrical section. As seen in above Photo 3.12, this equipment has been well maintained. Each component is inspected and cleaned twice a year. All technical sections within the division make routine inspections and perform related preventative maintenance which is recorded in weekly reports.

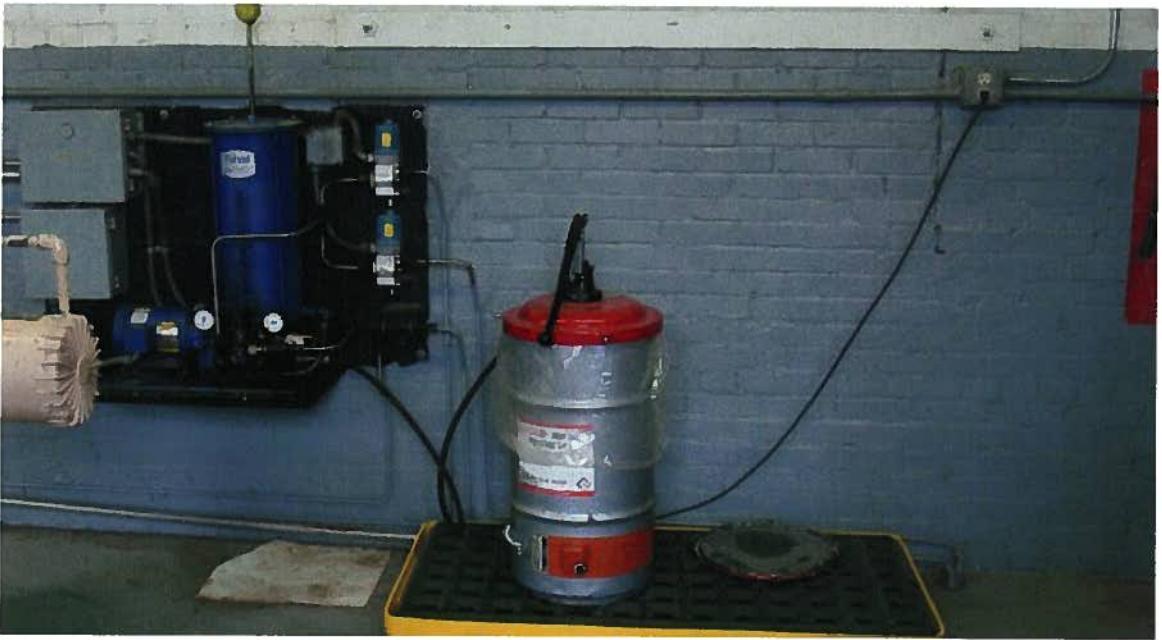
Photo 3.15 - SAX Farval Lubrication System

The Farval lubrication system (Photo 3.15) provides each pump with a measured amount of lubrication at prescribed times. The transfer of grease from the storage container to the Farval's main cylinder has experienced some problems with air pockets. If the Farval system fails to operate correctly, there are alarms in place that prevent a pump from starting or take the pump off line. These alarms transmit to the SCADA, informing the operator of the problem.
