CITY OF DALLAS INTERIOR LEVEE DRAINAGE STUDY WEST LEVEE – PHASE II

VOLUME 2 of 2 – PUMP STATION ASSESSMENTS

January 2009

Large Able (LAX) Pump Station

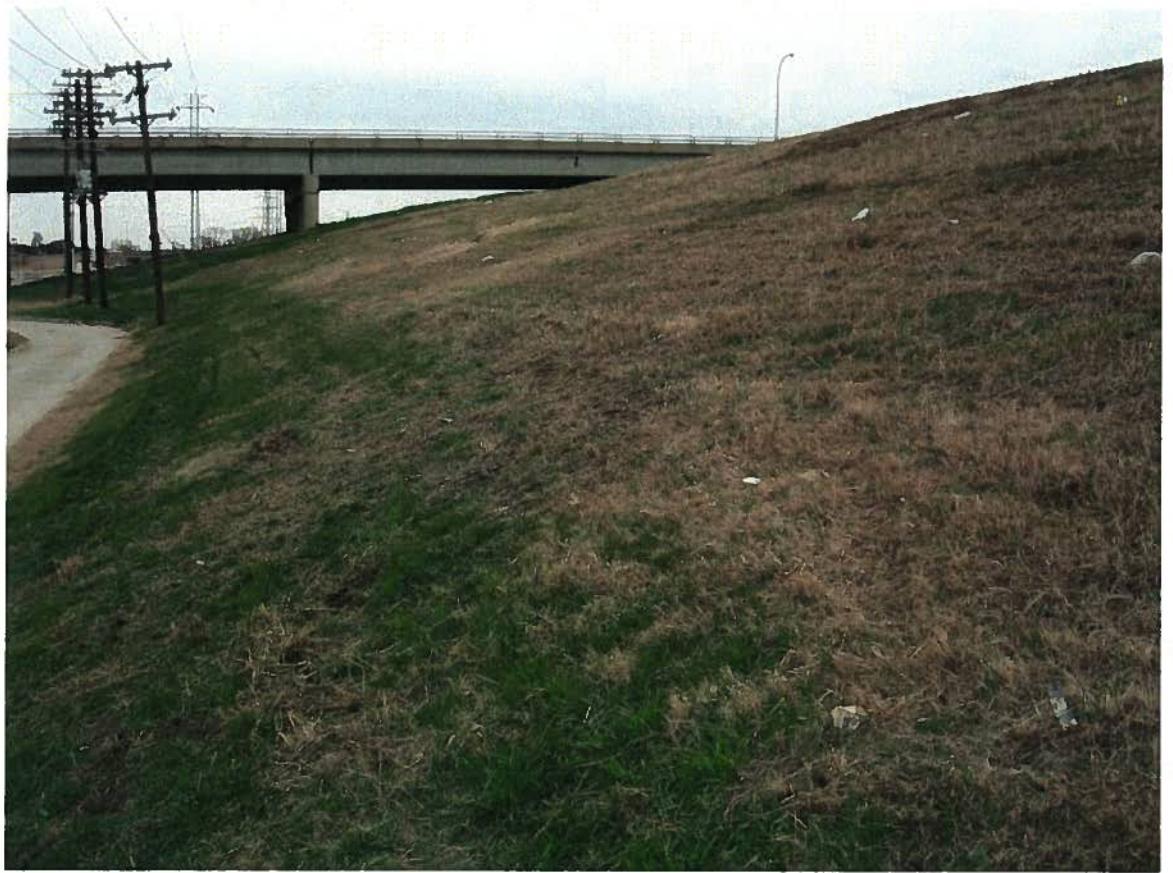
The east side of the levee facing the station is well maintained with the slope even and smooth. There is excellent grassy ground cover throughout the east side of the levee. Trash seems to be a problem at this site, both from the trash blowing in from the sump area and from the homeless that frequent the area. (Photo 3.17) The road on top of the levee ends prior to reaching this site but there is a road at the bottom on the station side which extends south. This route does provide Flood Control personnel access to other areas of responsibility.

Photo 3.16 - SAX Station Side of East Levee

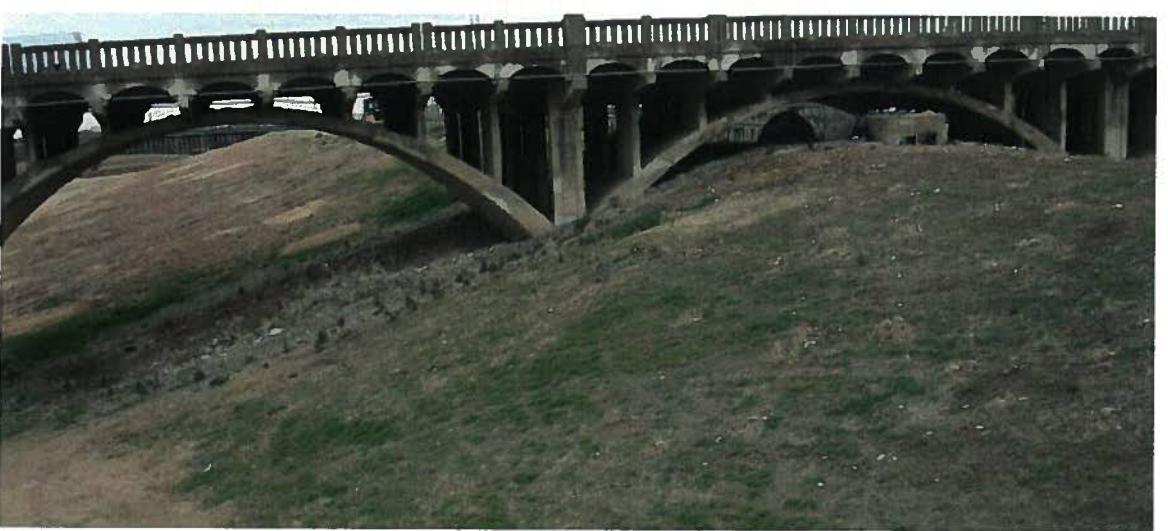
The west or river side of the levee to the north is in good condition. There is vegetation coving most of the slope, but vegetation is sparse in areas lacking full sunlight. (Photo 3.17) To the south, a concrete apron covers the slope beneath the bridge crossing the levee and the vegetation is growing up to the edge of the apron. (Photo 3.18)

Photo 3.17 - SAX Levee Looking North

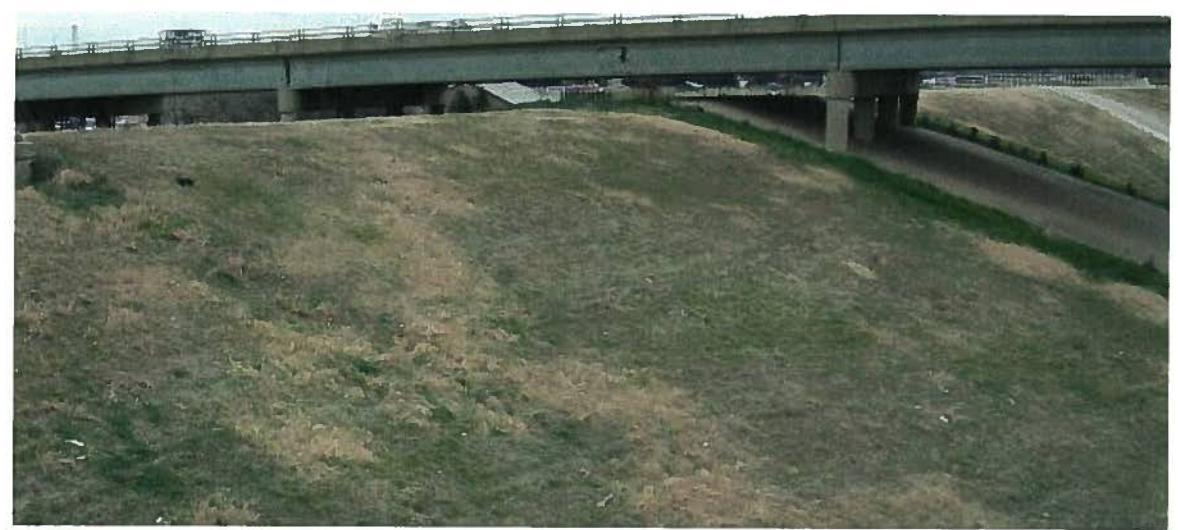
Photo 3.18 - SAX Looking South

The slope is covered in shallow ruts that were caused during mowing, probably because the ground was wet at the time of mowing. These should level out over time.

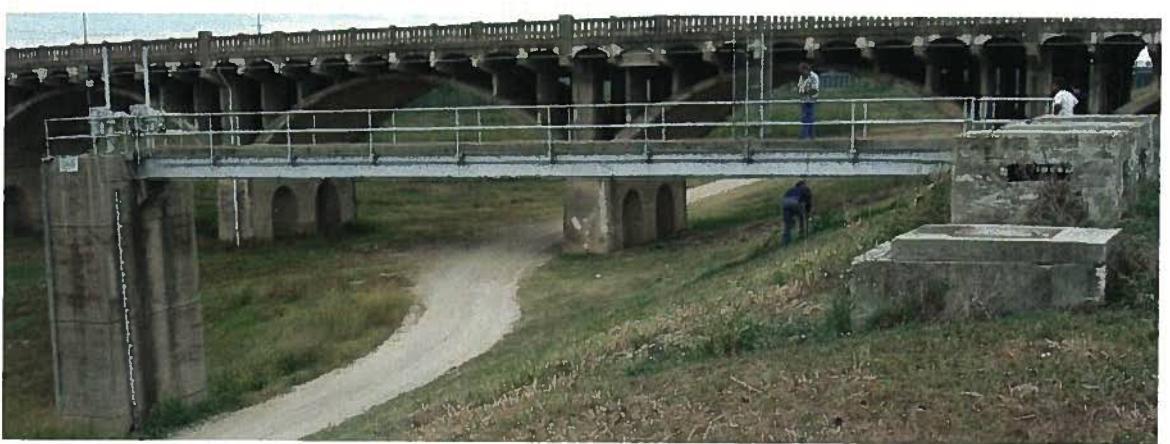
The elevated bridge and valve vault appear to be in excellent condition. There are not any noticeable signs of the concrete structure moving or cracking. The metal bridge and its concrete walkway are also in excellent condition. (Photo 3.19)

Photo 3.19 - SAX Valve Structure and Elevated Bridge

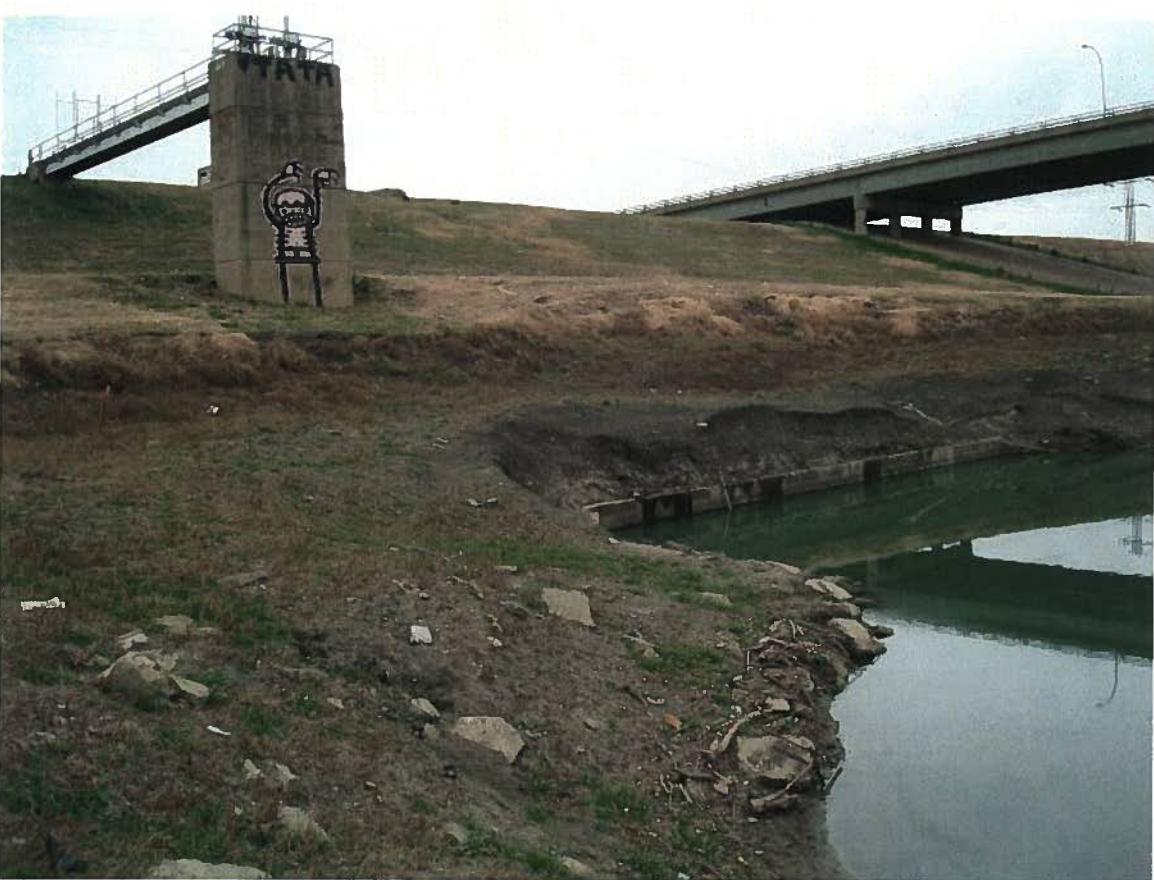
The area surrounding the outlet structure is lightly vegetated dropping off to loose soil just above the structure. There are no signs of previous rip-rap. Although there had not been significant rainfall at the time of observation, there were signs of water leeching from the soil above the structure. The lose soil appears to be very unstable and likely to continue washing down in front of the structure into the outfall area until the area is stabilized. (Photo 3.22) The outlets are beneath the water's level and the water is too murky to determine any existing conditions below the water line. The exposed portion is in excellent condition.

Photo 3.22 - SAX Outfall structure, Valve Vault and Bridge Upper Left

- It is recommended that the City of Dallas expedite repairs needed on the North sluice gate.
- This site be considered for adding appropriately sized rip rap to surround the Outlet structure as a measure to stabilize the area.
- Personnel have no safe access up or down the levee. A stable pathway should be added.
- The addition of lights and GFI outlets installed on the valve vault would be helpful to personnel required to inspect and work on its equipment.

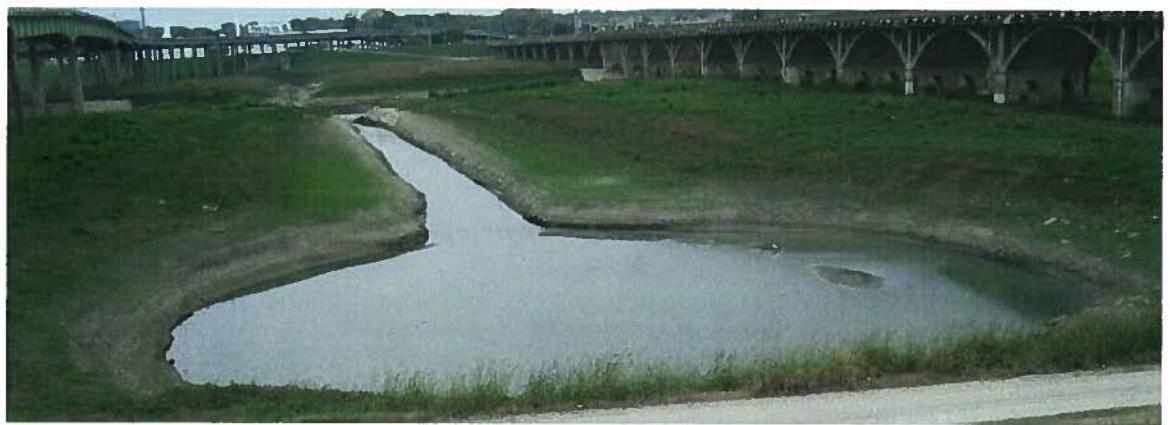
The circular pond of water at the structure's discharge shows heavy silting on the Northwest portion of this area. (Photo 3.23) This could be the soil that washed down from above the outfall structure. It is recommended that the area surrounding this structure be graded down and replaced with the appropriately sized rip-rap.

Photo 3.23 - SAX Outlet Pond and Channel

The banks along both sides of the outfall channel make a smooth transition to the water's edge with excellent vegetation growing within a couple of feet of the water's edge. (Photo 3.23) The channel to the river was clear of obstacles.

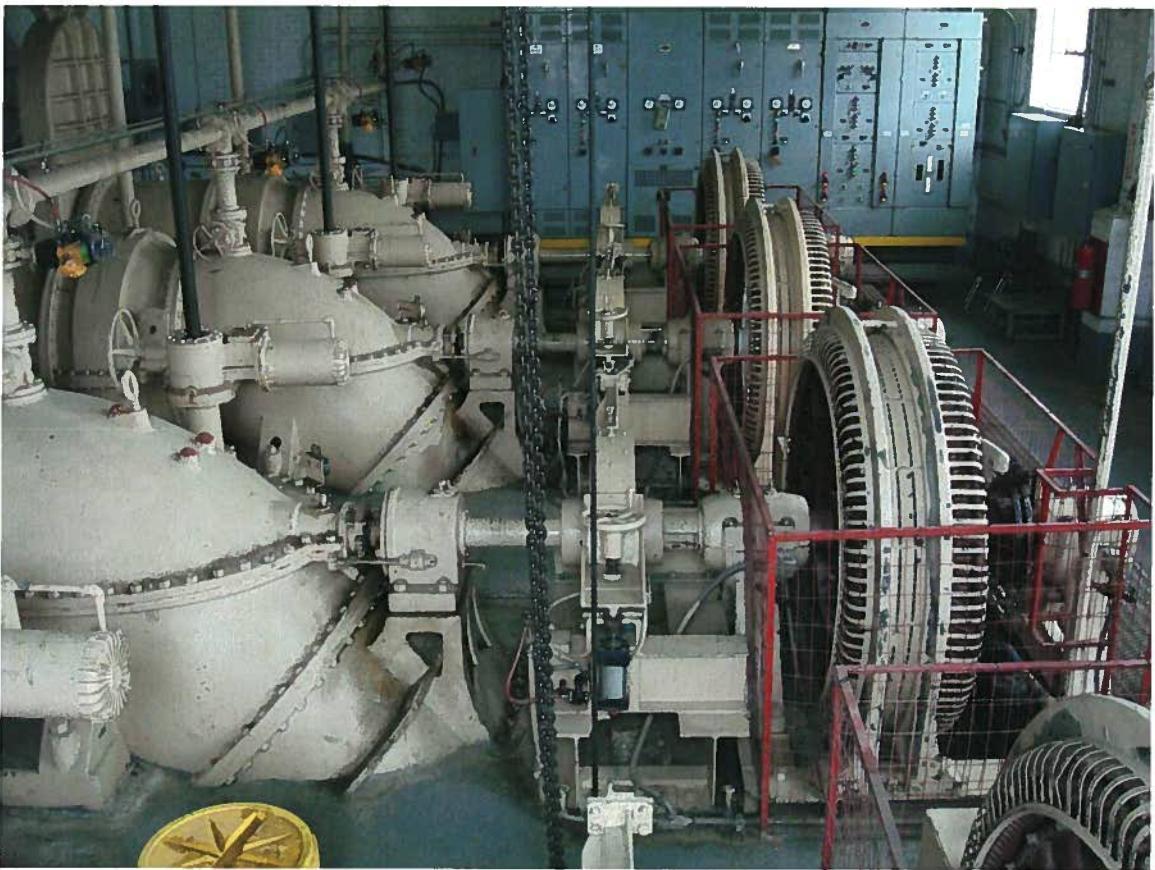
The building equipment consists of four horizontal pumps and motors; a priming system consisting of two vacuum pumps, an air compressor and pneumatically operated valves attached to a header system to carry off the priming system's wastewater; four large gate valves for isolating the pumps; switchgear, motor controllers, circuit panels, electrical conduit running throughout the structure to the equipment, one abandoned in place oil lubricating system and one active automated grease lubricating system. (Photo 3.3) Open area and workspace is very limited, making removal of equipment difficult and hazardous.

Photo 3.3 - OBX pump room looking north from South entrance

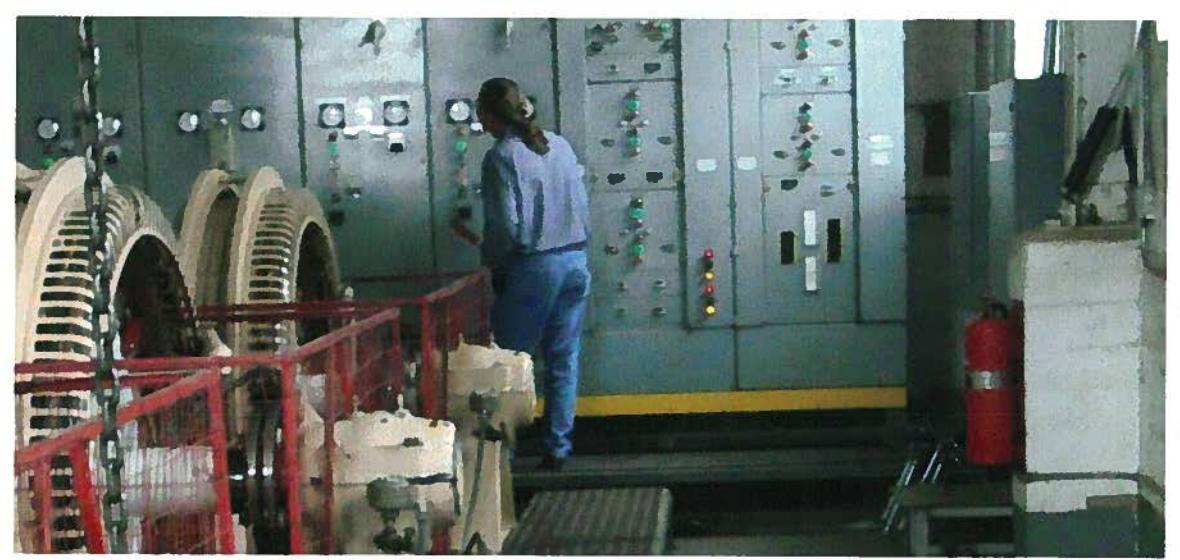
The switchgear and motor controllers are in excellent operational condition for their age but protective relays are minimal by today's standards.

Photo 3.4 - OBX open platform mounted switchgear

The cabinets are mounted against the North wall (Photo 3.4) on an open framed platform. The electrical service enters the station through the North wall with exposed buss bars (Photo 3.5) running down the wall into the top of the gear. These busses are surrounded with a wire cage in plain view. Electrical conduits exit the bottom and are routed along walls and floor to equipment and breaker panels.

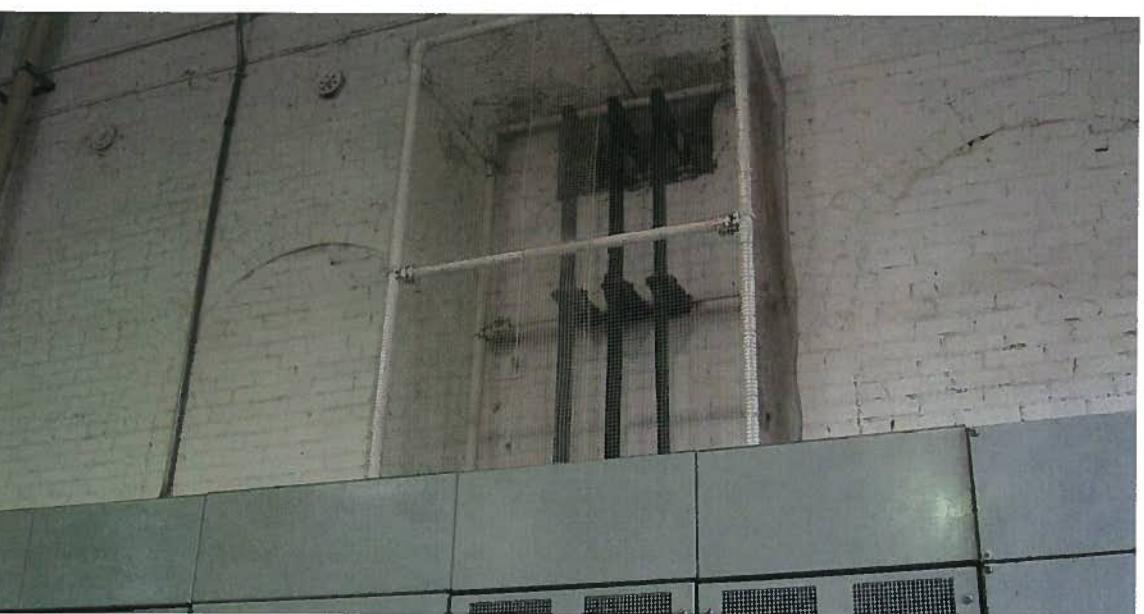
Photo 3.5 - OBX Buss bars on North wall

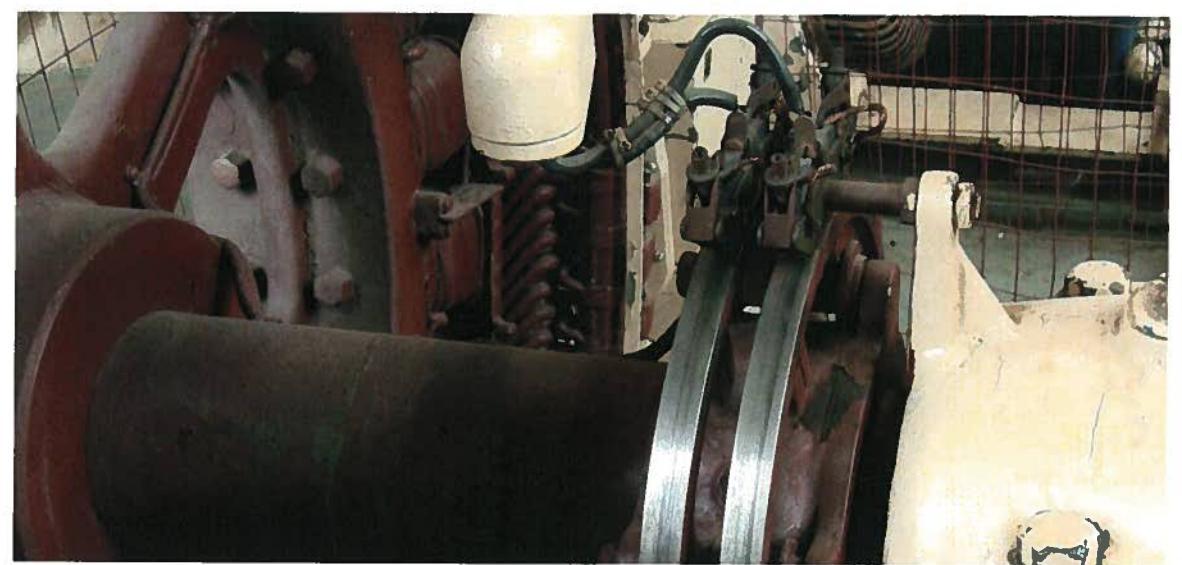
- Age of pumps and motors The station's four horizontal units, with its synchronous type motors, have a very old and outdated configuration with exposed slip rings, brushes, rotor, stator and braking system on the coupler. (Photo 3.6) To operate safely and efficiently, these exposed slip rings require a clean and polished surface or the brushes vibrate, causing arching, which in turn causes pitting of the rings. This pitting and arching escalates. Left unchecked, this will cause destruction of the slip rings, motor failure and fire. The bearing surfaces of any horizontal unit not routinely run will develop flat spots, resulting in vibration and ultimate bearing failure. This type of motor is best suited for long and continuous run times, where maintenance and/or operation staffs are available to monitor the units in operation and keep exposed slip rings clean. These units were not new when delivered. They were acquired from New Orleans, Louisiana in 1945. Although they are operational and reliable, their age is well beyond their useful life expectancy. Large synchronous motors were beneficial for keeping electrical cost down. Induction motors fitted with capacitors are now commonly being used to gain the same electrical cost benefits associated with synchronous motors.

Photo 3.6 - OBX Motor brushes and slip rings

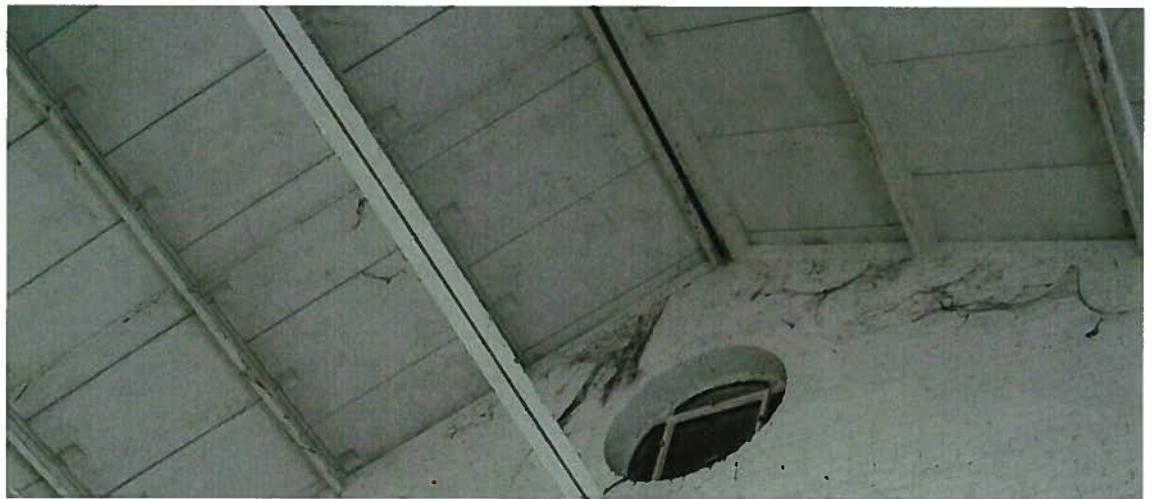
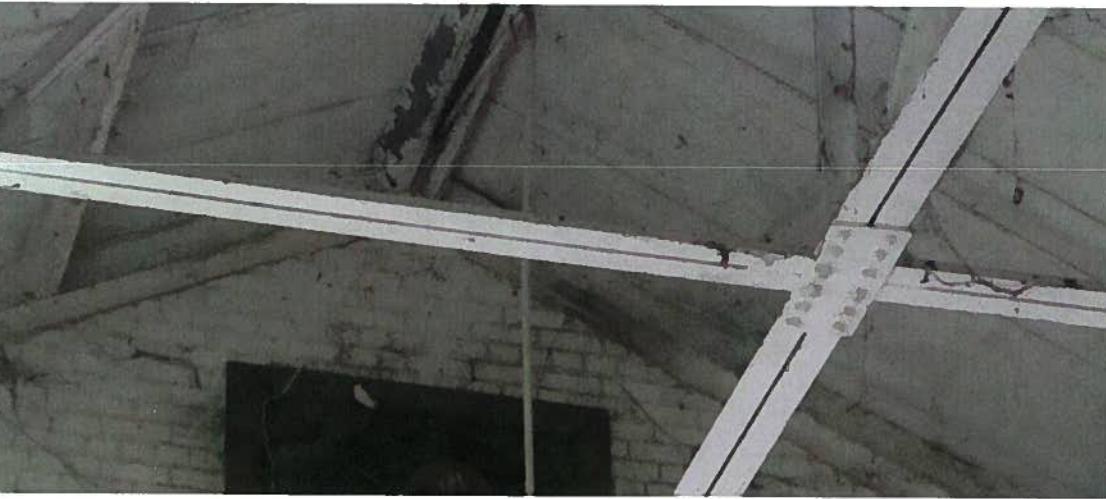
The building's roofing system on the interior requires only minor maintenance with rust removal and painting of the metal supports (Photos 3.7 & 3.8).

Photo 3.7 - North Interior Roof Peak

Photo 3.8 - South Interior Roof Peak

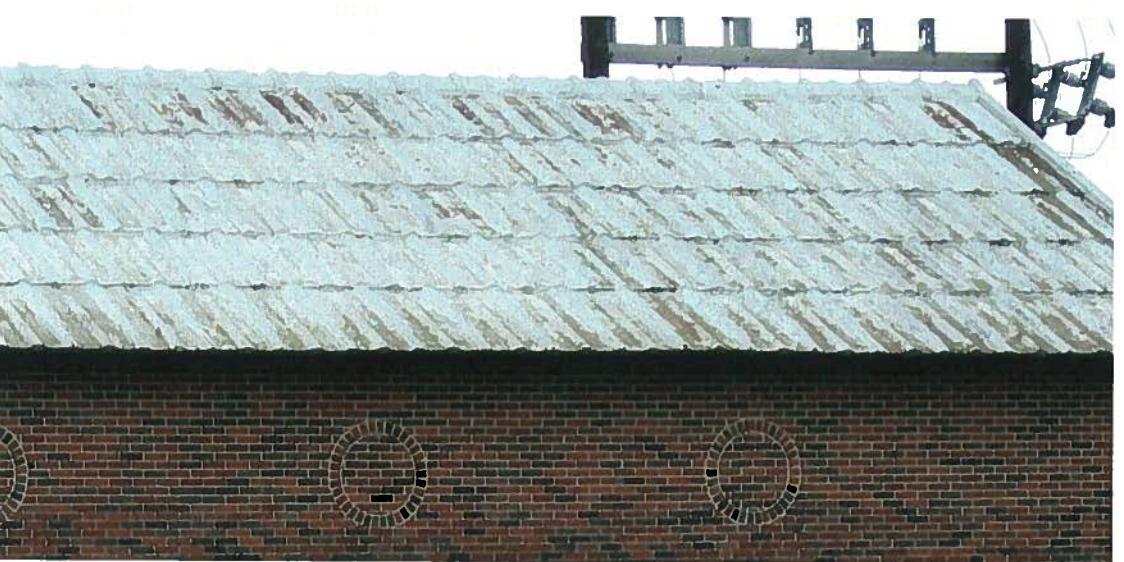
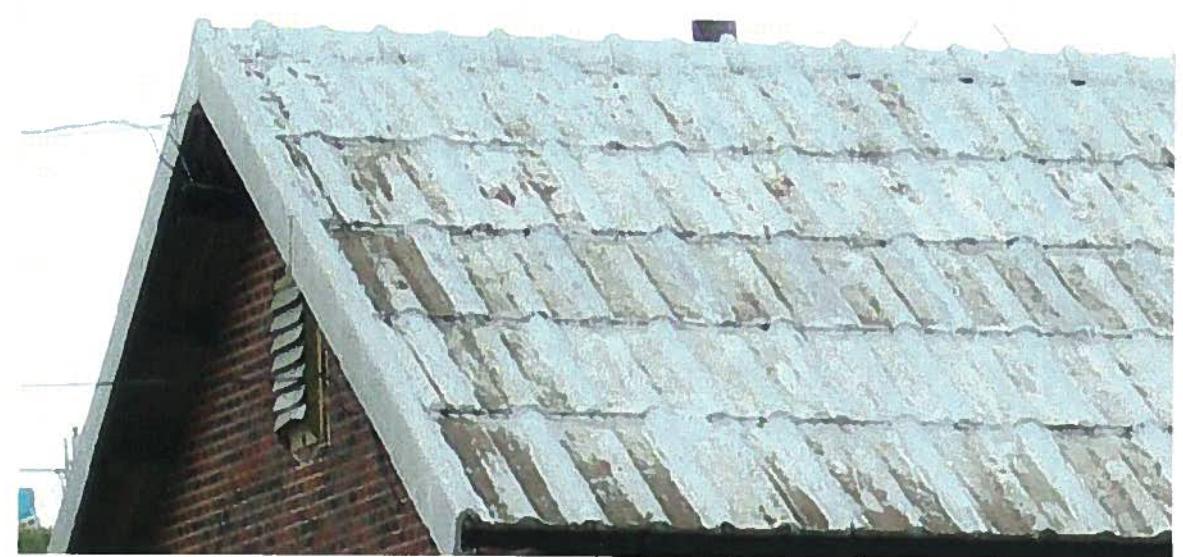
The exterior of the roofing system appears to be in excellent physical condition. There were no broken tiles noticed and all shingles were overlapped properly. There is staining discoloration (as seen in Photos 3.7 & 3.10) that appears to be rust. This could be a sign that water has leached under the surface, corroding the fasteners that hold the roofing system in place. As a precaution, this should be inspected and verified by a roofing contractor or the City of Dallas' Building Services.

Photo 3.9 - East Roof exterior

Photo 3.10 - East Roof Exterior Close-up

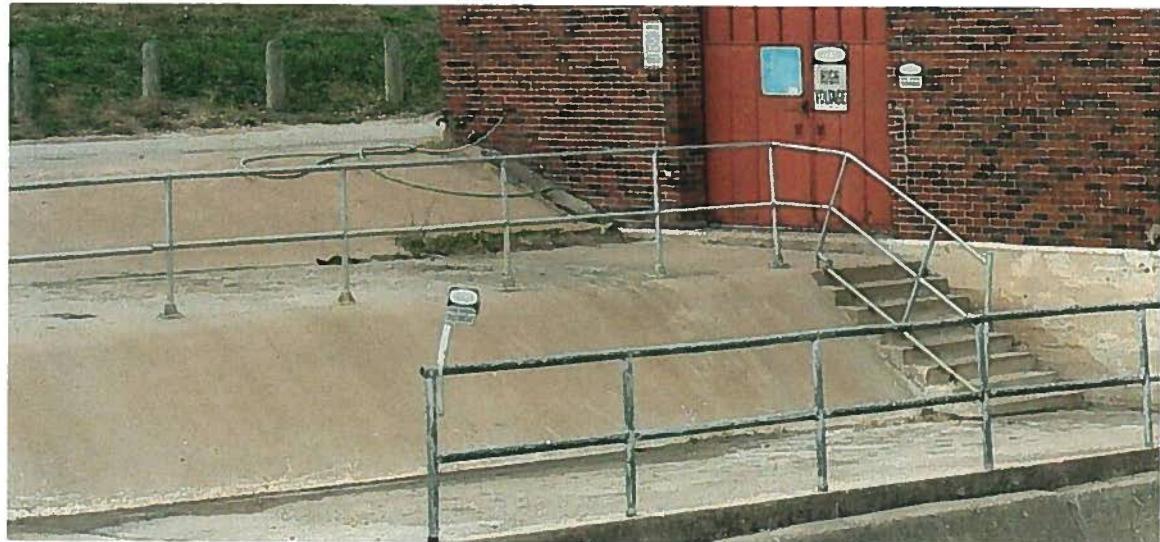
Rolling concrete drives are around the perimeter of the pump station. (Photo 3.11) The routine use of heavy equipment at this location without any warnings of an uneven road surface has the potential of vehicle's wheel catching an edge and veering over into the station or personnel. If the driver attempts to compensate by pulling back the load could roll off and could also cause injury or damages. Marking the pavement areas with rubber traffic poles, street reflectors or paint would provide drivers better visibility, especially during foul weather and at night. The installation of permanent barricades is recommended. As an alternate, a removable barricade system would provide added protection.

Photo 3.11 - Rolling surfaces

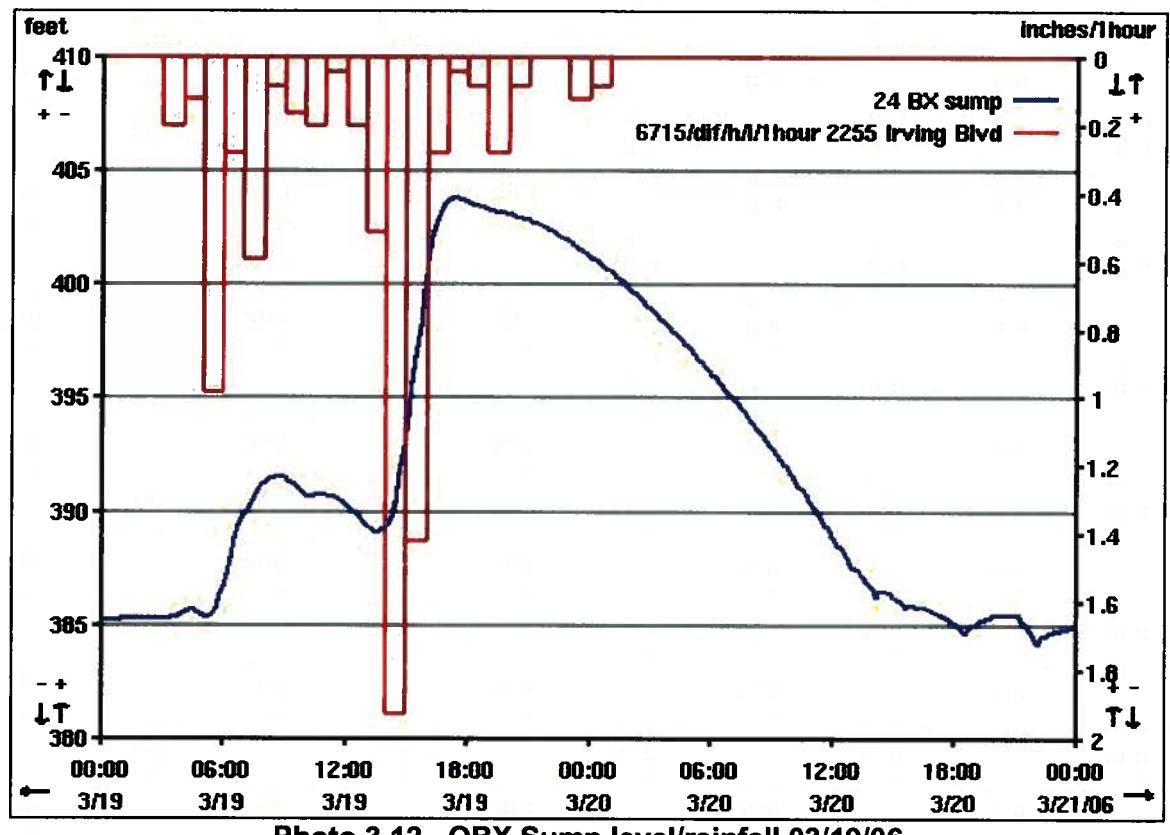
Photo 3.12 - OBX Sump level/rainfall 03/19/06

The graph in Photo 3.12 shows water levels reached at or above 404.0 msl. This station could be lost to flooding if rainfall exceeds the event of March 19, 2006. The employees reported that the water level was above the bottom of the Irving Blvd. Bridge, shown in the upper left corner of Photo 3.13. The station has several 2" holes core drilled through the floor to remove standing water. These holes are secured with threaded stoppers during high water incidents. During the period mentioned, even though the drainage holes were plugged, water was observed seeping through small cracks in the pump room floor. The entrance to the station (Photo 3.11) had to be sandbagged as water levels threatened the station. The pump room floor is even with the bottom of the staircase, also seen in Photo 3.11. With a water level at the station's only point of entrance and exit, the station would be flooded with over four foot of water instantly submerging motors and switchgear. Any personnel in the station could be easily injured, drowned and/or electrocuted, with fatalities a very real possibility.

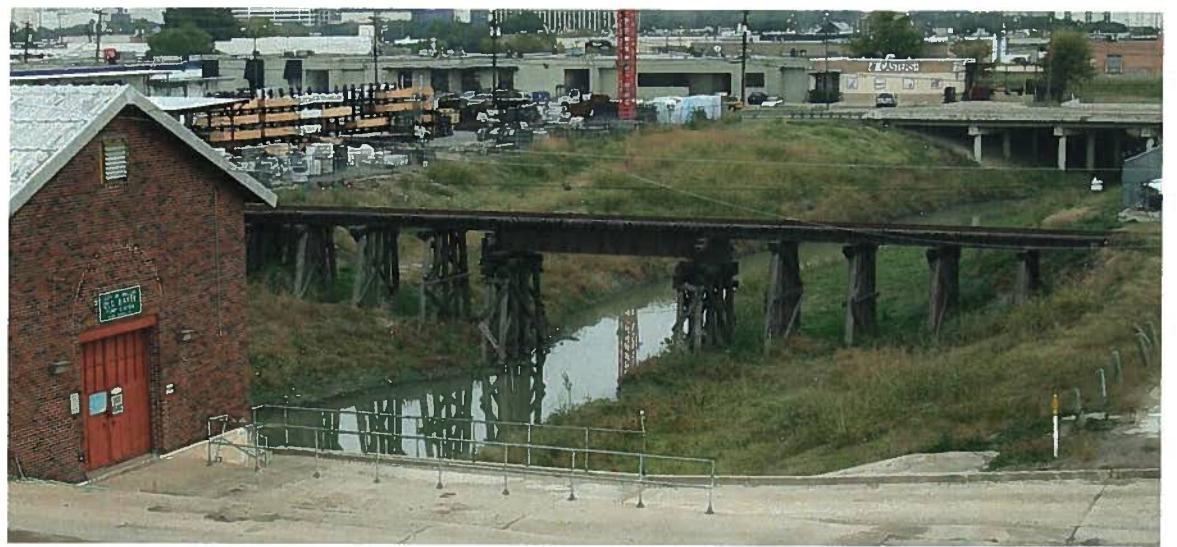
Although not the property of the City of Dallas, the railroad bridge west of Irving Blvd. (Photo 3.13) is a concern. The supporting timbers capture a large amount of debris, creating a restriction to the flow of water and increasing the potential to damage the bridge. The City of Dallas and the railroad might both benefit if a new bridge structure was built. A low water weir with a sluice gate built into the new bridge would provide a way to isolate the sump area from inflow for maintenance activities. This would be much easier and safer than the use of sandbags, which is the current practice.

Photo 3.13 - Top of OBX Levee looking to Irving Blvd. Bridge

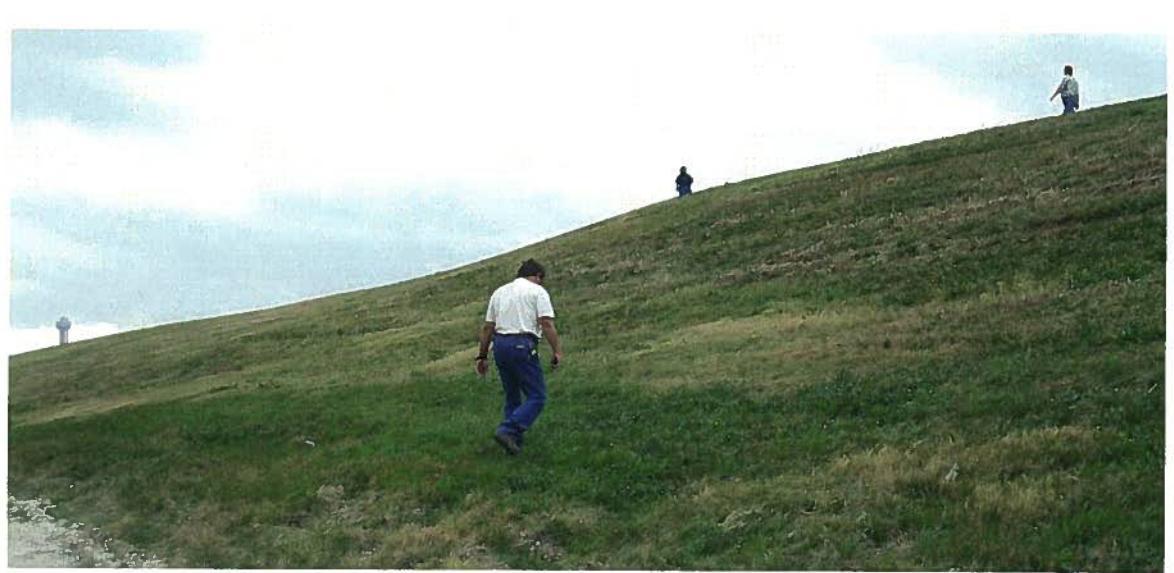
The levee has poor pedestrian access. Climbing to the top of the levee is a safety hazard. (Photo 3.16) The only safe method for accessing the outfall structures on foot is to walk the road intended for vehicular traffic +/- 500 yards north and then back +/- 500 yards to the outfall structure. Employees climb the slope for routine inspections. This is difficult in good weather conditions but these stations are only in operation in foul weather, and when it becomes necessary to check the outfall, it would be nearly impossible. I recommend a safety measure to improve the staff's accessibility by designing an acceptable pathway that would not interfere with grounds maintenance. A slightly recessed narrow stairway with removable rails has been used at other City of Dallas locations with success.

Photo 3.16 - OBX Levee access to Outfall Structures

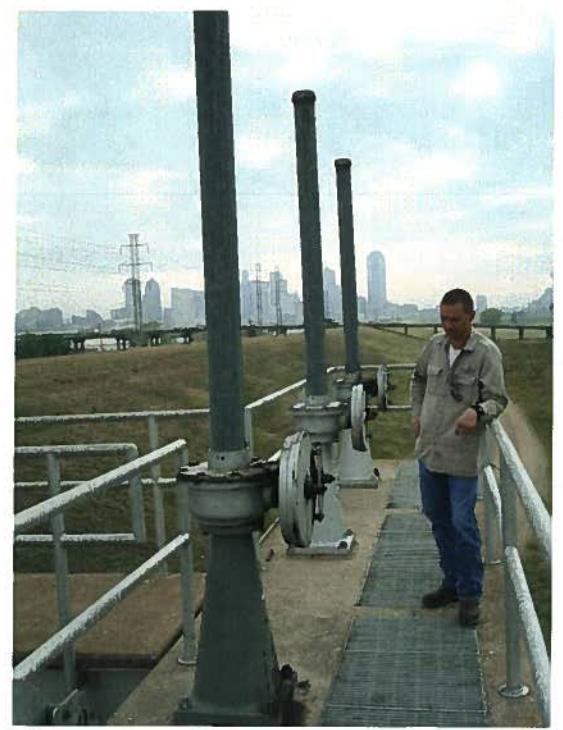
The outfall gates were in the fully open position, with the threaded portion of the shaft protected by a slotted metal sleeve (Photo 3.17). The slot provides a visual indicator for the valve's position. It also allows a visual inspection of the threads. The threads were clean with no signs of any build up of grease or dirt. Each shaft is properly coated with a light application of grease.

Photo 3.17 - OBX Outfall Sluice Gates

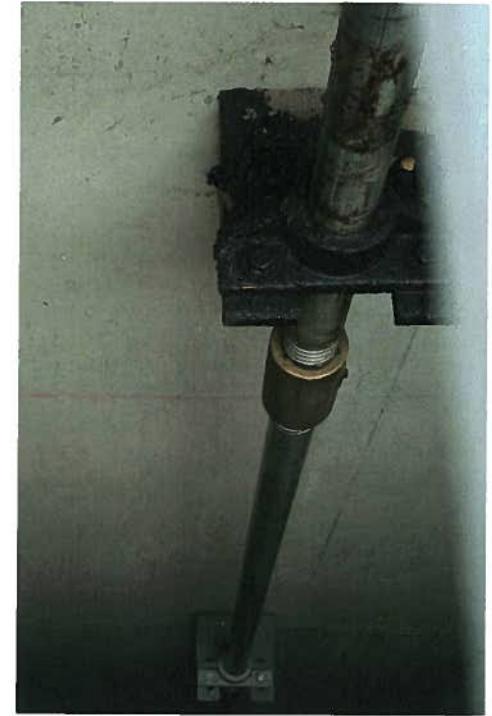
The portions of shafts extending down through the structure (Photo 3.18) to the gates were also clean and greased. Employees operated and performed maintenance on these valves the week before inspection. Each shaft was visually observed while the shafts rotated with no out of true movement. The braces holding the shaft did not show any movement while the shaft was in motion. The base of the Operator showed no signs of being separated from its foundation. This can be caused by over torque.

Photo 3.18 - OBX sluice gate shaft in Outfall Structure

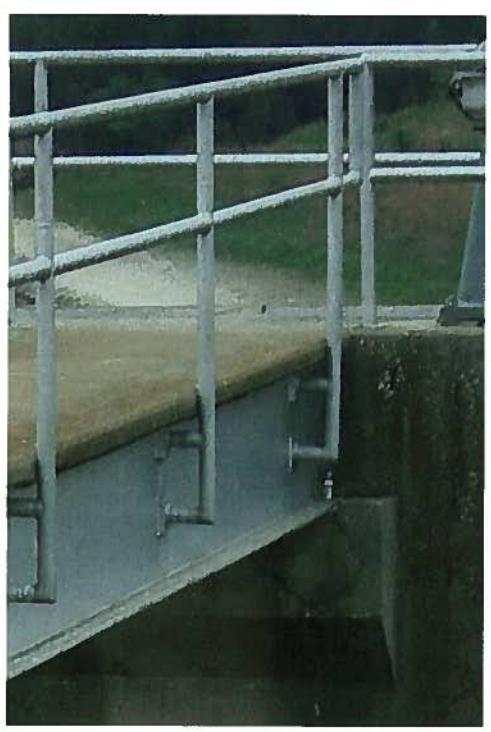
• The outfall structure (Photos 3.19, 3.20 & 3.21) has one visible structural defect on the Northwest point where the bridge anchors to the main structure. This appears to have been patched in the past. There is a slight misalignment being caused by movement between the structure and the landing on the levee. Because of the weight bearing down on this support and the fact that this is a reoccurring problem, it would be advisable to have a structural engineer inspect this and determine what action is needed.

Photo 3.20 - OBX Bridge Support

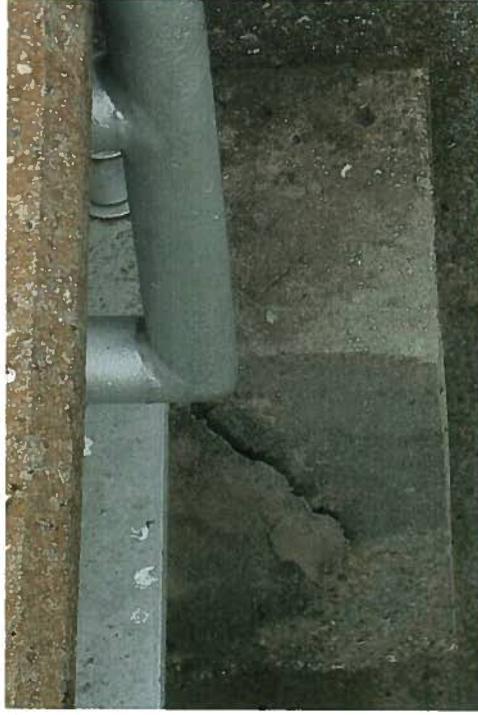
Photo 3.21 OBX Support Closeup

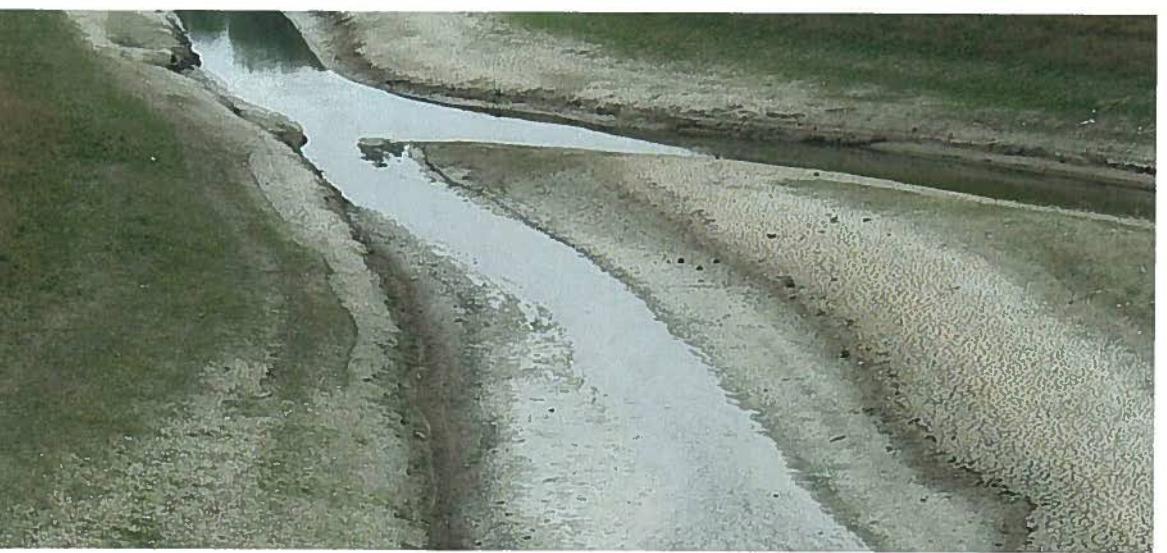
• The Outfall channel has a slight build-up of silt with heavier build-up at the junction where the channels of the two stations intersect. (Photo 3.22) OBX does not run very often, averaging only 2 or 3 times annually. This is not a problem at

There is some very minor slippage along the South bank of the outfall channel that needs to be monitored. It does not require any action at this time.

Photo 3.22 - OBX and NBX Outfall channel to of the Trinity River

the current time but the channel should be dredged when time and equipment become available.

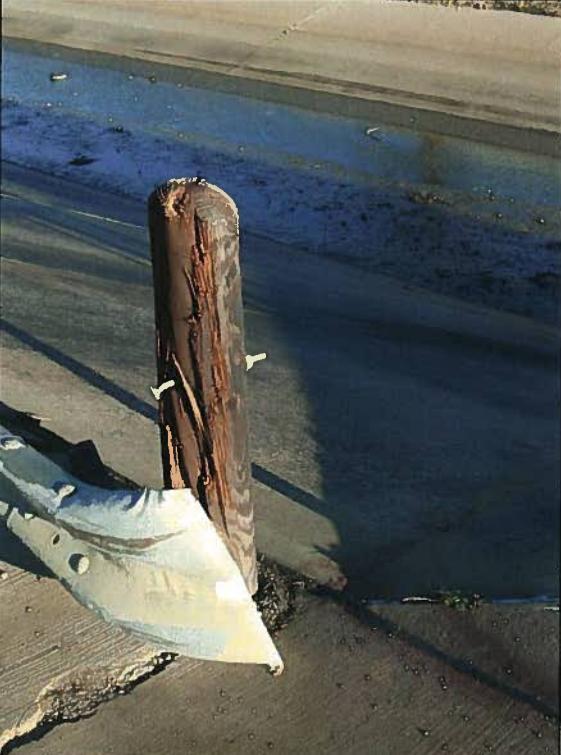
- The guardrail along the West sump wall has obvious damage (Photo 3.6). The rail is slightly bent, but reusable. The split bollard is not repairable. Due to the location, a larger bollard post composed of steel and concrete is recommended.

Photo 3.5 NBX North Wing Wall Sealant Failure Photo 3.6 - NBX Bent Rail and Bollard

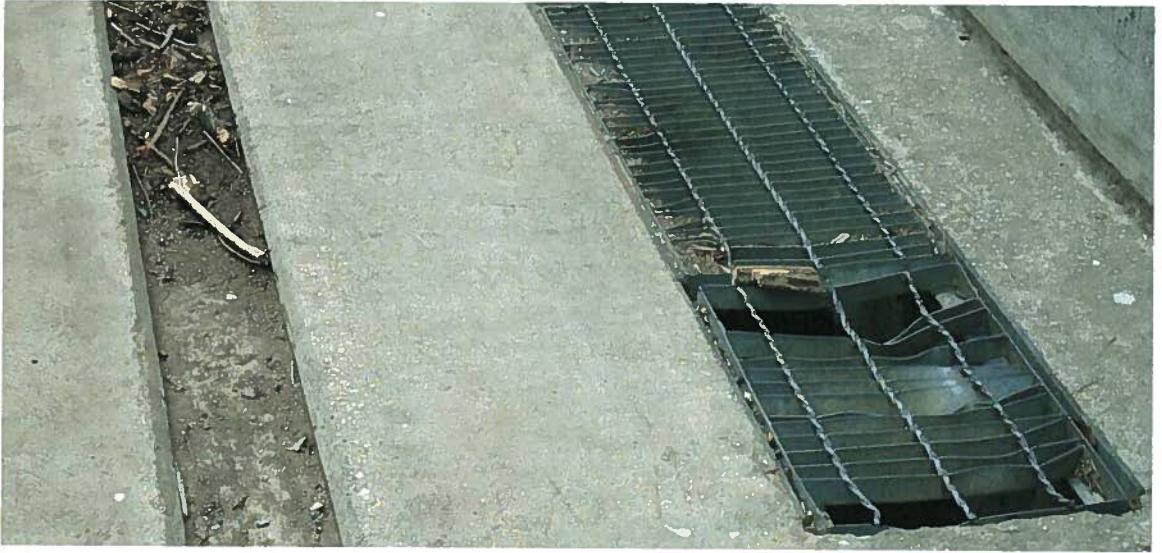
Photo 3.7 - NBX Grates Behind Screens

• The grates covering the drain holes behind the screen and rake system have been damaged. The resulting damage to the grates makes them a trip hazard and unusable. (Photo 3.7) Removal of the grates by the workers then creates even more

of a trip hazard. Replace damaged grates in high traffic areas to prevent potential injuries.

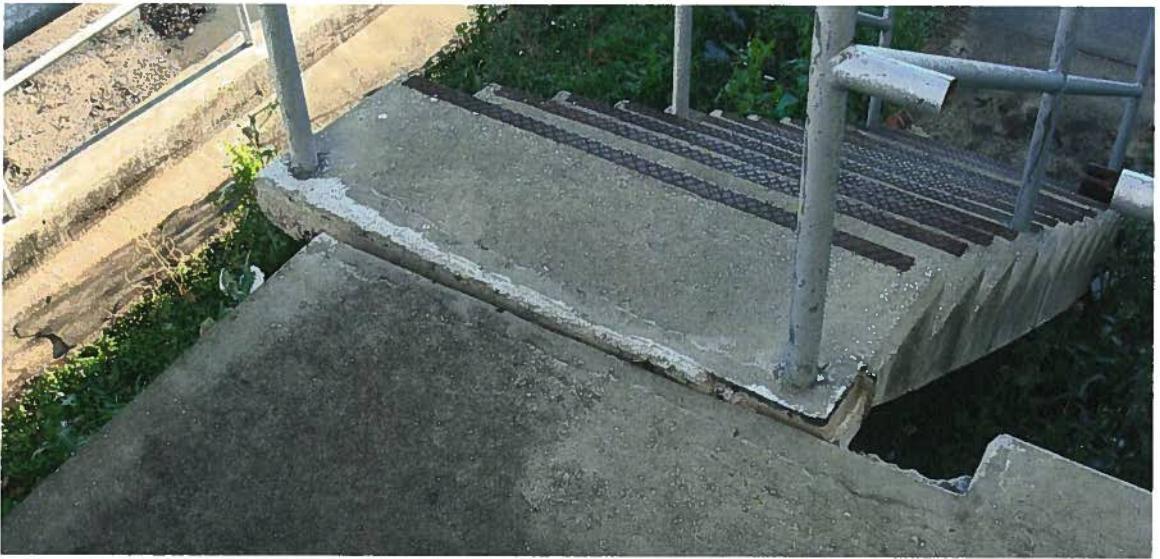
• The stairway and the handrail at the South entrance to the screens are out of alignment. (Photo 3.8) This requires the use of a crane or other heavy equipment to move it back into its original location. The steps then need to be pinned in place and handrails welded together.

Photo 3.8 - NBX Stairway to Screens

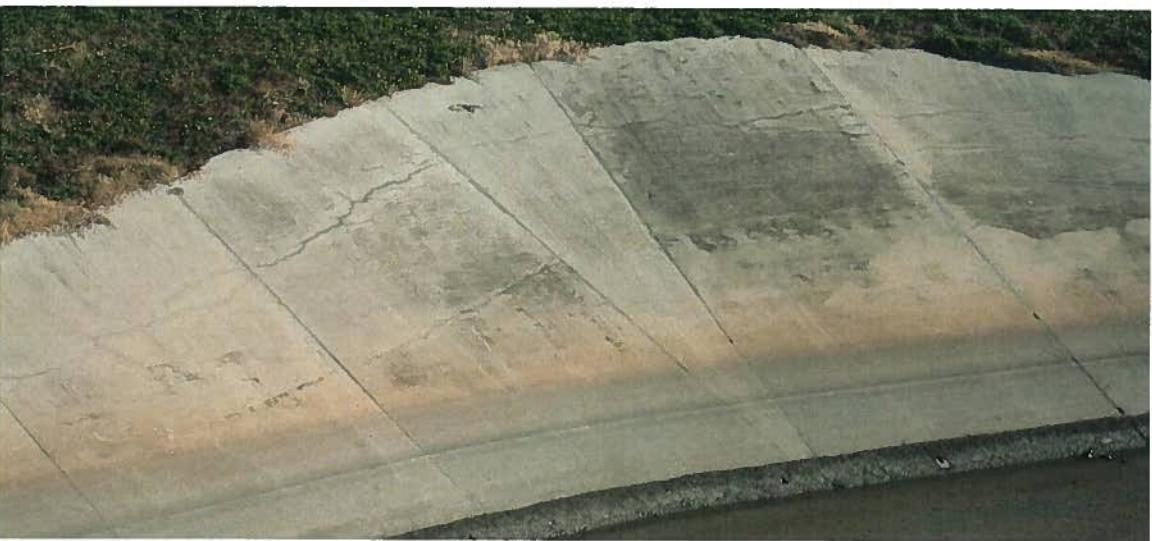
• The east apron wall of the sump area has a minor crack running north to south across the entire length. Signs of ground water seepage are present along sections of this crack. (Photo 3.9) A Structural Engineer should inspect this crack and make a recommendation.

Photo 3.9 - NBX East Apron of the Sump Area

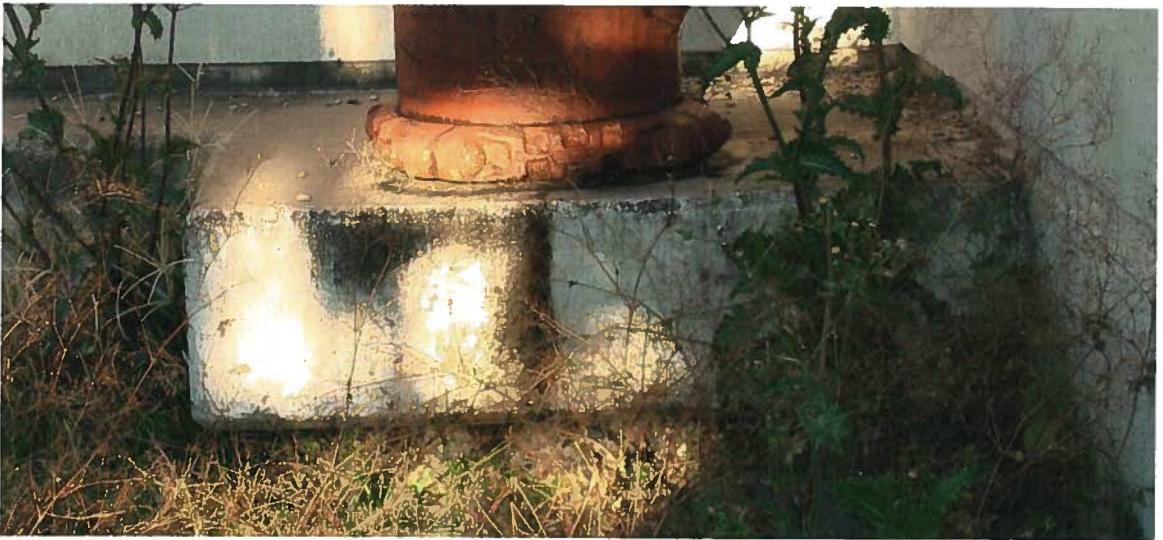
Soil has washed out the area around the Southwest corner. There is no soil supporting the section of the foundation, which serves as a support for the low flow pipe. (Photo 3.10) This should be backfilled and compacted to reduce the potential for damage to the pipe or foundation.

Photo 3.10 - NBX Low Flow Pipe Southwest Corner of Building

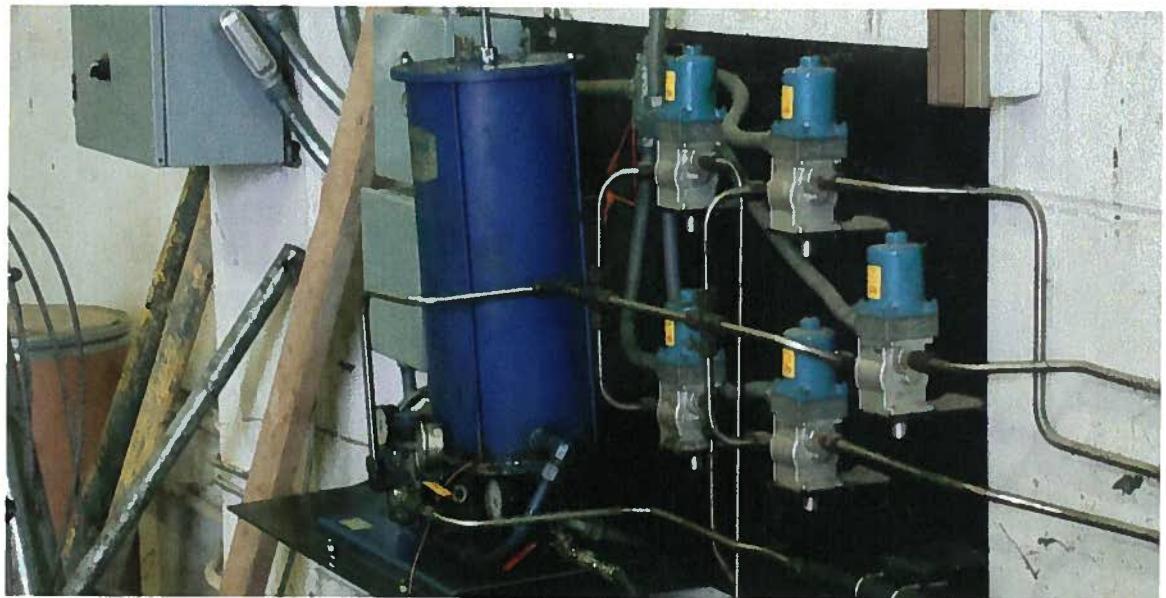
The Farval lubrication system (Photo 3.14) provides each pump with a measured amount of lubrication at prescribed times. The transfer of grease from the storage container to the Farval's main cylinder has experienced some problems with air pockets. The delivery of grease to the farthest pump is also experiencing some intermittent difficulties. When the Farval system fails to operate correctly it sends the alarm state to the SCADA. The SCADA then prevents that unit from starting. If the unit is running, the SCADA will send the unit a stop command. This alarm condition is sent to the operator's workstation informing the operator of the problem.

Photo 3.14 - NBX Farval Lubrication System
