CITY OF DALLAS INTERIOR LEVEE DRAINAGE STUDY WEST LEVEE – PHASE II

VOLUME 2 of 2 – PUMP STATION ASSESSMENTS

January 2009

Large Able (LAX) Pump Station

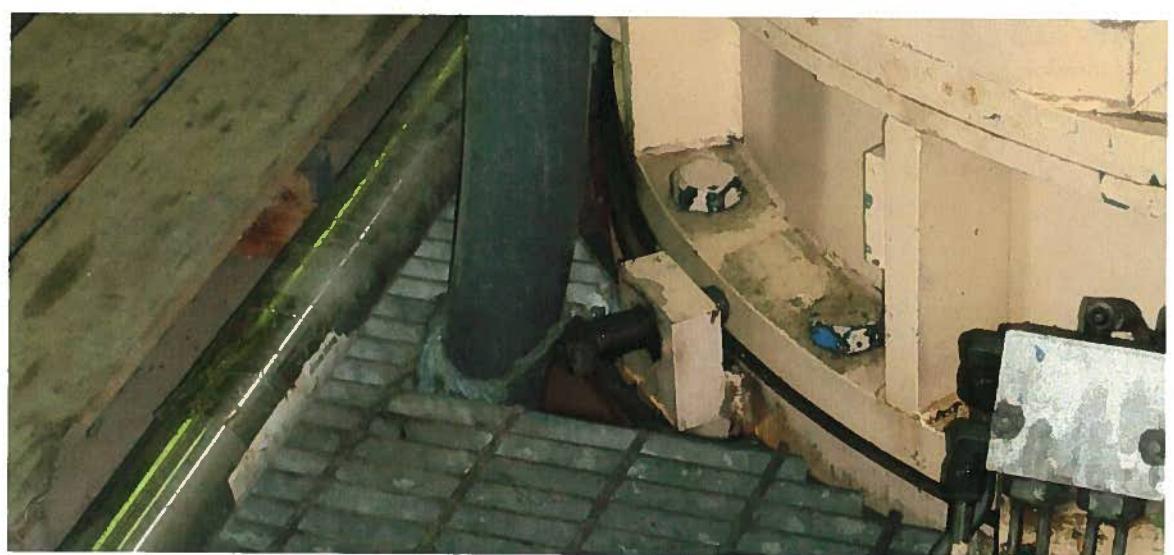
Photo 3.16 - NBX Motor Jack Bolt and Motor Leads

- Jack bolts, used during alignment, are in conflict (Photo 3.16) with other items associated with the motor. This problem exists on several units at this station. The example shown could become a serious problem if vibration causes the bolt to wear through the conduit into the motor leads. It is recommended that the jack bolt be removed once alignment is completed and the motors are bolted in place, or install a new reshaped piece of conduit for the motor leads and widen the hole through the grates to allow the conduits to be routed away from Jack Bolts.

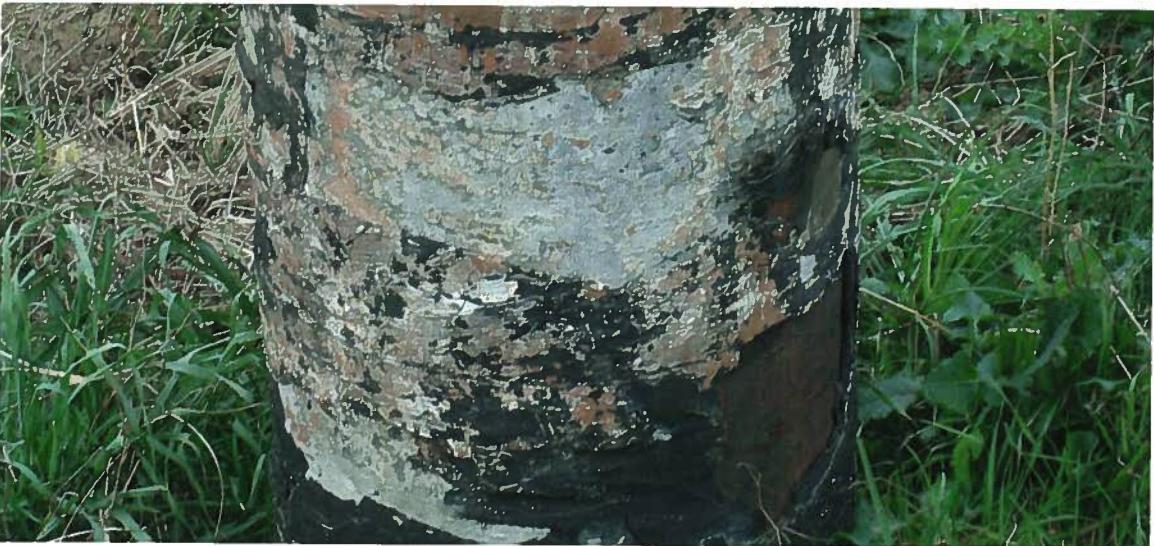
Station plans show all discharge pipes leaving the station to be made of steel. The steel on the standpipes has protective wraps exposed at ground level that are rapidly deteriorating. (Photo 3.18) The soils in the area are assumed to be corrosive and were the reason for the installation of these protective wraps. Test sections of all piping need to be uncovered and inspected to determine the condition of the pipe to check the extent of corrosion or other damages.

Photo 3.18 - NBX Corrosion on Standpipe

- Plans show that discharge pipe from NBX is steel. There are concerns for potential corrosion and metal loss.
- Corrosion on the Standpipes is serious enough to justify having the area surrounding these pipes excavated to determine how much corrosion damage there is below grade.
- Add a concrete apron or rip-rap under the heavily shaded areas of the structures in the outfall area.
- Add heavy rip-rap to the area surrounding the outfall structure to prevent further soil erosion.
- Add a footpath to the Outfall area.
- Remove silt in the channel between the Gravity Gates and the river.

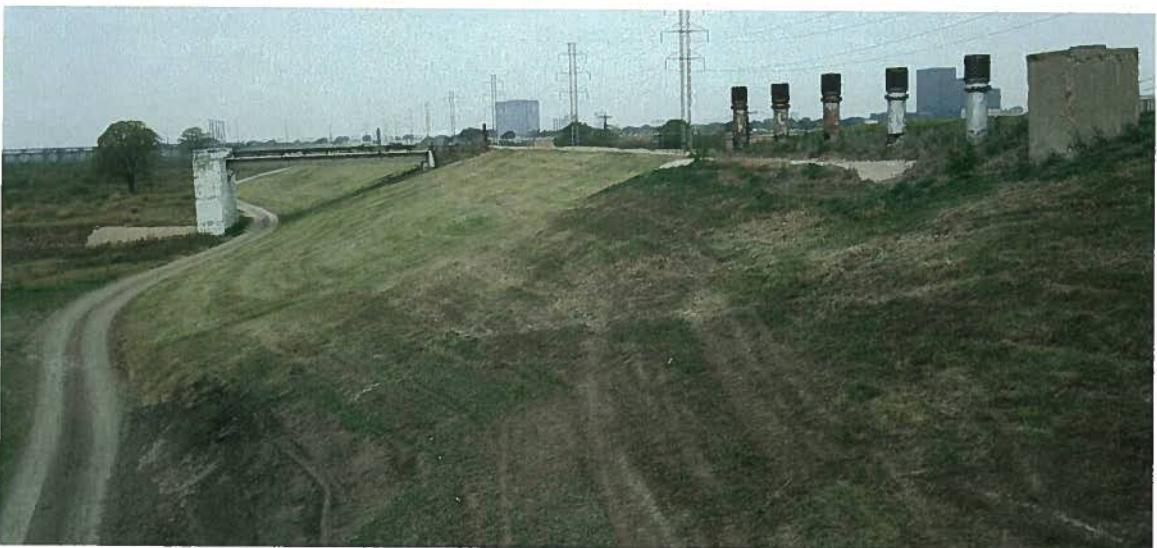
The station side of the levee is in excellent condition, with excellent groundcover and no signs of any irregular areas. The riverside of the levee (Photo 3.19) has equipment tracks, sparse vegetation, and all vegetation is gone where the levee bottoms out to the lower road. This area could wash out if not protected. City staff monitors this area daily and intend on taking action to remedy this.

Photo 3.19 - NBX River's Side of Levee

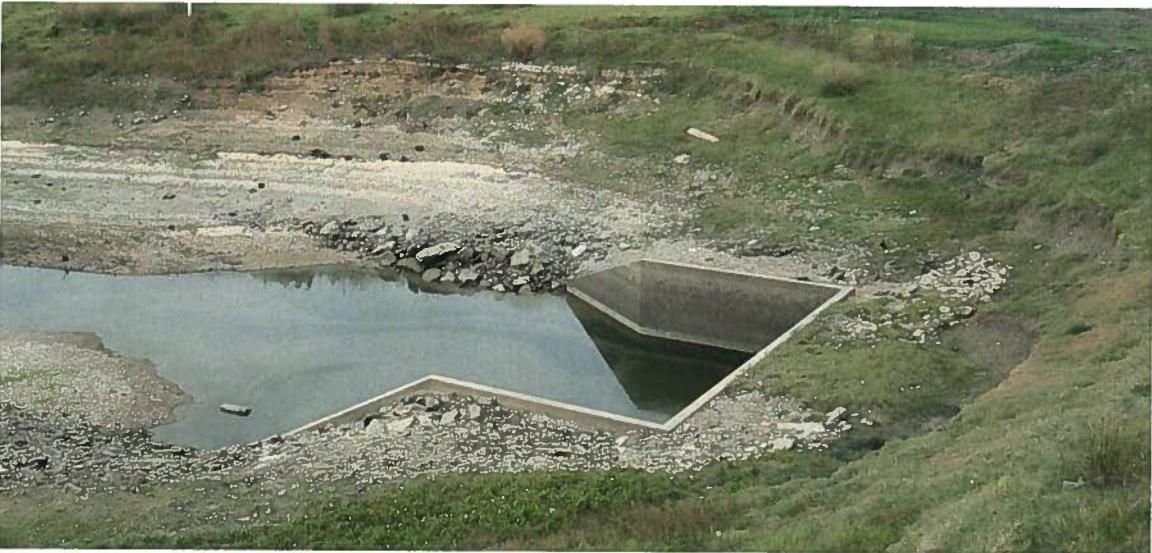
The area surrounding the NBX outfall structure is level with the top of the structure within a 12 to 15 foot perimeter. (Photo 3.20) The edges of this perimeter show signs of erosion from past rain events. There is no path to this area and footing is hazardous. This is an area not normally requiring access, but even a crushed rock path would be useful in maintaining safety for personnel.

Photo 3.20 - NBX Outlet Structure

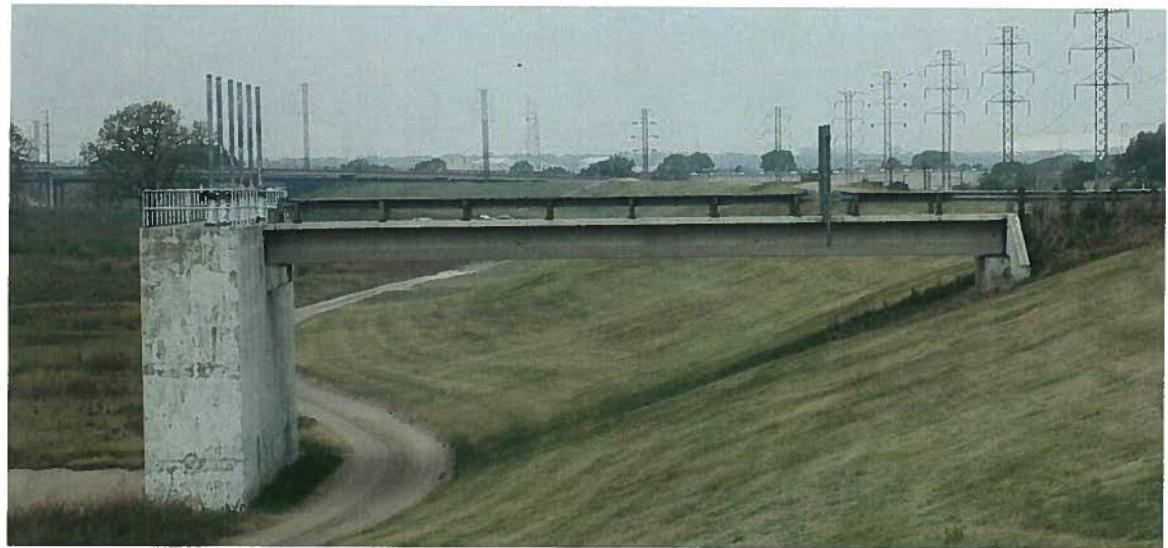
Photo 3.21 also shows that silting is more prevalent on the south edge of the outfall, but the entire channel has noticeable build-up in areas. City personnel indicate that the channel routinely requires clearing. As mentioned in the OBX report, NBX and OBX outfall channels join before reaching the river. The NBX flow has caused silting at their junction.

Photo 3.21 - NBX Gravity Flow Valve Vault Structure

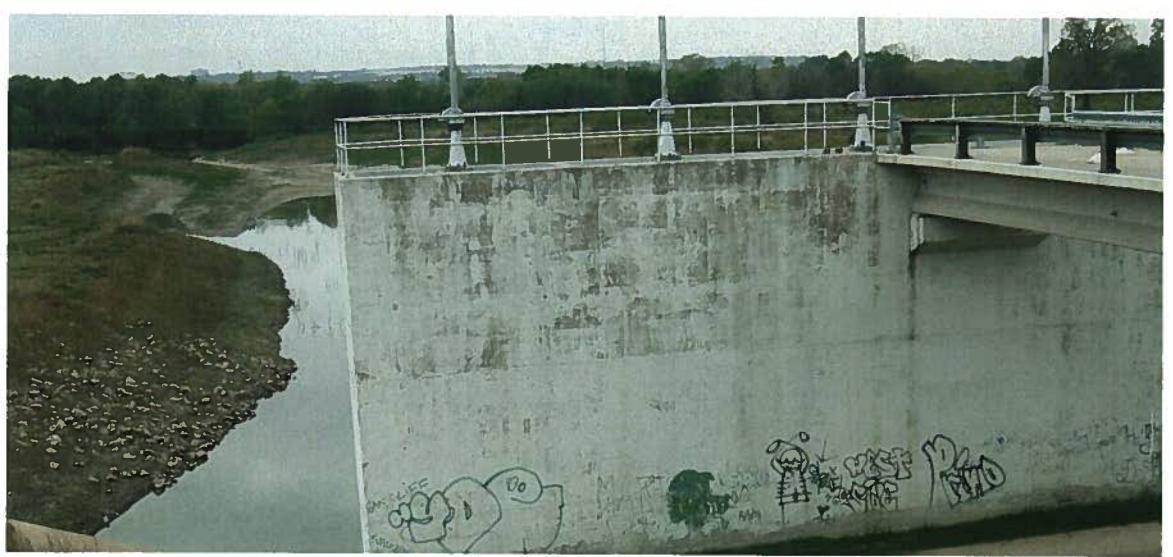
The area under the bridge structure on the levee is sparsely vegetated for the upper third of the levee surface, where a minimal amount of sunlight is able to reach. This area will always be difficult to maintain with any form of ground cover. A concrete apron would remedy this problem and reduce maintenance upkeep. The main valve structure appears to be in excellent condition. The six gate stems are covered and all shafts are clear of debris. The six mains are each 10 feet square with manually operated sluice gates. At the current time, silt has blocked the western two thirds of the channel (Photos 3.22 & 3.23) resulting in standing water.

Photo 3.22 - NBX Gravity Gate Structure, Notice Silted Up Completely to River

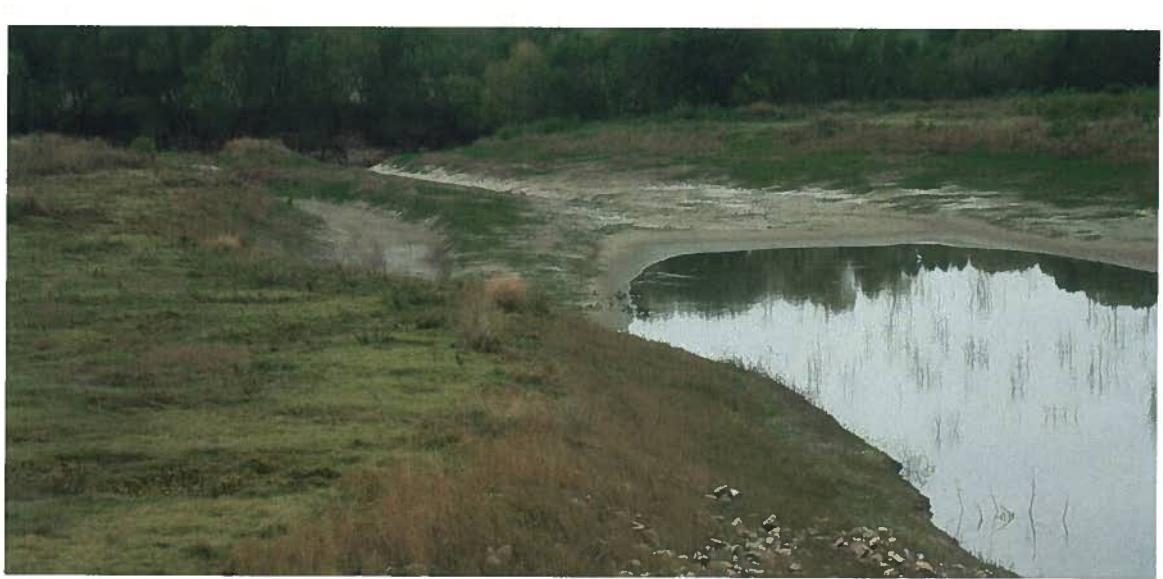
Photo 3.23 - NBX Gravity Gates Channel Silt Build-up

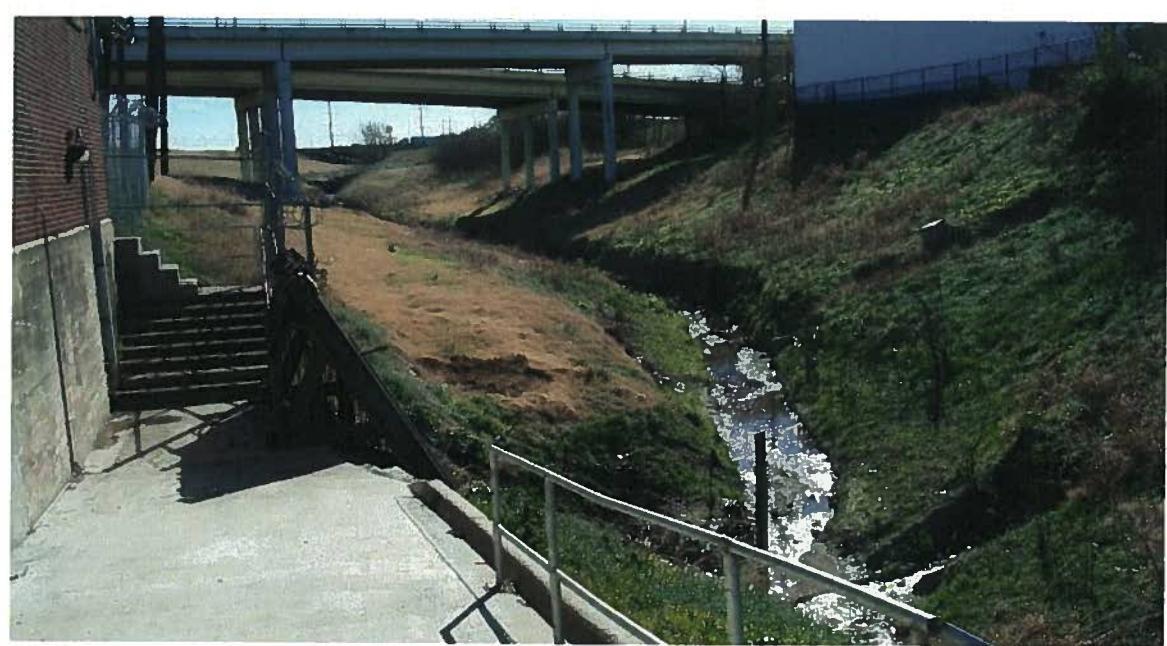
Photo 3.3 - CX Sump Channel Looking South

The channel feeding the sump area is very narrow, not more than six feet across and a three to four feet deep drop-off. This is sufficient for light rain events and the everyday runoff from various sources. Above the drop-off, the channel spreads outward +/- 20 feet on each side in a gradual grade. (Photo 3.3)

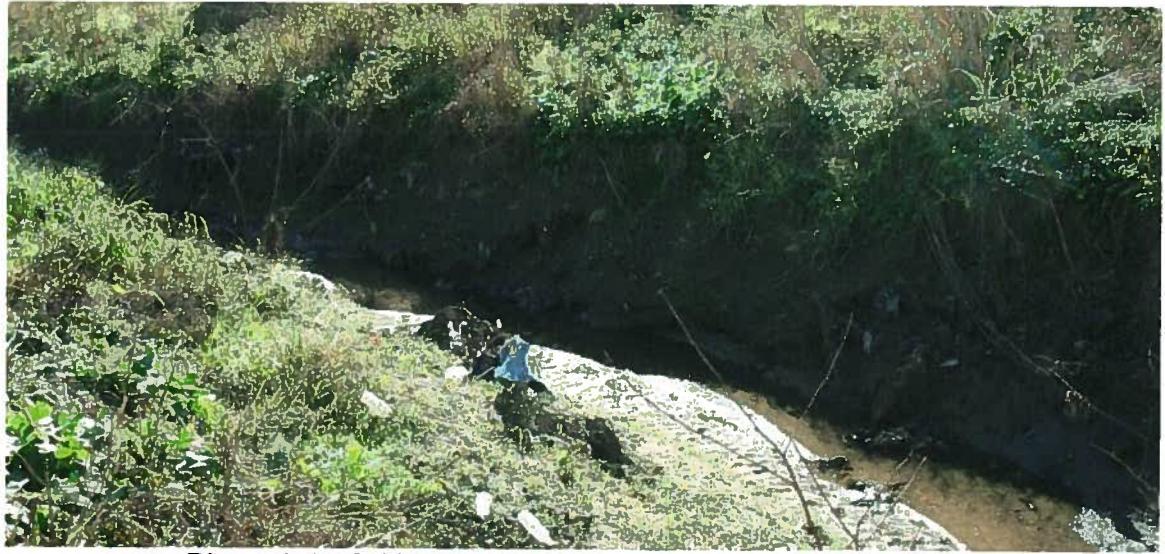
Photo 3.4 - CX Narrow Lower Section of Sump's Channel

Heavy vegetation covers the upper wider portion of the channel preventing slippage. This tapers at a gradual slope before making an almost vertical three foot drop off into the primary channel. Although this is a severe drop off, there are no signs or indications of erosion or recent slippage. (Photo 3.4)

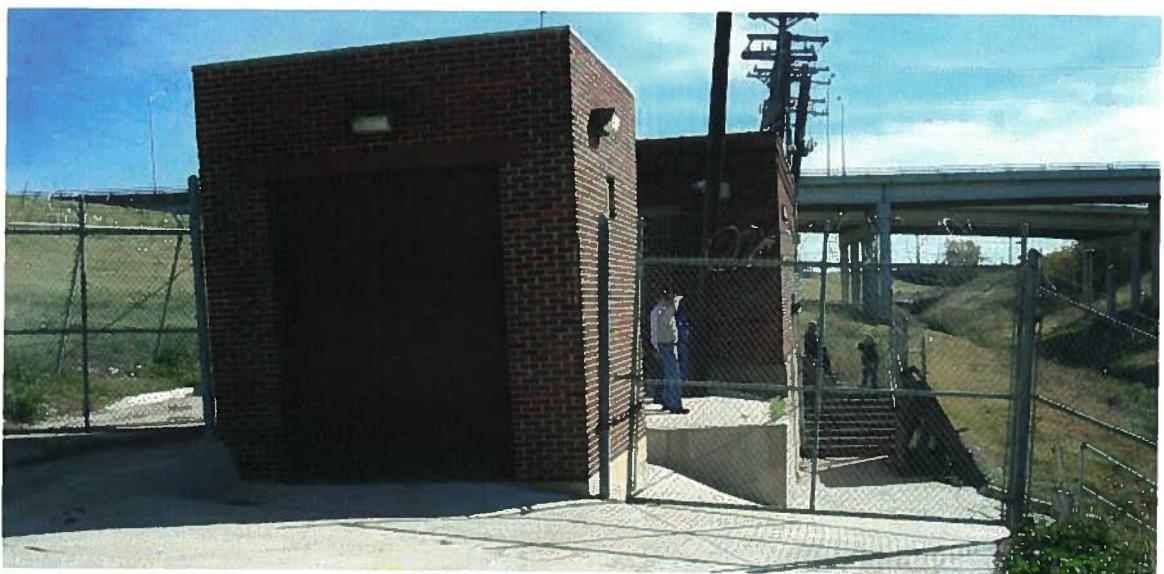
Photo 3.5 - CX, new paved surfaces

The area surrounding the CX site experienced drainage problems with water coming off of the western slope of the levee. The division's personnel were able to pave around and between the two stations to eliminate most of this problem. Addition of handrails are needed for personnel safety and curbs added to prevent vehicles from rolling off into the sump or the drop off between the buildings. (Photo 3.5)

- Newly paved areas around the station are not well marked and lack any safety provisions for personnel and vehicles. The new driveway has no curb to redirect run-off and there is a vertical drop off along the western edge of the driveway into the sump. Bollards installed along the drive would provide drivers a visual clue and some protection from going off the edge. Handrails or bollards with a rail between the buildings need to be added. There is an unsafe drop-off between these buildings on the west side.

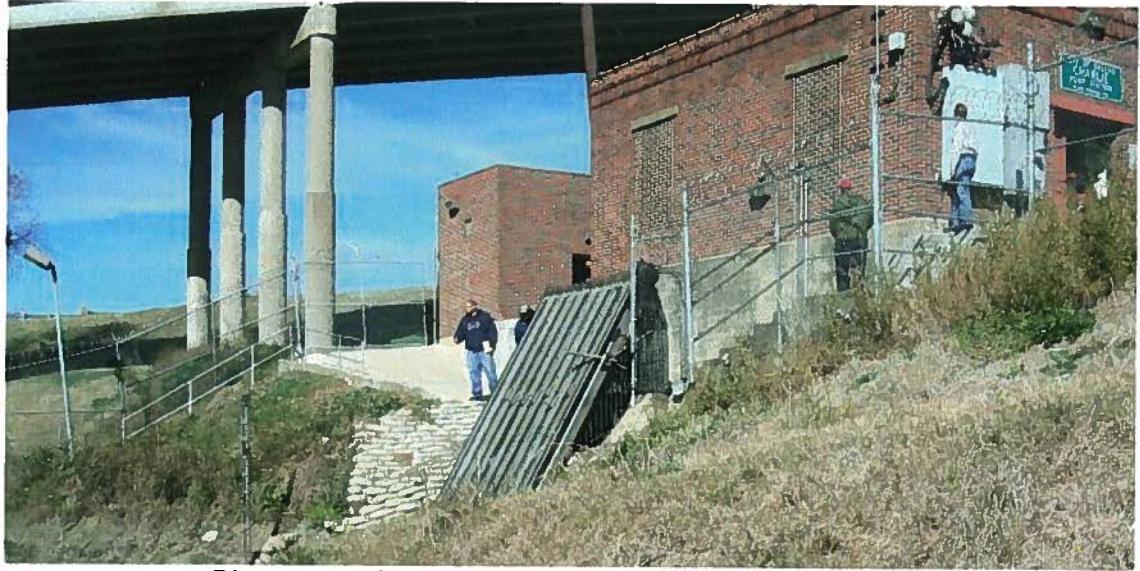
Photo 3.6 - CX Sump Area with Improvised Wing Wall

An improvised wall made out of concrete filled bags was placed on top of the existing wing wall. (Photo 3.6)

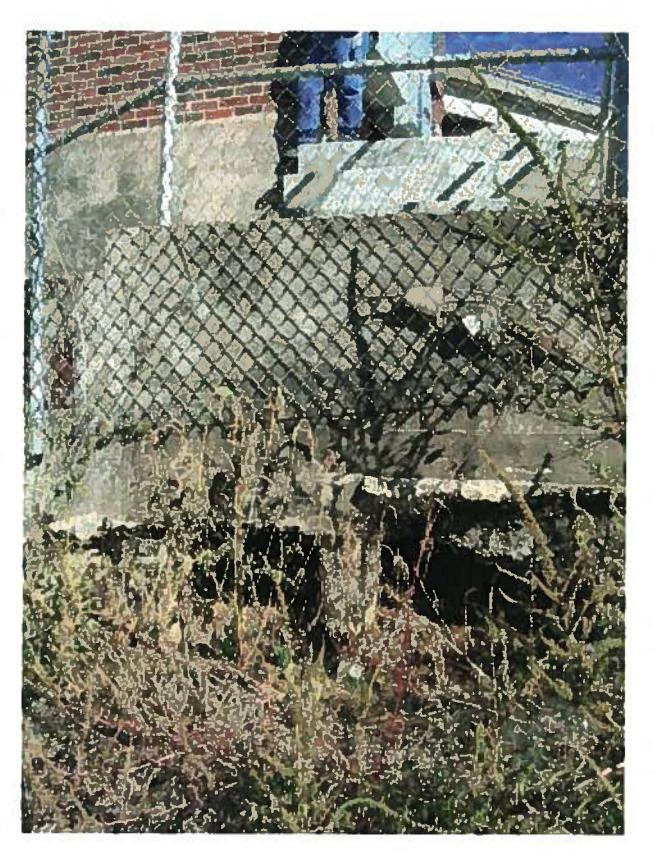
Photo 3.7 - CX South Stairway to Screens

Run-off was also a problem on the south end of the main pump station. The stairway leading down to the screens is unsupported for a height of +/- two feet where soil has washed out. It appears that new paving is covering old, re-directing the run-off but the soil needs to be replaced and compacted correctly. A concrete apron on both sides of the screens may still be required to eliminate problems in this area. (Photo 3.7)

- A concrete apron is needed on both sides of the screens from the existing wing walls to the paved area surrounding the west side of the site. Run-off has caused damage in the past and is the reason for the extensive paving. The addition of a concrete apron will prevent any additional run-off from damaging the banks to the screens.

- The area under the south staircase leading down to the screens is severely undermined by erosion and needs to be repaired as soon as possible.
- There is damage to the brickwork that extends through the walls to the interior that indicate movement. The brickwork on the north and south walls has damage around the area where the overhead crane's rail was supported. A Structural Engineer's inspection of the site and its buildings are advised.

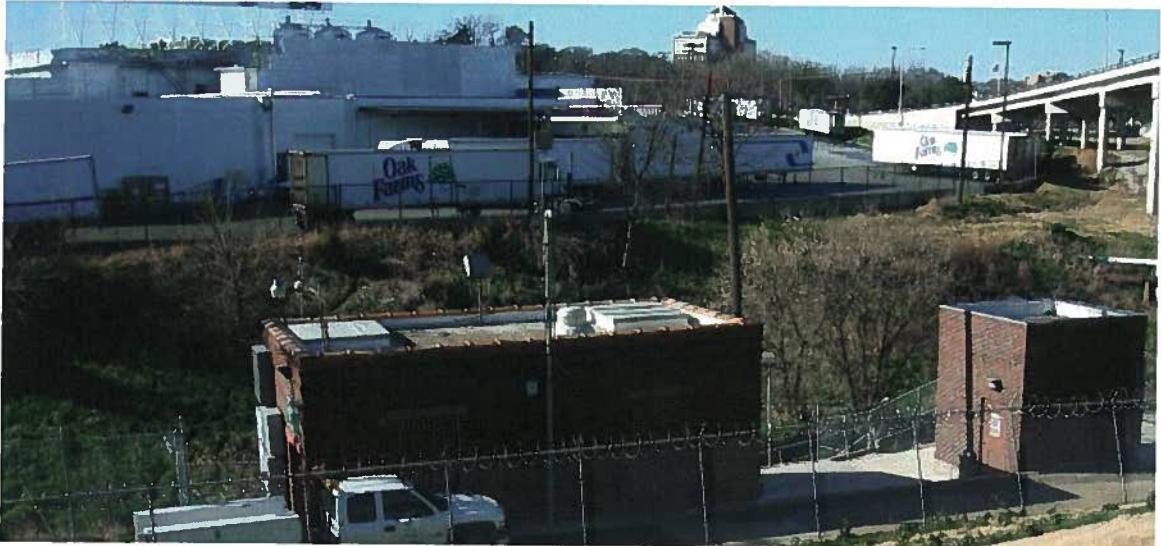
Photo 3.8 - CX, Industries along the Channel

The channel's west bank has industrial sites built right up to the bank. This appears to be a potential problem. Whatever washes from these sites goes directly into the channel. The possibility of hazardous waste coming from these industries is not currently monitored. The debris coming into the site is hauled to a public landfill. There are restrictions on what may be dumped at these landfills and this could become a costly problem. All flood waters are discharged into the Trinity River, another health concern.

The current accountability in place for the industries is not known or if it is being monitored and recorded. The City of Dallas is actively involved in environmental management, having created a new Environmental Department that both the Streets and Water Departments are heavily involved with the pilot program. (Photo 3.8)

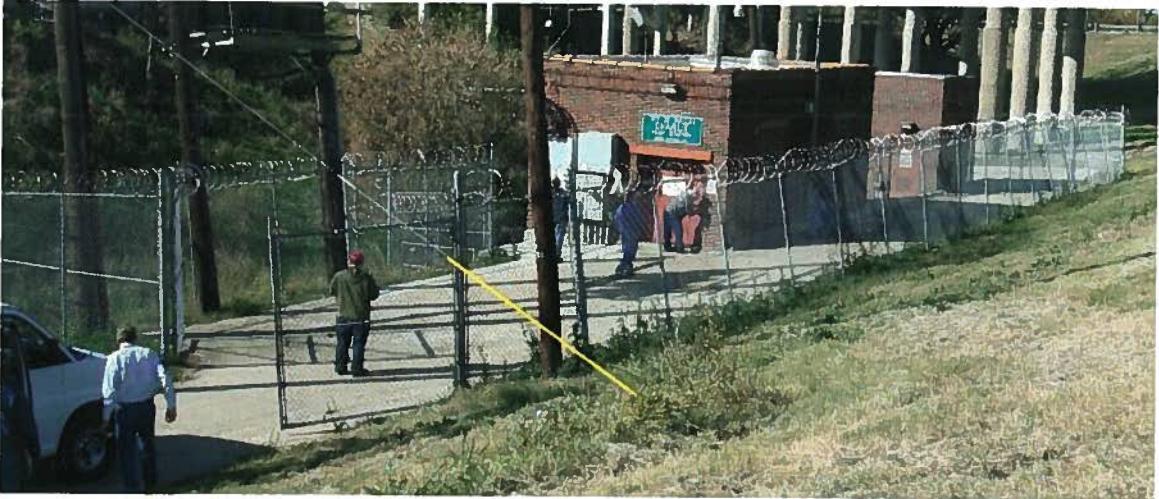
Photo 3.9 - CX Security Fencing

There is adequate exterior lighting for personnel to perform their required tasks. The fence surrounding this area is in good repair and a deterrent against vandalism. (Photo 3.9)

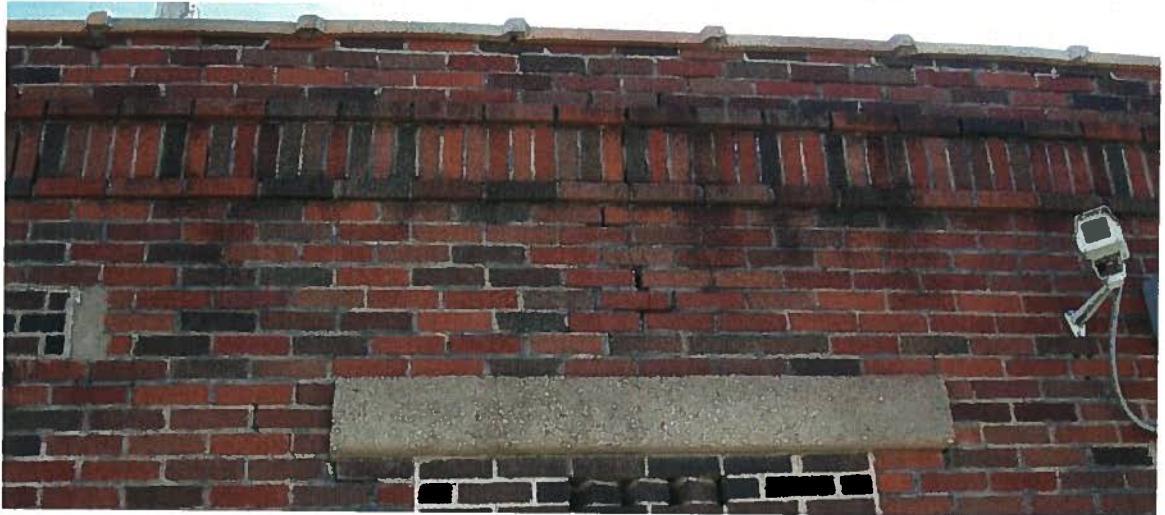
Photo 3.10 - CX Brickwork above Exhaust Fan North Wall

suggesting movement. There is a more serious concern with the brickwork at both the north and south ends of the building that supported an overhead crane. There is external separation extending internally as if something too heavy was lifted. (Photos 3.10 and 3.11) A thorough inspection by a Structural Engineer would be advisable to see what repairs may be needed.

Much of the decorative band around the upper exterior wall requires re-grouting. A few of the joints on the capstones surrounding the roof also need attention. (Photo 3.10) When having the re-grouting done it is also advisable to apply a sealant to the brickwork. Moisture appears to be causing the paint on the interior wall to fail.

- The brickwork on the main pump room's exterior needs to be re-grouted in areas that have fallen out. The application of sealant to the brickwork should lessen the paint failure problems inside the pump room.

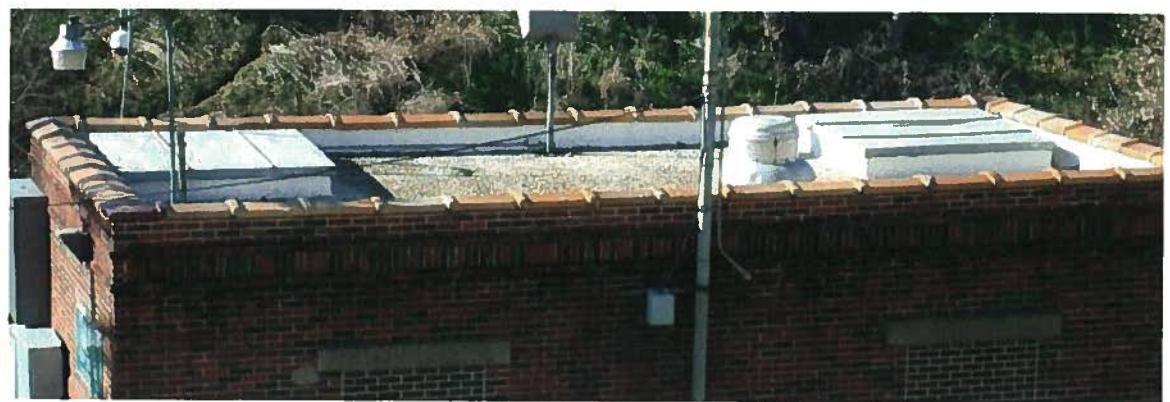
Photo 3.12 - CX Main Pump Room's Roof

There are no signs of the roof leaking on the main pump Room Building. The roof is concrete and appears to have a membrane with rock topping. There are no signs of ponding or leakage inside or out. A large equipment hatch is above each pumping unit to allow crane access. (Photo 3.12) These hatch penetrations have an excellent lip height above the roof's surface to prevent water from entering the pump room, should the roof not drain properly. The hatch on the north has minor damage along the seam

that may allow very minor amounts of rain to seep into the building. A small amount of leakage is normally not a concern, but this is directly above an electric motor and should be monitored during a rain event to see if repairs are necessary. There is a third roof penetration for ventilation that shows no signs of leakage.

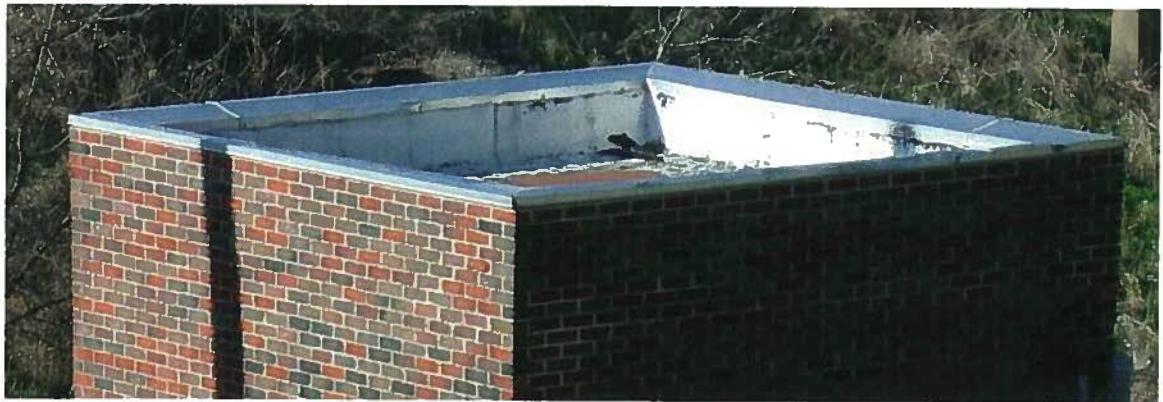
Photo 3.13 - CX Low Flow Pump Station

The roofing system on the Low Flow building does not show any signs of leakage internally, but the roofing system shows signs of wear that will need repair or replacement in the near future. The sealant or painted area has cracked where the walls and roof meet. This is normally the first area to fail and should be monitored. This appears to be a membrane type of roofing system, but there is not any rock covering the roof's surface area, this is usually placed over a membrane for its protection. (Photo 3.13)

- Have Equipment and Building Services (EBS) inspect the roof on the Low Flow Pump Room to determine when and if repairs or replacement of the roof is necessary. Also, inquire if a rock cover is appropriate for this roof system.

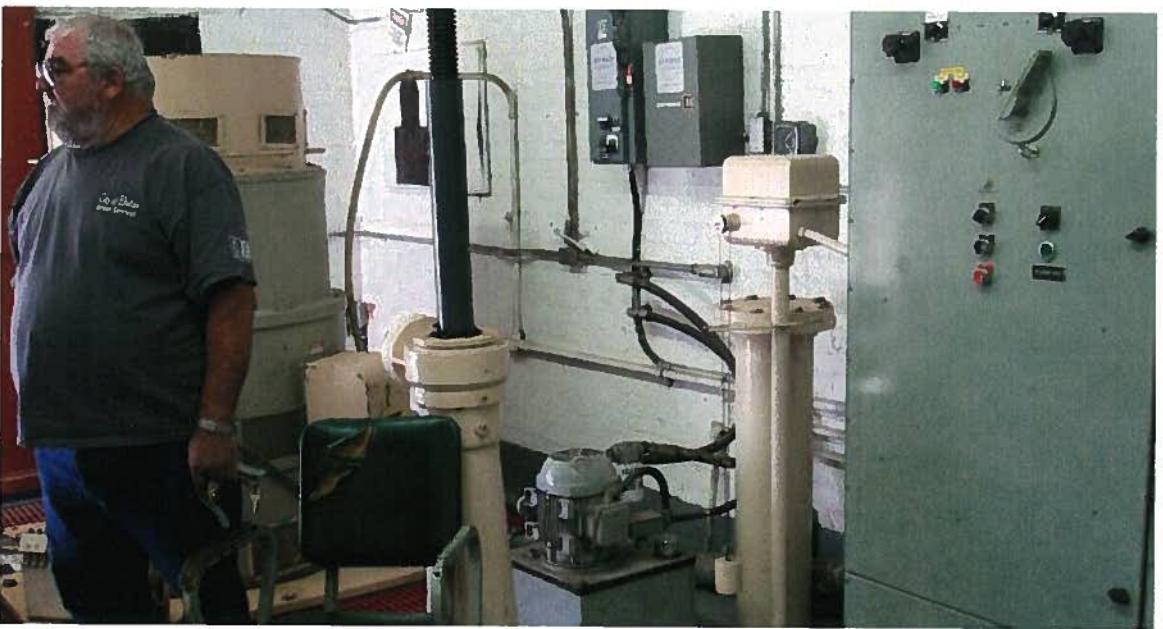
Photo 3.17 - CX Hydraulic Pump (bottom center of picture) 13

The hydraulic pump for the screen and rake system is mounted on the floor between the #2 pump, the switchgear panel, the south manually operated sluice gate and the sump level tube. (Photo 3.17) Although this is operating correctly, The choice of hydraulics in this application is questionable. There are no obvious benefits and there are several liabilities. Electricity is still required to run the hydraulic pump and there are pressurized lines that can break and spill hydraulic fluid. If this goes into the sump, there is a possible hazardous spill to deal with. There are connections that will leak at some point, hydraulics are affected by temperatures, etc. As mentioned in the Exterior Equipment Section, there is a problem with the structure's brickwork and a Structural Engineer should be called in to see what action should be taken. Inside the pump room there are numerous areas where the paint has popped off the brick, which may indicate that moisture is leaching through the brick causing this problem. Bricks are porous and may require a sealant on the exterior surfaces.

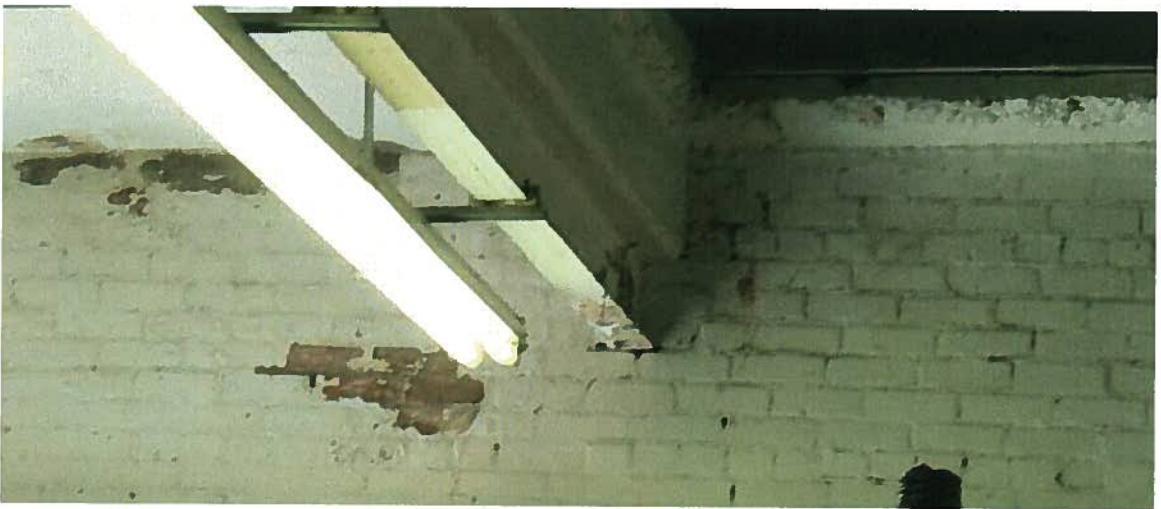
Photo 3.18 - CX Rail at South Wall

The overhead rail that was used for the hoist in this station may not be properly sized for this building's structure. The original design of hatches above the main units was to

allow a mobile crane to pull equipment through the roof hatches. If the overhead hoist's rail running north/south the length of the building is original, its purpose was to handle auxiliary equipment or possibly removal of the motor from the pump. The supporting walls have some damage around both contact points. The original hoist may have been replaced at some point with one having a larger capacity or the motors now in place weigh more that the supports were designed to lift safely. Although no longer used for lifting the damaged areas on the walls should be checked. (Photo 3.18)

- Have EBS inspect the roof of the Low Flow Station for wear. Repairs or replacement may be needed in the near future.
- Have Structural Engineer inspect brickwork and support structure for overhead crane.

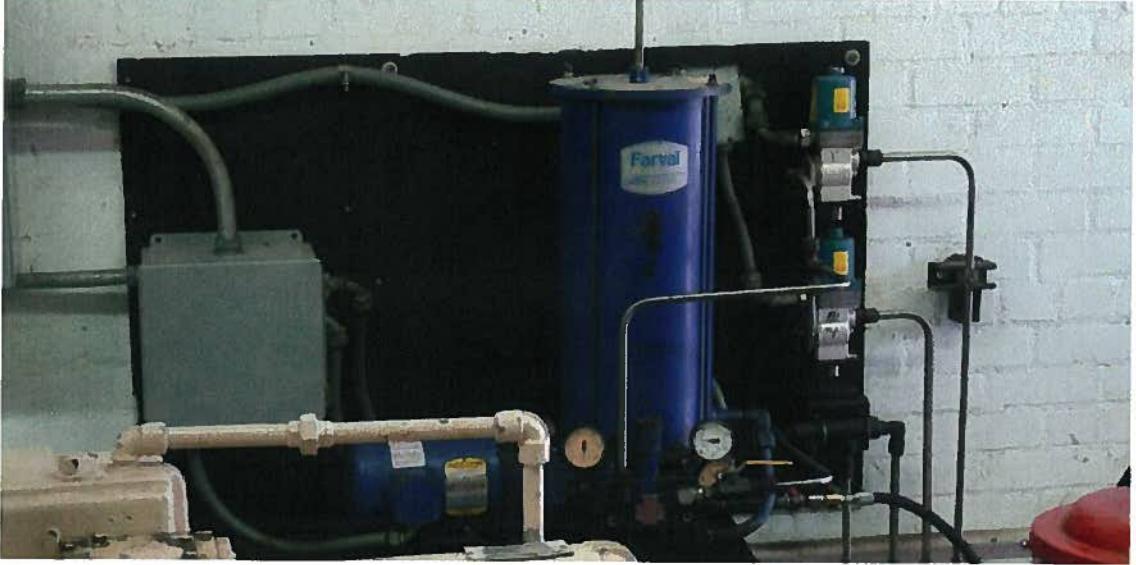
Photo 3.19 - CX Farval Lubrication System

(Photo 3.19) The Farval lubrication system provides each pump with a measured amount of lubrication at prescribed times. The transfer of grease from the storage container to the Farval's main cylinder has experienced some problems with air pockets. The delivery of grease to the farthest pump is also experiencing some intermittent difficulties. There are alarms in place that prevent a pump from starting or take the pump off line if the Farval system fails to operate correctly. These alarms transmit to the SCADA, informing the operator of the problem.

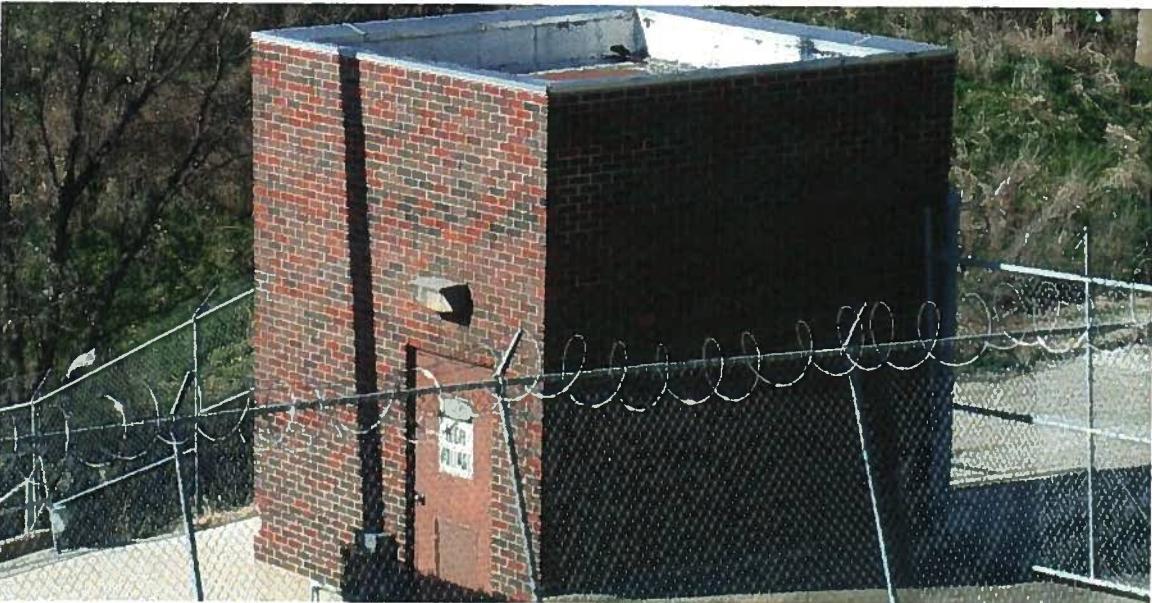
Photo 3.23 - CX Low Flow Pump Station's South Entrance

As mentioned in the comments for the main station, the hinged door should be equipped with a kick bar for emergency exit and a lit exit sign unless the fire marshal approves the existing hardware.

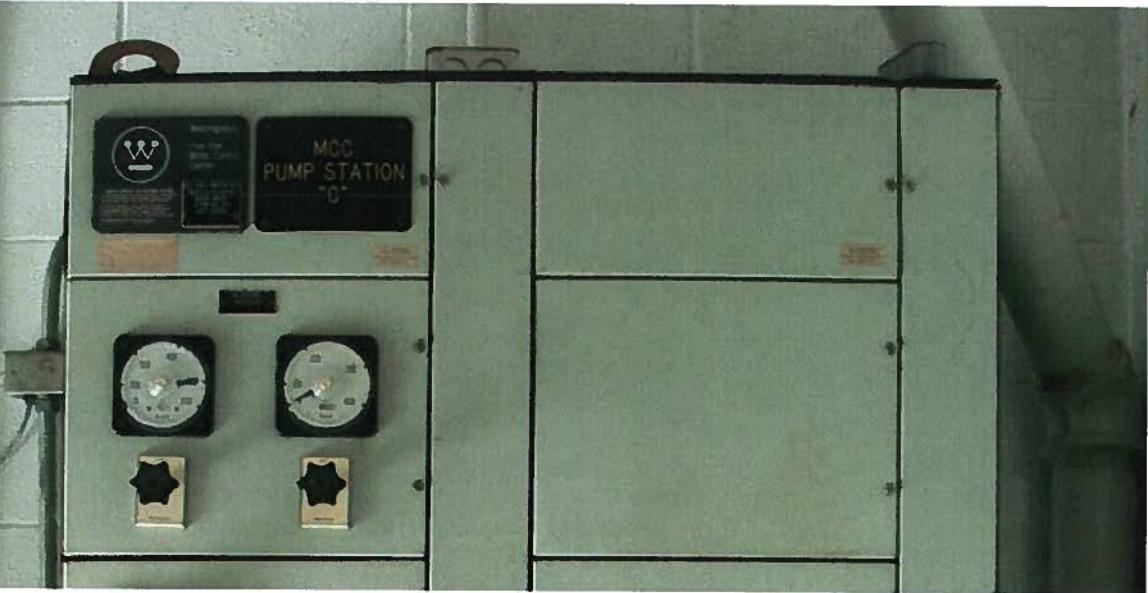
Photo 3.24 - CX Low Flow roof drain over switchgear (down right side in picture)

The roof drain of this building is directly above the switchgear and the drain line runs through the station rather than outside the station. (Photo 3.24) This may not be a code violation but the penetration in the roof for the drain is a potential leak on to medium voltage gear. It is a good design practice to keep water outside the building when possible. The roof should have scuppers with drainpipes down the outside walls to eliminate this concern.

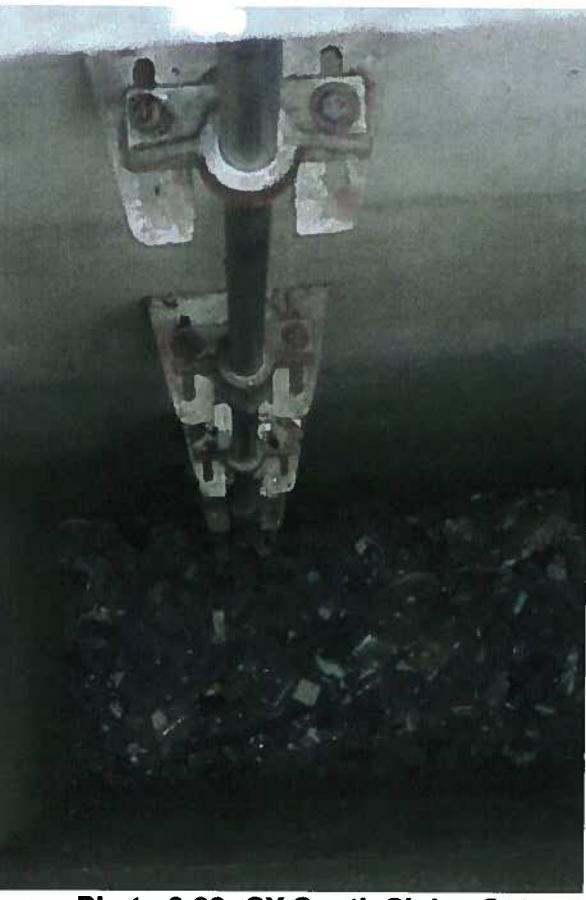
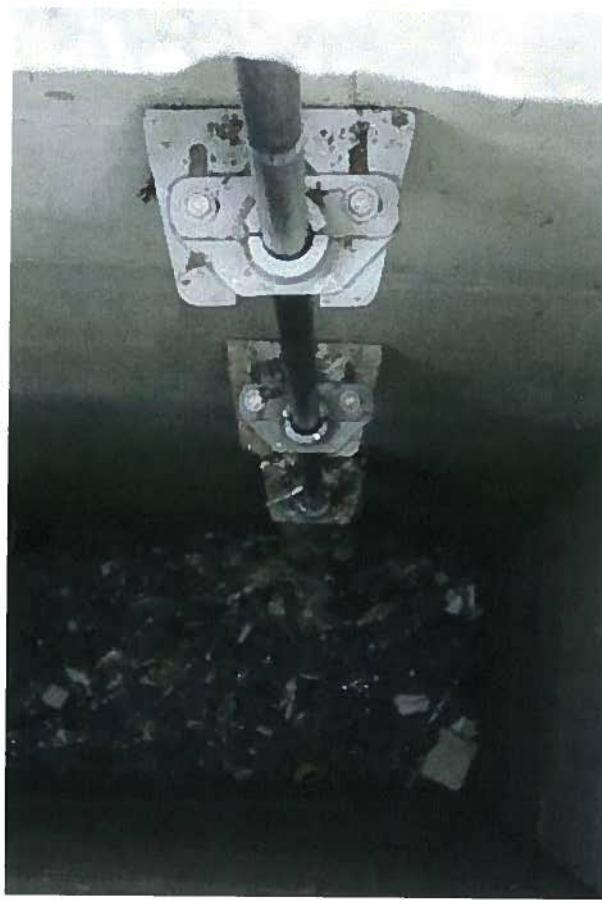
There are two electrically operated sluice gates at the end of the structure. Their operators and upper valve stems are well maintained. The shafts extending down into the vault are straight and the wall mounted shafts supporting them are secure. There are beginning signs of corrosion on some of the fasteners. It is suggested that a cleaning and re-coat of the fasteners with the silver paint is needed and appears to be working well in this environment. (Photos 3.28 & 3.29)

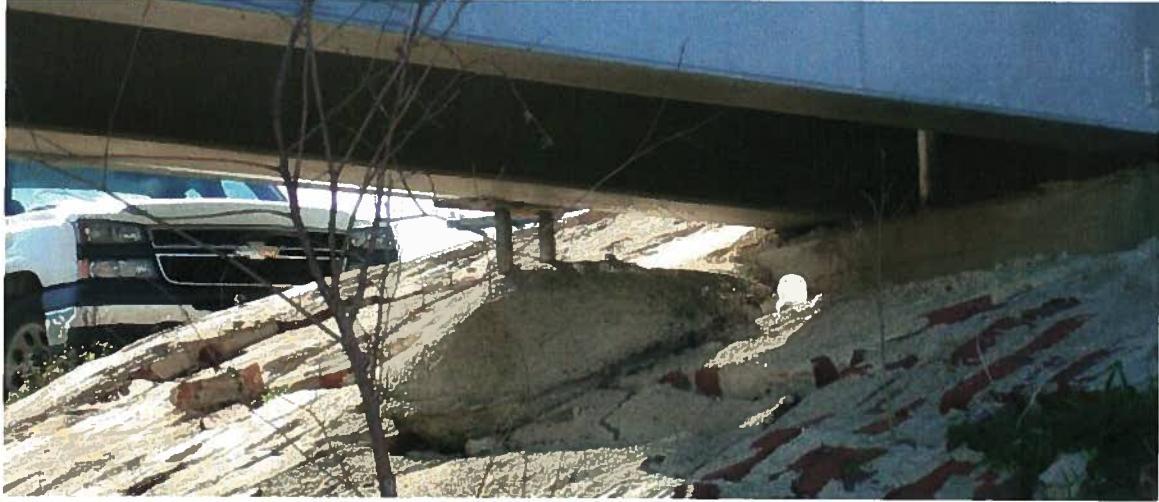
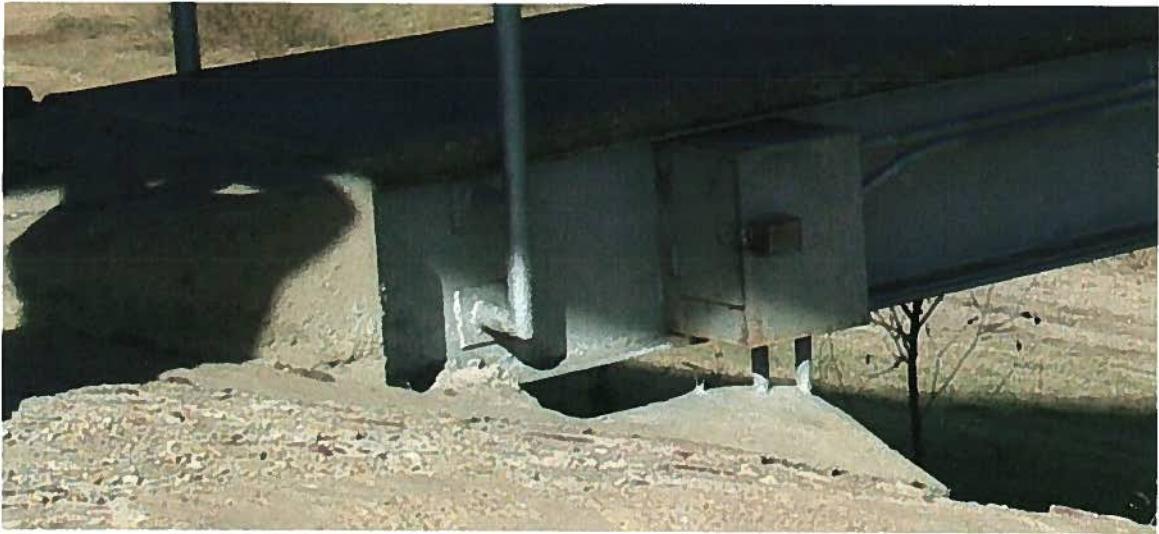
On the opposite end of this structure, a brick and mortar apron under the landing requires repairs or replacement. The weight has caused some settling resulting in some areas breaking apart and others dropping down. This can be seen where the valves electrical service comes out of the ground and fastens to the bridge. The mortar mound is unsupported at the lowest end. (Photos 3.30 & 3.31)

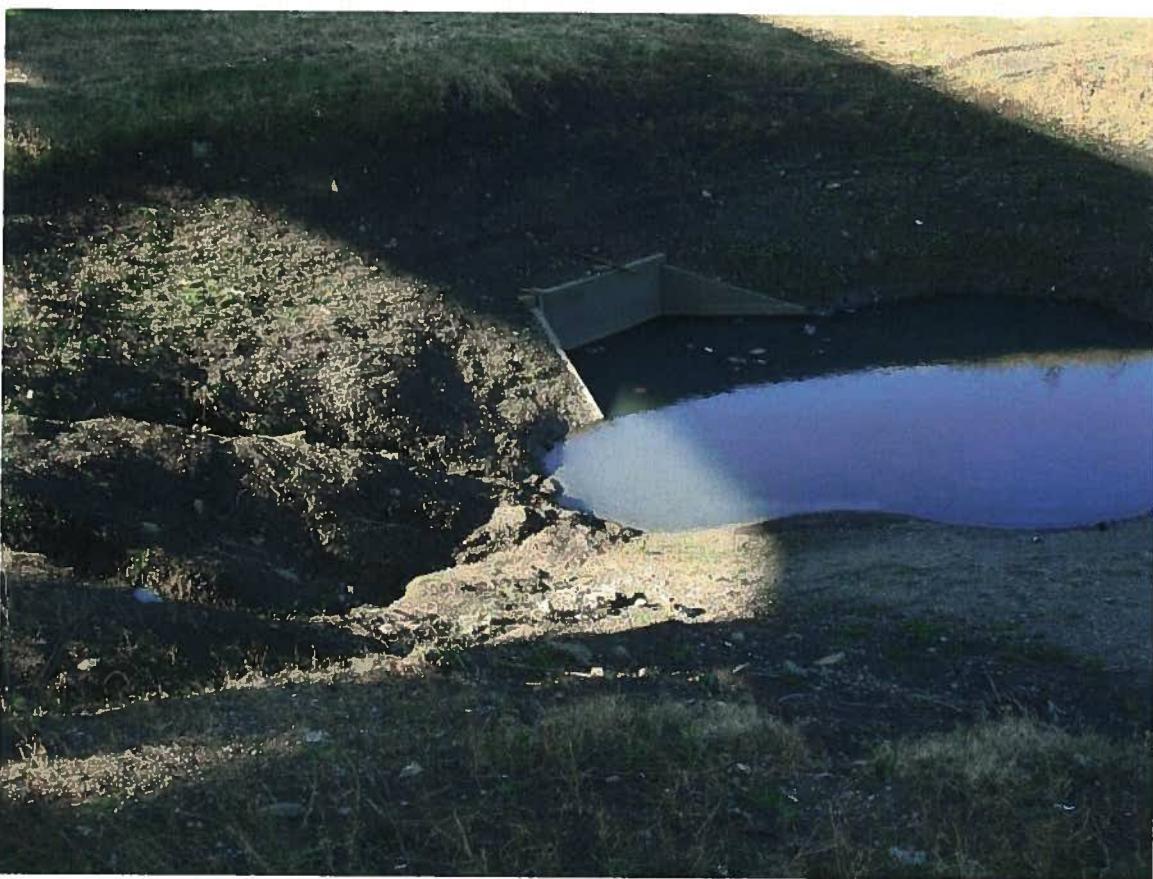
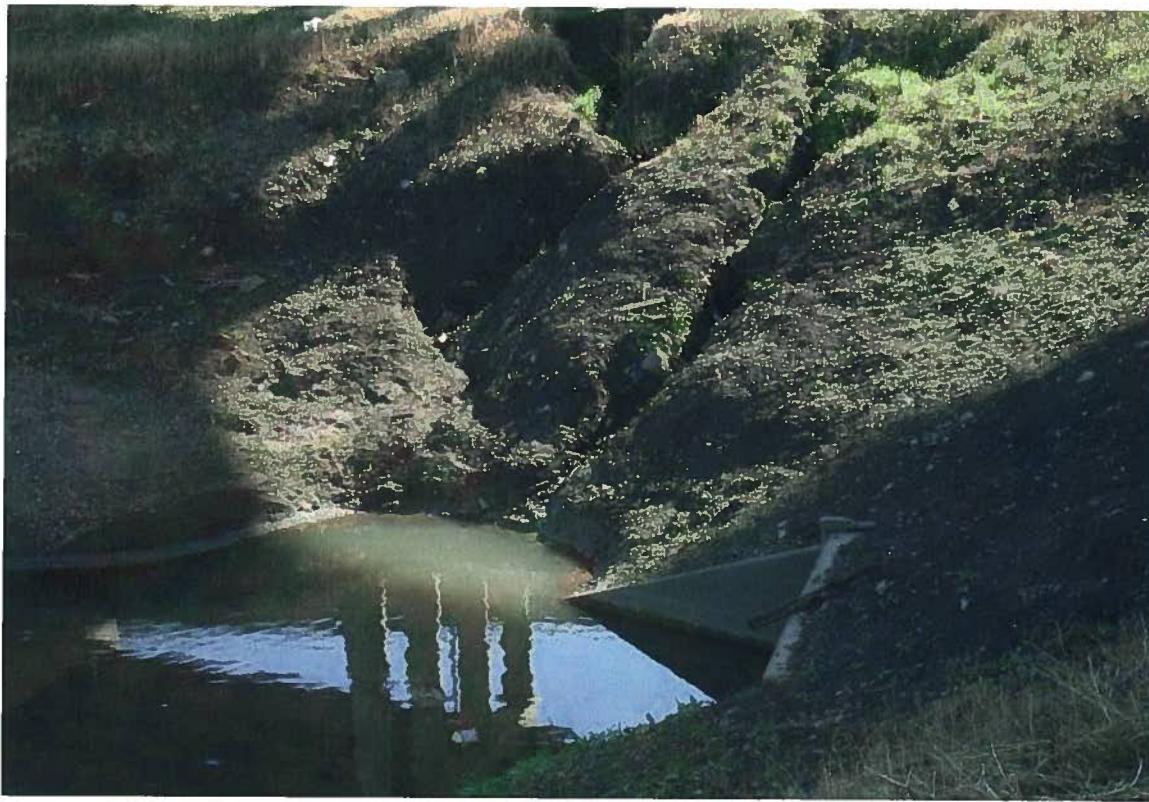
At the outlet structure, the vegetation stops +/- 25 feet from the water's edge. There is no sign of previous rip-rap near or at the structure. Water has washed out portions of the surrounding banks and the channel is narrow and winding from slippage. (Photos 3.32 & 3.33) The lose soil appears to be very unstable and likely to continue washing down in front of the structure into the outfall area until stabilized.

The circular pond of water at the structure's discharge shows heavy silting and erosion along south bank of the outlet structure and continuing down the channel to the river. It is suggested that the south side of the channel be graded at a more gradual slope and the channel cleared to the river.

The area surrounding the Outfall structure is also at a steep slope. It would be difficult and unsafe to attempt to establish and maintain a ground cover to bind the soil. Appropriately sized rip-rap is a good choice for this application and site.

- It is recommended that the outfall channel be re-sloped on the south bank to lessen slippage and erosion and straighten the channel.
- It is recommended that this site be considered for adding appropriately sized rip rap to surround the Outlet structure as a measure to stabilize the area.
- The apron at the bridge landing needs to be repaired or replaced.
- Personnel have no safe access up or down the levee. A stable pathway needs to be added.
- The addition of lights and GFI outlets installed on the valve vault would be helpful to personnel required to inspect and work on its equipment.
