CITY OF DALLAS INTERIOR LEVEE DRAINAGE STUDY WEST LEVEE – PHASE II

VOLUME 2 of 2 – PUMP STATION ASSESSMENTS

January 2009

Large Able (LAX) Pump Station

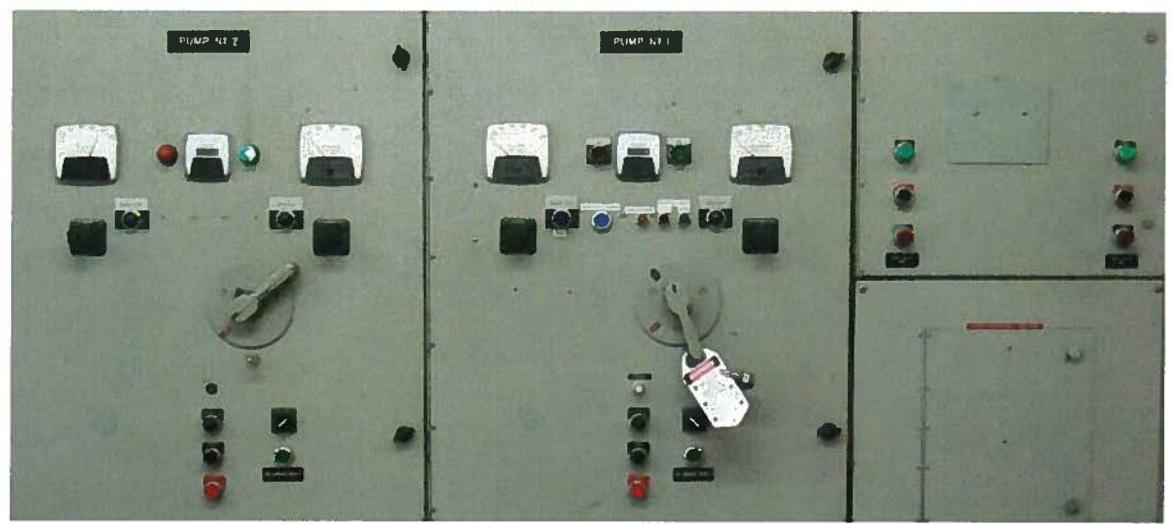
In the event of a SCADA failure, personnel are able to manually operate this station from the switchgear cabinet by switching controls from remote to local and selecting the start or stop switch (Photo 3.1). Indicator lights and instrumentation provide the necessary information to an Operator. An operational chart provides guidelines when and which unit is to be put on line or taken off.

Photo 3.1 - DX Manual Controls on Switchgear

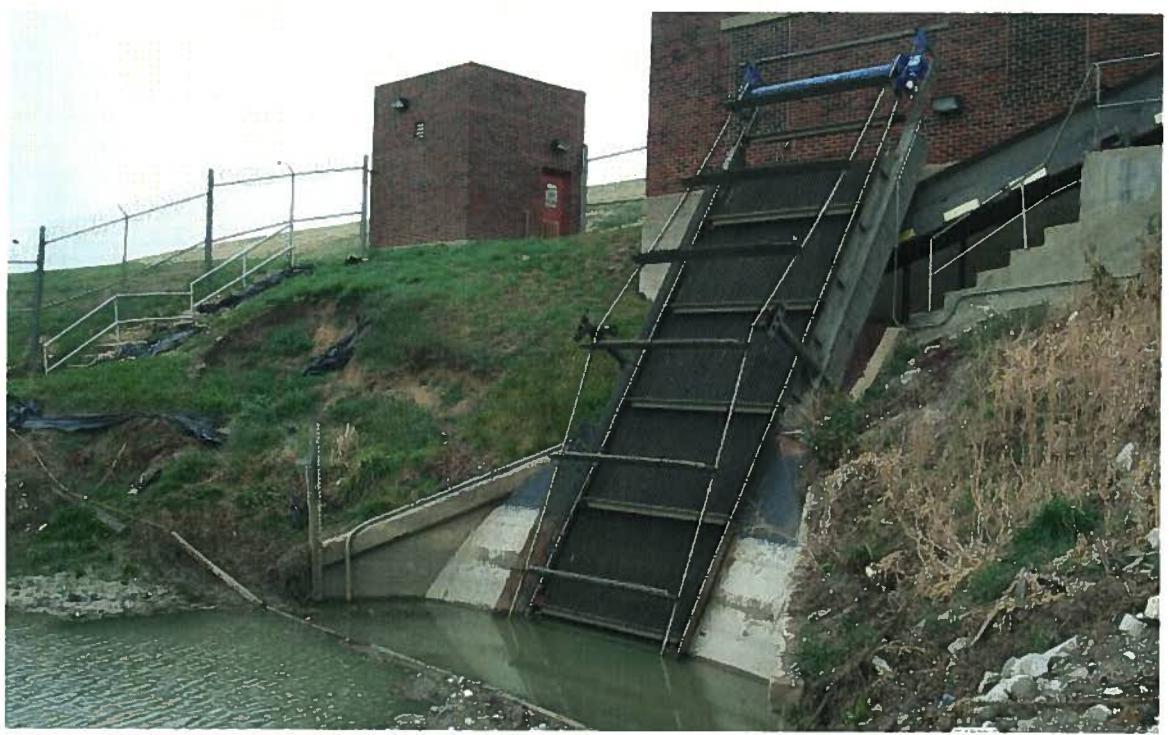
The DX screens are narrow in width, similar to those seen at Charlie Station. The screen's rake system is once again completely different from the other stations. The rakes rotate in front of the screens rather than behind them. In place of protruding rods, this system has shelves with a serrated lip that protrude towards the screen. The shelves rotate over the screens so the serrated edge points away from the screens on the back side of the rotation. (Photo 3.2)

Photo 3.2 - DX Screens

Talking with personnel, this system works well with small objects and floating debris. It has problems with large objects such as tree limbs, being too cumbersome to lift or fit between the two layers of rakes. When large objects work their way into the screens, it causes the rakes to lockup. Moving this system to another location that handles smaller debris has been discussed. There is merit to this idea as a better application for this design.

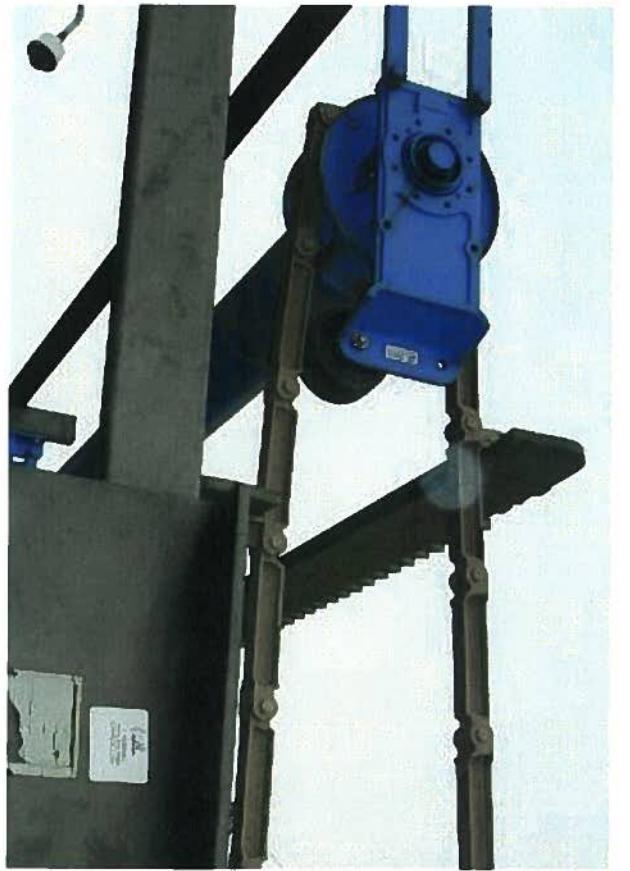
The rakes mount to a hinged rail that locks in a straight line on the outward exposed section. The hinge design bends inward at the bottom of the rotation allowing the rakes to make contact against the screen while lifting debris. These hinged sections supporting the travel of the rakes look insubstantial, not designed to withstand a heavy impact. (Photo 3.3)

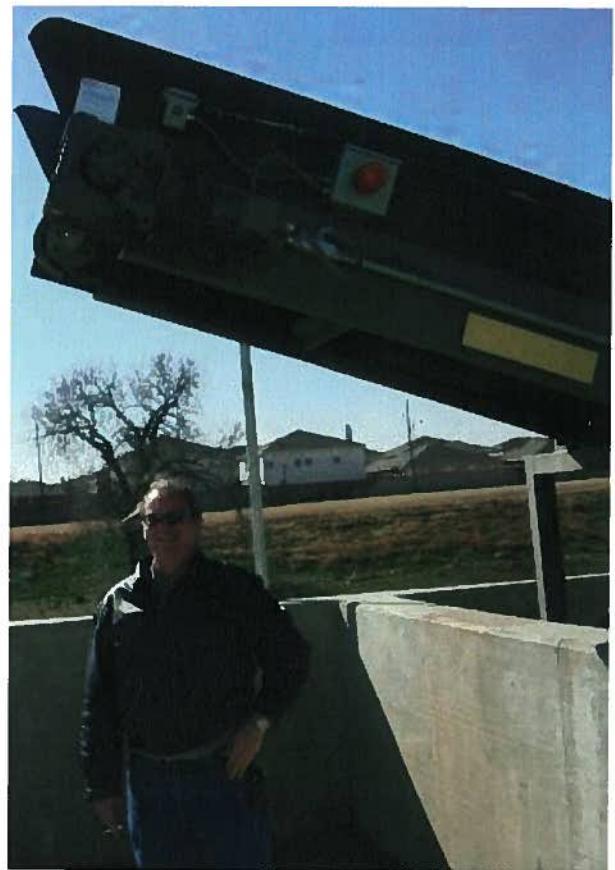
- The conveyor belt has an emergency shutoff that is triggered by tugging on a wire line that runs the distance of the machine. This is an excellent safety device but it takes a step ladder to reach the reset switch. The reset switch is located on the high end of the conveyor, well over eight feet in the air. This is impractical and unsafe. Relocate this switch to a practical location.

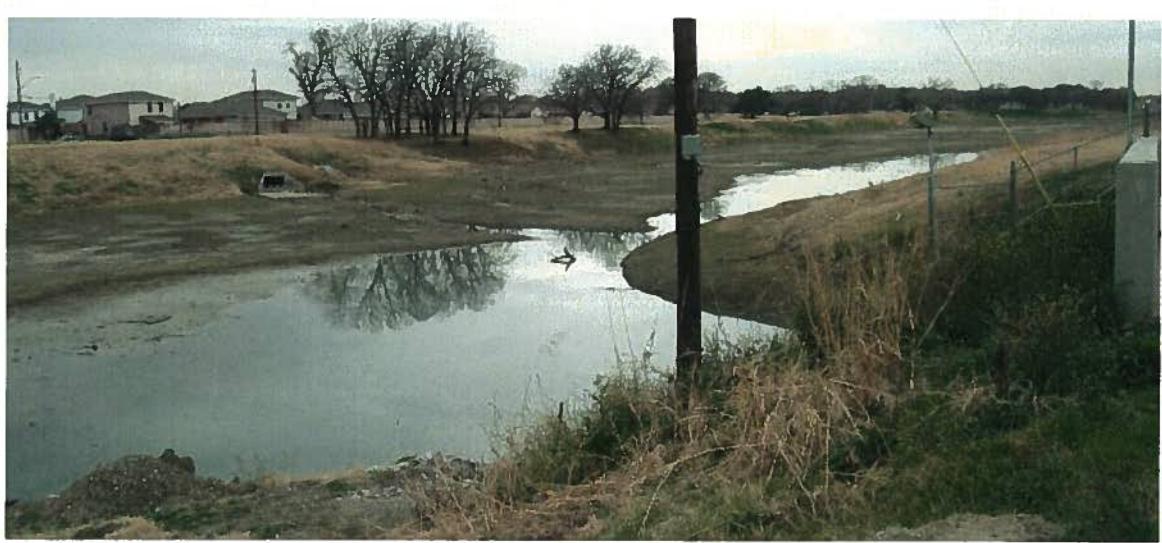
The Delta station has a very large holding area for a sump. The banks are on a gradual slope and have excellent ground cover, with no signs of slippage or erosion. (Photo 3.5)

Photo 3.5 - DX Sump Area Looking North

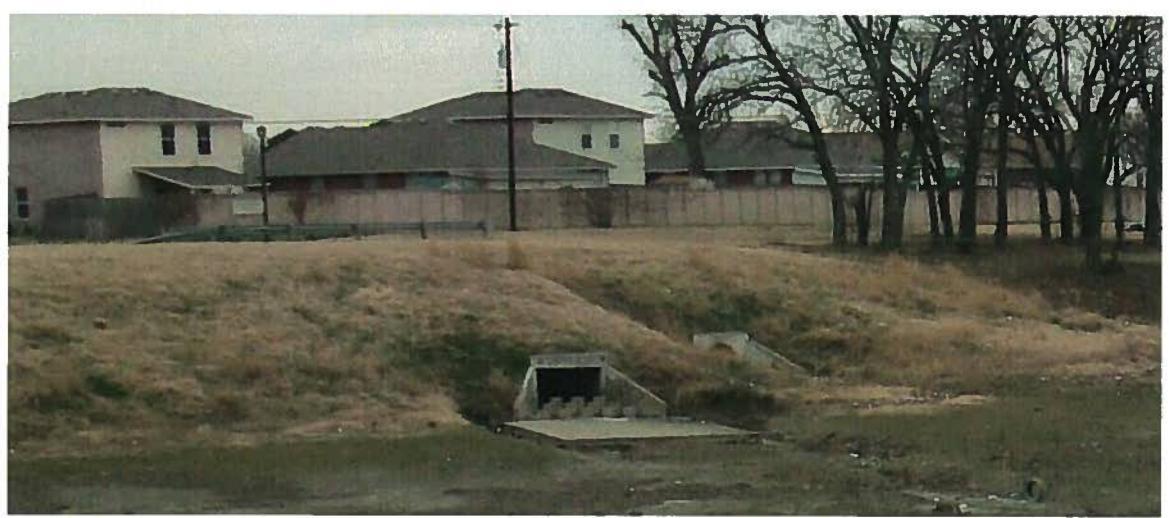
The sump backs up to a residential area and is not fenced off. Although it is only flooded for short periods, this area should be considered hazardous. No signage was visible to warn of flash flooding. The slope into this large sump is very gradual, making it appear shallow, but it is deceptively deep and the large open discharge structures are easily accessible and inviting to neighborhood children. (Photo 3.6)

Photo 3.6 - DX Discharge Structures to Sump Area in Residential Area

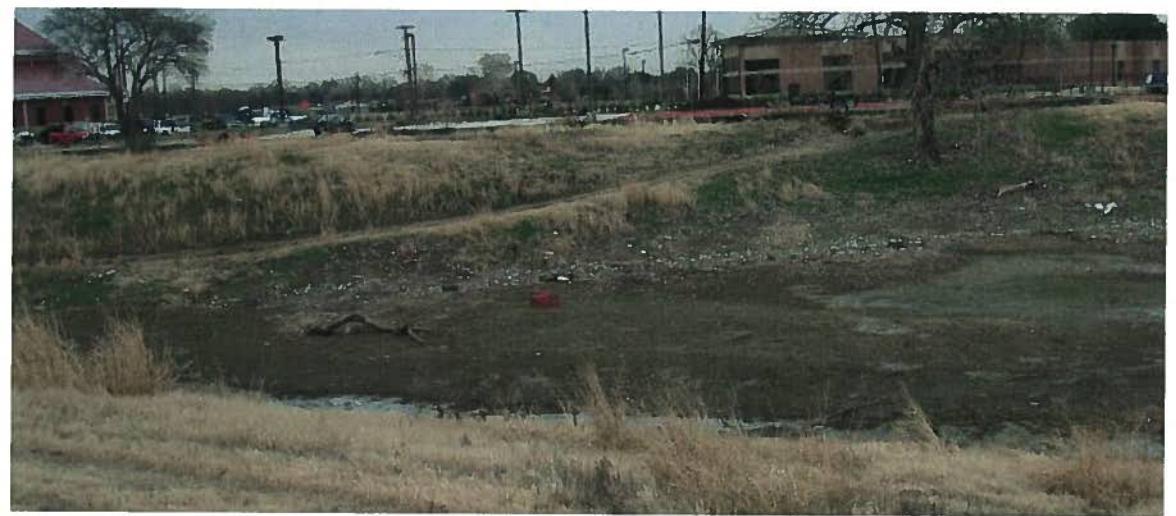
There are signs of routine traffic passing through the sump. A path across the southern end of the sump appears to be a neighborhood short-cut. This supports the concern that parents and/or children are not aware of the potential danger. This could be a potential legal liability to the City of Dallas, requiring mitigation. (Photo 3.7)

Photo 3.7 – Path through DX Southern Section of Sump

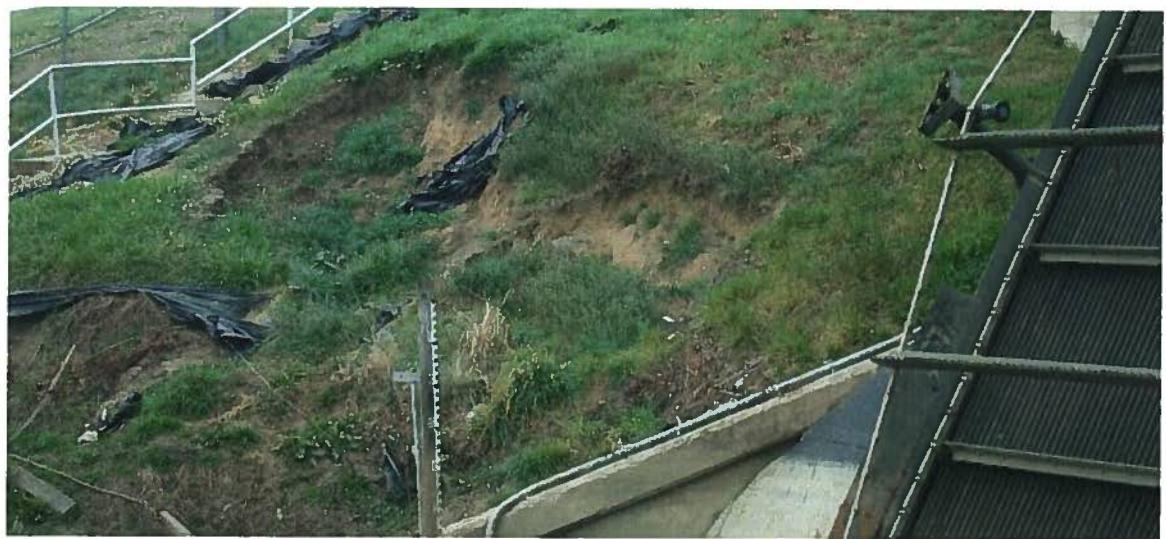
Photo 3.9 - DX, slippage on north side of screens

The north side of the screens has slipped and it appears there was an attempt to fix the problem with groundcover. The steep angle of the slope and flooding of the area will make it impossible to maintain any natural groundcover. A concrete apron over to the existing stairway and additional stairway on the side of the screens would be a better solution. (Photo 3.9)

- The groundcover area on the north side of the screen is not stable and shows signs of attempted repairs. A concrete apron with a stairway bordering the screens would prevent future slippage and safe access for personnel.

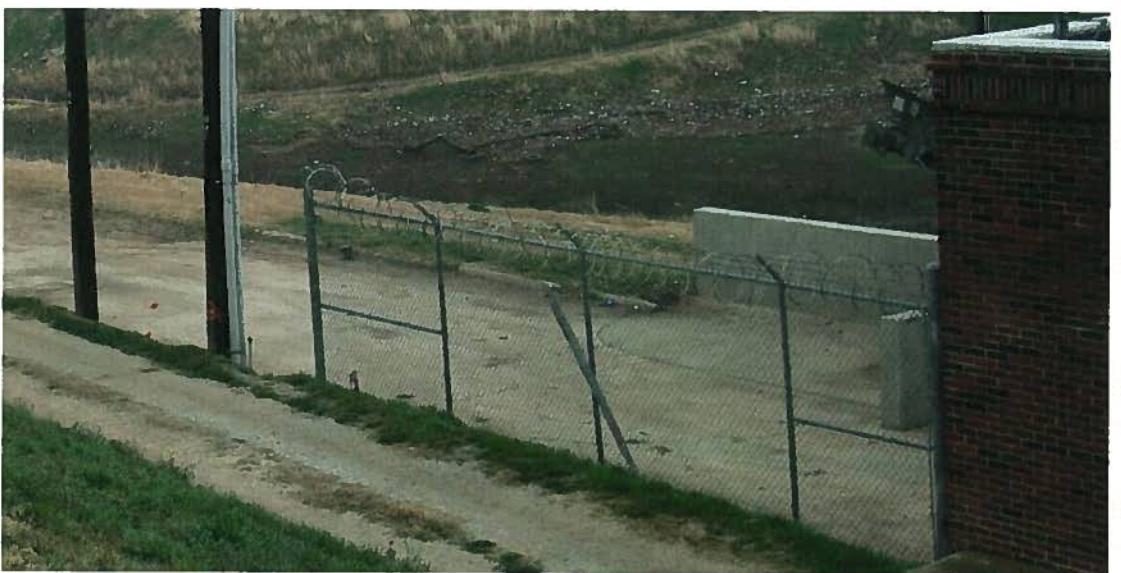
There is adequate exterior lighting for personnel to perform their required tasks. The fence no longer provides any security. The section across the south end was removed for access to improve the paved area to the conveyor. This work is completed and the south fence line requires relocation to encompass the new paved area. As mentioned above, the City of Dallas has a price agreement for repairs, replacement or new installations on fencing. (Photo 3.10)

Photo 3.10 - DX South Fence Line Replacement Required

- Replace the fence and gate on the south end of Delta's site.

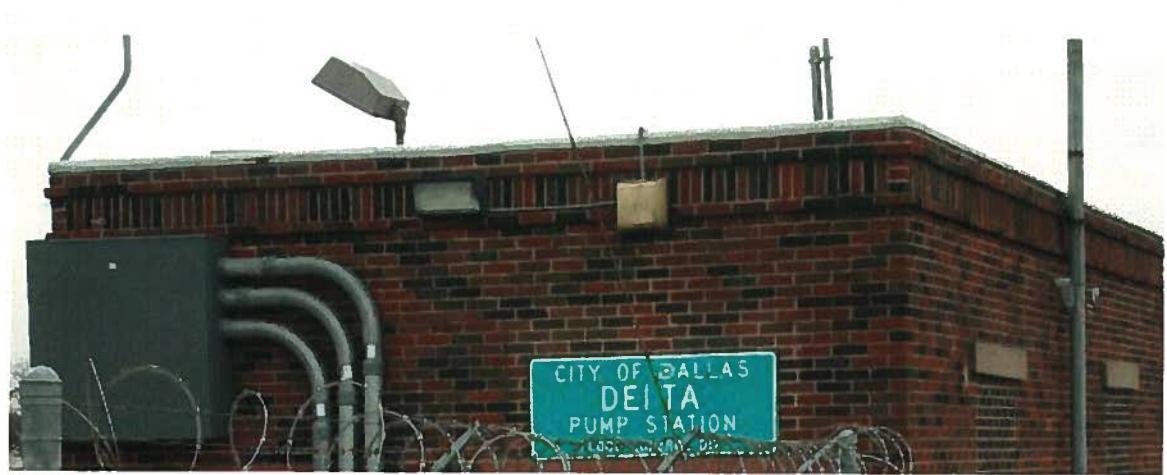
Photo 3.11 - DX, Flashing on East Roofline of Low Flow Station

There are no visible signs of movement in either the main station or the low flow pump station. The original capping on top of the main pump room has been replaced with what appears to be a solid concrete cap. A 90 degree metal flashing covers the top layer of brick and the capping on top of that with a thin layer of cement or mortar coating the flashing. (Photo 3.11)

- There is a strip of flashing missing on the east roofline of the low flow building. Repairs are needed to prevent water damage. The EBS department within the City of Dallas should be notified of needed repairs.

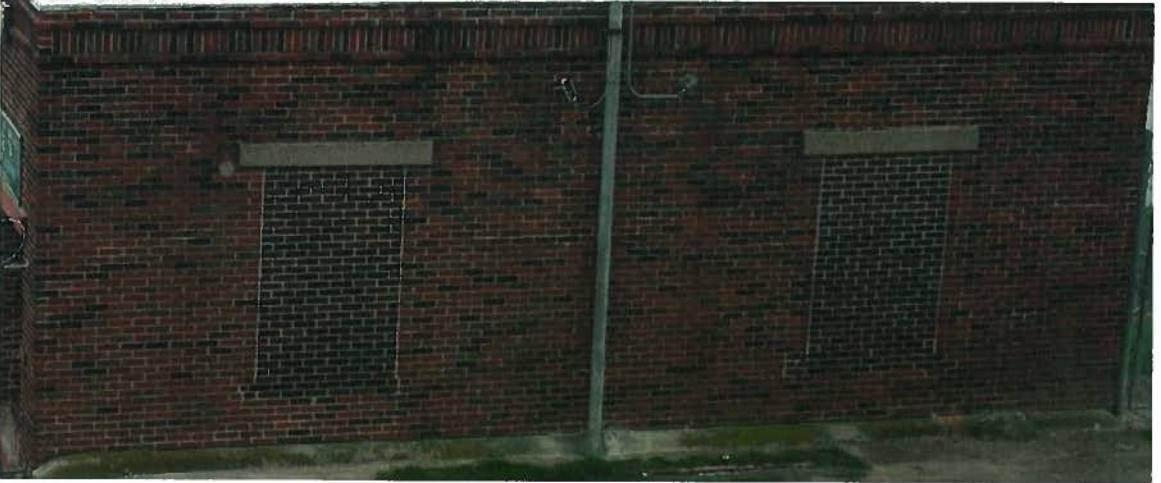
All the grout work is in good condition. (Photo 3.12) It is not known when the bricks were last sealed but there are not any noticeable signs of moisture leeching through.

Photo 3.12 - DX West Wall's Brickwork

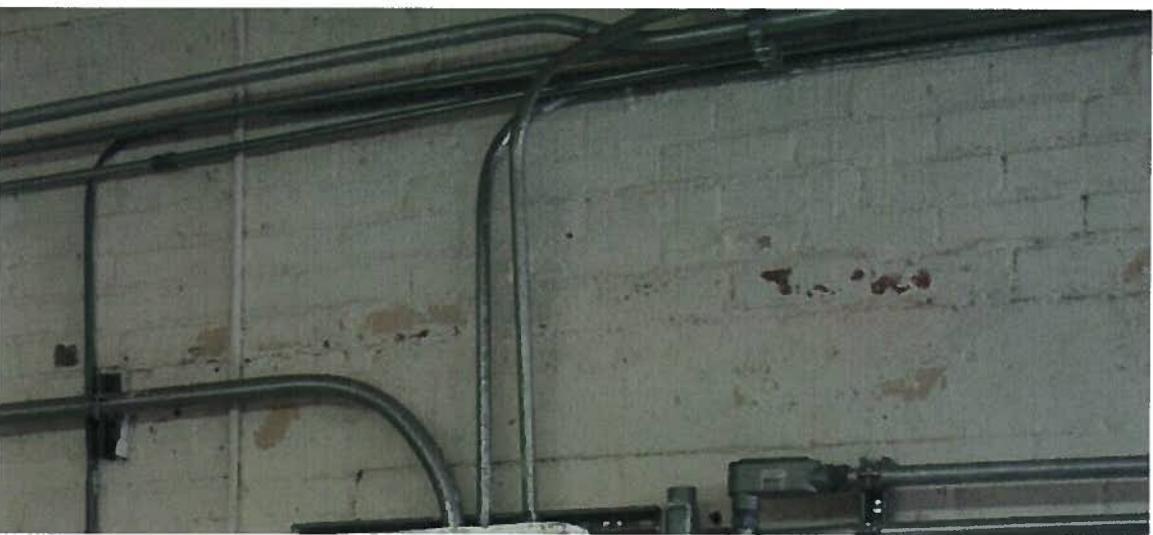
All paint on the interior that has flaked off, has a seal coat of paint beneath that is holding. (Photo 3.13) It would still be a good idea to have all brickwork sealed at the same time if possible

Photo 3.13 - DX Interior Wall Paint

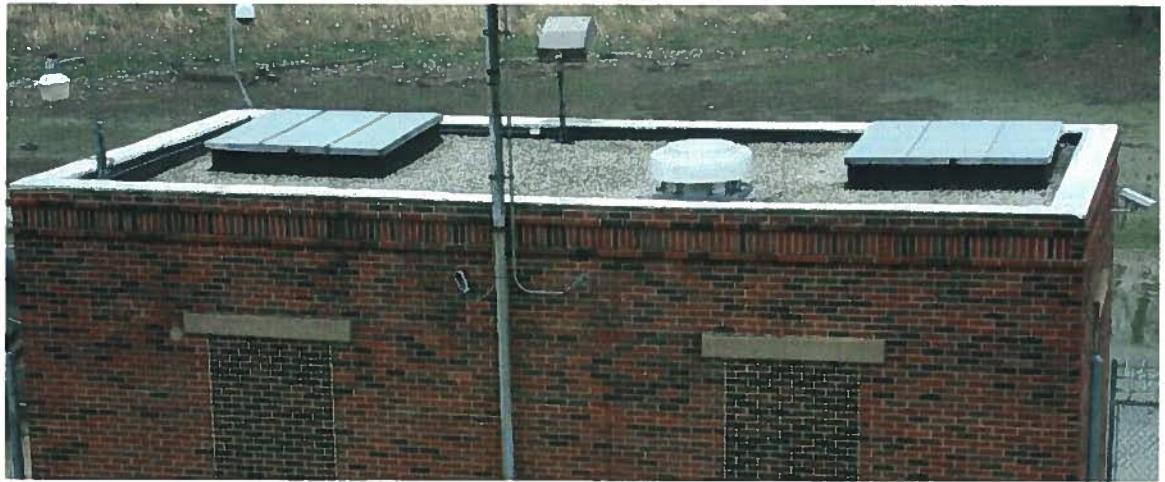
A large equipment hatch is above each pumping unit to allow crane access. (Photo 3.14) These hatch penetrations have an excellent lip height above the roof's surface to prevent water from entering the pump room should the roof not drain properly. The hatch covers are in excellent shape providing a weather tight seal. There are no visible problems with the station's exhaust fan.

Photo 3.14 - DX Main Pump Room's Roof

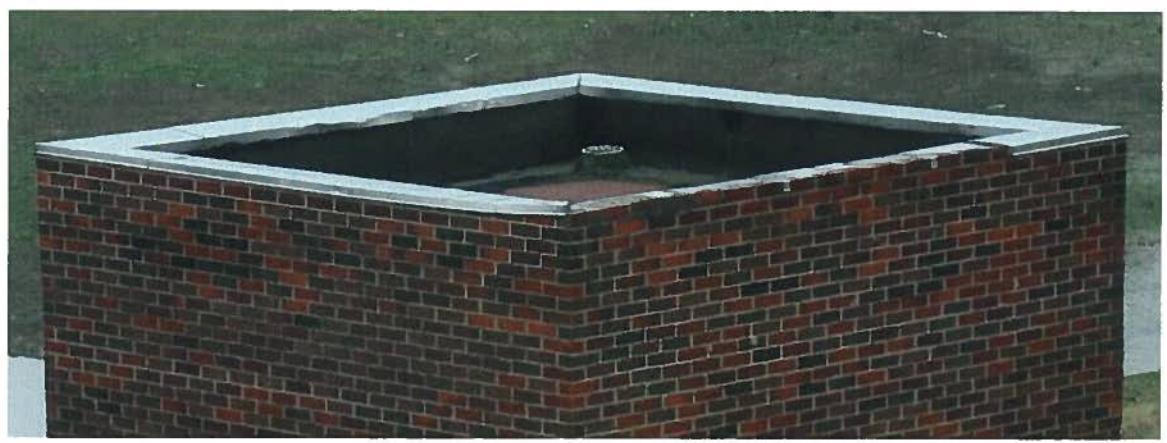
The roofing system on the Low Flow building does not show any signs of leakage internally, but the roofing system may be allowing water to enter between the roofing system and the brick along the east wall where most of the top flashing is missing. This appears to be a membrane type of roofing system but it only extends down the walls and onto the roof for a +/- 6 inch lip. This is a solid roof with no seams, so this type of system is sufficient. (Photo 3.15)

Photo 3.15 - DX Low Flow Pump Station

- Have EBS replace flashing on east roof line of the Low Flow Station.
- The obsolete level instruments have mercury switches. Although these are no longer in use and just being stored in place, they are a safety concern. These are located at several of the older stations. These should be brought to the attention of the responsible party, possibly the new Environmental Department to insure proper handling and disposal.

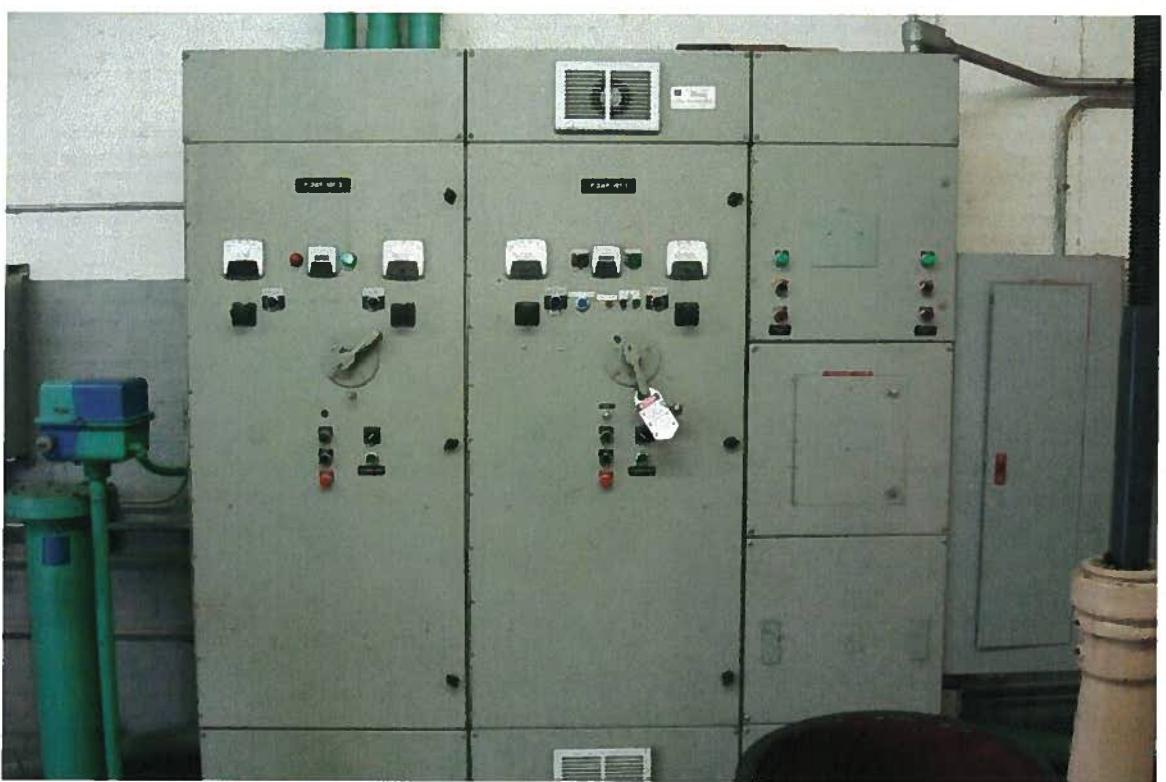
Photo 3.16 - DX Main Pump Room West Wall

The electrical cabinets are mounted on a raised concrete base and are against the west wall between the two main pumping units. (Photo 3.16) Electrical service enters the building through the upper portion of the south wall on the west corner. The electrical service enters the switchgear from the top. Only the motor leads exit from the lower sides of the cabinets, the remaining runs exit the cabinets through wall mounted conduits to the circuit panels and breakers.

The switchgear itself is in good operational order. As in other stations, its age makes acquiring parts difficult, the protection devices are the old mechanical type, and meters are out of calibration. The relays are minimal, requiring onsite personnel to see and reset alarm trips. By comparison, modern electronic protection offers dial-in capabilities, event recordings, warning and alarm conditions, programmable features, etc.

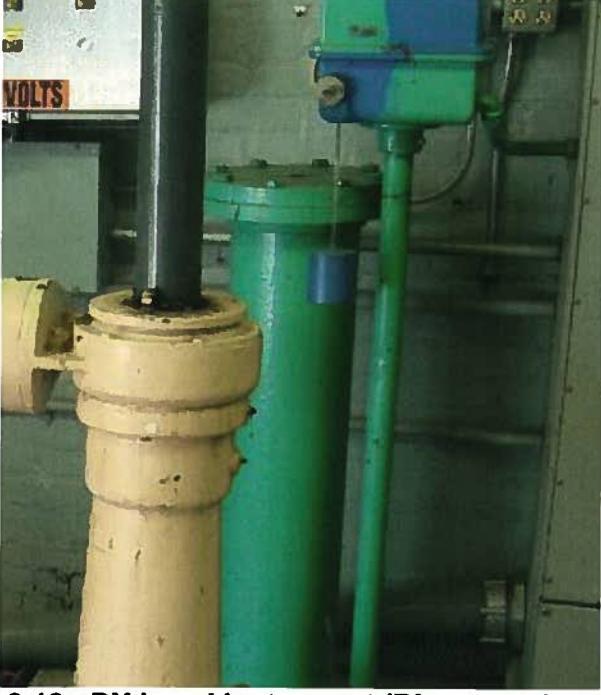
3.18 - DX Level Instrument (Blue green)

This instrument uses mercury switches that cannot be disposed of by normal means. Any disposal of a hazardous substance or material requires special procedures for disposal. This should not be a major problem as the mercury is contained in a sealed glass tube.

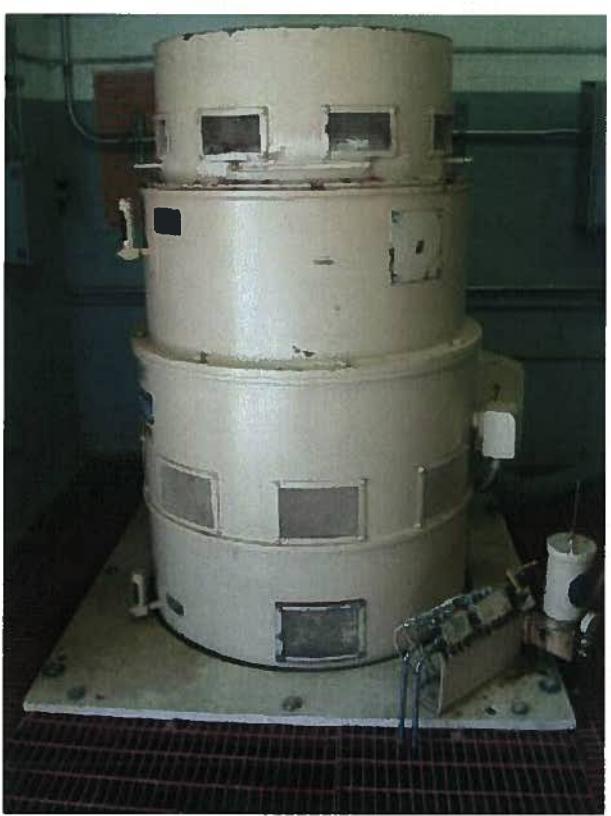
Photo 3.21 - DX #2 Pumping Unit

Ventilation is currently directed towards the motors and switchgear before being exhausted out of the building. (Photo 3.21) air circulates from the sump up through the grates surrounding the motors, and is then exhausted through the roof's exhaust fan. AC is recommended for new or refurbished electrical switchgear areas to increase its service life. AC would also help control humidity. A/C is not practical at this location.

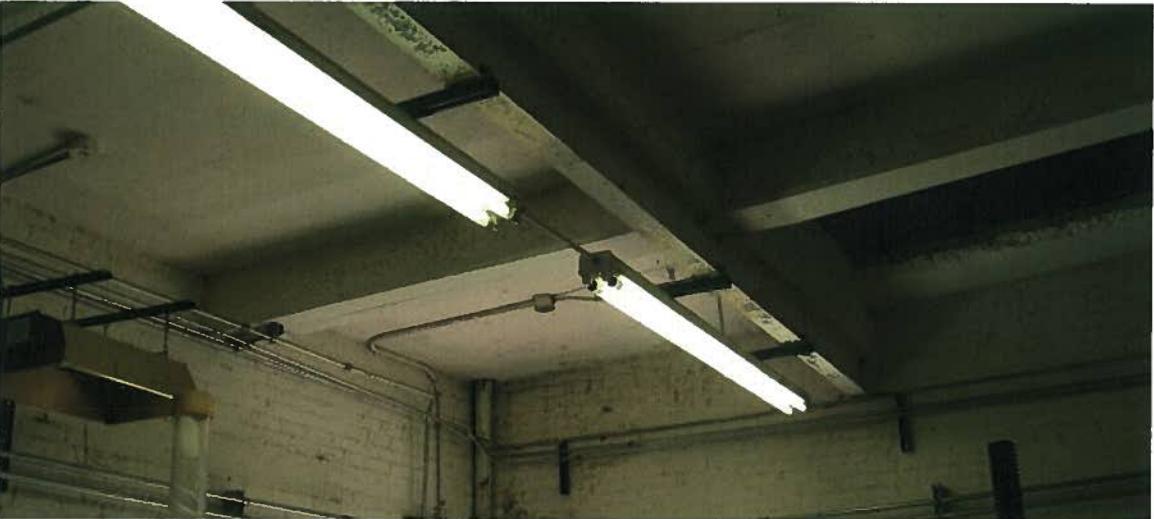
Photo 3.22 - DX Overhead Lighting Attached to the Rail System

The overhead crane has been removed from this building and the rail now supports the station's lighting. (Photo 3.22) The lighting was improved by adding fluorescent fixtures, providing adequate light that is easily maintained.

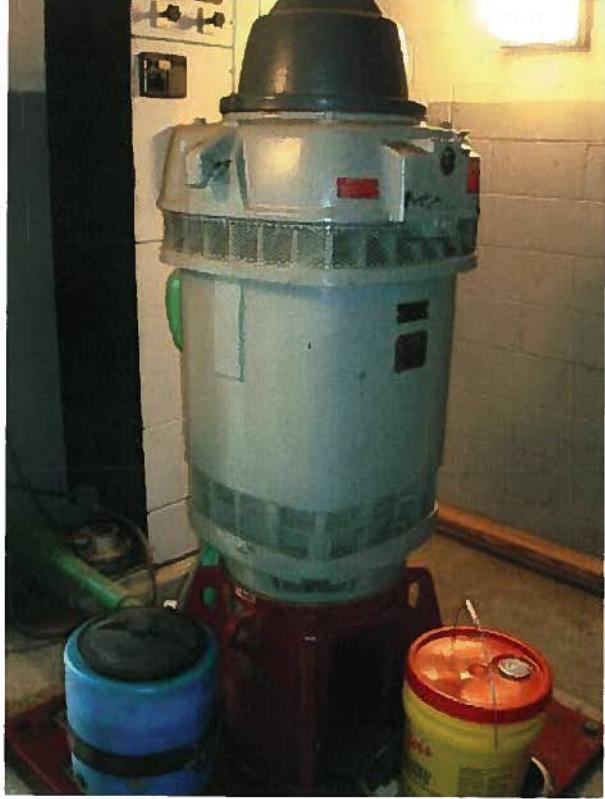
The low flow pump has a self contained lubrication system that mounts on the side of the motor base. This is an oil reservoir with a regulated drip to keep the unit lubricated. The pump will not start if the oil level is low or empty, but will not take the pump off line if it goes dry while running. This is a weekly check list item. The oil reservoir is filled as needed and this condition is not seen as a problem. (Photo 3.25)

Photo 3.25 - DX Low Flow Pump

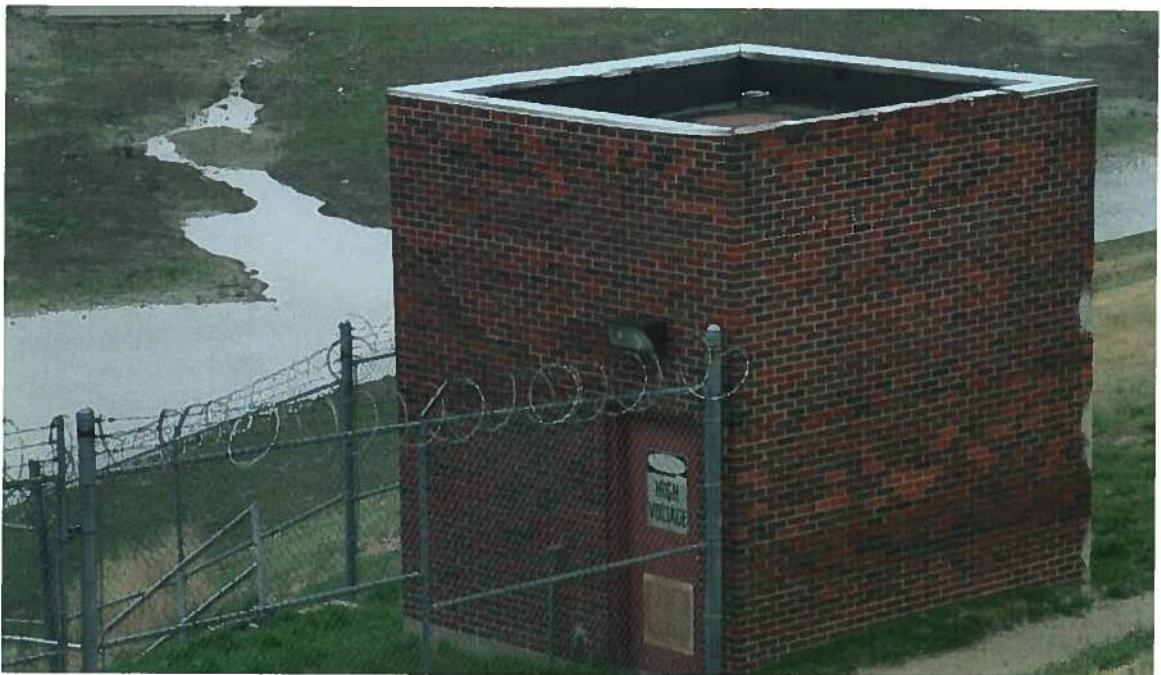
The building is just large enough to house the pumping unit and switchgear comfortably. Equipment is removed through the north roll up door. Normal foot traffic enters through a hinged door on the south wall. (Photo 3.26)

Photo 3.26 - DX Low Flow Pump Station's South Entrance

As mentioned in the comments for the main station, the hinged door should be equipped with a kick bar for emergency exit and a lighted exit sign unless the fire marshal approves the existing hardware.

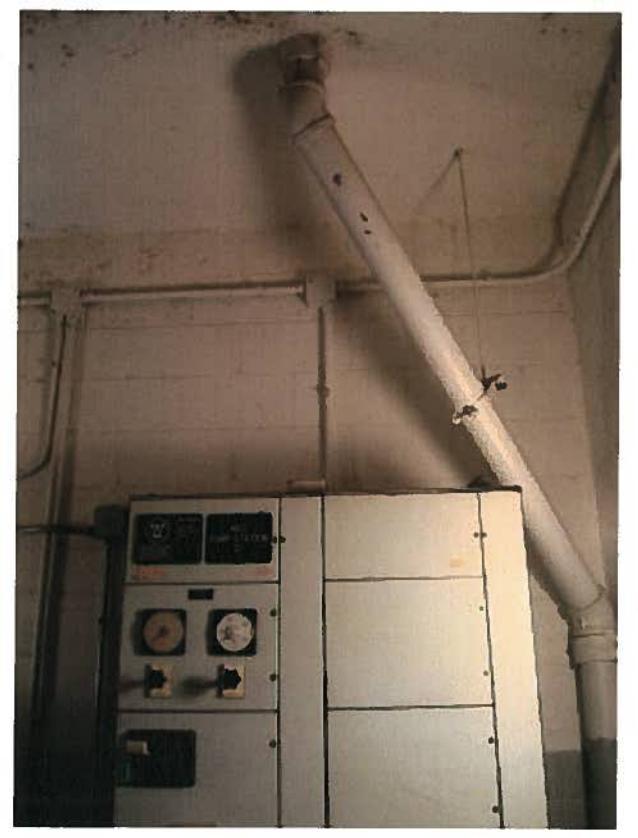
The roof drain of this building is directly above the switchgear and the drain line runs through the station rather than outside the station. (Photo 3.27) This is not a known code violation, but the penetration in the roof for the drain is a potential leak on to medium voltage gear. It is a good design practice to keep water outside the building when possible. The roof should have scuppers with drainpipes down the outside walls to eliminate this concern.

Photo 3.27 - DX Low Flow roof drain over switchgear

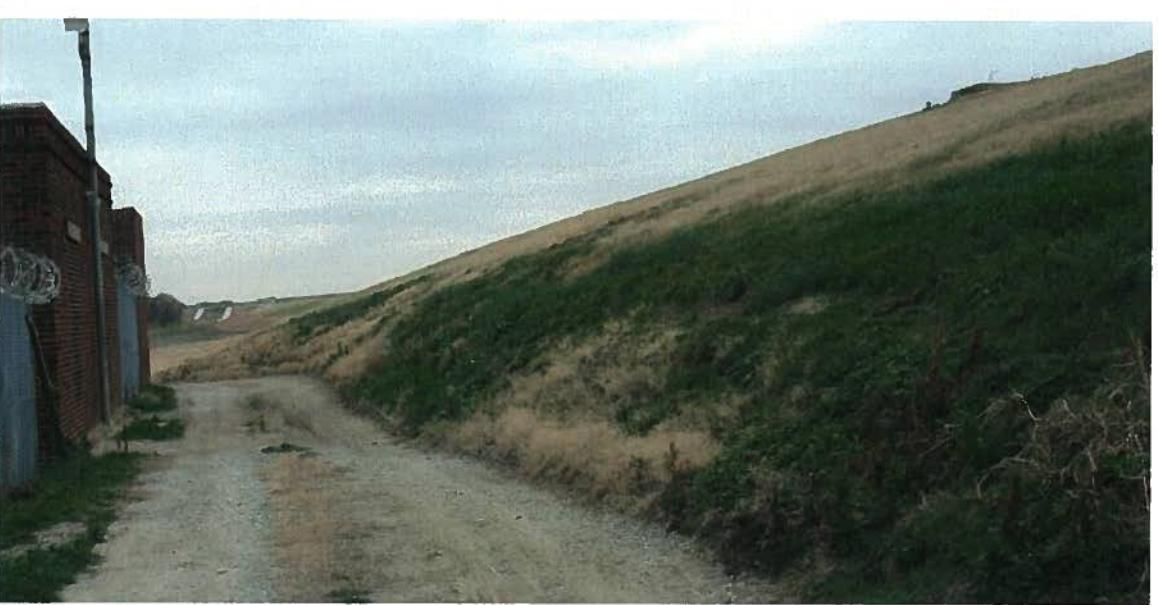
The west side of the levee facing the station has excellent groundcover and is well maintained. The slope of the levee changes to a slightly steeper grade near the bottom to make room for the road that passes between the bottom of the levee and the Delta site. There are signs of slippage and the increased angle make mowing difficult. (Photo 3.28) A retaining wall along the site's length would eliminate both concerns.

Photo 3.28 - DX Road Between Levee and Station, Slope Steepened to Allow Road

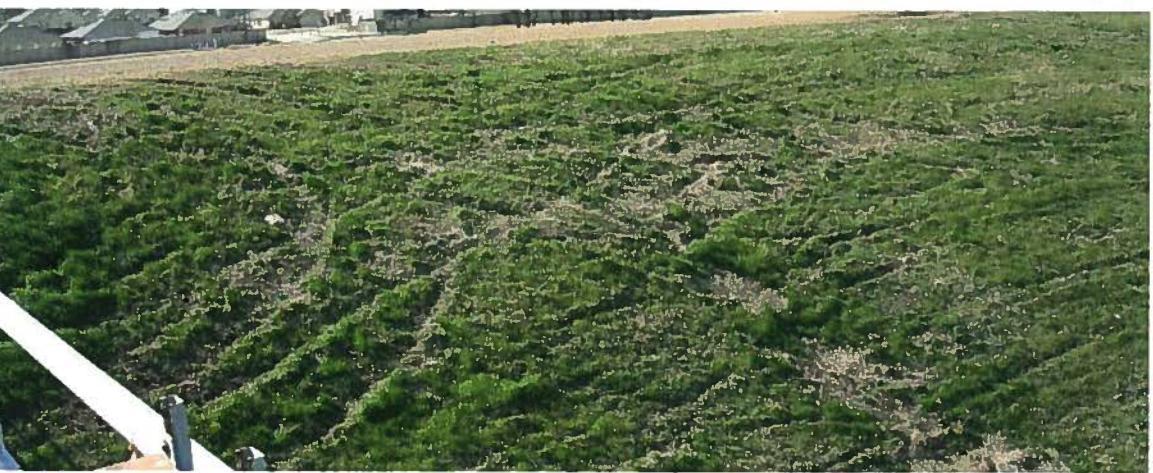
The road on top is routinely graded and in good repair. The east side of the levee has excellent ground cover and is in good shape. There are numerous ruts in the ground cover where it appears it was mowed while wet. This should correct itself in time. (Photo 3.29)

Photo 3.29 - DX West Levee, East Side

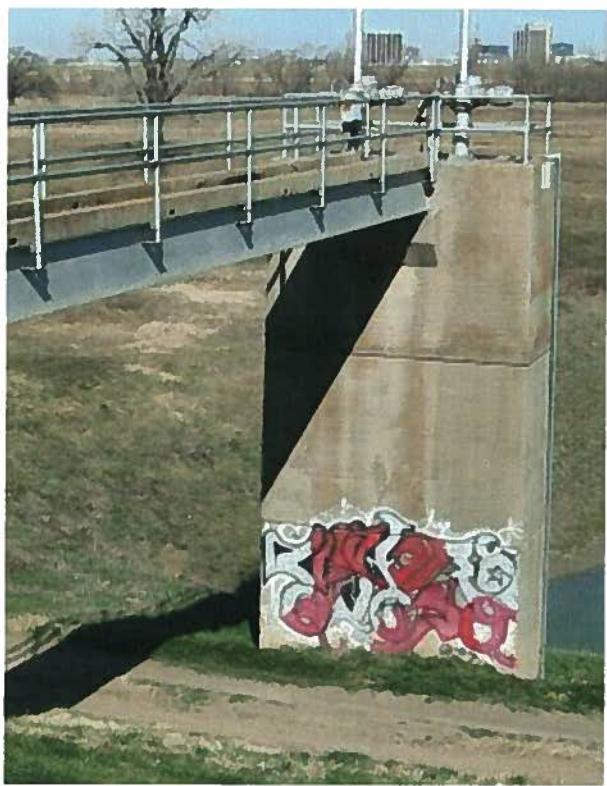
Photo 3.31 - DX Bridge and Valve Structure

This is the only location inspected that has excellent groundcover all the way up the levee under the bridge structure. (Photo 3.30) The elevated bridge and valve vault appear to be in excellent condition. There are not any noticeable signs of the concrete structure moving or cracking. The metal bridge and its concrete walkway are also in excellent condition. (Photo 3.31)

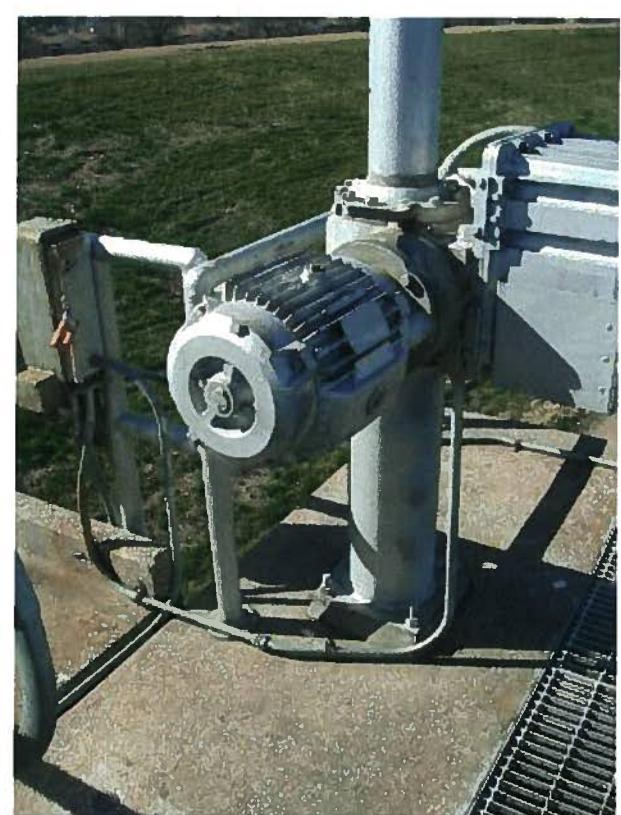
There are two electrically operated sluice gates at the end of the structure. Their operators and upper valve stems are well maintained. The bases show no signs of movement, a sign that too much torque has been applied (Photo 3.32)

Photo 3.32 - DX Electric Operated South Sluice Gate

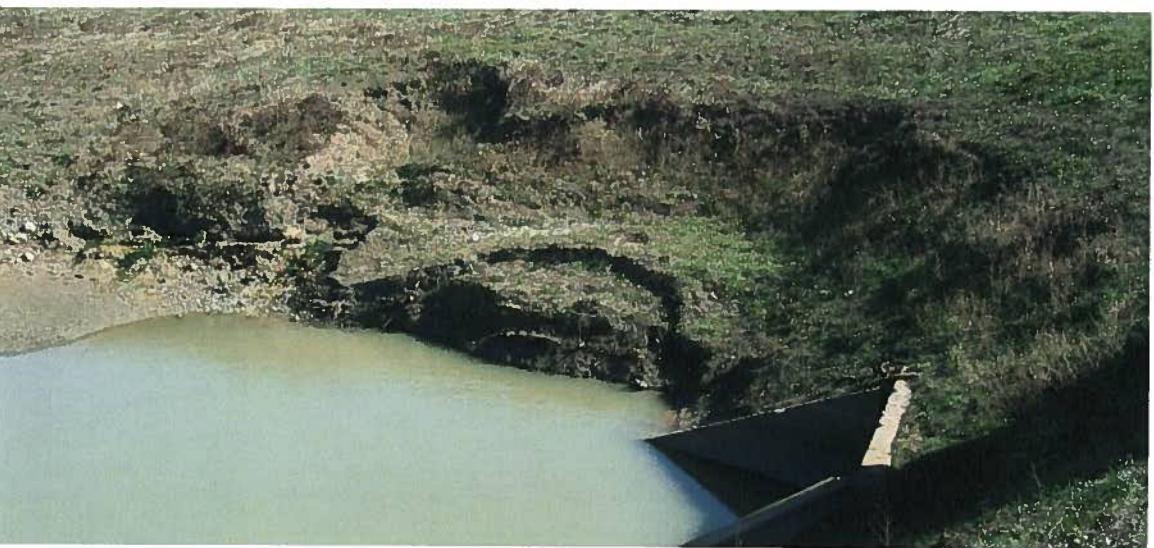
The South bank at the outlet structure has seen heavy slippage in the past. Groundcover is established in the area but there continues to be signs that the soil is still unstable. (Photo 3.34) The slope above the outlet structure has a shallow slope +/- 20

feet before making contact with the outfall structure. This along with the ground cover appears to be preventing slippage.

Photo 3.34 - DX Outfall Structure

The southern bank of the channel is showing minor problems and grading it back at a lesser angle would be helpful. Rip-rap around the structure may not be necessary at this location but it would improve the ability to avoid damages at the outfall structure from flood waters.

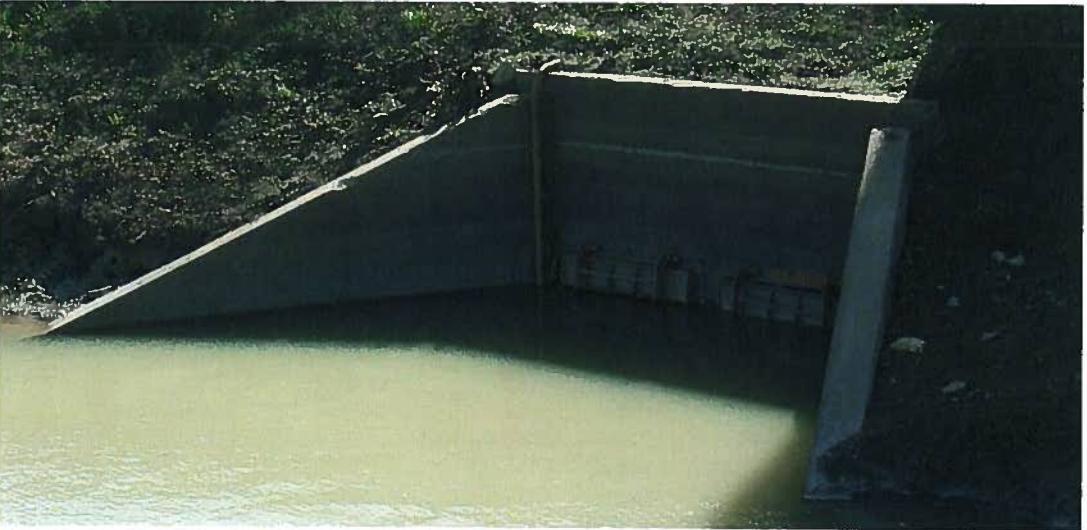
The exposed section of the outfall structure appears to be in good shape with minor chips on edges. (Photo 3.35)

Photo 3.35 - DX Outfall Structure

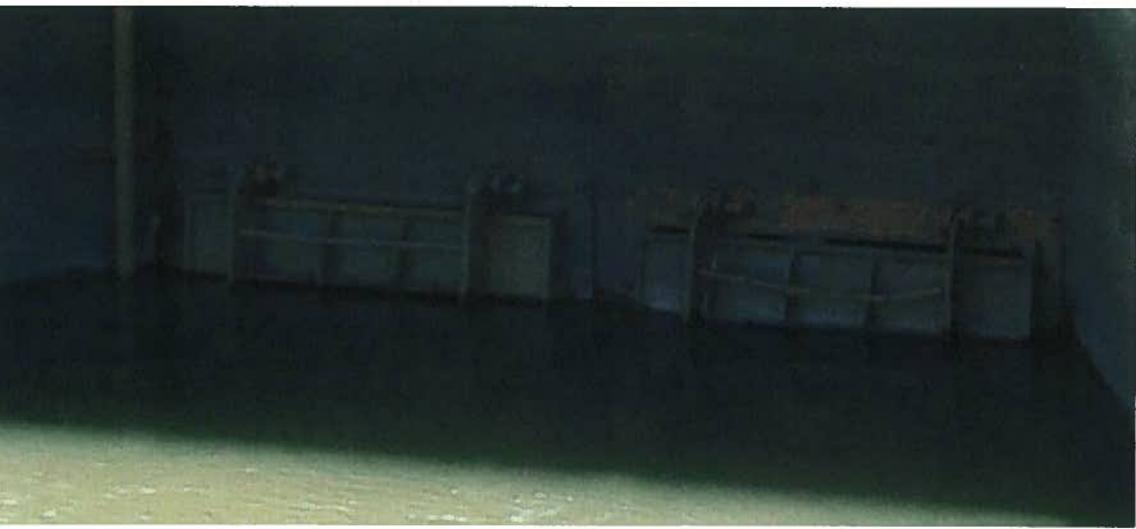
The north gate is not fully closed and may have silt built up preventing a full closure. There could also be a minor problem with the hinged gate itself. There is minor damage to the upper stiffening strut. This should be looked at by lifting the gate above the water

line to inspect for additional damage that could be causing an alignment problem. (Photo 3.36)

Photo 3.36 - DX Outfall Hinged Gates

- Personnel have no safe access up or down the levee. A stable pathway needs to be added.
- The addition of lights and GFI outlets installed on the valve vault would be helpful to personnel that are required to inspect and work on its equipment.
- An inspection of the north sluice gate is required to better determine its condition. There is a bent strut exposed above the waterline and the gate is partially open which could be an alignment problem or just silt built up under the gate.

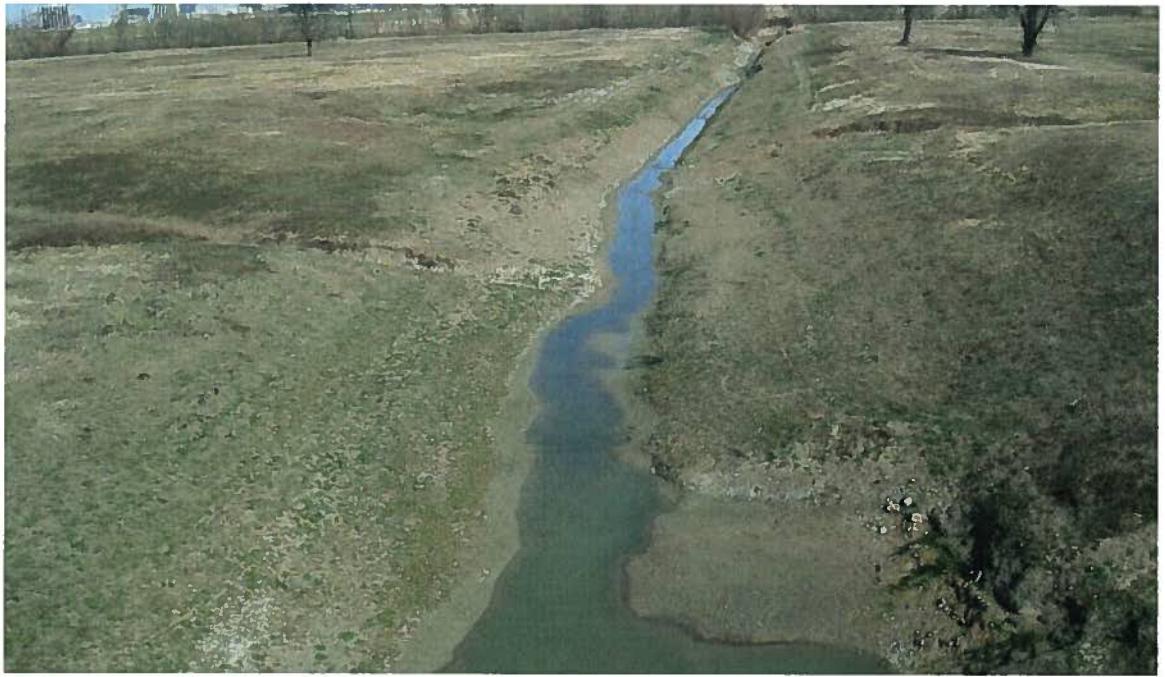
The channel from the outfall structure has minor silting but is in excellent shape overall. The south bank appears to be the main issue with its bank at a steeper slope being more prone to minor washout. (Photo 3.37)

Photo 3.37 - DX Outfall Channel

• It is recommended that the outfall channel at the structure be re-sloped on the south bank to lessen slippage and erosion. Grading the south bank to the river would also lessen washout.

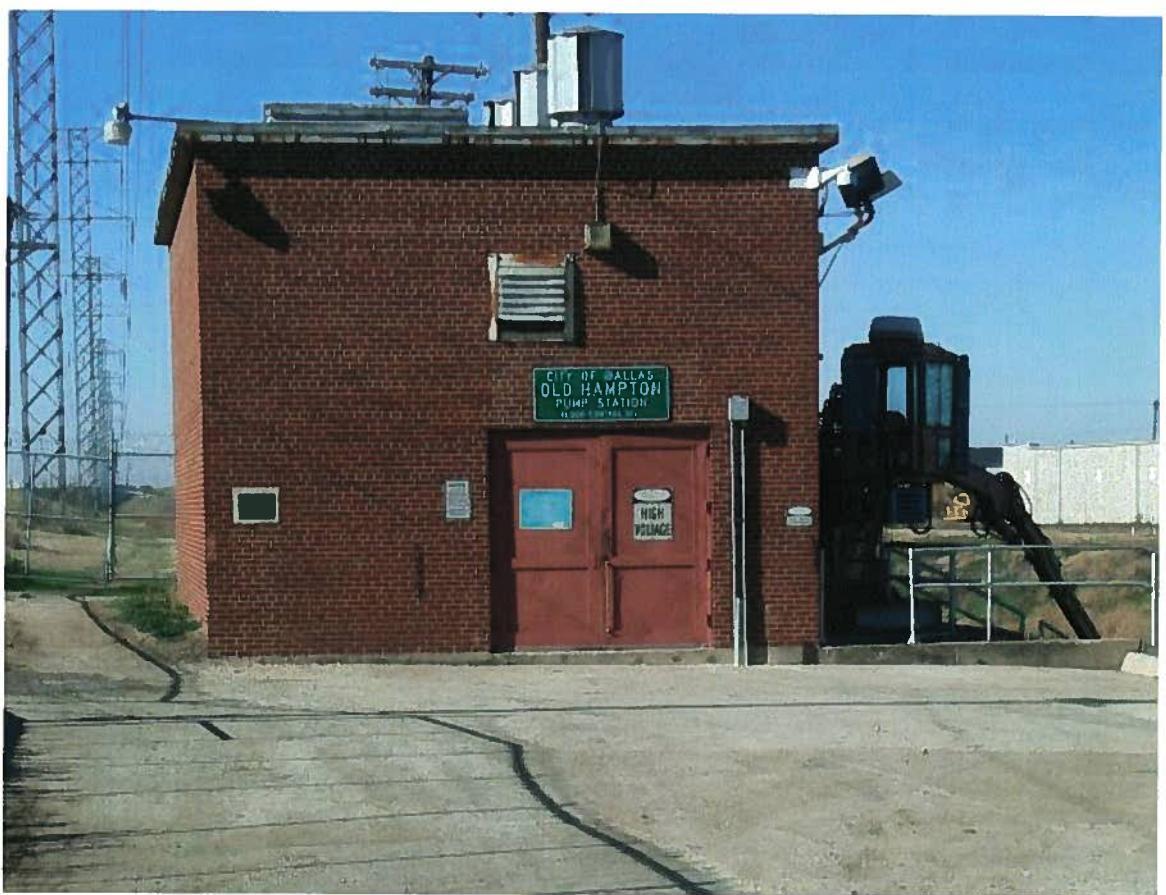
Photo 1.1 - Old Hampton Pump Station (OHX)
