CITY OF DALLAS INTERIOR LEVEE DRAINAGE STUDY WEST LEVEE – PHASE II

VOLUME 2 of 2 – PUMP STATION ASSESSMENTS

January 2009

Large Able (LAX) Pump Station

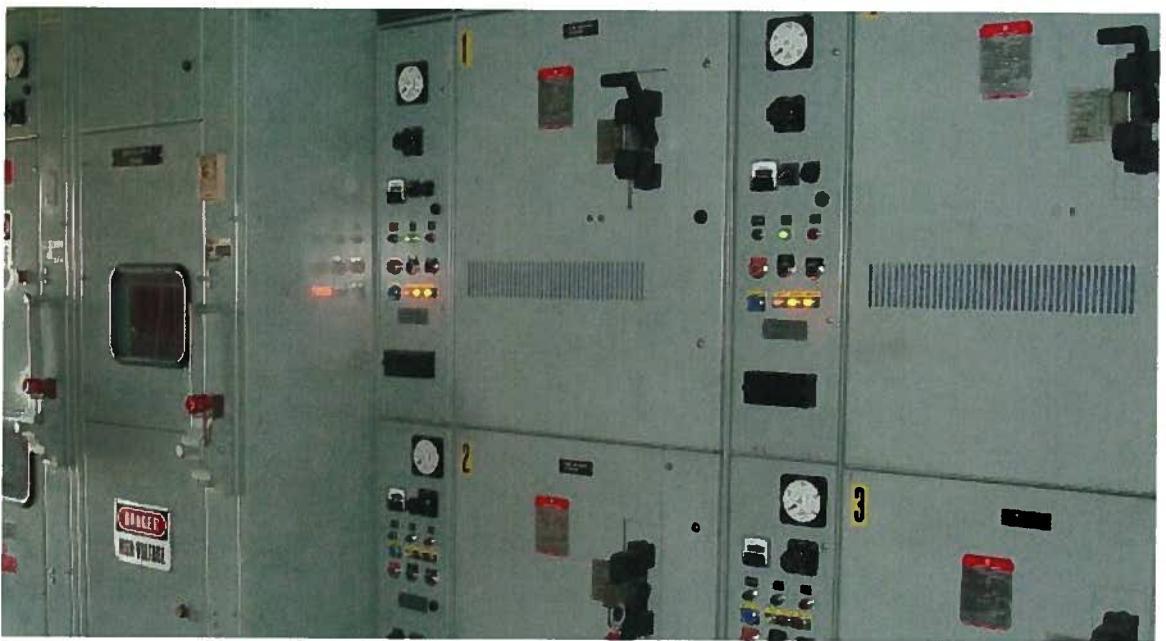
In the event of a SCADA System failure, personnel are able to manually operate this station from the switchgear cabinet by switching controls from remote to local and selecting the start or stop switch. (Photo 3.1) Indicator lights provide the necessary information to an Operator. An operational chart provides guidelines as to when each unit is to be put on-line or off-line.

Photo 3.1 - OHX switchgear and manual controls

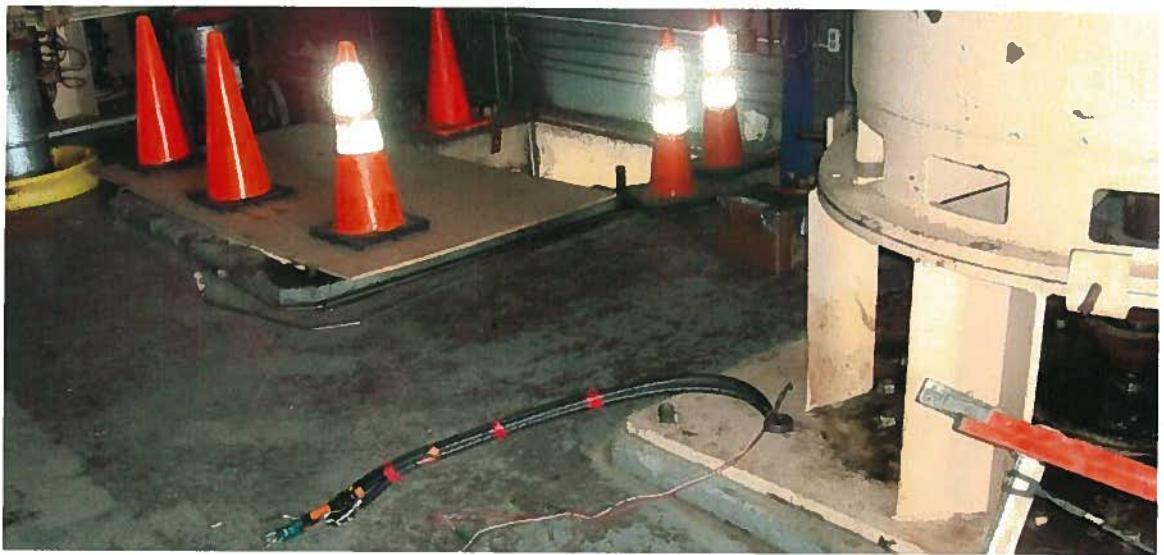
At the time of this report, two of the main units are out of service, #2 & #3 are tagged and locked out. The #2 unit has been pulled and floor penetration is covered with plywood and barricaded with traffic cones. (Photo 3.2) Also note motor leads of #3 and lubrication lines of #2 left lying on the floor.

Photo 3.2 - OHX Motor Removed, Opening Improperly Protected

For the safety of personnel, more sufficient barricading should be provided when pumps are removed. The possibility and potential consequences of someone getting injured call for a more substantial safeguard surrounding the worksite. (Photo 3.3)

- When personnel leave a worksite, regardless of whether teardown maintenance is underway, construction, or cleaning, the site must be safe and clear of hazards. Although attempts were made to secure and mark the area of work, additional effort is needed. A heavy steel plate to cover the entire opening, a welded rail system to surround the opening, and moving trip hazards are necessary to provide a safe environment. Wires and lube lines need to be secured and off the floor.
- Every station needs a storage area. Personnel are placing parts and materials wherever there is room at most locations. Lockable enclosures can be installed along with shelving to provide on-site parts and materials storage.

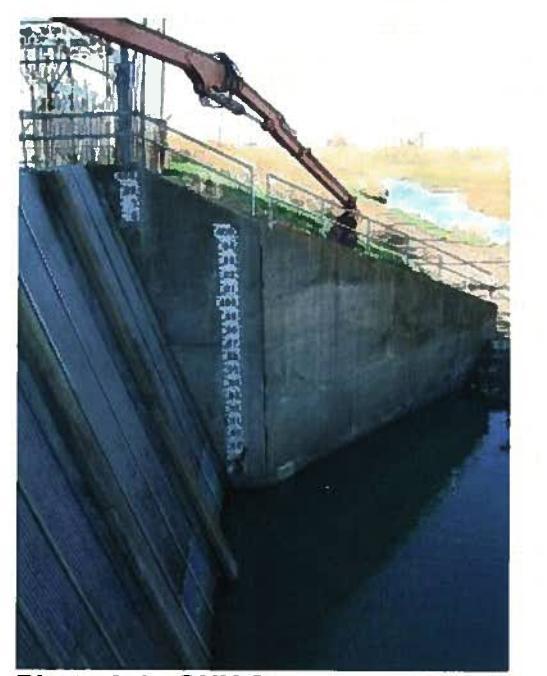
The Old Hampton Station (OHX) is located to the North of the New Hampton station (NHX) and shares the same sump area (Photos 3.4 & 3.5). The screens at this site are shielded from major impacts by having the sump area flow by the stations. Large floating objects in the channel cannot plunge directly into the screens. Debris is pulled off the screens at OHX using the trash crane shown in Photo 3.4. The debris is then loaded into dumpsters, hauled to and emptied at the public landfill.

Photo 3.4 - OHX Screens and Trash Crane

- There are not any safety precautions or training for those personnel required to work on clearing the screens. This is hazardous work when the station is online. A strong current to the screens is caused by the pumps. Anyone falling into this area would be in a life-threatening situation.

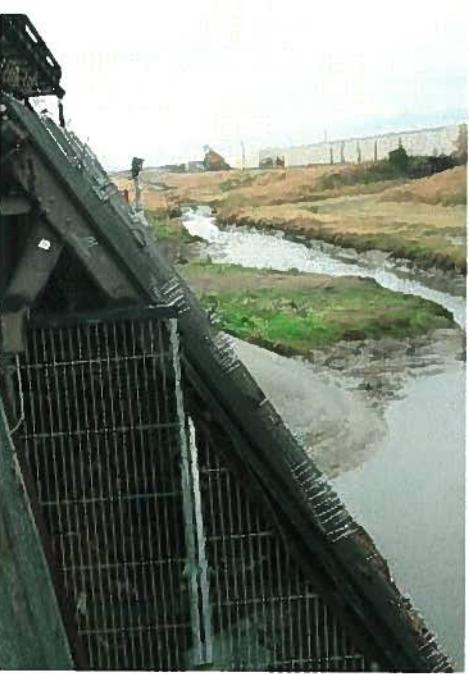
Photo 3.5 - NHX Screen, OHX's Inlet in view

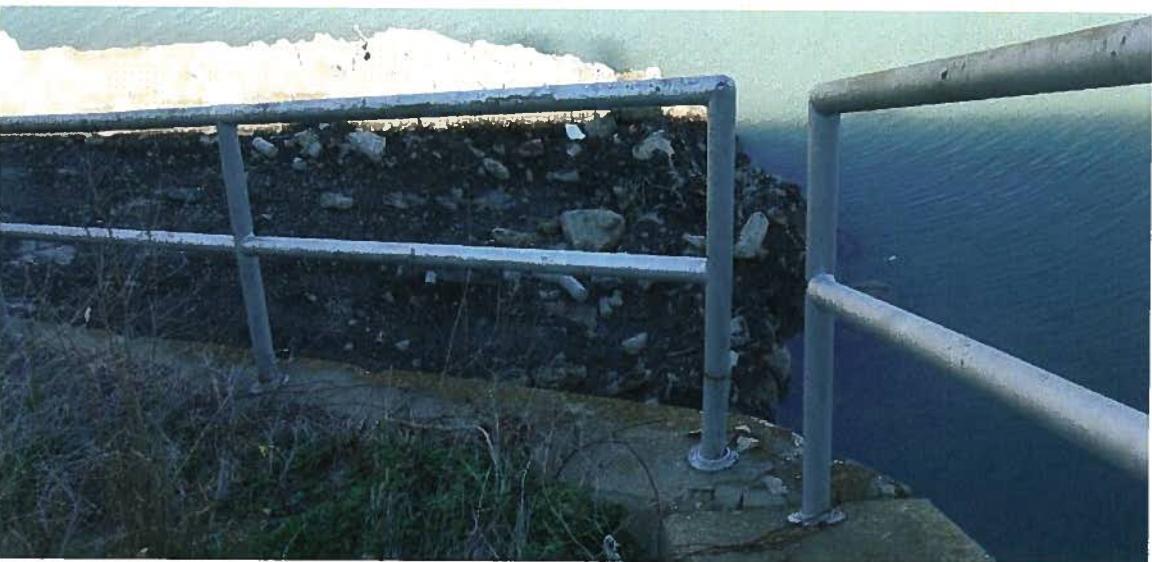
Photo 3.6 - OHX, North Wing Wall, Second Joint Showing Stress Cracks

There is concern about the integrity at OHX's north and south wing walls. There is a noticeable movement and damage at two of the joints. A Structural Engineer should make a closer examination to determine if repairs are necessary. (Photos 3.6 & 3.7)

- The wing walls and the west bank of the sump area is a concern. As stated above, the north and south wing walls show signs of damage and movement. OHX parking area repairs along the west bank, the power pole shifting requiring a second pole as a brace and other power poles also leaning toward the sump all indicate that the soil in this area is unstable. It is recommended that a geotechnical engineer be called in to investigate.

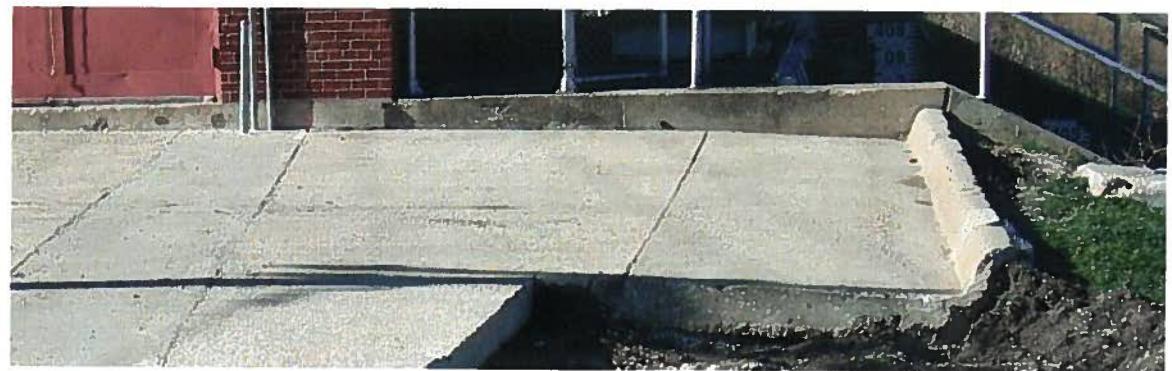
Photo 3.8 - OHX, West Bank Parking Area

Numerous indications of unstable conditions can be seen along the west bank of the sump area at the OHX site including the damage and movement of the wing walls, on-going repairs to the parking area along the Sump's west bank, (Photo 3.8) and tilting telephone poles along this same bank. (Photo 3.9) Additionally, one pole between OHX and NHX required a secondary pole be installed to support and brace a power pole that has a severe tilt. (Photo 3.10)

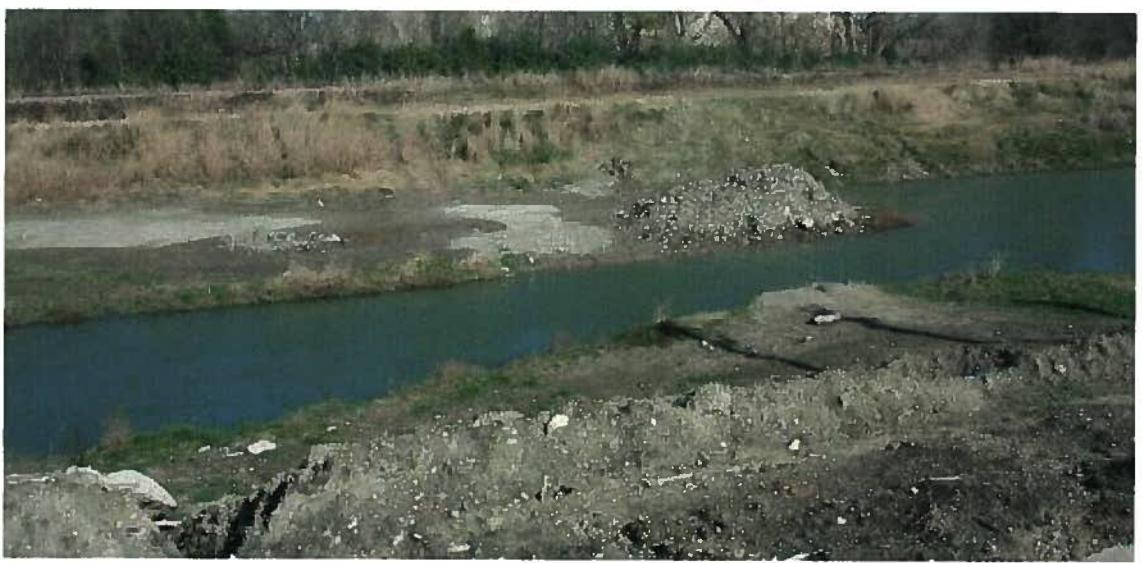
There is dirt piled on the east bank from the sump area. This is scheduled for removal per division's personnel. A temporary unpaved service road along the west bank was installed leading down into the sump area. The sump area at the Hampton site is not paved and requires access for heavy equipment to clean out large debris that is not pulled up at the stations. It appears that this temporary road was for this type of activity. (Photo 3.11)

Photo 3.11 - OHX Sump, Pile on East Bank - Service Road on West Bank

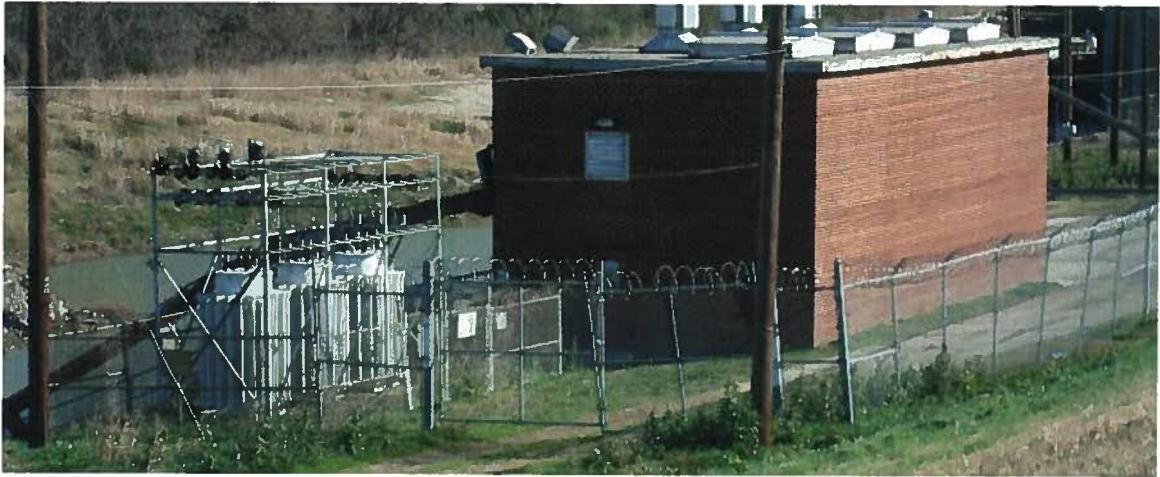
The fencing around the perimeter of OHX is not adequate for preventing vandalism. The razor wire added to the top of the 8 foot chain link fence indicates that security is a concern. This effort is not effective if a gate is loosely chained and out of alignment causing a gap under its entire length. The electrical provider also needs to repair their adjacent fence surrounding their transformer yard. The missing barbed wire on their fence makes it a simple matter of climbing their fence and stepping over into the station and the entire Hampton site. (Photos 3.12 & 3.13) A concrete mowing strip along the fence would lessen the chance of tunneling or high weeds hiding a cut fence. The driveway should be paved to the fence perimeter to provide an anchor point for the gate and prevent rutting.

Photo 3.12 - OHX North and West Fence Line

Vandalism has occurred at the pump stations and vagrants are commonly living within the levee area. For the safety of intruders, employees and equipment, it is recommended that security and lighting in and around the site be upgraded per the recommendations above.

- Fence repairs are required to improve security. A mowing strip should have been installed when the fence was built. A concrete strip added at the gate areas would improve the ability to secure those access points. The power company needs to be contacted to make repairs to the fencing surrounding their equipment, to remove the ability for someone to step across where the City of Dallas and the power company's fences meet.

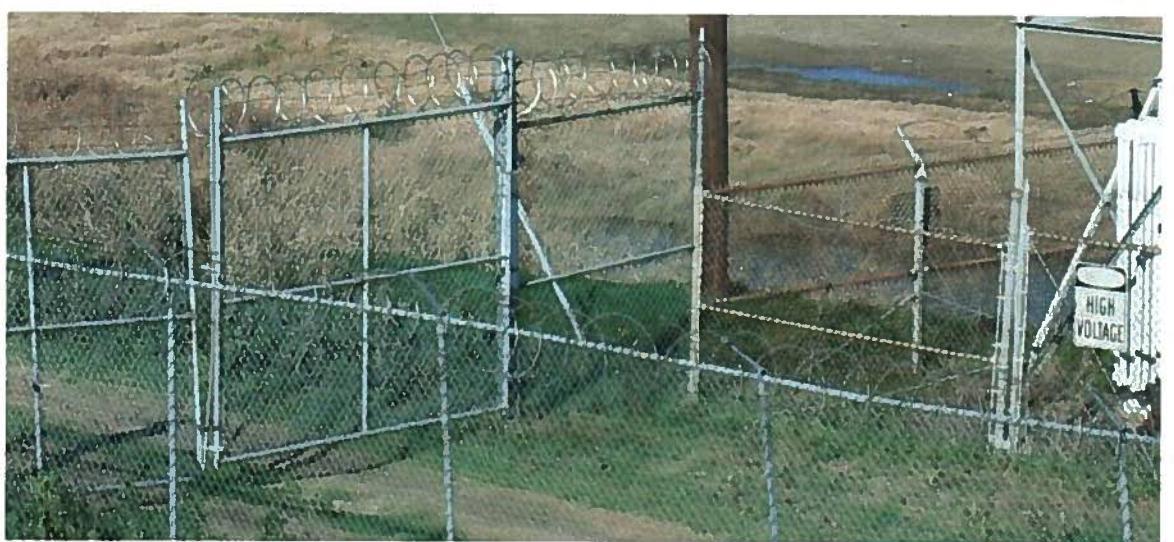
Photo 3.13 - OHX North Gate and Transformer Yard

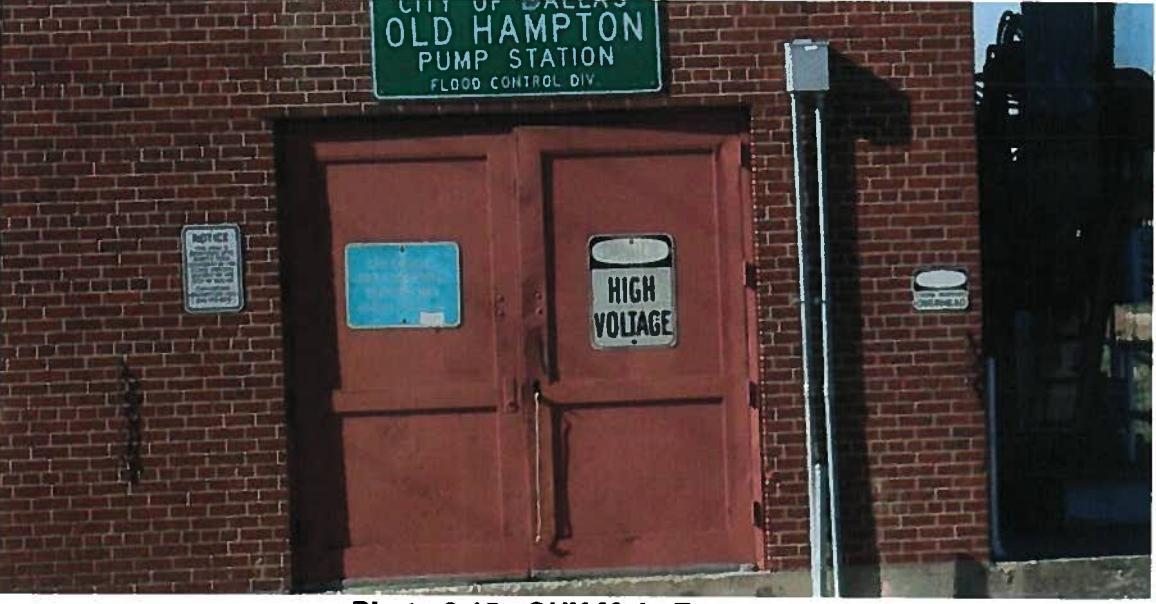
Photo 3.15 - OHX Main Entrance

The entrance to this station needs replacement. The entrance on the south wall does not have a handle, latch or any means to open from the outside. (Photo 3.15)

The only way to enter the building is through the door on the north. The south entrance can only be opened from inside the building. The appearance of this entrance implies that numerous attempts have been made at repairs. Replacement would be a better option and adding panels of safety glass would also provide some much needed natural light into the building.

- Doors on this building need to be repaired or replaced. The entrances should have panic bars and exit lights inside for emergency exits.
- The sealant needs to be removed and replaced around the bottom edge of the building along the east wall.

- There are two access points into this building. The South entrance is a hinged double door. There is not an outside latch, padlock, doorknob, etc. Access to the pump room is through the door on the north end of the building. This entrance is locked with a deadbolt and should be replaced with a kick bar to provide an emergency exit. Natural light cannot enter this building. There are no emergency exit signs or a fire alarm system. Lighted exit signs need to be installed on all exits. Repair or replace the hinged double door, preferably with doors that have safety glass to allow some natural light into the building.

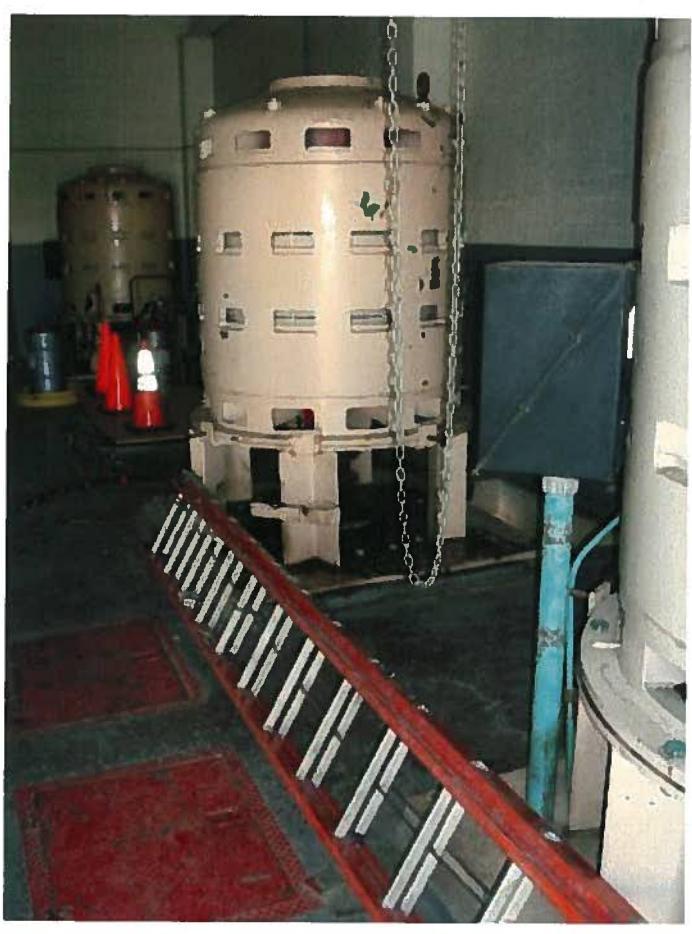
Photo 3.16 - OHX Looking South on West Wall

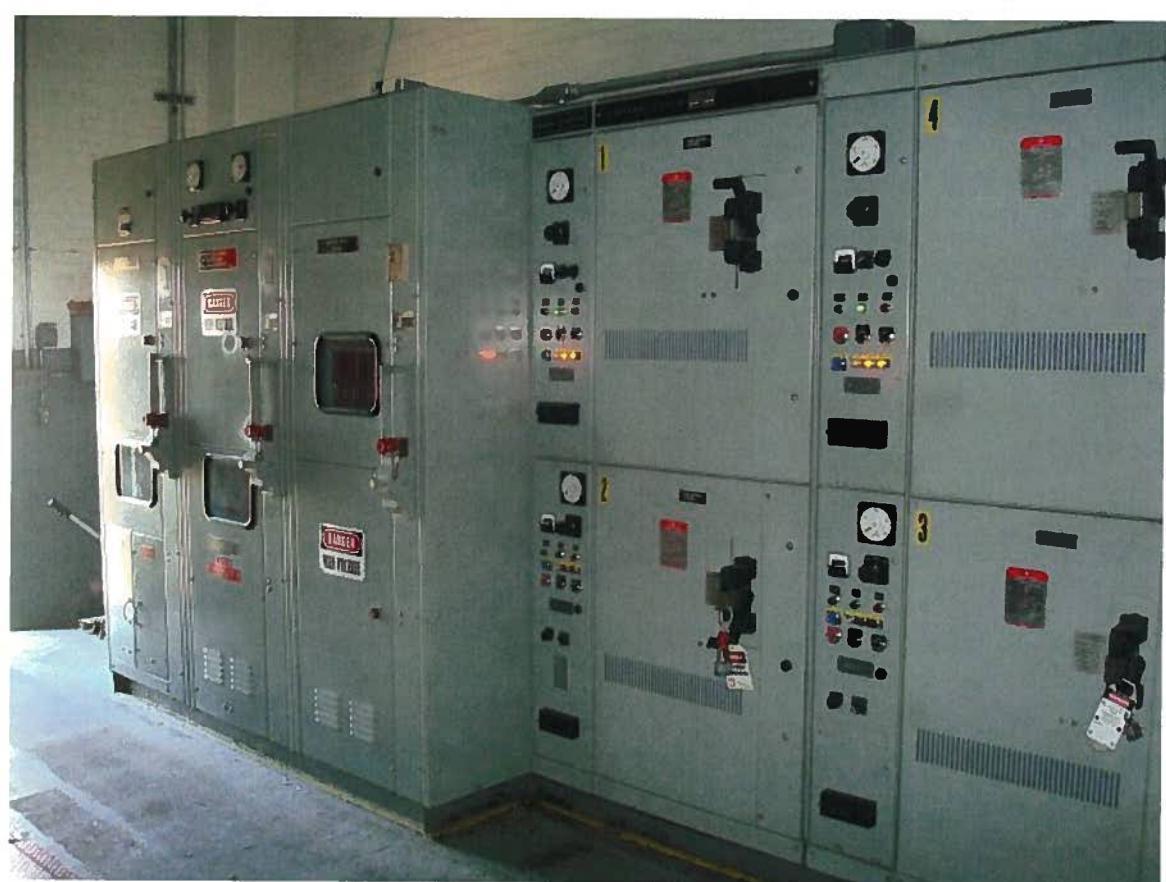
The electrical cabinets are raised off the floor slab and mounted against the wall. (Photo 3.17) All large cable runs are below floor level. New conduit runs are secured firmly to the walls and not in conflict with other equipment. The switchgear itself is in good operational order but as in other stations, its age makes acquiring parts difficult and the protection devices are the old mechanical type and are not calibrated. Personnel do not have the equipment or experience to calibrate these relays. The information transmitted to the SCADA reflects these discrepancies, which are then altered within the SCADA to read, "What is believed to be correct". The switchgear equipment is at or past its expected service life. The relays are minimal, requiring on-site personnel to see and manually reset alarm flags. By comparison, modern electronic protection offers dial-in capabilities, event recordings, warning and alarm conditions, programmable features, etc.

Photo 3.17 - OHX Switchgear Cabinets and Controls

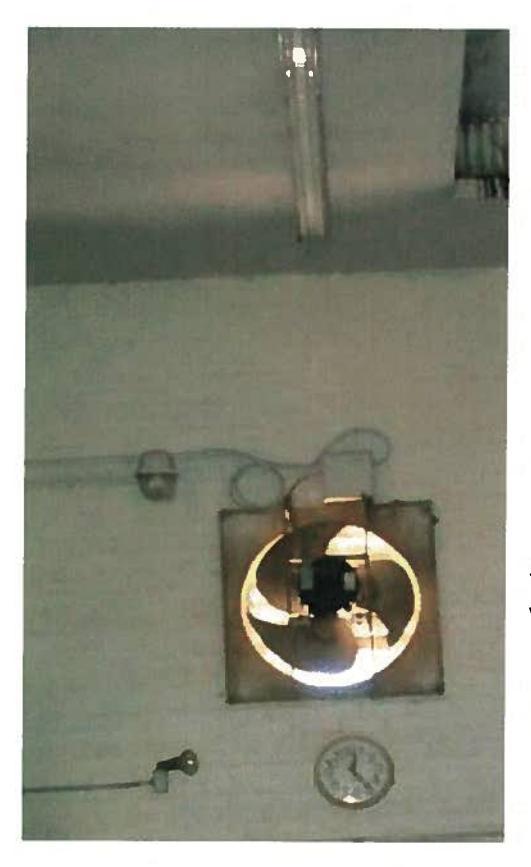
There is only one exhaust fan that is gable mounted on the south wall, with an external louver cover. (Photo 3.18) The lowest blade in the louver is missing. There is also a place for a second exhaust fan on the North gable. This fan was removed some time in the past, but the external louvers are still in place. There are no air vents at ground level. It appears air is pulled in around the base of the motors. The exhaust fan and roof vents may be causing air to short circuit by being pulled from the ceiling rather than at floor level. A smoke test could provide information on the air circulation within the station. AC is recommended for new or refurbished electrical switchgear areas to increase its service life. This is not practical at this location but pulling air across the equipment would be something that should be tested inhouse.

Photo 3.18 - OHX Lighting and Exhaust Fan

The lighting system is piece meal (Photo 3.18) with combinations of fluorescent ceilingmounted fixtures, incandescent flood lights and wall packs with mercury vapor or metal halide. The high ceiling makes it difficult to change bulbs or make repairs and the multiple types of fixtures require more types of bulbs to carry in stock. For this facility the wall pack units would be well suited and could be installed by electrical staff when time permits.

- There is no safe method of changing light bulbs or repairing these fixtures mounted on the ceiling. The area within the building would allow for easy installation of wall packs around the perimeter at a height that could be serviced with a step ladder.

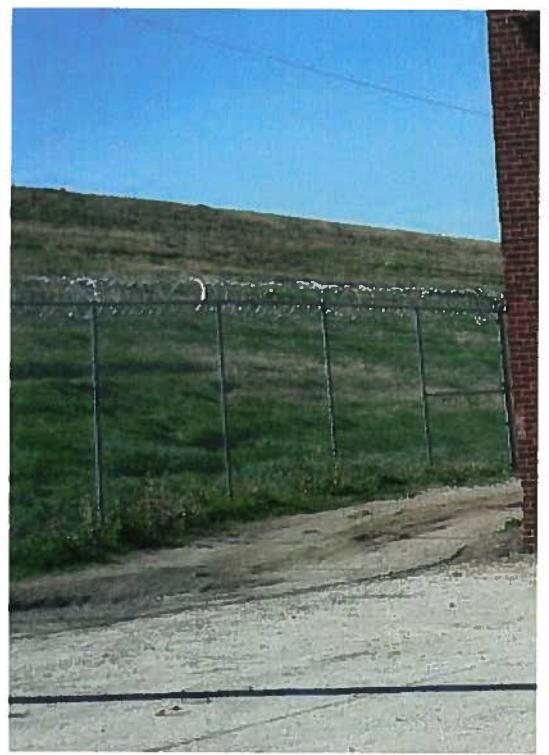
All equipment in the pump room is accessible to the overhead crane, but a mobile crane must be used when it becomes necessary to pull a pump. The extraction of a pump is done through the equipment hatch above the unit. An unpaved driveway on the west side of the building provides an area for a mobile crane to access the equipment hatch. This not may be adequate to safely support such a heavy vehicle under load conditions. The driveway's condition is acceptable for most traffic but heavy equipment is questionable for long term use. It is also very restrictive for a large piece of equipment, such as a mobile crane. The driveway does not have an adequate approach for a long vehicle and pot holes add to this problem. (Photos 3.20 & 3.21)

Photo 3.20 - OHX, Pot Holes

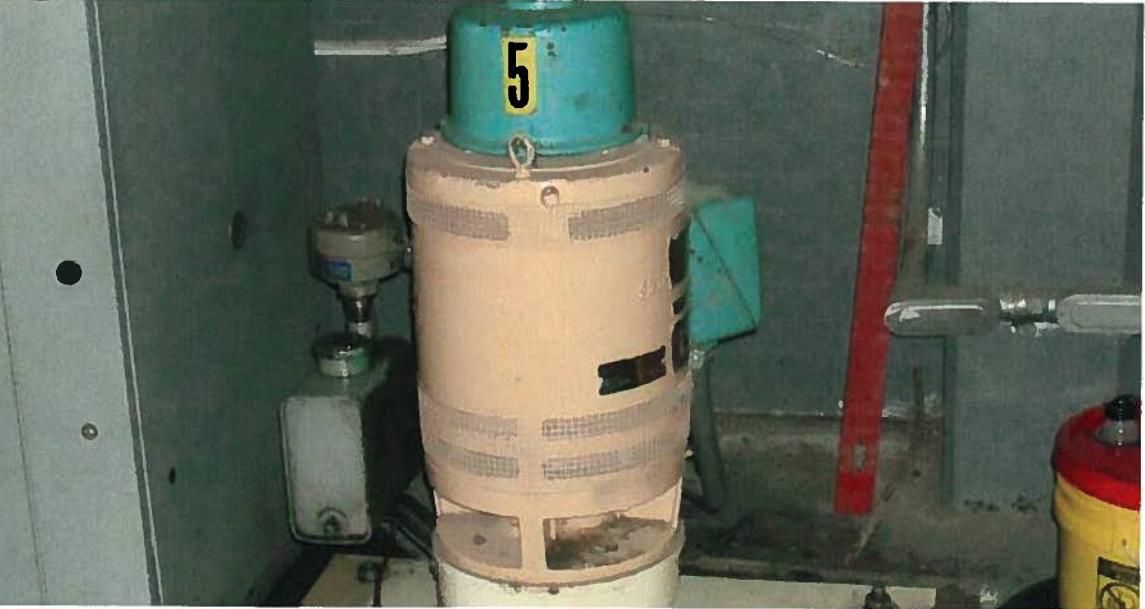
Photo 3.21 - OHB Low Flow with Oil Lubrication System

The low flow pump #5 has a separate oil lubrication system with a reservoir attached to the unit.

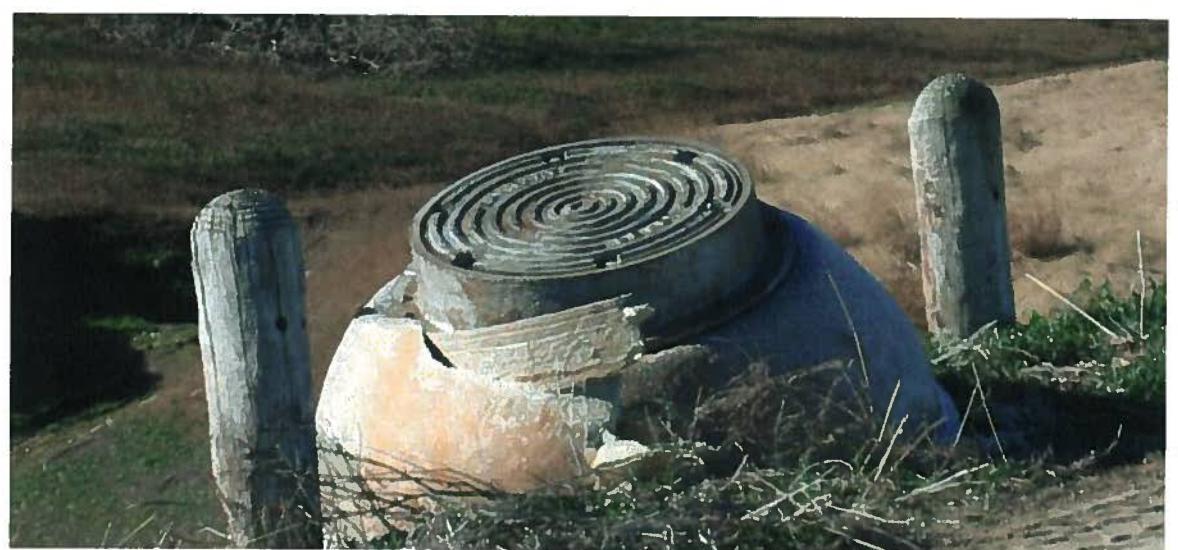
The east side of the levee facing the station is not quite up to as high a standard as seen at the Baker site, but is well maintained. The road on top is compacted dirt that receives routine grading to keep it in shape. There are protruding vaults at numerous locations that appear to have been brushed by passing vehicles. (Photo 3.22)

Photo 3.22 - OHX manhole on levee

If this road is used at night or during foul weather, it would be easy to miss seeing these structures. This department has a street sign division. I suggest that border signs be made from reflective material and attached to the roadside corners or bollards.

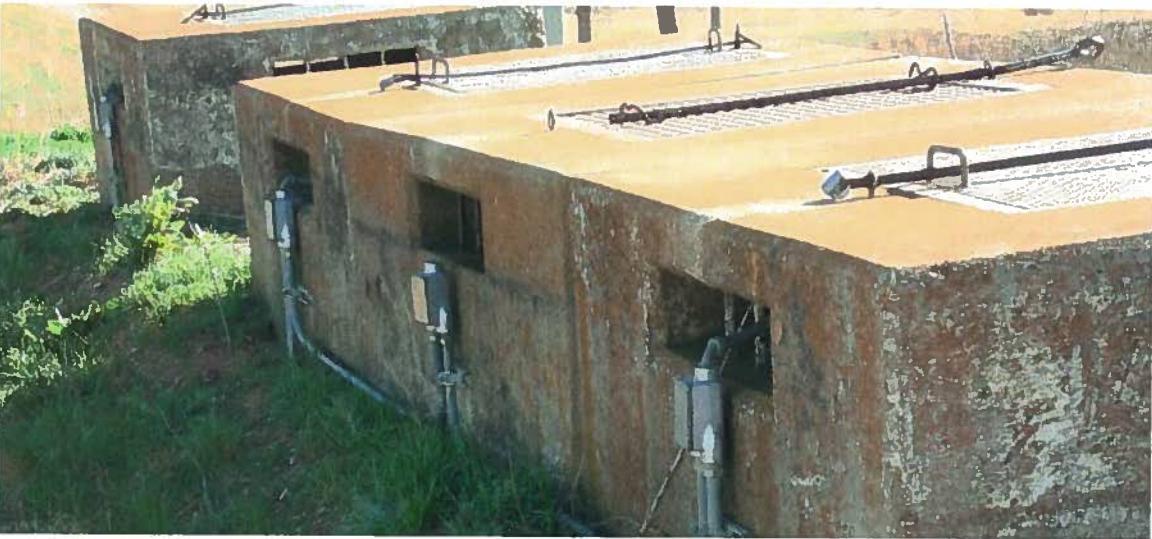
The valve vaults on top of the levee appear in excellent shape. Access to these should be considered a "confined space" when working within. It is not the depth but the limited entrance and confining area within that define these vaults as "confined space". (Photo 3.23)

Photo 3.23 - OHX Valve Vaults

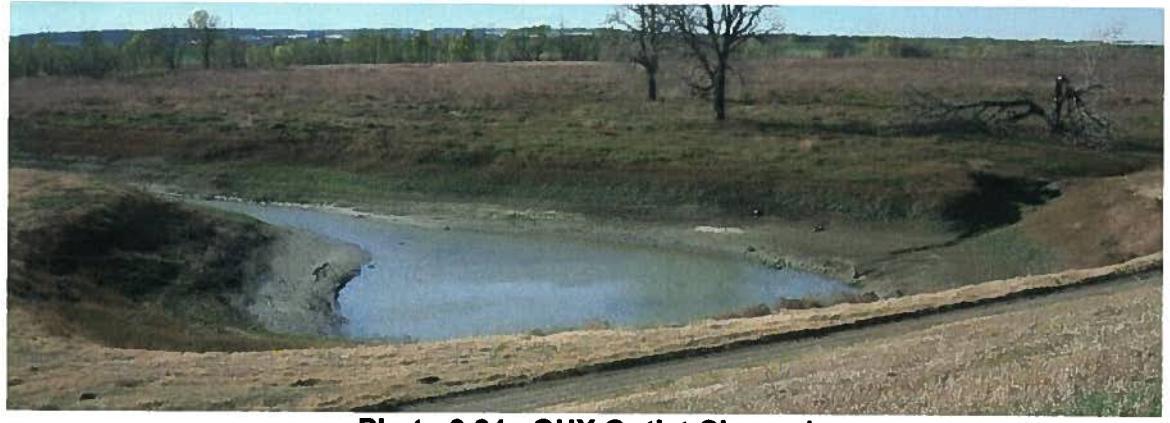
The west, or river side of the levee is in excellent shape, with the slope on an even grade and the area surrounding the outfall showing no signs of recent slips. The area surrounding the outlet structure is rounded with a gradual slope to the banks. (Photo 3.24)

Photo 3.24 - OHX Outlet Channel

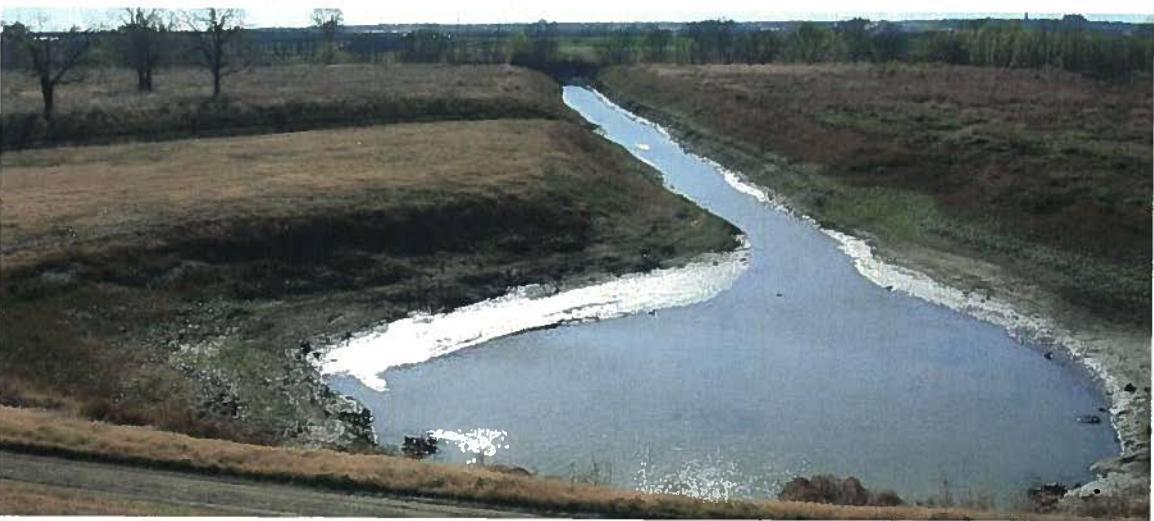
The channel to the river was clear of obstacles (Photo 3.25) with silt forming a smooth transition into the banks. This small build up of silt was low and not needing any attention in the near future. Ground crews maintain these areas and routinely check to see if clean out needs to be scheduled.

Photo 3.25 - OHX and NHX Channels to River

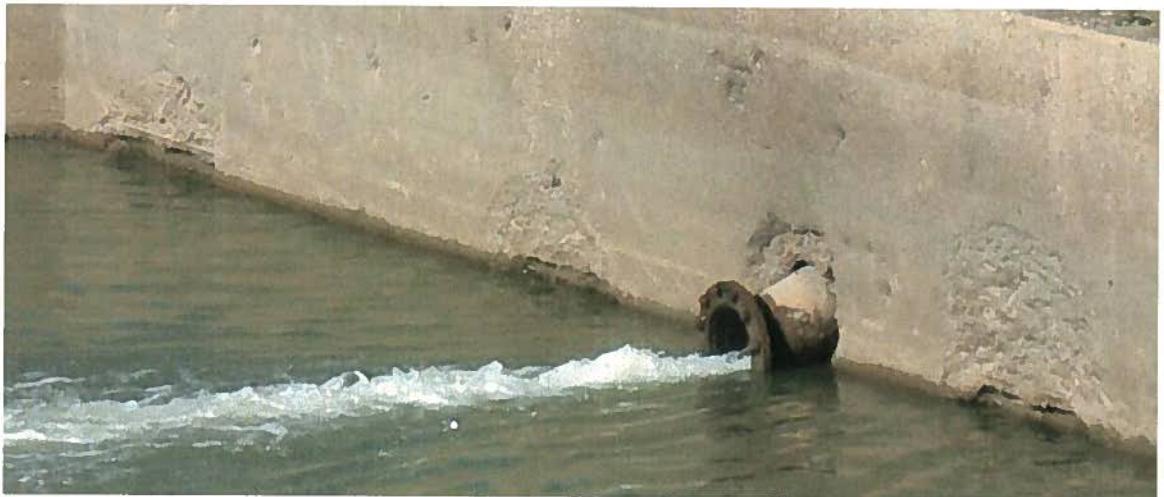
The above water section of the Outlet structure does not show any signs of movement or cracking. There is spalling above the low flow and the discharge lines from the main pumps. This may be an indication of minor movement of the pipes but it is recommended that it be inspected by the Structural Engineer along with the other areas of concern. (Photo 3.26) Other than this observation, the structure appears sound.

Photo 3.26 - OHX Spalling Visible at Top of Pipes

- The outlet structure has spalling above the discharge lines that should be looked at by a Structural Engineer to eliminate any concerns.

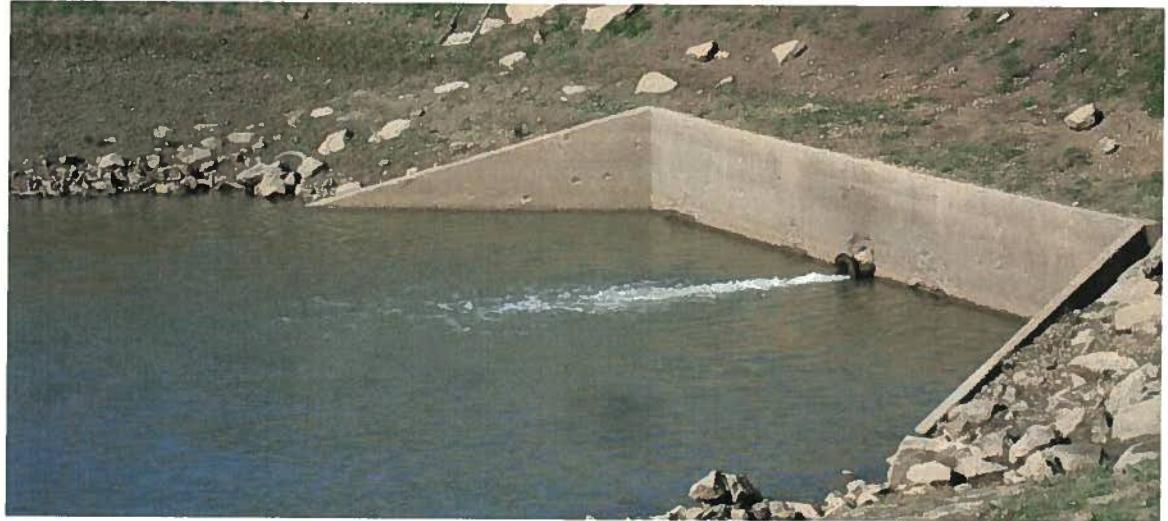
It appears that rip rap was added around the structure at some time in the past. (Photo 3.27) Most is now gone but should be considered for replacement here and at other similar locations.

Photo 3.27 - OHX Outfall Structure

A base rock of the current size, topped off with a larger size rip rap would add more stability to the area surrounding the outlet.

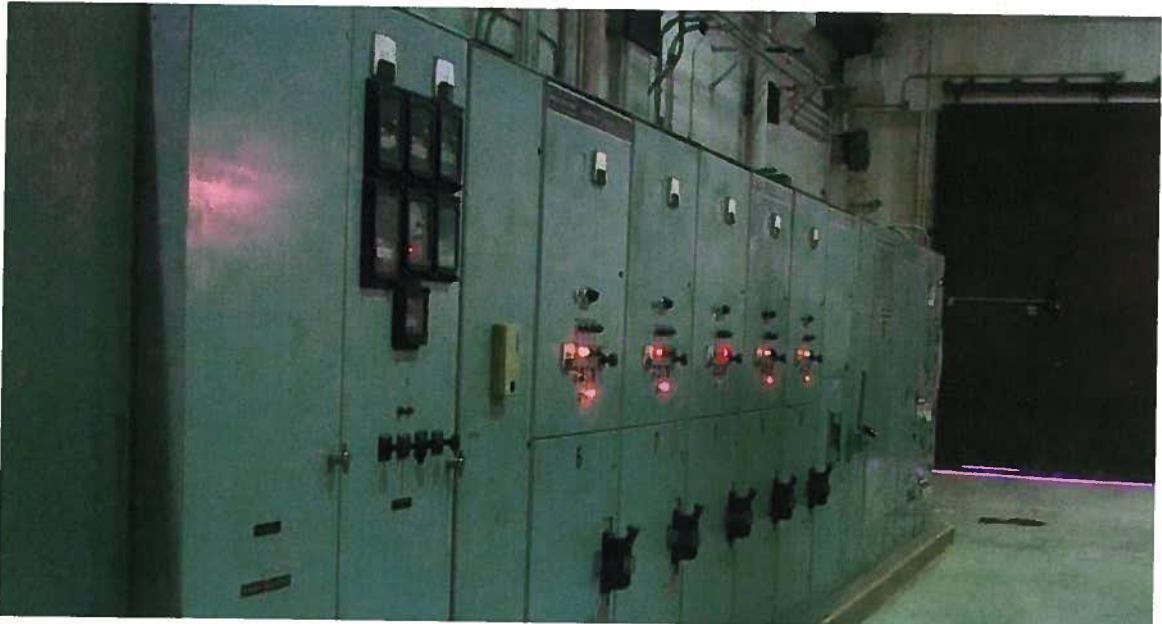
In the event of a SCADA System failure, personnel are able to manually operate this station from the switchgear cabinet by switching controls from remote to local and selecting the start or stop switch. (Photo 3.1) Indicator lights and trip relays along with labeling provide the necessary information to an Operator. An operational chart provides guidelines as to when each unit is to be put on-line or off-line. At the time of this report, all units are in-service.

Photo 3.1 - NHX Switchgear and Controls

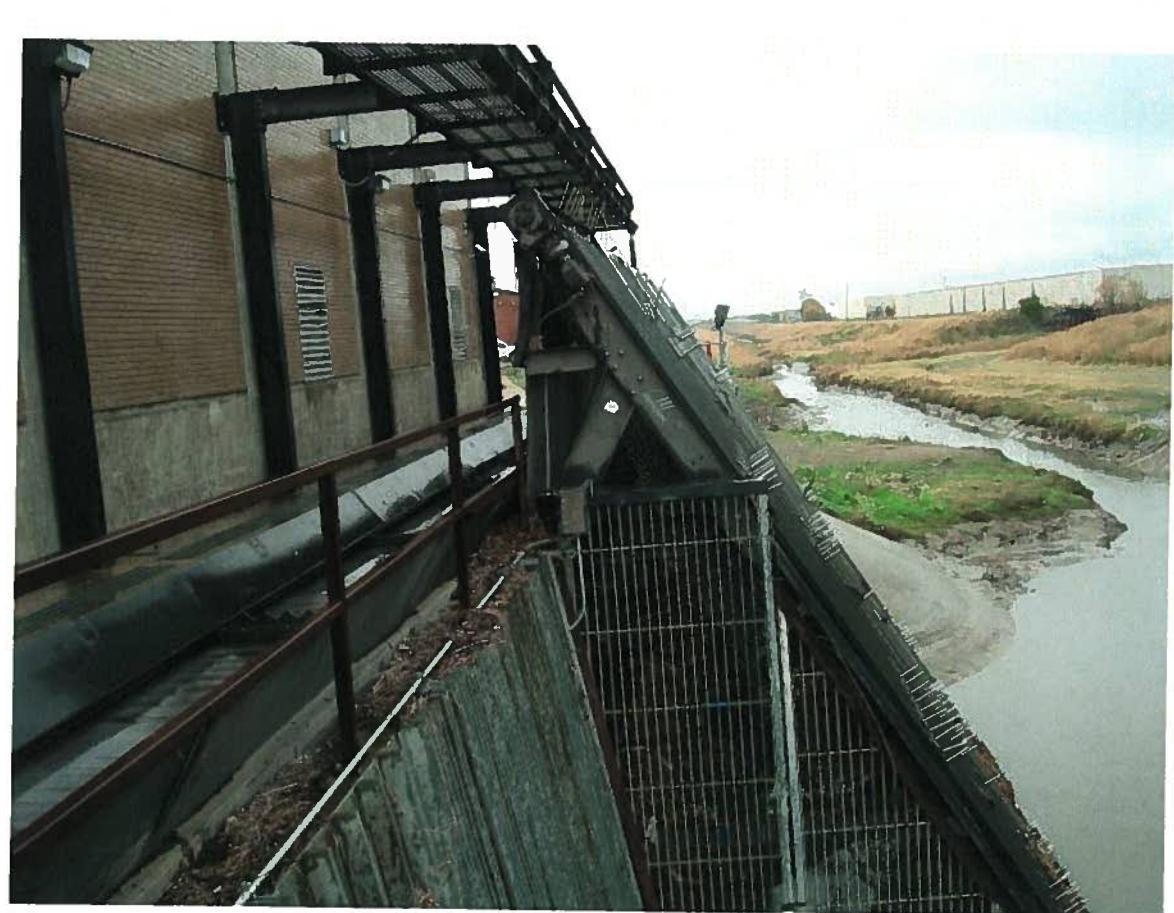
The New Hampton Station (NHX) is located to the South of the original Hampton Station, (OHX) sharing the same sump area (Photo 3.2). NHX is the primary station at the Hampton site. OHX is only used when the capacity of NHX is exceeded or when NHX has units out of service.

Photo 3.2 - NXH and OHX Screens

The screens at NHX and OHX are perpendicular to the sump's channel. This alignment helps shield the screens from major impacts but the 90 degree turn does cause a silt build-up at the inside corners, and debris not caught by the screen system accumulates in the sump area. This sump area is not paved, which makes clearing the channel more labor intensive than at other pump station sites that have a surrounding concrete base and apron. Heavy equipment is required for cleaning and repairs at this site. Drying out the site is time consuming and weather dependant.

The report on OHX mentions possible problems along the west bank with signs that the bank may be unstable. The addition of a concrete sump area should be considered to possibly eliminate this condition.

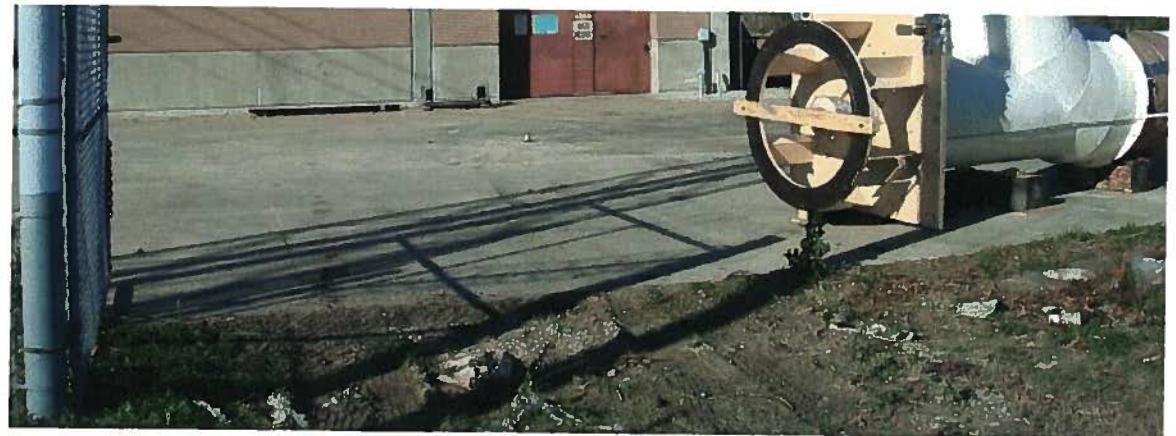
The paved surfaces and security fencing surrounding the NHX section appear to be in excellent condition. Security is a concern due to the adjoining OHX's fencing and gates issues mentioned in the OHX report. The two large gates at the south entrance to NHX are both used regularly. The main entrance is on the paved drive and the larger secondary gate is used when heavy equipment is needed. The paving ends prior to the secondary gate and the weight of the equipment has made some ruts that, if not corrected, will create a gap under the gate. (Photo 3.3)

Photo 3.3 - NHX South Heavy Equipment Gate

- Roof vent covers are beginning to corrode at the edges and need to be cleaned and painted before it becomes a problem.
- The paving on the site needs to be extended to include the secondary gate at the south entrance to prevent ruts from becoming easy access under the gate for vandals.

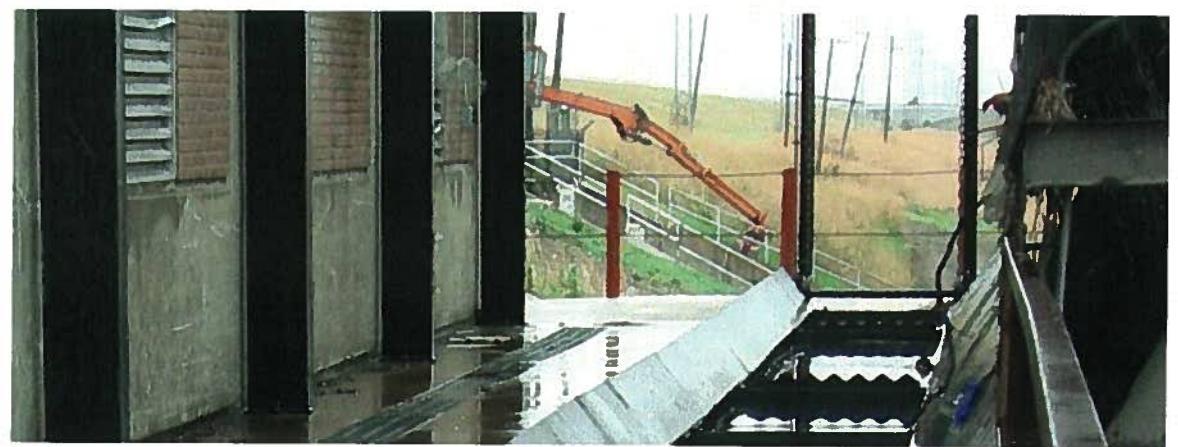
Photo 3.5 - NHX Cable and post barricade/handrail

None of the handrails on site have toe boards, which should be considered for any area where tools or other items might be easily lost into the sump (see O.S.H.A.1926.451(g)(4)). The barricade/handrail at the north end of the screens (Photo 3.5), located on the top edge of a concrete slope into the sump, is a heavy duty cable and post system, but under the above O.S.H.A. standard may not meet its intent.

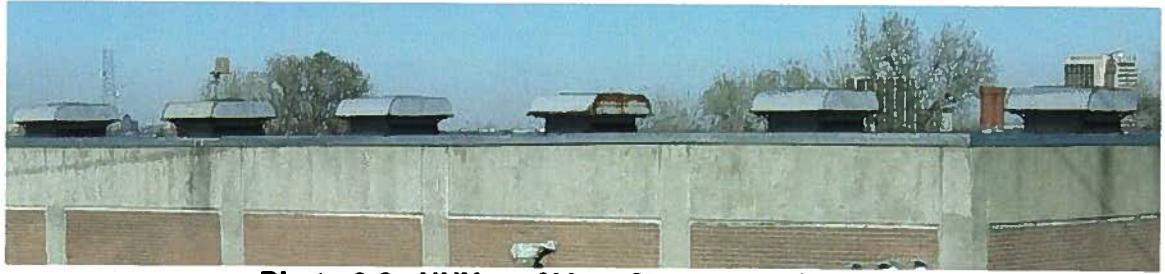
Photo 3.6 - NHX roof Vent Covers and flashing

(Photo 3.6 & 3.7) The roof vent covers are showing signs of corrosion at the edges and some of the end caps. There does not appear to be any physical damage to the metal, but close inspection would require access to the roof. The flashing surrounding the roof's perimeter shows no signs of corrosion. There are not any signs of blockage to the roof's drainage system.

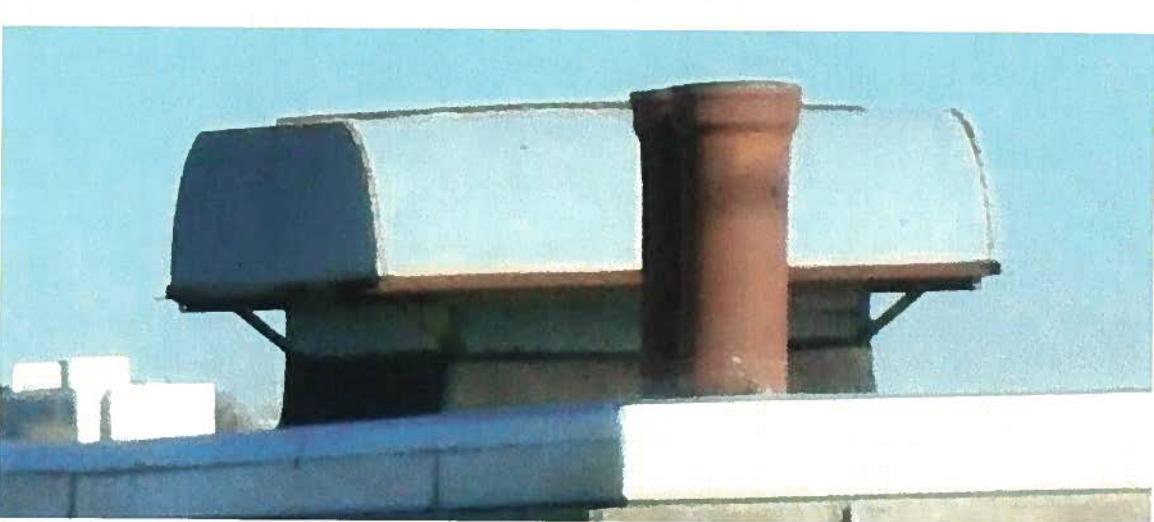
Photo 3.7 - NHX Roof Vent Cover Close-up

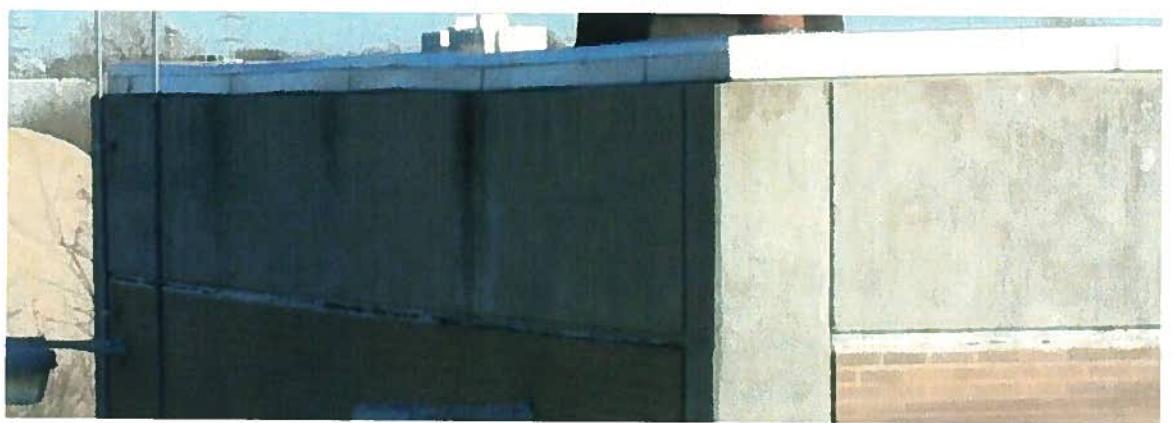
The brick work appears to be in excellent condition. There is no noticeable loss of grout in the joints, no separation, or cracked bricks. There is a sealant failure where the bricks and concrete meet near the roof, and some minor sealant failure areas around the building's foundation, where the walls and sidewalk meet. (Photo 3.8)

Photo 3.8 - NHX Sealant Failure Between the Brick and Concrete

- The seam between the brick and concrete on the outer walls has failed in several locations (Photo 3.8). There is also some separation around the foundation and the sidewalk.

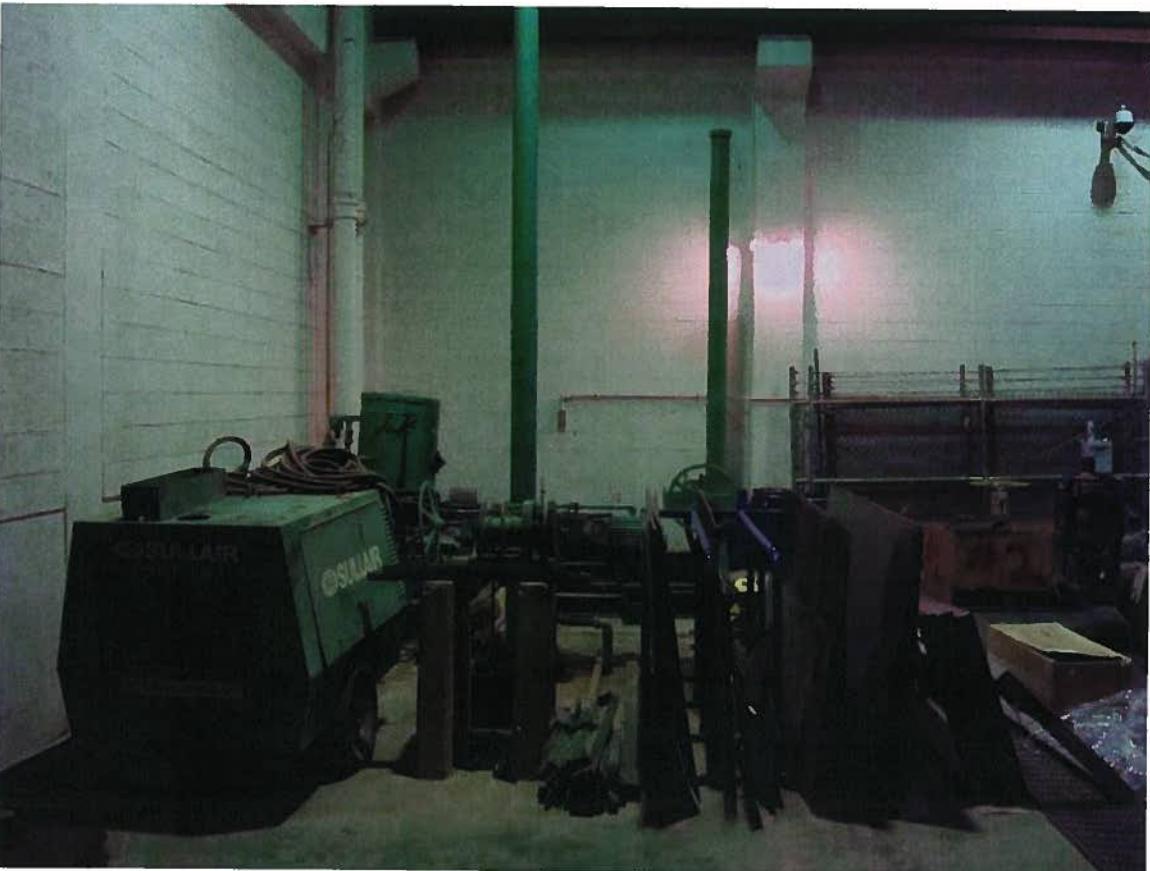
This station's design does not allow for further build-out. There is not adequate space within the building for any additional pumps and switchgear. Any expansion at the Hampton location would require new construction. There is some space that might be utilized for storage on the south end. It is currently being used for this but could be better utilized if a caged area was installed and industrial shelves were used to organize materials. This would not be able to contain everything currently in the station, but would improve the situation. (Photo 3.12)

Photo 3.12 - NHX Storage
