CITY OF DALLAS INTERIOR LEVEE DRAINAGE STUDY WEST LEVEE – PHASE II

VOLUME 2 of 2 – PUMP STATION ASSESSMENTS

January 2009

Large Able (LAX) Pump Station

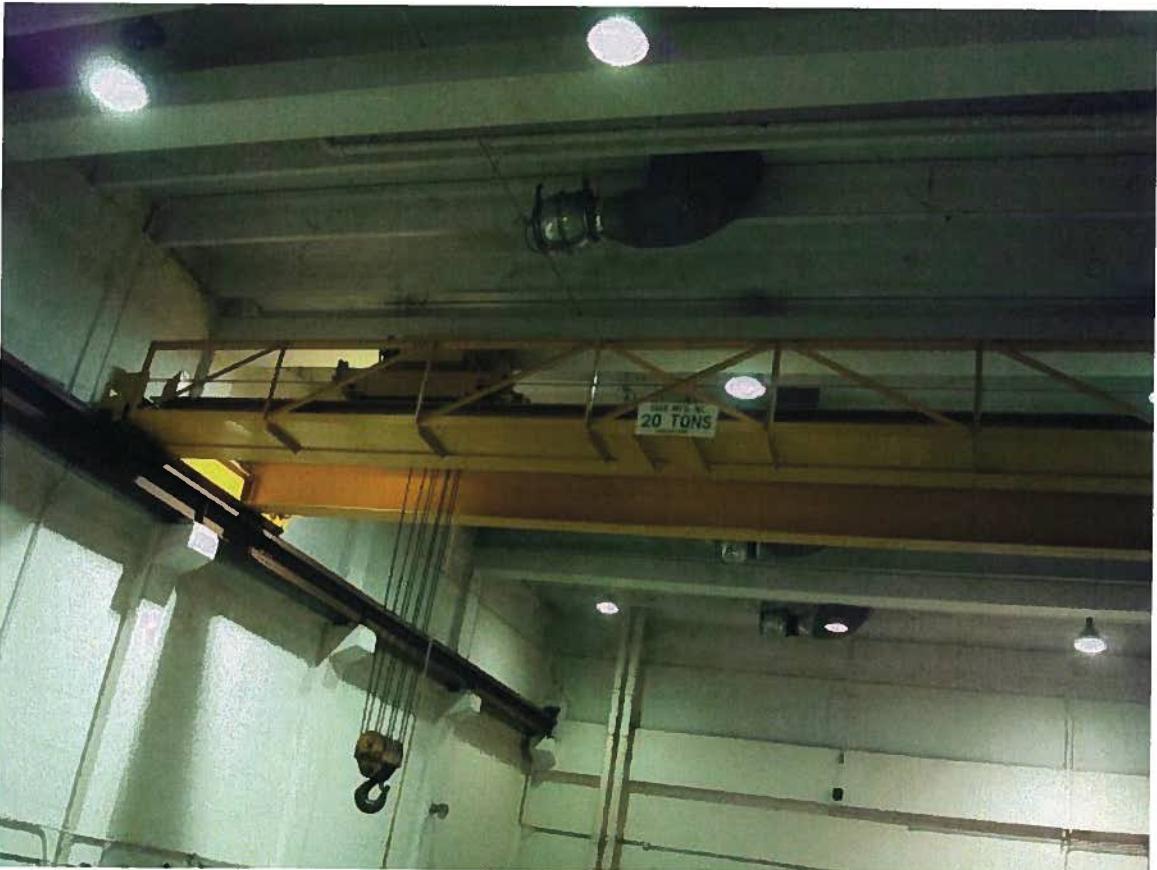
The roofing structure is composed of concrete double "T" beams, supported by rectangular beams along the top of the walls (Photo 3.13) and spanning the pump room overhead. These are sealed and painted and appear to be in good shape. Spacing between beams is uniform with no visible signs of cracks or leakage at the seams. The exhaust fans mount internally to the beams with the exhaust vent penetrating the beam and roofing system with no signs of leakage at these penetrations. The lighting system also has ceiling mounted fixtures. These require personnel to ride the overhead crane to change bulbs or make repairs.

The main pump room has an electrically operated 20-ton crane (Photo 3.13) used to pull and install equipment. The bridge travels north – south and the dolly, east – west. All equipment in the main pump room is accessible to the crane. It is in working order and inspected by division personnel.

Photo 3.13 - NHX Double "T" Ceiling, Square Support Beams, Exhaust Blowers, 20 Ton Crane and Overhead Lighting

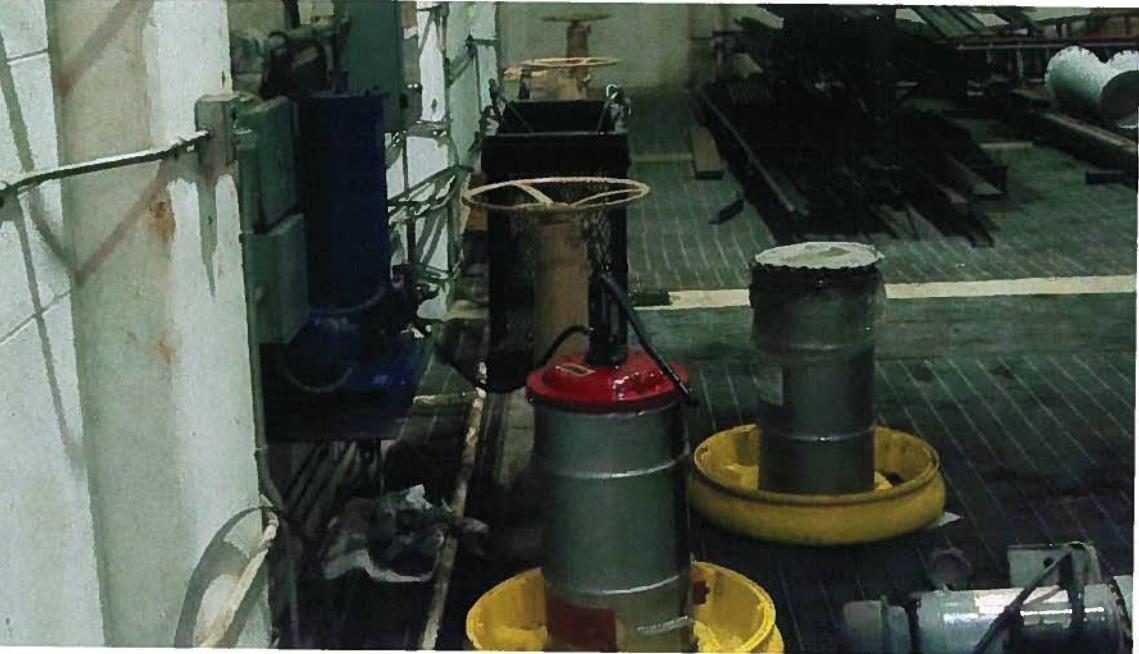
The Farval lubrication system (Photo 3.14) provides each pump with a measured amount of lubrication at prescribed times. The transfer of grease from the storage container to the Farval's main cylinder has experienced some problems with air pockets. The delivery of grease to the farthest pump is also experiencing some intermittent difficulties. There are alarms in place that prevent a pump from starting or take the pump off line, if the Farval system fails to operate correctly. These alarms transmit to the SCADA, informing the operator of the problem.

Photo 3.14 – NHX Farval Lubrication System

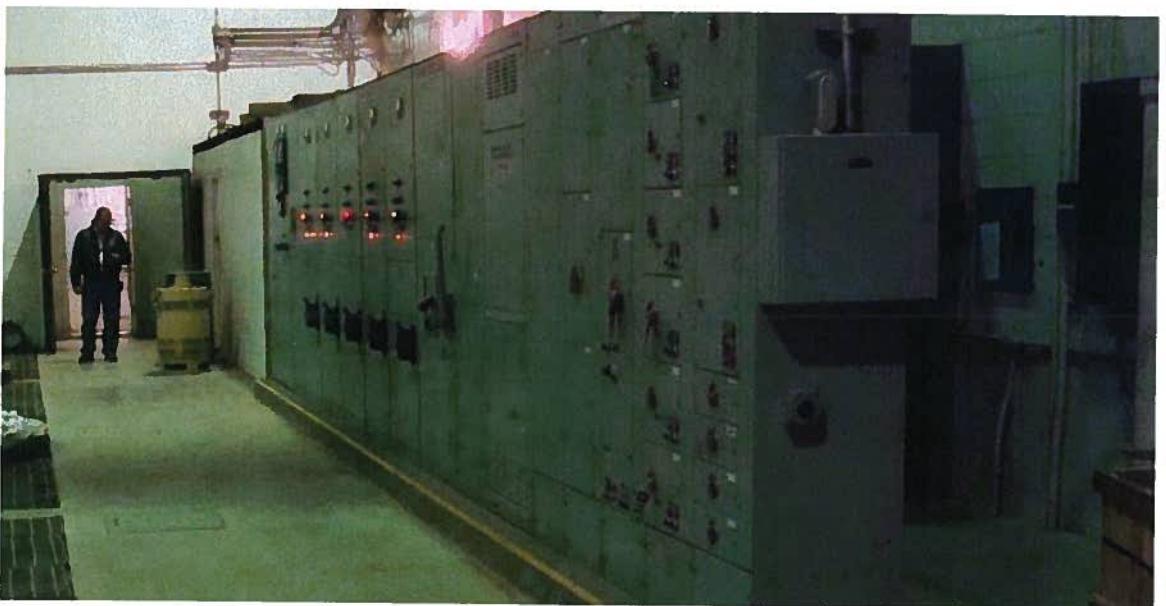
Photo 3.15 - NHX Switchgear with Attached Storage Area

The electrical switchgear is located on a solid raised concrete base. (Photo 3.15) The line of cabinets runs parallel to the pumping units, with a distance of 6 feet between the back of the cabinets and the east wall. Personnel have walled in this area to store electrical parts. Access is by key or climbing over the wall.

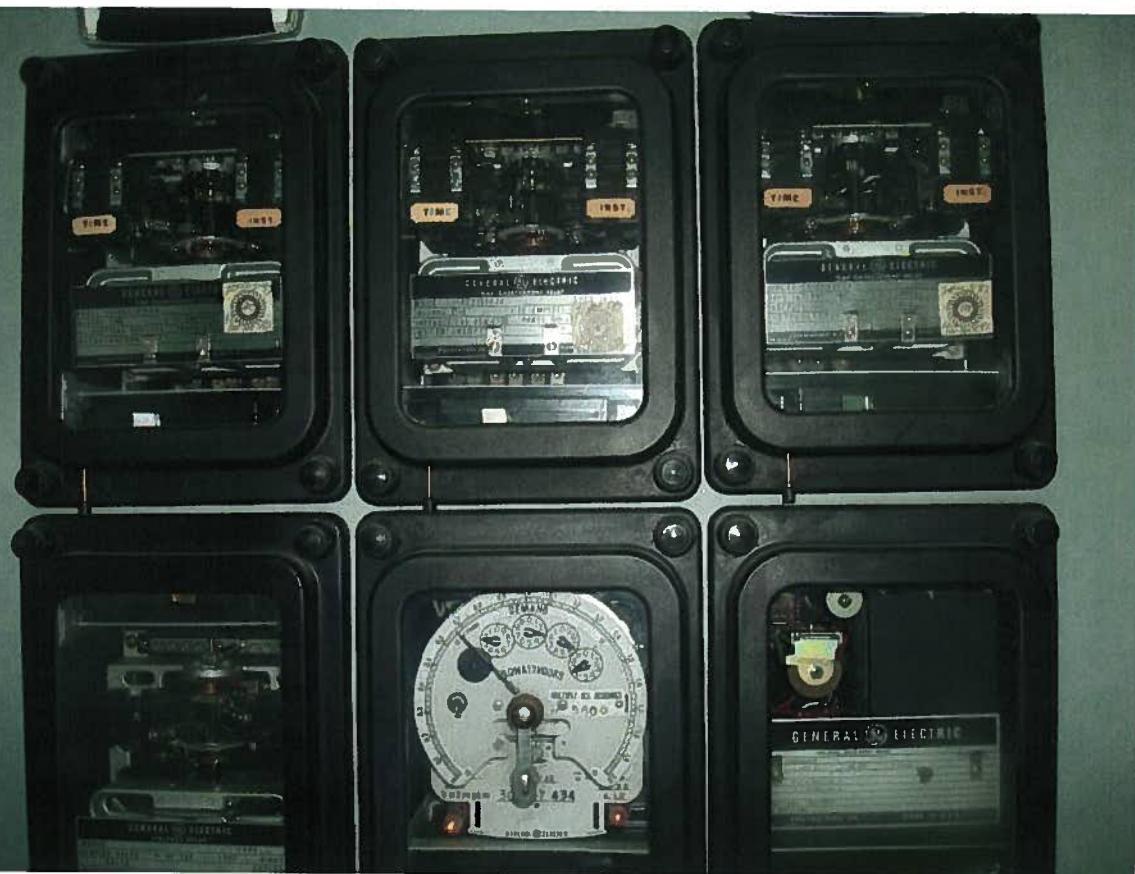
Photo 3.16 NHX Switchgear's Manual Protection Relays

This switchgear equipment is at or past its expected service life. Its alarm relays are minimal, requiring on site personnel to see and reset alarm flags. By comparison, modern electronic protection offers dial-in capabilities, event recordings, warning and alarm conditions, programmable features, etc.

If it is the City's intention to keep this equipment for any length of time, it would be worthwhile to have thermal imaging performed to expose hot spots within the gear. This technology can detect problem areas before a failure or damage can occur. It would be an excellent investment for this division to purchase their own equipment and make routine inspections.

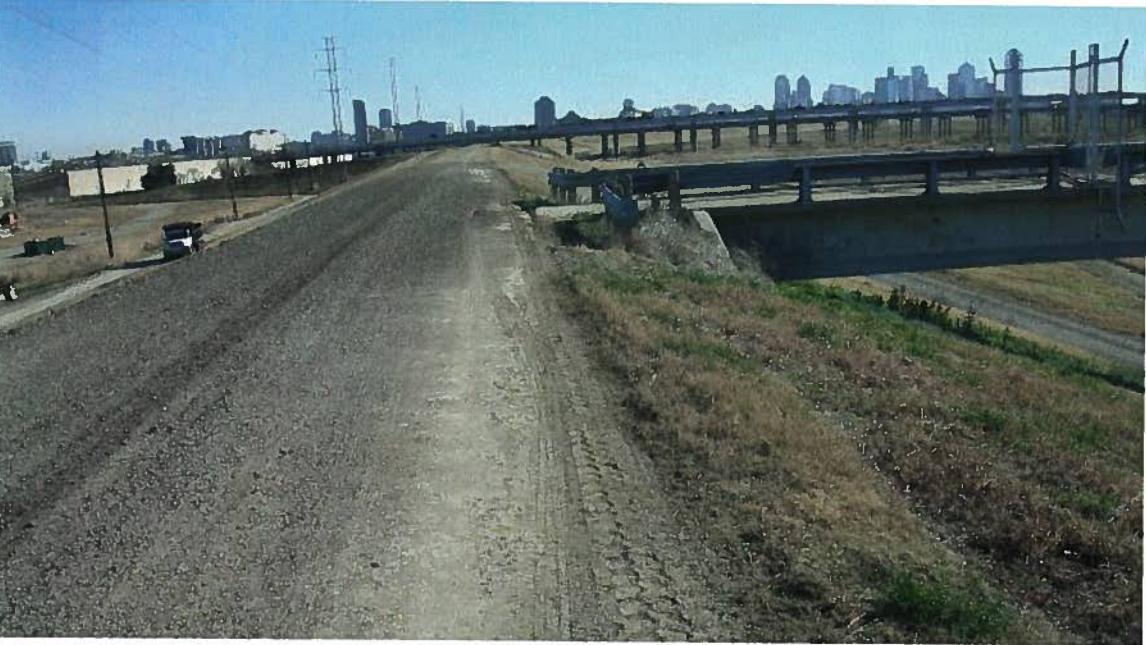
The east side of the levee facing the station is not quite up to as high a standard as seen at the Baker site but is well maintained. The road on top is compacted dirt that receives routine grading to keep it in shape. (Photo 3.20) If this road is used at night or during foul weather, the structures along the road require better markings.

Photo 3.20 - Levee Road at NHX and OHX

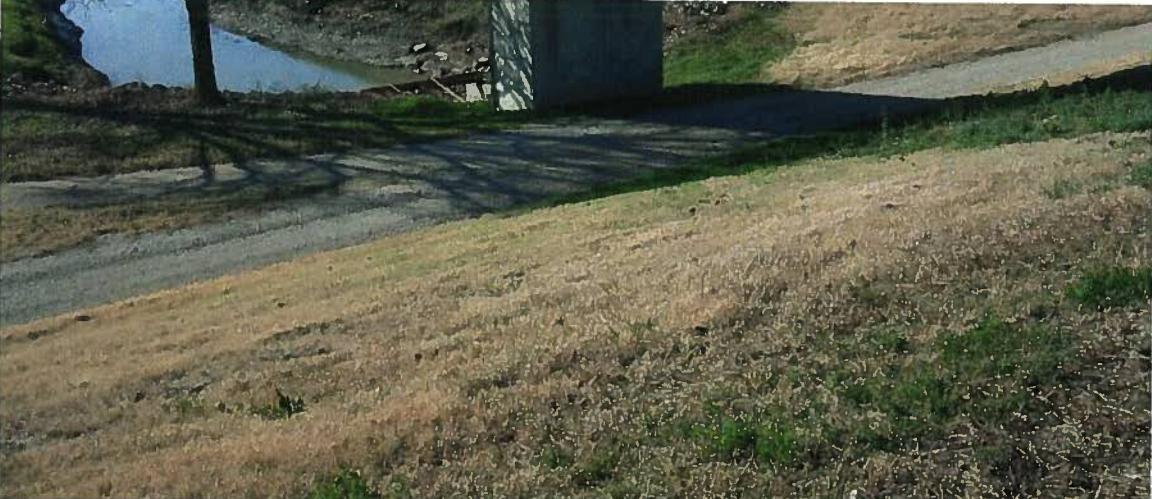
Photo 3.21 - NHX Levee on River Side

The west or river side of the levee down to the lower road is in excellent shape, with the slope on an even grade. (Photo 3.21) The slope area surrounding the outfall has been lined with rip-rap. (Photo 3.22)

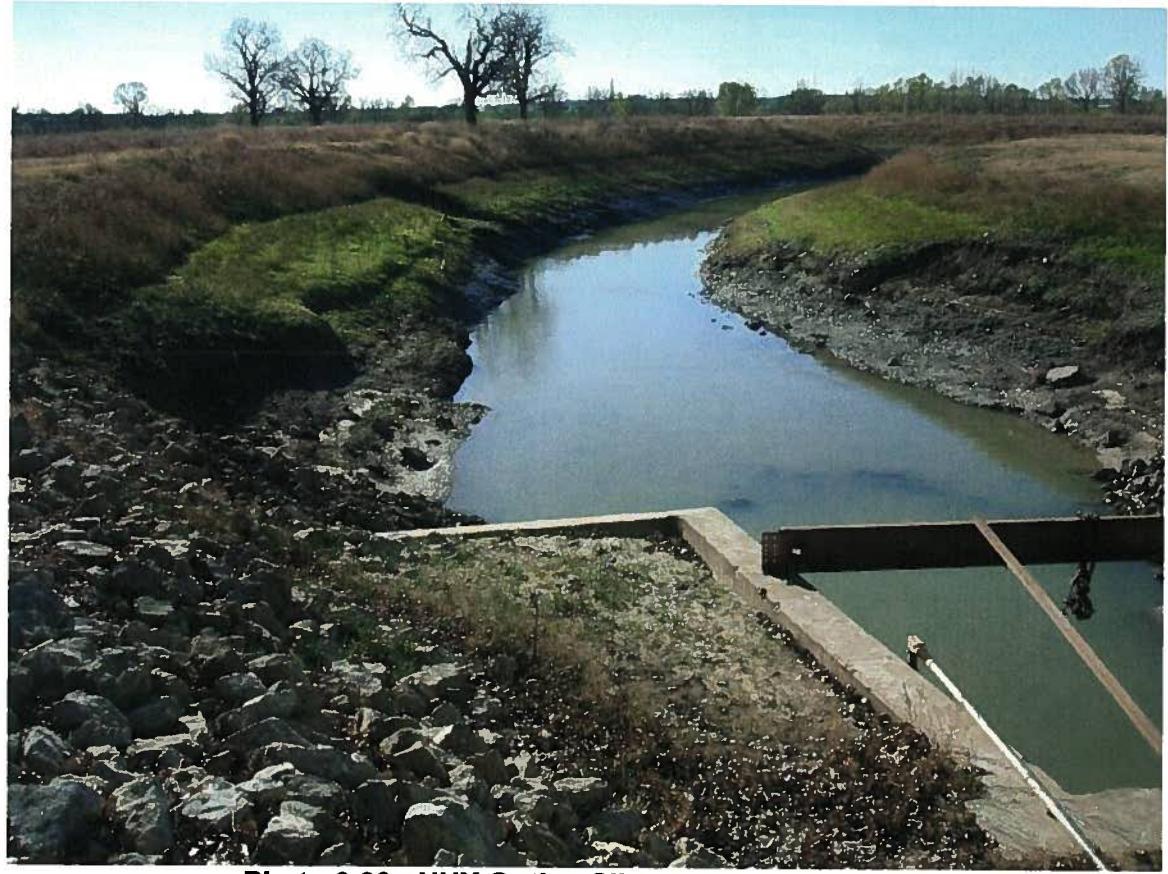
Photo 3.23 - NHX Outlet, Slippage on Both Banks

Approximately 40 feet west of the outlet structure, the rip-rap ends and there are signs of wash-out and slippage on both banks for the next fifty feet, with a scattering of rip-rap

visible on the water's edge and in the channel. (Photo 3.23) Past this point, the banks appear stable as the channel turns north to intersect with the OHX channel and flow on toward the river. (Photo 3.24)

Rip-rap at the outlet structure is the preferred approach for stabilizing the slope at the outlet structure, however, the size being utilized is not sufficient for the velocity and volume of water being discharged.

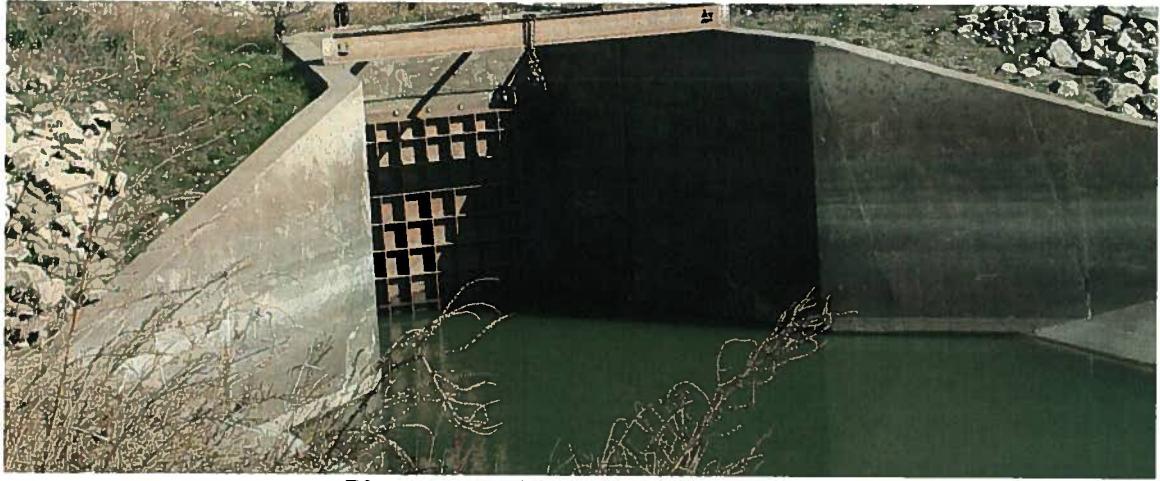
The outflow structure appears to be in excellent condition. There is no sign of movement or damage to the concrete or loss of soil at the structure (Photo 3.25)

Photo 3.25 - NHX Outfall Structure

The exposed portion of the flap gate also appears to be in excellent condition but a visual inspection of the hinge pins is not possible without removing these pins. This should be scheduled as part of the preventive maintenance plan.

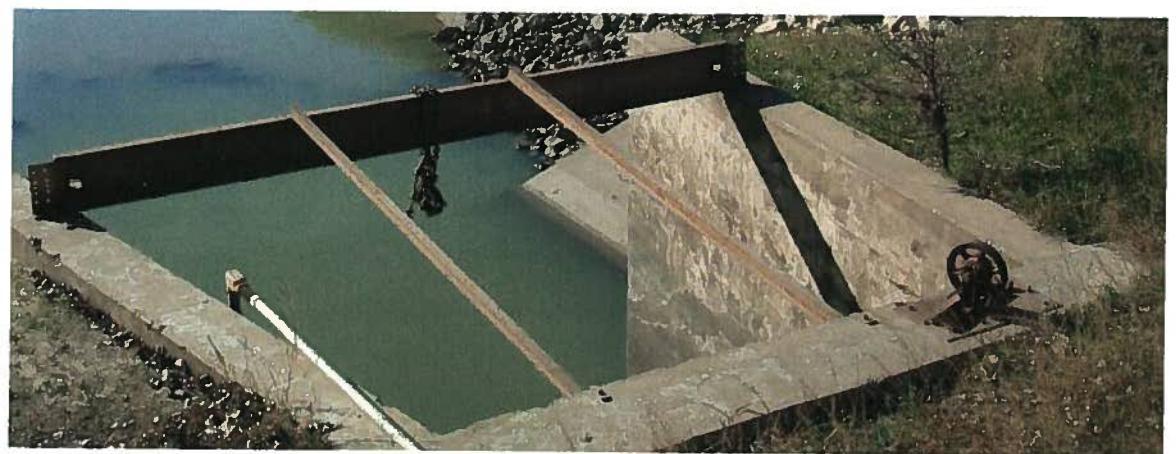
An "I" beam has been installed across the walled portion of the structure. (Photo 3.26) A manual winch has been secured to the center of this beam. Its purpose is to open the flap for internal inspections. It appears that this was built and installed in-house. Although it seems to have performed its intended function in the past, the stability and safety of this apparatus is questionable. There is a need for access to this line and a better design is needed for the safety of the personnel required to open this valve.

Photo 3.26 - NHX "I" Beam across Outfall Structure

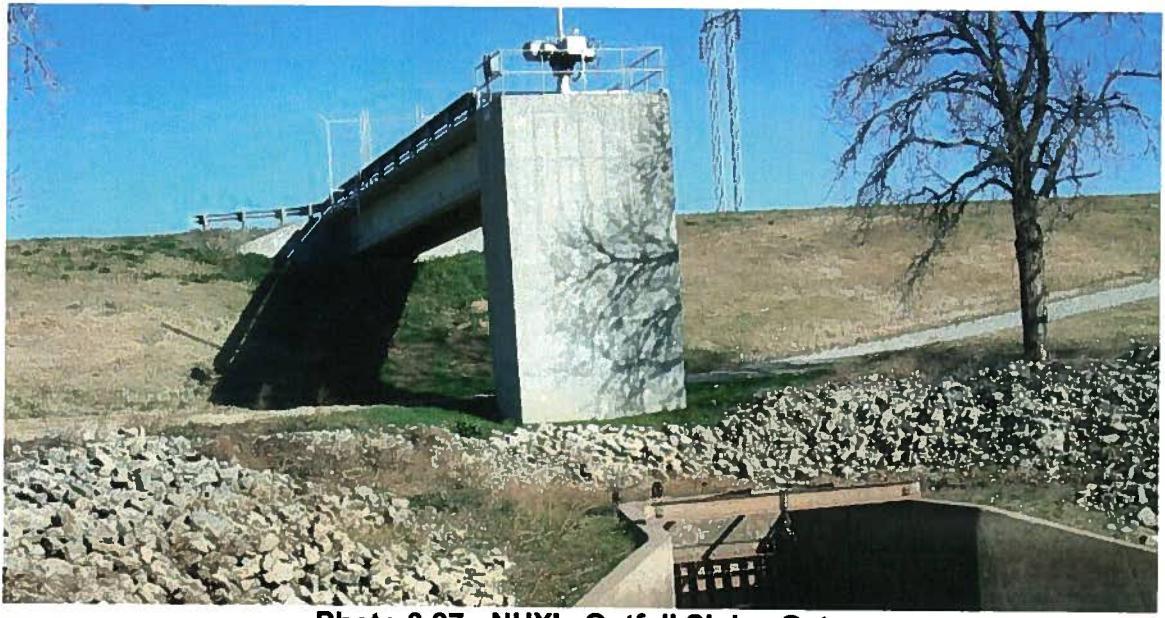
Photo 3.27 - NHX's Outfall Sluice Gate

The discharge line for NHX goes through the levee. A bridged structure extends from the top of the levee to the vault where the sluice gates are located. (Photo 3.27)

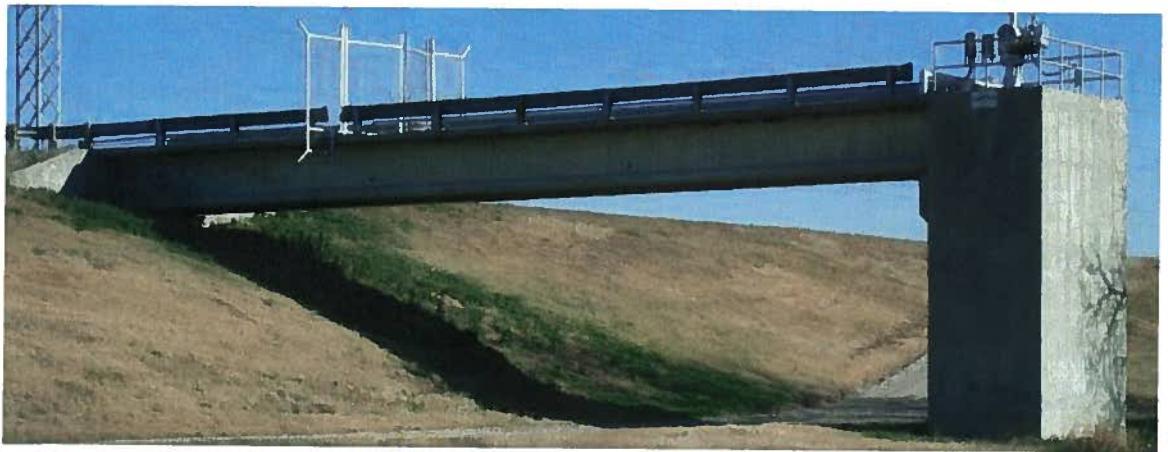
Photo 3.28 - NHX Sluice Gate Structure and Bridge

The vault housing the stem and motor-operated sluice gate appears to be in excellent condition. No apparent signs of movement or cracking were found. (Photo 3.28)

There are tiny divots in the concrete. There are no evident structural defects in the bridge crossing from the levee to the main valve vault. The area directly below bridge and levee is sparsely vegetated with only weeds due to little or no sun light. This area should be covered with rip-rap or concrete to prevent erosion.

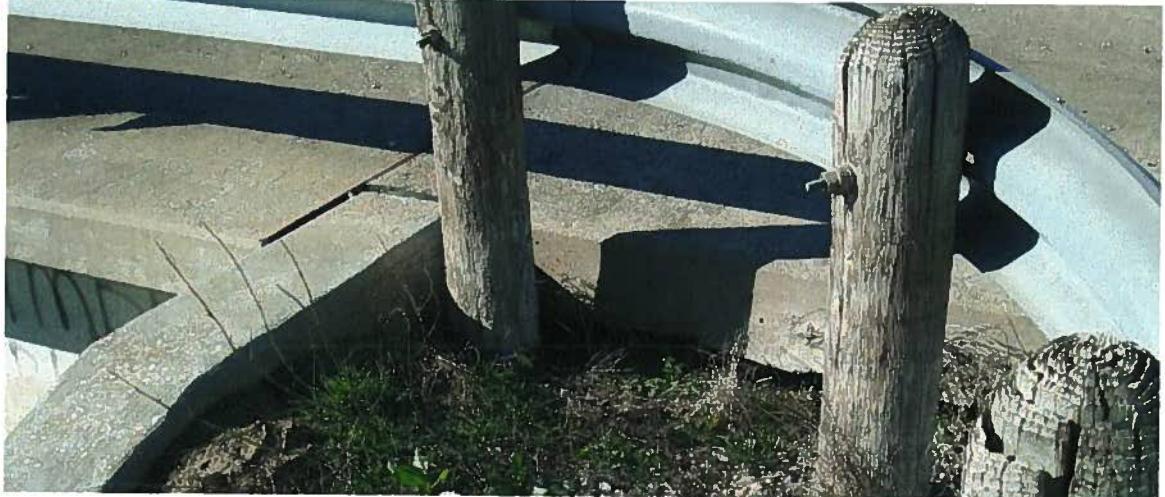
Photo 3.29 - NBX Bridge landing foundation on levee

The bridge landing on the levee has lost soil around its foundation. (Photo 3.29) This area should be backfilled with a more stable material. Topsoil will only be washed away if vegetation is not immediately planted to anchor the soil.

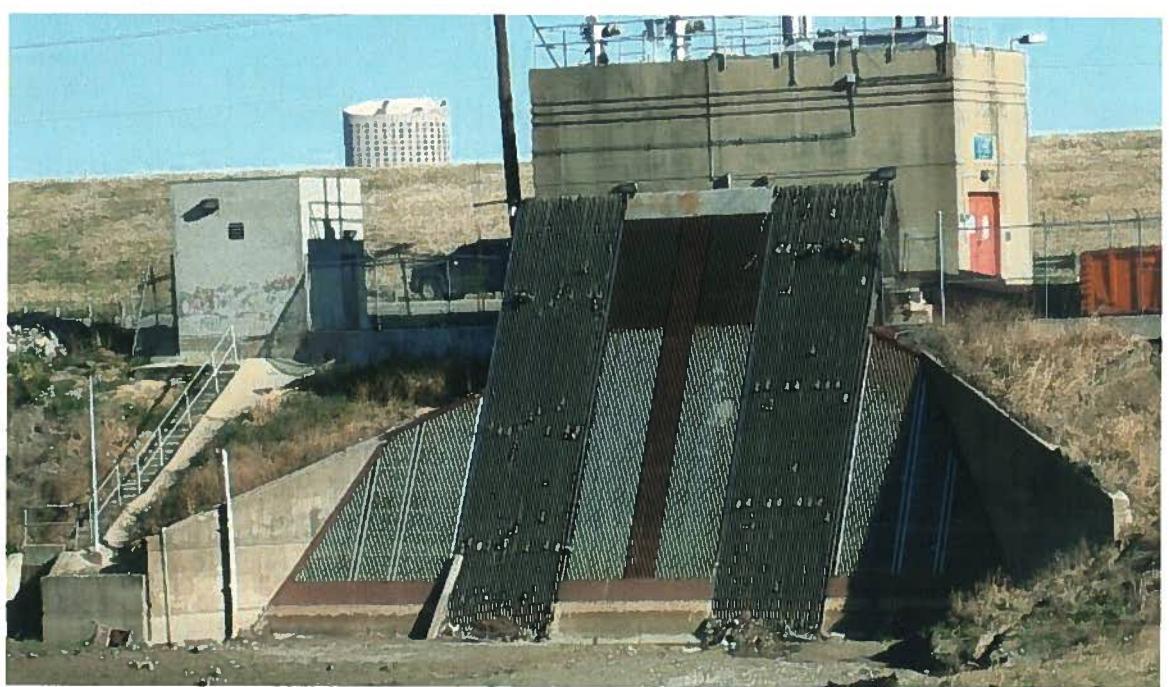
Photo 3.2 - PX Screen and Rake System

The PX screens have a wider surface area than the other flood water stations. Two Automated rake sections cover approximately one third of the screen's surface area. The remaining screened sections have the potential to trap debris due to the current caused by the pumps. It is not safe for personnel to remove trapped debris by hand due to restricted access to these areas. (Photo 3.2)

The main channel into the sump area has a straight approach, allowing large objects to make a high velocity impact into the screens. There are no signs of damage but it appears that sections of the screens may have been replaced adding credence to the potential for damage.

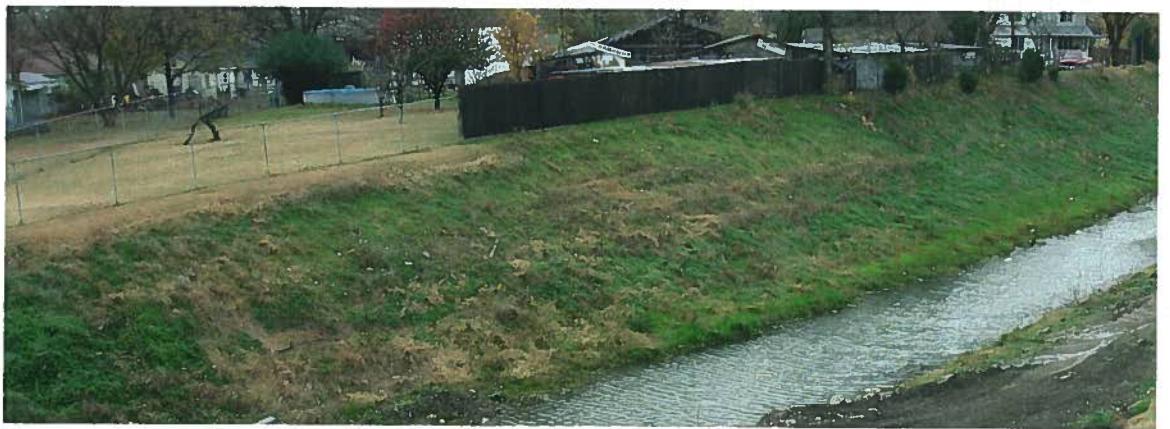
Photo 3.3 - PX North/South Channel to Sump

The channels feeding the Pavaho Station are wide and long, terminating in a large sump area. Both channels and sump are located within a residential area. It appears that the majority of residents have installed fencing to provide a barricade between their property and the channels. (Photos 3.3 & 3.4) Residential streets come to a dead end on the east side of the sump area. Guard Rails separate the street's end from the slope leading into the sump. (Photo 3.5)

All banked areas to the channels and the sump have gradual slopes with excellent ground cover. There appears to be no signs of slippage or erosion within sight of the station. (Photos 3.3 - 3.5)

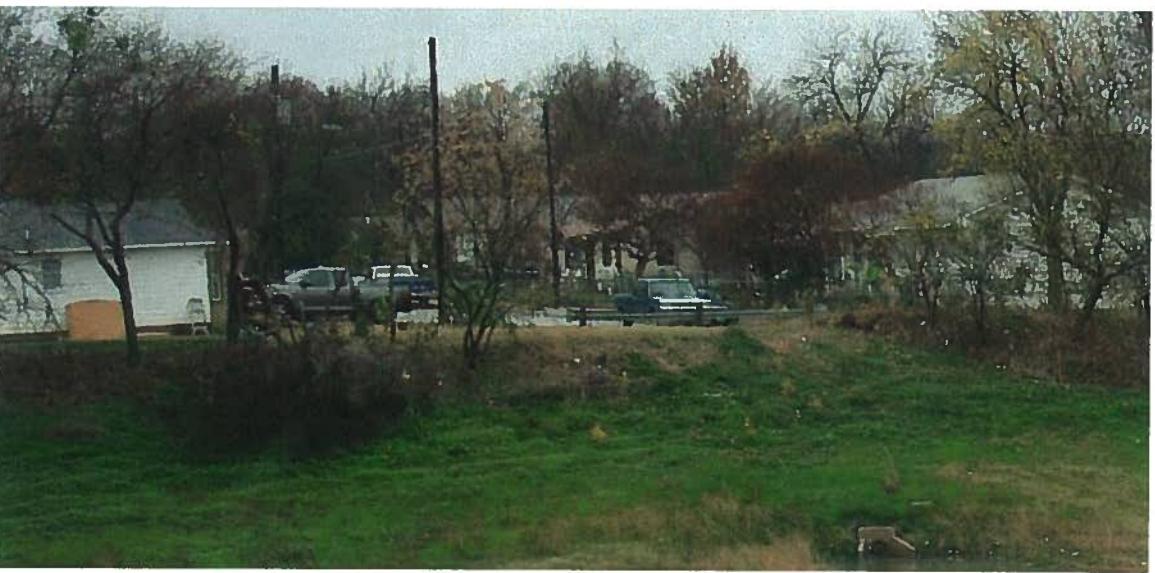
Photo 3.5 - PX East Bank of Sump

Although only flooded for short periods, these areas should be considered hazardous. The roads dead ending at the sump only have guard rails. There are no signs posted to warn of flash flooding.

Neighborhood children have easy access to this area and they may not be aware of the potential danger. Recent incidents occurring within the Metroplex area demonstrates a potential legal liability to the City of Dallas. Mitigation is recommended.

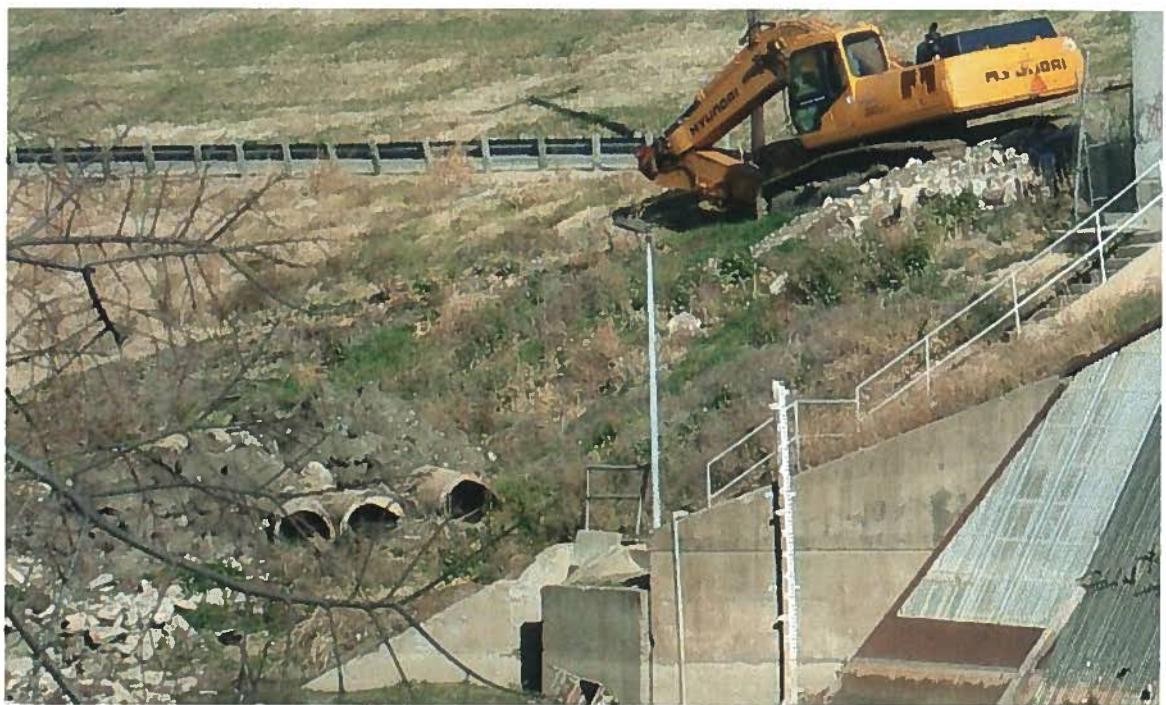
Photo 3.6 - PX East Bank of Sump, North Side of Station

(Photo 3.6) Construction equipment was on site at the time of the inspection. The east/west channel has a temporary service road on its north bank extending over the north/south channel. This may be an indication that the problem with the blocked low flow pump's inlet may be cleared.

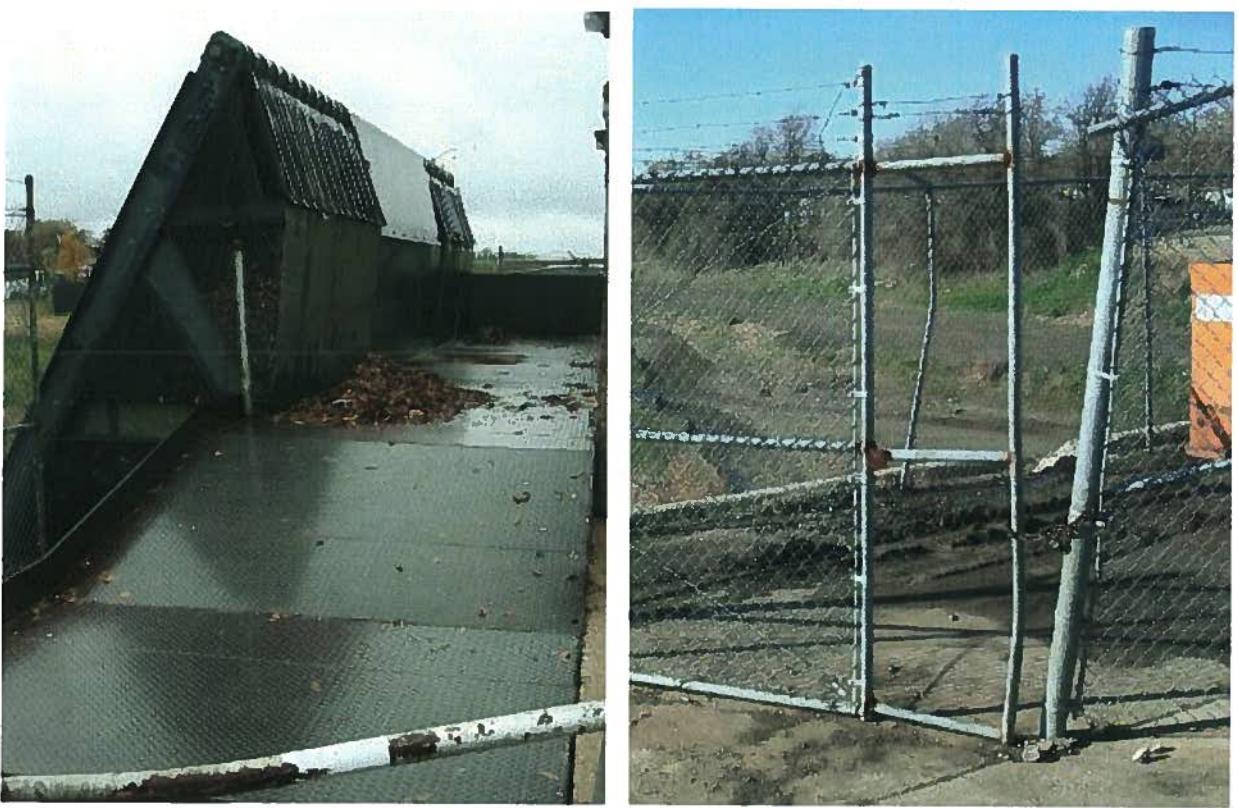
Photo 3.8 - PX Ramp to Debris Drop-off

This station does not have a conveyor system to carry debris to a dumpster. Debris drops behind the screens onto a plated passageway easily accessible for personnel using pitchforks. The area is too limited for the safe use of a skidsteerer. The landing area requires a 90 degree turn to enter and exit an incline to the debris. There is little room to maneuver while between the building and the screens and the there is insufficient rails to prevent a fall while on the ramped area. There were handrails installed on this ramp but they are damaged and sections of the handrails are missing. The use of a skidsteerer in these tight quarters may have been responsible. (Photo 3.8)

The passageway's metal plating has a raised pattern providing some footing in a very wet area. The rakes dump debris onto the plated area and drain back into the sump. There are not any drainage holes in the plating but does appear to have a slight slope to drain water away.

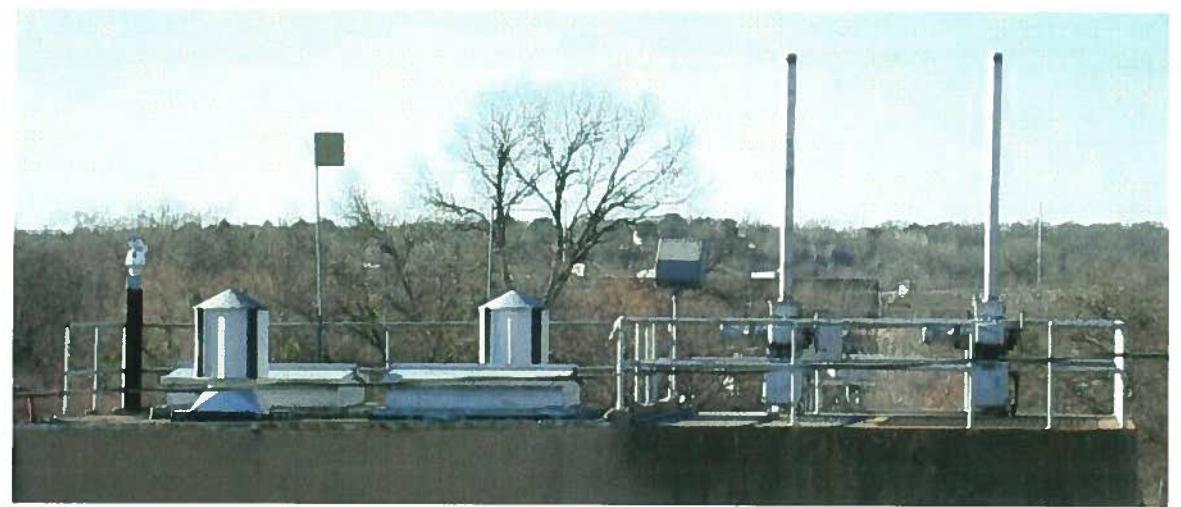
Photo 3.10 - PX Main Pump Station's Roof Looking West

The two electric sluice gate operators mounted on the roof are controlled from the SCADA or locally in the pump room. When maintenance or inspection is required, they are accessed by the use of a long extension ladder kept inside the station. The roof has been fitted with handrails for the safety of personnel while on the roof but, it does not meet the current OSHA standard. (Photo 3.10)

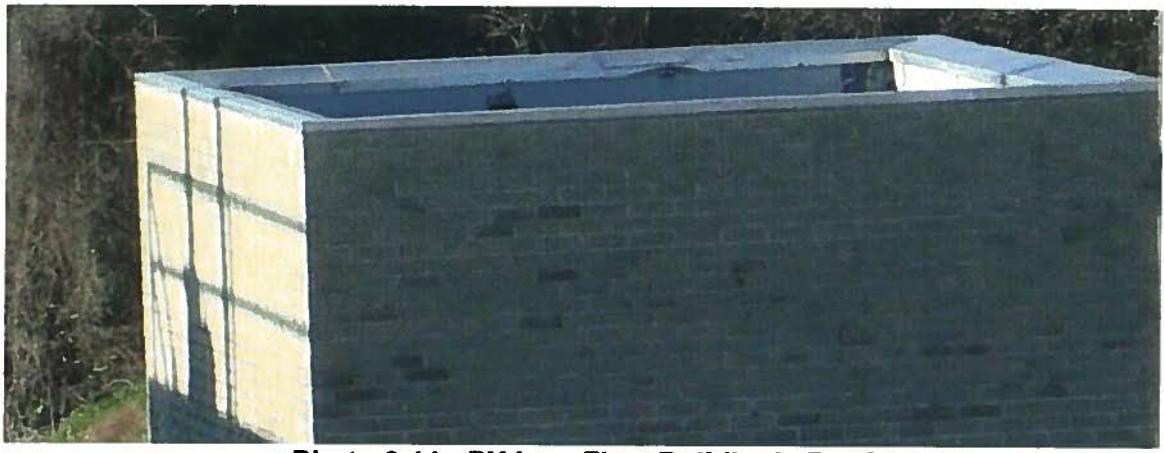
Photo 3.11 - PX Low Flow Building's Roof

The brickwork is in excellent condition but the grout lines could use re-pointing and a sealant added to the bricks. The cap on the roof's perimeter is a solid flat metal that appears to be aluminum. It is sloped to drain onto the building's roof where the water is carried through a drain line that runs through the ceiling to beneath the foundation to the sump area. (Photo 3.11)

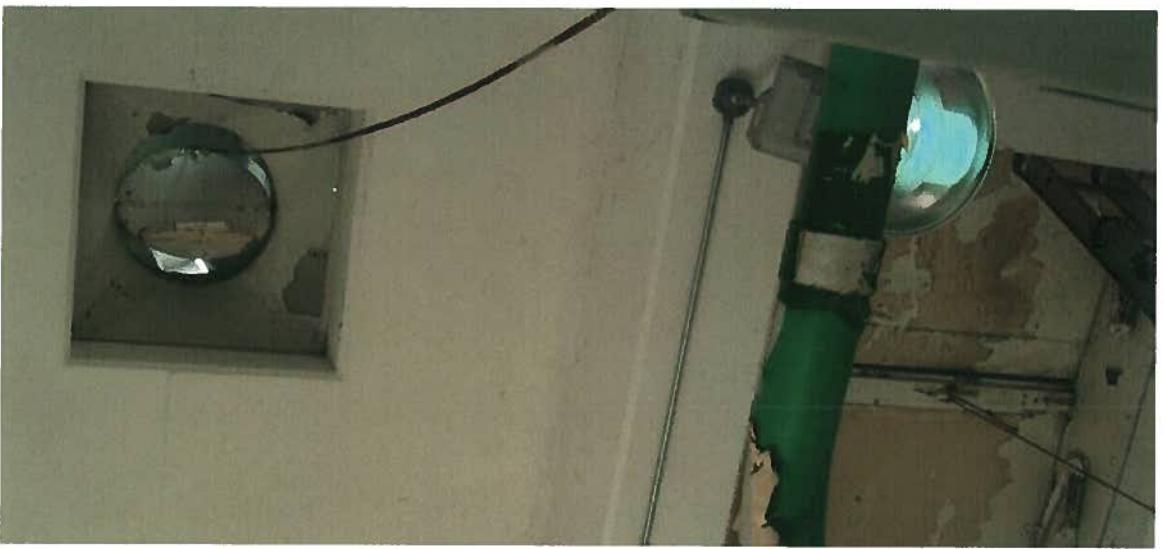
Photo 3.12 - PX Exhaust Vent, Equipment Hatch and Station Lighting

(Photo 3.12) There are no exhaust fans in this station. Air is circulated from the floor grates around the motors that are open to the sump, and the air exhausts through the roof vents. This would be a concern if it were decided not to decommission this station, once the new station is completed. If PX is to remain in service, forced air ventilation should be installed in the existing exhaust vents in the roof. This improvement would be something that could be accomplished in-house. The hinged double doors need to have new hardware installed. A kick bar is needed to allow for emergency exit. A lighted exit sign may also be required.

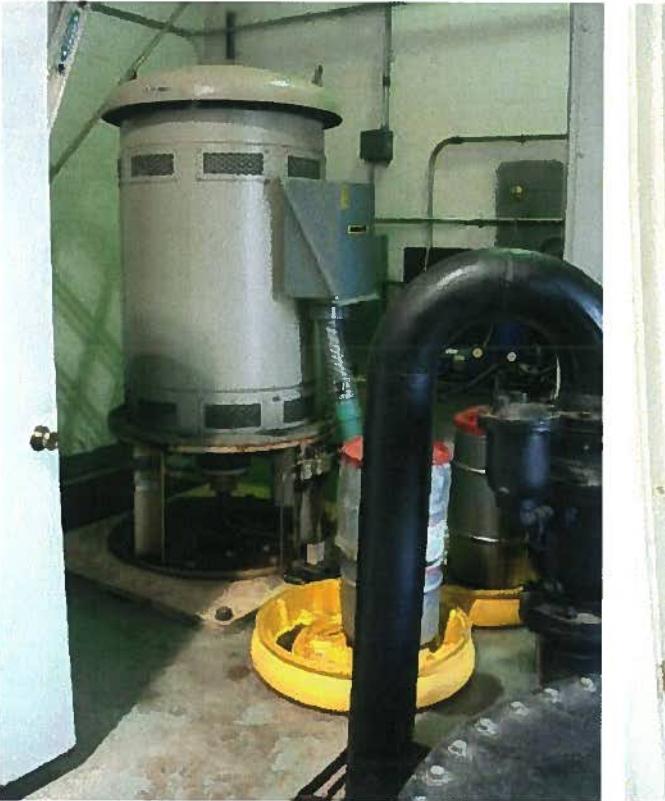
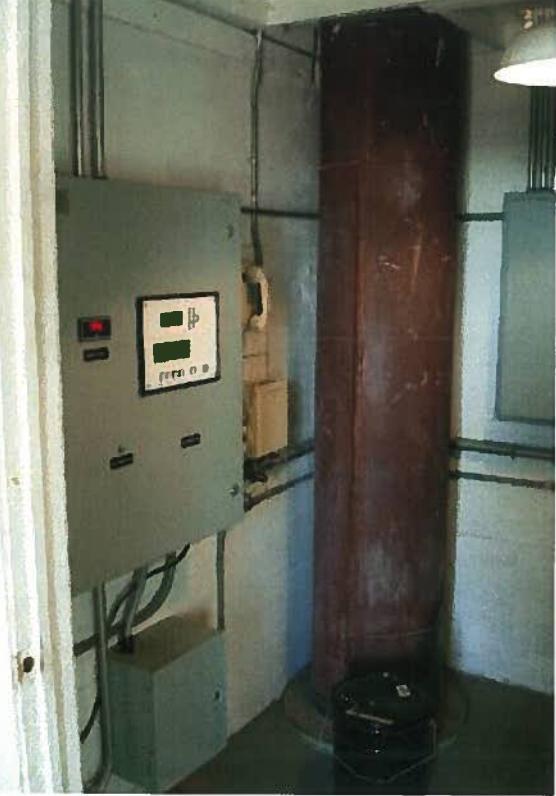
Photo 3.13 - PX #1 Pump, #2 Flange Cover, Lower Right

The #1 vertical pump is the only unit visible in the pump room. The #2 Flygt pump, is a submersible unit that sits beneath the water. There is only the flanged plate and air relief valve visible that is over its location. (Photo 3.13)

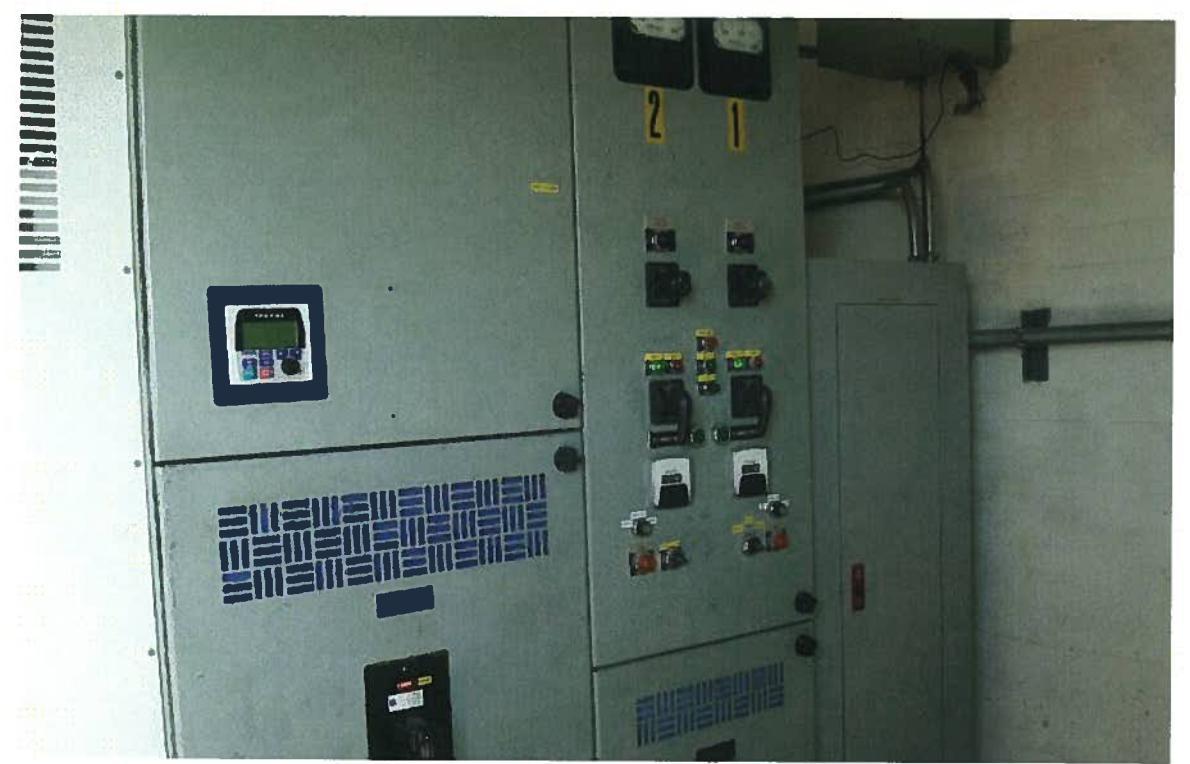
Photo 3.15 - PX Switchgear and Pump Controls

The station's electrical cabinets mount on a raised concrete pedestal and are perpendicular to the east wall. (Photo 3.15) This allows access to the back of the switchgear for maintenance and repairs.

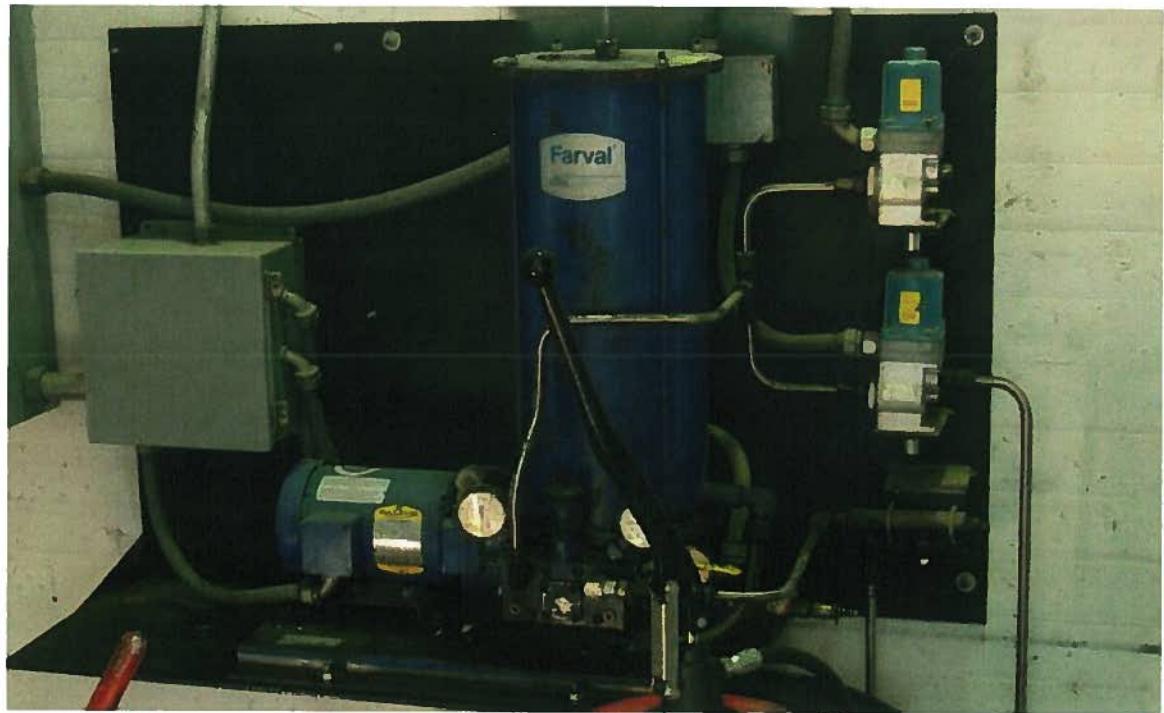
Photo 3.16 - PX Farval Lubrication System

The Farval lubrication system (Photo 3.16) is also used at this station as it is on all other flood water pumps. This may be overkill for a station with only one pump but it is in place and functioning as designed by providing the #1 pump with a measured amount of lubrication at prescribed times. If the Farval system fails to operate correctly, the alarms in place prevent a pump from starting or take it off.

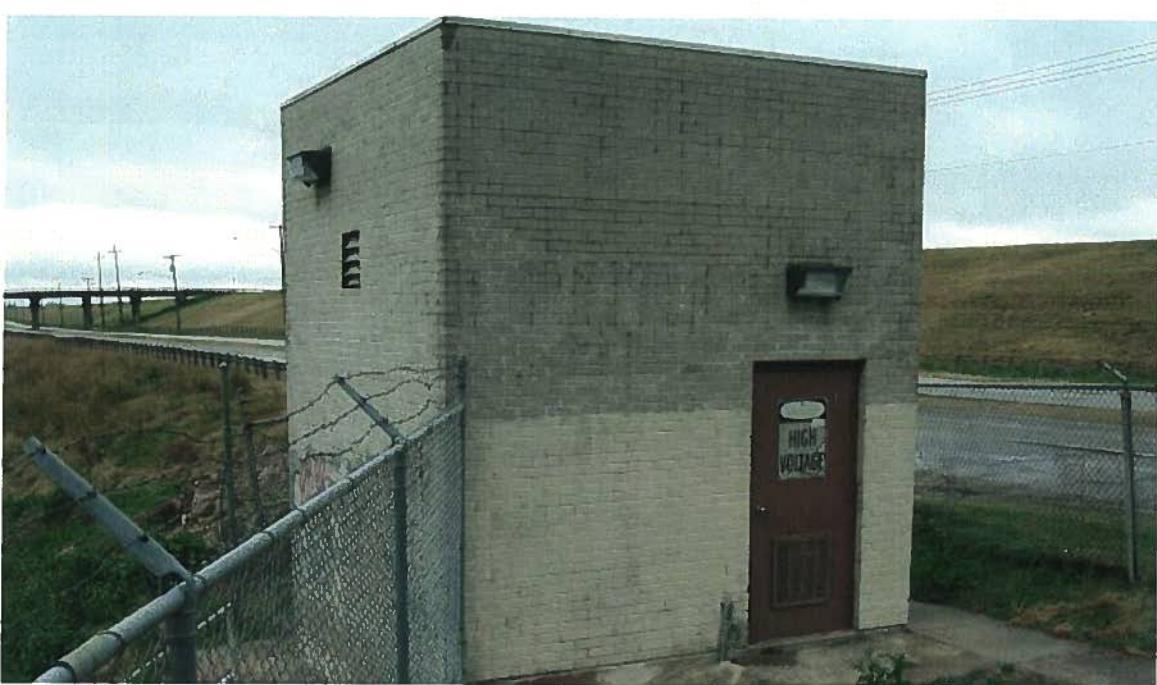
Photo 3.17 - PX Low Flow Station

The low flow pump is located in a separate building. There are two points of entry. The south wall has a single hinged door used for normal inspections and access. (Photo 3.17) As mentioned in the comments for the main station, this hinged door should be equipped with a kick bar for emergency exit and a lighted exit sign, unless the fire marshal approves the existing hardware.

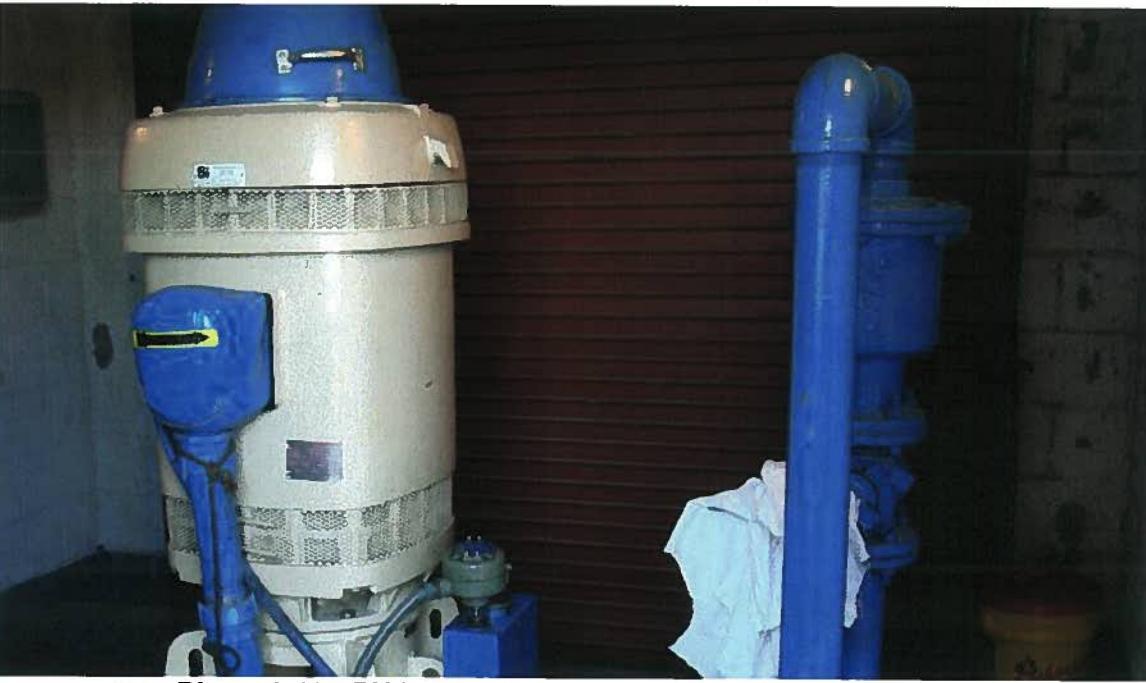
Photo 3.18 - PX Low Flow Equipment Door on North Wall

The equipment door is difficult to use as intended. There is not a paved surface providing vehicle access and the fence does not have a gate allowing a vehicle to the equipment door.

The North wall has a large equipment roll-up door for removal and installation of the equipment. (Photo 3.18) As mentioned, there is not a paved surface or drive of any sort to the equipment door.

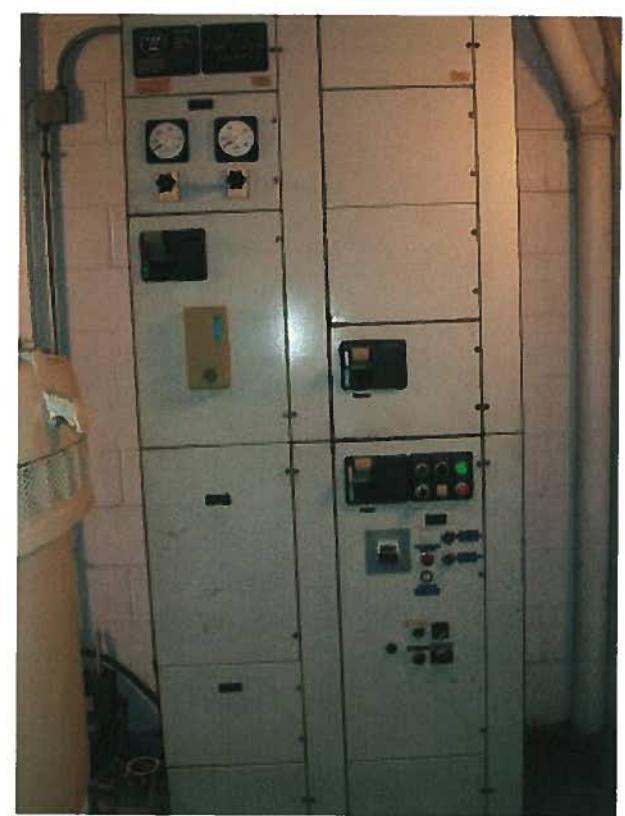
Photo 3.20 - PX Low Flow Switchgear

Power to this building passes through the main station and goes underground into the bottom of the low flow station's switchgear. (Photo 3.20) The building is just large enough to house the pumping unit and switchgear comfortably.
