CITY OF DALLAS INTERIOR LEVEE DRAINAGE STUDY WEST LEVEE – PHASE II

VOLUME 2 of 2 – PUMP STATION ASSESSMENTS

January 2009

Large Able (LAX) Pump Station

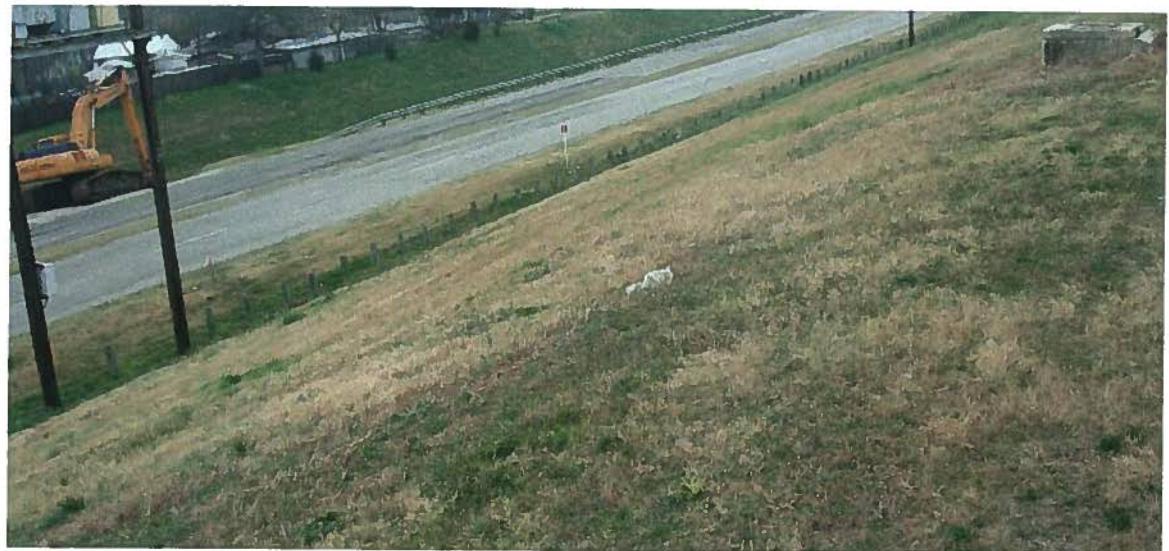
Photo 3.20 - PX West side of West Levee

The west side of the levee facing the station has excellent groundcover and is well maintained. The slope of the levee changes to a slight grade, leveling off to a flat shoulder for +/- 8 feet before intersecting with the road that passes between the levee and the station. (Photo 3.20)

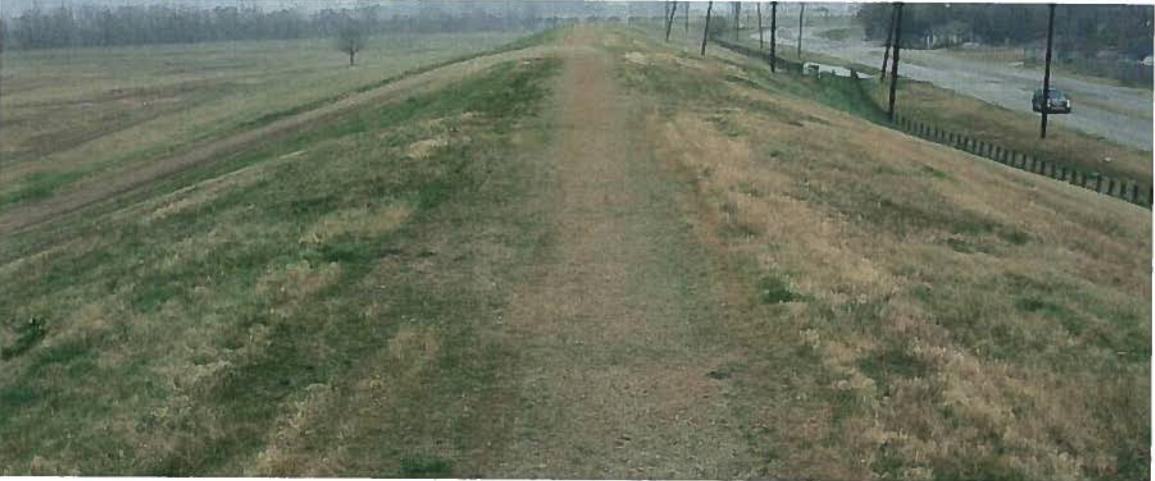
Photo 3.21 - PX Road on Top of West Levee

There are roads on top and bordering the west levee's east slope. These are routinely graded and in good repair but not all weather type roads. Any rainfall makes these roads hazardous for light vehicles and heavy equipment could cause damage. (Photos 3.21 & 3.22)

The levee's top road at PX is not as clearly defined. Groundcover encroaches on both sides. An approved systemic herbicide would remove this and not affect the road surface.

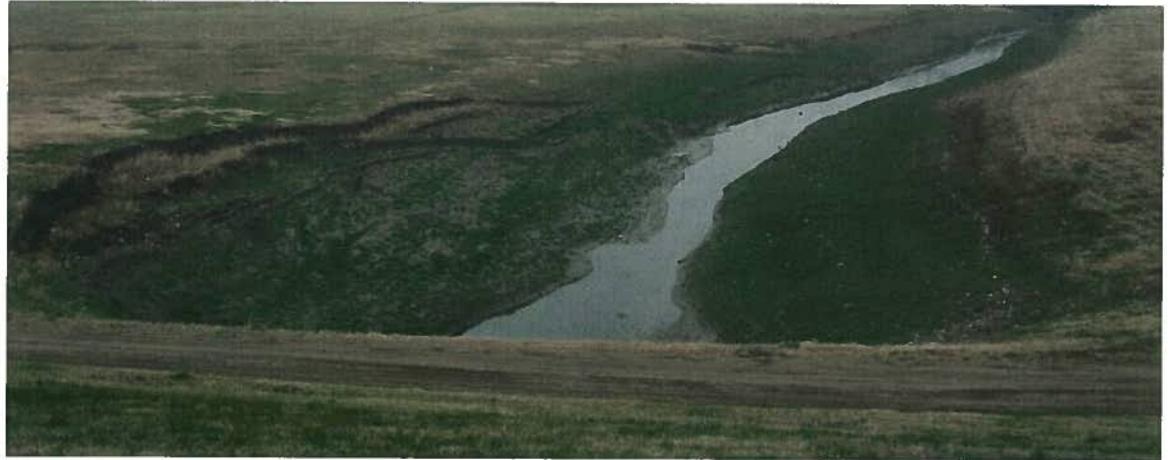
Photo 3.23 - PX Outfall Channel to the River

(Photo 3.23) The north bank of the outfall is unstable and there are signs of major slippage from the outfall structure for a distance of +/- 100 feet. This problem continues down the length of the channel until it reached the river. This area needs attention in the near future to prevent slippage from closing the channel as seen at NBX's gravity sluice gate's channel.

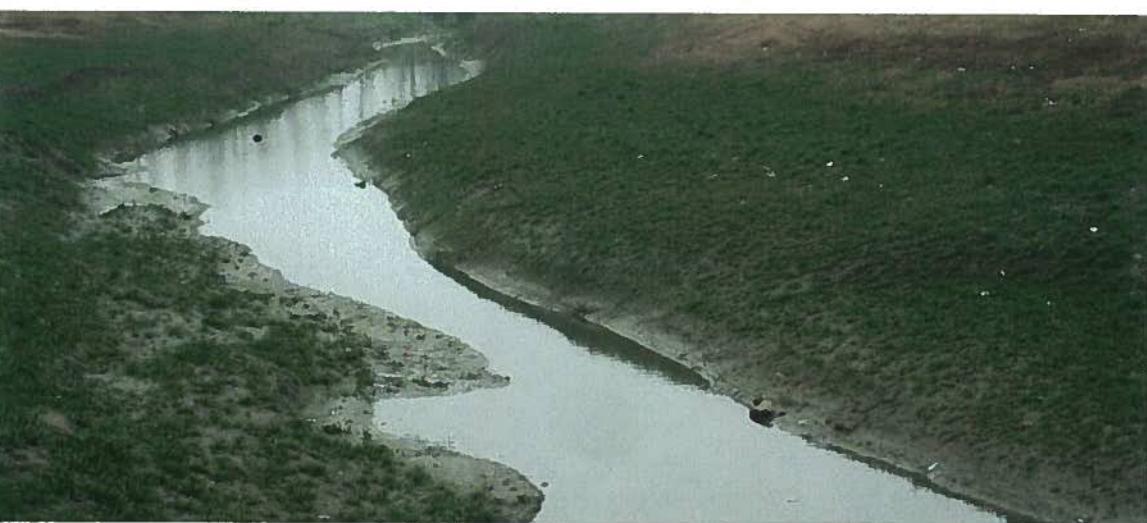
Photo 3.24 - PX South Bank of Outfall Channel

The south bank is in much better condition. This slope appears to be the result of slippage over a greater distance from the channel and over a long time period. (Photo 3.24) The groundcover appears to have stabilized the south bank along most of the channel but there is a large amount of silt at the outfall structure on both north and south sides that needs to be removed. (Photo 3.25)

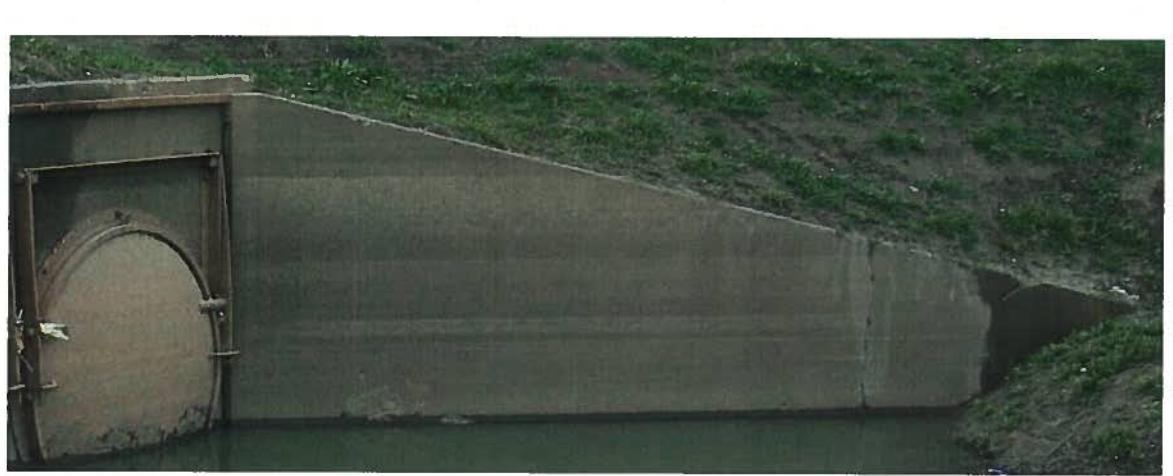
Photo 3.26 - PX Hairline Crack running up/down on the North Wing Wall

The outlet structure has damage to the north wing wall. There is a hairline stress crack running up/down the wall but there are no signs of movement in the forward/backward or up/down planes. The remaining walls and disks appear to be in good shape and the disks seat properly so the silt has not washed through the station where silt is also heavy. (Photo 3.26)

The outlet structure appears to have soil washed over the wing walls. The soil appears stable above the outlet structure but as the sides slip, it is believed the soil over the structure will also begin to slip.

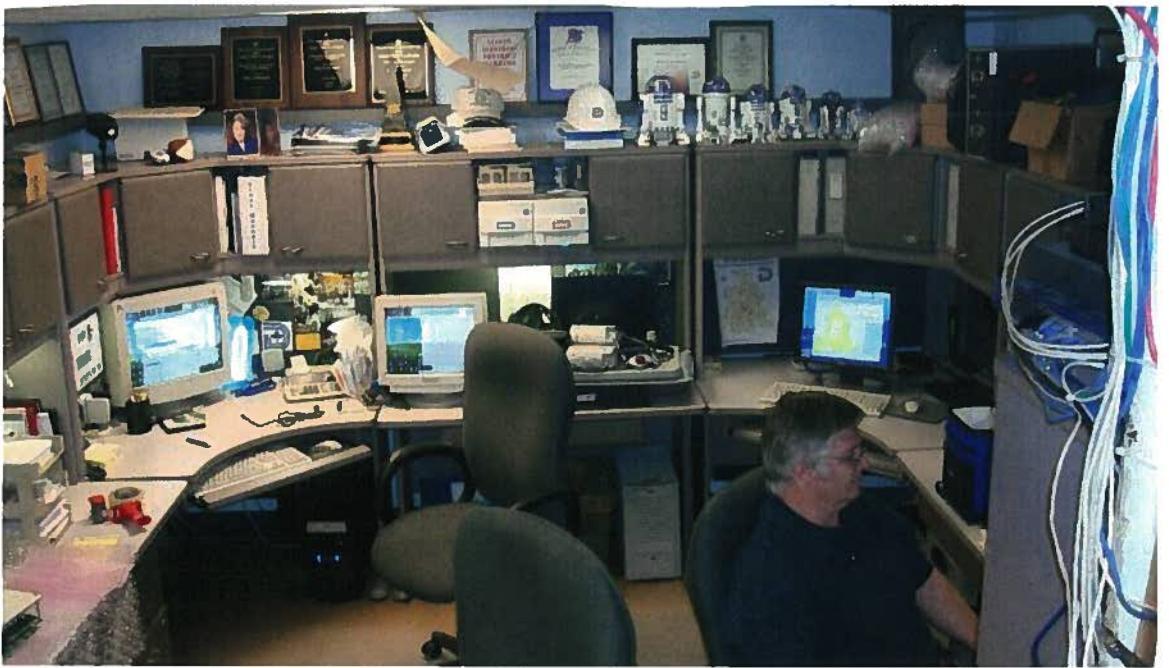
Current Design: Installed in 1990-91, the Supervisory Control and Data Acquisition (SCADA) system is from HSQ, San Francisco, CA and the Alert system for rain & stream gauges from Hydro Links, Sacramento, CA. Both SCADA & Alert are Dual server systems with a hot backup, meaning both servers have identical live data with one designated as in control. When the control unit fails, the other server takes command automatically.

Photo 1.1 - SCADA Computer Office

- The SCADA system is not protected from fire. Funding needs to be found to provide adequate protection to this City of Dallas capital investment and critical component of the Flood Water System. Additions of fire walls in the building also need to be installed but the fire extinguishing system needs immediate attention.
