APPENDIX C
BASE CONDITION RISK ASSESSMENT

PART I
RISK ASSESSMENT
TRINITY RIVER CORRIDOR

Trinity River Corridor Dallas Floodway near Dallas, TX

7 September 2012

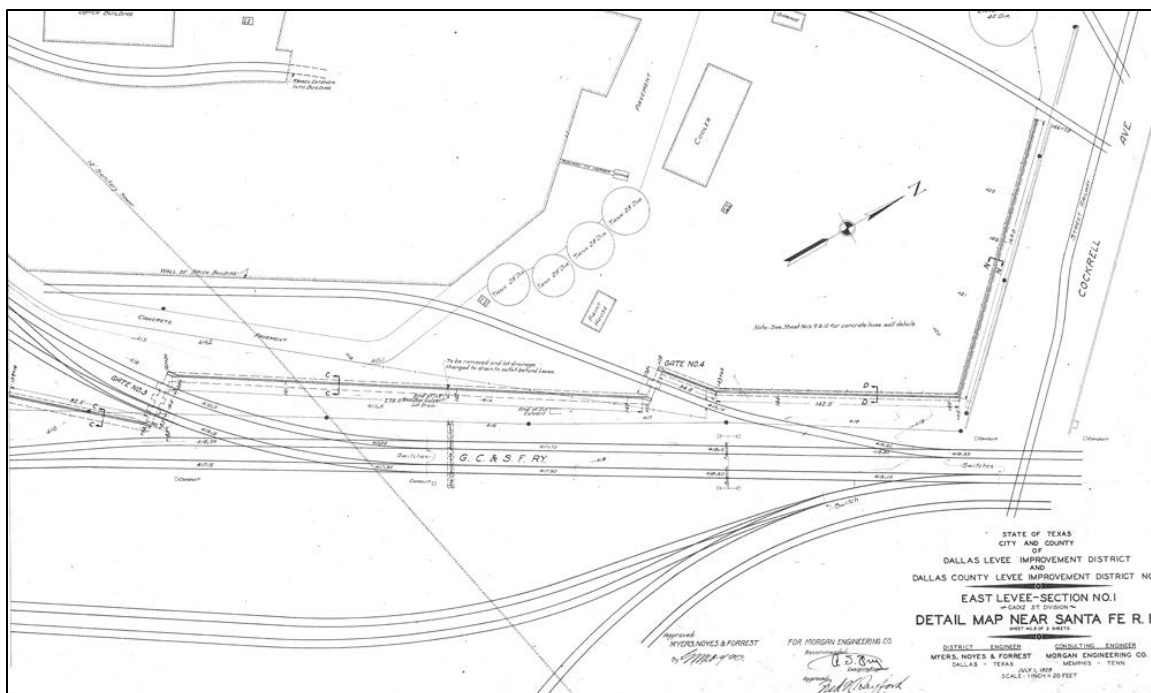
Event Information	
Loading Condition:	Hydrologic
Failure Mode:	Failure of Floodwall by Moment/Shear or Overtopping
Location:	Concrete Floodwall
Event and Initiator:	Very Large Flood
Influence Factors	
More Likely (Adverse)	Less Likely (Favorable)
Nappe at 1' depth of overtopping impacts beyond the concrete footing leading to possibility of eroding foundation soils	Stop log house built against wall on landside will buttress the wall in this location
Overtopping flows will plunge onto foundation imparting erosive forces to soil	The wall is keyed into the footing to help resist shear.
Rebar could be deteriorating (corroding) within the wall (but no evidence of this)	A large stretch of the floodwall is buttressed by a parking lot on the land side
	Reinforcing steel was placed on the upstream face and tied into the footing to resist moment
	Joint seals have been repaired which helps keep water from squirting through the joints and eroding the foundation of the wall

Could drop rip rap on landside in locations of overtopping erosion, if materials and equipment were available
	If pool develops on landside of wall it could dissipate energy and prevent undermining

Likelihood Category: Moderate

Confidence: Moderate

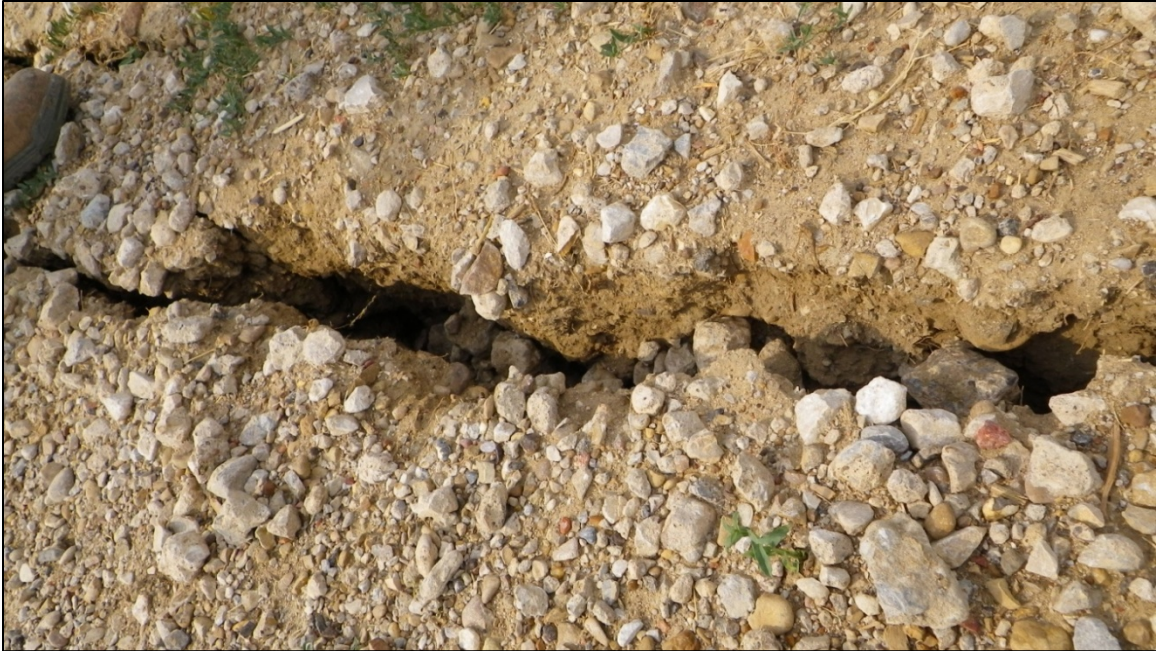
Event Information	
Loading Condition:	Hydrologic
Failure Mode:	Scour Through Desiccation Cracks in the Crest
Location:	High Liquid Limit CH Material Near Embankment Crest
Event and Initiator:	Flood Near Crest Elevation
Influence Factors	
More Likely (Adverse)	Less Likely (Favorable)
embankment.	downstream have not been observed on the levees
Gravel surface may mask traverse cracks at crest	Gravel surface may mask or reduce cracking by providing some protection of the underlying soils from drying
Water has not been high enough against the slopes of the levees to enter some of the observed desiccation cracks – it is uncertain if they connect in through-going fashion	Most areas of cracking highly plastic, erosion resistant
Bad incidents have occurred in Australia and Arizona due to desiccation cracking in the crest of embankment dams	Flood fighting is aided because distresses can be observed
	Cracks may swell shut once they are exposed to water from the river. Desiccation cracking observed in dry season, during rainy season they tend to close up

Cracks traverse to crest are likely not deep (less than five feet) – observed cracking is longitudinal or occurs down on the embankment slope
	Water would need to be near crest of levee to provide enough water and head to drive failure mode
	Possibly short duration of loading of water sufficiently high to enter and erode the cracks, particularly for local thunderstorm loading

Longitudinal cracking in the crest of the embankment.

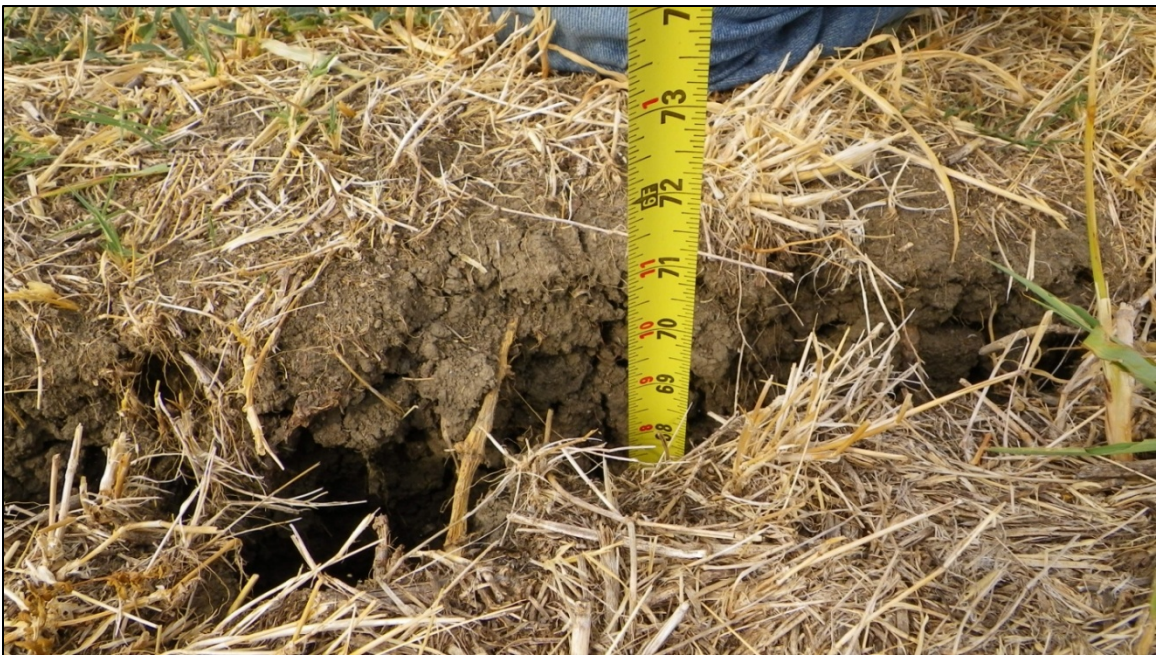
Depth of longitudinal cracking in the crest of the embankment.

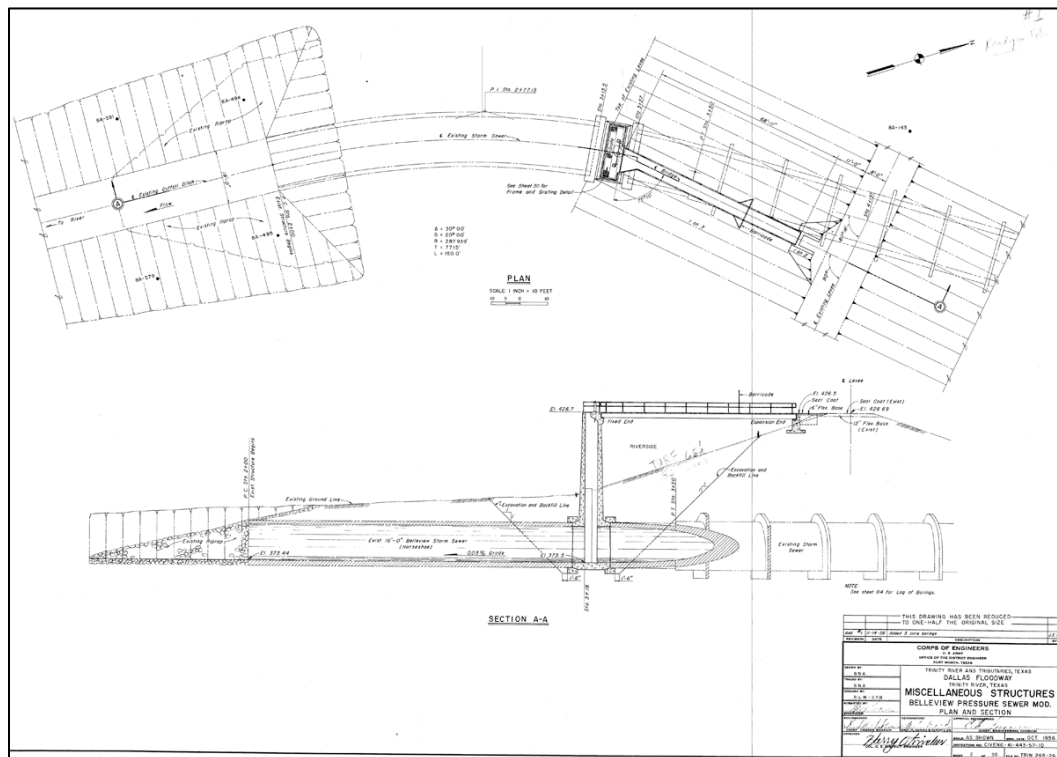
Event Information	
Loading Condition:	Hydrologic
Failure Mode:	Rupture or Leak of Pressurized Conduit
Location:	Any of the Pressurized Conduits where Passing through Levee Embankment
Event and Initiator:	Flood Greater Than Historical
Influence Factors	
More Likely (Adverse)	Less Likely (Favorable)
Bellevue sewer is within approximately eight feet of levee base and its outfall is near the river side embankment toe, which leads to a shorter seepage path that could affect the embankment	Video inspection of indicates concrete is in good shape
The pressure head within the conduit could approach 50 feet based on the elevation of inflows to the pressure conduits	Material near conduit (Bellevue sewer) is CH, which is more plastic and erosion resistant
Conduit joint treatment is unknown, it is not known whether waterstops were installed which would mitigate concerns at the joints	Some conduits have been run pressurized for six to eight weeks with no observed problems

Bellevue conduits are old, constructed in the 1920's, and have seepage collars which have been shown to reduce the density of fill adjacent conduits due to difficulties with compacting adjacent fill	
Not sure what type of soil material was used for backfill around the conduits; silty material would be more erodible

Likelihood Category: Very Low to Low **Confidence:** Moderate

Rationale: It is likely that high plasticity erosion resistant soils were placed adjacent to the conduit and indications are that the conduits are in good shape.

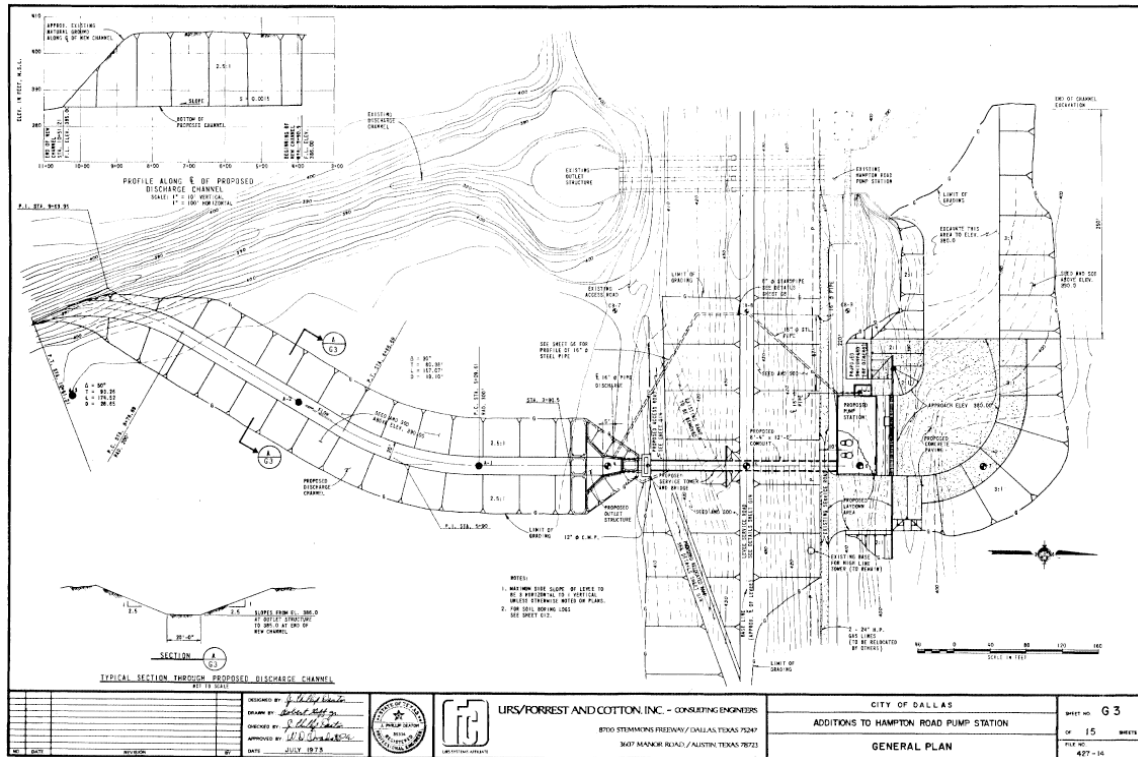
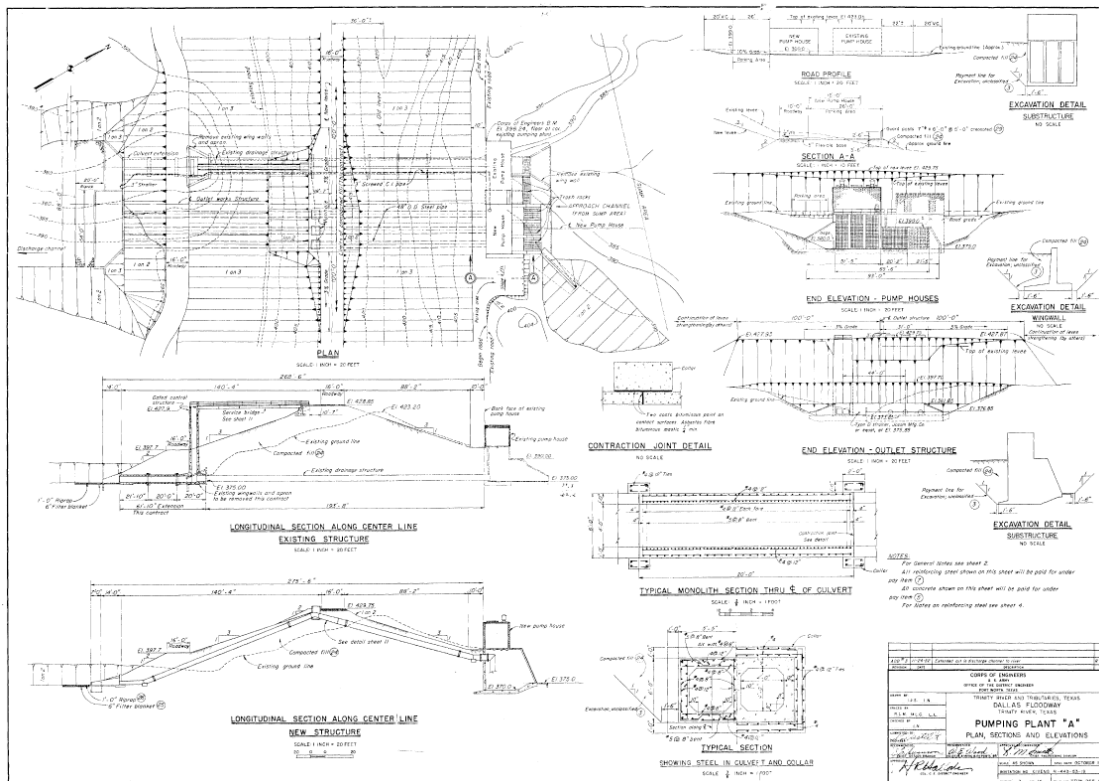
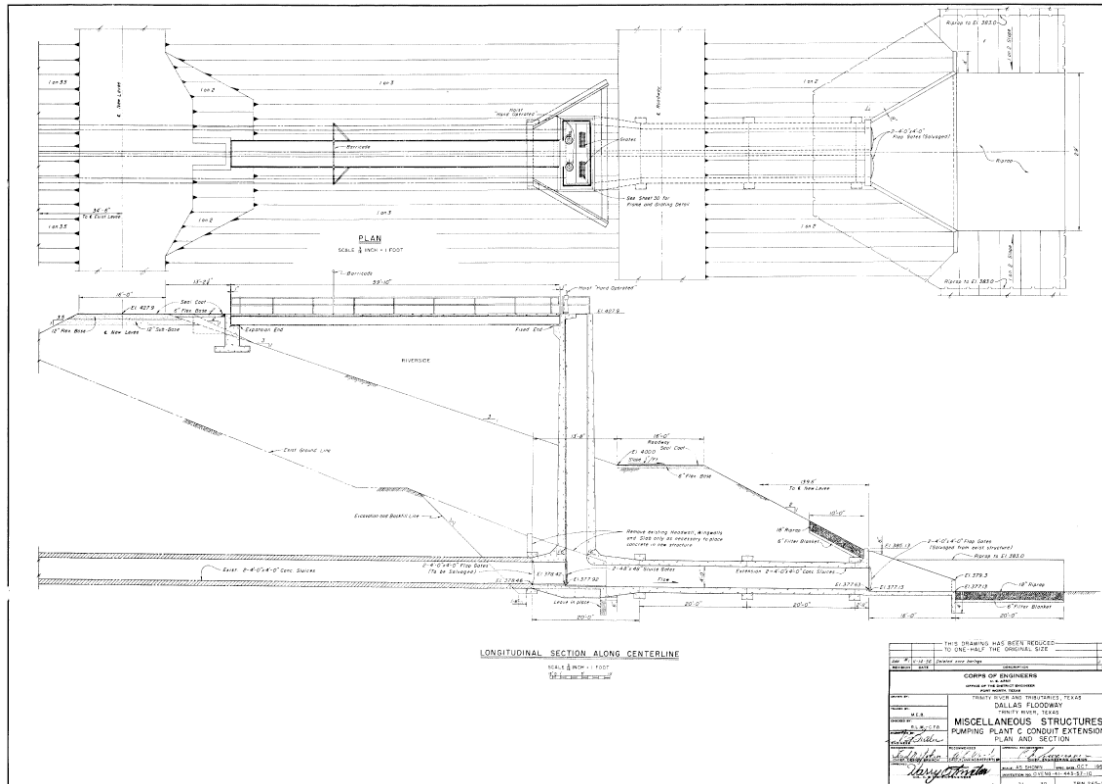
Loading Condition:	Hydrologic
Failure Mode:	Scour Along Embankment Penetration
Location:	Any Conduit or Penetration through the Levee Embankments
Event and Initiator:	Flood Greater Than Historical
Influence Factors	
More Likely (Adverse)	Less Likely (Favorable)
Pump station conduits are shortest seepage path and are a location this could develop	No performance issues have been observed that would suggest flaws exist along any of the conduit
Seepage collars were constructed in the top part of the conduit (through soils) at some locations which make it difficult to compact soil in this area	Landside conduit connected to pump houses would limit any exit areas for soil movement
A narrow slot was left adjacent to the upper part of a conduit where it would have been difficult to compact soil	Lower portion of conduits were cast against rock cut in some locations would not be an erodible seepage path
Gravity drains were constructed in 1930's and have seepage collars	Filter (sand/gravel) was placed surrounding the conduit at the protected side in some locations which should mitigate potential erosion along the conduit

Average gradient is approximately 0.25 which is large enough to move poorly compacted erodible soils	A headwall was constructed at the river side of some conduits would help lengthen and seal the seepage path along the conduit
	Some pump stations conduits were constructed in high plasticity erosion resistant clays
	Conduits are covered by a roadway on the protected side in most areas which would lengthen the seepage path and reduce the gradient

Likelihood Category: Low

Confidence: Moderate

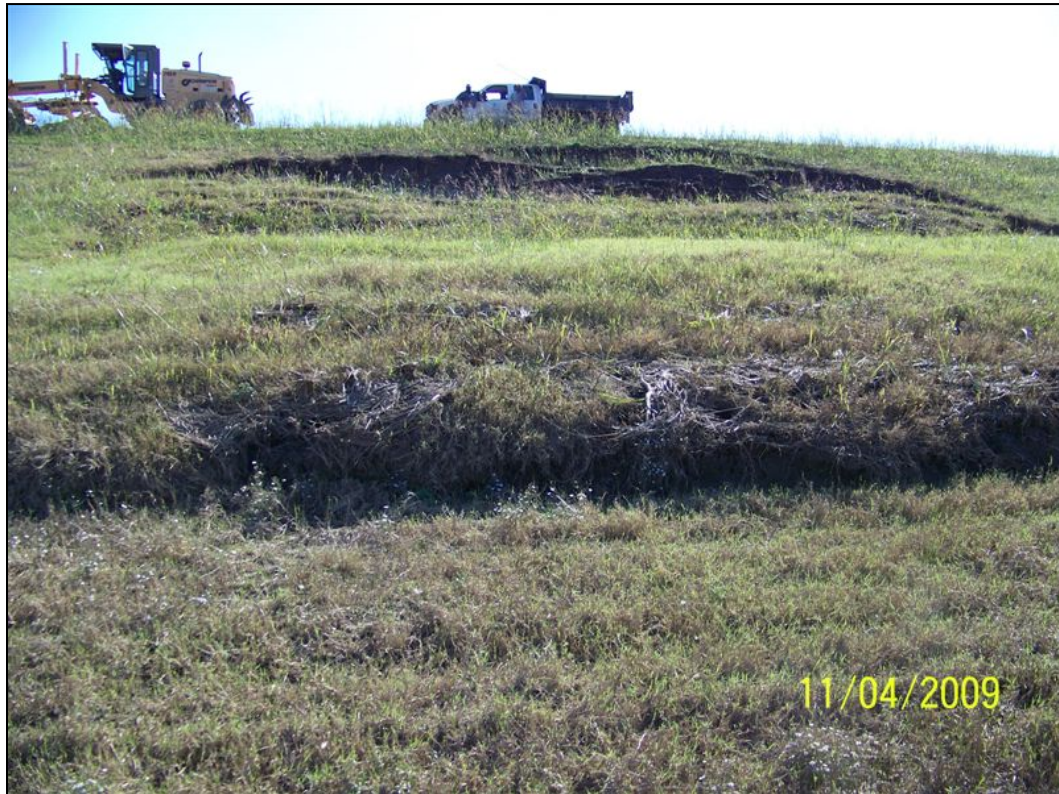
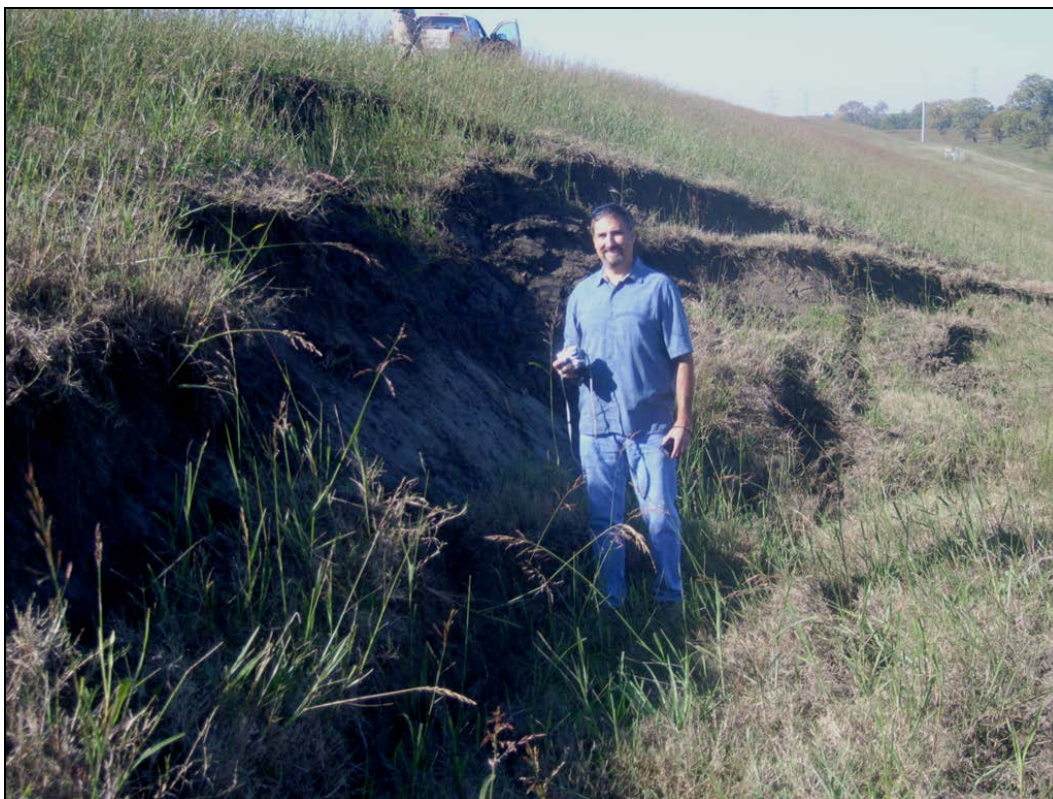
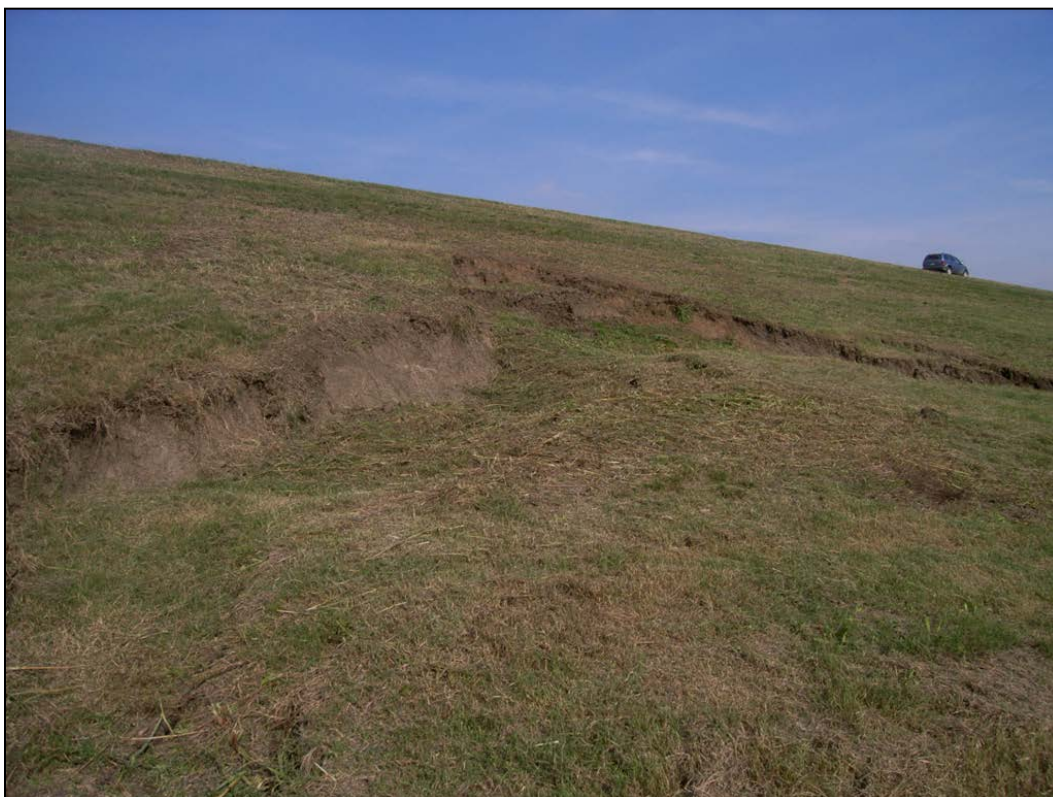
Embankment slope slides have been prevalent throughout the history of the levee system. Although none of these have breached a portion of the crest of the levee, the possibility exists that this could occur at higher stage levels than have been experienced to date.

The majority of the discussion related to this potential failure mode concerned input parameters for seepage and stability analyses. These are discussed in more detail in the risk assessment section and appendices of this report.

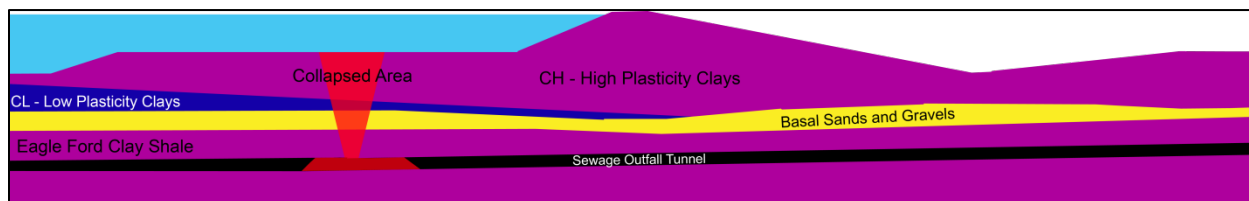
Figure 16 - Levee Section at the collapsed area

The risk assessment team held a teleconference to discuss the impacts of the existing tunnel situation. The team decided to qualitatively assess the risks posed by the existing system. The team felt that there is a significant chance that a void exists below the levee itself. If this void were to lead to a collapse during a flood event, it could cause a 10-15 foot collapse of the crest of the embankment. If the flood was significant – even for storms with less than 100-year recurrence – this could cause the embankment to overtop and breach. The team used the original matrix from the PFMA, which is shown below.

The team believes that the risks posed by the tunnel are at least an order of magnitude higher than any other failure mode evaluated by the team. There is a significant amount of uncertainty with this situation.

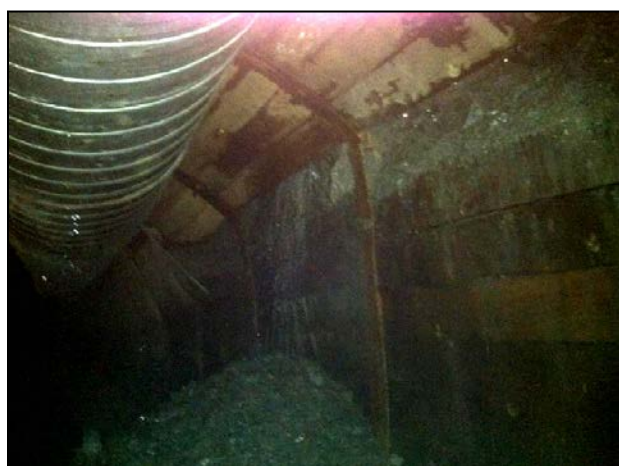
During the risk assessment, a sewage outfall tunnel was being constructed beneath the levee. This failure mode was considered during the PFMA session and determined to be a low risk. However, the team assumed these conduits were built as they were planned using the methods as they were approved. Before completion of the outfall tunnel, on 28 January 2012, a large area of the tunnel collapsed and stopped up to the ground surface near the river side of the levee. Flowable fill was placed into the sinkhole to stabilize the area. 350 to 450 cubic yards of flowable fill were placed in the sinkhole. A remedial grouting operation was immediately begun to fill the void and the collapsed area of the tunnel with low mobility grout.

Figure 17 - Photo of the Initial Collapse

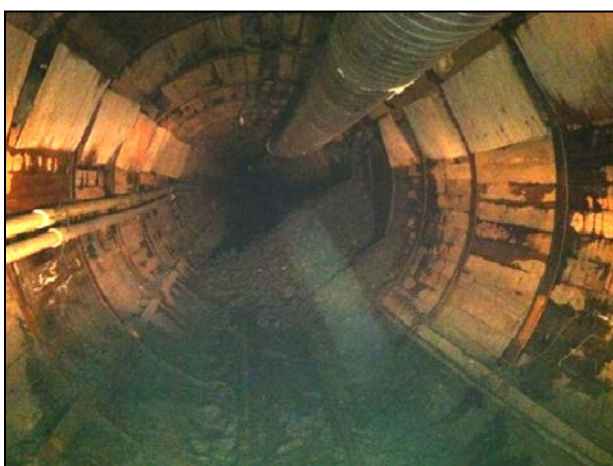
Piezometers near the collapsed area with tips in the basal sand show regional groundwater dropping significantly at the time of the collapse and rebounding over several days. These instruments also show an identical response approximately one month after the initial collapse with no surface expression of distress. This could indicate a collapsed area, likely between the land-side toe of the levee and the initial collapsed area.

Figure 18 - Photo of the Collapse Progressing

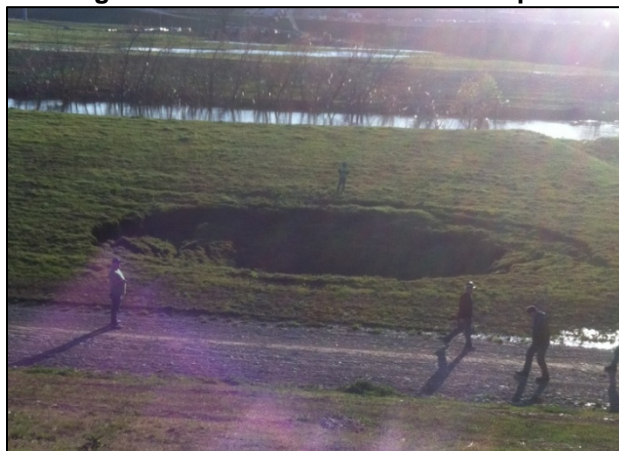
Figure 19 - Photo of the Sinkhole

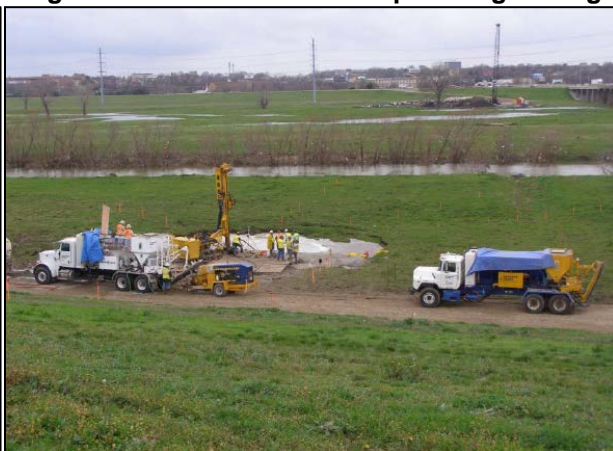
Figure 20 - Photo of the Remedial Grouting

Currently, the land side of the collapsed tunnel area is full of water. The City of Dallas is considering options to safely replace the water, re-establish the tunnel, construct the outfall structure, and possibly remediate any damage caused during the collapses.

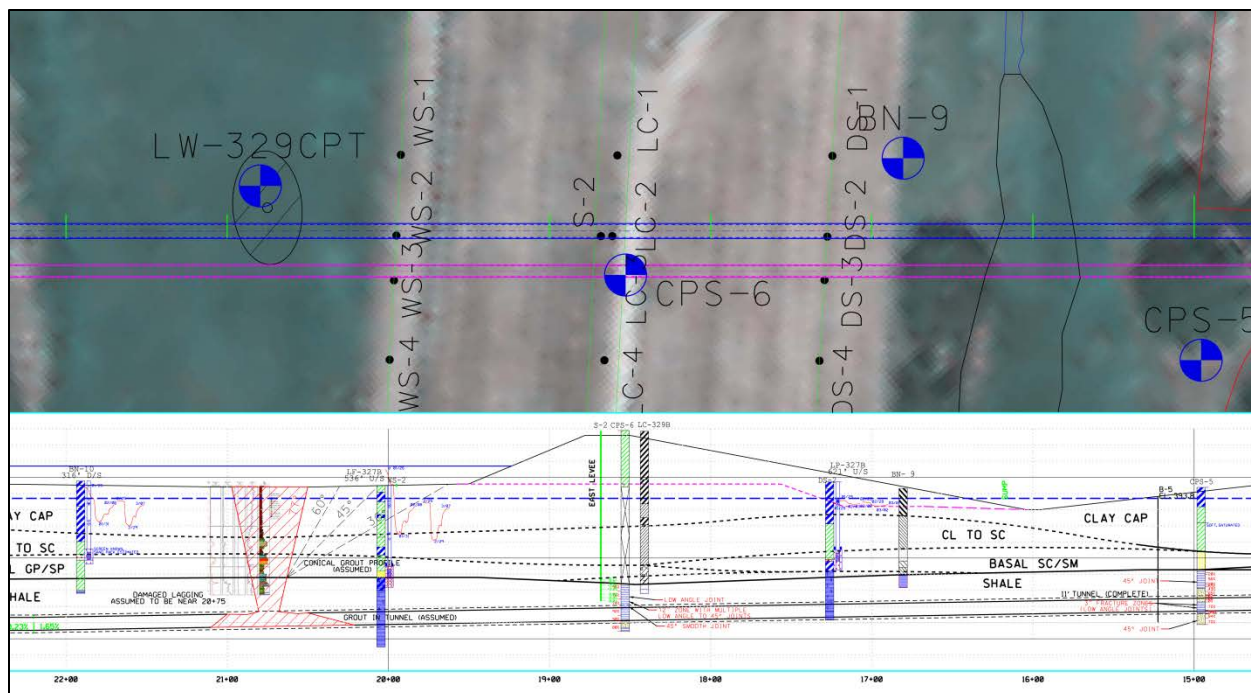
Figure 21 - Cross-section showing instrumentation and nearby borings.

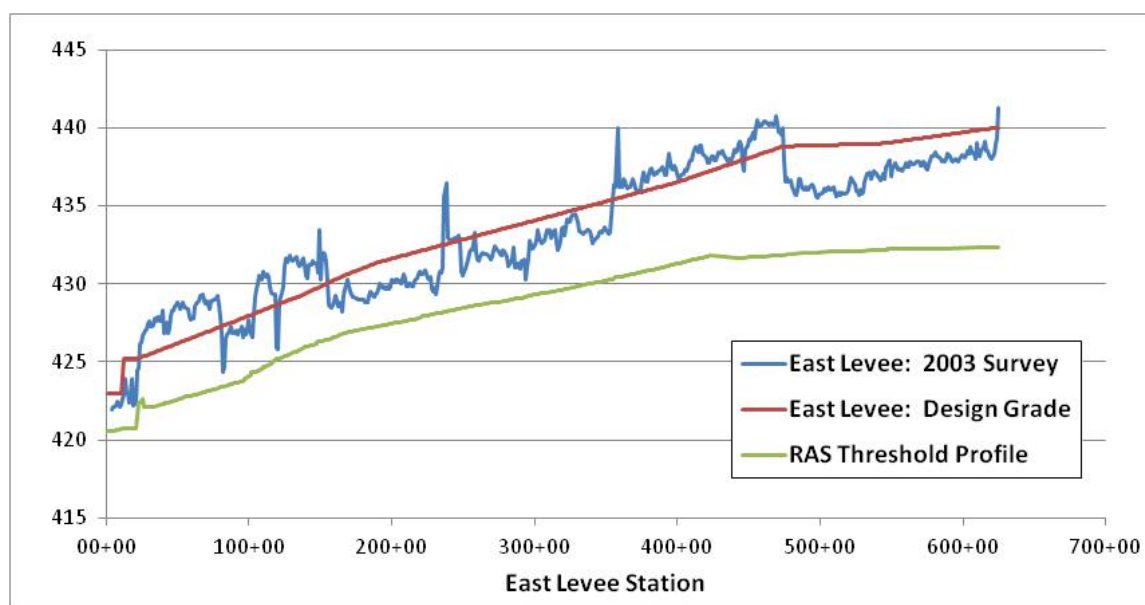
Figure 73 - East Levee Crest Profile

In its present state, the top of levee profile (or crest profile) of the Trinity River Levee System at Dallas has significant variability compared to expected water surface profiles. The original design grade (circa 1952) of the levee has been altered due to a combination of settlement, sloughing, local crest restoration projects, and construction tolerances. It should be noted that the 1950s design of the project left the tie-back floodwall on the downstream end of the East Levee, and by doing so allowed for a natural first overtopping location of the system. The profile of the East and West Levee systems including design grade, surveyed crest grade (2003 survey), and the modeled “threshold” flood water surface profile is shown in Figure 75 and Figure 76 below.

It is expected that overtopping will occur at the east downstream floodwall first. The largest modeled flood that does not cause overtopping at the downstream floodwall was labeled as the “threshold flood”. For a larger flood, it is expected that levee sections further upstream would also overtop.

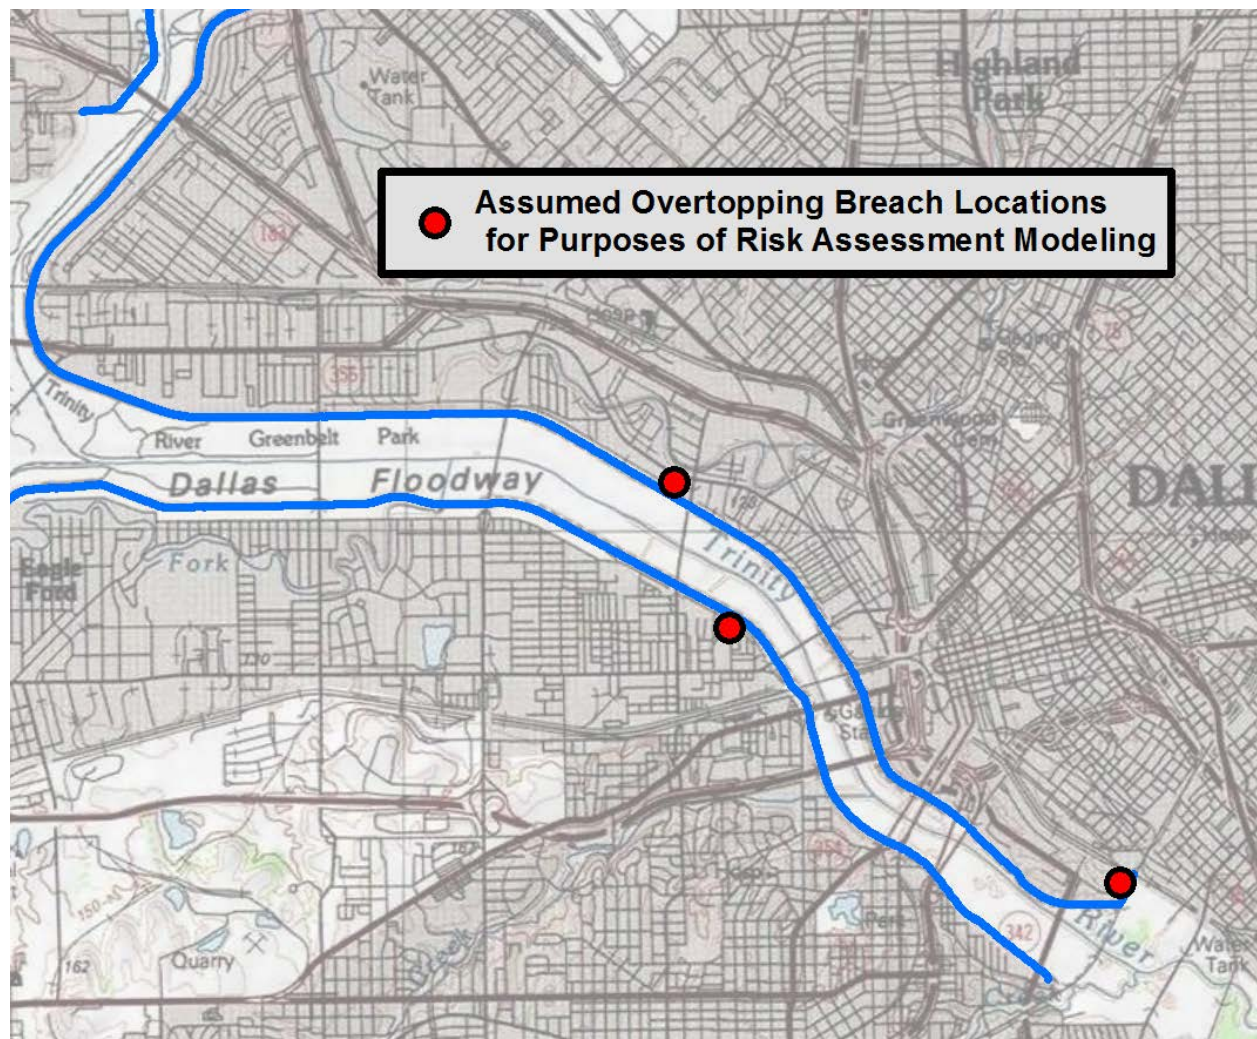
Figure 75 - Modeled Overtopping Breach Locations

Three overtopping failure locations were considered and two overtopping flood scenarios (larger than the threshold flood) were considered. A plan view location of the selected overtopping driven breach locations is shown in Figure 77 below. The maximum depth and duration of overtopping for each scenario was determined based on HEC-RAS unsteady flow modeling and was used to inform the expert elicitation for the Risk Assessment (see Table 30 below).

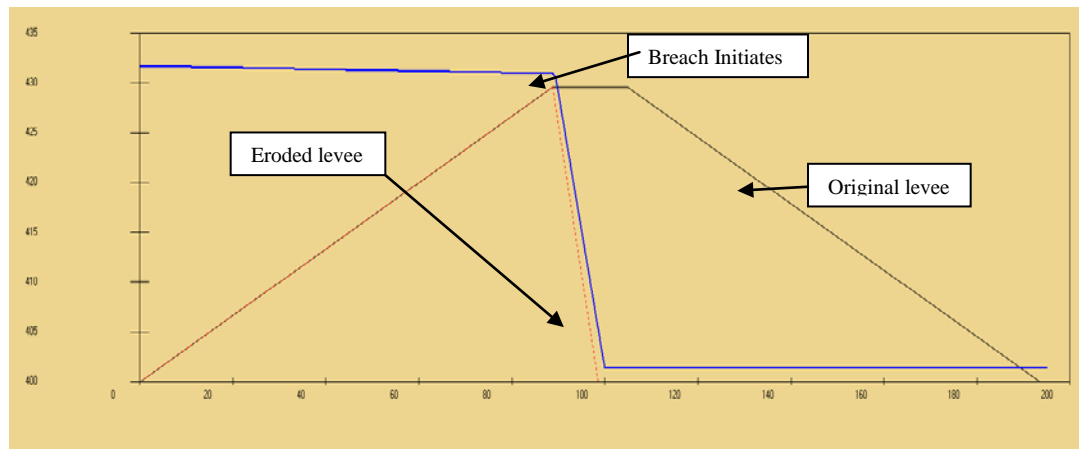
Figure 77. Graphical Depiction from WinDAMB model

For WinDAMB breach initiation begins when erosion first begins on the upstream (river) side of the levee crest. This is the point when downcutting begins to increase flow over the levee. Any erosion on the crest downstream from this point or downstream slope does not indicate breach initiation. Figure 79 shows when breach initiation begins.

For the range of values examined – breach width ranges from 118 ft To 167 ft when there was a full breach to the toe of the levee. One run did not initiate breach and two runs initiated breach but did not completely fail the levee by downcutting to levee toe

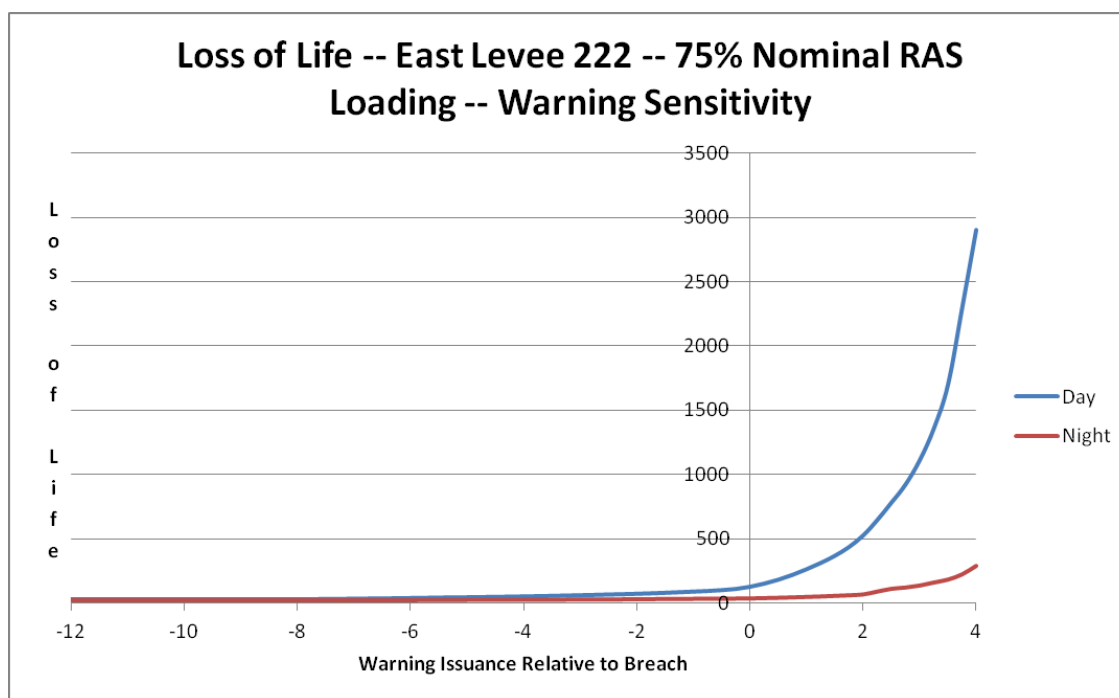
Figure 86 -- Loss of Life for Varying Warning Issuance Assumptions – E222 75%

Figure 88 shows that results are relatively insensitive to the warning issuance assumption unless warning goes out after breach. This suggests that Global Instability results, which have significant warning opportunity time, are not sensitive to this assumption. Meanwhile, results for Internal Erosion failures, which are not expected to have advanced warning, are significantly impacted by this assumption. The large difference between day and night results is both a factor of the gross difference in PAR from Day to Night, but also the spatial difference in PAR – Day

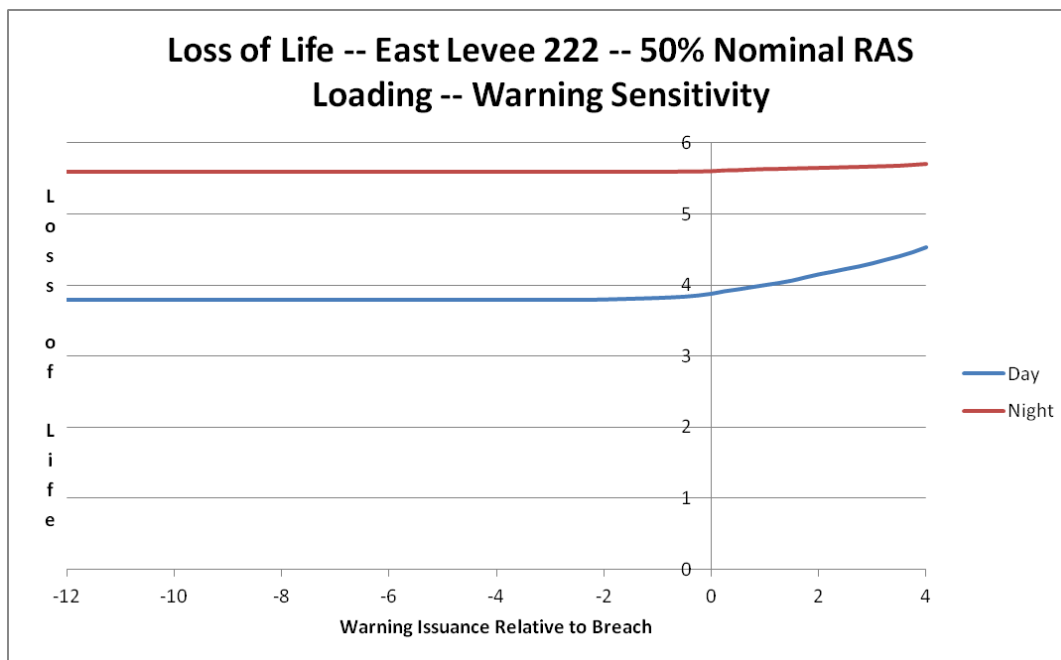
Figure 87 -- Loss of Life for Varying Warning Issuance Assumptions – E222 50%

Figure 89 shows that less severe events are particularly indifferent to warning issuance assumptions. This is factor of the vast amount of time it takes for the breach to widen and the leveed area to fill.

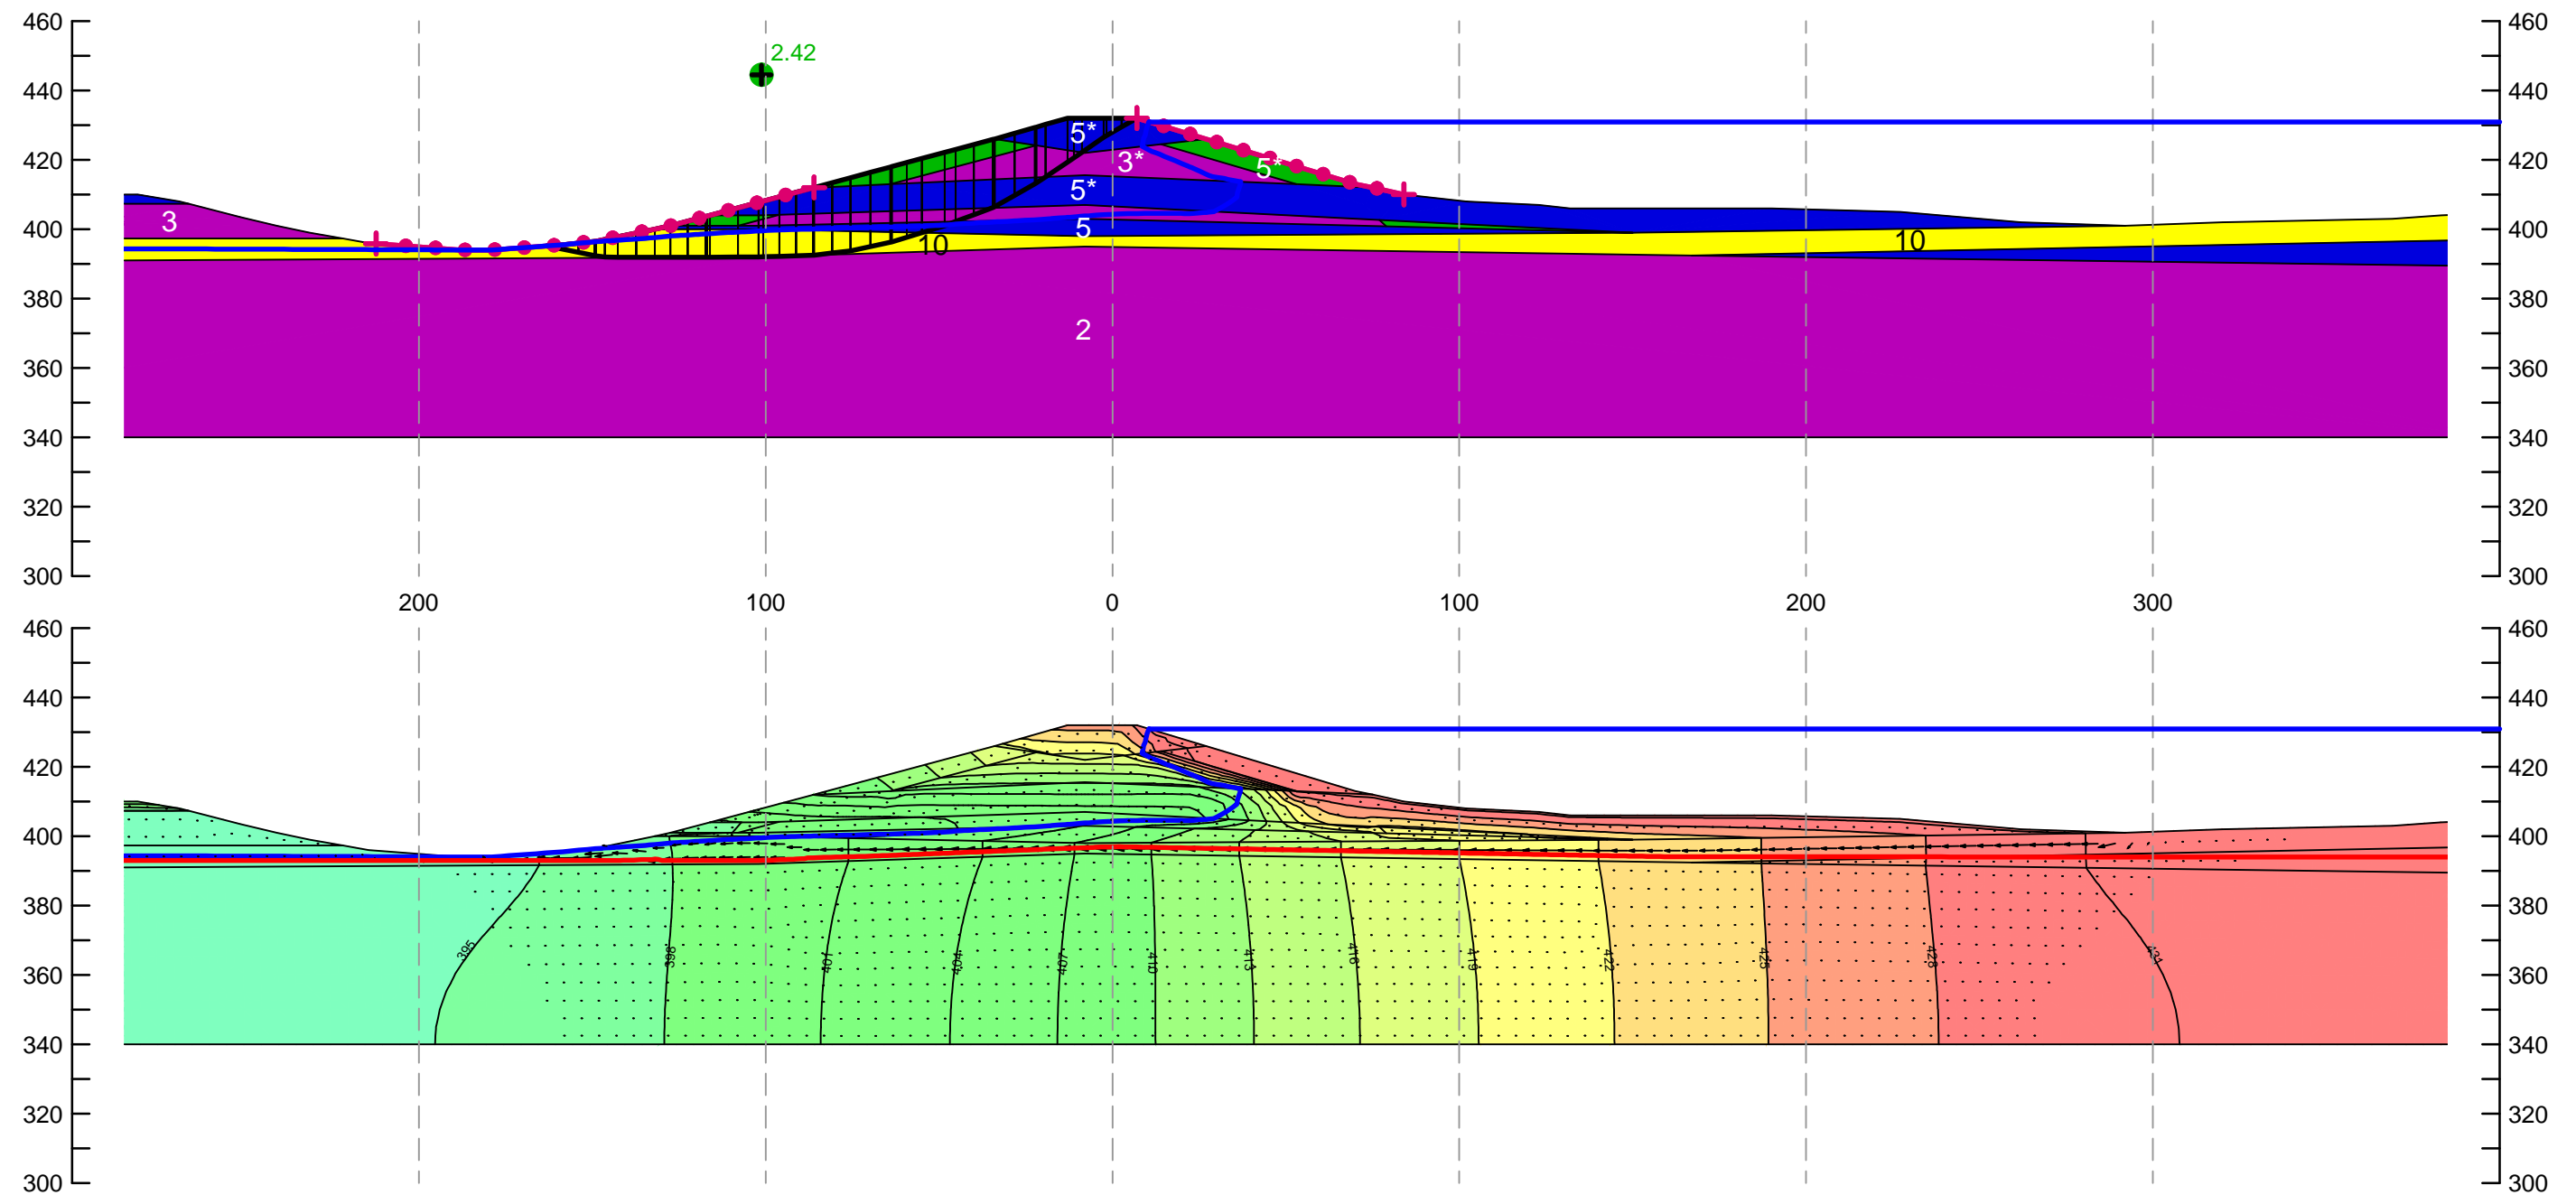
7

WEST LEVEE STA 250+00
