APPENDIX C
BASE CONDITION RISK ASSESSMENT

PART I
RISK ASSESSMENT
TRINITY RIVER CORRIDOR

Trinity River Corridor Dallas Floodway near Dallas, TX

7 September 2012

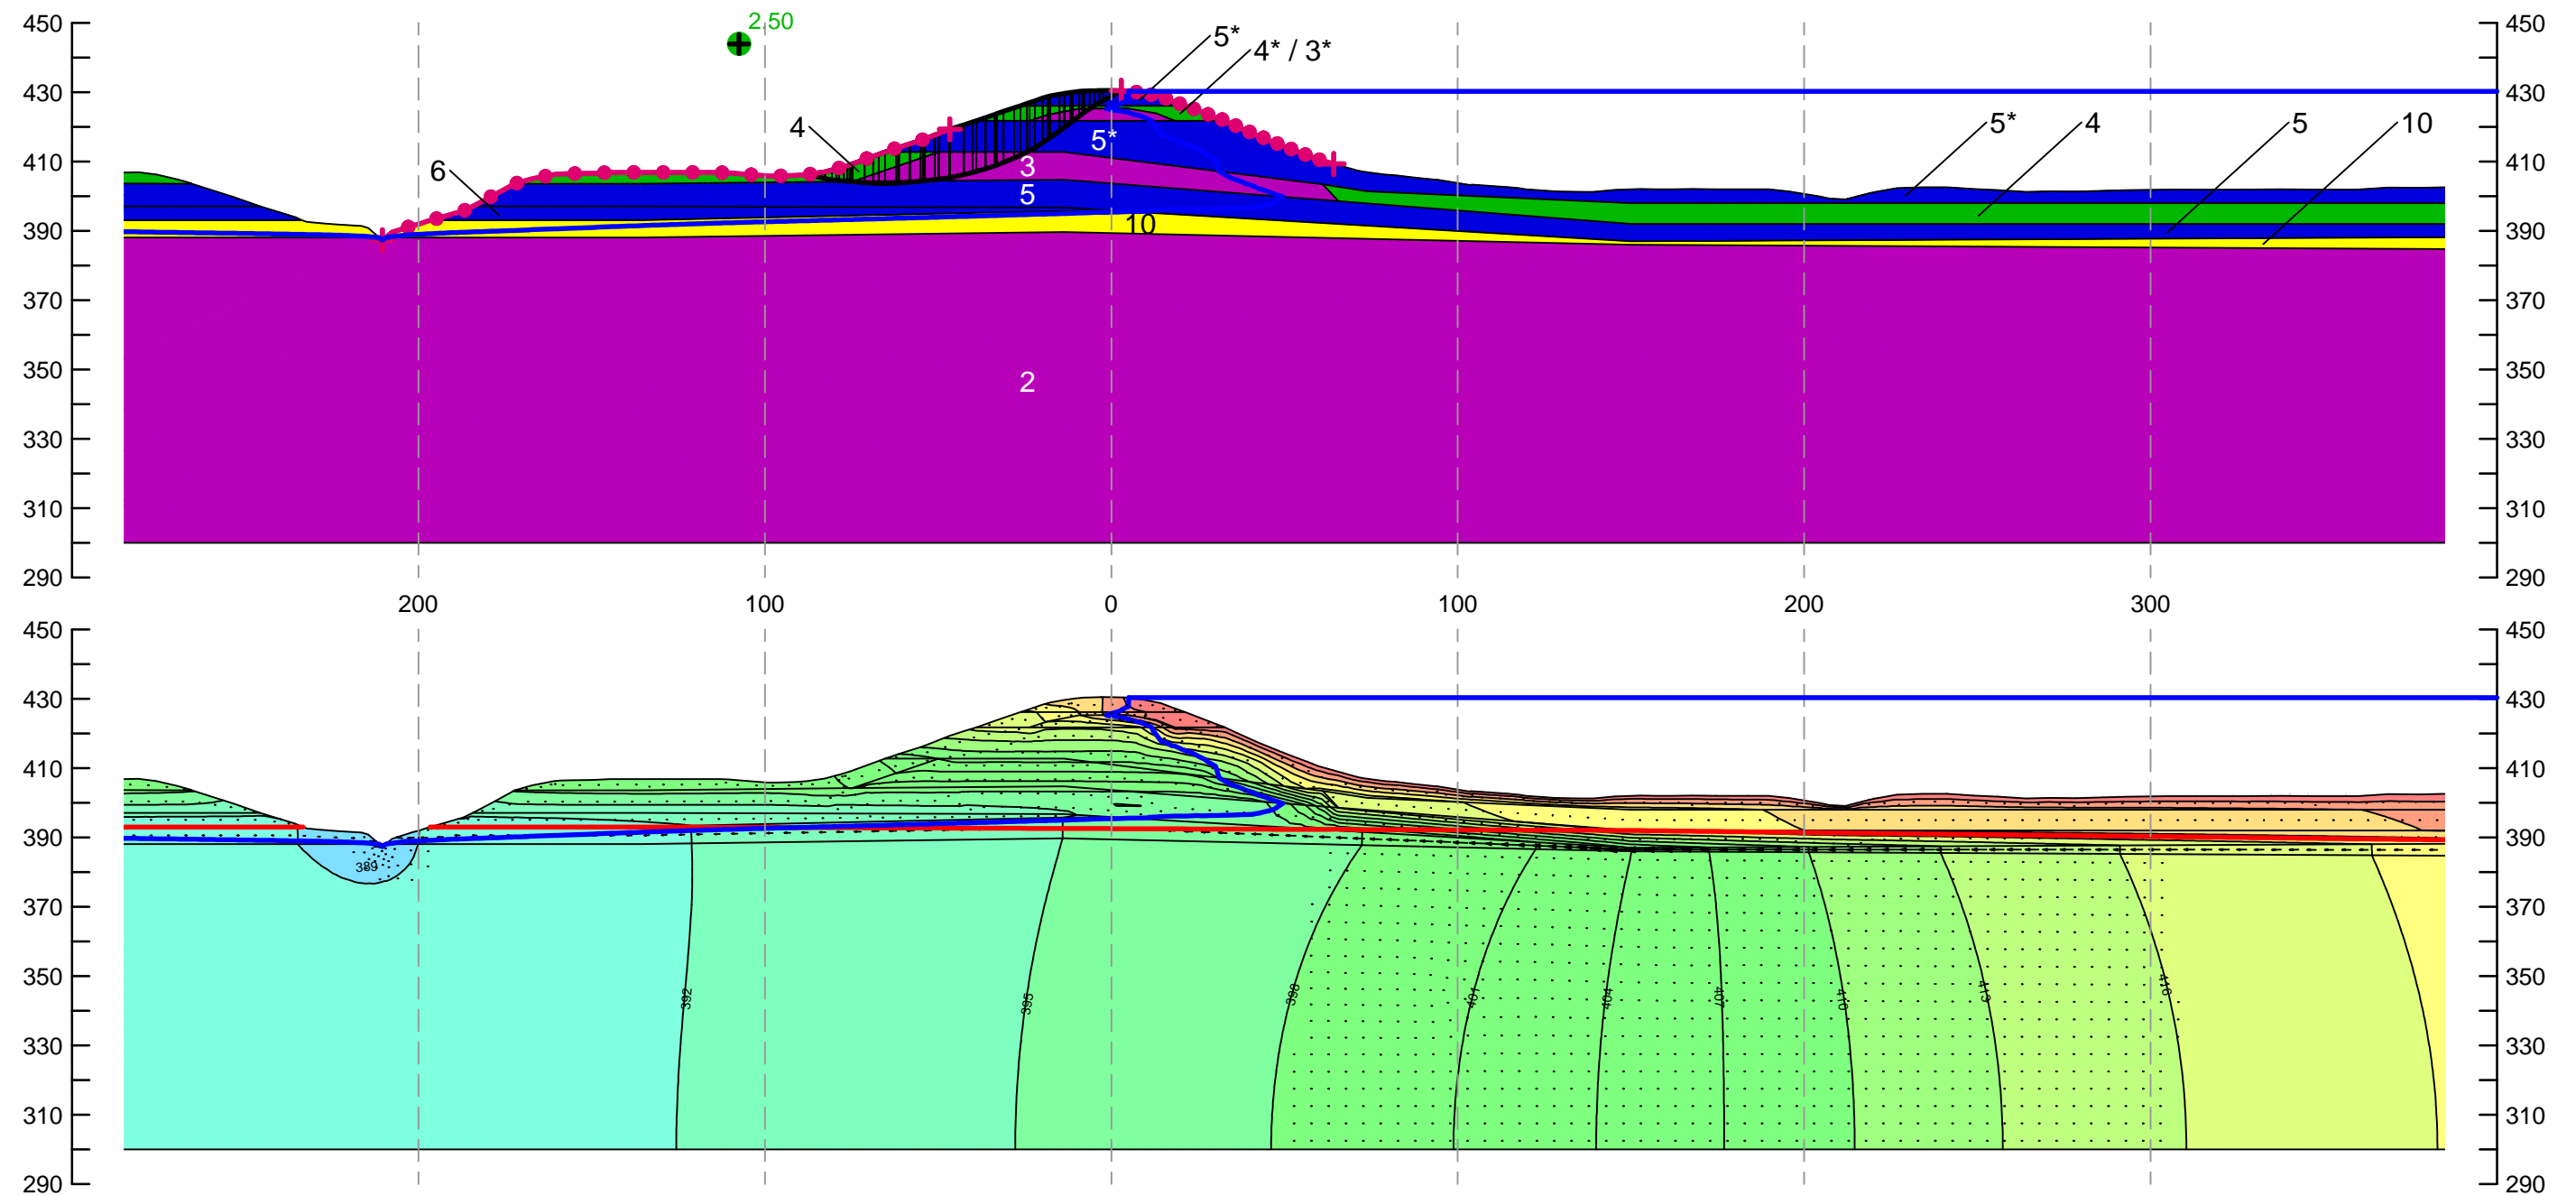
6

WEST LEVEE STA 188+00

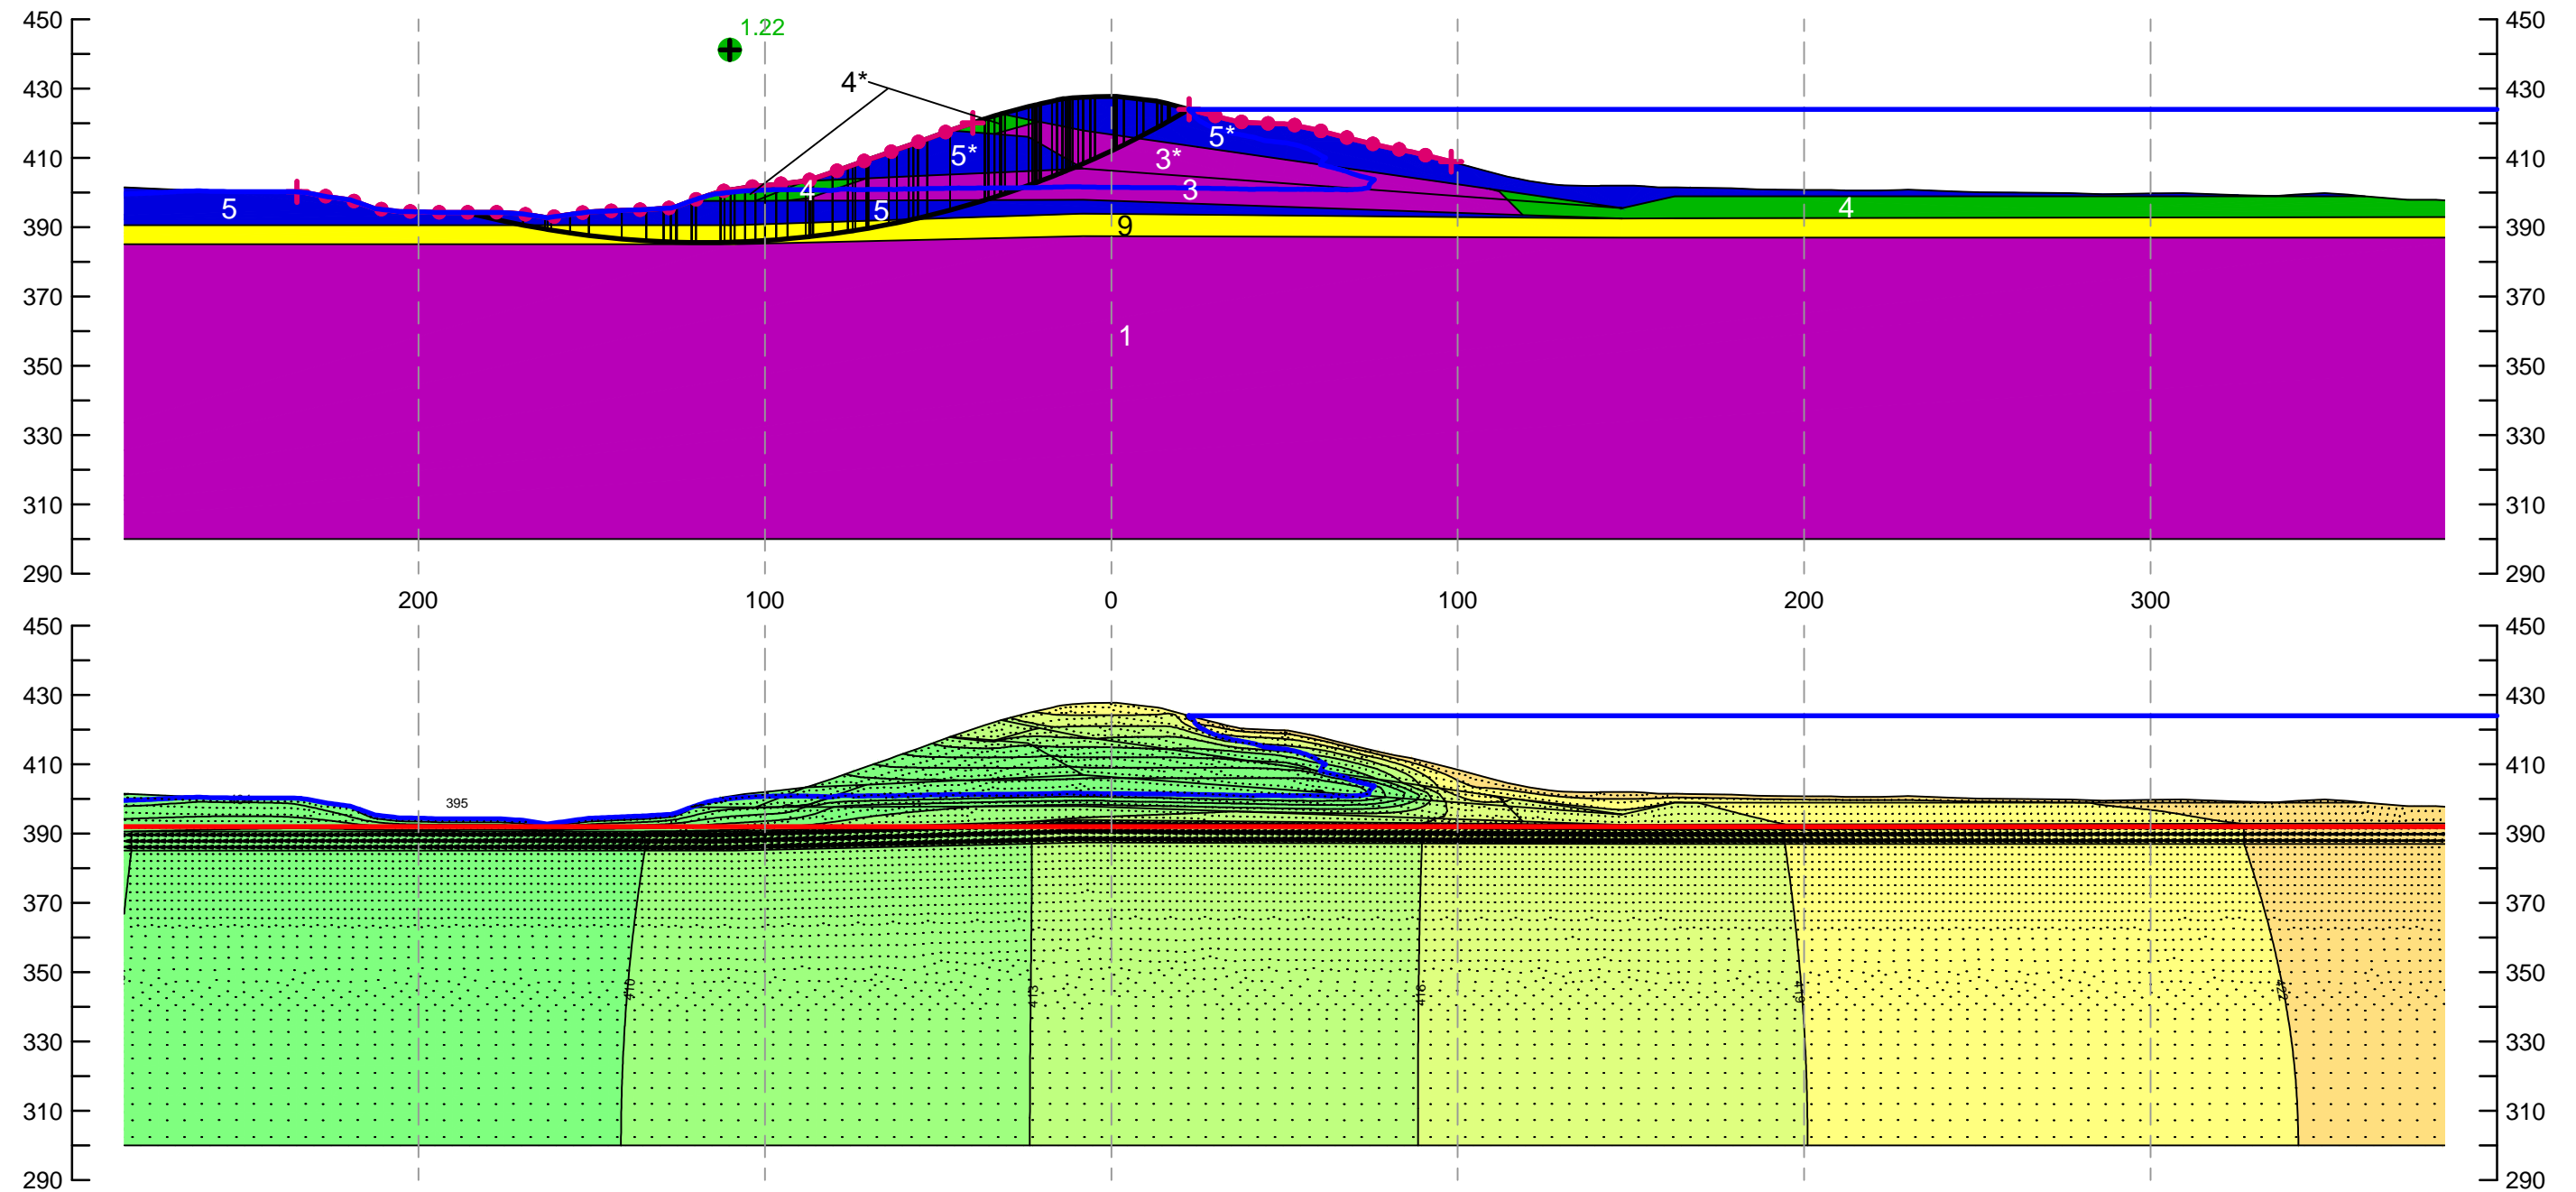
5

WEST LEVEE STA 10+00

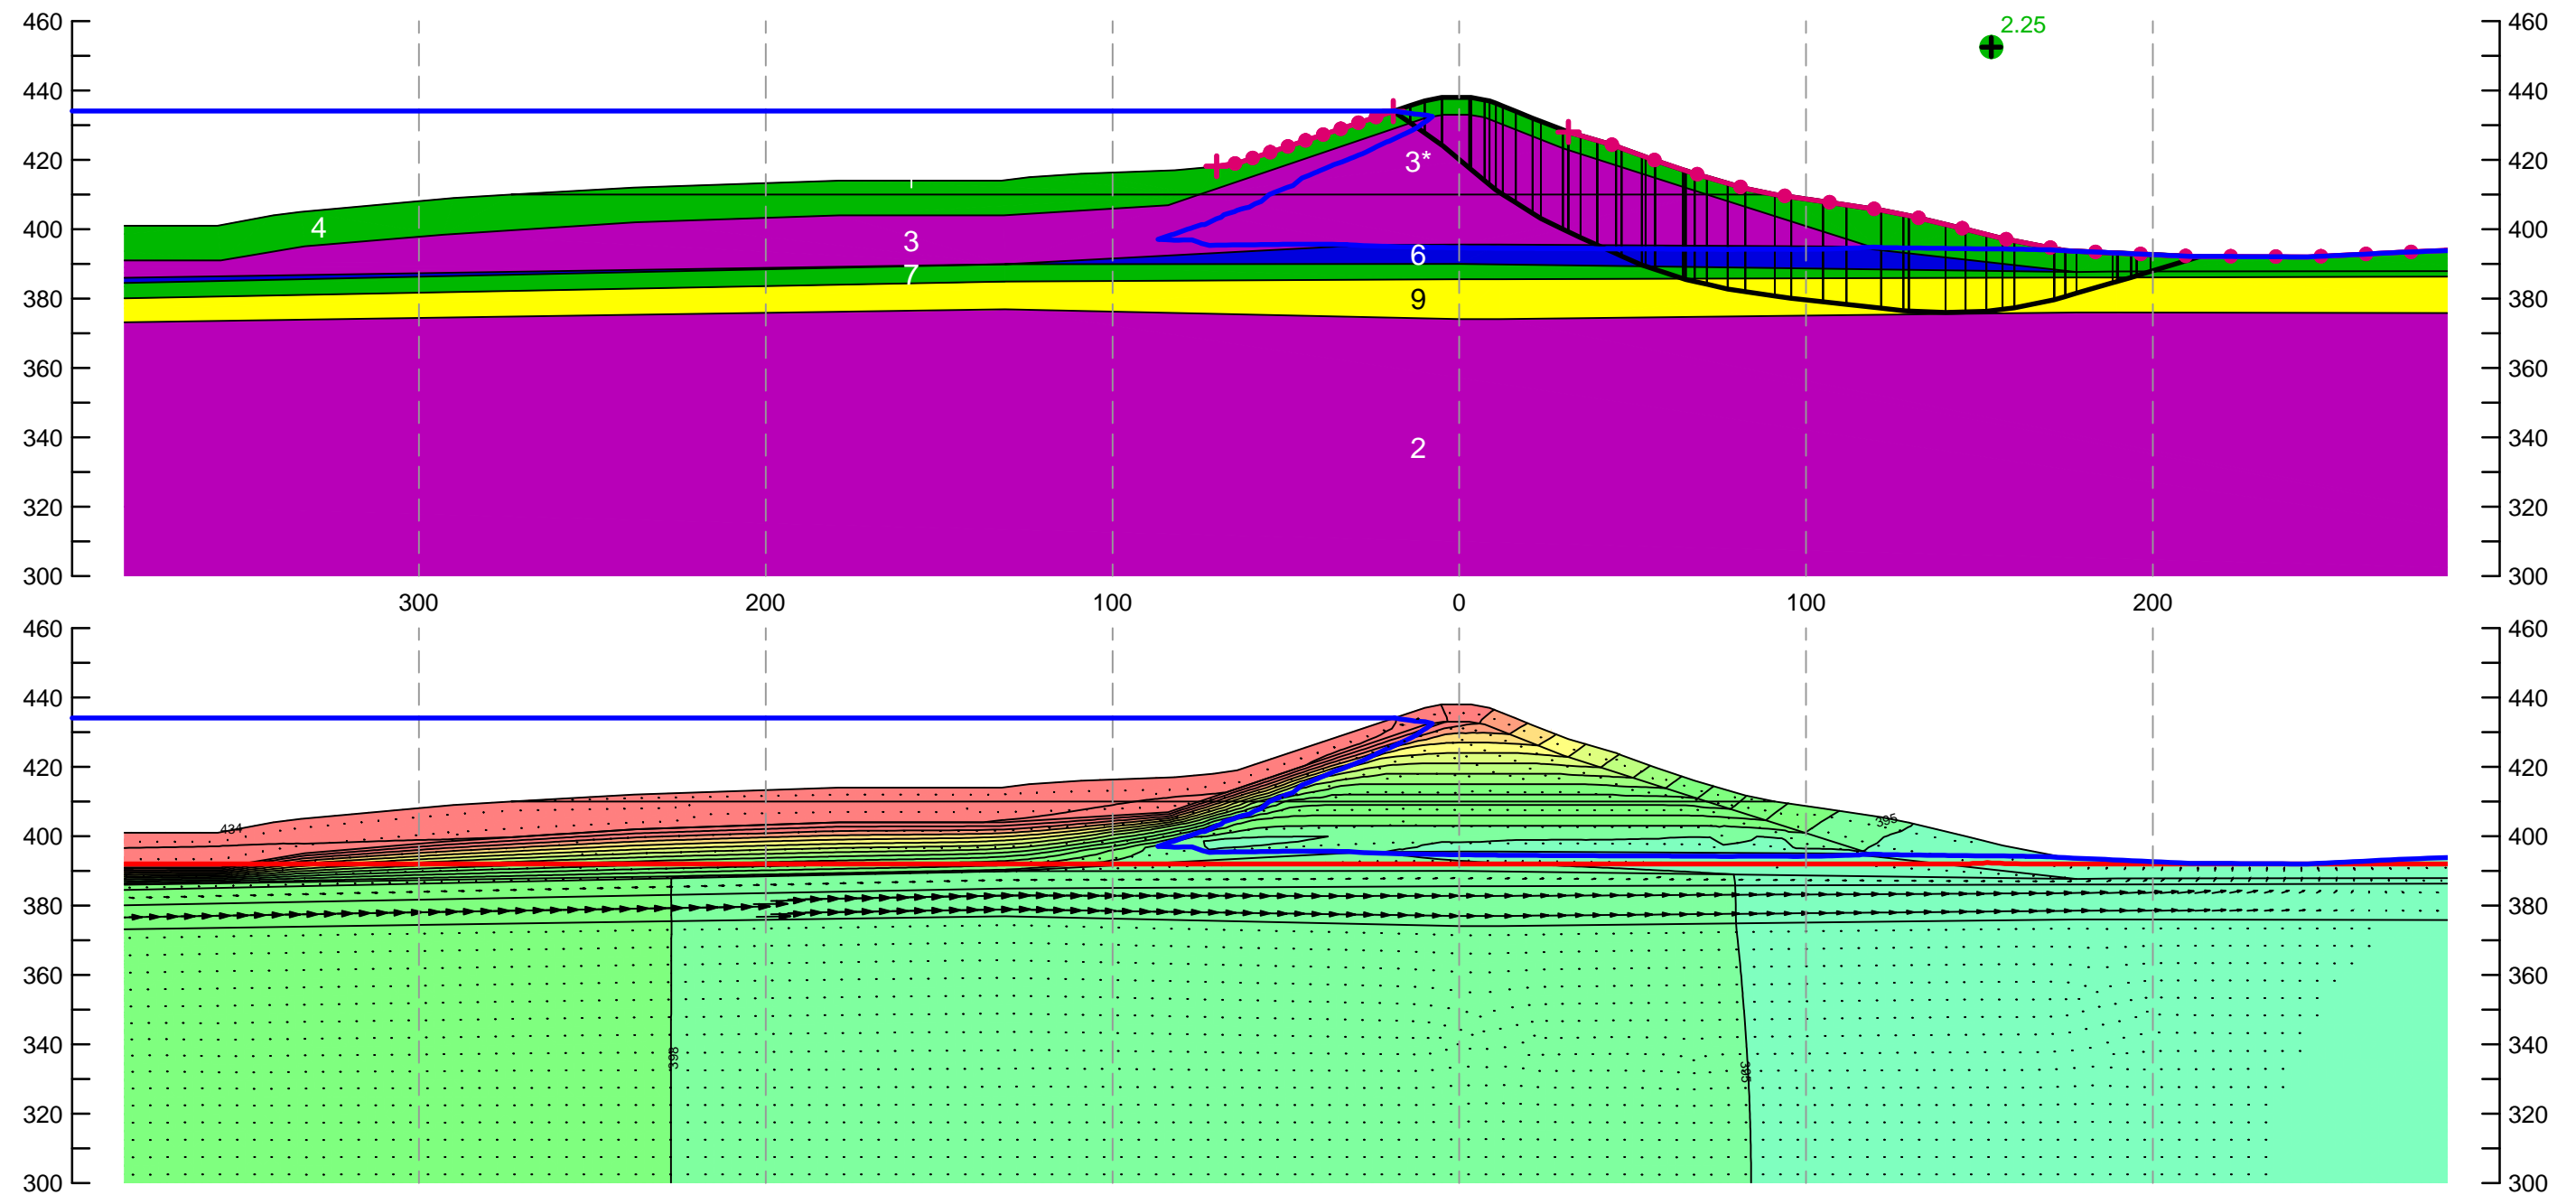
4

EAST LEVEE STA 410+00

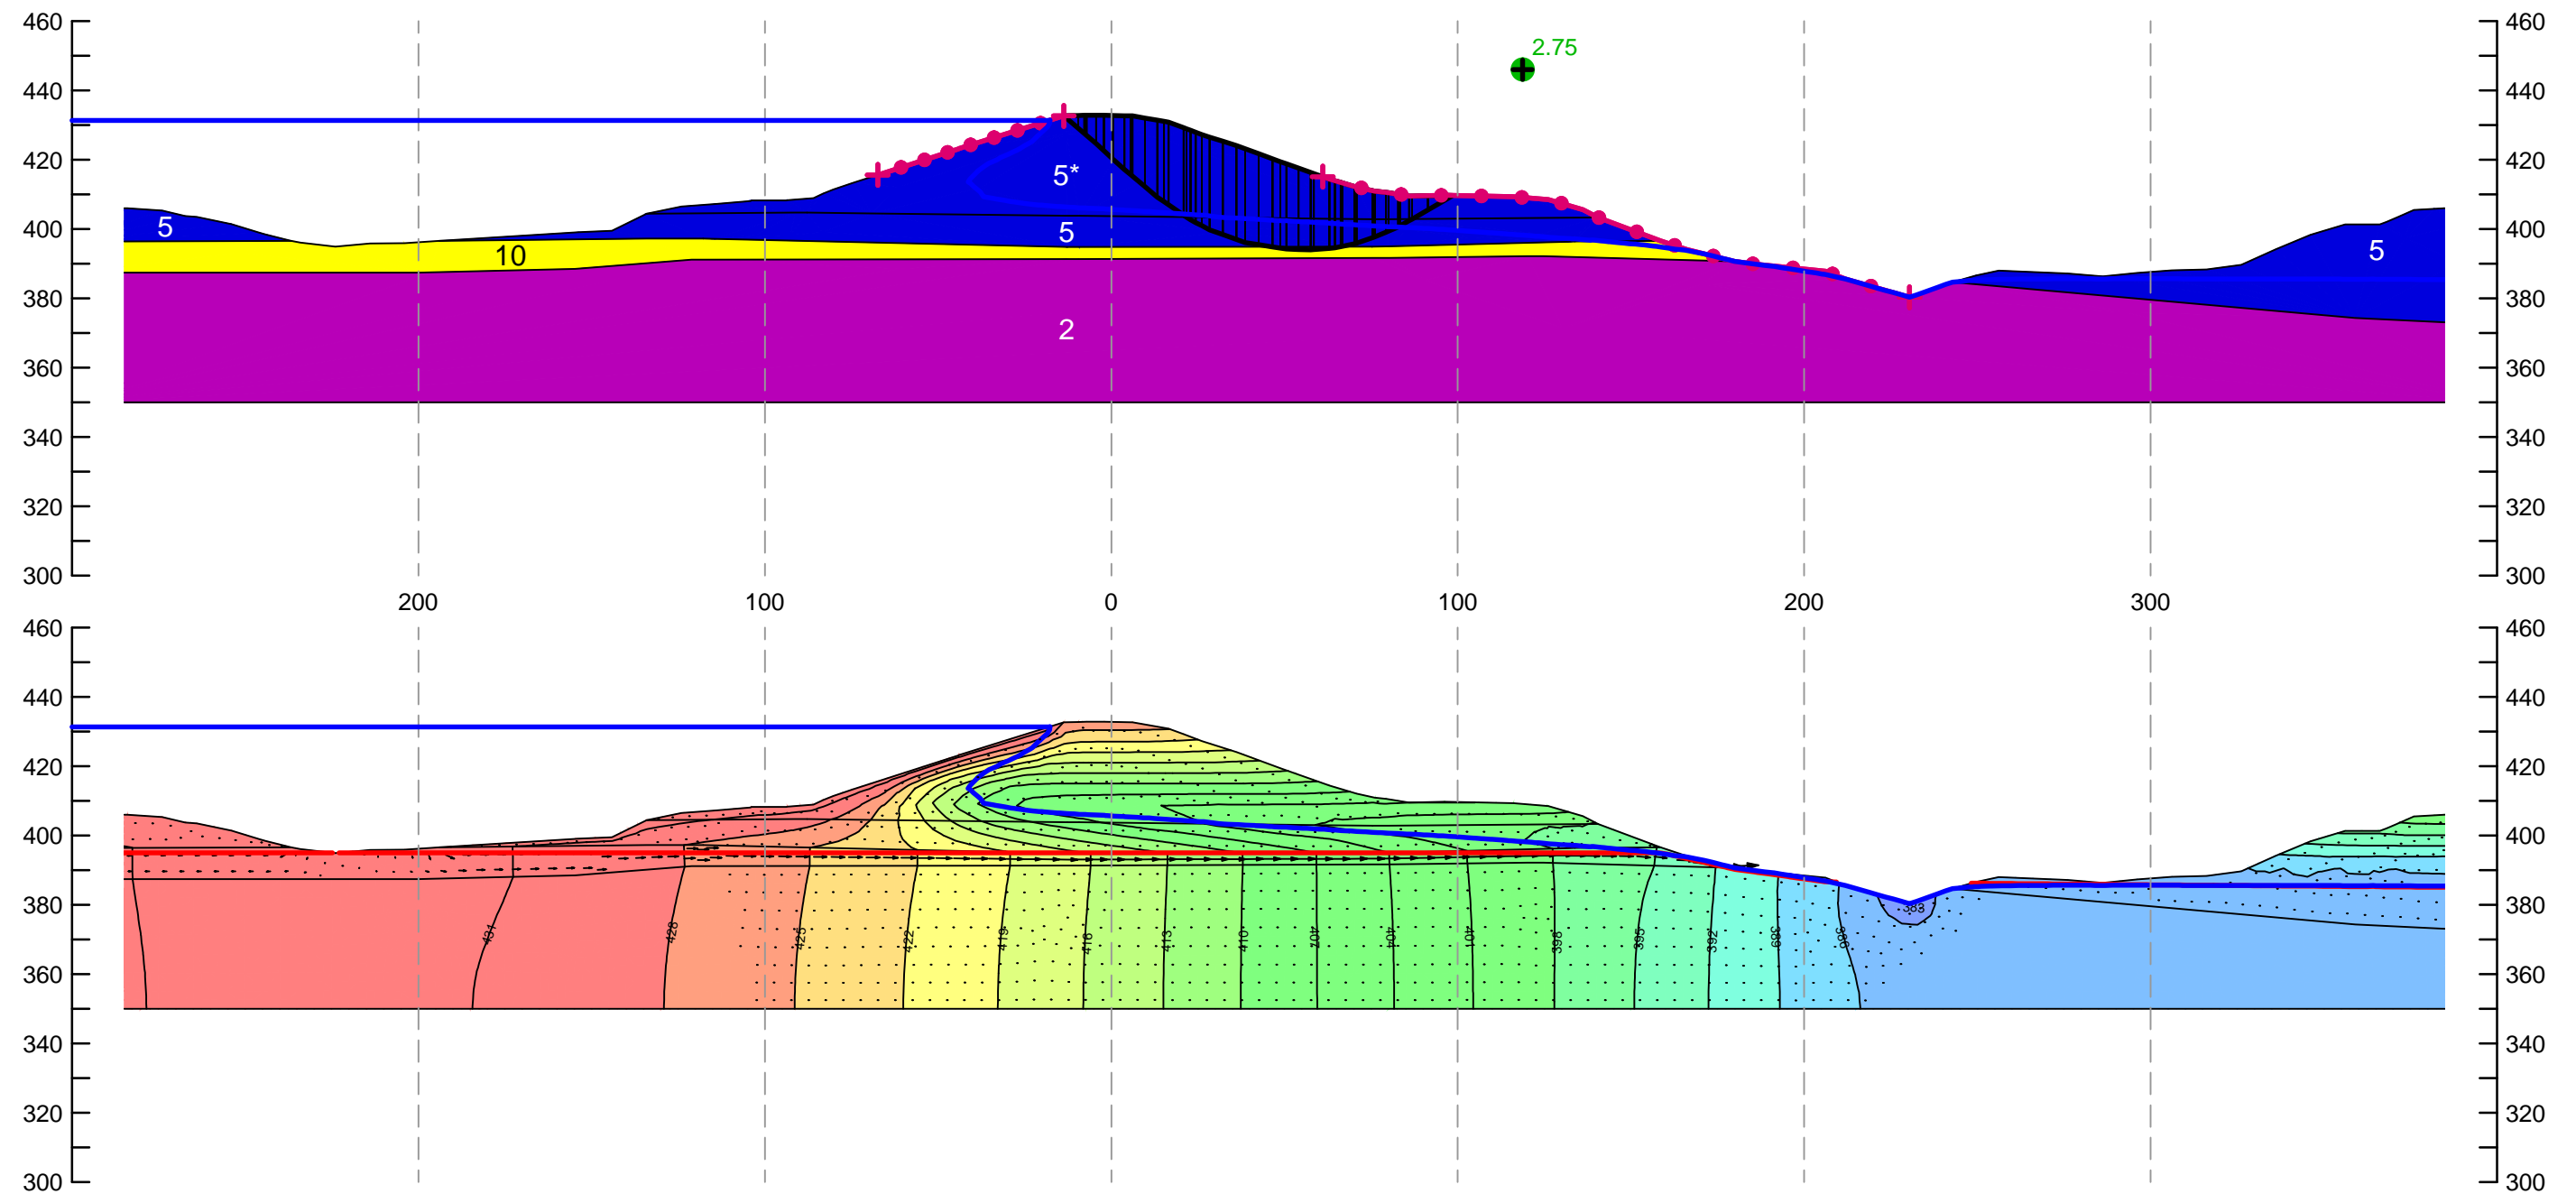
3

EAST LEVEE STA 311+00

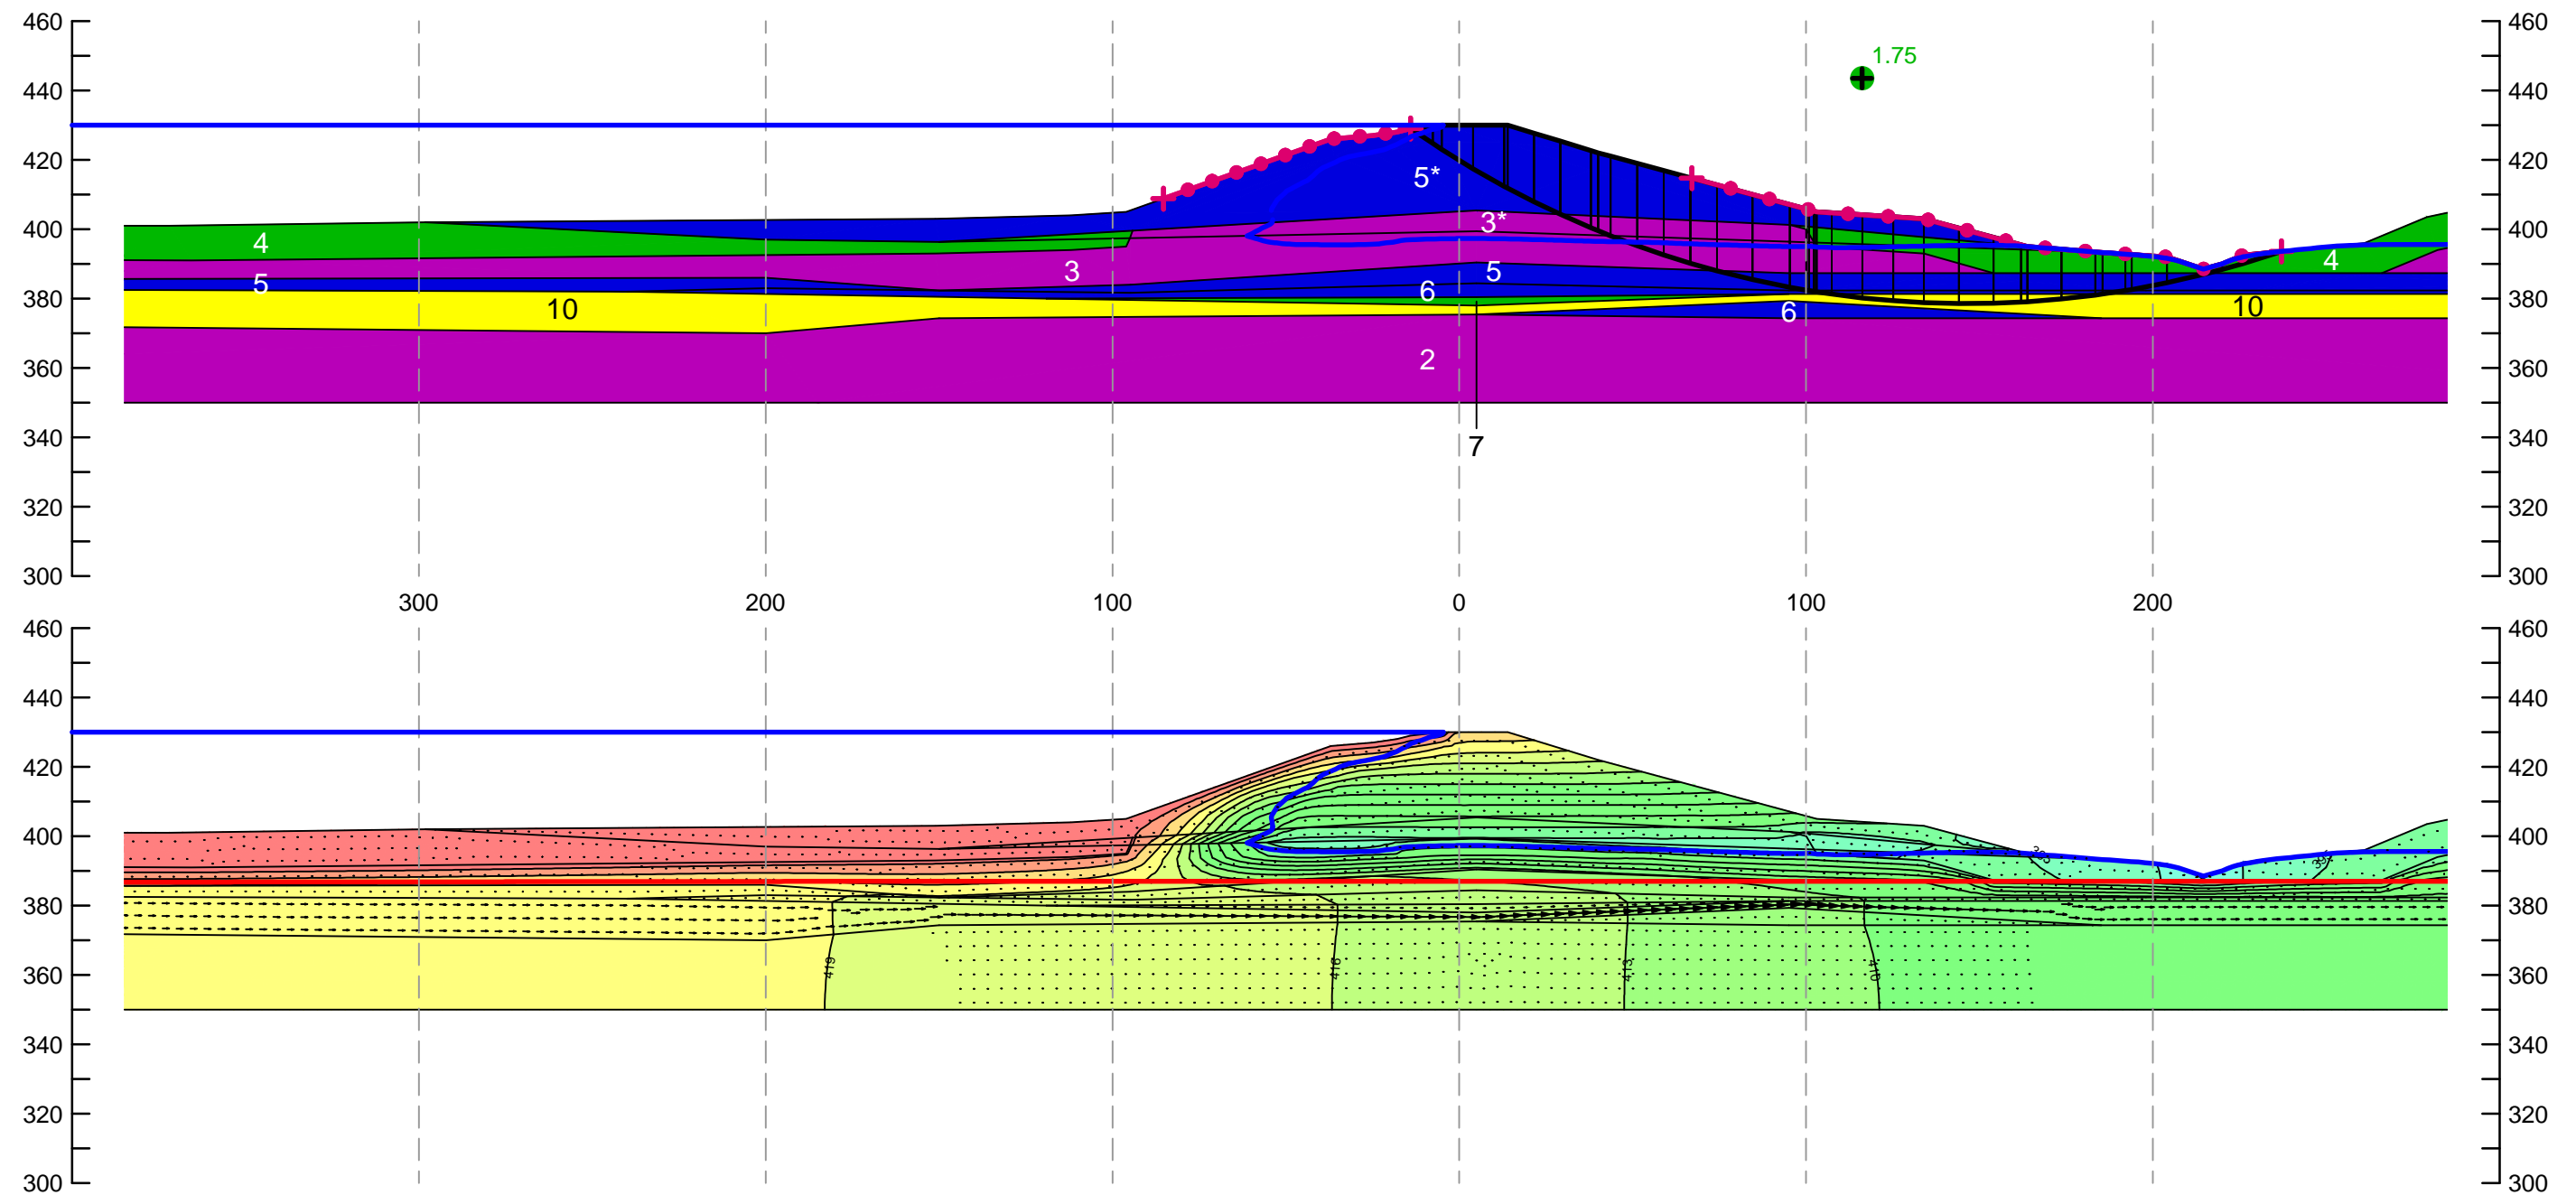
2

EAST LEVEE STA 220+00

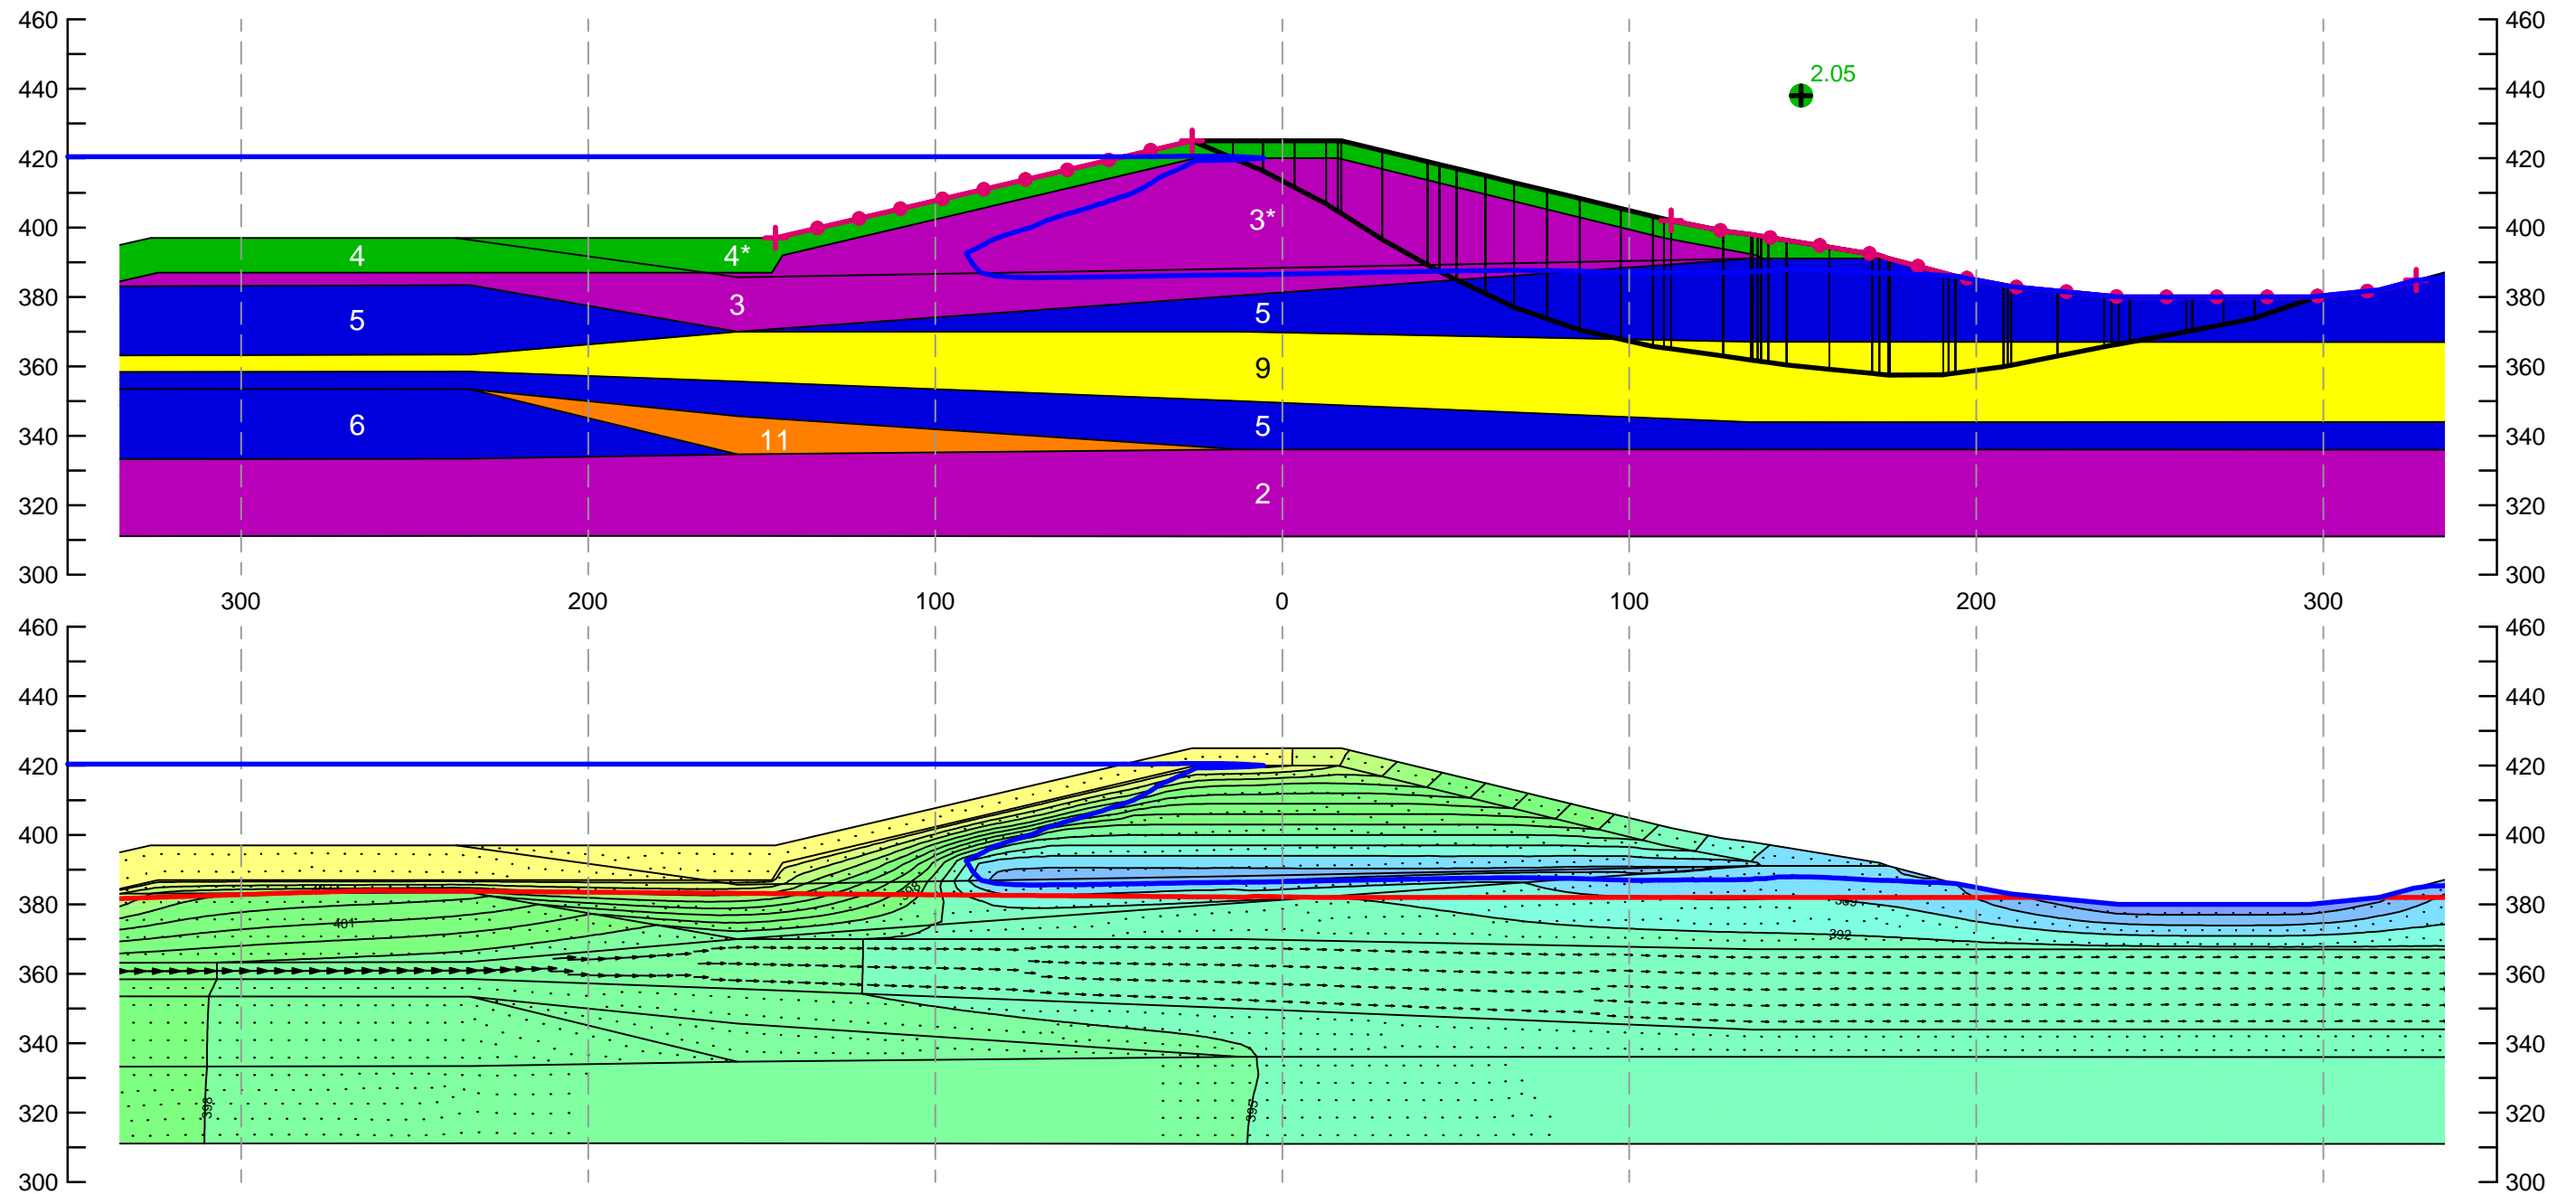
1

EAST LEVEE STA 74+00

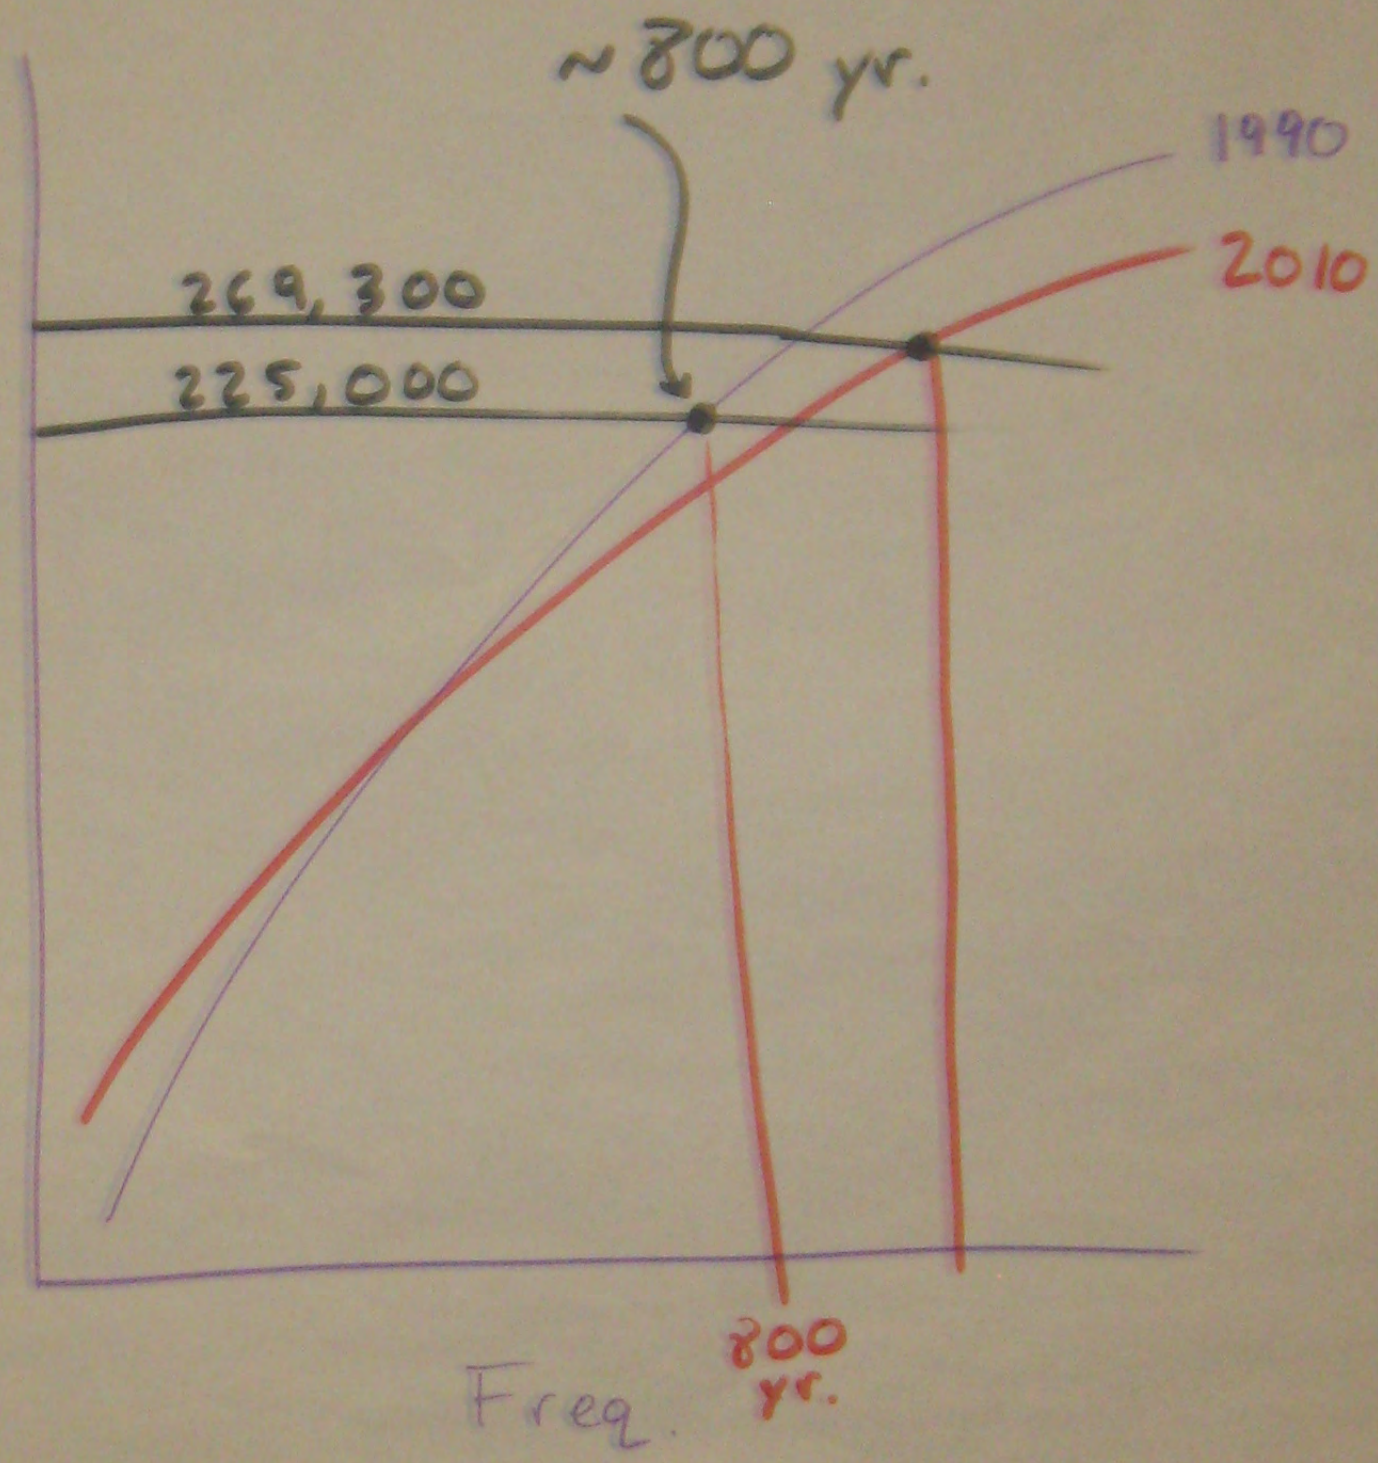
DALLAS FLOODWAY - PFM #2 - OVERTOPPING, LEVEE EROSION BREACH

- MULTIPLE LOCATIONS WILL BE LIKELY OVERLAP
- JOHNSON GRASS SLOPE COVER MORE "CLUMPY", * COULD BE "NICK" POINT
- DESICCATION CRACKING NEAR D/S CREST COULD BE "NICK" POINT
- COULD HAVE MORE ERODIBLE MATERIAL AT SURFACE
- DEBRIS BLOCKAGE AT BRIDGES COULD EXACERBATE
- WIND-INDUCED WAVES COULD EXACERBATE

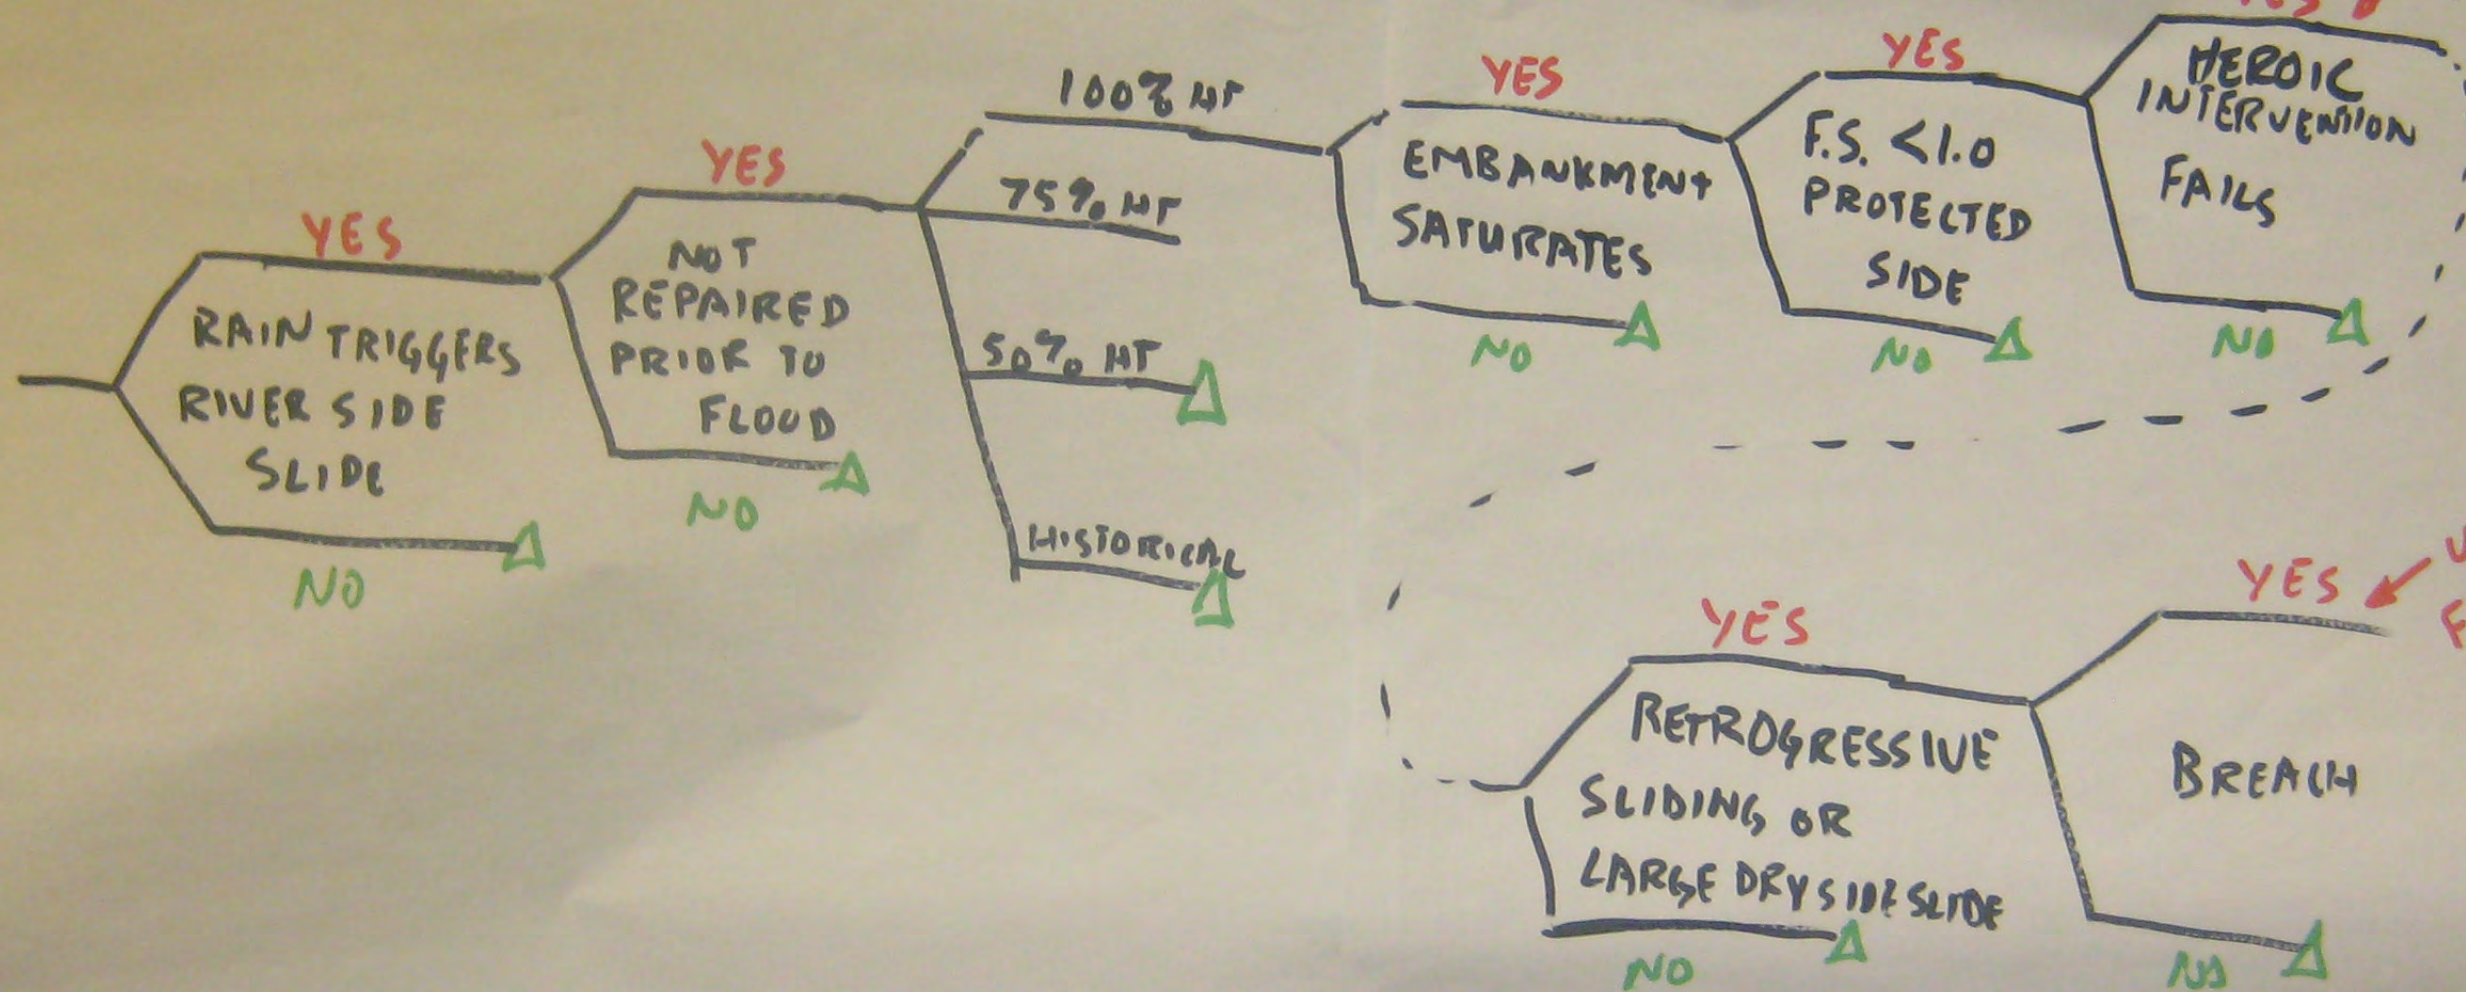
DALLAS FLOODWAY - DFM 13A - GLOBAL INSTABILITY - PROGRESSIVE SLIDING

RATIONALE: HIGH PERMEABILITIES NEEDED
TO GET SATURATION SEEM UNLIKELY GIVEN
GOOD PERFORMANCE AND TENDENCY FOR CRACKS TO
CLOSE - BUT UNCERTAINTY WITH CONDITION
OF 1930'S EMBANKMENT MATERIAL

- ENVIRONMENT WHERE CH MATERIAL PRONE TO DESICCATION
- 1930'S EMBANKMENT EXPOSED PRIOR TO 1950'S CONSTRUCTION
- COULD SATURATE DISSLOPE TO DEPTH OF OPEN CRACKS ON PROTECTED SIDE

- SEEPAGE ANALYSES INDICATE EMBANKMENT WON'T SATURATE WITH UNDISTURBED CH K VALUES
- CRACKS TEND TO CLOSE ON WETTING
- CRACKS TEND TO CLOSE ON LOADING FROM OVERLYING 1950'S EMBANKMENT CONSTRUCTION
- BAD 1930'S & 1950'S MATERIAL WOULD NEED TO OCCUR AT SAME LOCATION
- UNLIKELY CRACKS WOULD BE FILLED W/ HIGH PERM MATERIAL.
