APPENDIX C
BASE CONDITION RISK ASSESSMENT

PART I
RISK ASSESSMENT
TRINITY RIVER CORRIDOR

Trinity River Corridor Dallas Floodway near Dallas, TX

7 September 2012

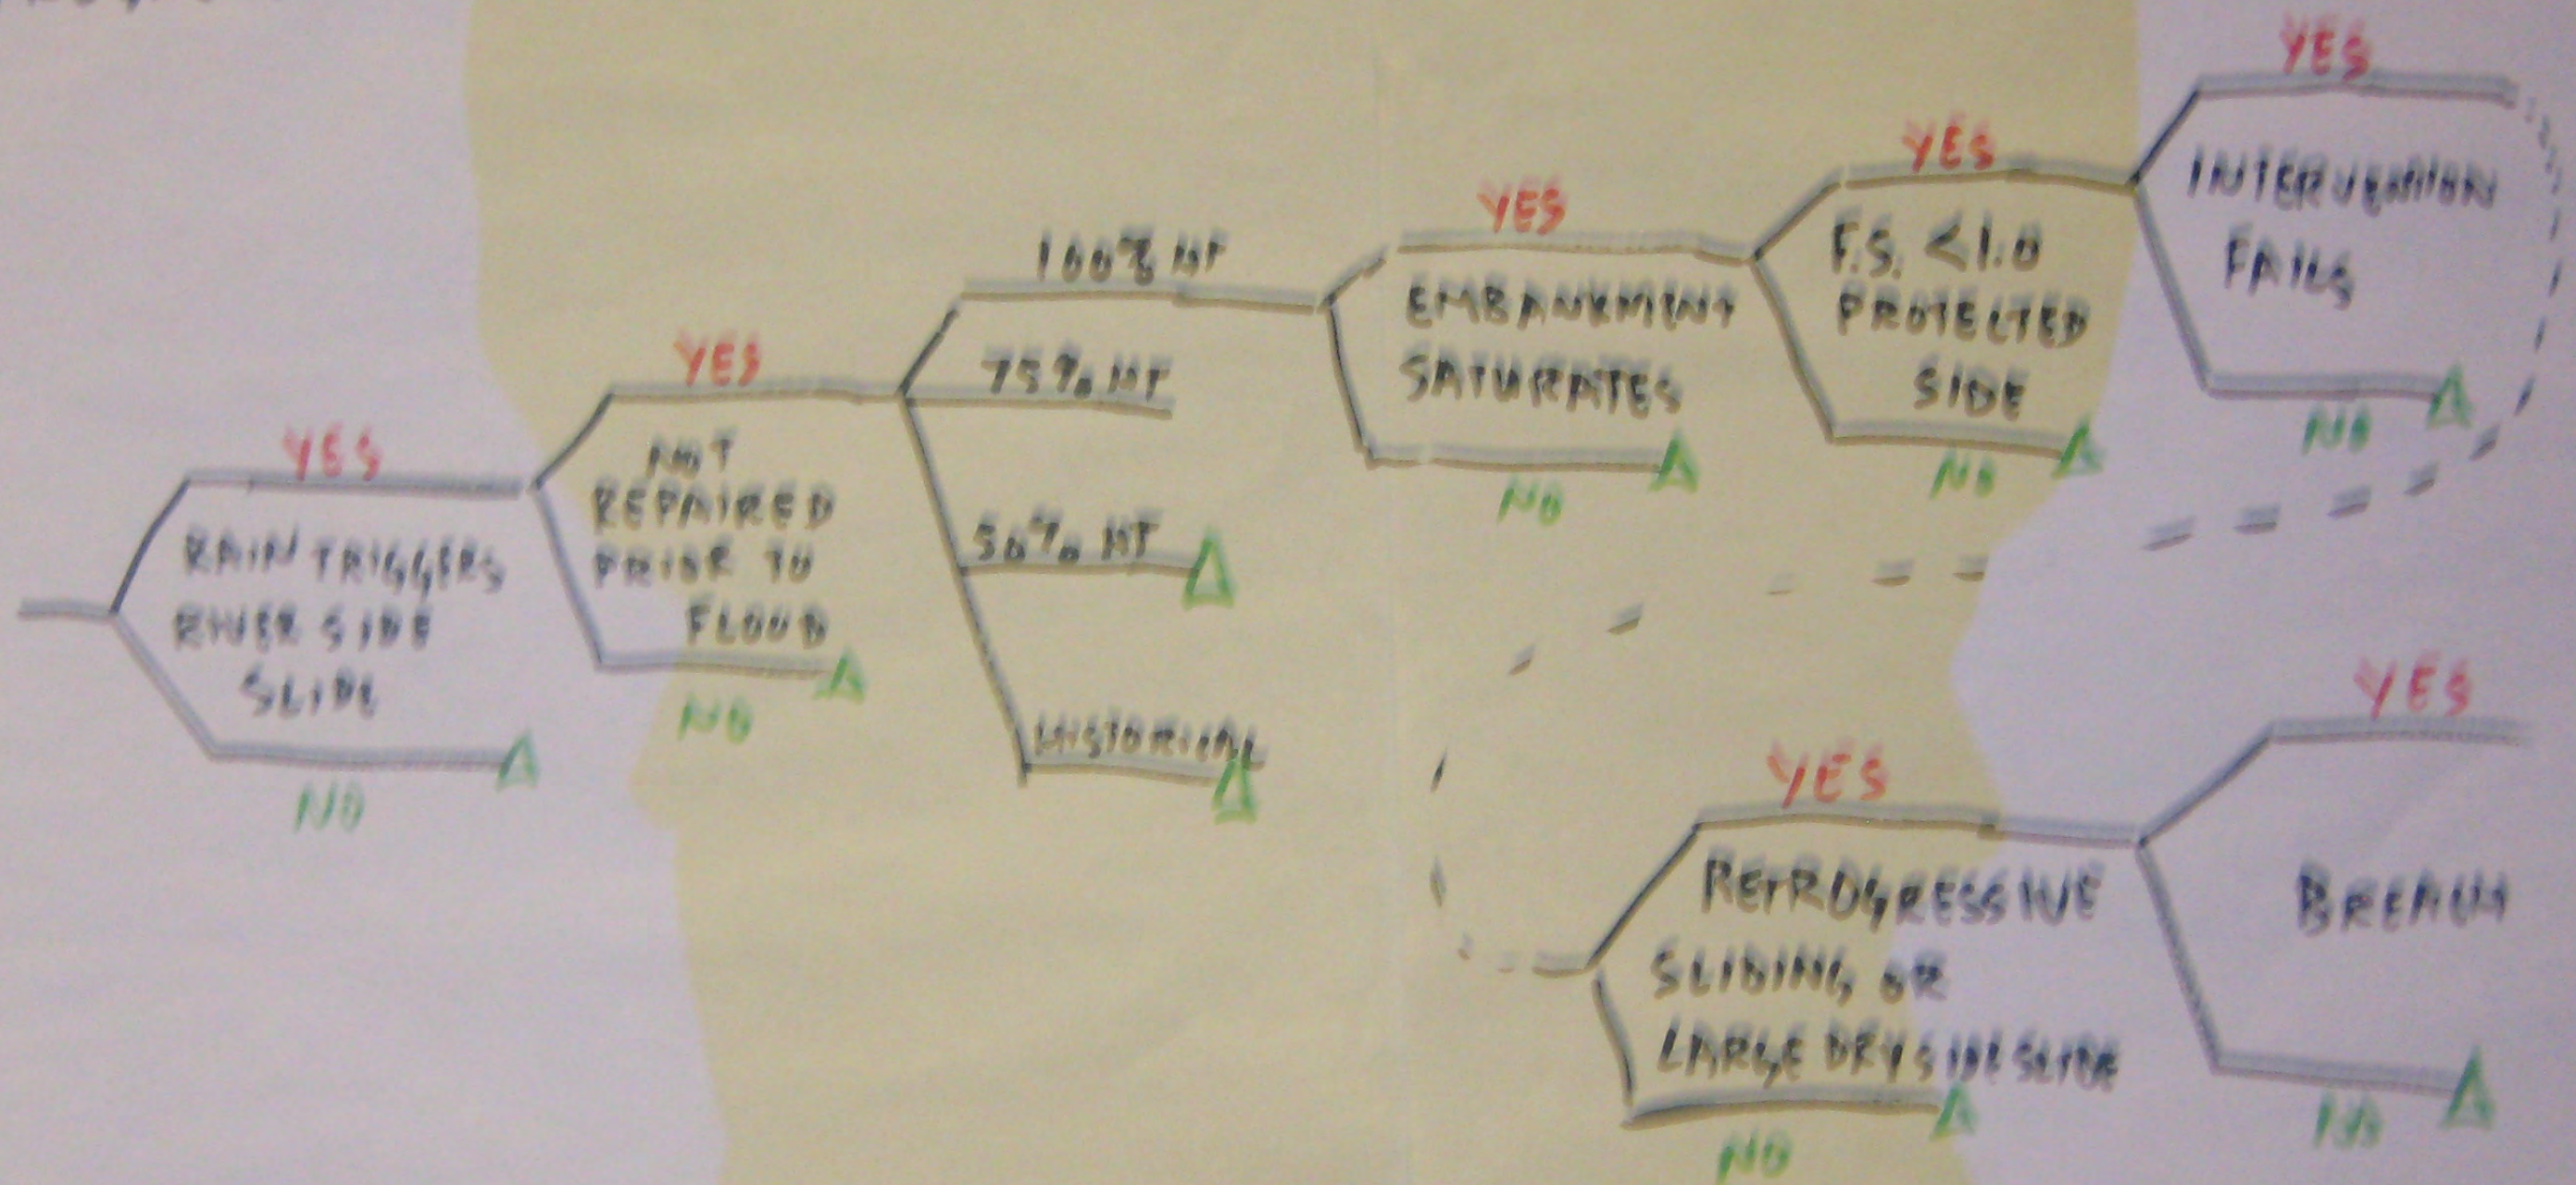
DALLAS FLOODWAY - DFM 13A - GLOBAL INSTABILITY - PROGRESSIVE SLIDING

- ONLY ONCE HAD SLIDES BOTH SIDES AT SAME TIME, BUT THEY WERE NEAR TOE OF LEVEE
- ~~ABOUT 11% CHANCE OF HAVING SLIDES IN ANY GIVEN YEAR INCLUDING ALL TYPES OF SLIDES~~
- 310 SLIDES 50-YR OBSERVATION
- 2006 DROUGHT - FOLLOWING ^{5-10-YR} RAIN EVENT → 20 SLIDES
- DESICCATION CRACKING HAS BEEN OBSERVED ON LEVEE CREST
- HISTORICAL SLIDES DOWNSLOPE FROM CREST
- SKARPS TYPICALLY 4'-6' HIGH - SLIDE DEPTHS ~ 8'
- SOME SLIDES DEEPER

- MODELED FAILURE SURFACES INTERSECT RIVER LEVEL - WON'T TAKE MUCH MOVEMENT TO LOSE FREEBOARD
- WOULD TAKE A MAJOR EFFORT TO DEAL WITH THIS SITUATION
- SAFETY ISSUE FOR FLOOD FIGHTERS
- RARE TO SEE CRACKS BEFORE SLIDES ON OTHER LEVEES
- DUMPING MATERIAL ONTO SLIDE PROVIDES MORE DRIVING FORCE

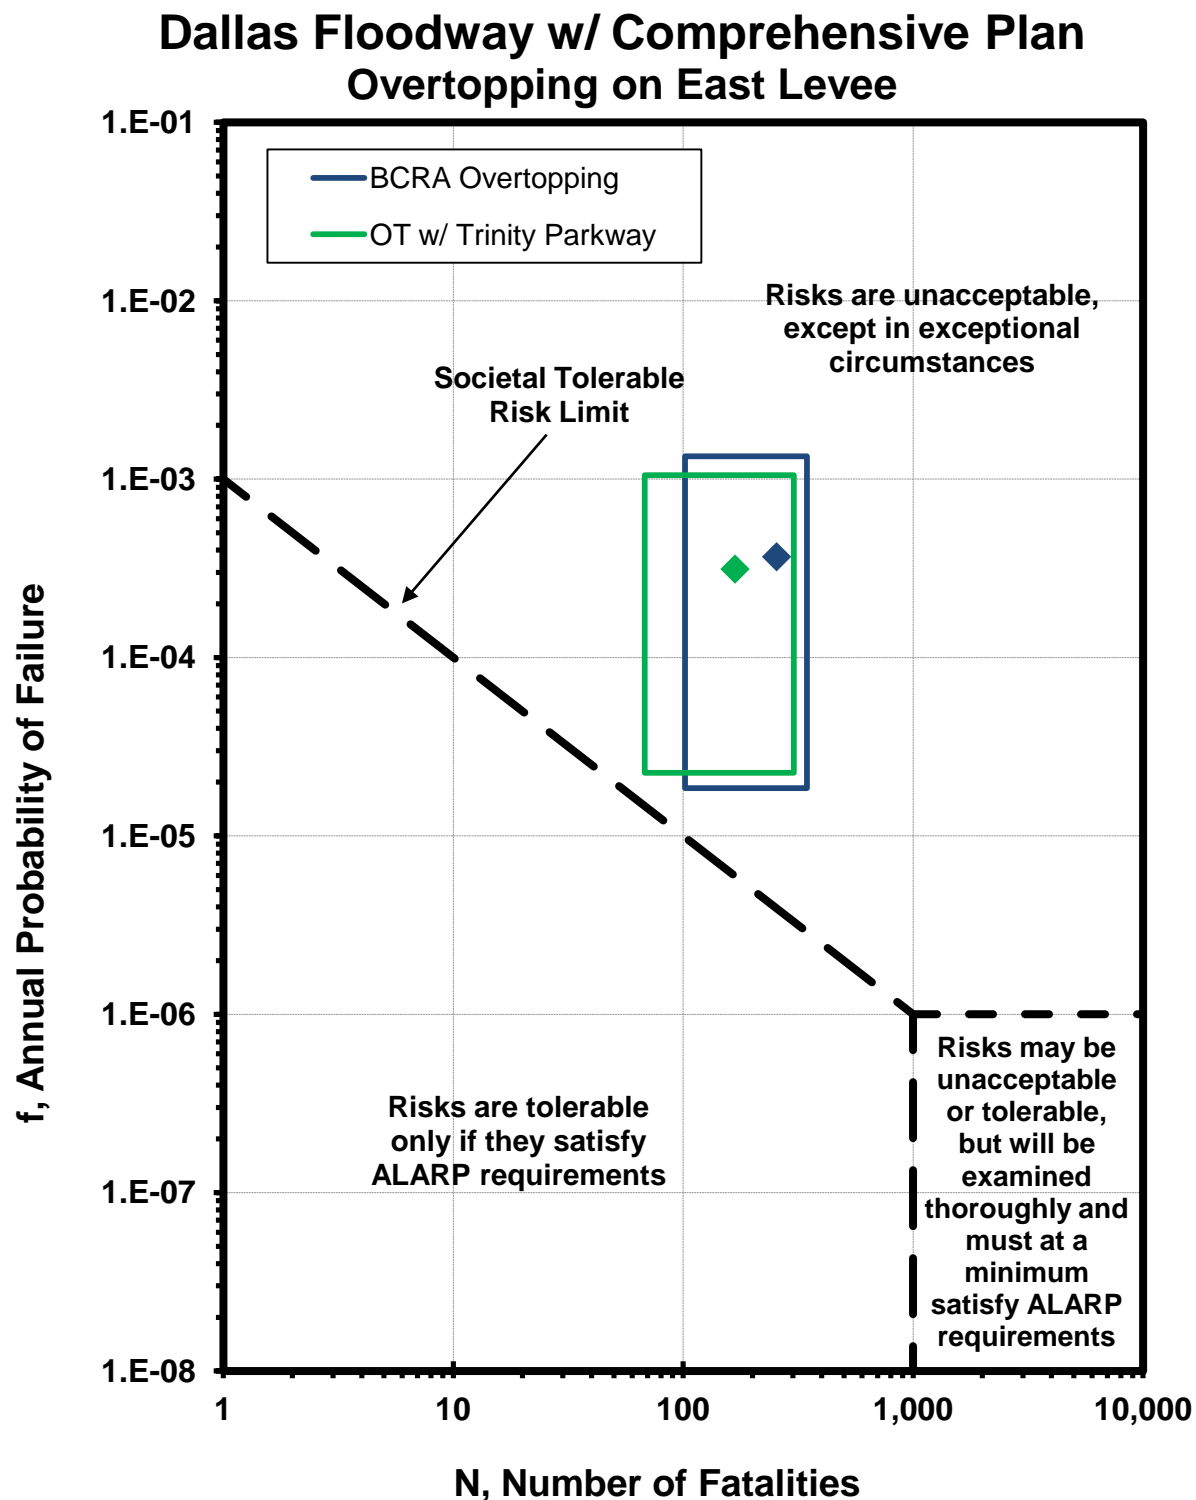
Figure 9. f-N plot for PFM 2, Overtopping, on the east levee alignment. Original BCRA and with-Trinity Parkway conditions shown.

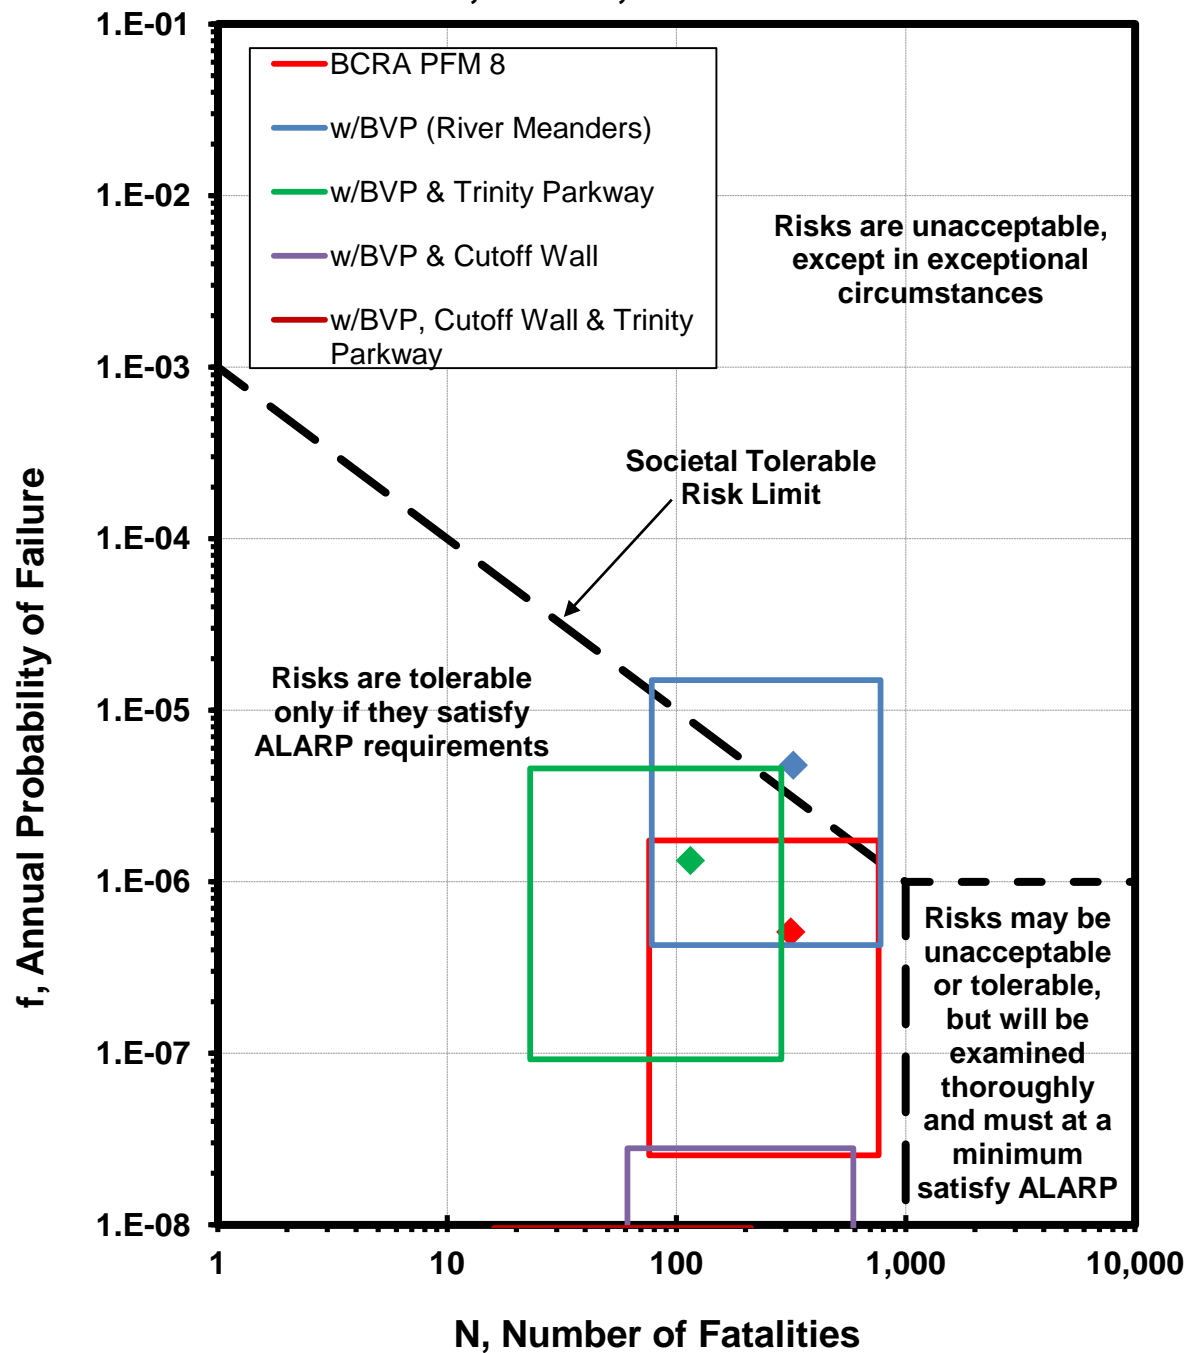
Dallas Floodway w/ Comprehensive Plan PFM 8, Heave, on East Levee

The f-N plot of PFM 8, heave on the east levee indicates the risk of failure increases above the tolerable risk guidelines with the placement of the river meanders in the Trinity River channel. However, placement of the roadway embankment decreases the risk to at or below guidelines, while the placement of a cutoff wall puts the estimated risk well below guidelines. Placement of both the cutoff wall and Trinity Parkway roadway embankment will, of course, lower the risk of failure even further.

Figure 10. f-N plot for PFM 8, Heave, on the east levee alignment. Shown are the (1) original BCRA condition, (2) with BVP (river meanders) in place, (3) with BVP and Trinity Parkway, and (4) with BVP and cutoff wall. The risk of Heave occurring with the BVP, cutoff wall, and Trinity Parkway in place is below $1\text{E-}8$ and is not shown on the graph.

The ability of the Dallas Floodway to reduce the risk of flooding the leveed area will be negatively impacted by implementation of the BVP in the area of Continental Avenue to Station 285+00. As a result, the RMC recommends that the existing cutoff wall be extended or an equivalent risk reduction alternative be implemented.
