**U. S. Army Corps
of Engineers
Fort Worth District**

**PLANNING DESIGN REPORT
AND
INTEGRATED ENVIRONMENTAL ASSESSMENT**

**WALNUT BRANCH SECTION 206
ECOSYSTEM RESTORATION PROJECT**

SEGUIN, GUADALUPE COUNTY, TEXAS

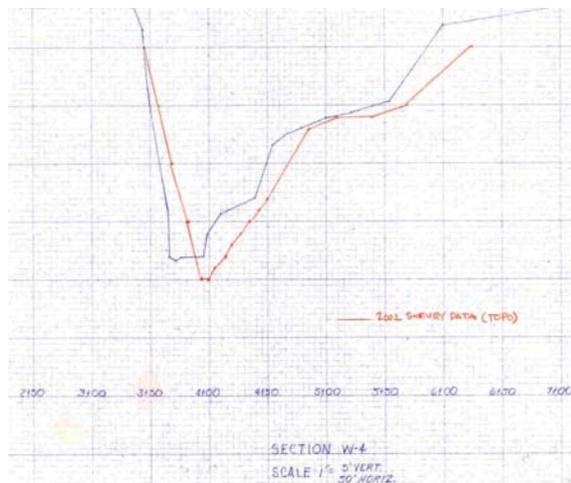
Cross-section plots

Given the uncertainty of the analysis, and the possible man-made alterations in the floodplain that could account for some of these observed changes in the cross-section geometry, these three plots indicate some erosion occurring the past 20+ years, but within reasonable limits given the time period and the frequency of floods.
