## APPENDIX B

### Geotechnical Report

The project area of the Upper Trinity Feasibility Study lies entirely within Dallas County, an area of low topographic relief. Located within the western part of the Gulf Coastal Plain near the northwestern limit of the East Texas Embayment, Dallas County is situated on the Black Prairie Belt, on the outcropping rocks of the Eagle Ford, Austin and Taylor Formations, (Figure 3-1 to Figure 3-3) which are three broad bands of Cretaceous rocks that are exposed on the surface within the county. These beds form the northern portion of the Gulf Coastal Plain, and strike nearly north and south with a gentle eastward dip. Within the project area, the Eagle Ford formation is overlain by alluvial flood plain deposits from the Trinity River, consisting of silt, sand and gravel. Additionally, residual soils derived from the Eagle Ford and Taylor Formations are present as high plasticity clays (Dallas Geological Society 1965).

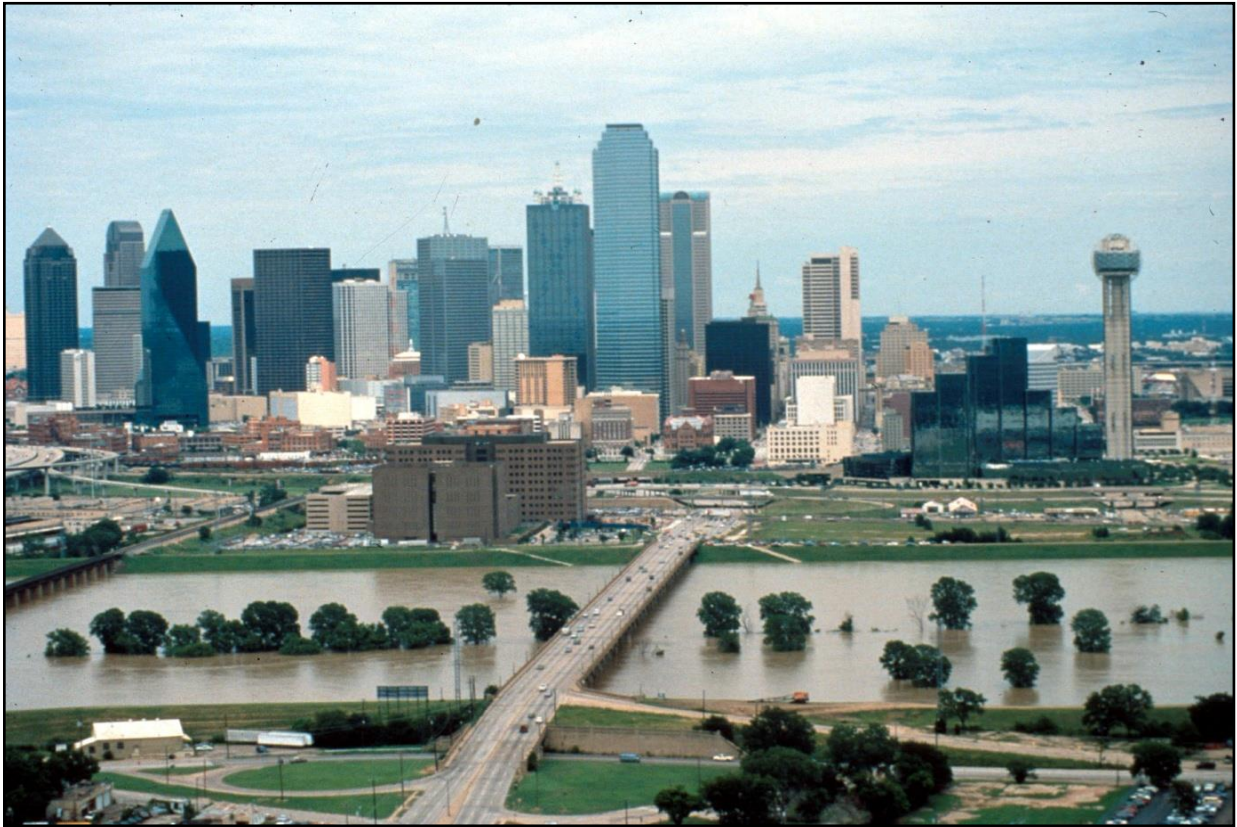
**Figure 7-4. 15 June 1989 Flood Event**

Figure 7-4 was taken on 15 June 1989 during a flood event that peaked at Elevation 409.6 on the Commerce Street gauge with a discharge of 43,000 cfs. A flood occurring a month earlier on 17 May 1989 peaked at Elevation 411.3 – a flood having an estimated frequency corresponding to a 15-year event. Although the water is high on the levee in this photo, it is still 20-feet below the design flood elevation of 429.4 (as measured at the Commerce Street gauge). Duration of flood events is also of significance when evaluating levee performance; however, stage hydrographs that show the retreat of floodwaters in hours or days are not indicative of the porewater pressures that exist within an embankment that has accommodated back-to-back floods or significant steady precipitation. After the back-to-back flood events in 1989, three slides required repair. Five slides requiring repair developed before and after the Pool of Record event in 1990. Two of the slides were discovered in January and the other three slides were discovered in July.
