## **APPENDIX B**

### **GEOTECHNICAL**

### Geotechnical Report

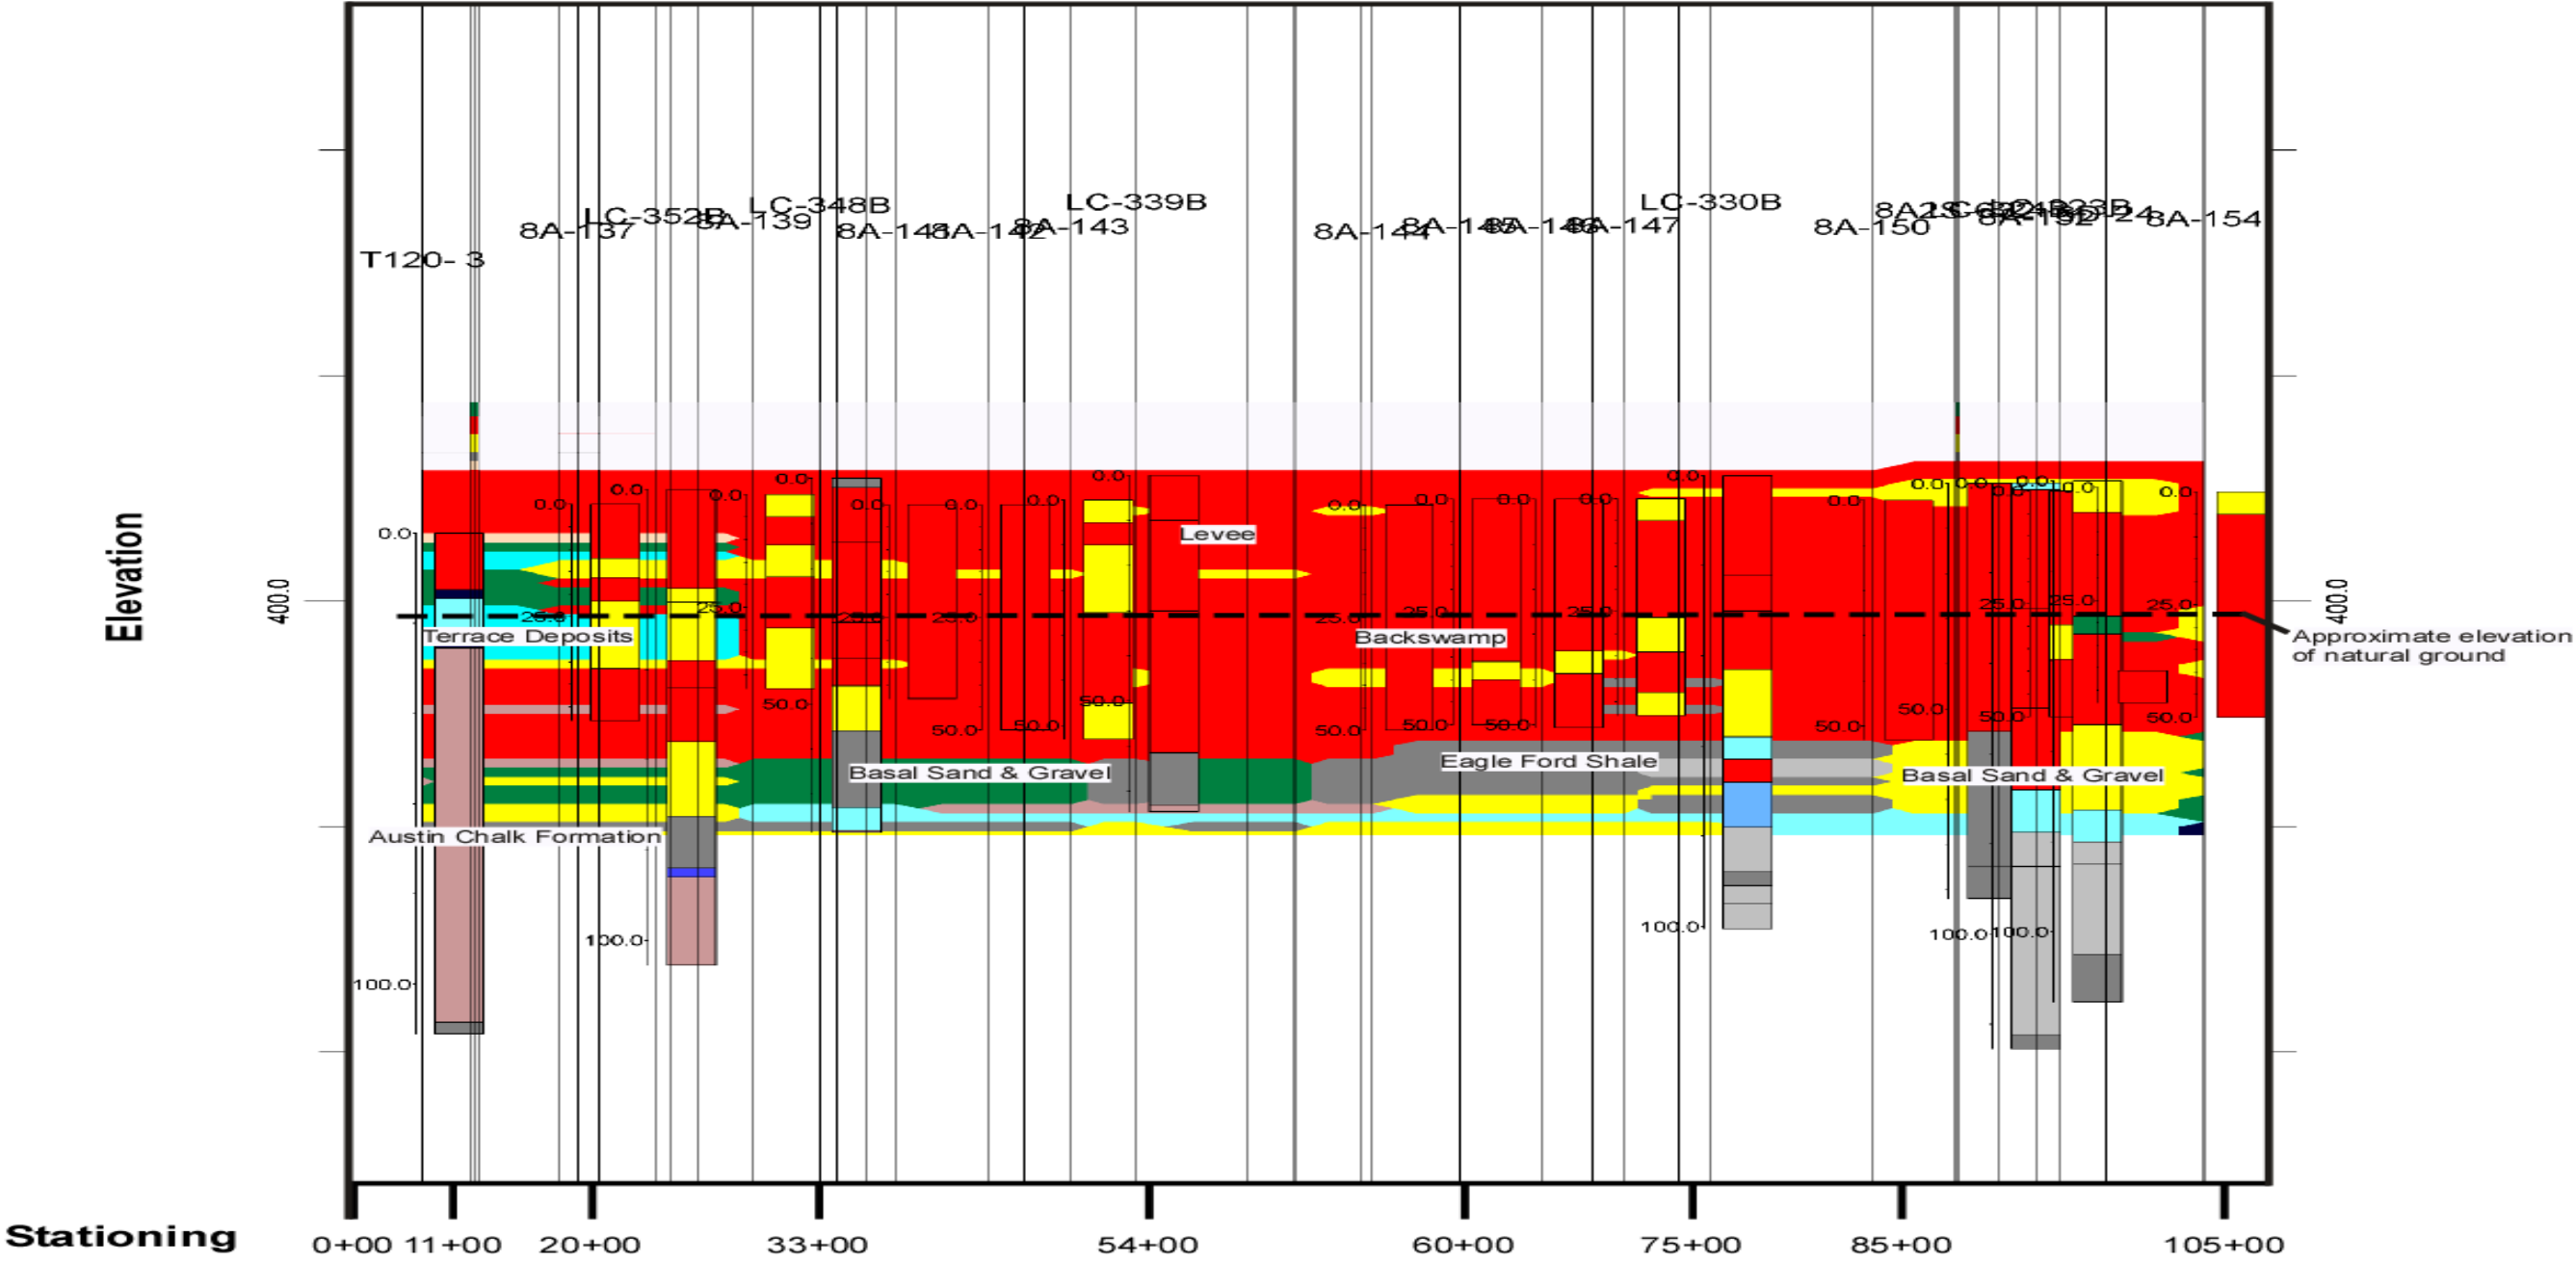
Figure 8-5. Reach 1 Geologic Cross-Section

The foundation for Reach 1 comprises a unique geologic setting relative to other reaches of the levee system. The levee in this area partially sits on the Austin Chalk Formation, and a mixture of the basal sands and gravels, and the Eagle Ford (Figure 8-5). Quaternary sediments in this area had been identified as terrace and backswamp deposits. Levees in this location are composed mostly of high plasticity clays.

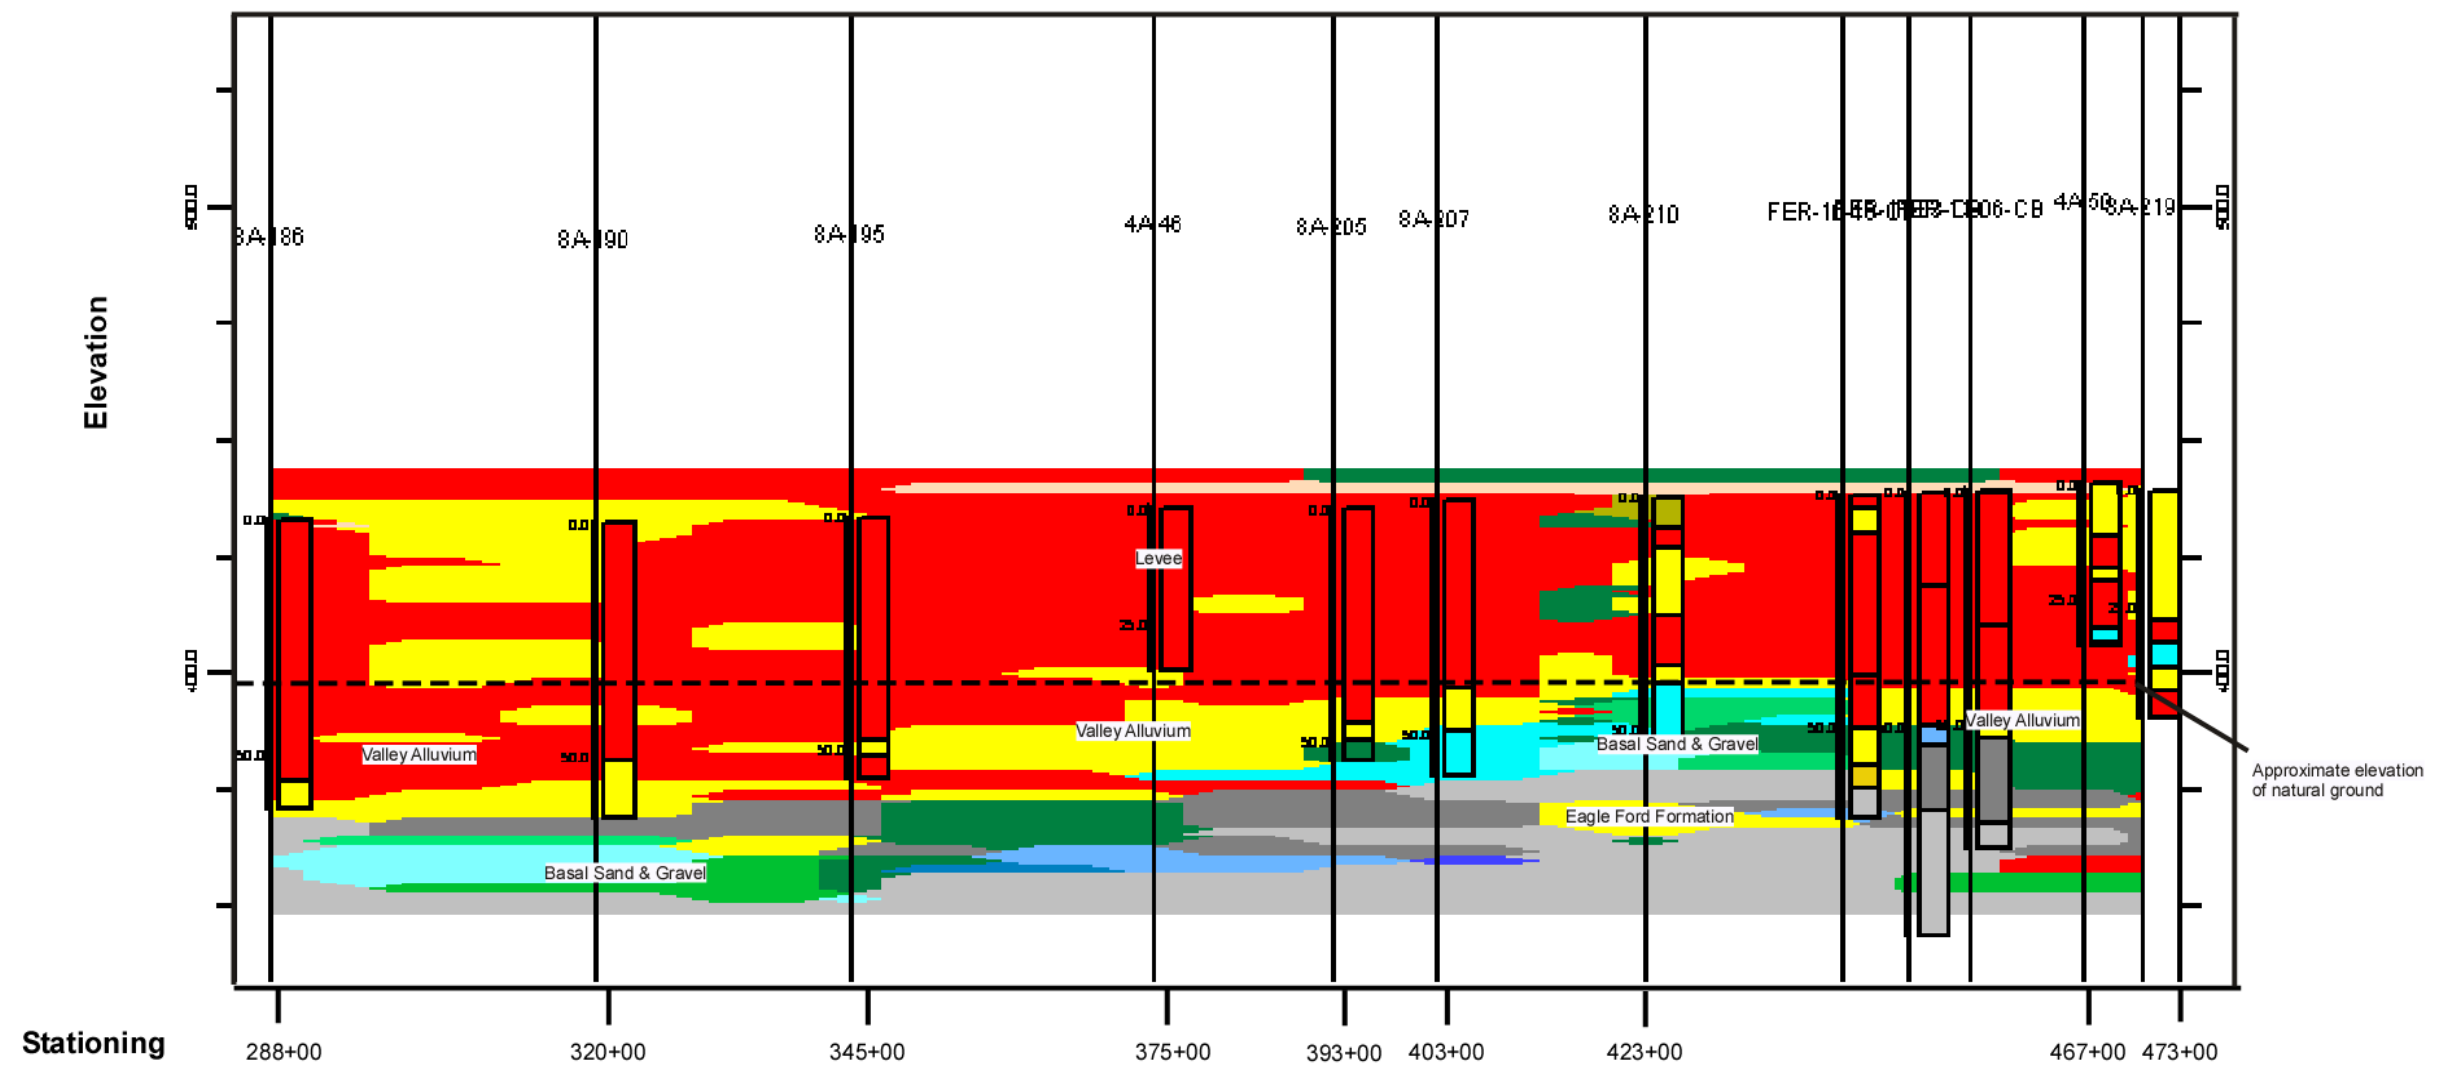
## Reach 4

**Figure 8-8. Reach 4 Geologic Cross-Section**

At Reach 4, the Eagle Ford in this area occurs in a topographic low (Figure 8-8). Overlain by an irregular shale surface, there is a continuous basal sand and gravel deposit, followed by undifferentiated alluvium deposits. This reach is characterized by a fairly thick sand and gravel layer (approximately 5-15 feet). Levees in this location are composed of sand lenses as well as CL soils. Levee composition is mostly high plasticity clay.

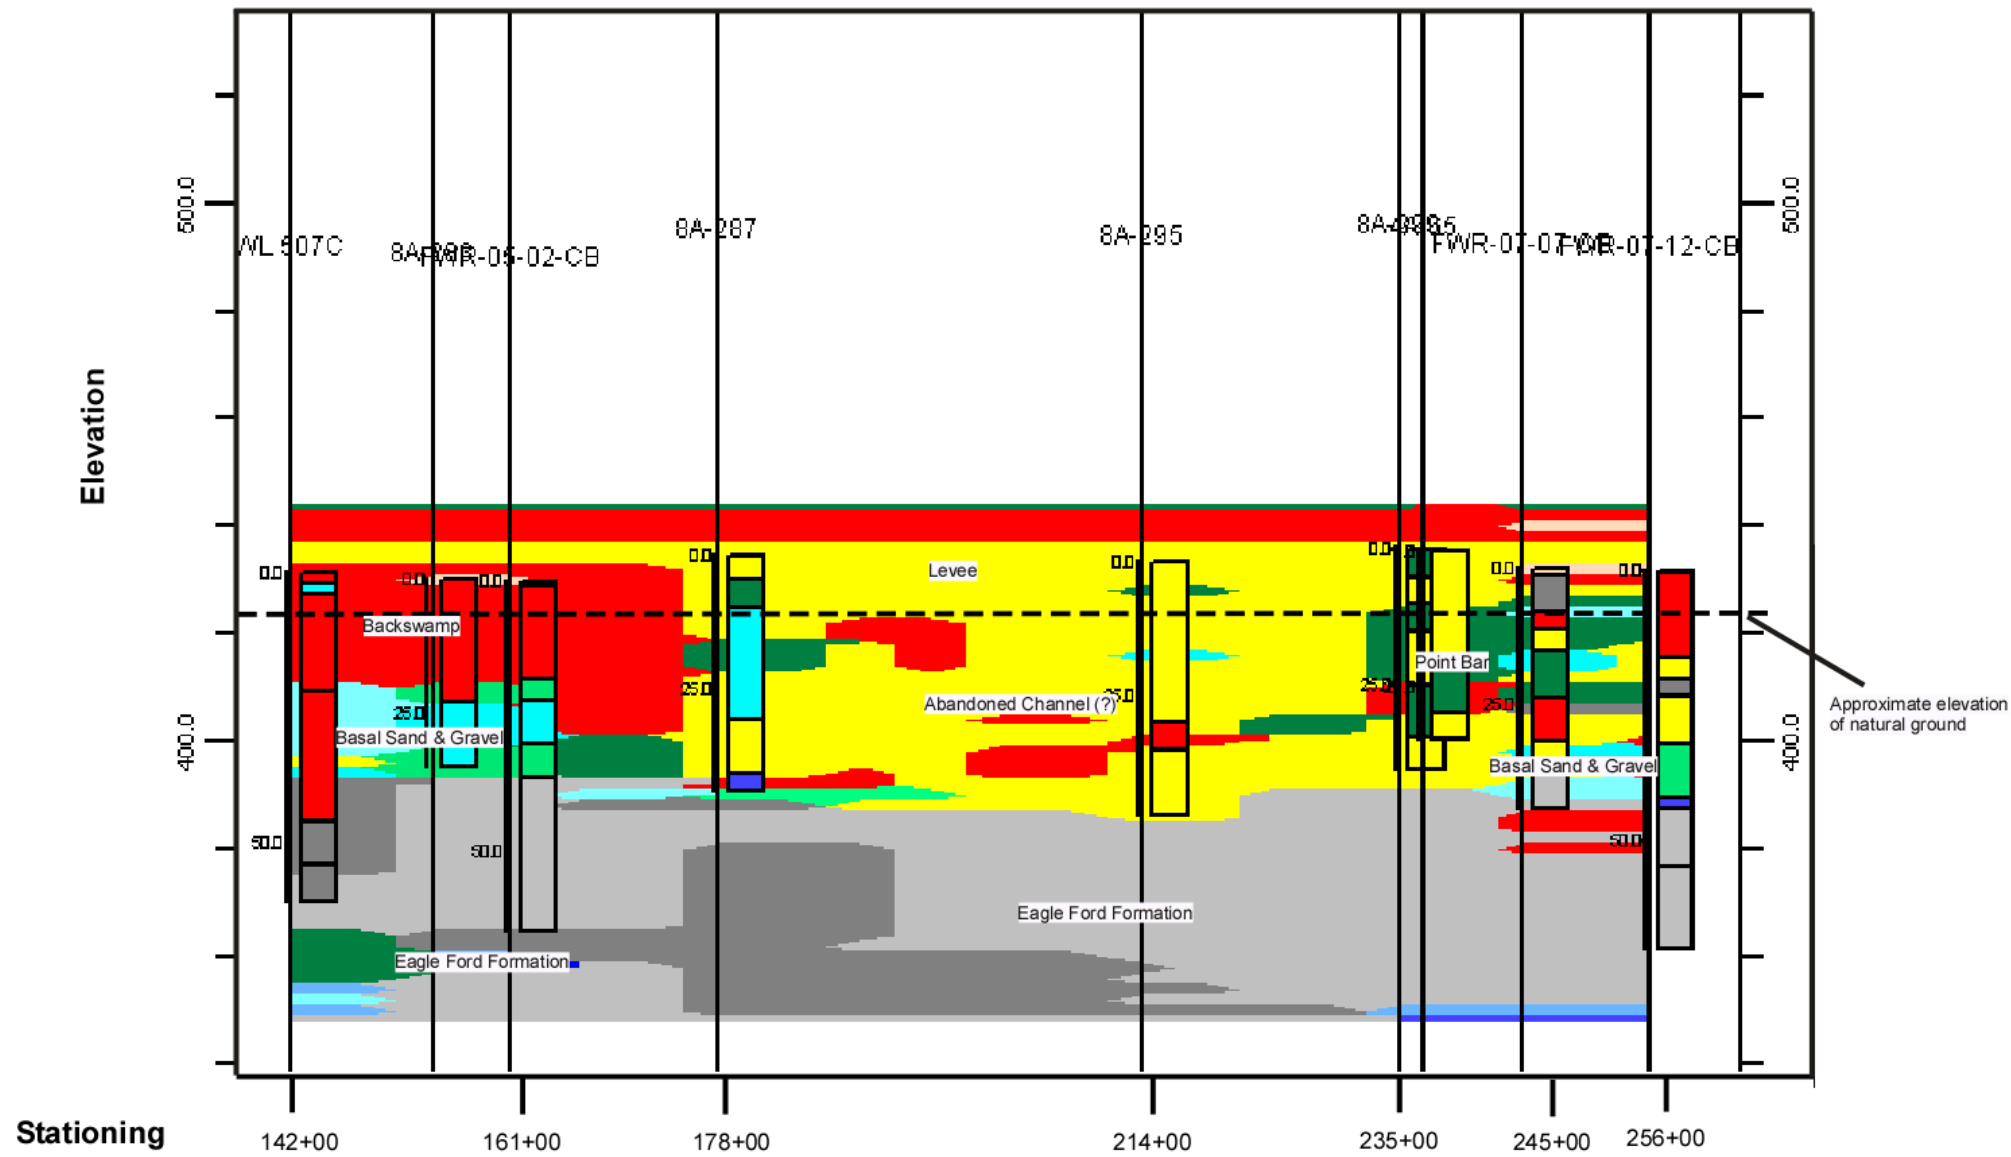
Figure 8-11. Reach 7 Geologic Cross-Section

Fairly thick and highly weathered Eagle Ford shale forms the bedrock for Reach 7 (Figure 8-11). Non-continuous basal sand and gravel deposits overlie the bedrock, followed by abandoned channel and point-bar deposits and backswamp. Levees within this location are mostly composed of lean clay.

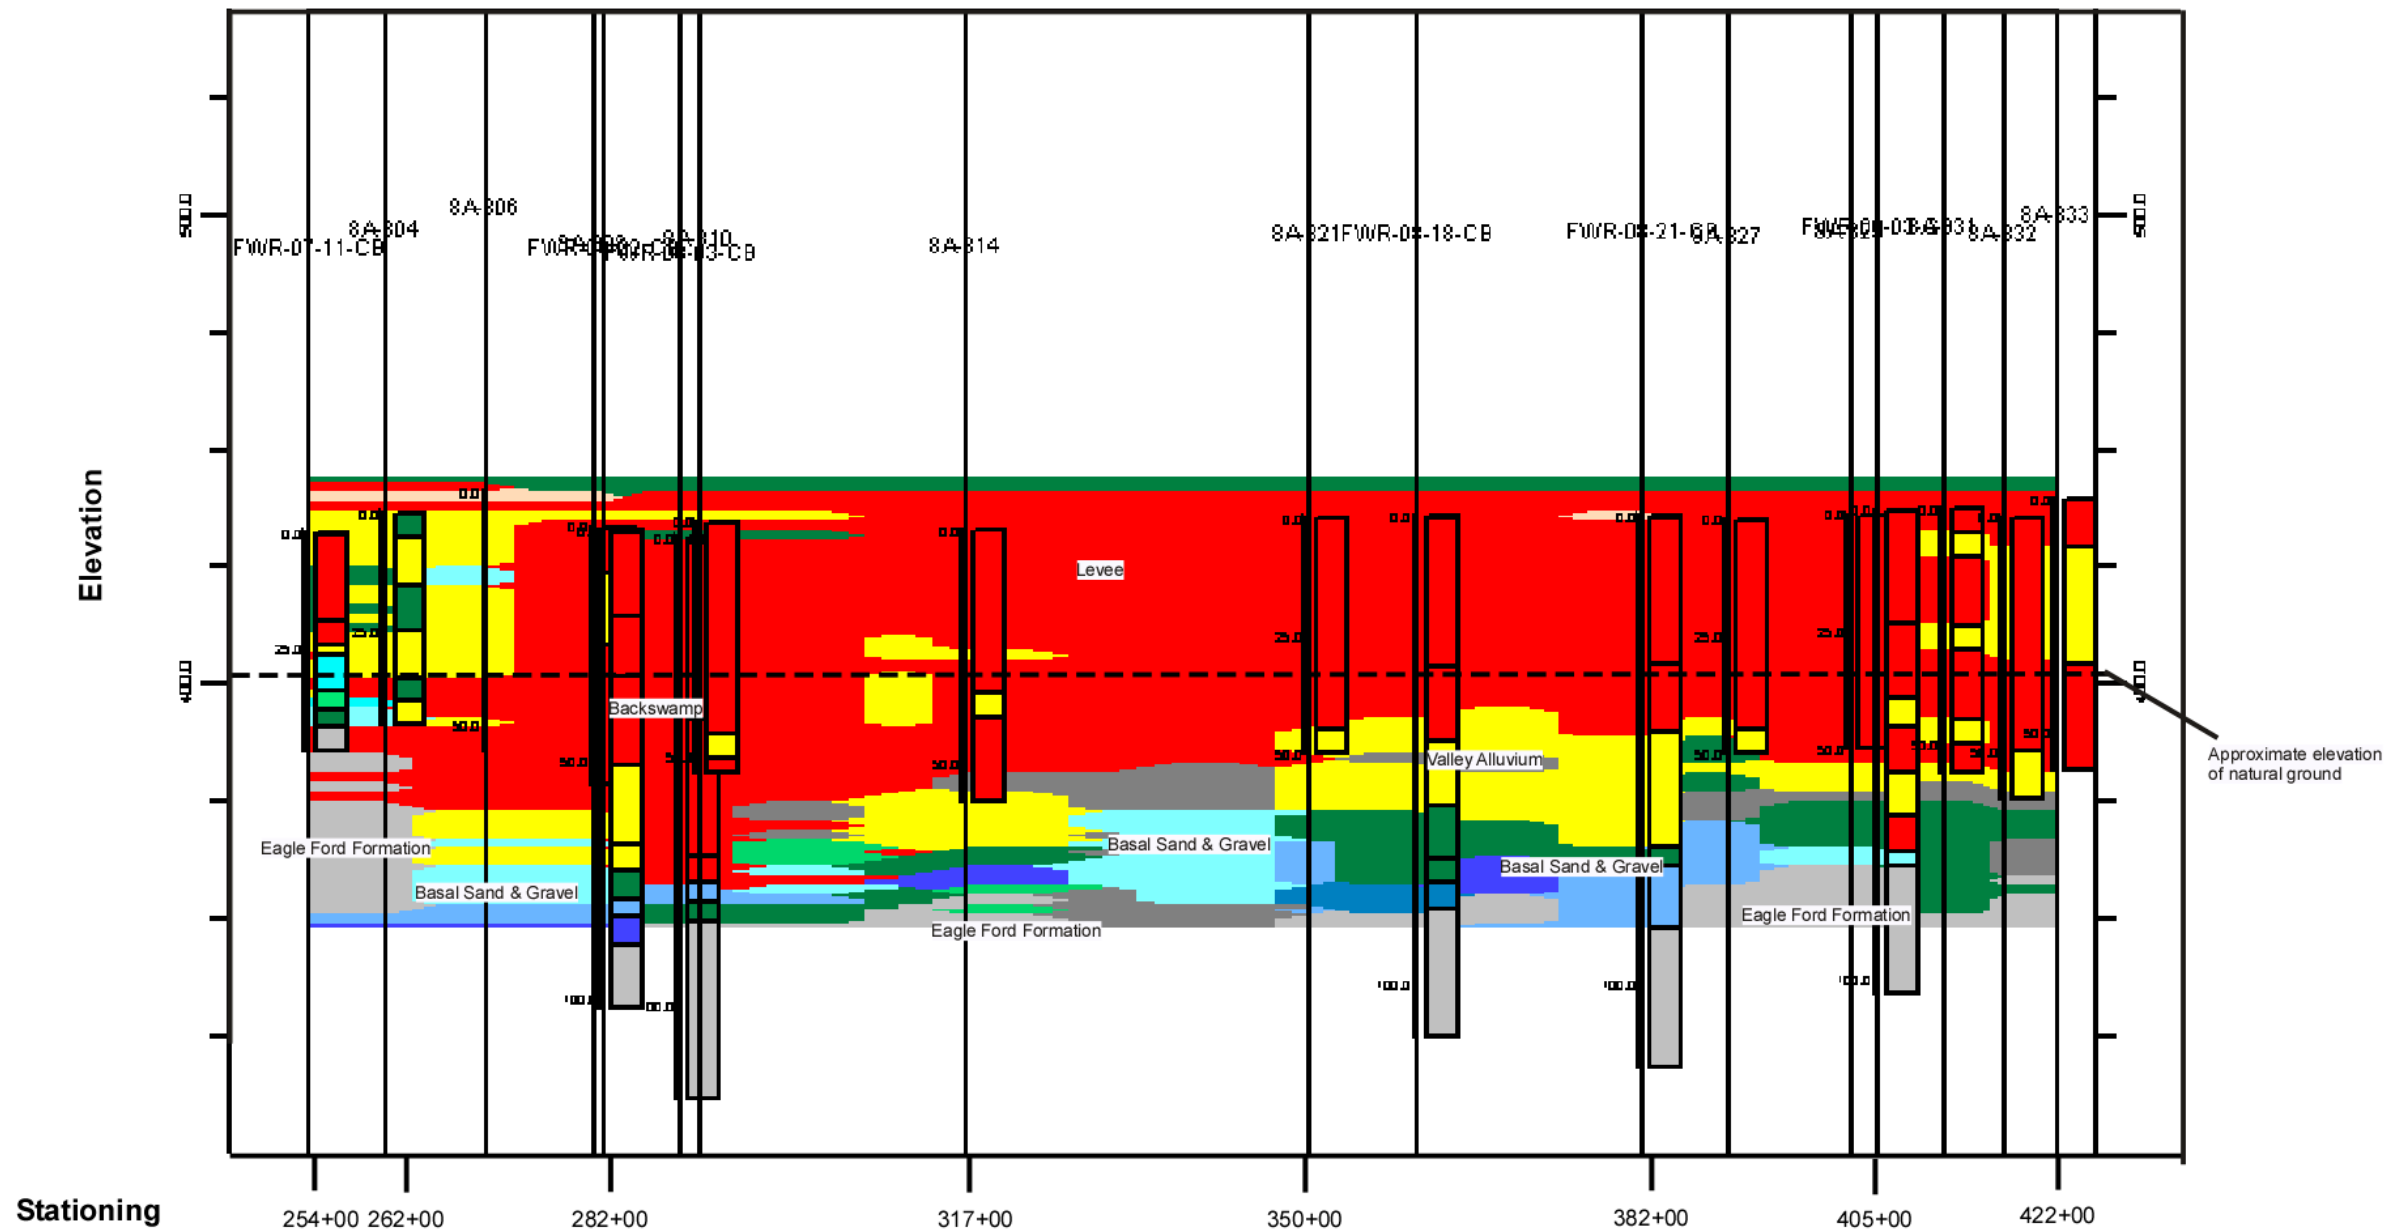
Figure 8-12. Reach 8 Geologic Cross-Section

A semi-continuous basal sand and gravel overlies irregular Eagle Ford shale at this location (Figure 1-12). Backswamp and undifferentiated alluvium deposits overlie the basal sand and gravel. Levees in the area are mostly composed of high-plasticity clay, with minor sand and lean clay lenses (Figure 8-12).

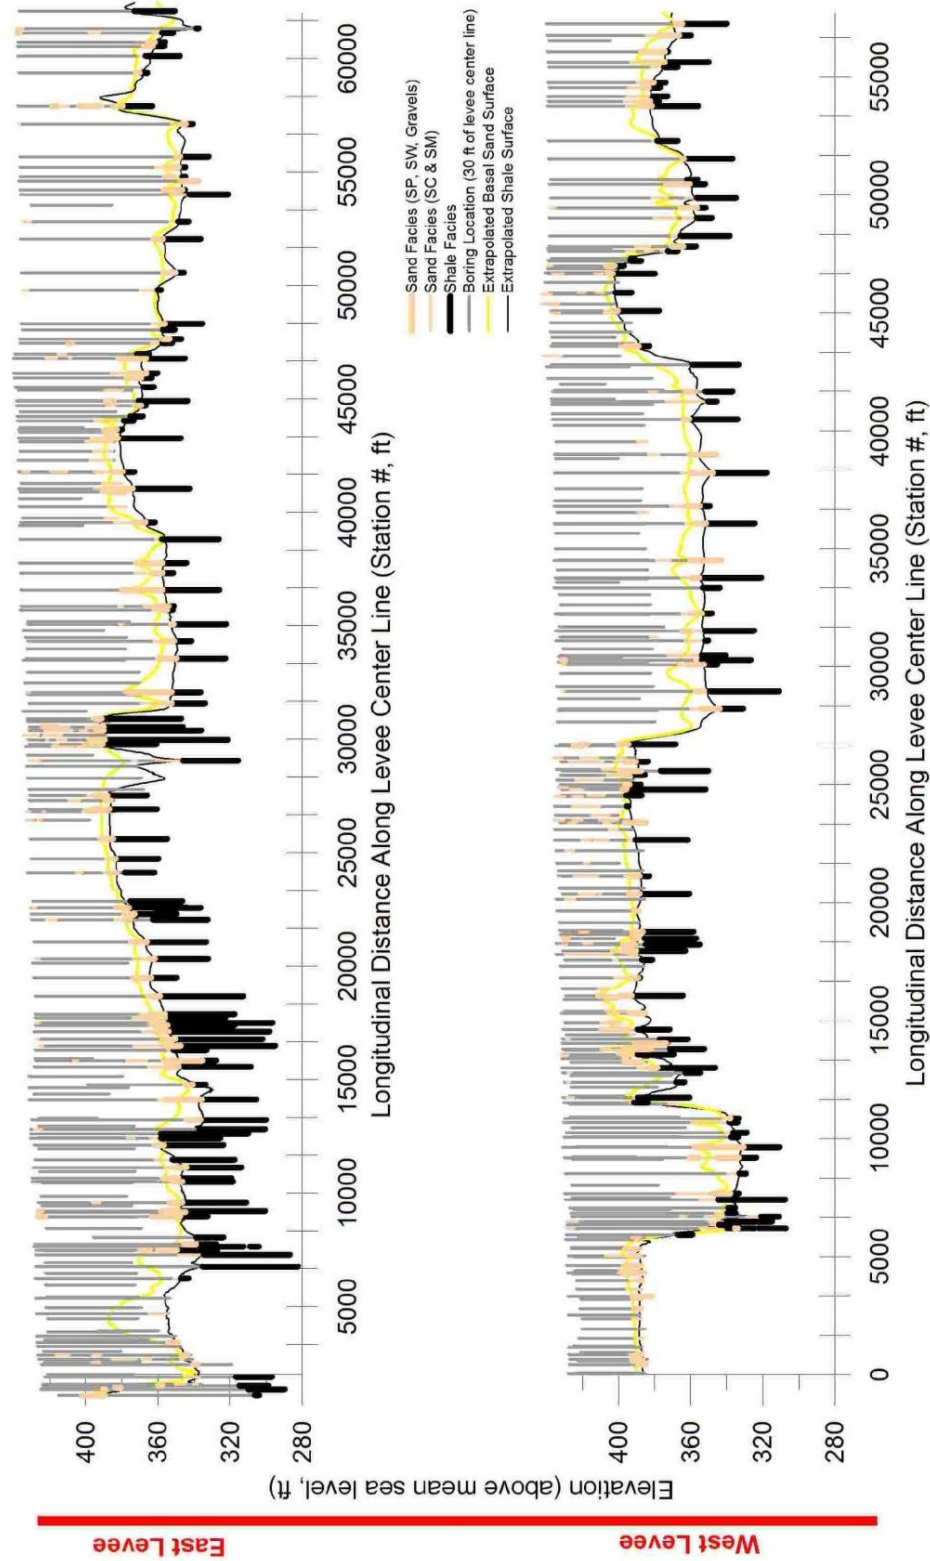
### Longitudinal Profile of Sand Facies along the Levee Center Line, Trinity River Levee System near Dallas, TX

Figure 9-1. Distribution of Sand Facies Along the Levee Center Lines

Figure 9-1 illustrates the distribution of sand along the longitudinal center line of the east and west levees. As depicted in Figure 9-1, the shifting location of the channel is illustrated by the gray lines. Dashed lines represent locations where the channel shifts position due to meandering and correspond with fluvially deposited sand lenses. The gray arrows represent a sudden shift in position due to channel avulsion or meander cutoff. Clay plugs may form in abandoned channels that fill with fine overbank sediments. These clay plugs are relatively impervious and may block or redirect seepage into more permeable material. Figures 9-2 and 9-3 display the same information as Figure 9-1, separated by reach and at a higher resolution. The majority of the sand identified within the borings is located within a relatively continuous basal layer resting on top of the bedrock surface; however, in a few notable locations, additional sand facies are identified elevated above the basal layer. Along the east levee, an area approximately spanning station values 30+000 to 31+500 in Reach 4 contains a number of borings with sand approaching the topographical surface.
