Appendix G Aquilla Lake Pool Rise Recreational Resources

The purpose of this appendix is to document the impacts of a 2.5 ft (Alternative A), 4.5 ft (Alternative B), and 6.5 ft. (Alternative C) pool raise on the existing recreation resources and to provide for the relocation and/or protection of those effected facilities. Since the Brazos River Authority is currently under contract with the U.S. Army Corps of Engineers (Corps) for the additional water storage capacity, this study will identify all the effected recreation facilities and resources, assign a cost to those facilities/resources, and provide for either relocation of those facilities from more frequent inundation by flood waters.

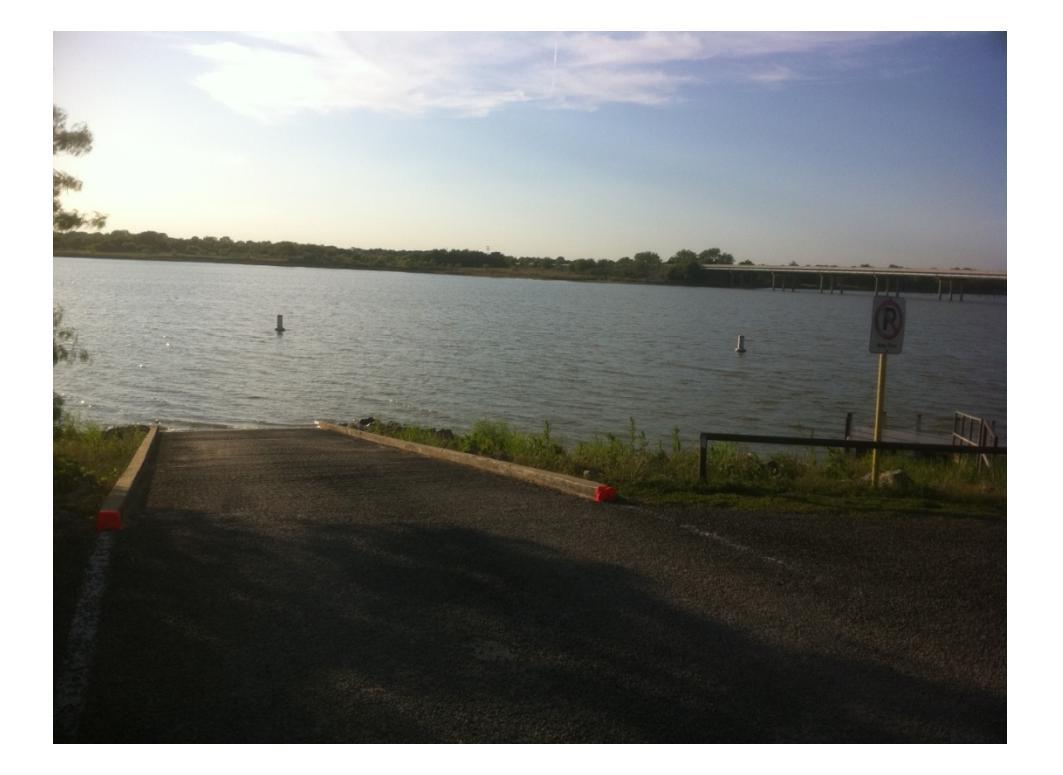
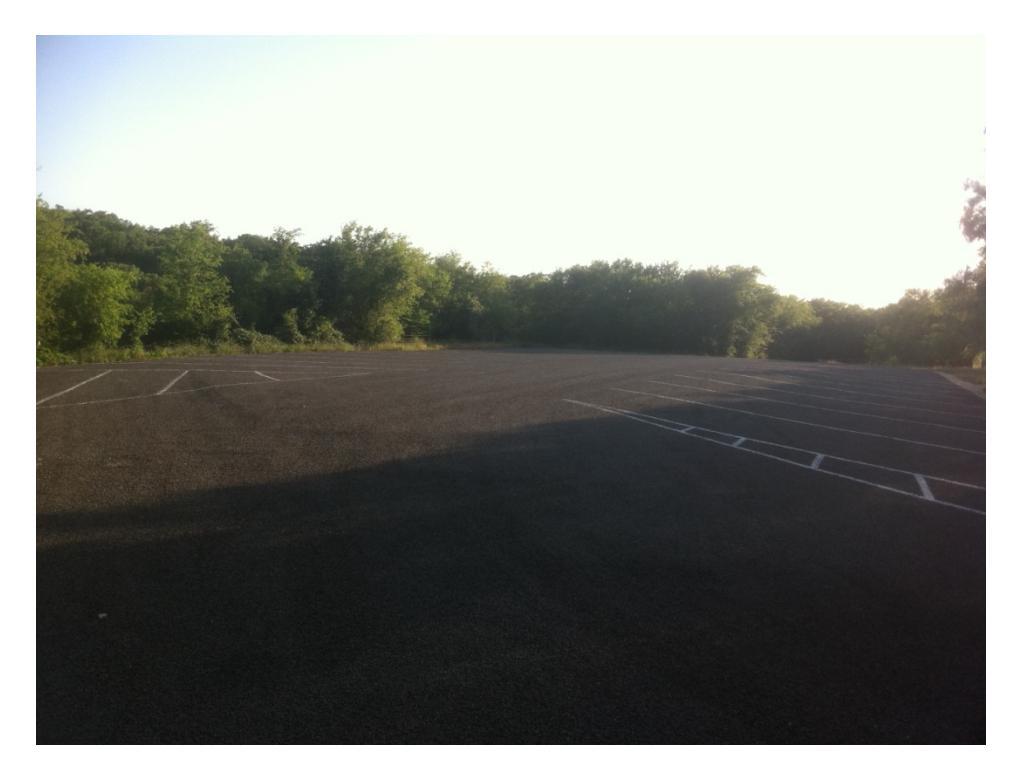
a. Dairy Hill Boat Ramp

(1) **Dairy Hill Boat Ramp**: Dairy Hill Boat Ramp is located on the south bank of the Hackberry Creek arm, approximately one mile north of Vaughn just west of FM 1947. The area contains one vault-type masonry toilet, a one-lane concrete boat ramp, courtesy dock and two paved parking lots. Dairy Hill has the highest annual visitation when compared to the other access areas at Aquilla Lake.

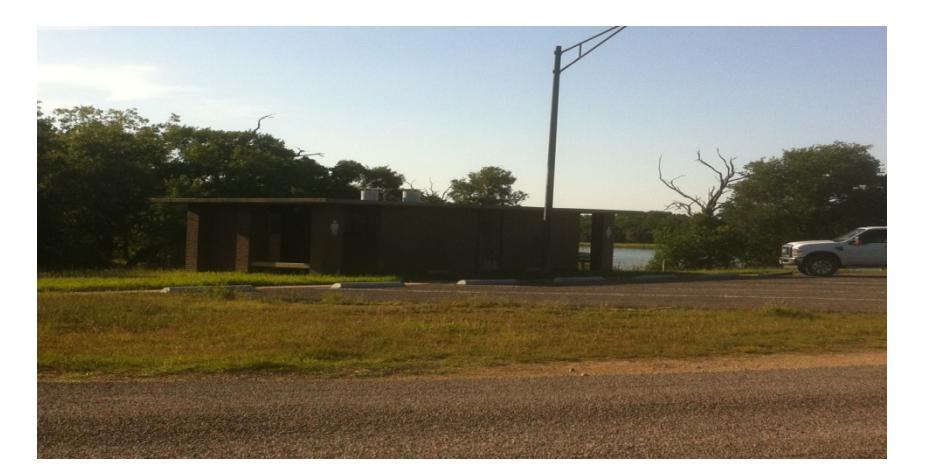
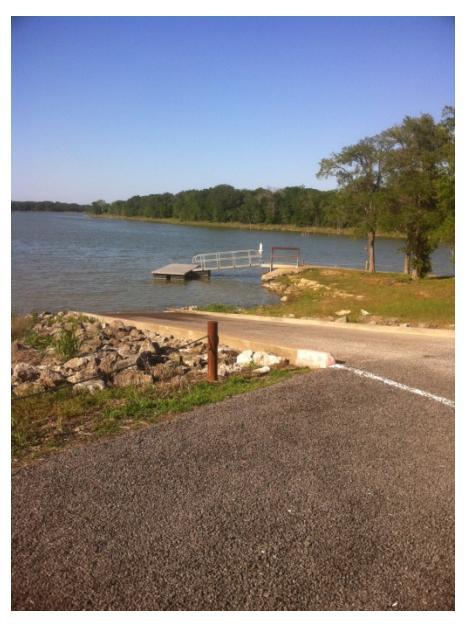
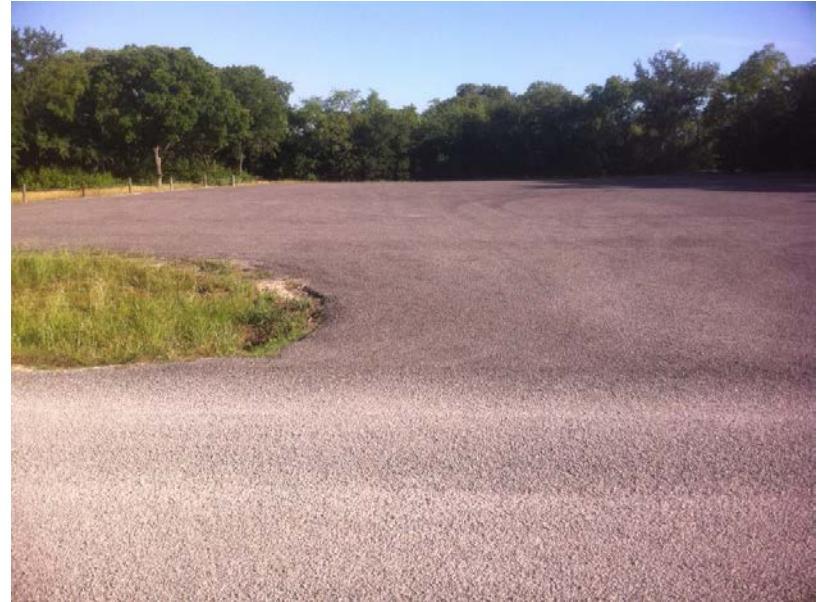
b. Old School Boat Ramp

(2) Old School Boat Ramp: Old School Boat Ramp is located on the lower west end of Aquilla Lake, approximately one mile north of the dam and two miles east of FM 933. The area contains a one-lane concrete boat ramp, two paved parking lots, and a masonry vault toilet. This area has the second highest annual visitation on Aquilla Lake.

When each proposed level of rise is considered, as well as the 5 year flood frequency, it is recommended to relocate most of the facilities at the Old School Boat Ramp. In addition, the FM 1534 Access Area will be rendered unusable. Since Aquilla Creek Access Area and Hackberry Creek Access Area have been closed, these facilities will not be replaced, however the existing facilities will be demolished prior to impoundment.

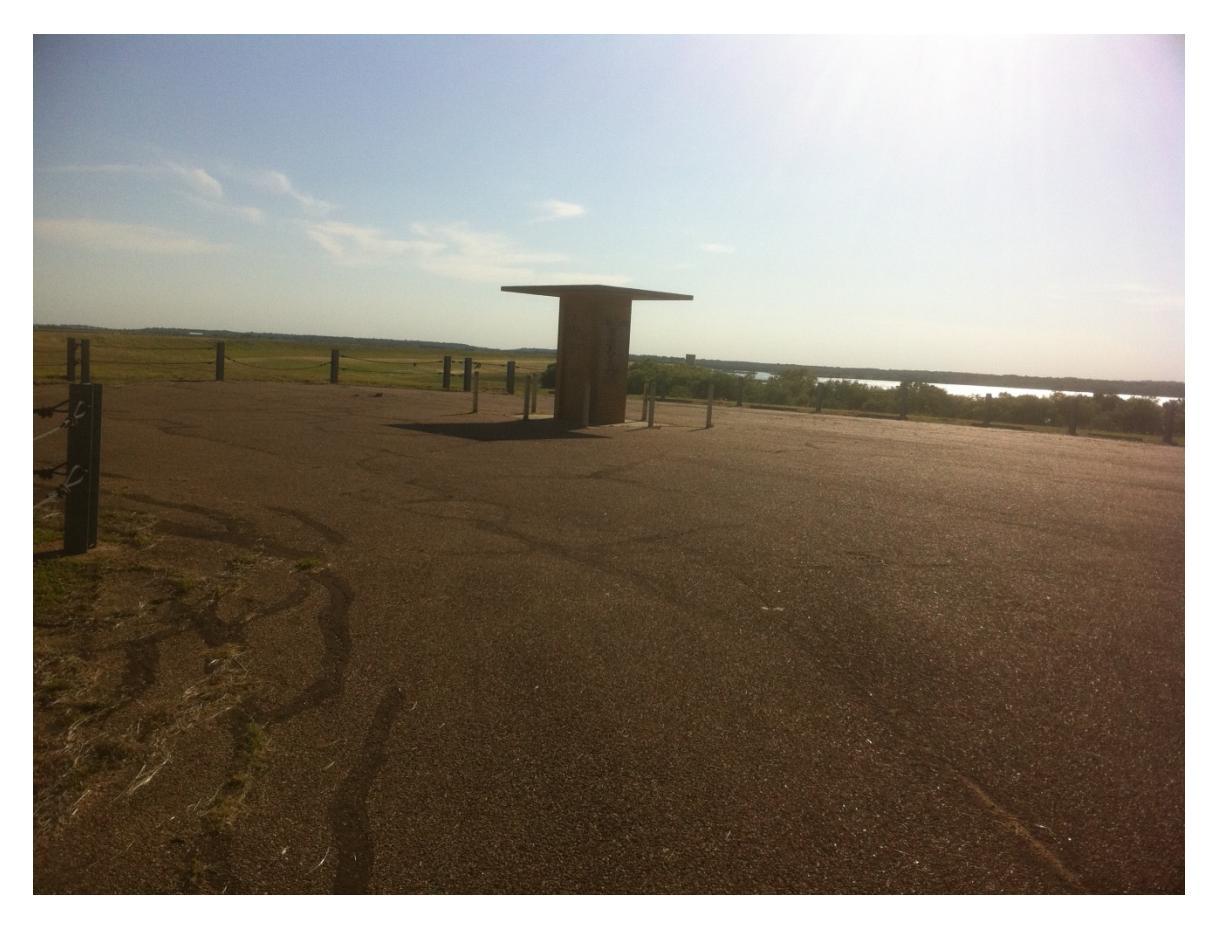
c. Visitor Overlook

(3) Visitor's Overlook (currently closed): Visitors Overlook is located on the east end of Aquilla Dam. It consists of one paved parking lot and has been closed for a number of years.

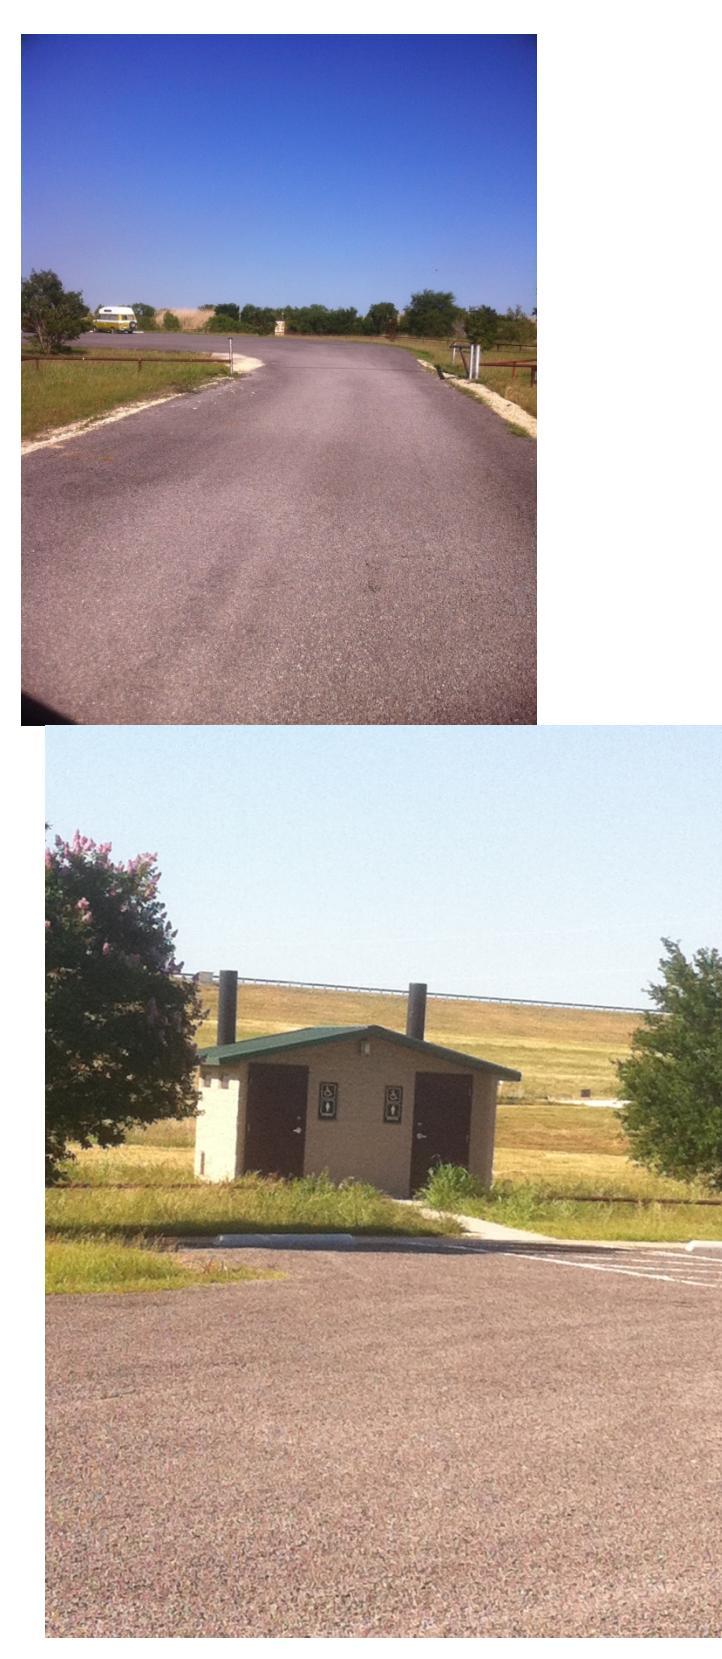
d. Outlet Area

(4) **Outlet Works and Fishing Platform**: This area is located just below the dam on old Highway 310, and contains a masonry vault toilet, paved parking lot, and fishing platform.

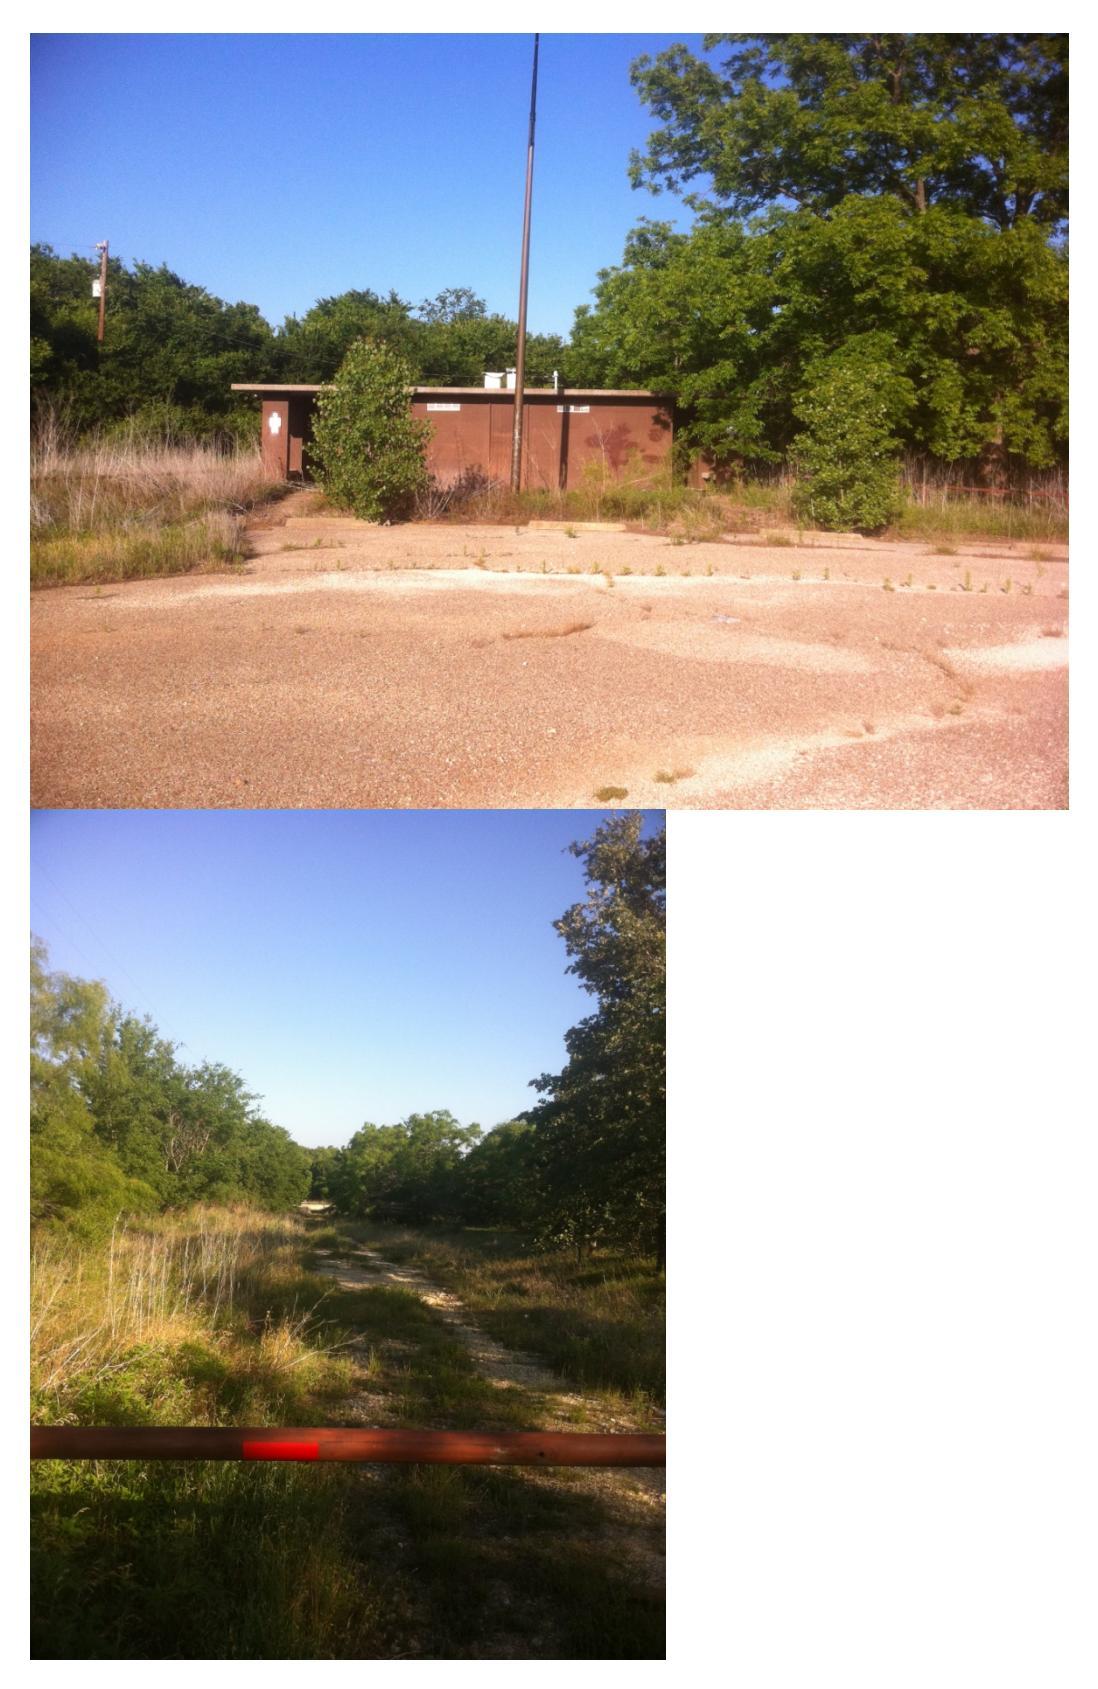
e. Aquilla Creek Access

(5) Aquilla Creek Access Area: (closed): Aquilla Access Area is located on the west side of the Aquilla Creek arm of the lake, west of the FM 1534 bridge. The area contains one masonry vault toilet and paved parking lot.

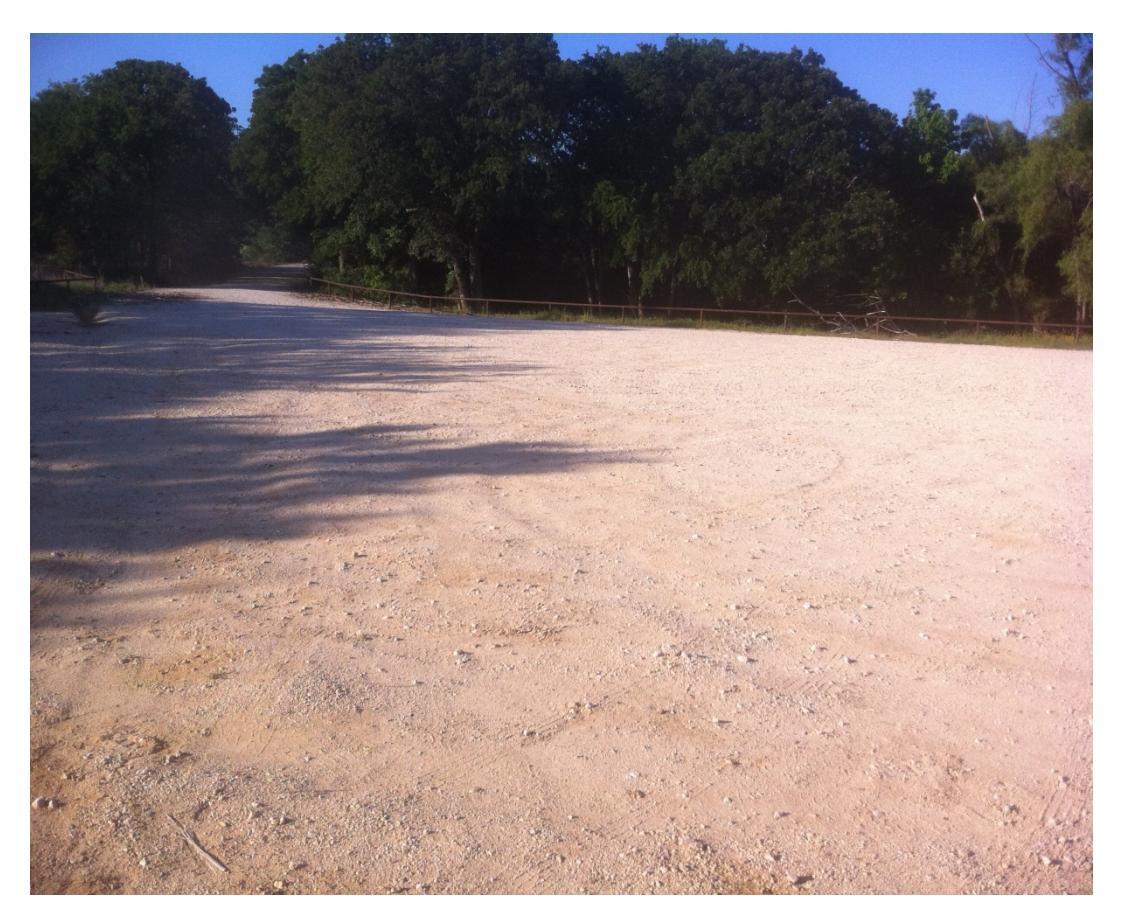
f. FM 1534 Access

(6) FM 1534 Access Area: This area is located on FM 1534, on the east side of the bridge spanning the Aquilla Creek arm of Aquilla Lake. The area contains a gravel parking lot and portable toilets. The area is the third most heavily used access area.

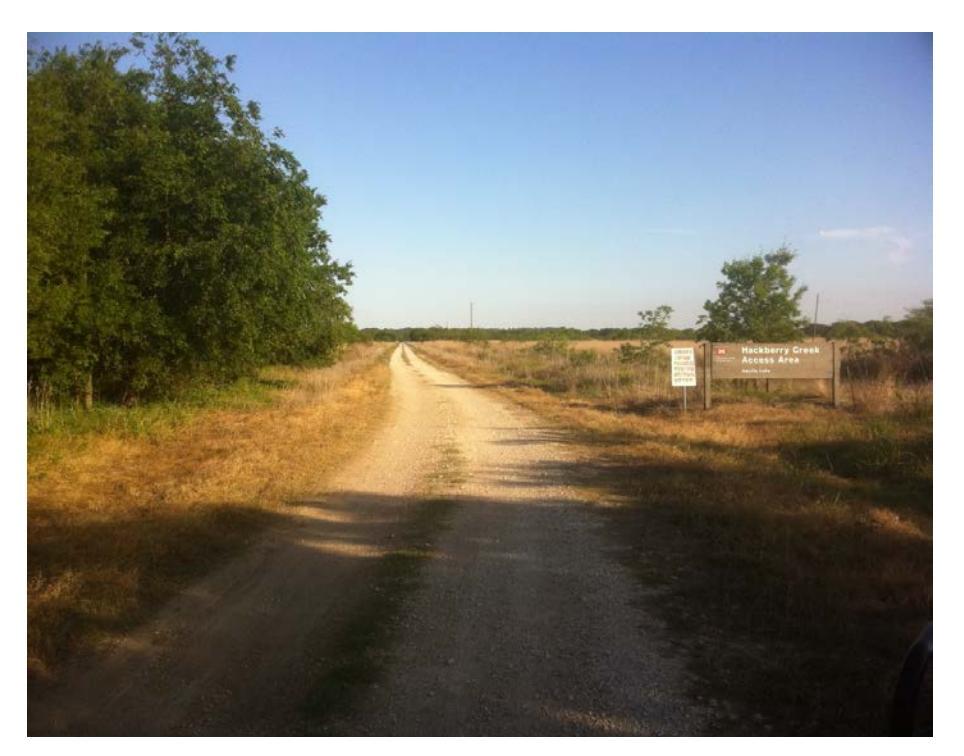
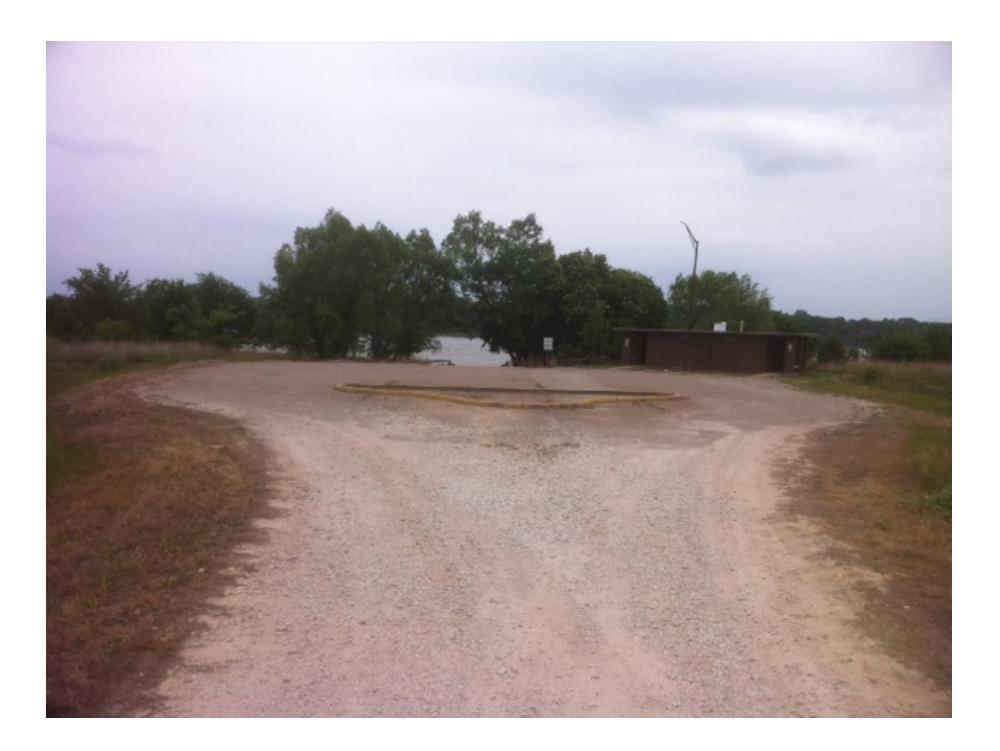
g. Hackberry Creek Access

(8) Hackberry Creek Access Area (closed): This area is located at the end of County Road 2428, approximately 2 miles east of FM 1947. It is situated on the north shore of the Hackberry Creek arm of Aquilla Lake. The area contains one masonry vault toilet, one small parking lot, and gravel access lane to the water.
